Manuscript Report
Number

291

ARCHAEOLOGY: HALIFAX CITADEL
FALL - WINTER 1977
by John J. Connolly
(1978)

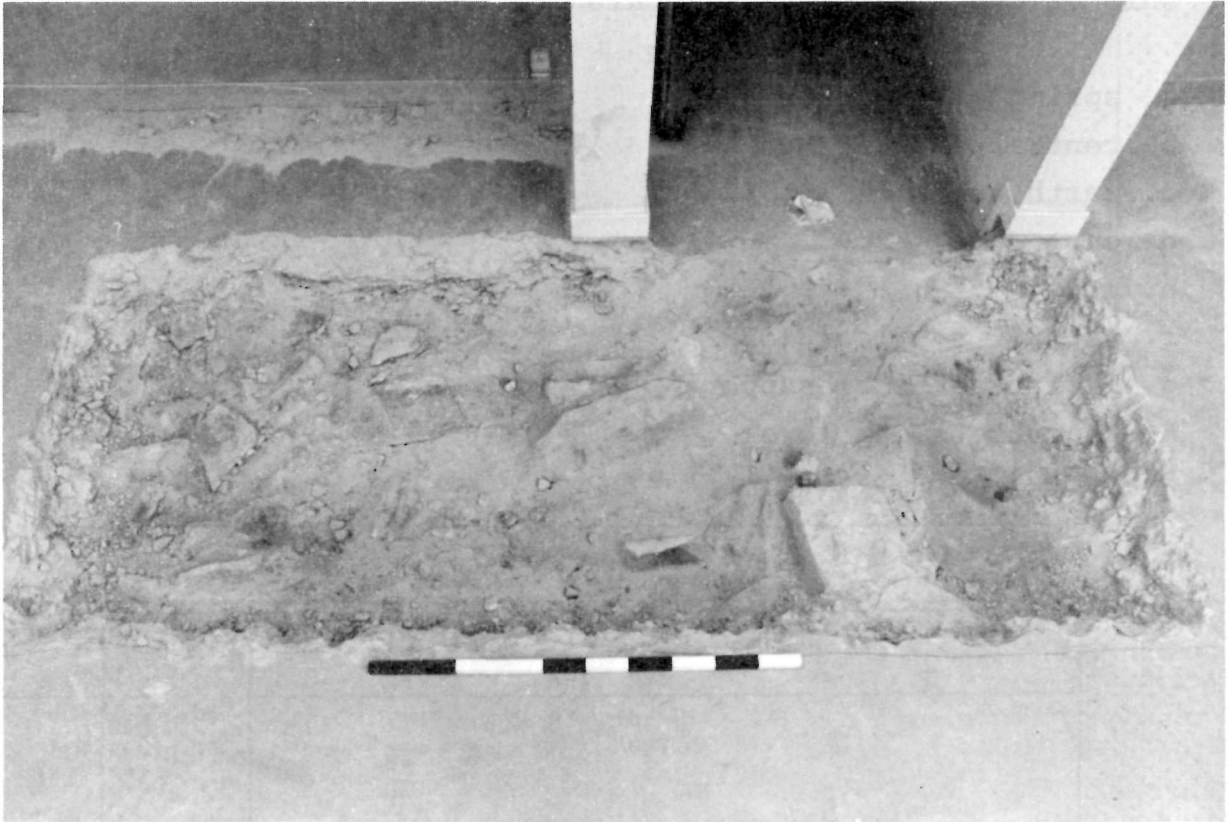
Figure 1

Area of excavation in the interior of the South Magazine.
(Scale = 1.0 meter)

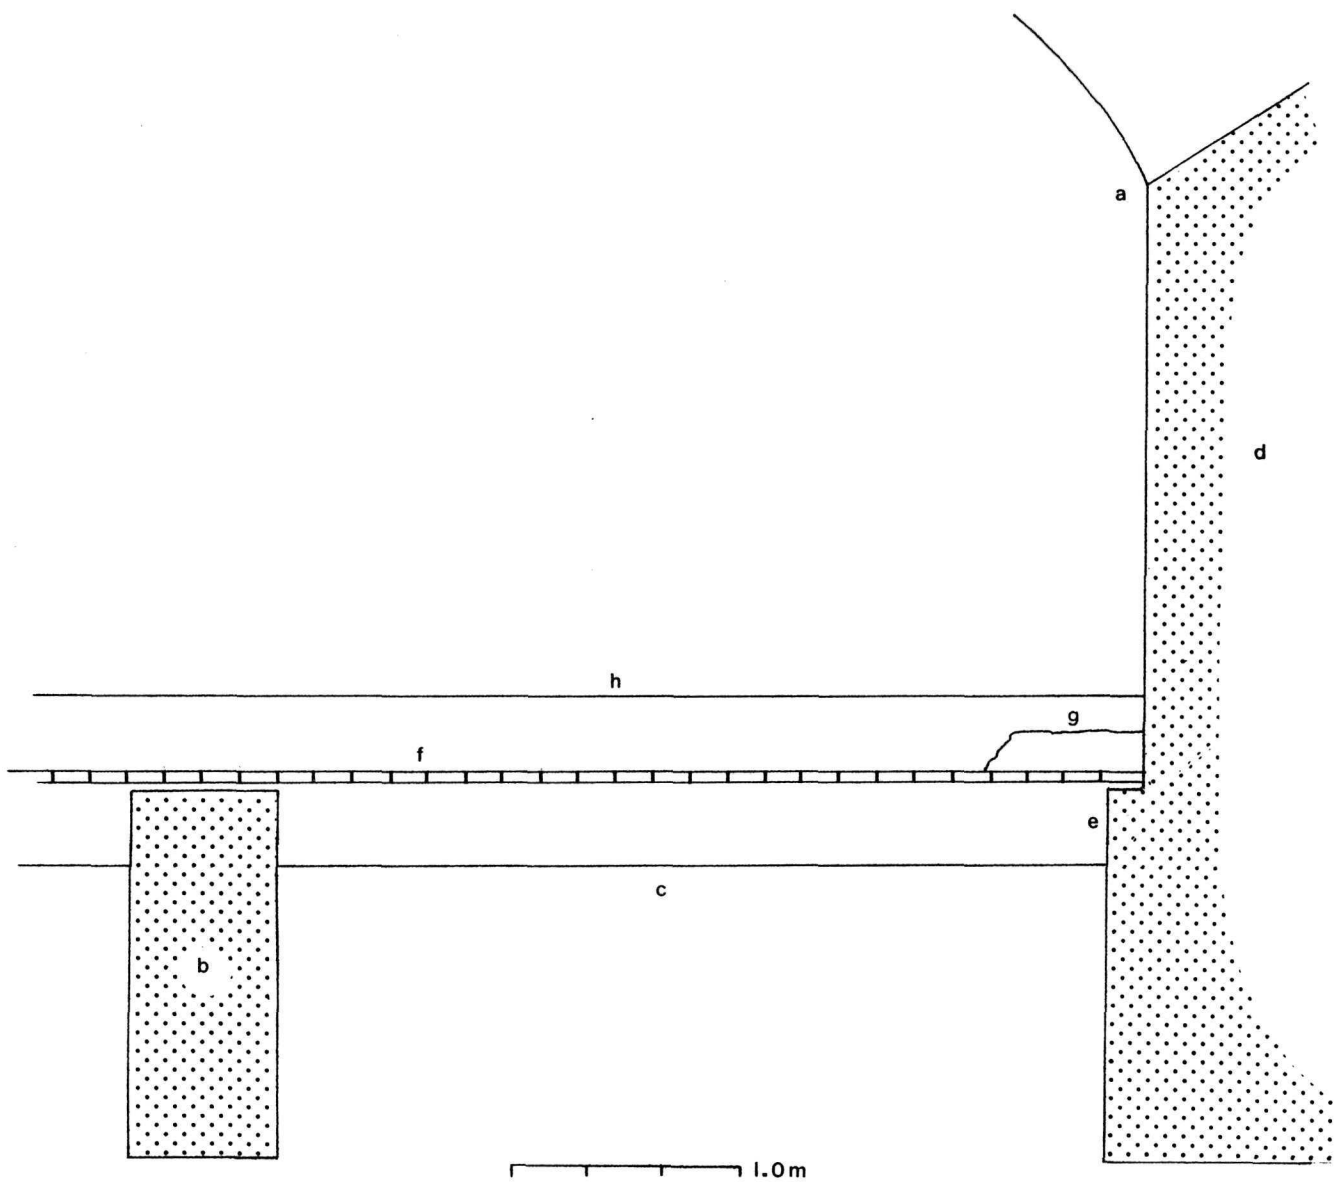
Figure 2

It would seem likely that the ledge under the asphalt and the bottom of the studs behind the wainscotting would represent the floor parameters pre 1859 (0.04 meters below the granite sill of the south door) whereas the altered height of the wainscotting and the top of the ironstone blocks (0.185 meters above the sill) would represent the post 1859 floor parameters.

Cross section of the South Magazine detailing the relationship of the floor levels (scale 3.0 cm. = 1.0 m.)

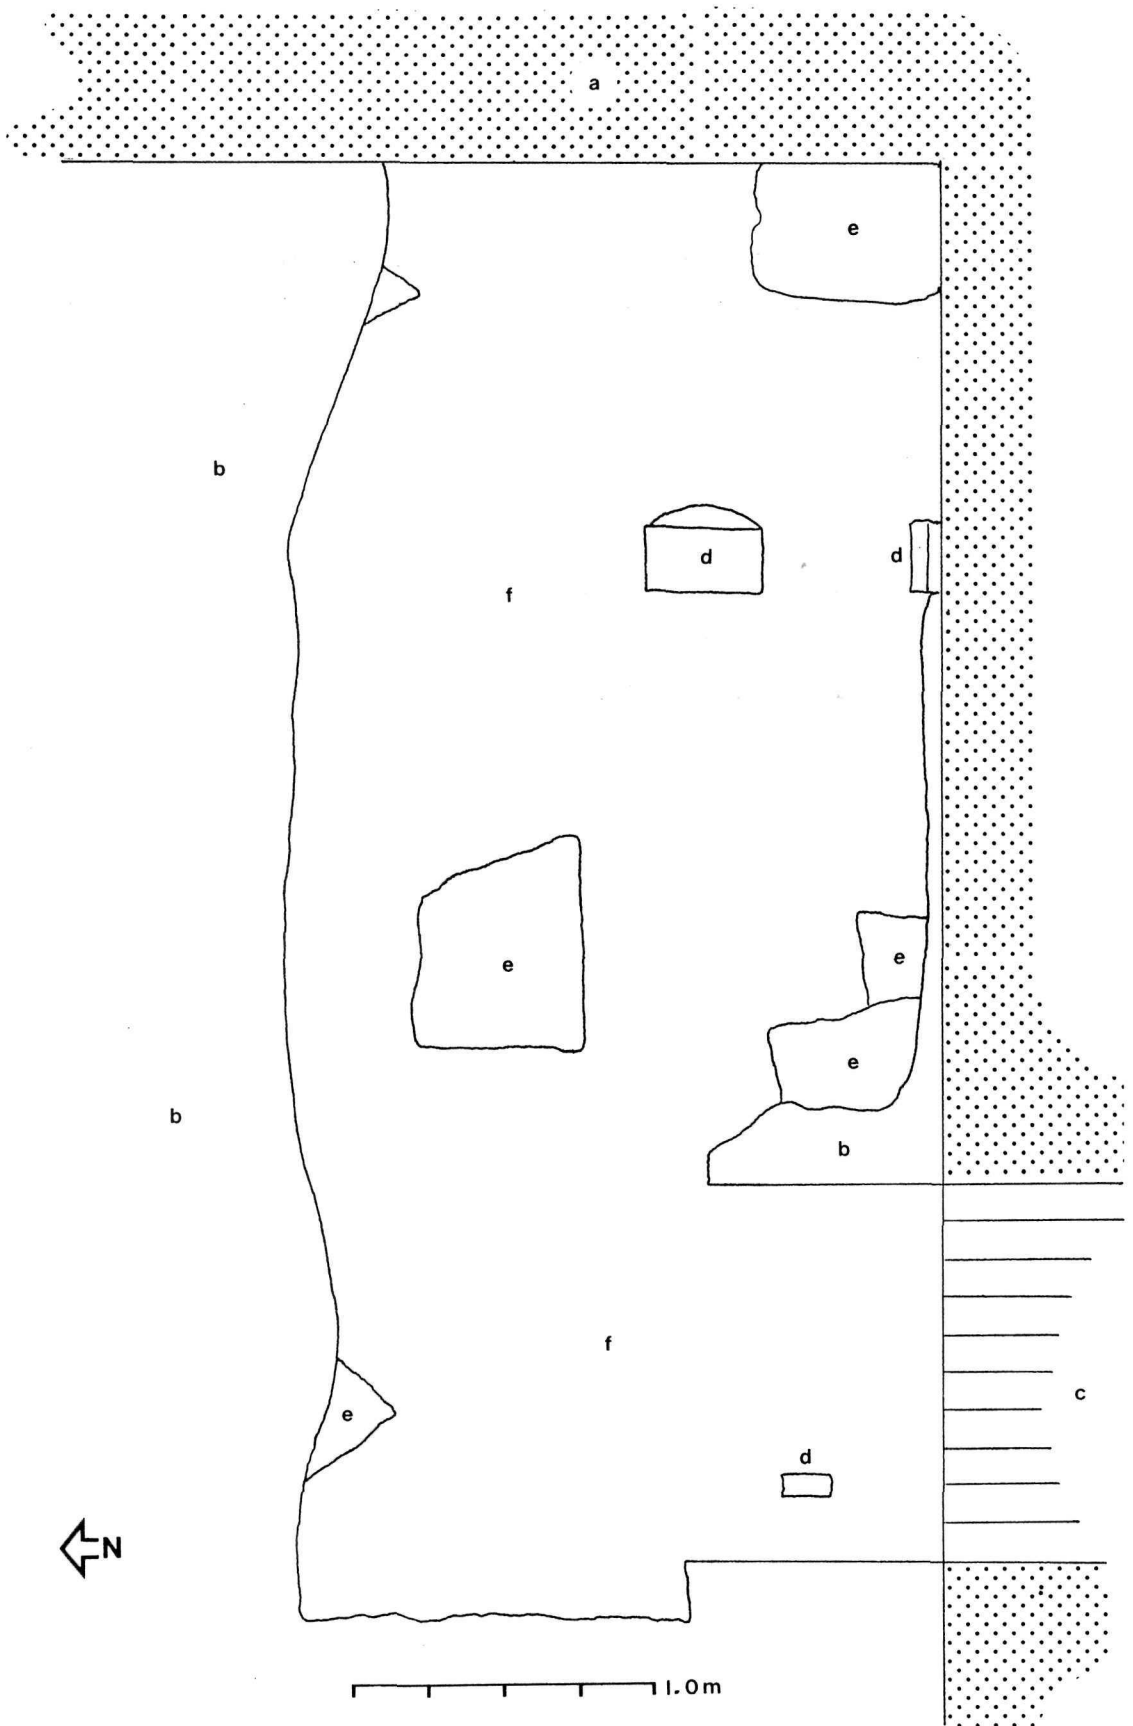
Figure 3

The alignment of the ironstone blocks and the bricks (Figure 3) suggested a north-south orientation of the joists

Overview of excavation in the South Magazine showing ironstone and bricks used to support 1882 floor (scale 4.0 cm. = 1.0 m.).

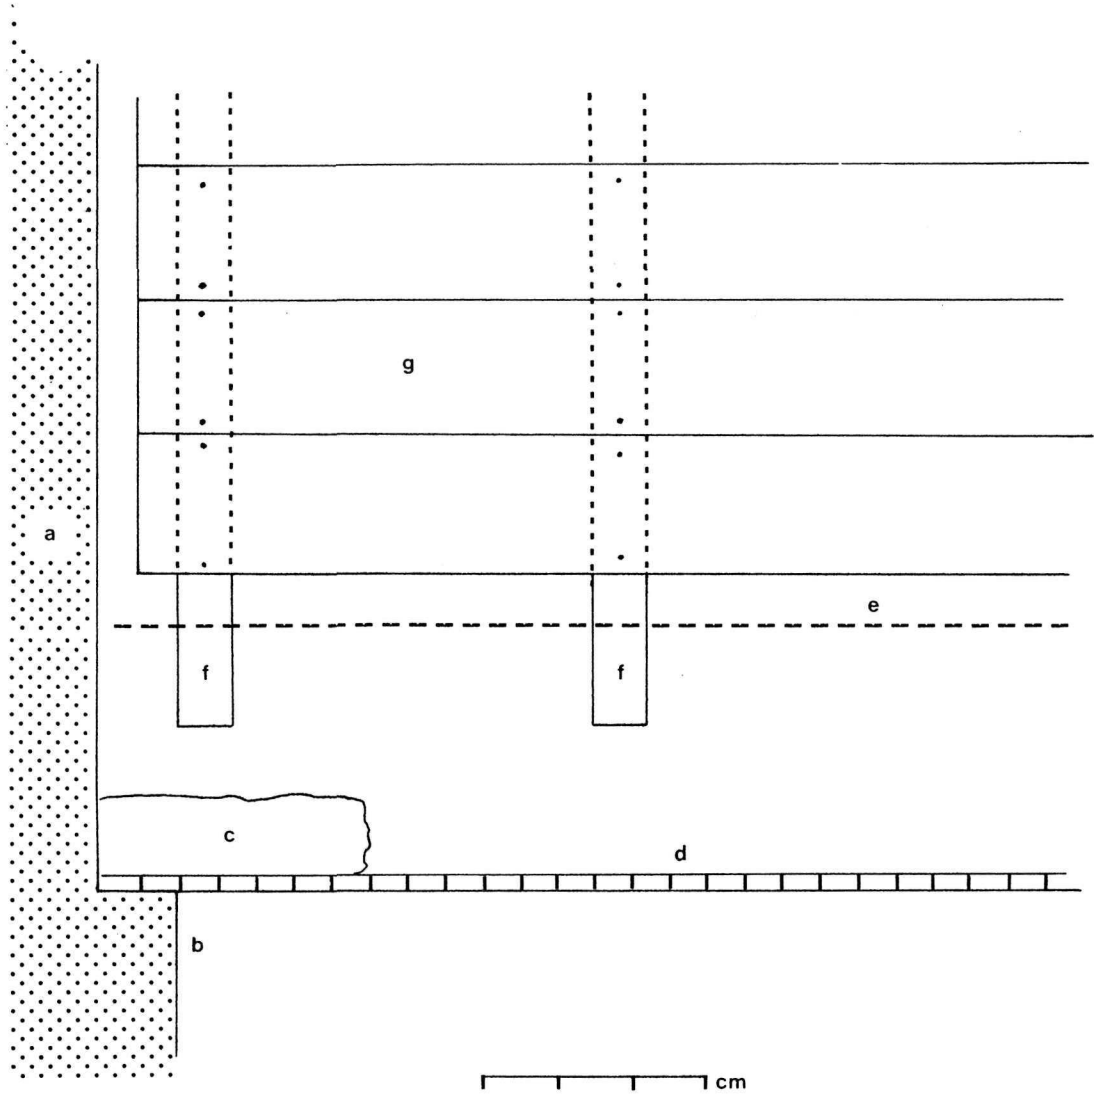
Figure 4

In addition to information obtained by direct excavation there were data gained through the removal of the modern wall covering of plywood and 2.0 in. by 4.0 in. boards. This was done to facilitate the removal of the concrete floor adjacent to the south wall in order to expose the complete corner of the magazine. When the modern wall covering was removed and the original was exposed the wainscotting was still in situ. It consisted of horizontal pine boards fastened to studs by copper nails and painted a gray-green colour. At the base of the wainscotting there were indications that it was modified to accept different floor levels (Figure 4). The studs to which the wainscotting was nailed extended to 0.23 meters below the last section of planking which exhibited signs of being roughly cut and did not have the tongue and groove joints like the balance of the planking. The fact that the wainscotting was still there had a direct bearing on the information that was obtained through excavation. The bottom levels of the wainscotting will establish the uppermost parameters of the historic floors.

Detail of wainscotting on the south interior wall of magazine establishing its relationship to the floors (scale 10.0 cm. = 1.0 m.).

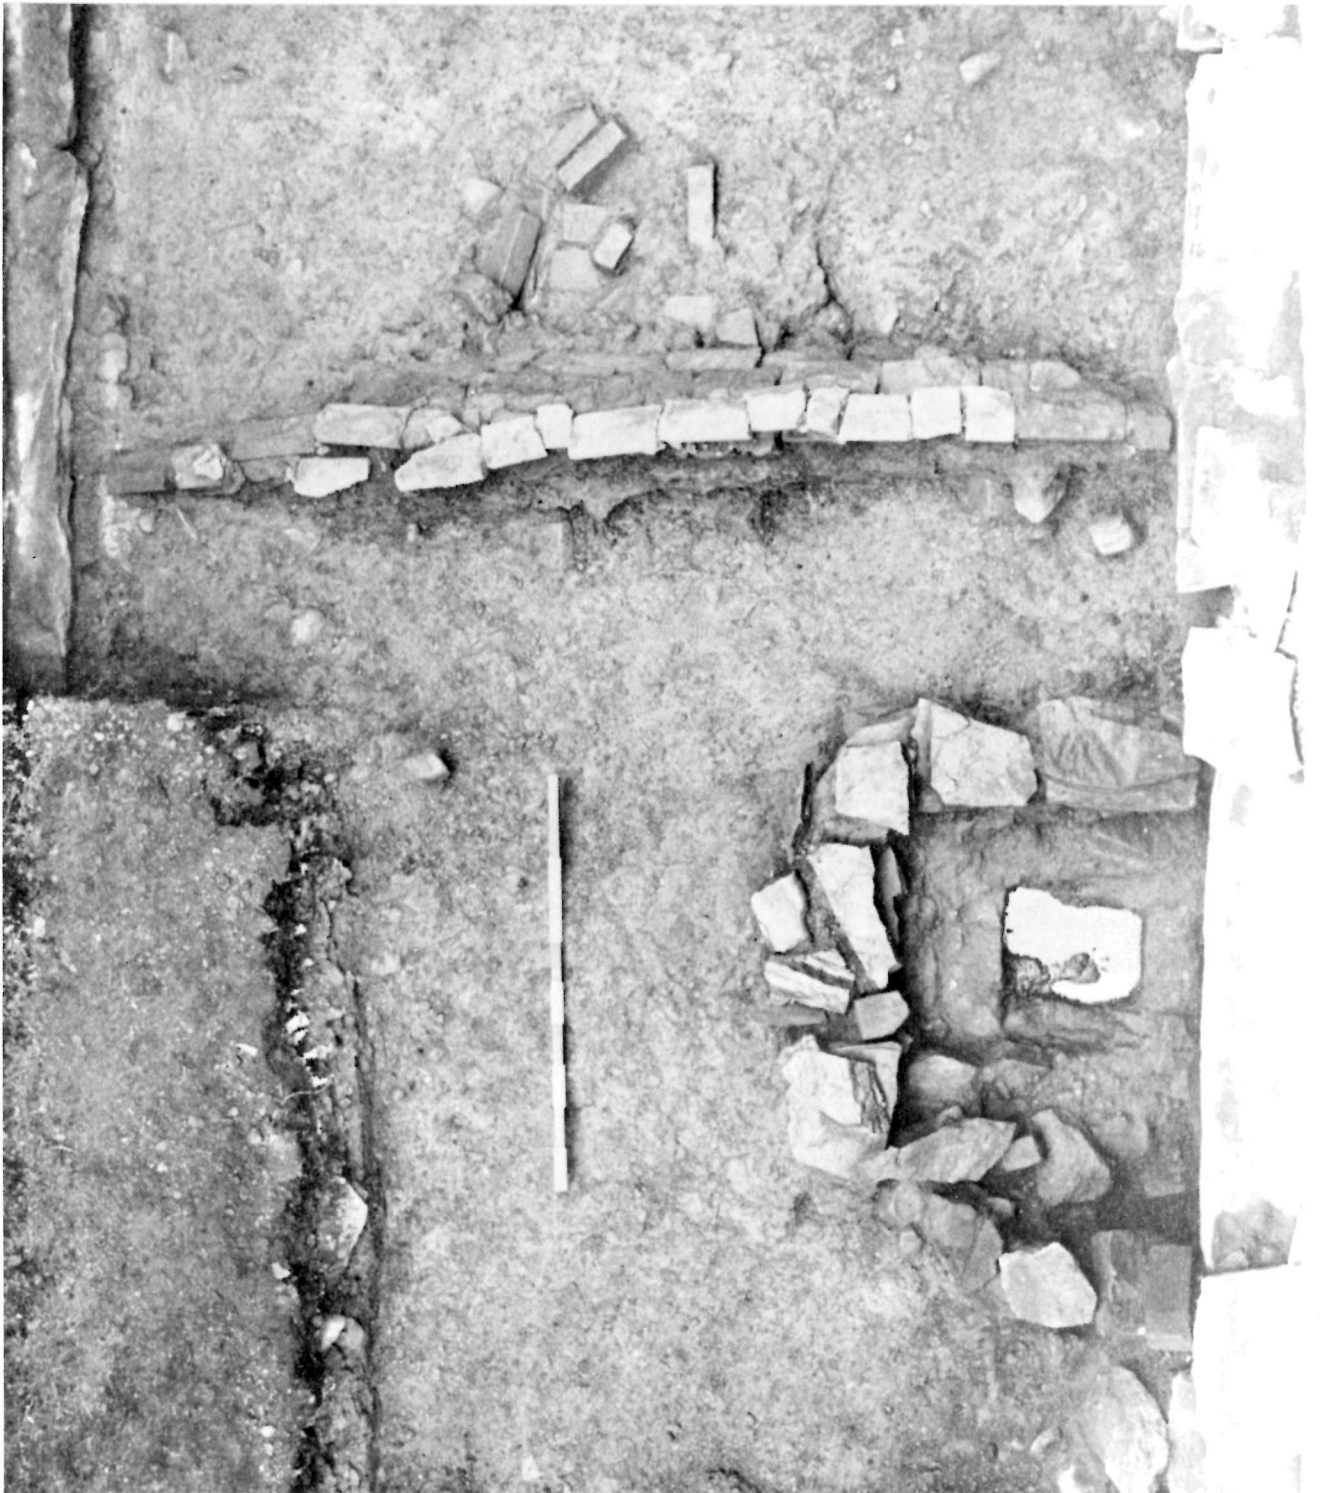
Figure 7

Overview of the area of excavation on the east side of the South Magazine (scale 1.0 meter).

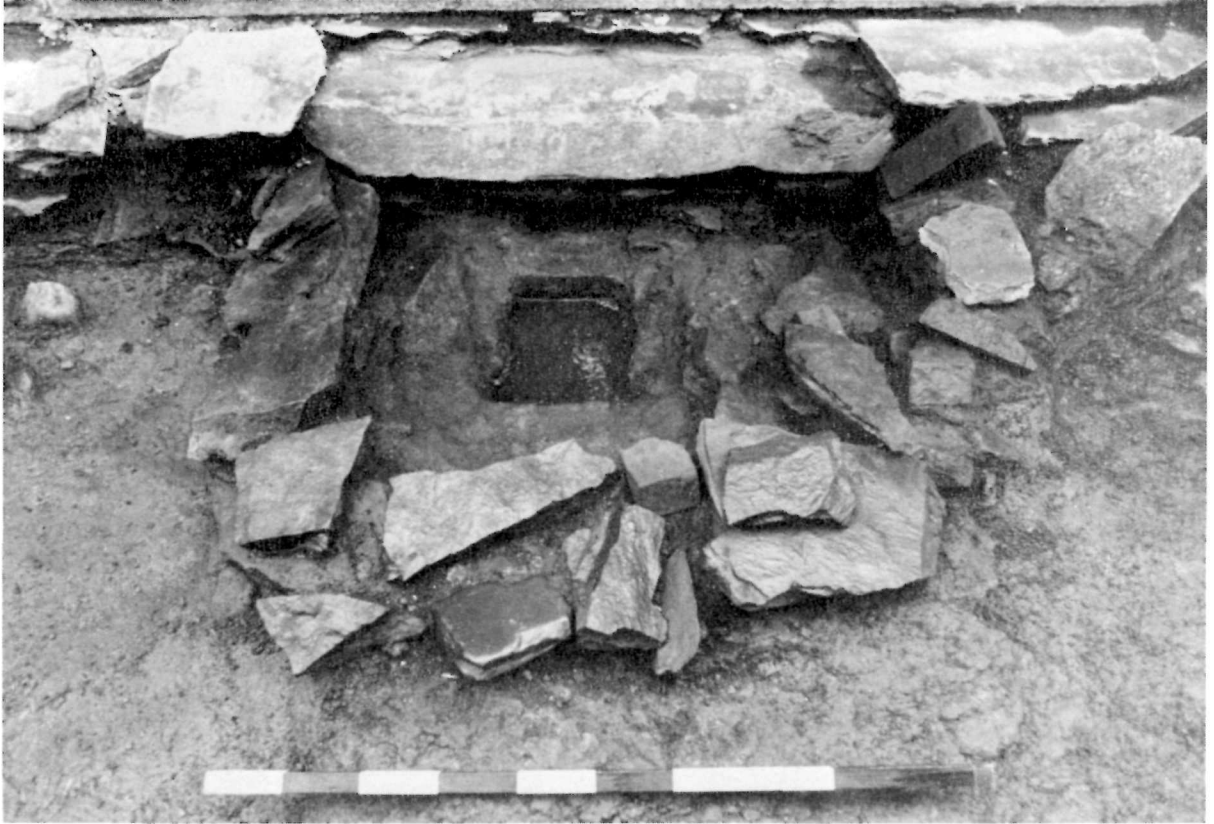
Figure 8

Detail of the drain area at its exit under the blast wall.
(scale 1.0 meter).

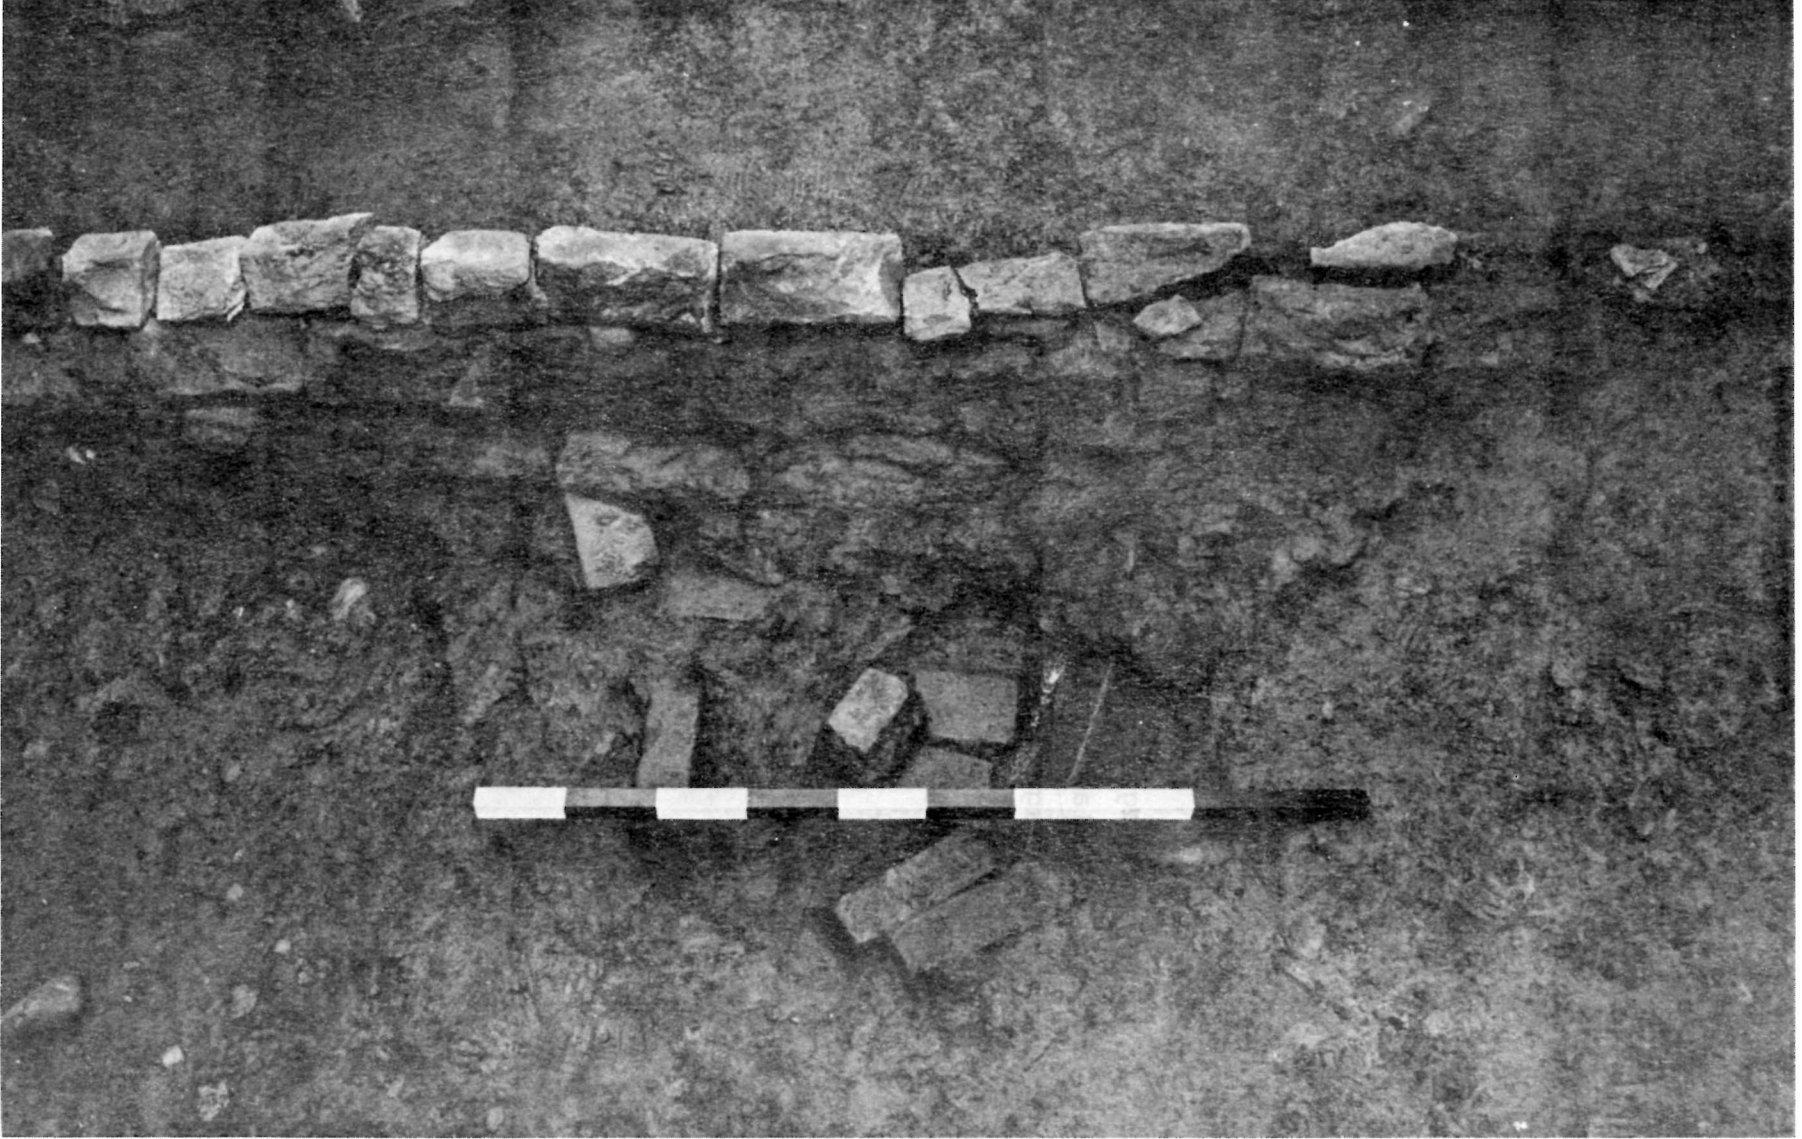
Figure 9

Detail of the unidentified brick feature adjacent to the drain. (scale 1.0 meter).

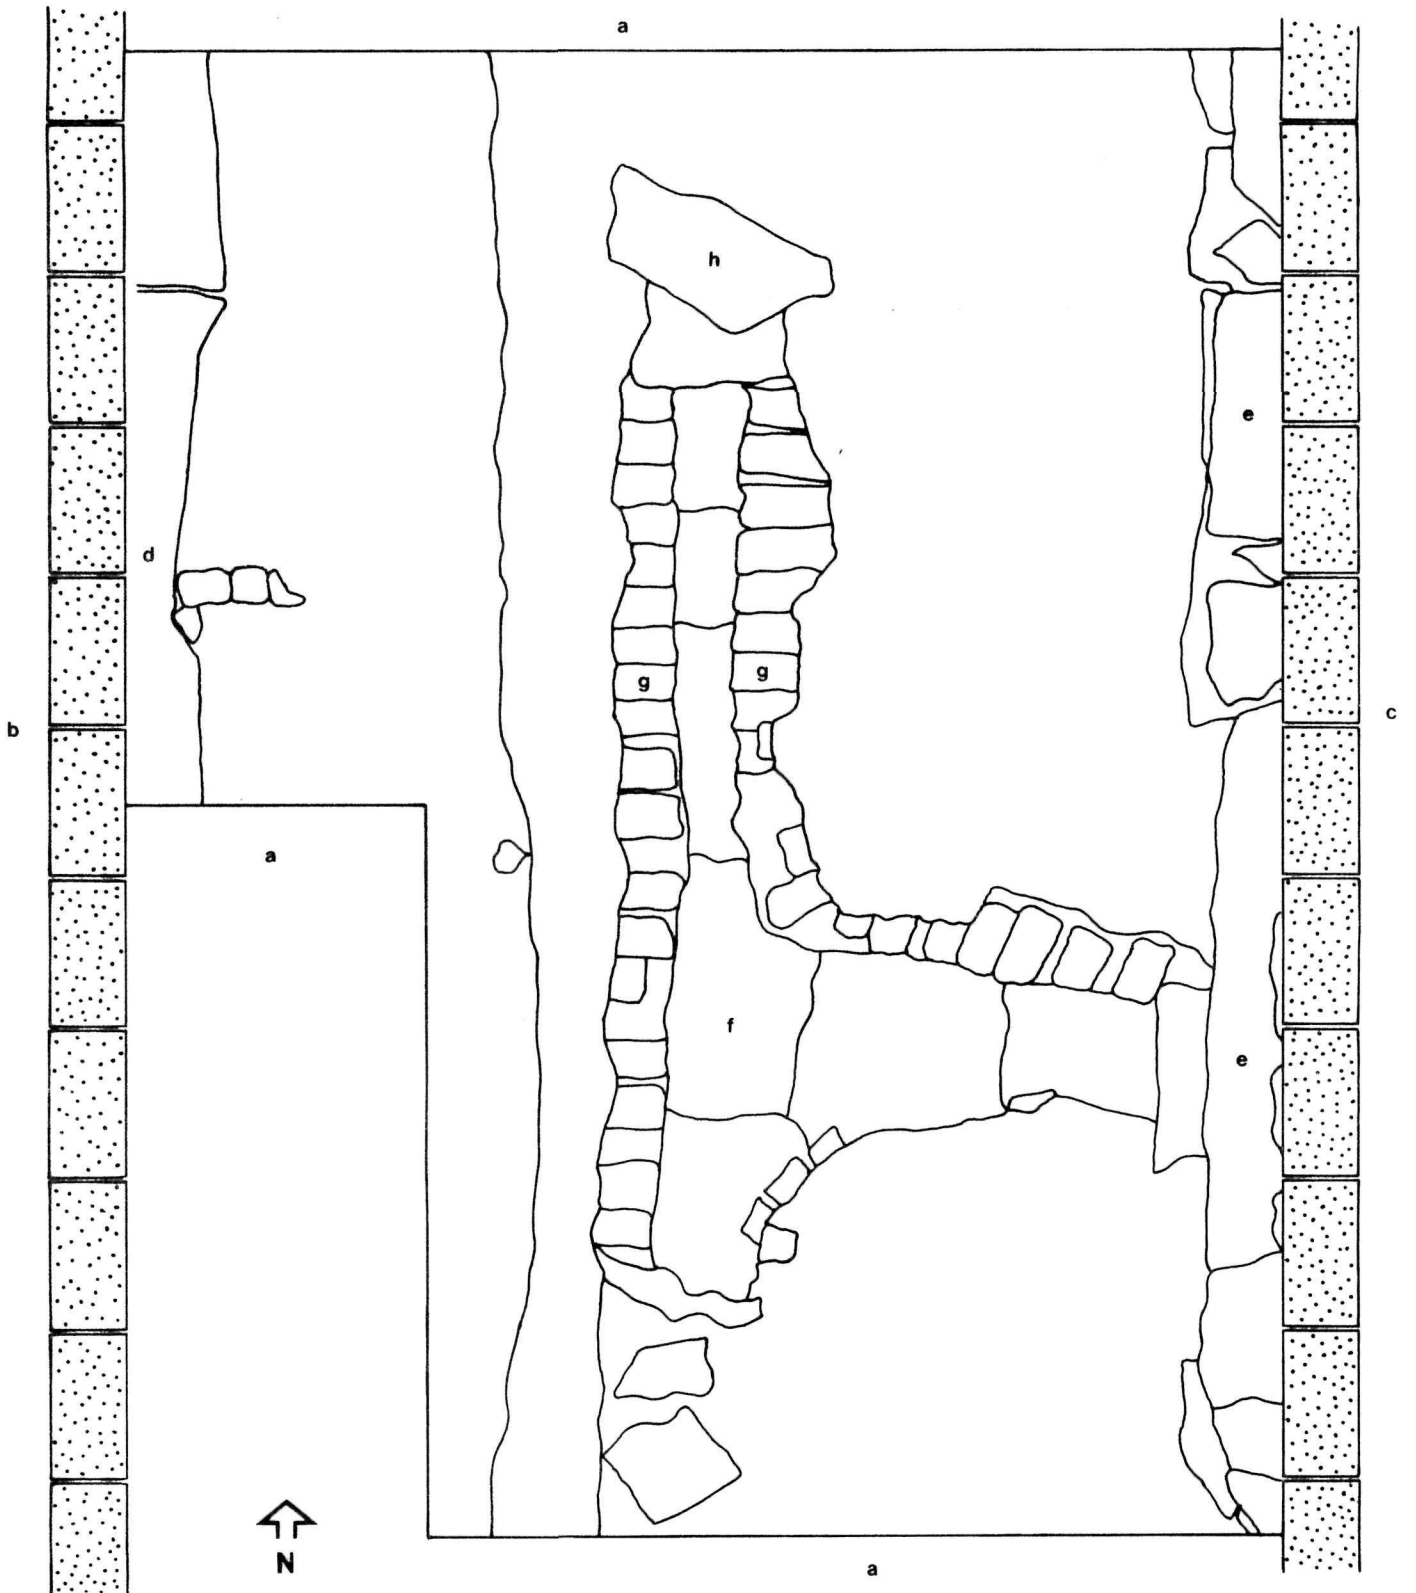
Figure 10

Overview of sub-operation detailing the sub-surface drain and its point of exit under the blast wall. (scale 5.0 cm. = 1.0 m.) (Drawing by J. Gasparac).

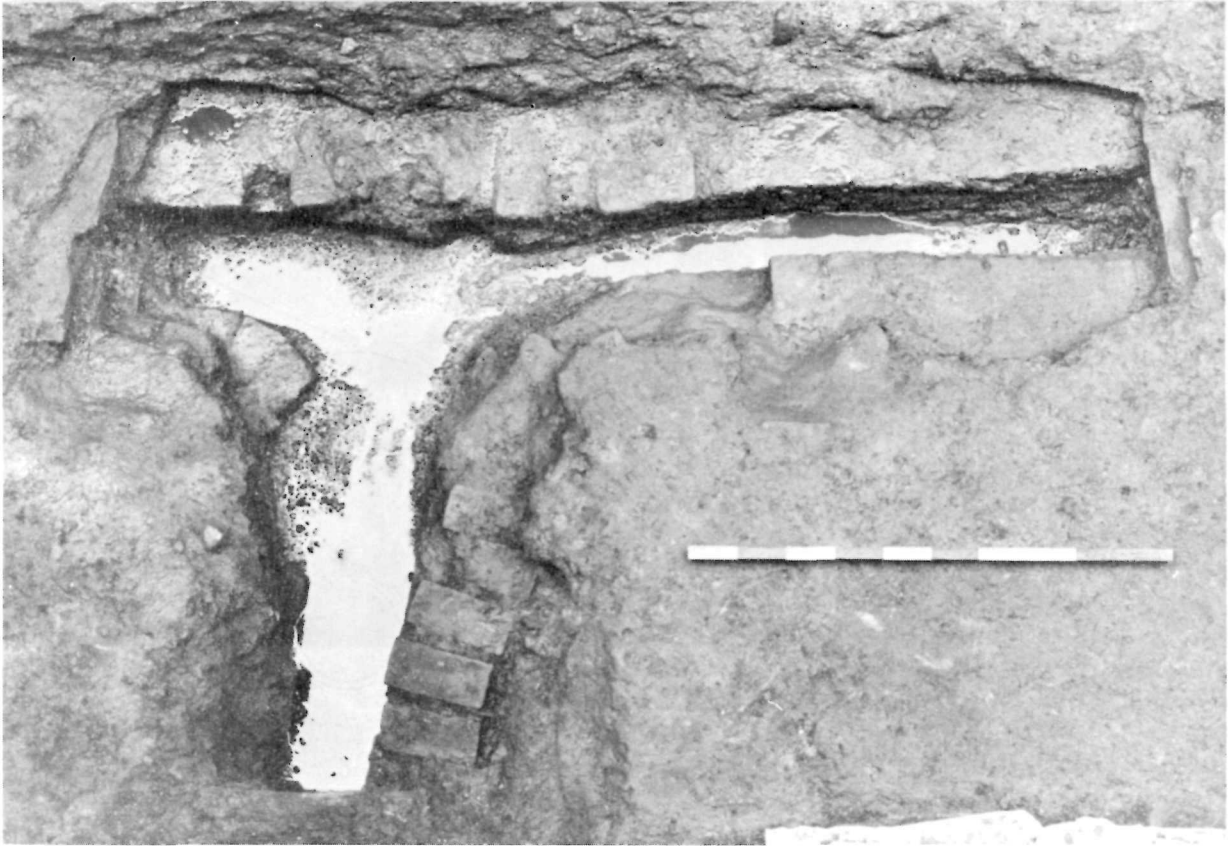
Figure 11

Overview of the confluence of the drain encircling the South Magazine and the exit under the blast wall. (scale 1.0 meter).

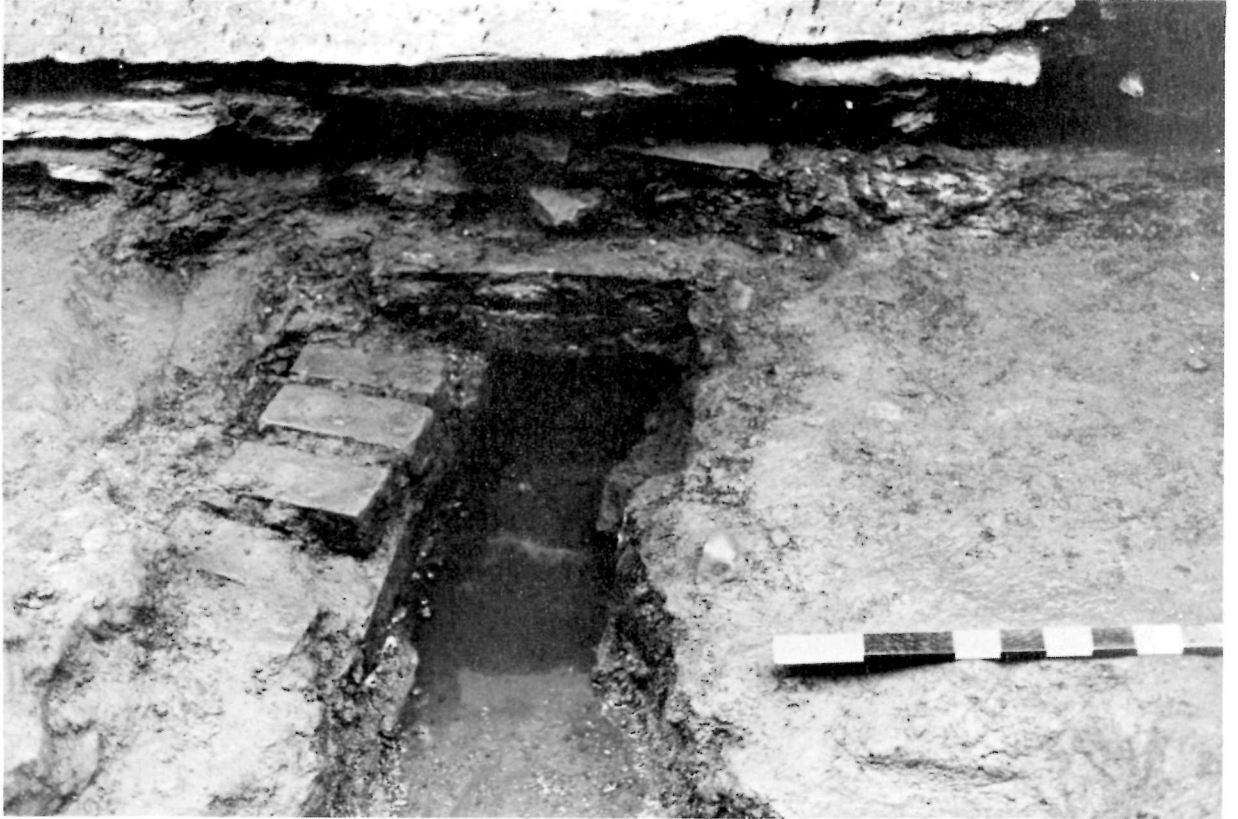
Figure 12

Detailed view of the drain outflow under the blast wall after excavation. (scale 0.50 meter).

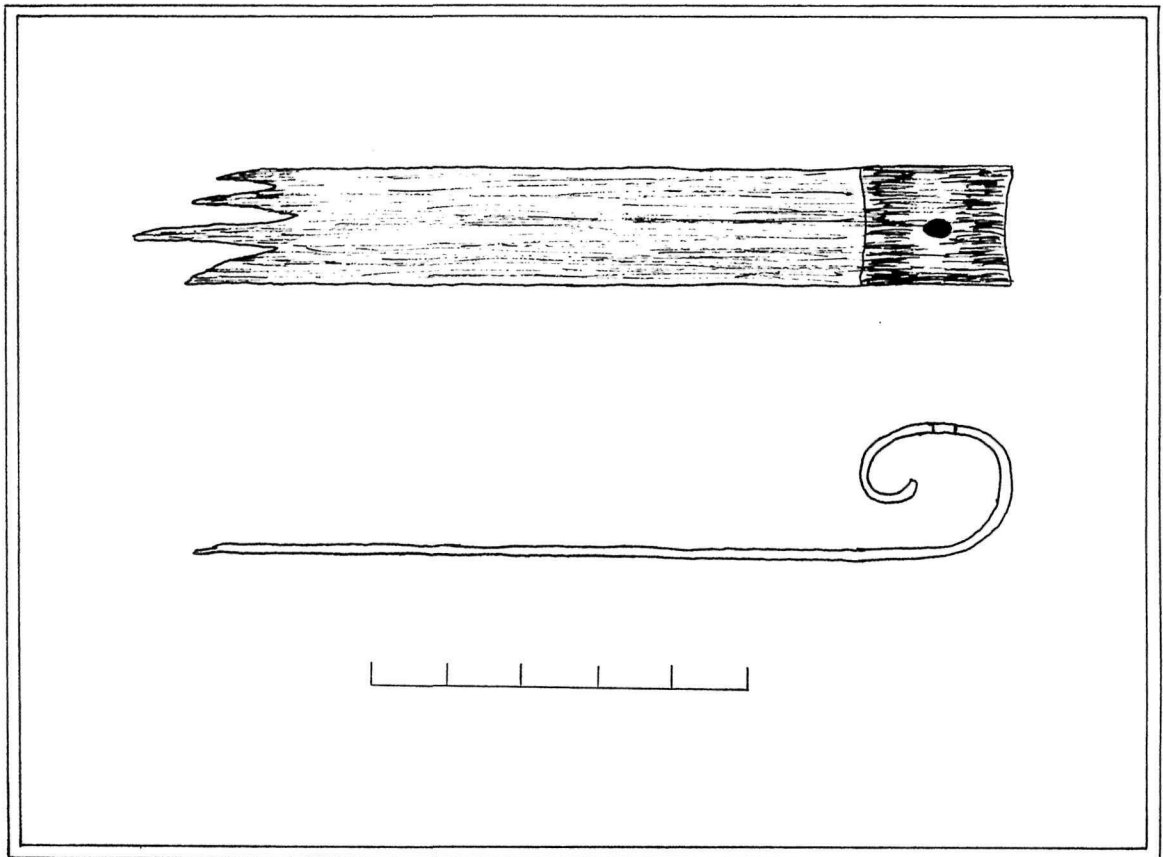
Figure 14

Detail of curved section of copper conductor from southwest corner of the South Magazine. (scale 5.0 cm. = 1.0 m.).

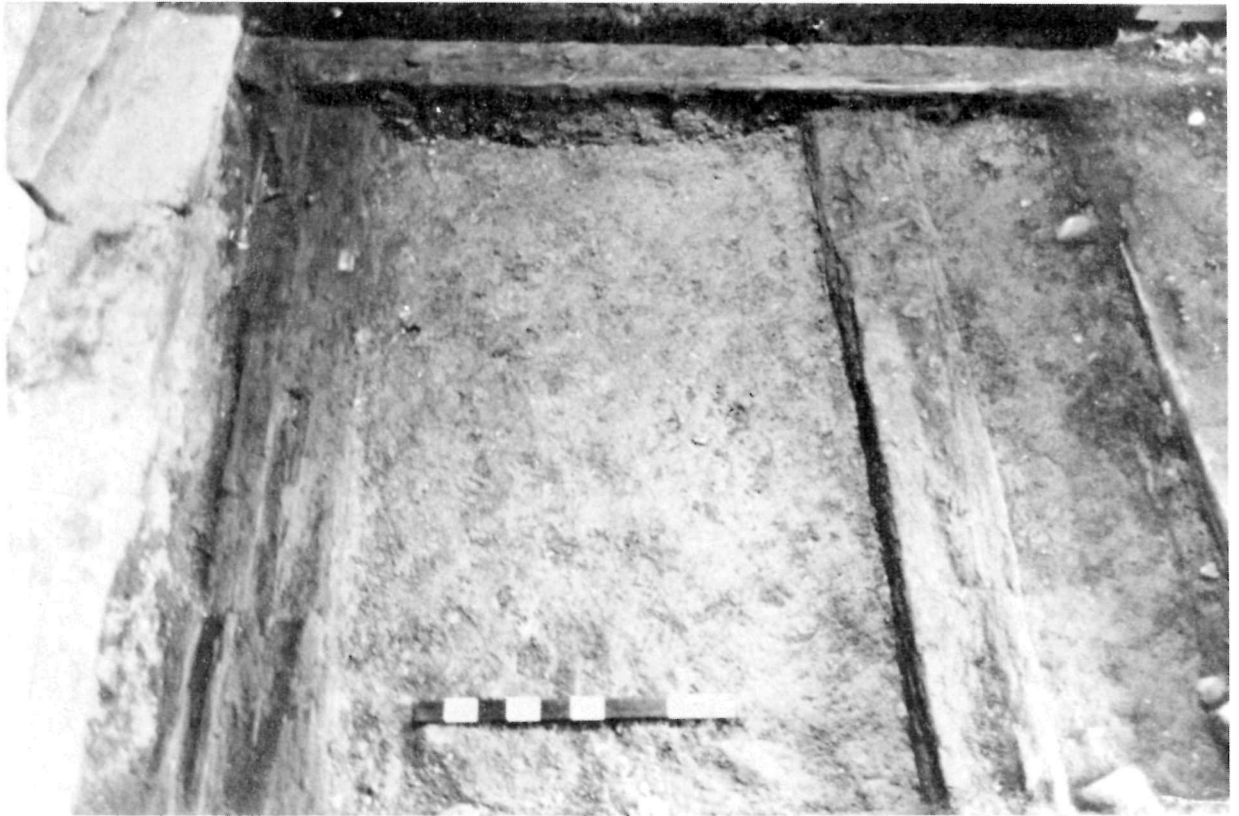
Figure 16

Sleepers for the wooden floor at the head of the stairs in sallyport three with one flooring board still in situ.
(scale: 0.50 m.).

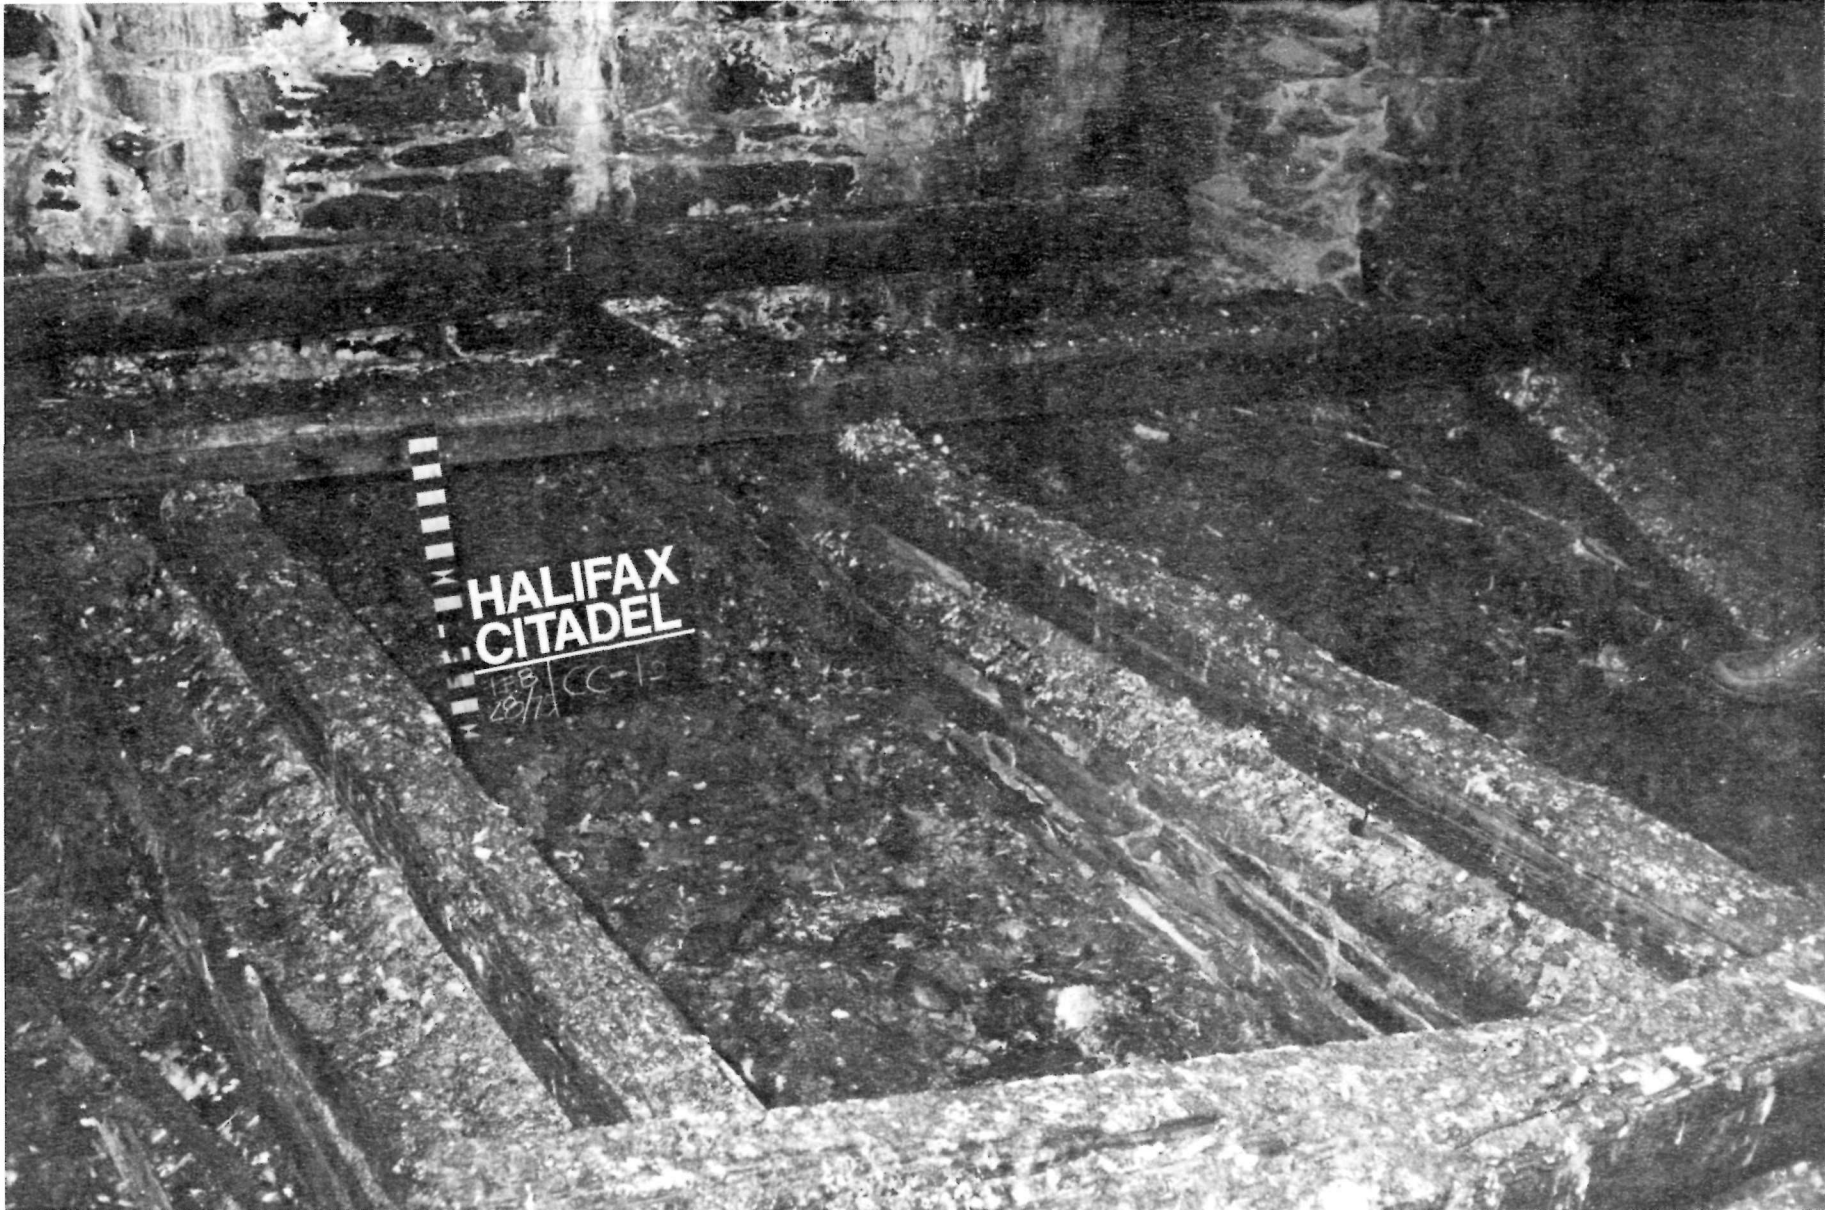
Figure 17

Extant masonry support walls for floor under gun platform in casemate 57. Some wood still in situ. Casemate floor is covered by a deposit of pigeon excrement.

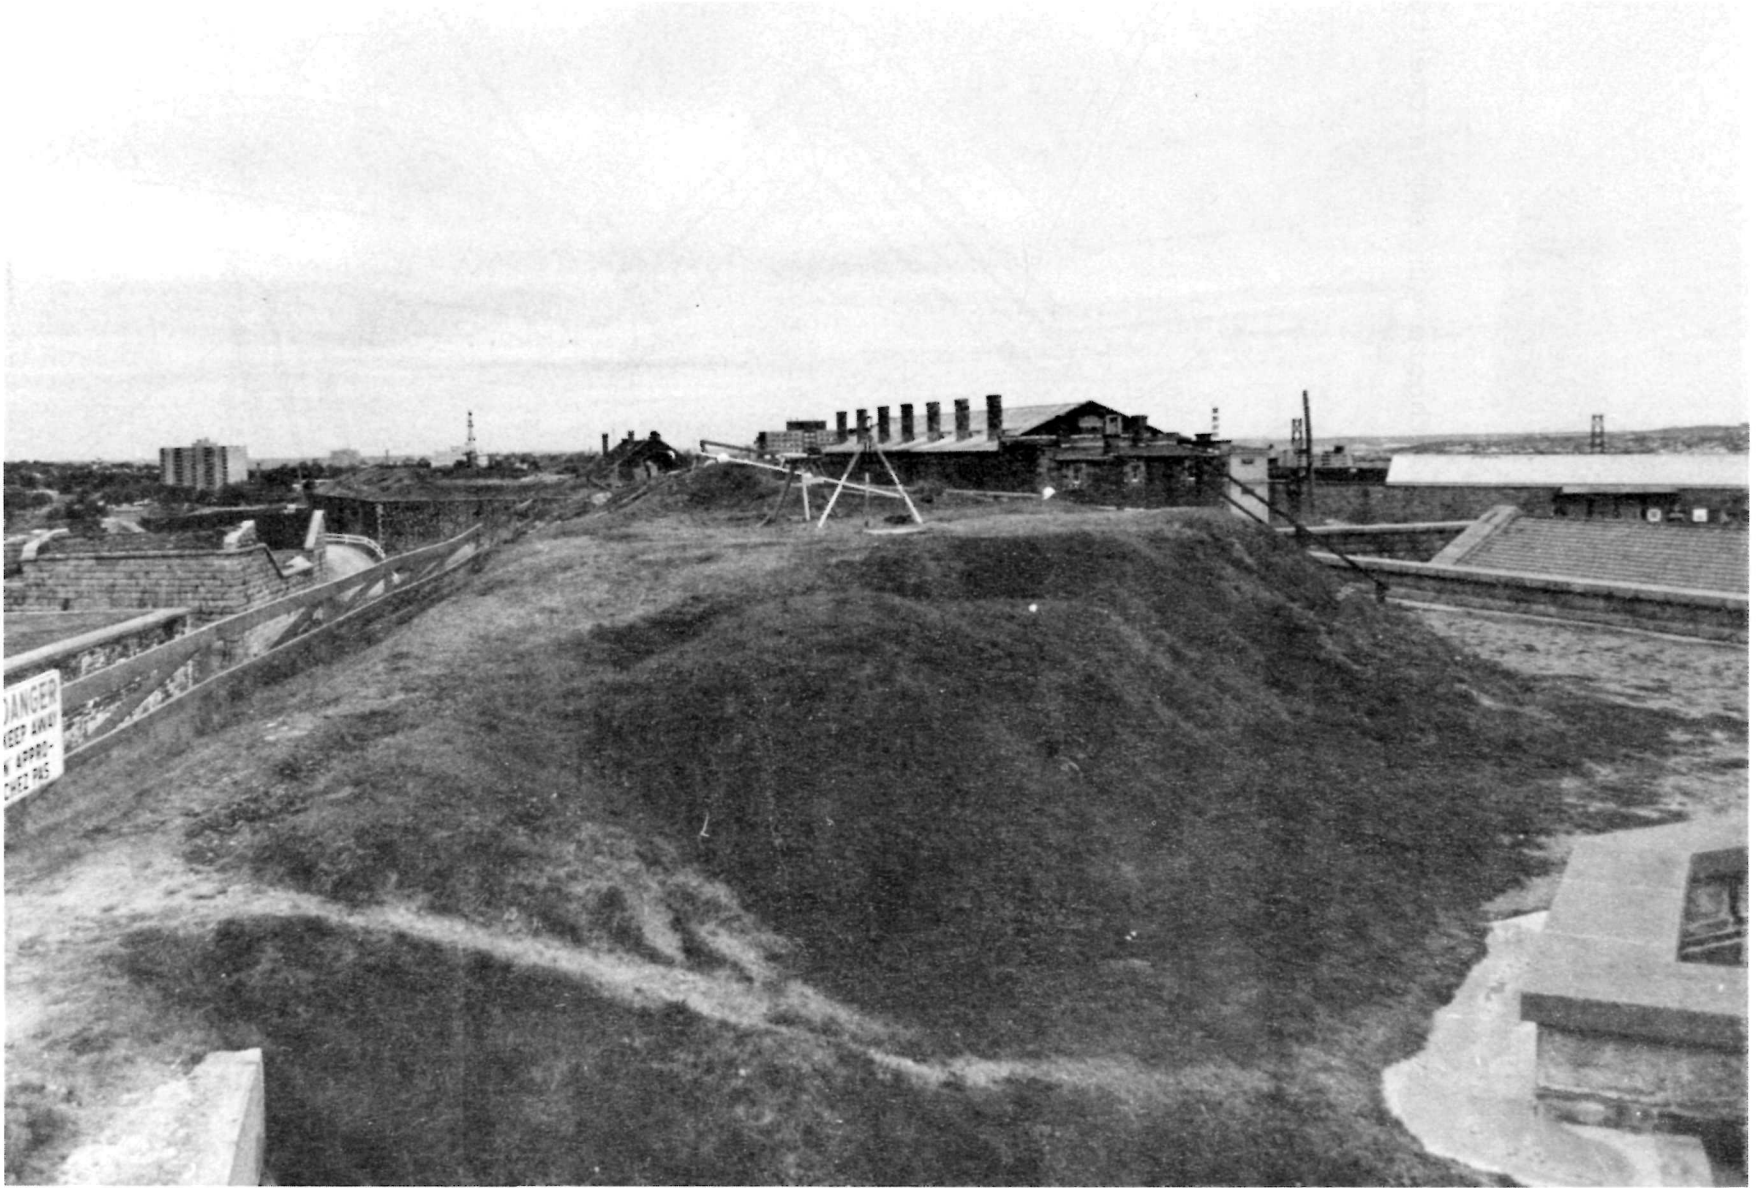
Figure 18

Overview of area of excavation on the ramparts of the southwest demi-bastion. Observe the large mass of fill that has been deposited.
