Manuscript Report
Number

291

ARCHAEOLOGY: HALIFAX CITADEL
FALL - WINTER 1977
by John J. Connolly
(1978)

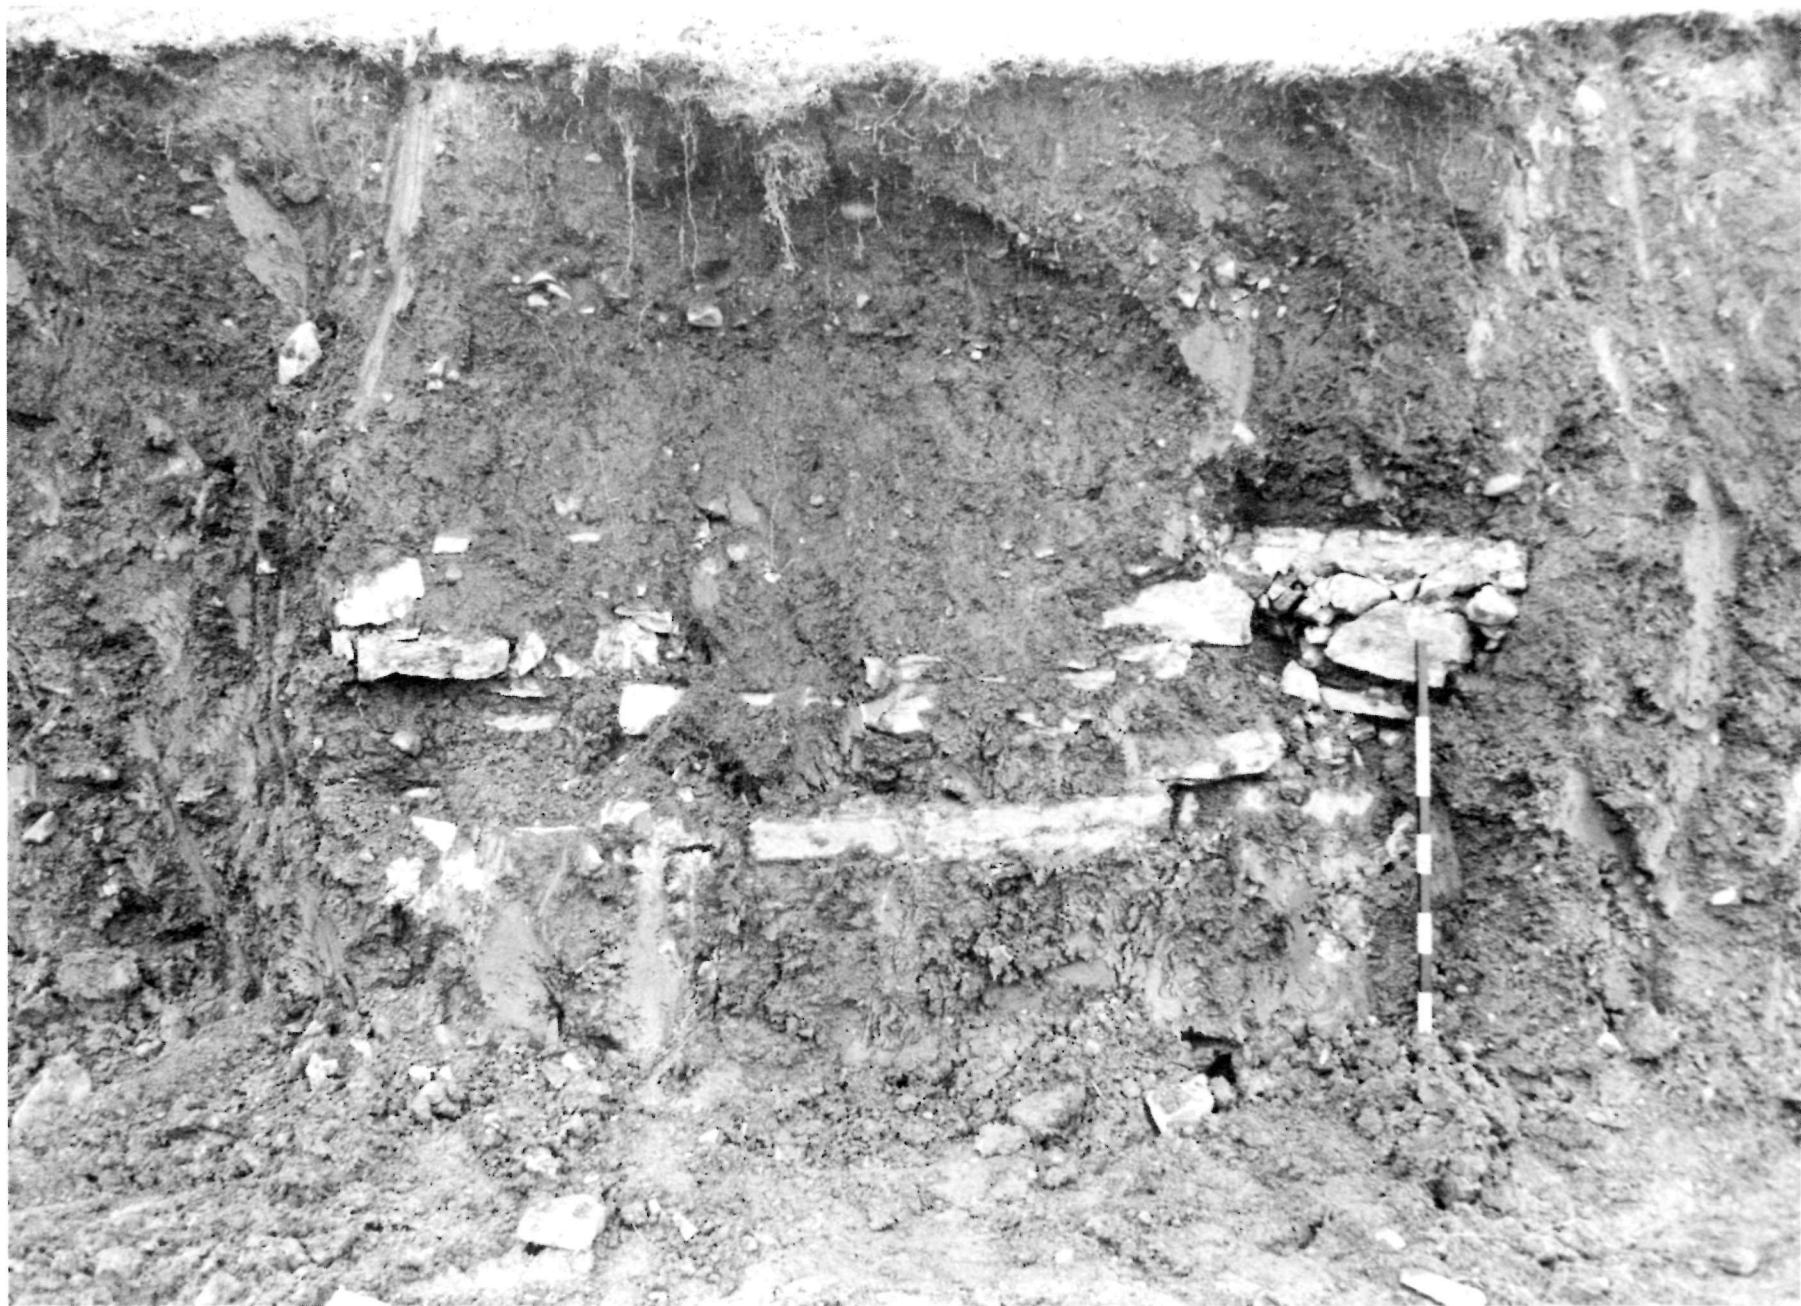
Figure 20

Extant escarp side of masonry smoothbore gun emplacement
after exposure by the backhoe. (scale: 1.0 meter)

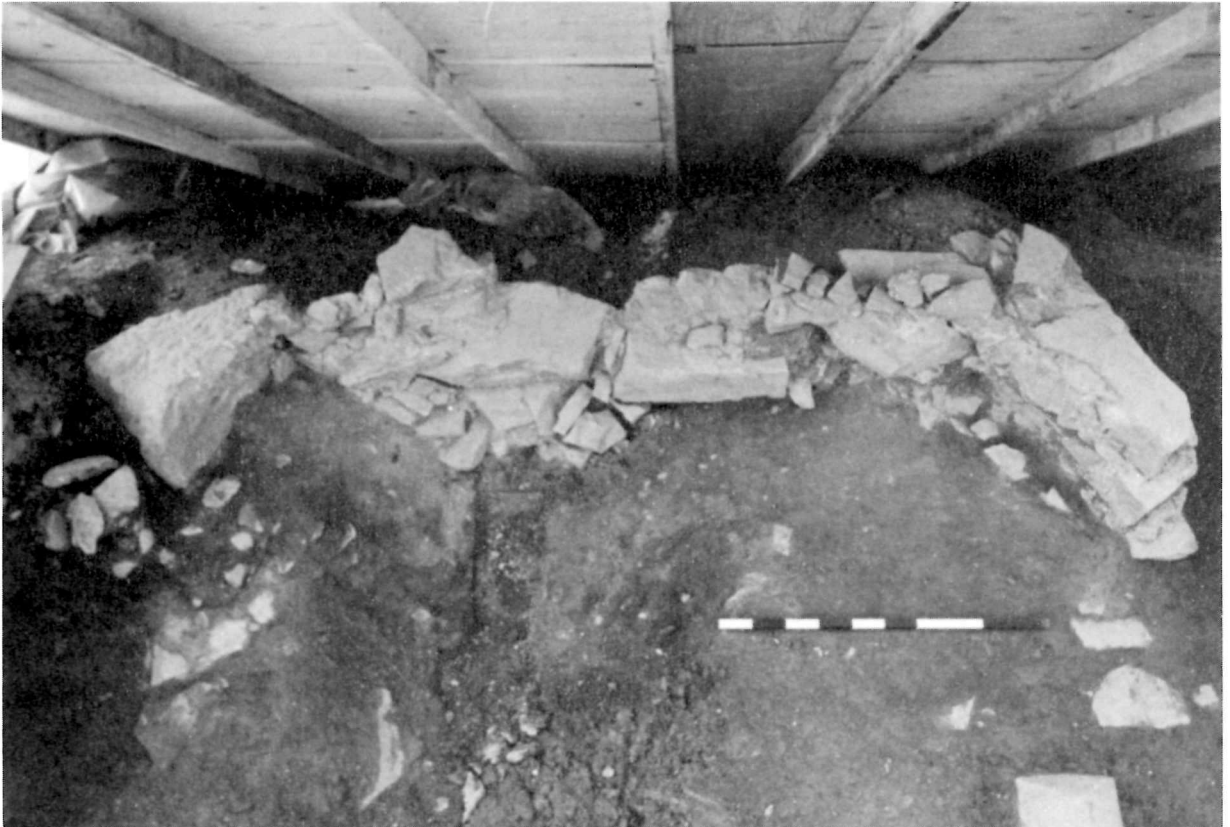
Figure 21

Overview of emerging masonry feature. Wood at top of photo is part of the shelter constructed so that work could continue on the gun emplacement during the winter. (scale: 1.0 meter)

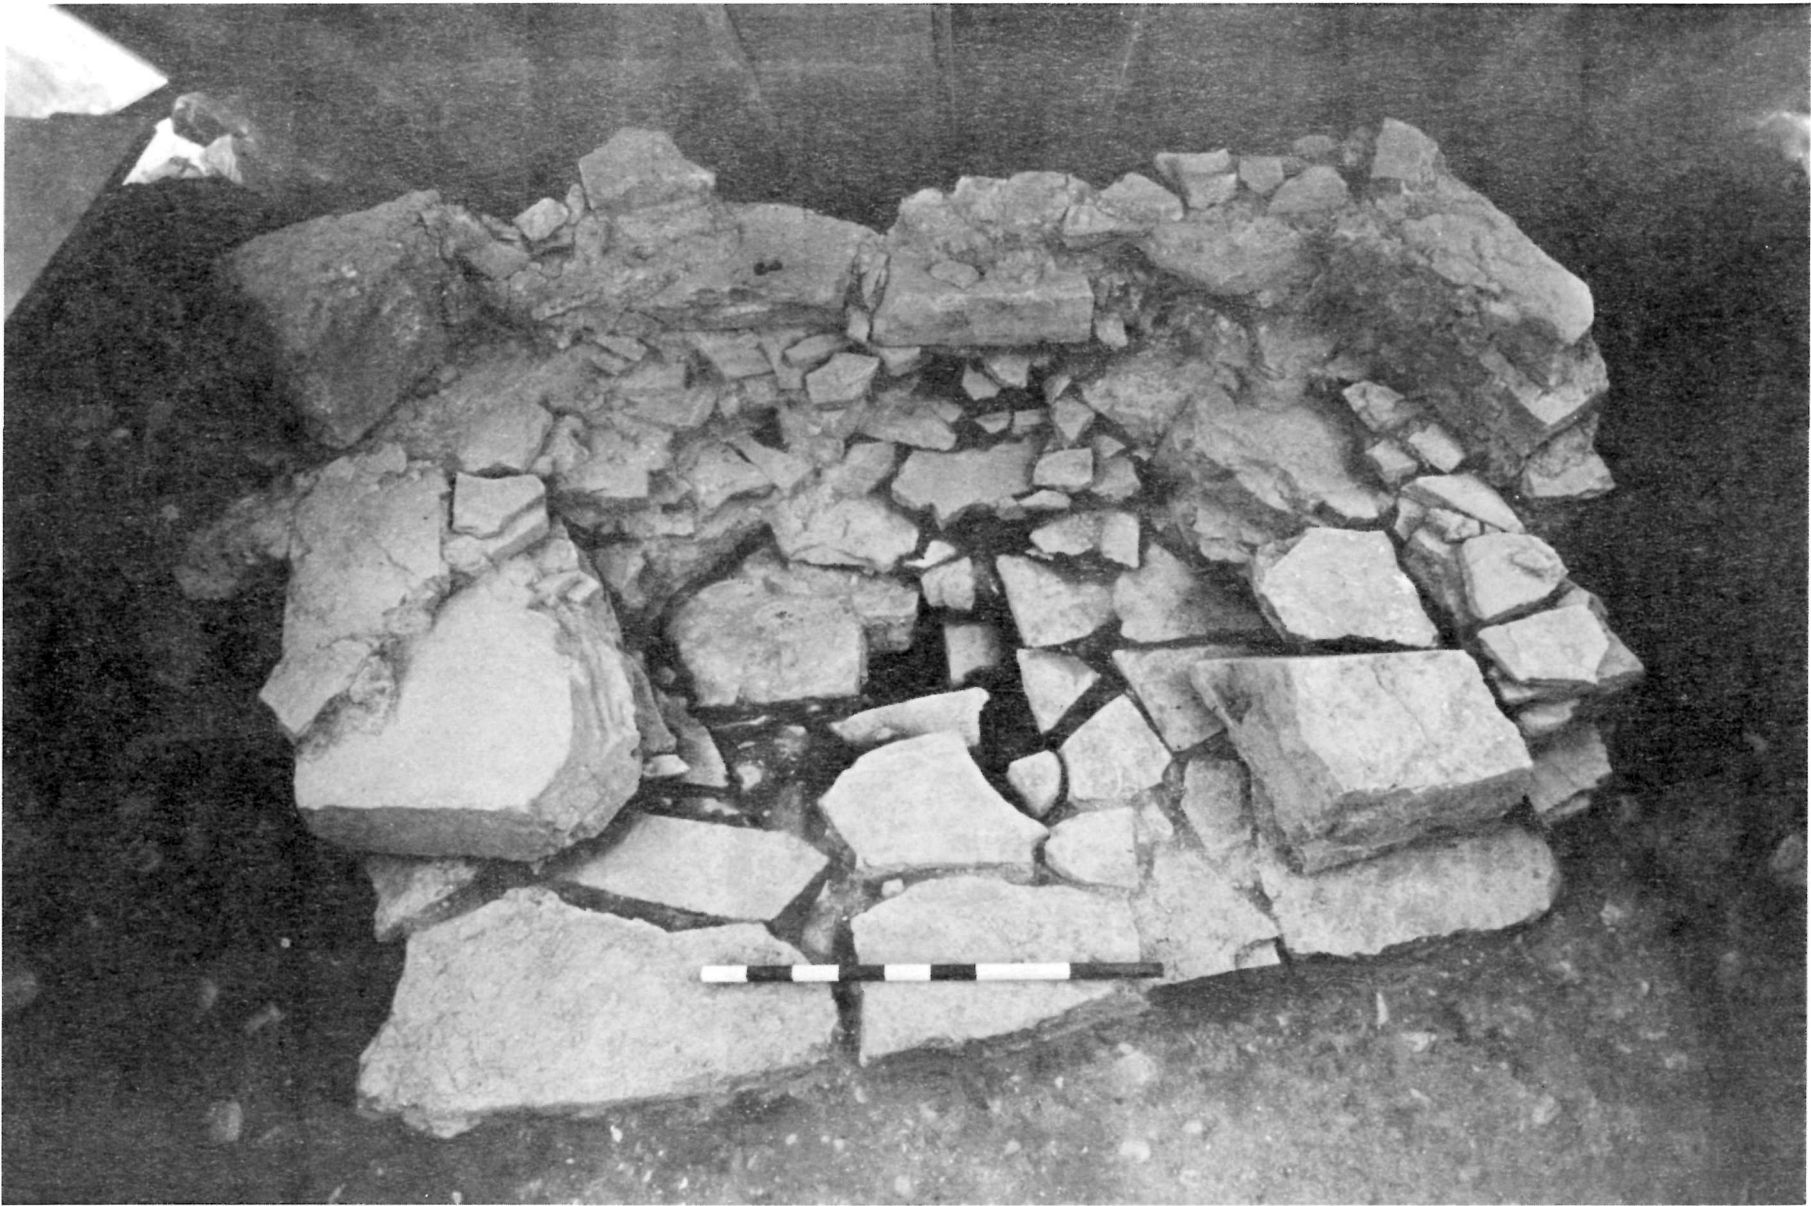
Figure 22

When the features were completely exposed it was evident that it was not in original condition. The feature we had been excavating was not the actual emplacement, which would have consisted of cut granite, but was the foundation which supported the granite.

Overview of excavated feature. This was the foundation of the emplacement constructed of ironstone rubble and mortar. Note the pivot hole in the centre of the feature. (scale: 1.0 meter)

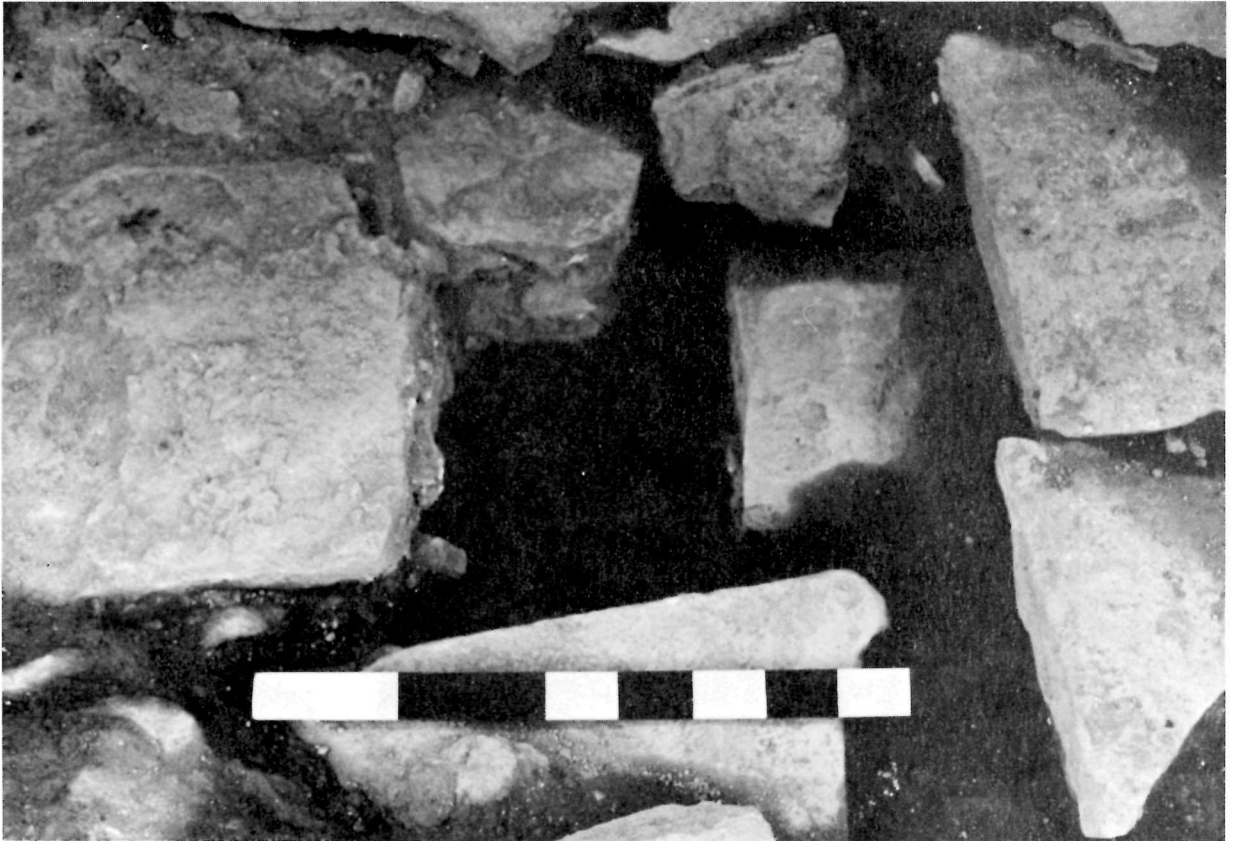
Figure 23

Detailed view of pivot hole. (scale: 0.50 meter)

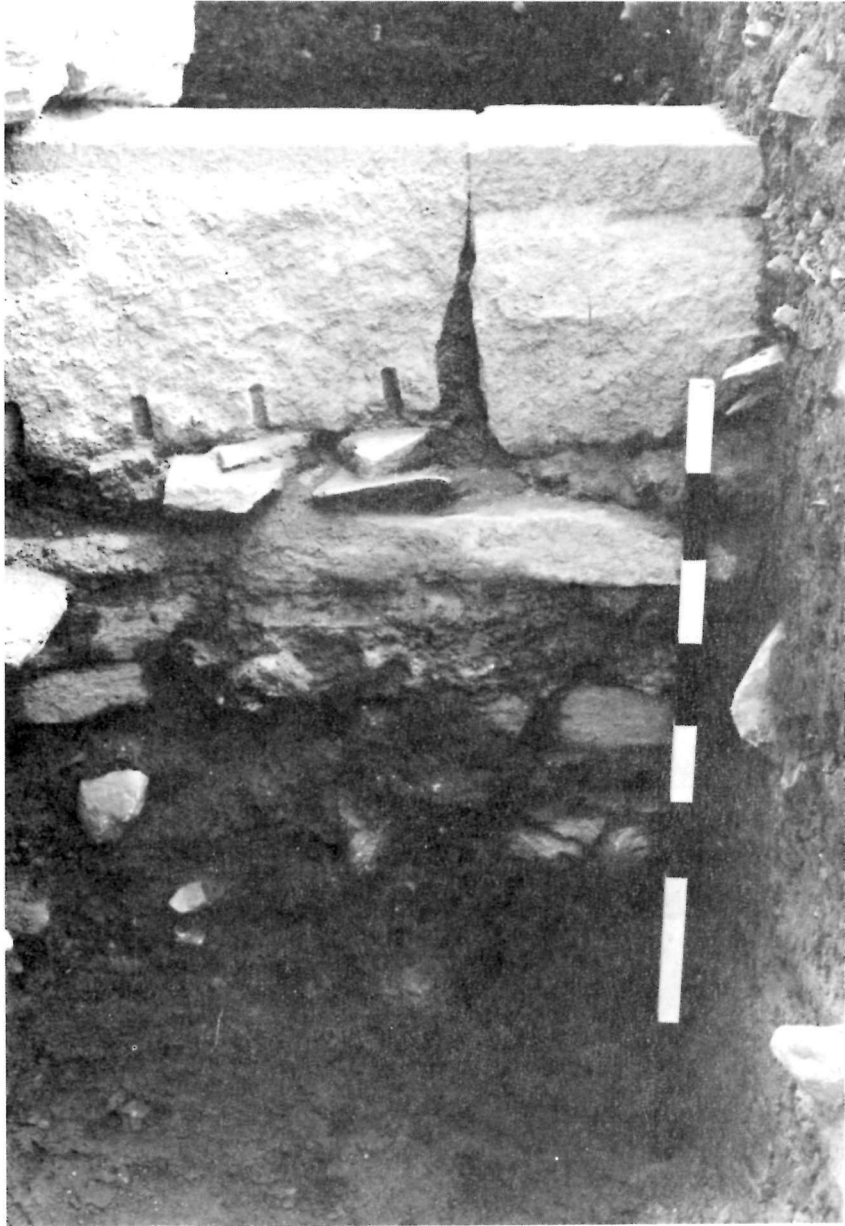
Figure 24

Given the fact that all the cut granite had been removed from the pivot area it was not anticipated that any of the cut granite would be found on the racer. However, excavations revealed the granite still in situ. Two of the segments were partially exposed along with their joint within the sub-operation (Figure 24). This would give the exact elevation of the gun, its radius and the detail of the cramp. The cut granite was dressed on the top surface for 0.30 to

0.31 meters and on the sides for 0.04 to 0.07 meters from the top surface. The balance of the granite was roughly cut. The total maximum dimensions of the stone are 0.41 meters high by 0.52 meters wide. Longitudinal distances were unobtainable until the balance of the racer was excavated. The top surface of the granite was 73.27 ASL. The lead covering the cramp that holds the joint together covers an area 0.10 by 0.40 meters. The granite was bedded on an ironstone and mortar foundation 1.10 meters wide by 0.75 meters high. Complementing the foundation were masses of ironstone located to the east and west sides to provide additional support and drainage.

Detail view of the granite racer and its foundation. Note the drafted, smooth surface of the granite and then the undrafted balance of the granite. Also note the drill holes for the splitting wedges. (scale: 1.0 meter)

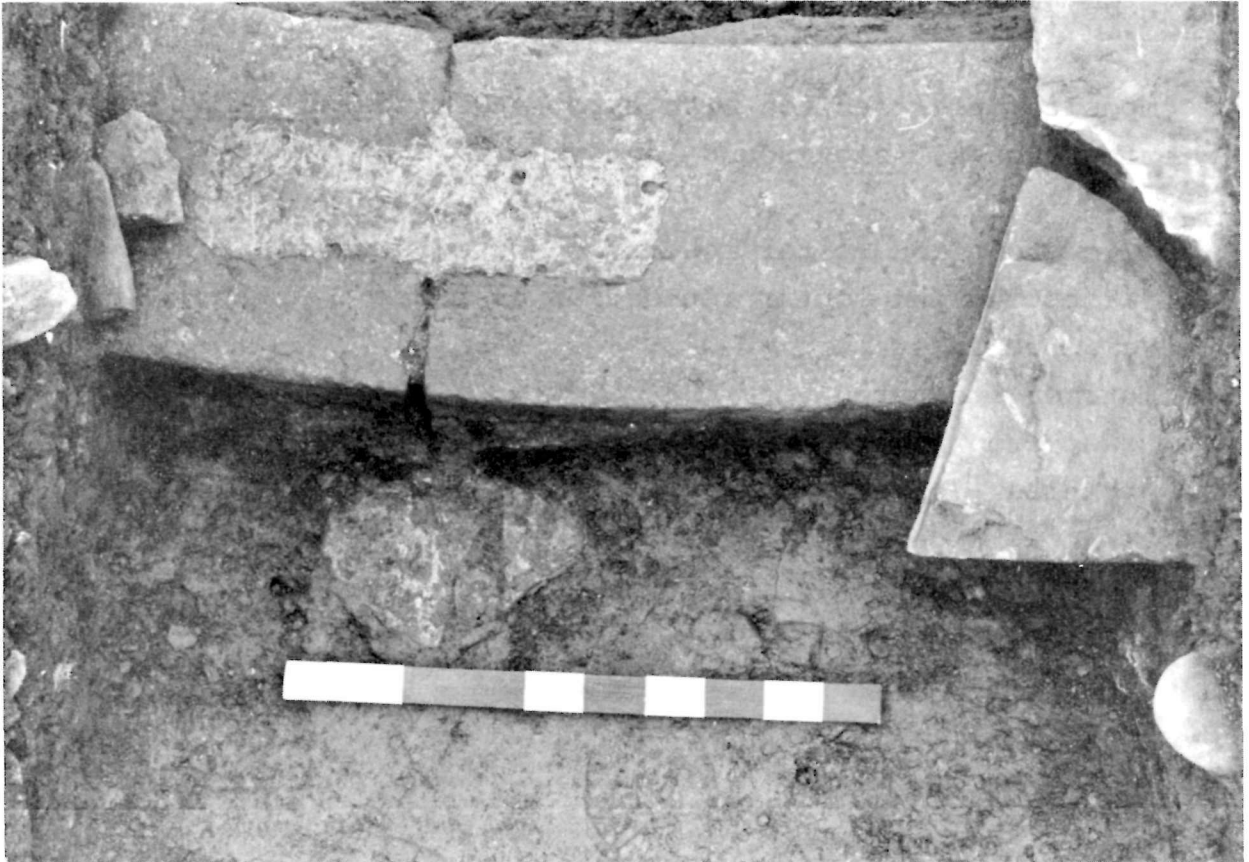
Figure 25

Detail view of lead covering the cramp joining the granite segments of the racer. (scale: 0.50 meter)

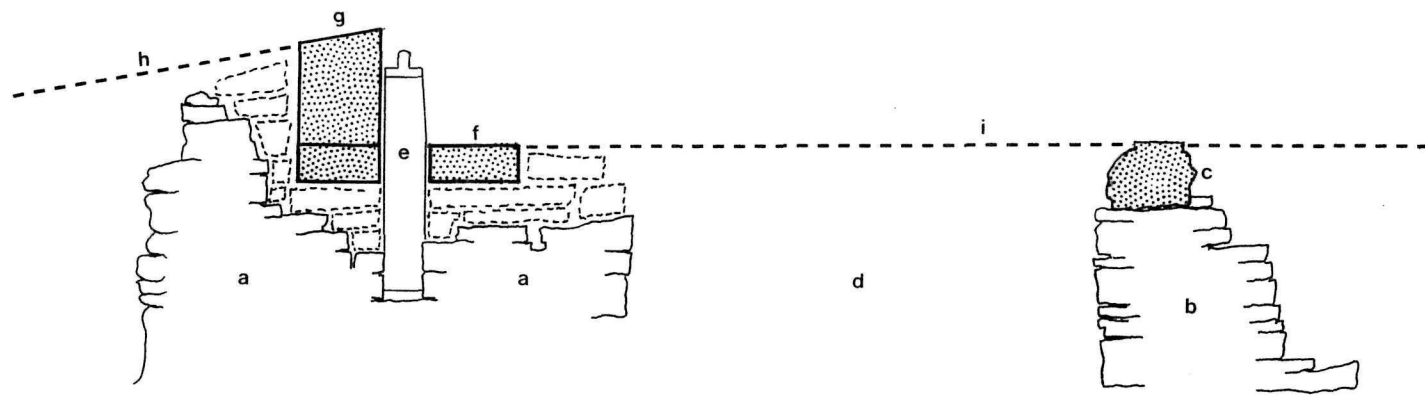
Figure 26

General maximum dimensions of the emplacement were 3.4 meters wide by 2.3 meters long by 1.1 meters high. A cross section of the emplacement (Figure 26) detailed the variation in the construction of the foundation. The emplacement was situated 5.30 meters east of the escarp wall and its maximum height was 1.40 meters (73.29 ASL) above the coping stone of the escarp wall. Construction materials consist of ironstone ranging in size from a cobble to large slabs and lime mortar. The ironstone in its present condition was still in place due to sheer weight. The majority of the lime had leached out of the mortar rendering the foundation unserviceable for reconstruction purposes. The square hole for the pivot was located 1.15 meters back from the front

Composite cross section with hypothetical genouillère,
terreplein and sole ground levels.

The emplacement, when reconstructed from available materials, should resemble the form represented in Figure 26. It is a composite of the excavated ironstone foundation and the granite racer (See Figure 26), the granite for the eight inch emplacement extrapolated from the 1846 plan, the embrasure wall or genouillère as it appears in the photo from 1879 of the northwest demi-bastion showing an in situ 32 pound emplacement, and the pivot which is partially extant at the entrance of the Citadel.

The granite surrounding the pivot should be at the same level as the racer, but its size is conjectural until an emplacement is excavated with granite in place. Given the factors that the foundation and the granite of the racer are larger than the plan from 1846, the granite around the pivot should be of a similar enlargement.

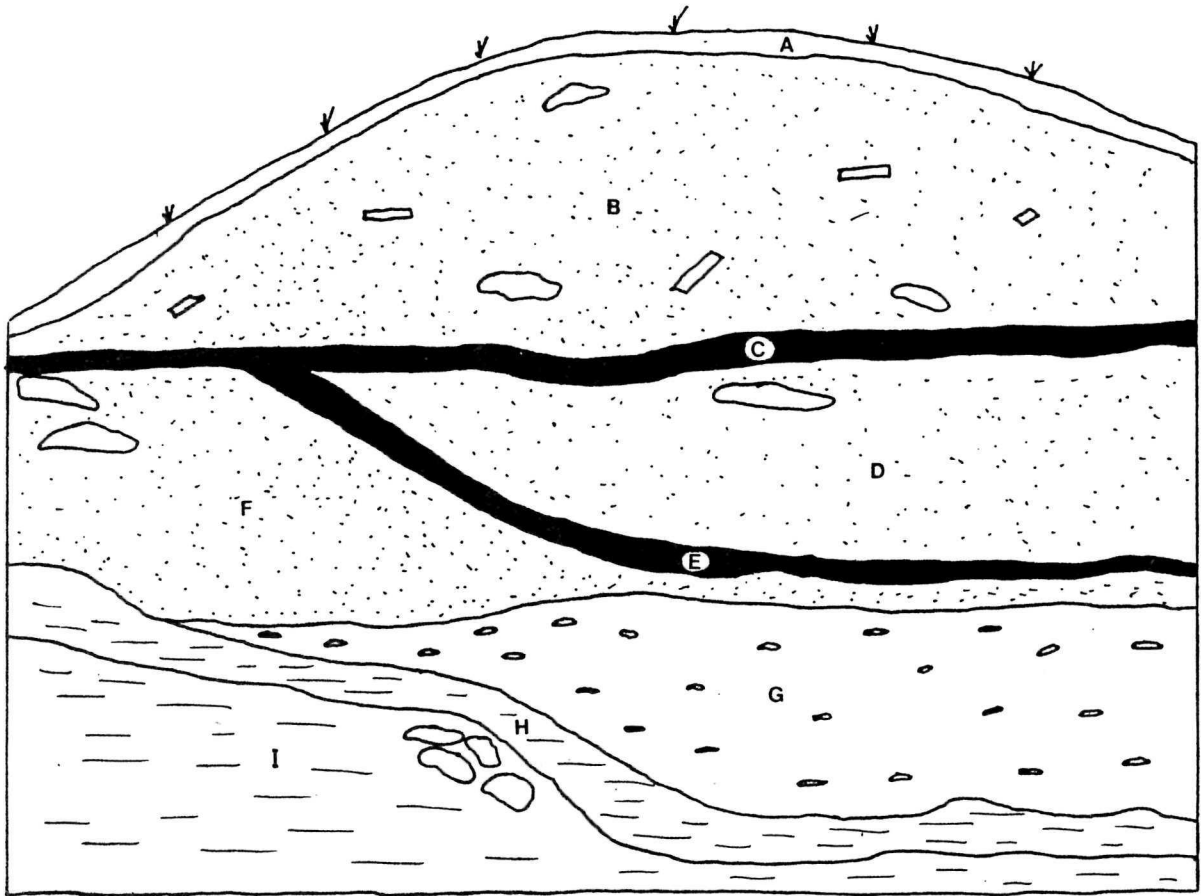
Soil profile illustrating strata of clay indicating the presence of the banquette. (scale 5.0 cm = 1.0 meter)
