Manuscript Report
Number

WEST CURTAIN WALL AND SALLY PORTS
THREE AND FOUR, HALIFAX CITADEL

by Richard J. Young

1976

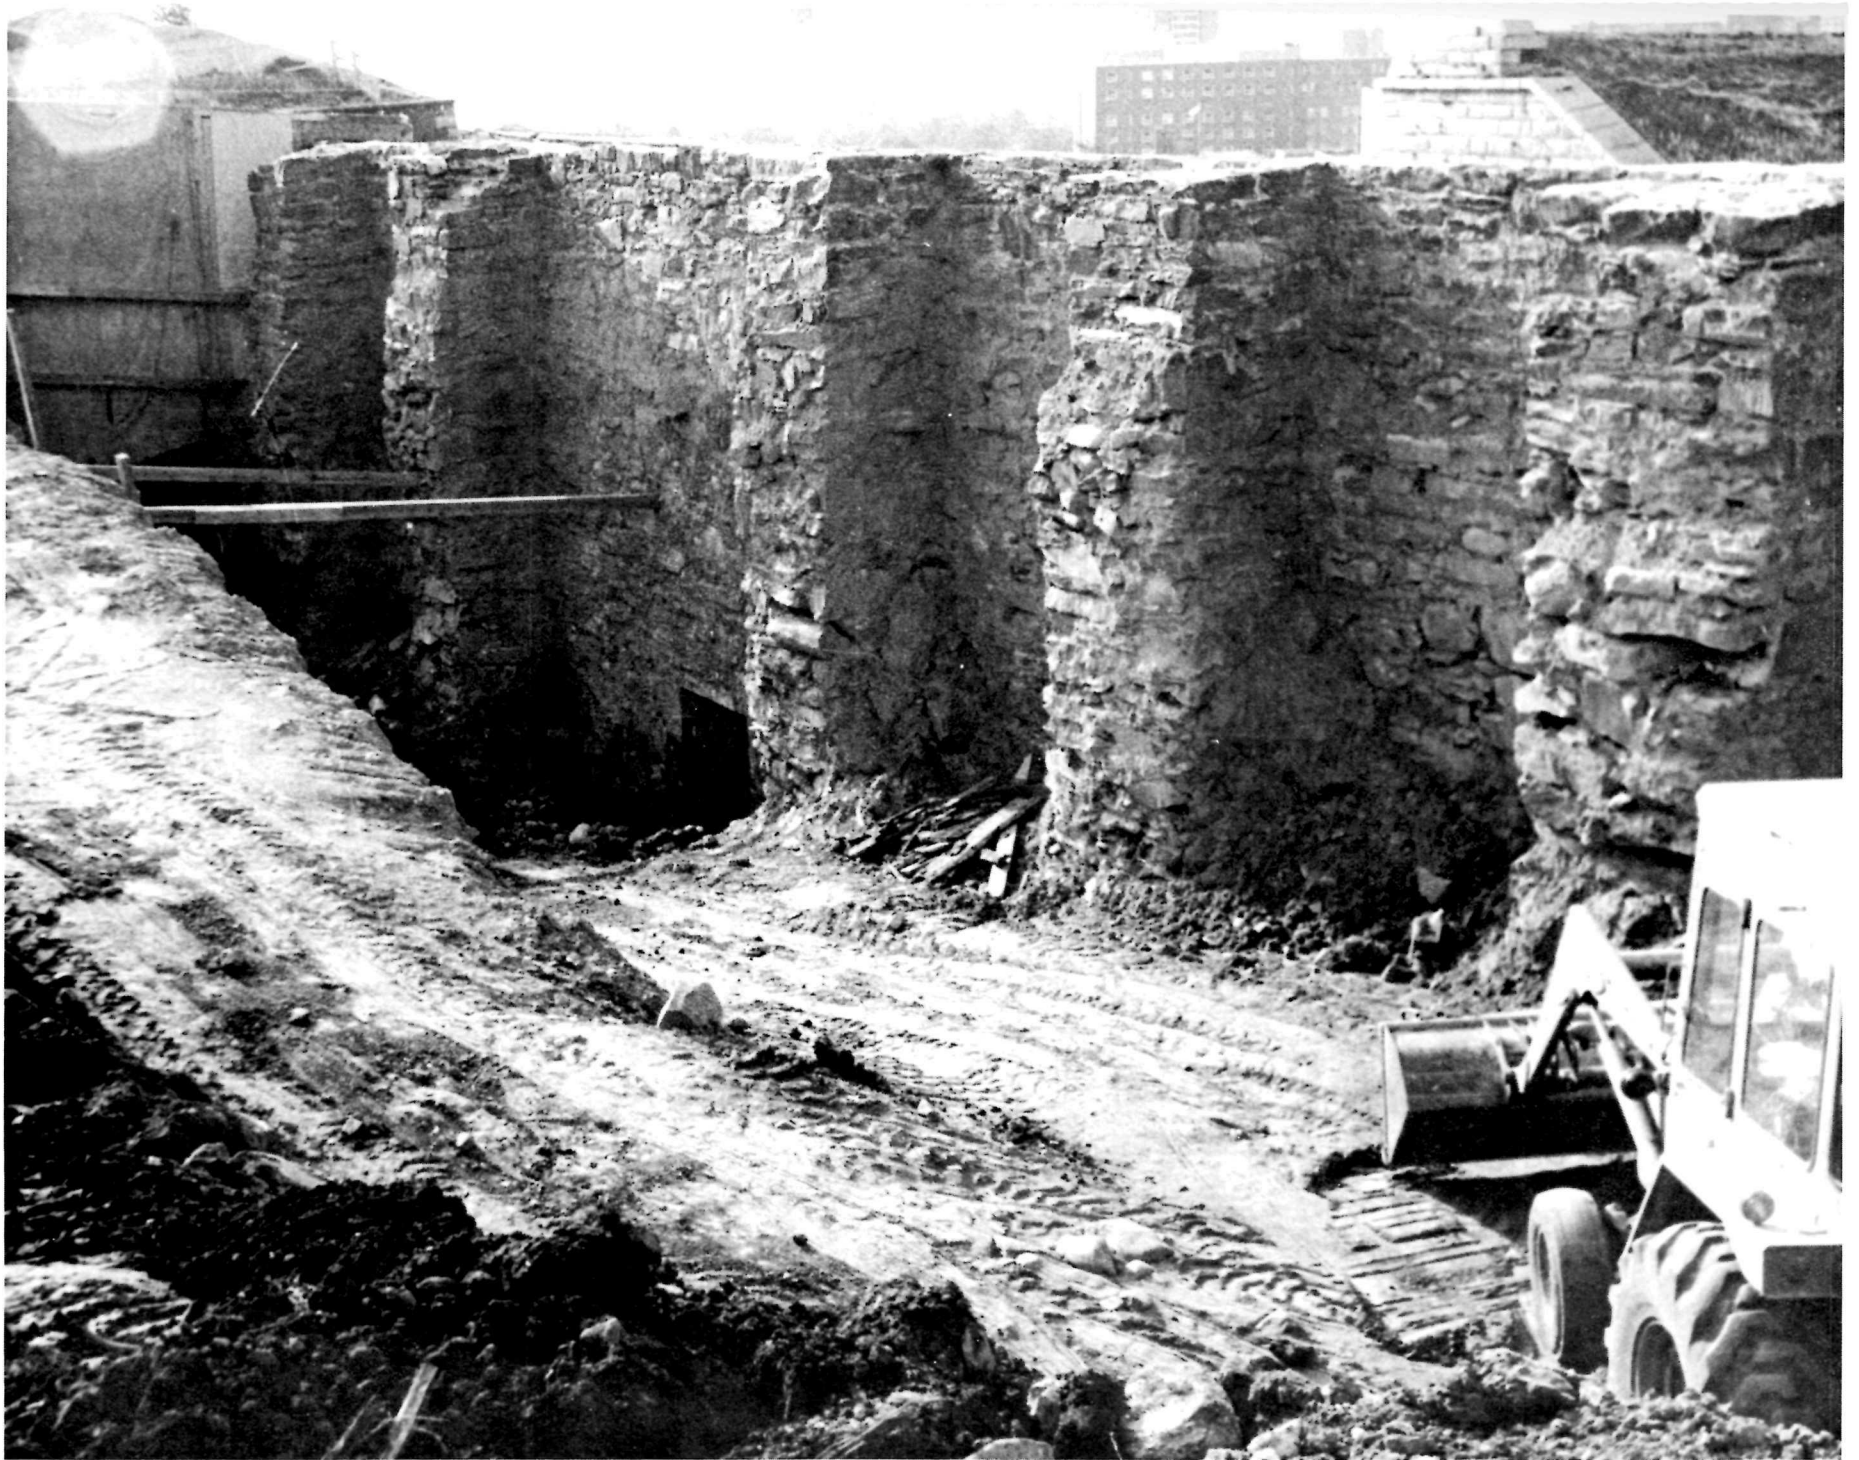
Figure 10

The excavation of the ramparts and earth fill behind the curtain wall for the proposed museum has enabled the as-found team to accurately number and measure the buttresses. Their findings echo the conclusion of the 1856 committee members who, after making an opening in the West Curtain Wall, stated that the "Counterfort partially laid open, rather exceeded the dimensions specified in the Contract and Plan".¹³ The buttresses are not only slightly larger than 4 feet by 5 feet but are spread an average of 12 feet apart rather than 13.¹⁴ Nicolls was determined to ensure that this wall did not collapse. (See Figure 10)

Photograph of the interior of the escarp wall taken by as-found team during the excavation of the ramparts for the museum. These buttresses have now been completely removed. The photo also shows the middle sally port opening in the wall.

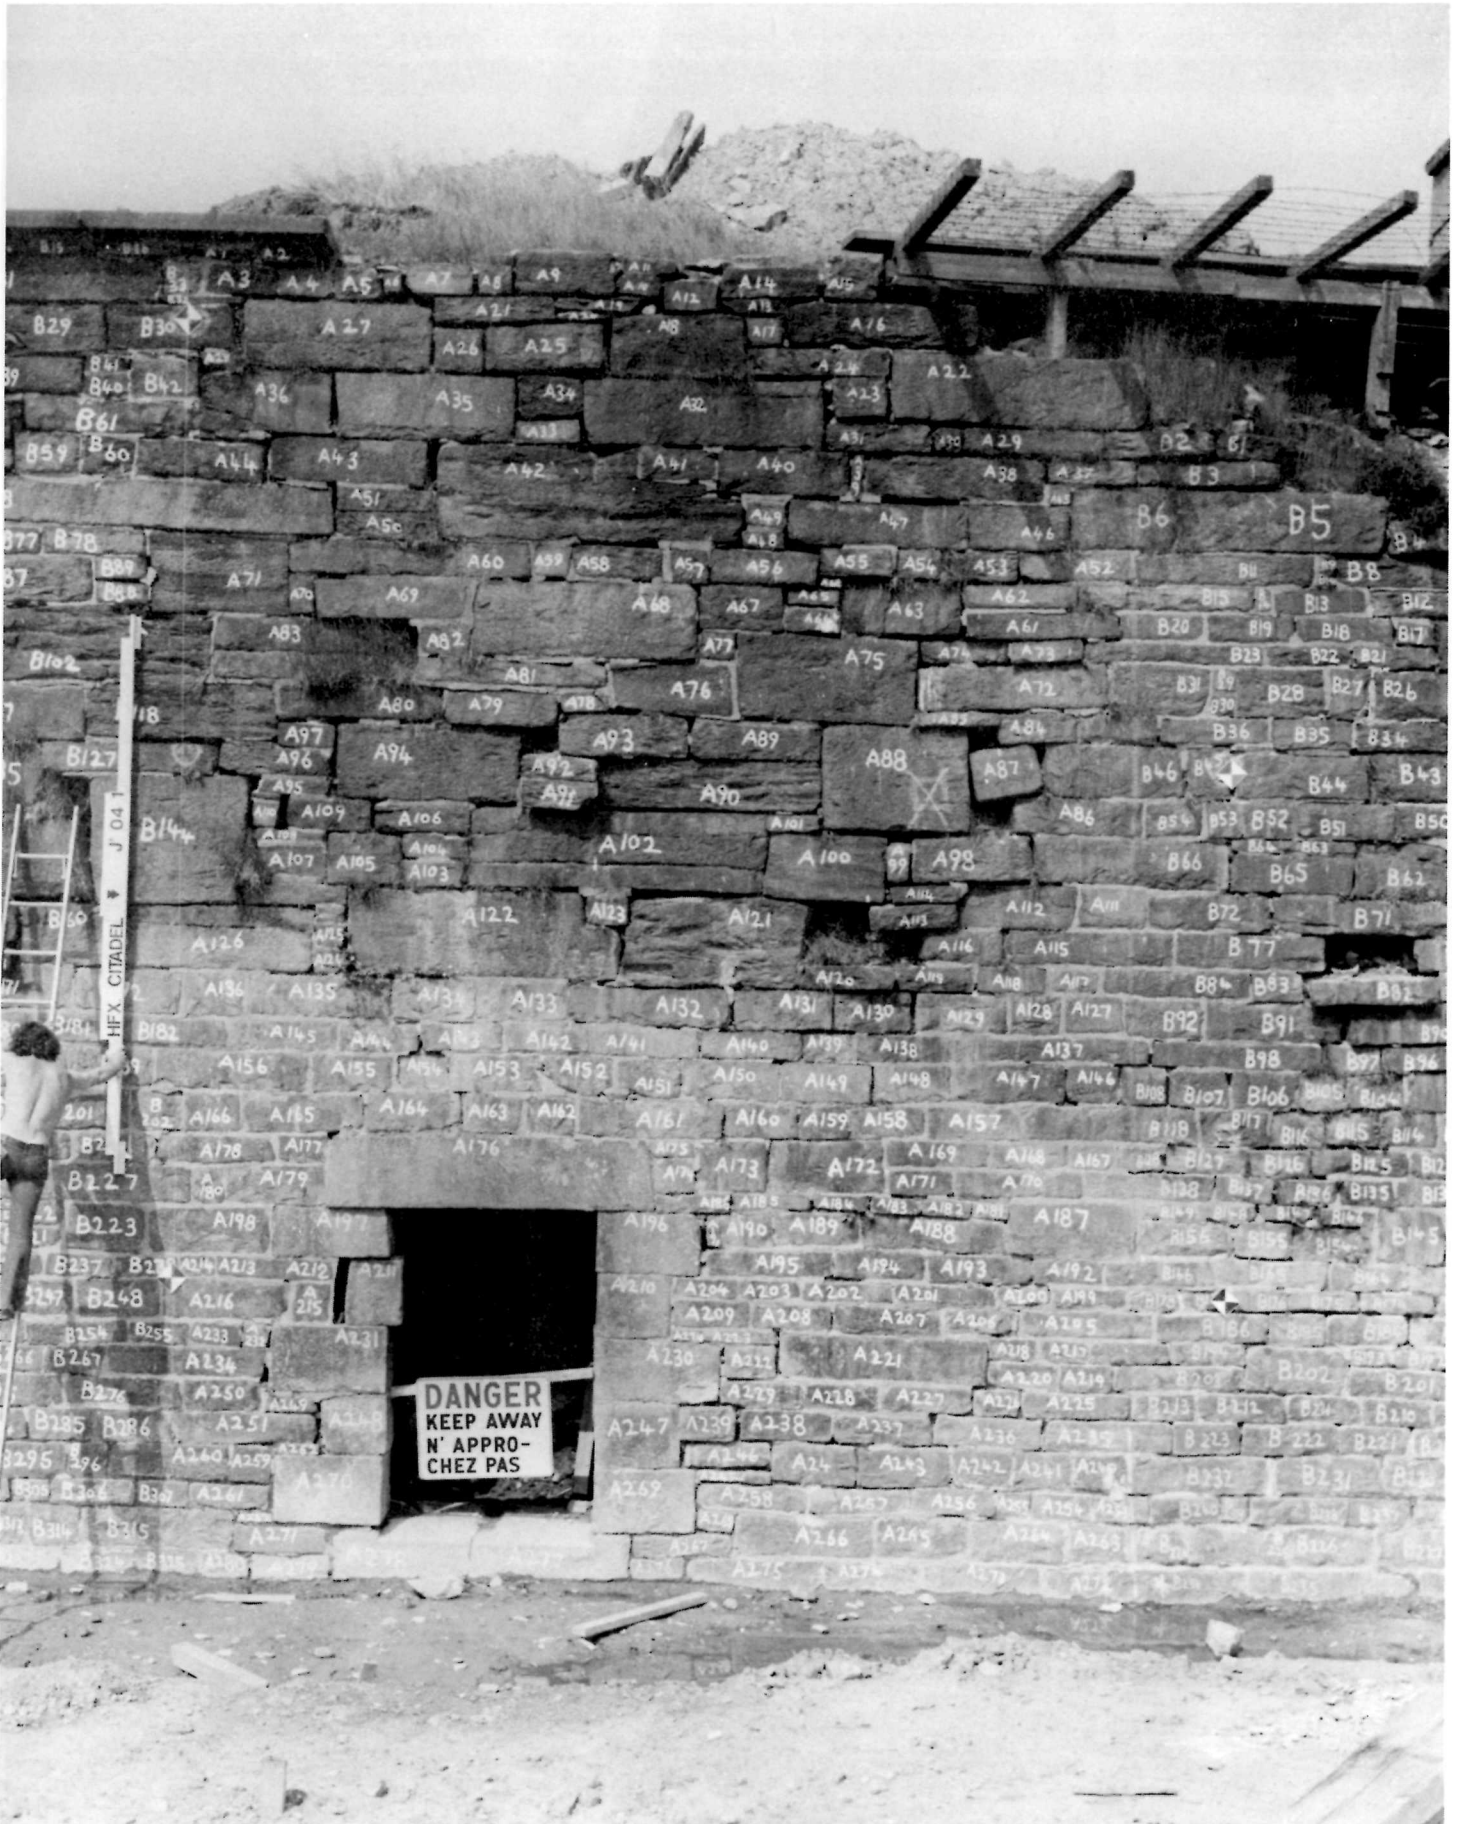
Rectified photography of south portion of west curtain wall, showing sally port 3 opening. It is very easy to identify the ragged line dividing the 1830 and 1831 sections of the wall. The 1831 section above and to the left of sally port 3 was built by Metzler, who used much larger stones than the Sappers and Miners were using the previous year. This line agrees with the line described in Boteler's 1832 plan of the wall. See also Figure 6.

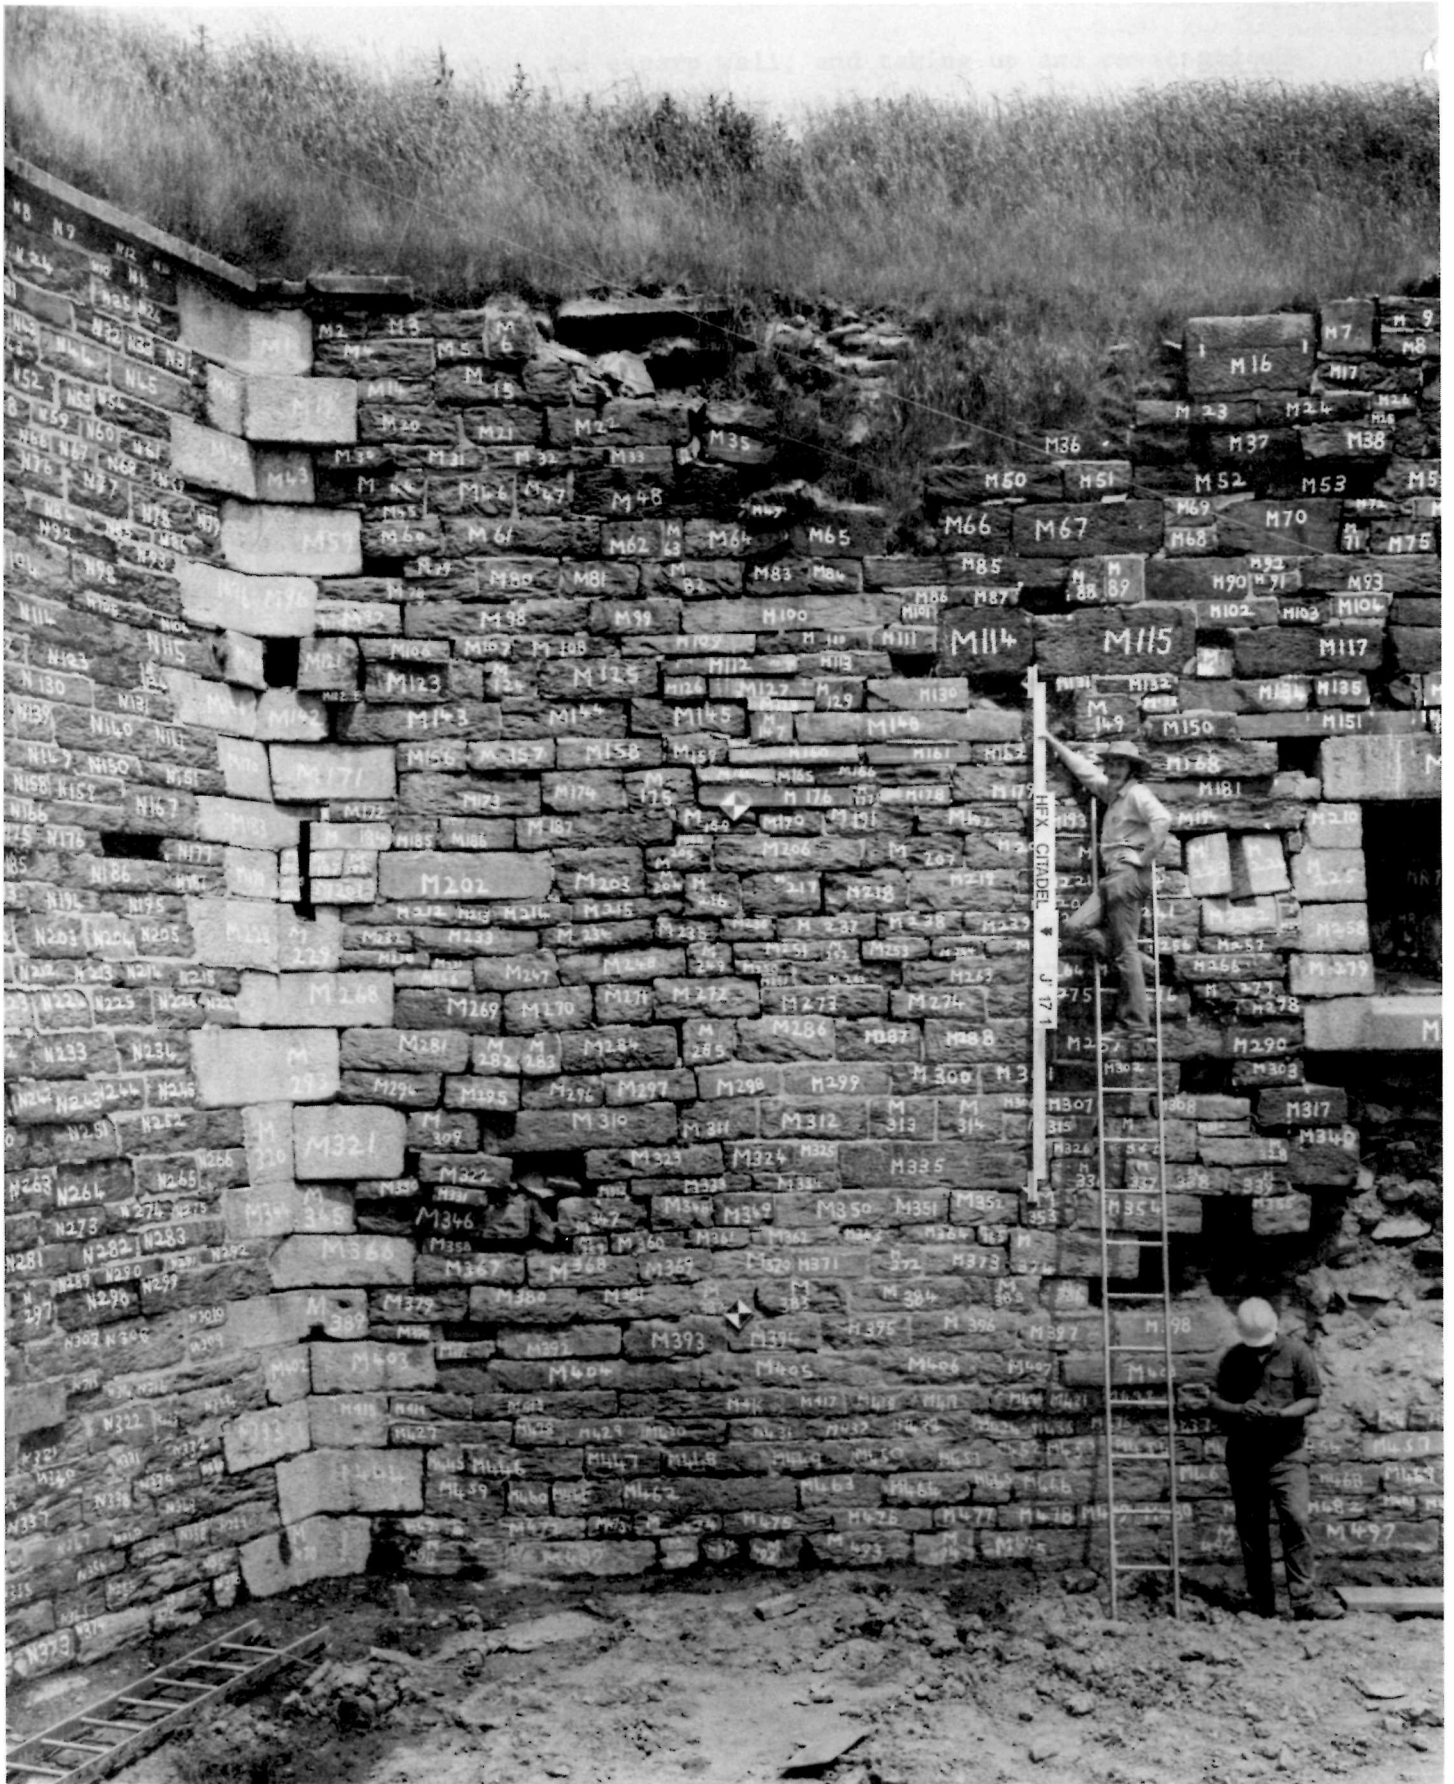
Figure 12

Rectified photography of north portion of curtain wall showing portholes and loopholes of casemate 12. Again the line between the smaller stones of the 1830 building season and those larger stones used in 1831 is clearly visible. See also Figure 6.

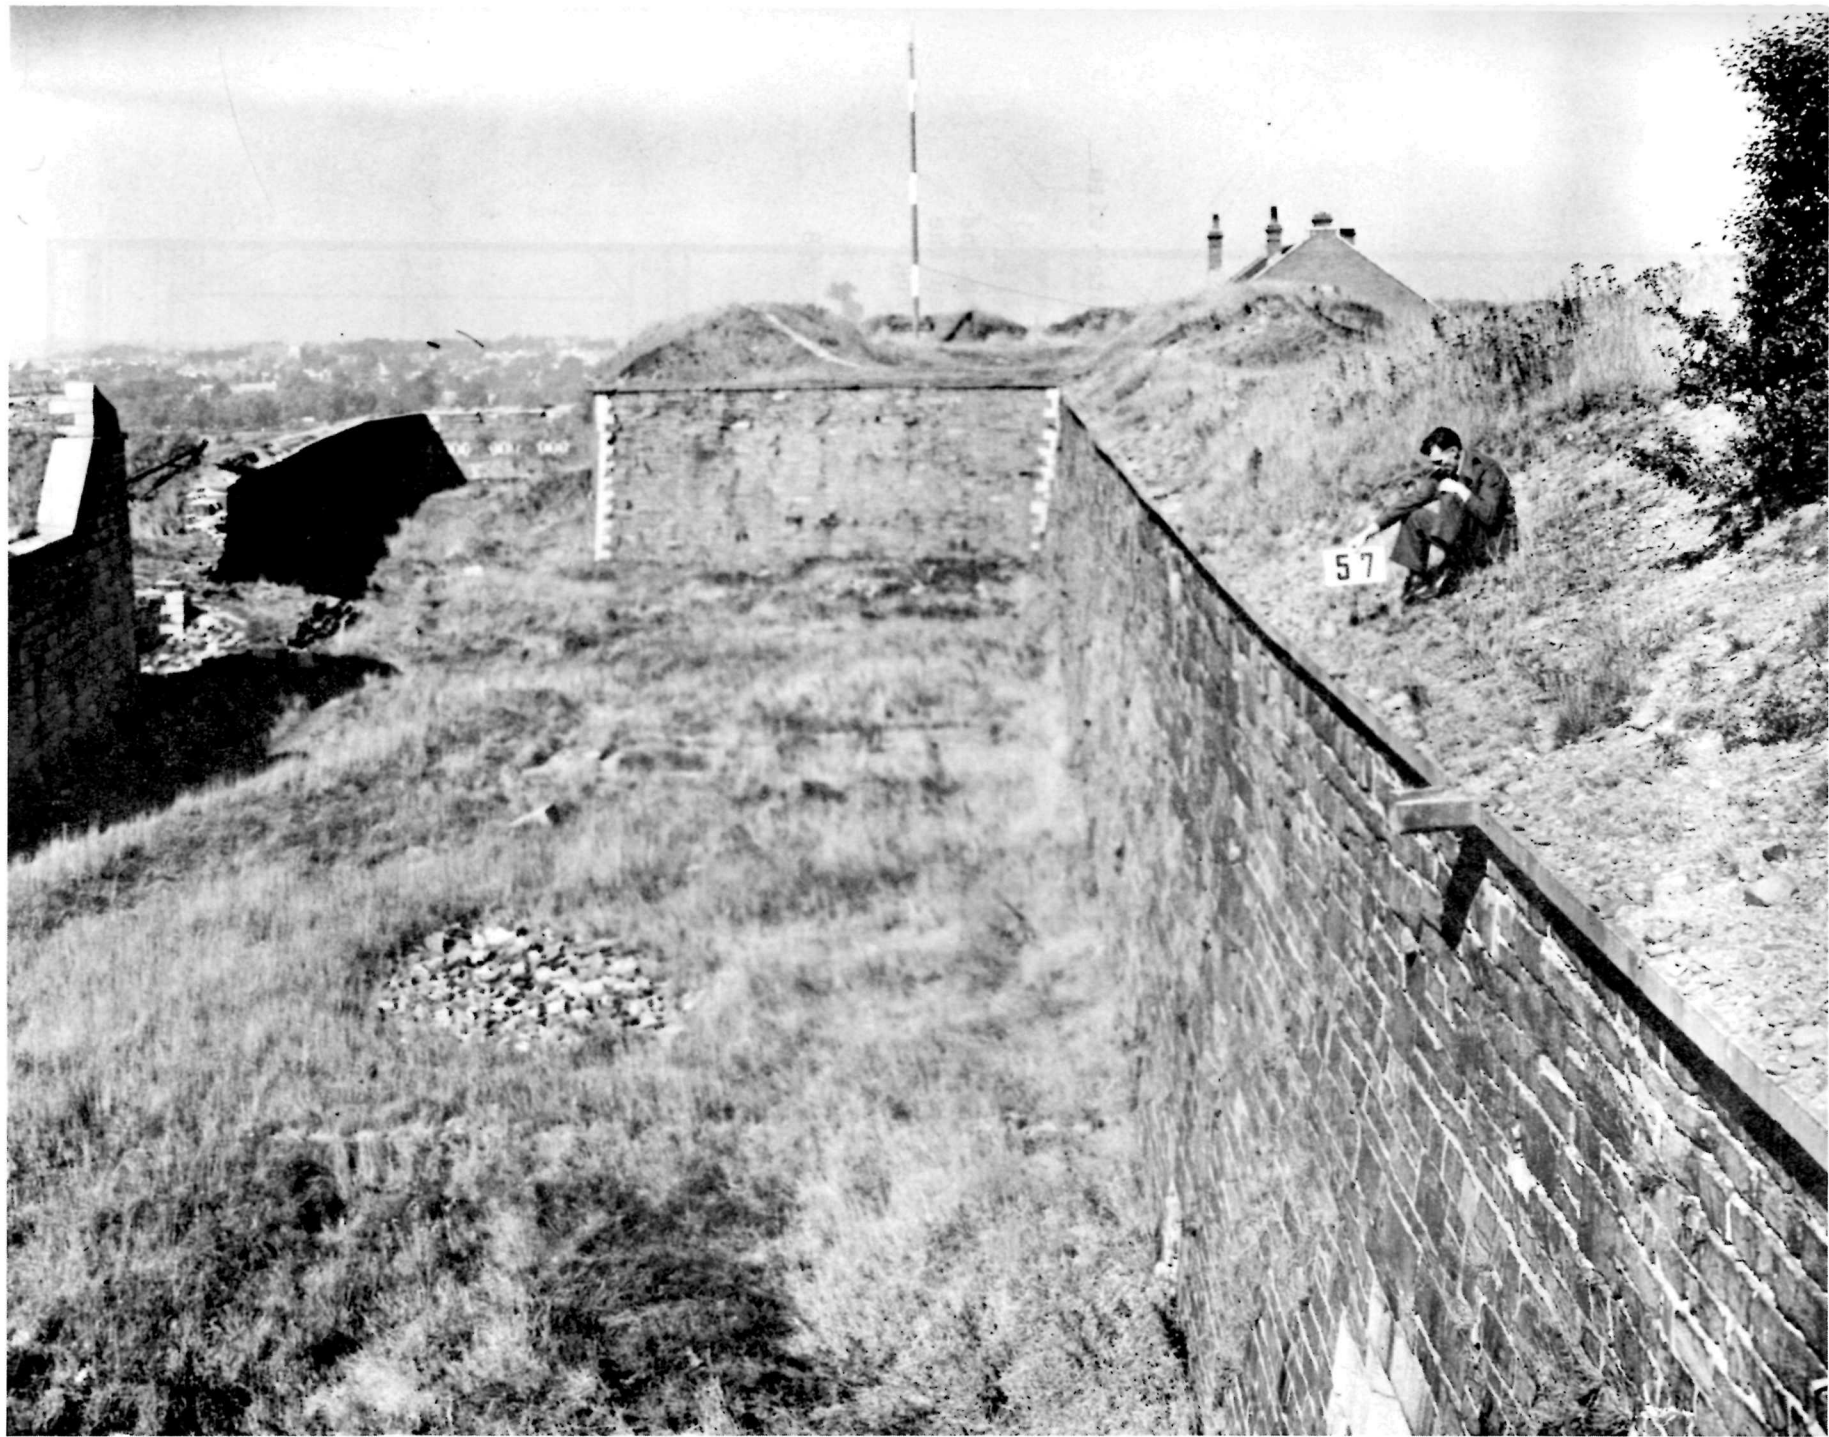
Photo from Massey Report 1950. This photo shows the coping stone above the curtain wall, on a casemated portion of the wall. The spout is visible in the middle ground of the photo.

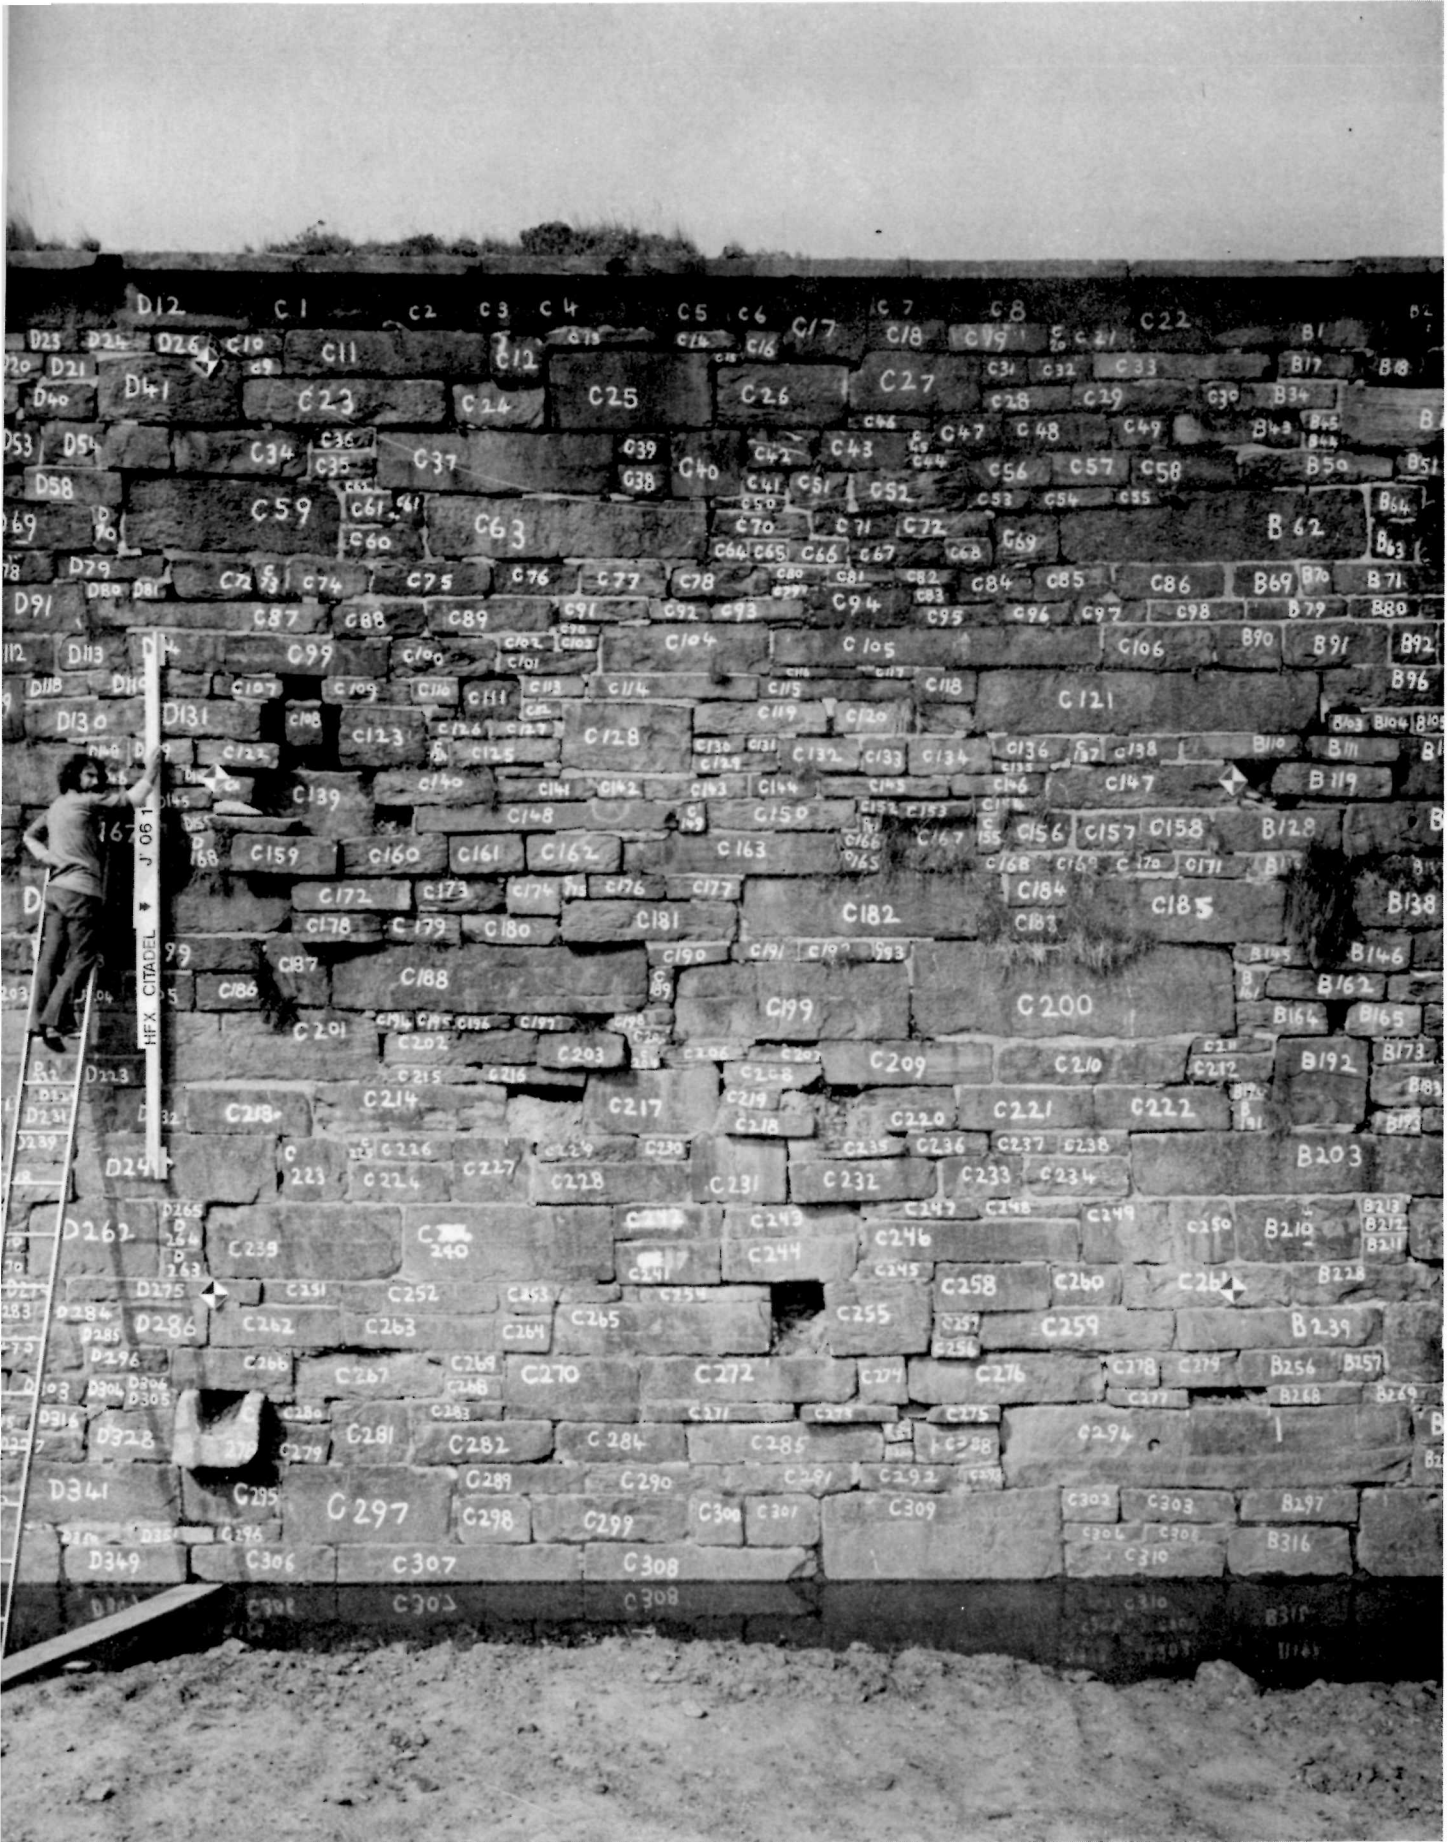
Figure 15

As-found photo of gargoyle west curtain wall. There are four of these granite scuppers spaced evenly between the sally ports, four feet above ditch level. Square wooden tubes behind the escarp wall carried water to an ironstone channel through the wall and out the gargoyles.

this feature into the 186 feet of the curtain wall built by Metzler that same year. Four such drainage systems were included in the curtain wall construction, spaced at equal intervals between the sally ports. The gargoyles were tooled granite, mortared into the wall, projecting out eight inches, four feet above ditch level. Understandably, no evidence of the square wooden tubes were found during excavation. They must have long since rotted. (See Figure 15)

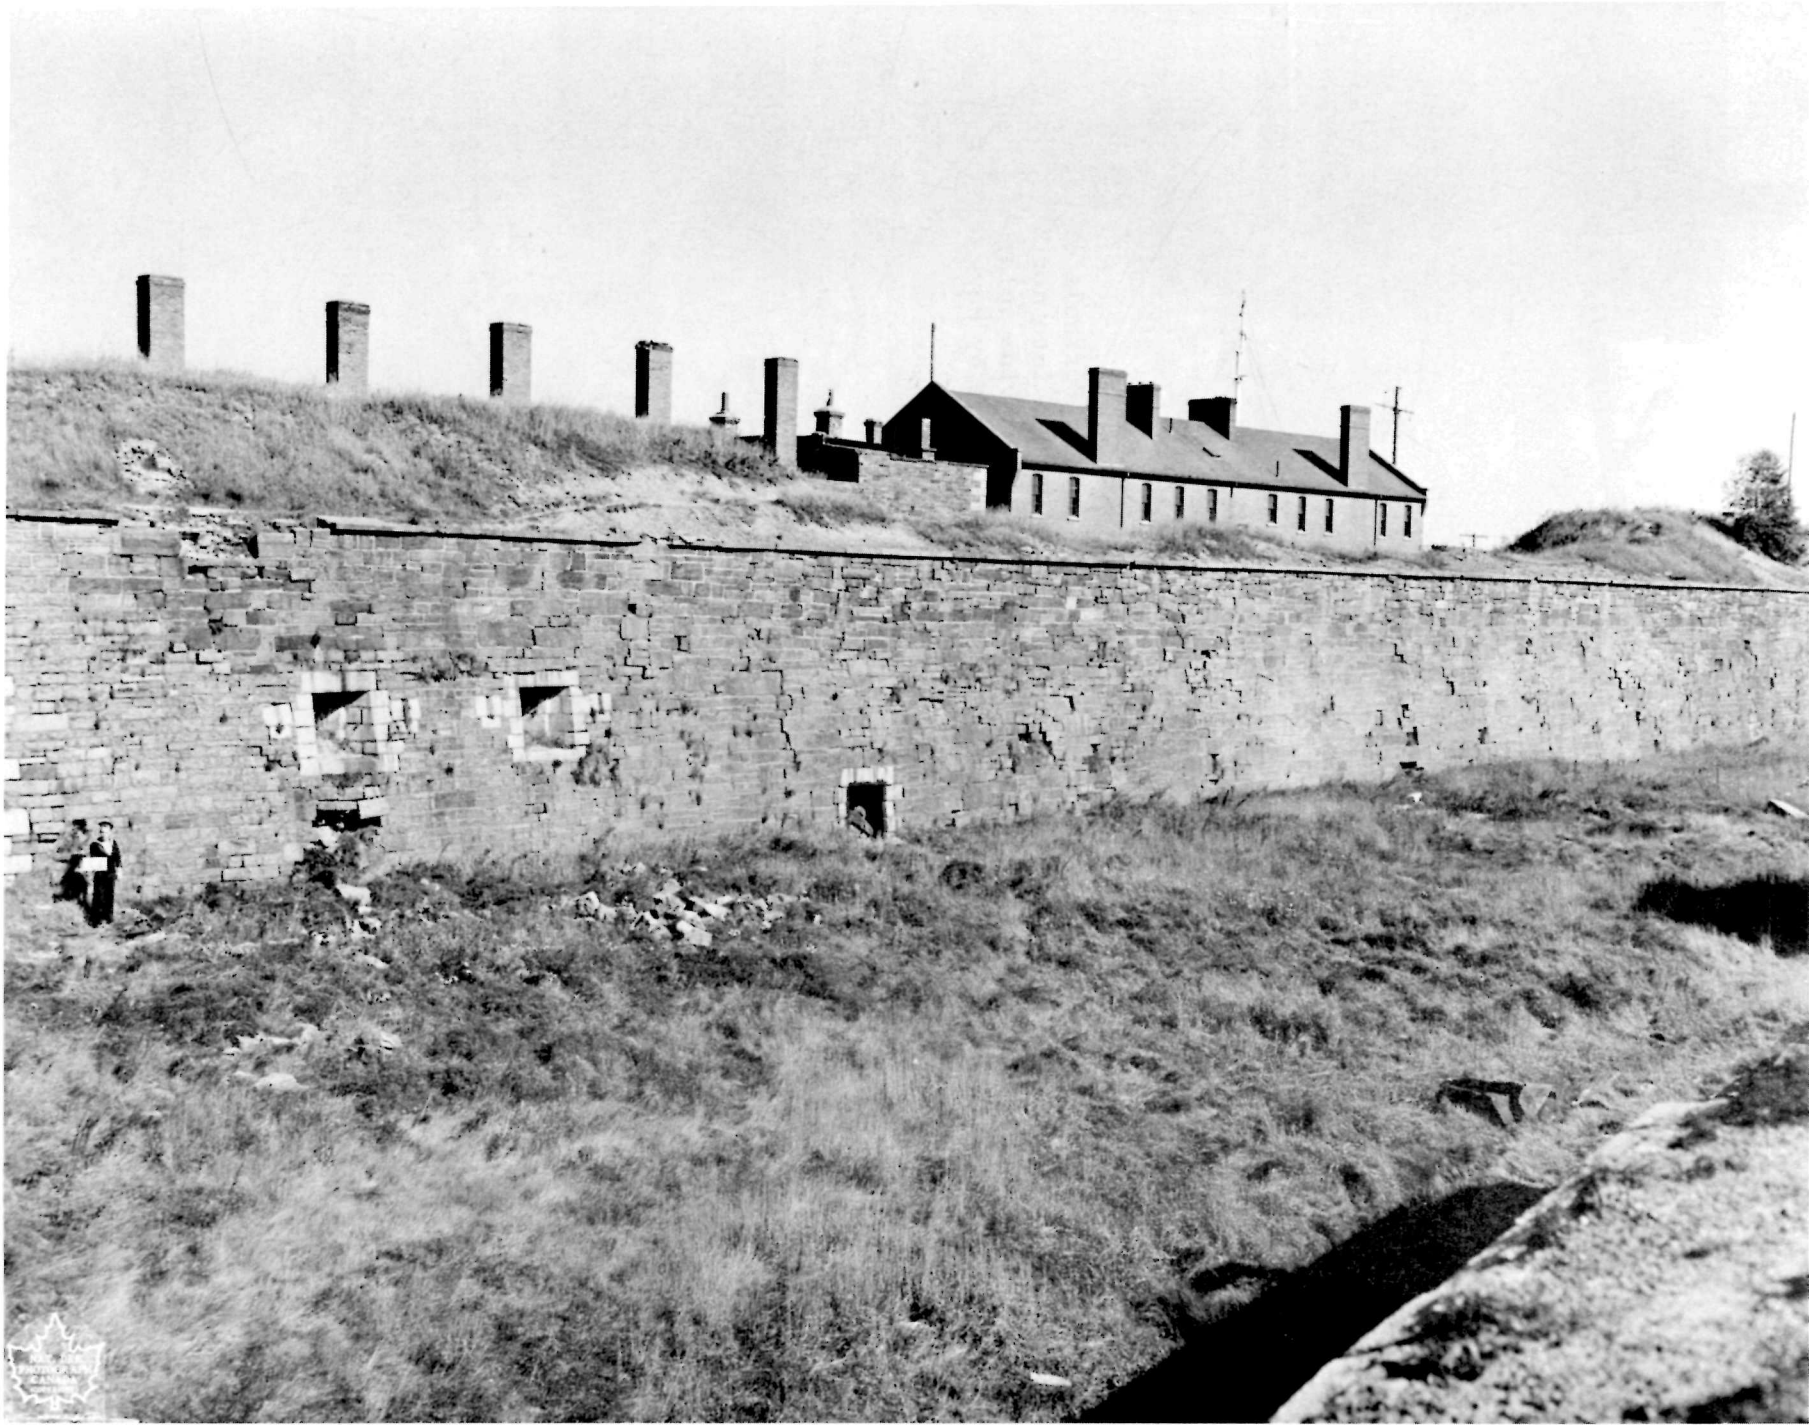
Photo of curtain wall from Massey report. Photo shows portholes as they existed in 1950. Notice steps on the south side of each porthole. These were chiselled into the granite to protect the gunners from ricocheting musket fire.

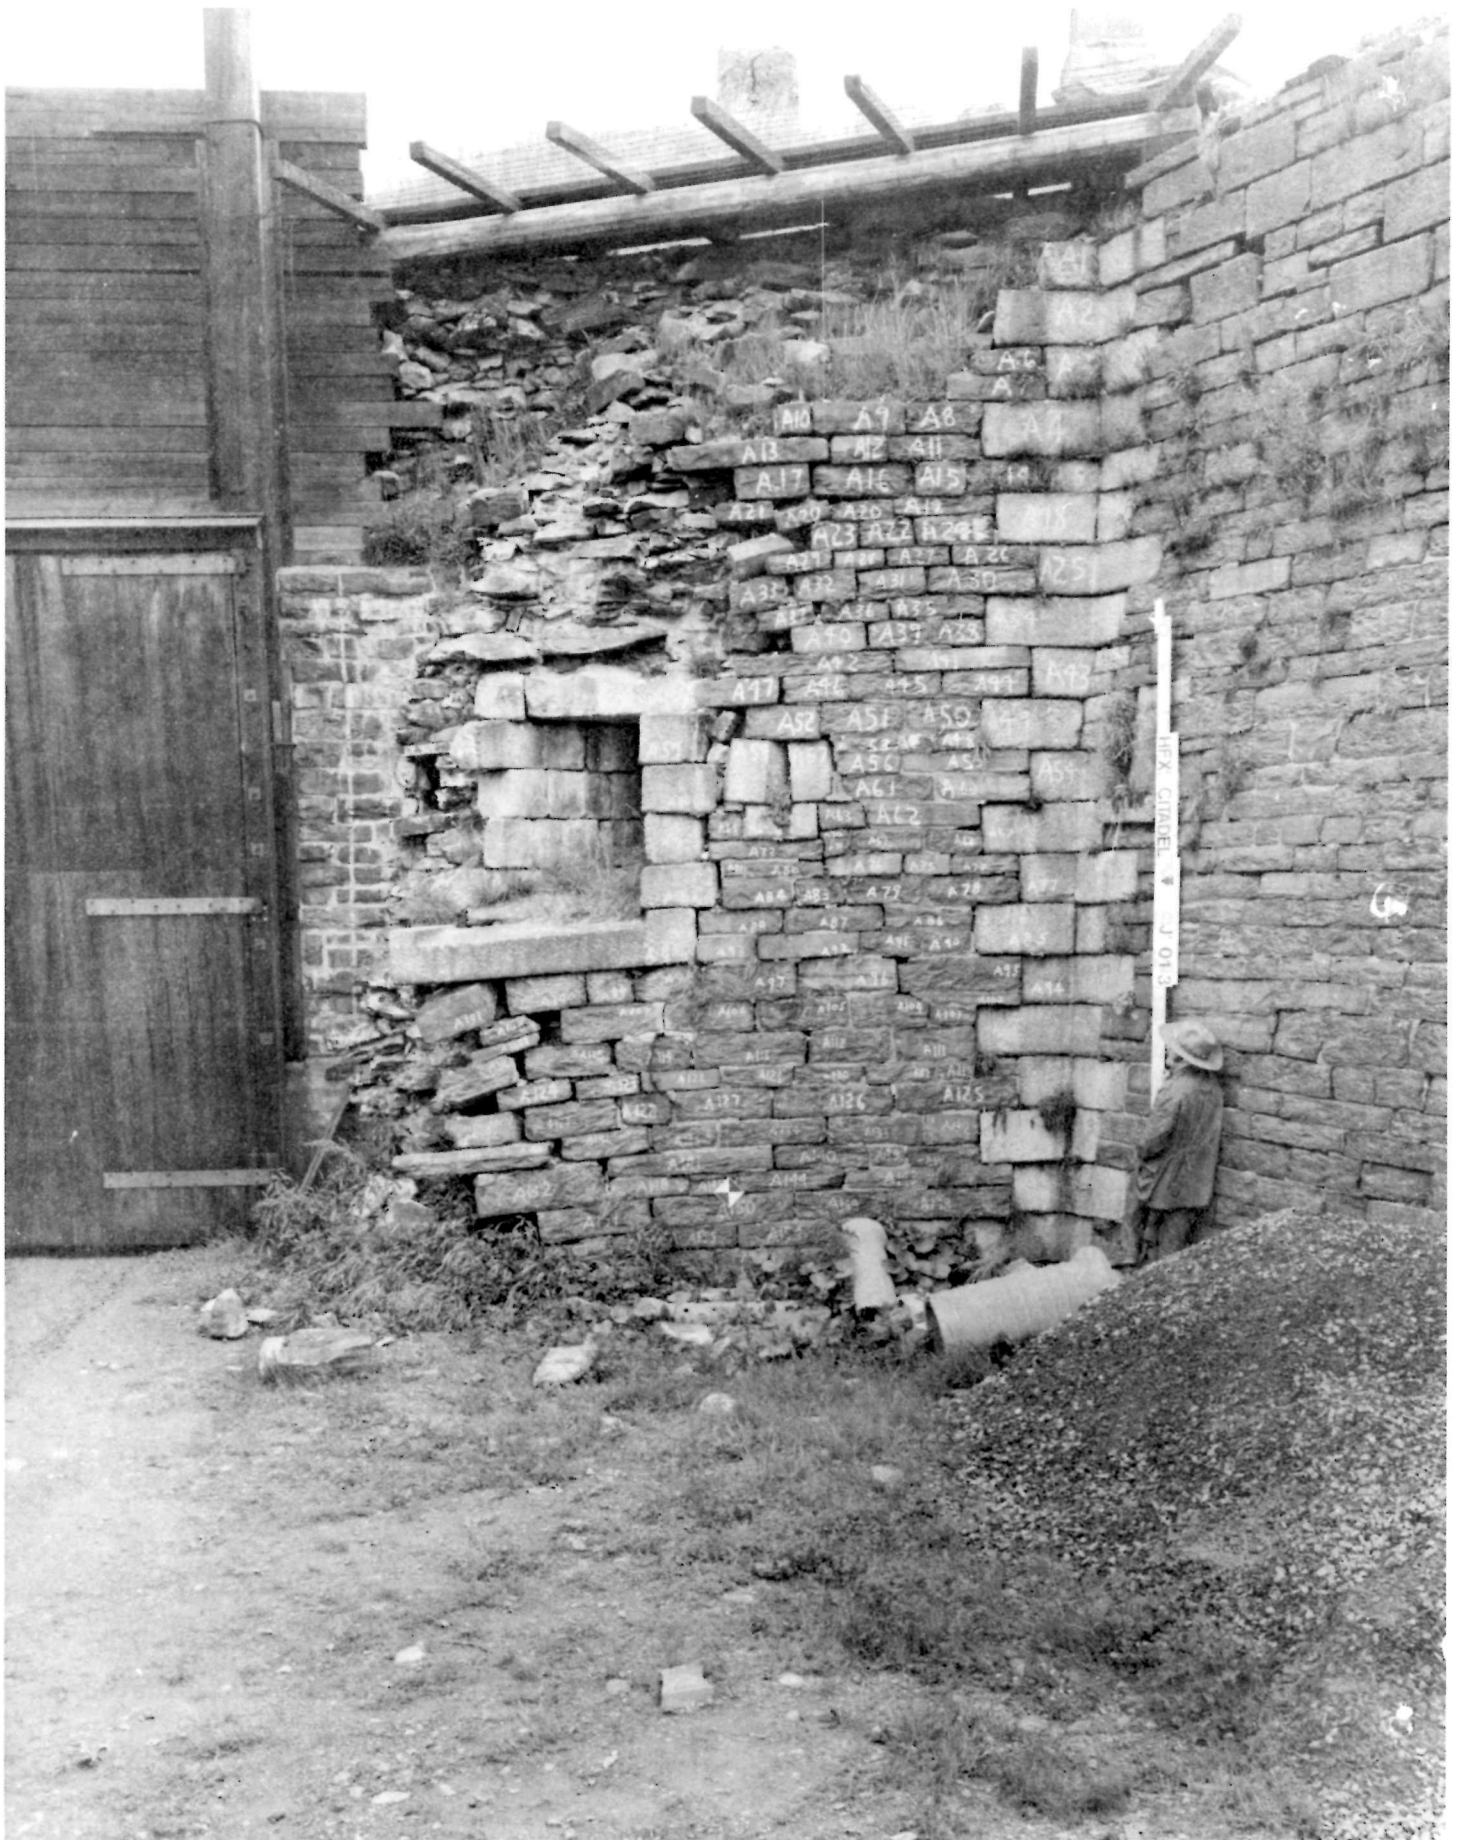
Figure 20

1973 as-found photo of south corner of curtain wall. Porthole of casemate 9 in a precarious state. Note step chiselled into north side of porthole and the granite sill chiselled to provide splay. The portion of the masonry still standing is that built by Hays in 1829.

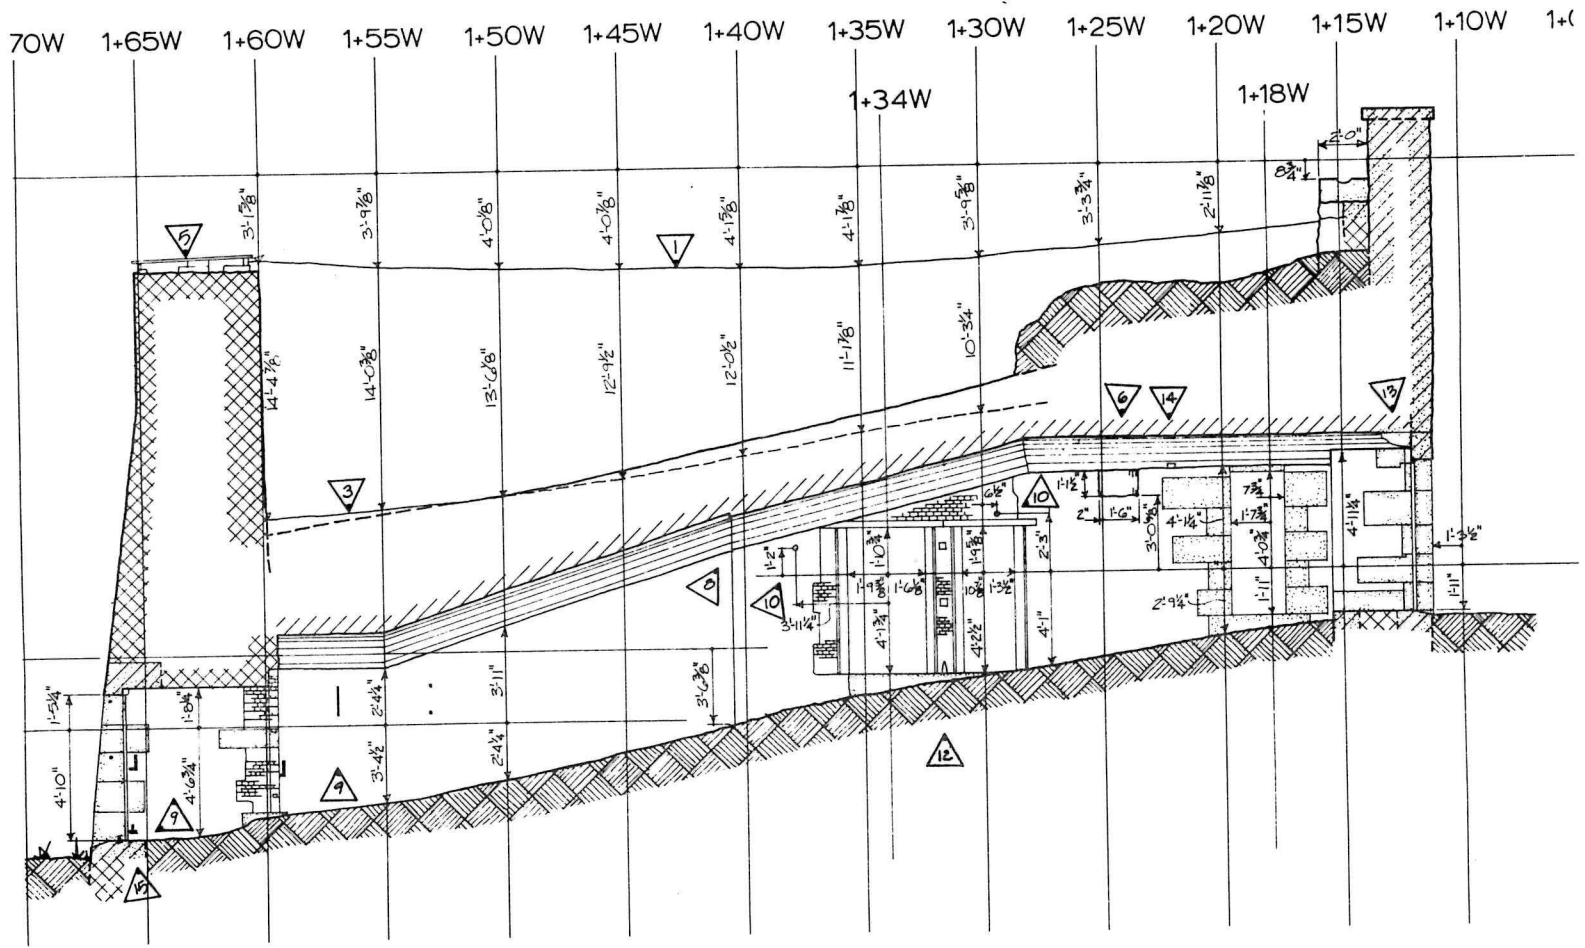
Figure 24

As-found profile of sally port 4, looking north. Note three openings in the pier wall. The one nearest the entranceway was the door to privy built in 1839. The next two are doors to casemate 56 and its recess room built after 1870. Floor profile after a century and a half of alterations and erosion. The sluice was buried when casemate 56 was built.

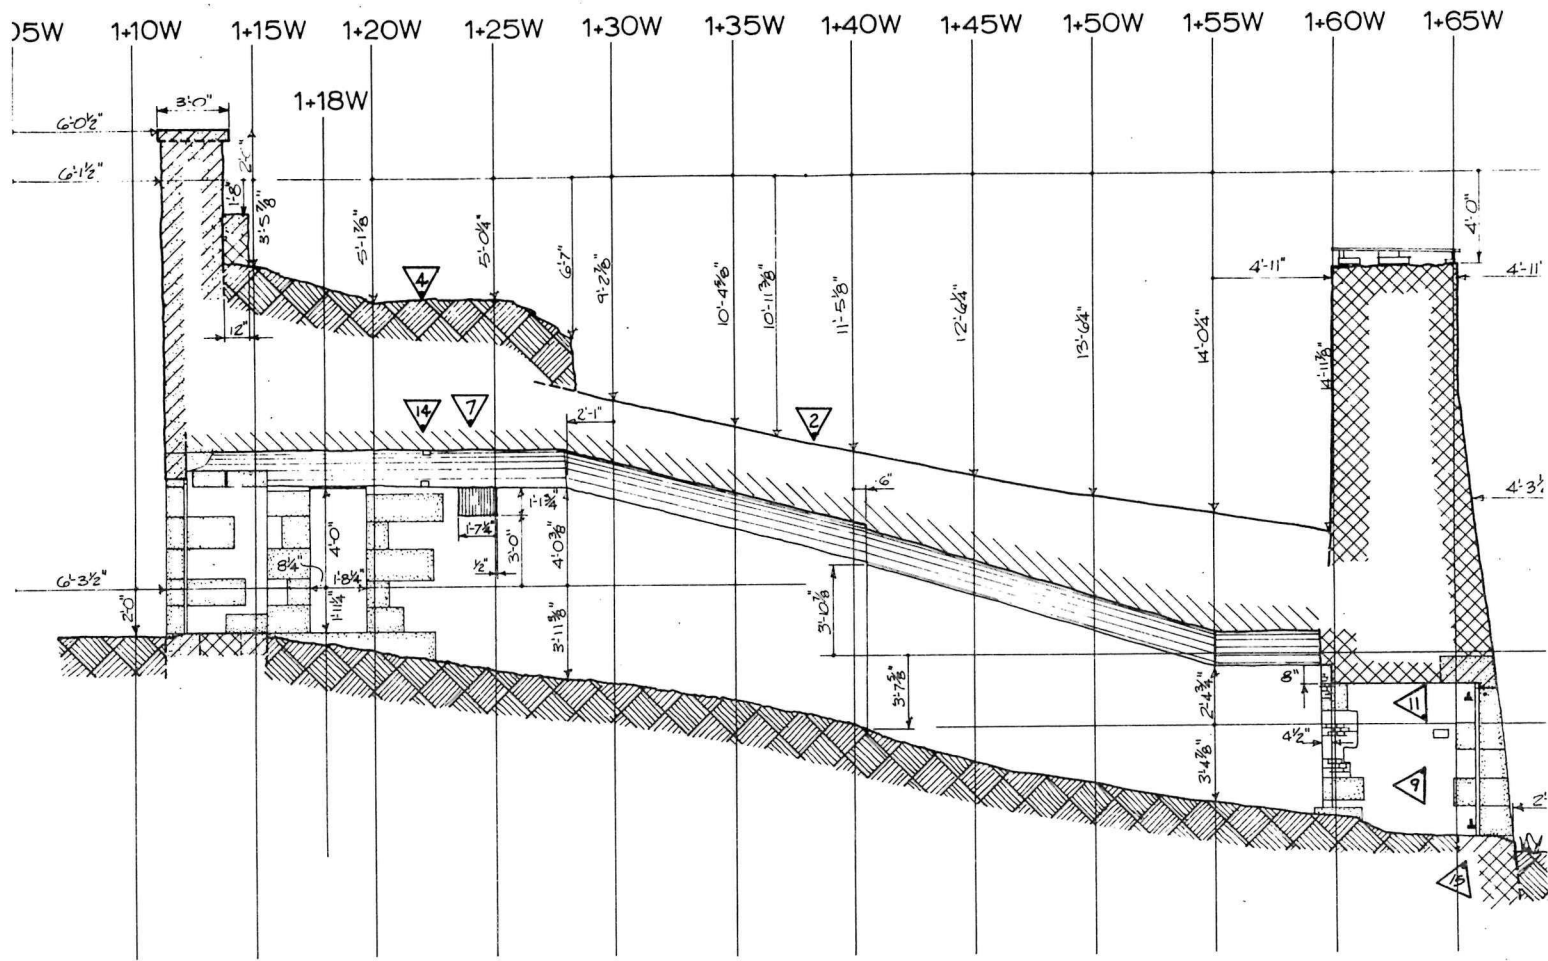
Figure 25

As-found profile of sally port 4, facing south. Door near entranceway was built in 1839 and filled in some time after 1870.
