Manuscript Report
Number

WEST CURTAIN WALL AND SALLY PORTS
THREE AND FOUR, HALIFAX CITADEL

by Richard J. Young

1976

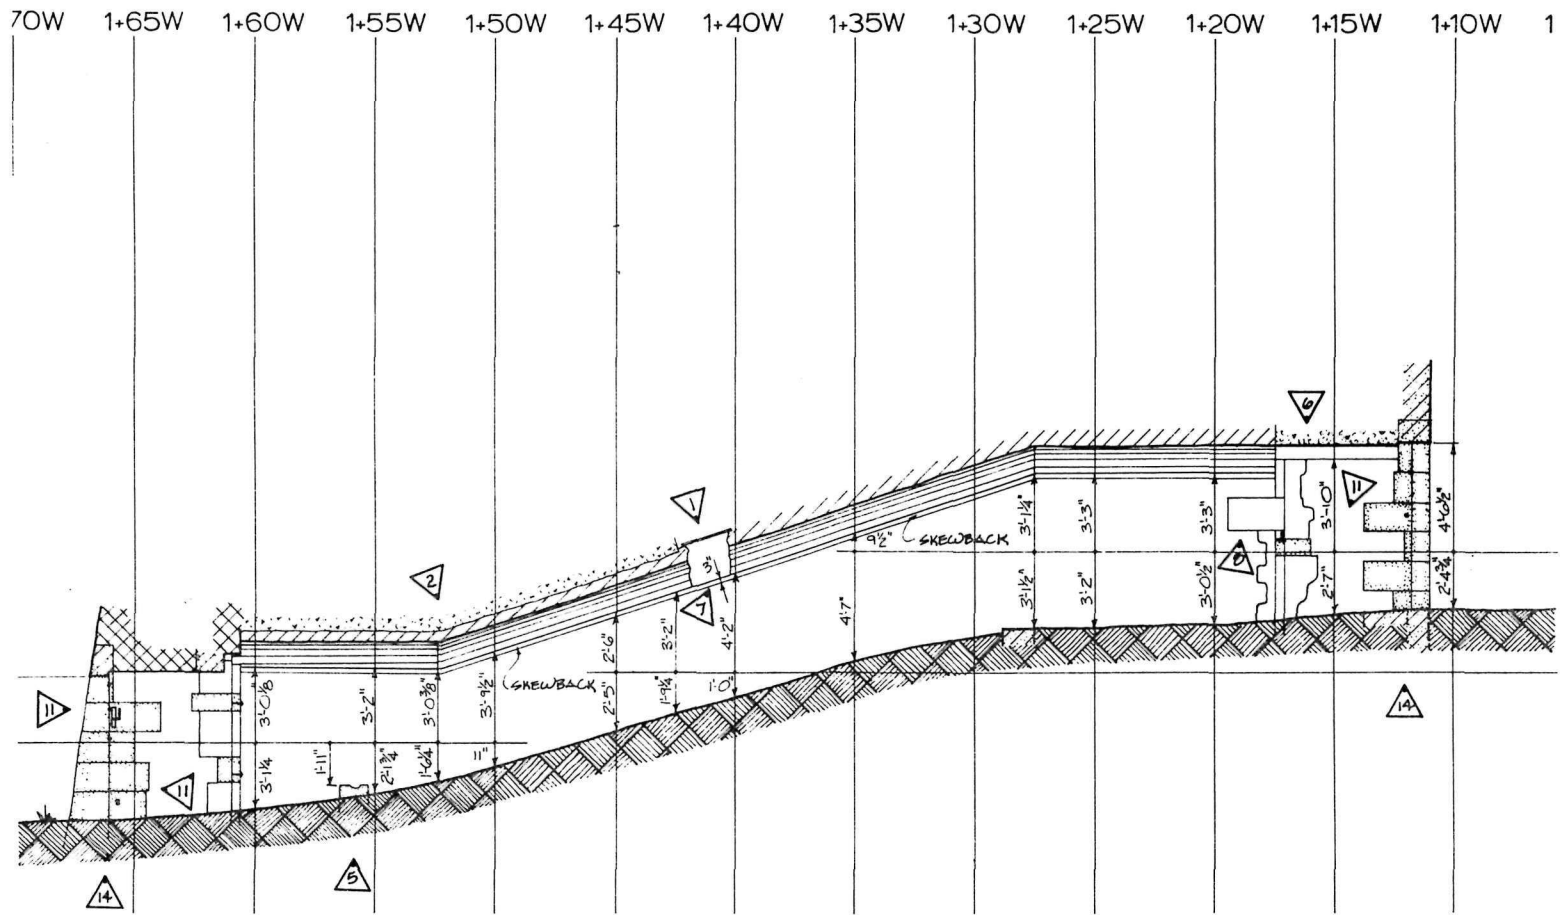
Figure 26

As-found profile of sally port 3, facing north. Note granite step at beginning of slope to ditch exit. The roof profile is that built in 1831 and presently being reconstructed.

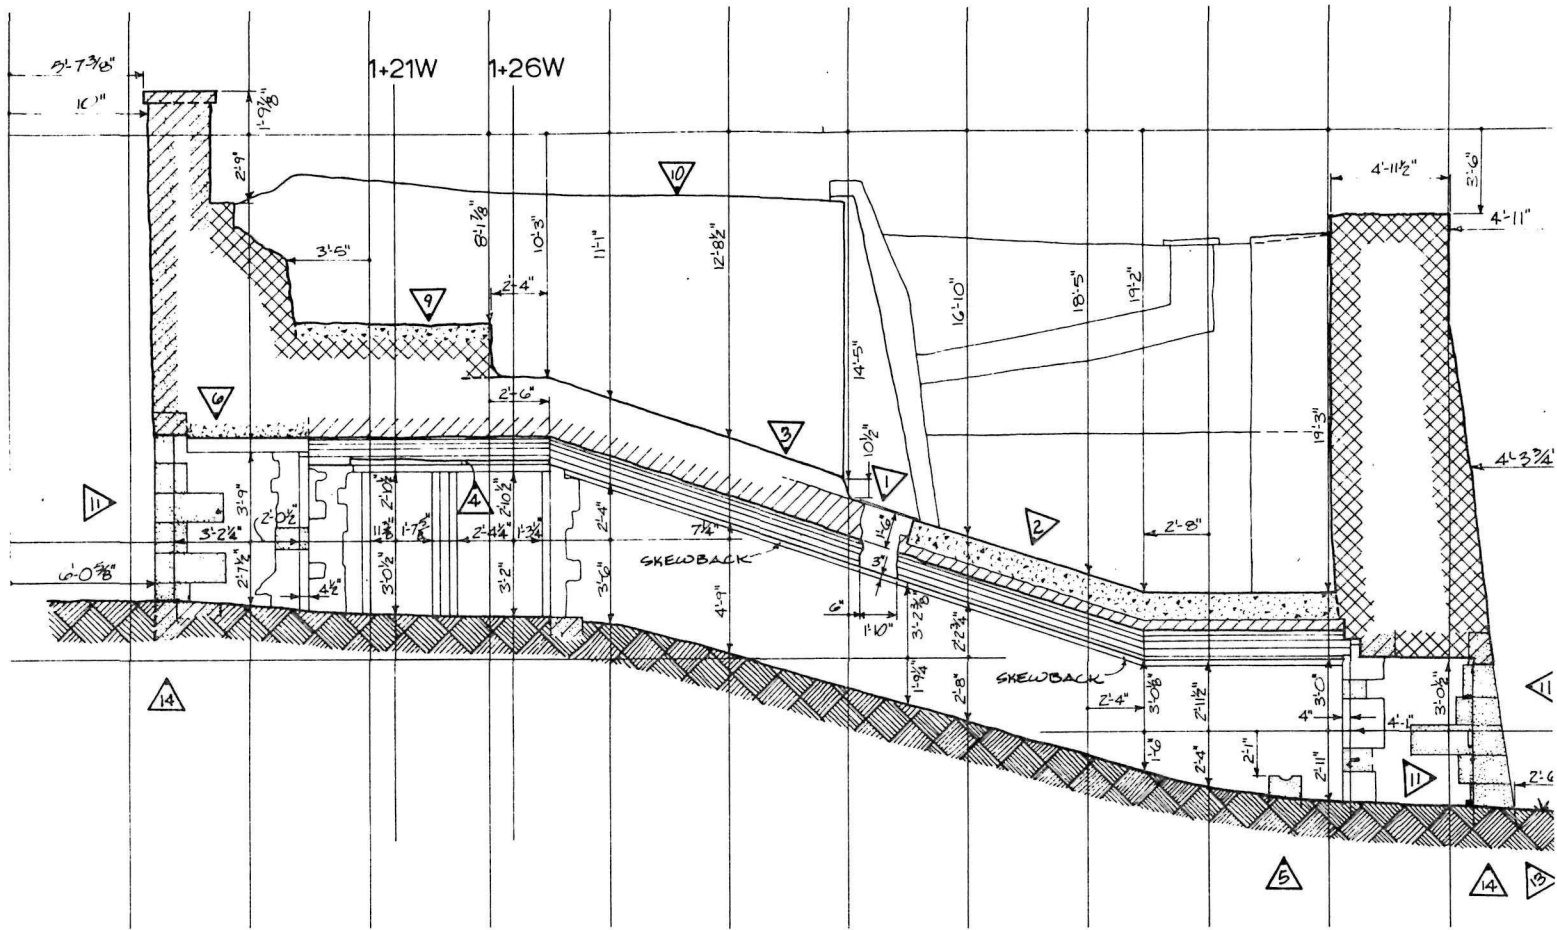
Figure 27

As-found profile of sally port 3, facing south. The two doors were built to provide an entrance to casemate 53 constructed some time between 1870-90.
