PICTORIAL REPORT  
V-1 LAUNCHING SYSTEM

COMBINED INTELLIGENCE OBJECTIVES  
SUB COMMITTEE

18 September, 1944

Dr. C.N. HICKMAN  
ALSOS MISSION

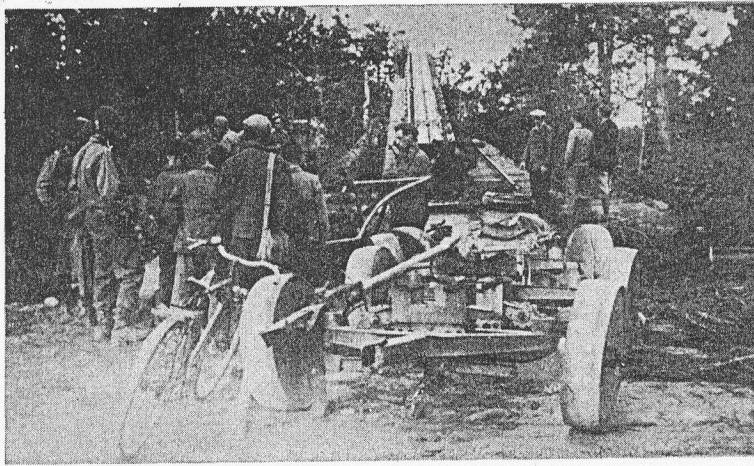
1. Breech view of wrecked ramp at site No. 17. Three road transportation cars are shown in the foreground.

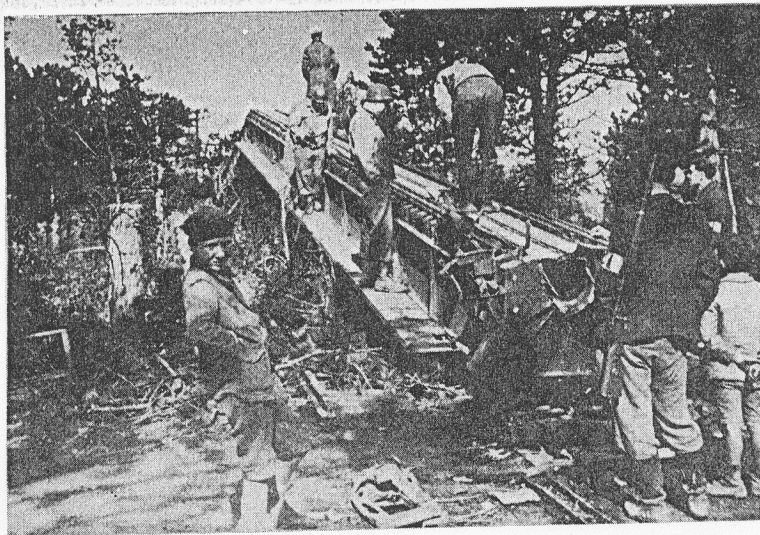
2. A closer view of the wrecked ramp at Sit No. 17. The elevation of all ramps measured was about 8.6 degrees. The cat walk at the left of the ramp is used by the crew in stringing the pipe valve along the slit. There is a hand rail along this side.

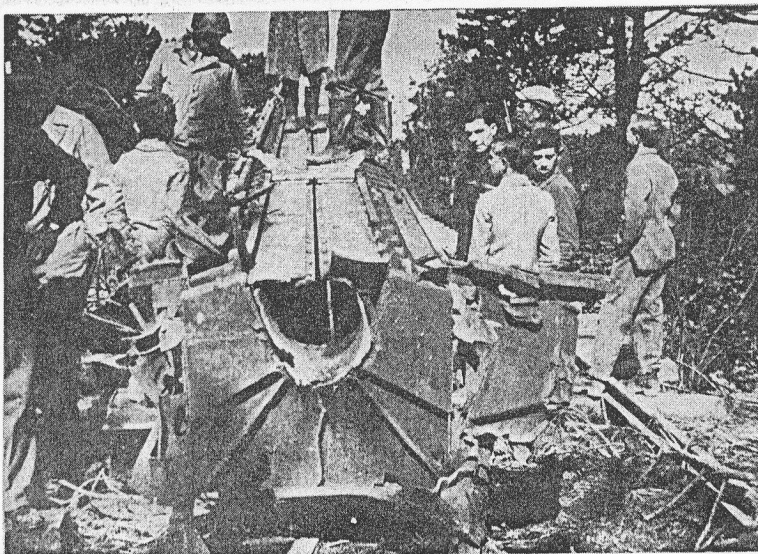
3. A still closer view of this ramp. The ribbed casting in the foreground is about 35" square and has a thickness of  $4\frac{3}{8}$ ". The split gun tube is welded in the "U" shaped part of the casting. The spacing between castings is  $10\frac{1}{8}$ ". These are welded together by the  $7\frac{1}{4}$  x  $\frac{3}{4}$ " plates at the top, by side plates and by "T" shaped members which have a screw that is attached to the top plates. Along the edges of the steel plates are two guide rails made of  $1\frac{1}{16}$  x  $\frac{5}{8}$ " strap steel. A saddle slides on the steel plates and is guided by these rails. A saddle may be seen on the ramp.

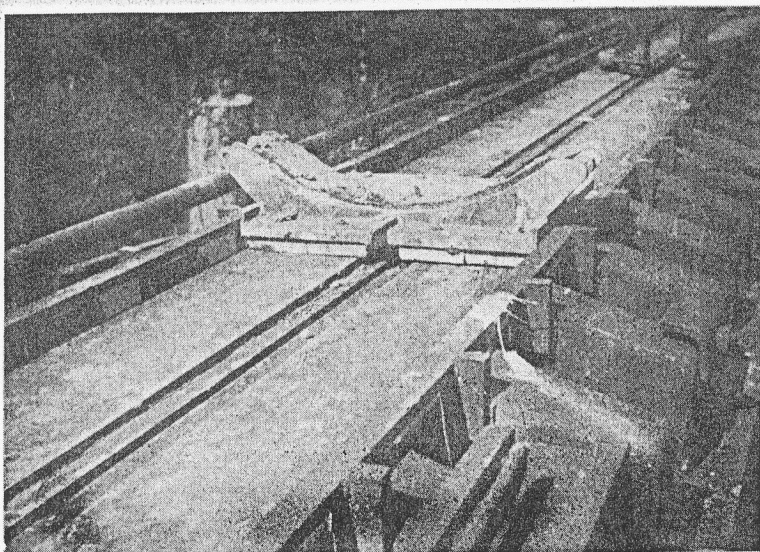
4. Close view of the saddle. The hand rail may be seen at the left.

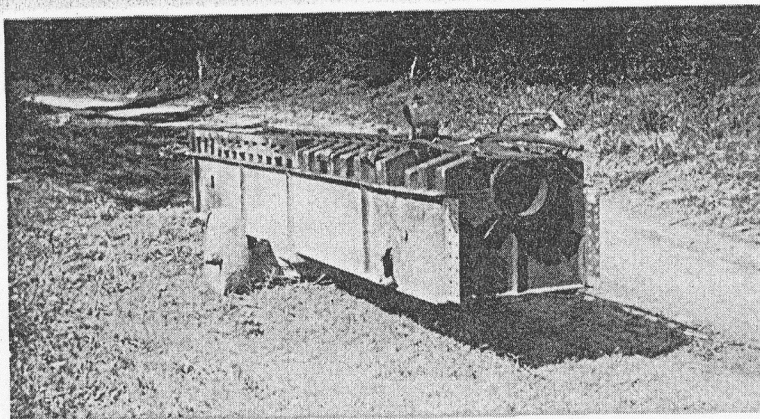
5. Breech section of a ramp loaded on a road cart at site No. 18. The breech of this section is on the far end and the flange portion of the tube was broken off. This section was probably going back for repair. The ramp is made in sections like this one. The length of a section is about 18 feet. The side plates are bolted together and the tube has flanges which are bolted together.

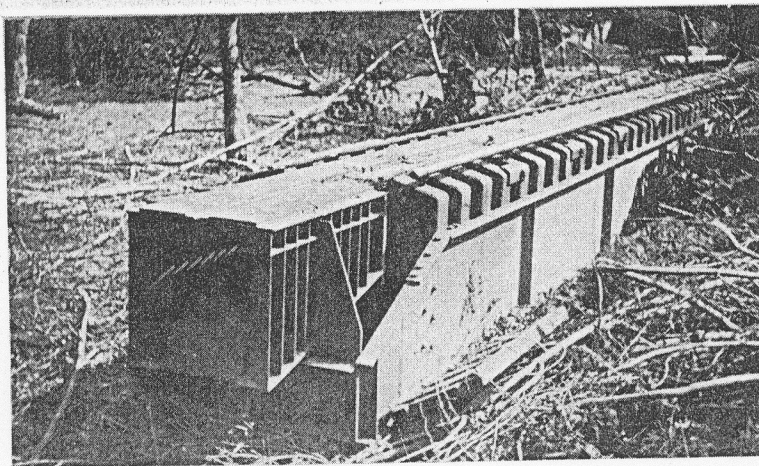
6. Muzzle end of wrecked ramp at site No. 18. The end of the ramp terminates in a muzzle break. This is probably used to vent the gun so that the robot will not be subject to the muzzle blast rather than to reduce recoil.

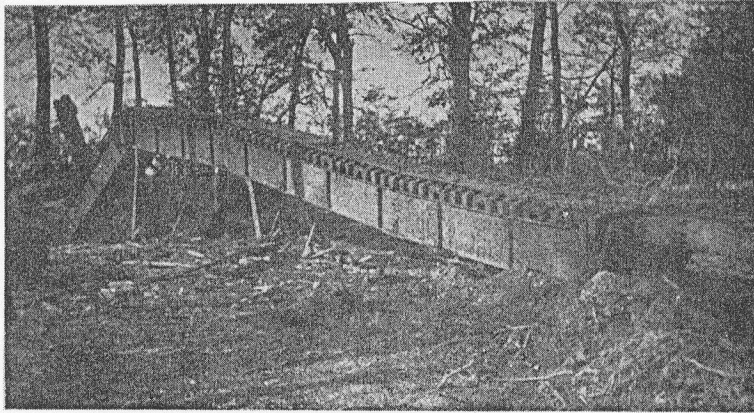
7. Portion of wrecked ramp at Site No. 21.

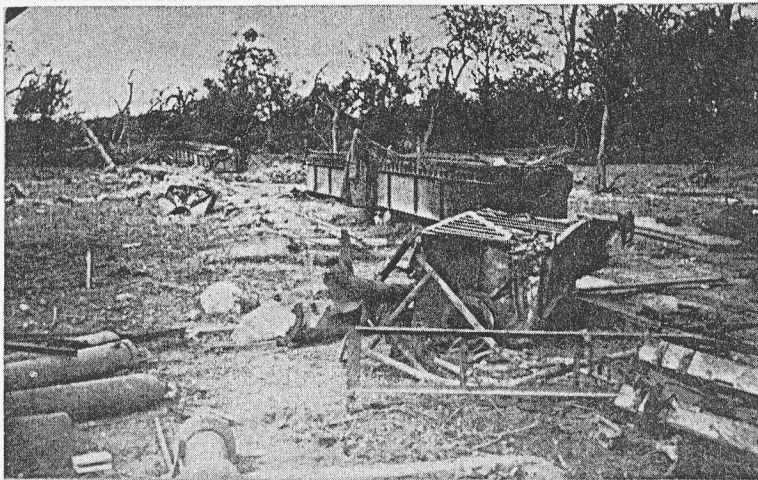
8. Breech end of wrecked ramp at Site No. 18. The end of this ramp shows the interrupted flange to which the combustion chamber is attached.

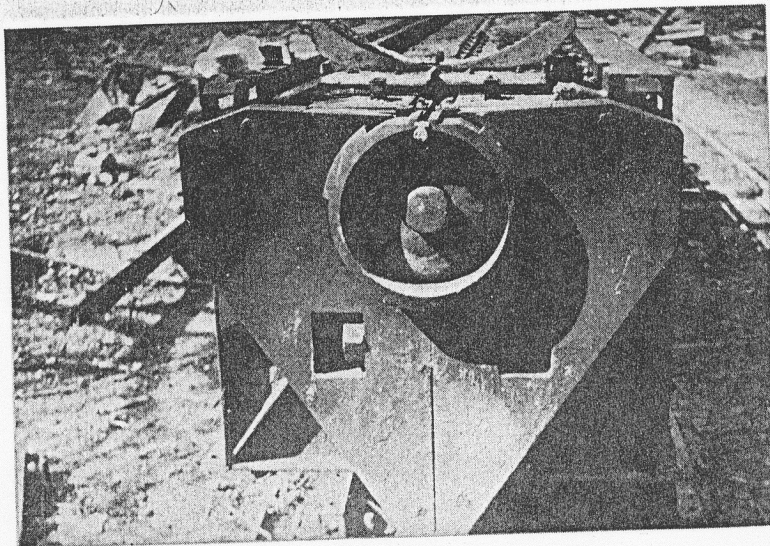
9. Close view of breech end of ramp at Site No. 18. The piston is in the split tube. Note the interrupted flange to which the combustion chamber is attached. A "T" shaped bolt may be seen in the tube slot. This bolt is screwed to the 1" diameter pipe valve that seals the slot. A saddle is shown on the runway of the ramp.

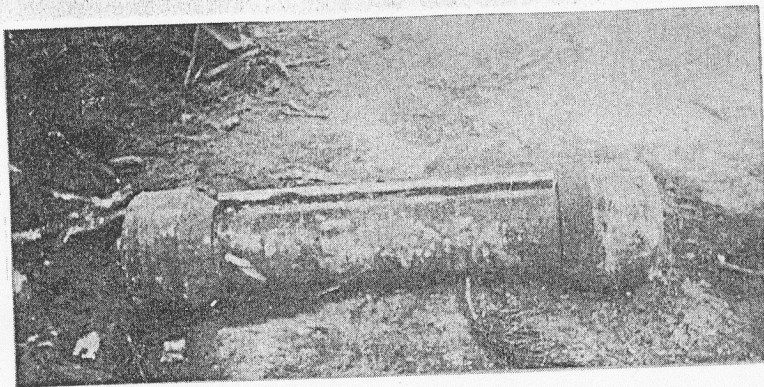
10. Side view of dumbbell shaped piston at Site No. 17. The length of the piston is 51 inches and the diameter of the end member is about  $11\frac{1}{2}$  inches. The middle pipe is  $7\frac{1}{4}$  inches in diameter. One of two shoes is shown in the picture. The piston weighs about 300 lbs.

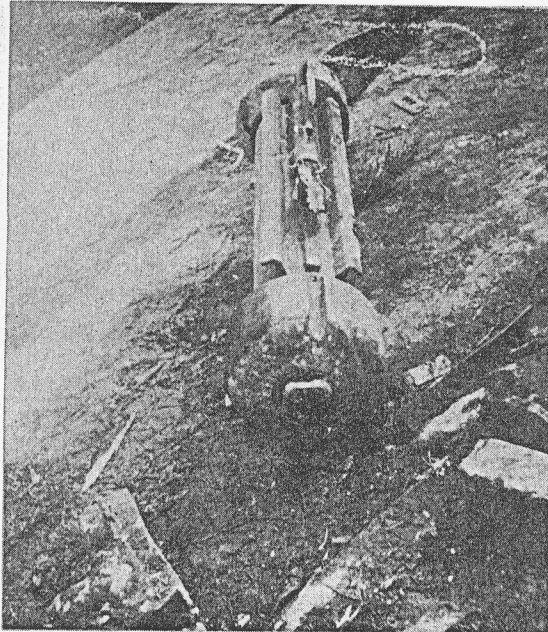
11. Rear view of the piston. Both shoes may be seen and the fin is at the far end. This fin is attached to a "U" shaped member through which the pipe valve passes. In this picture there is a piece of wood in the hole through which the pipe passes. It was wedged so tight that we could not remove it. The groove in the end portion of the piston is for the pipe valve.

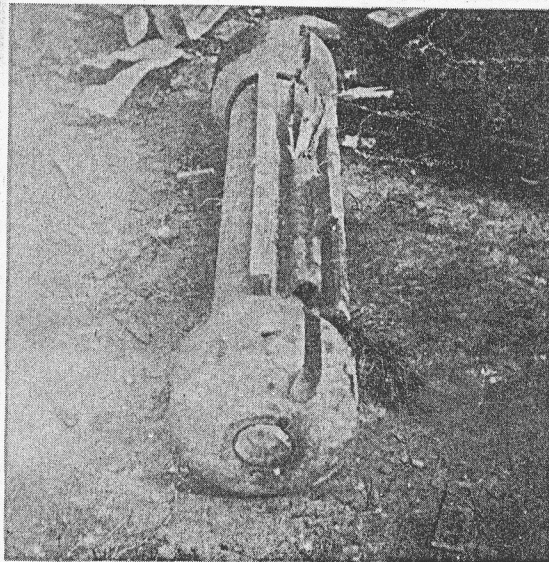
12. Front view of piston. This end also has a groove for the pipe

valve. The fin and hole through the pipe valve passes may be seen.

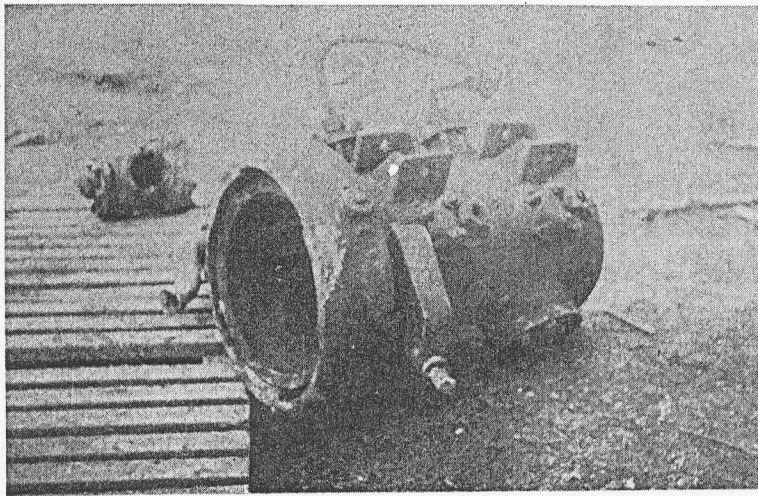
13. Combustion chamber at Site No. 17: These are 4 large aluminum tubes attached to this chamber which terminates in convex perforated discs. Hydrogen peroxide fuel is forced into the Chamber by compressed air. There are also 4 similar tubes and smaller perforated inlets for the potassium permanganate fuel. The combustion chamber, together with fuel tanks, compressed air cylinders and electromagnetic control valves are mounted on a four wheel car.

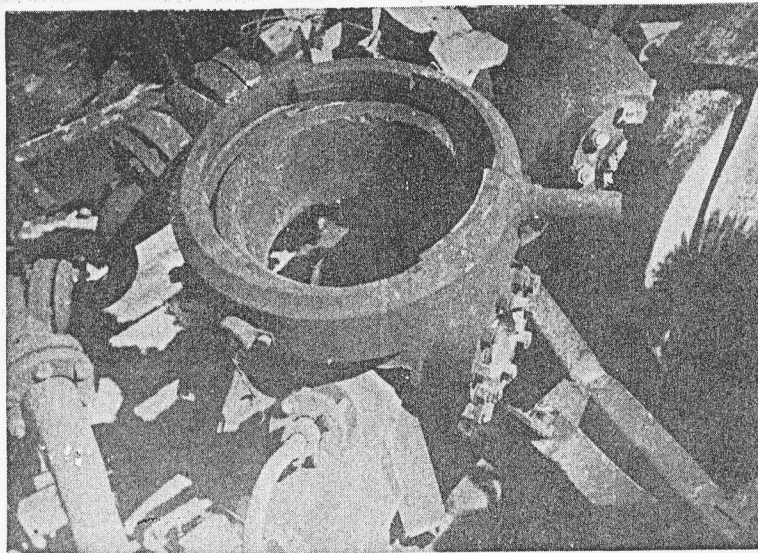
14. A close-up view of the combustion chamber showing the collar for attaching it to the launching tube.

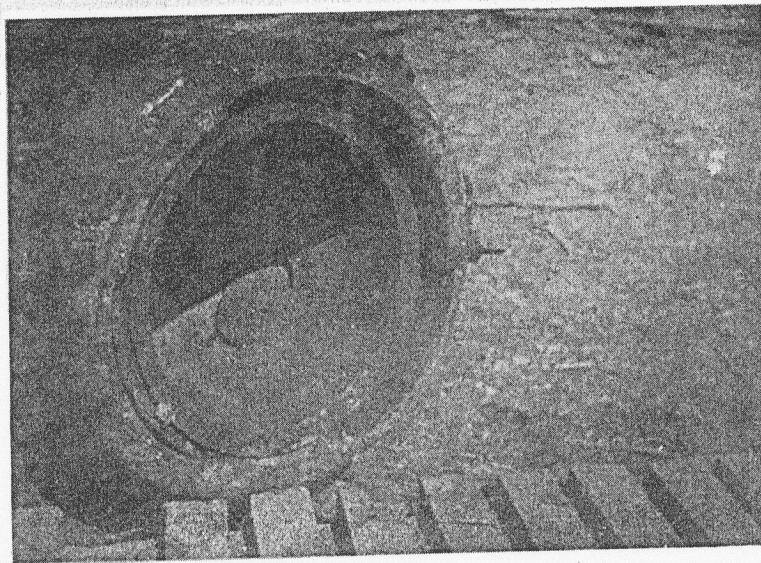
15. Interior of the combustion chamber showing one of the 4 inlets for the hydrogen peroxide fuel.

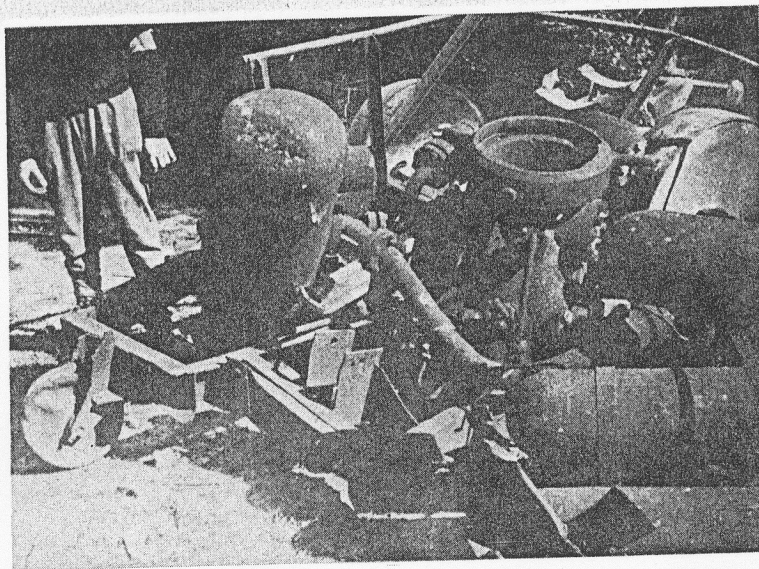
16. A wrecked breech car at Site No. 17, showing fuel cans, combustion chamber and compressed air cylinders.

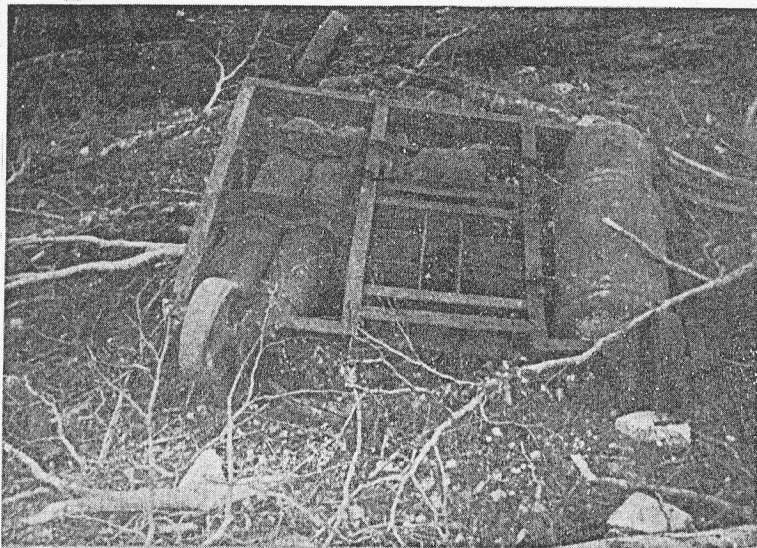
17. Wrecked breech car at Site No. 21. The car is upside down.

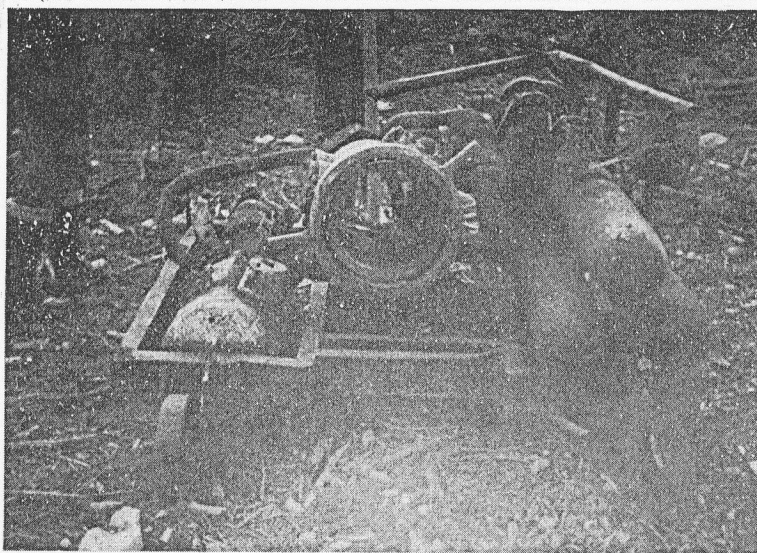
18. Front view of this car turned right side up. The hydrogen peroxide tank is on the left.

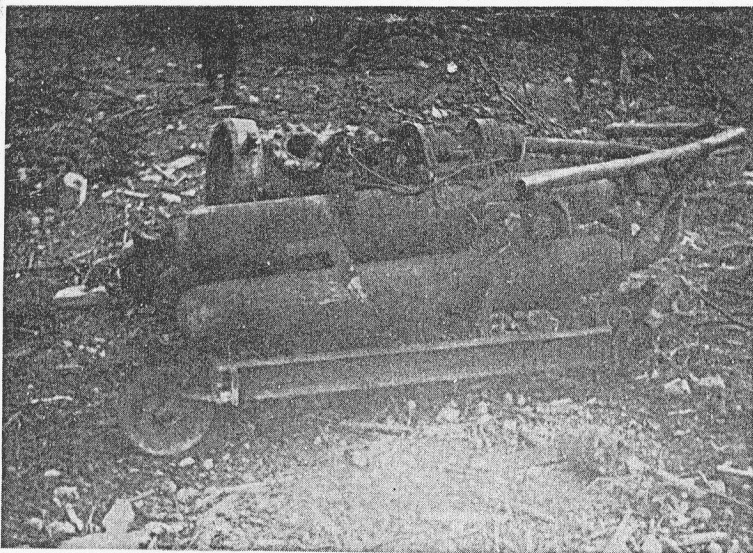
19. Side view of breech car. The compressed air cylinders are in the foreground.

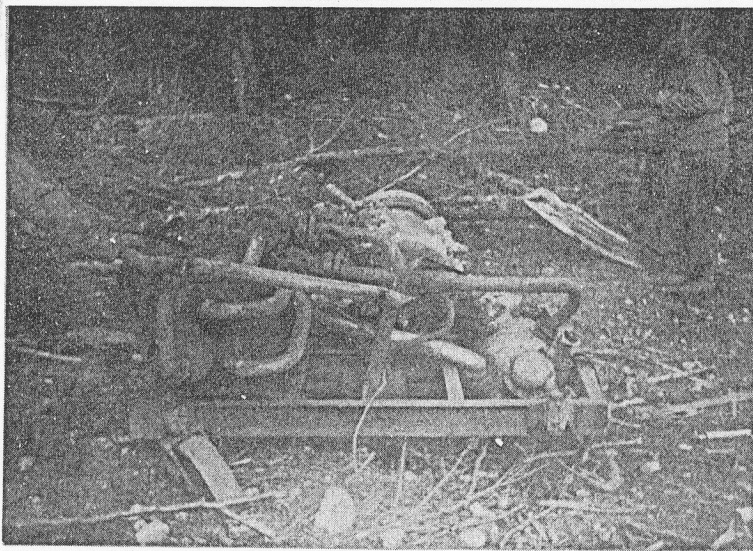
20. Rear view of breech car.

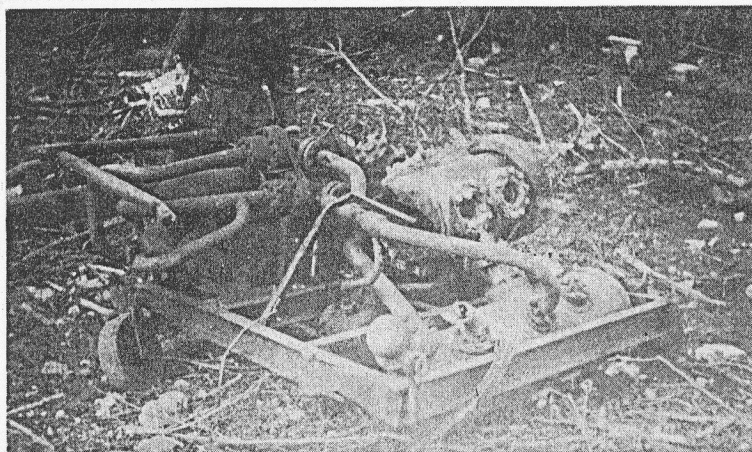
21. Diagonal view of breech car. This car is pushed up to the landing tube, the breech block chamber attached to the launching tube and by remote control the fuels are started. No spark is needed. It is assumed that the valve on the car increases the air pressure and thereby the quantity of fuel injected as the piston moves through the launching tube. In this manner constant pressure and constant acceleration may be obtained. At each site there is a house or wall provided with a large pipe passing through the wall. The breech car is pushed up to the pipe and the fuel tested. On the other side of the wall a drain ditch takes care of any excess fuel.

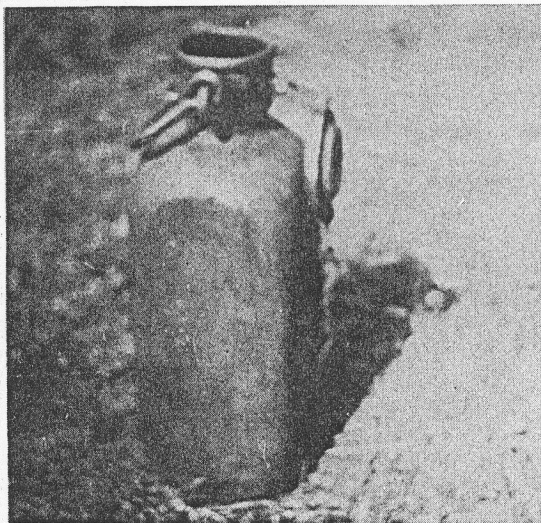
22. A potassium permanganate iron can at Site No. 18. This is probably a dose for one launching. The corresponding can for the hydrogen

peroxide fuel is made of aluminum and has a capacity of about 5 gallons. See double exposure picture No. 30 for outline of this can.

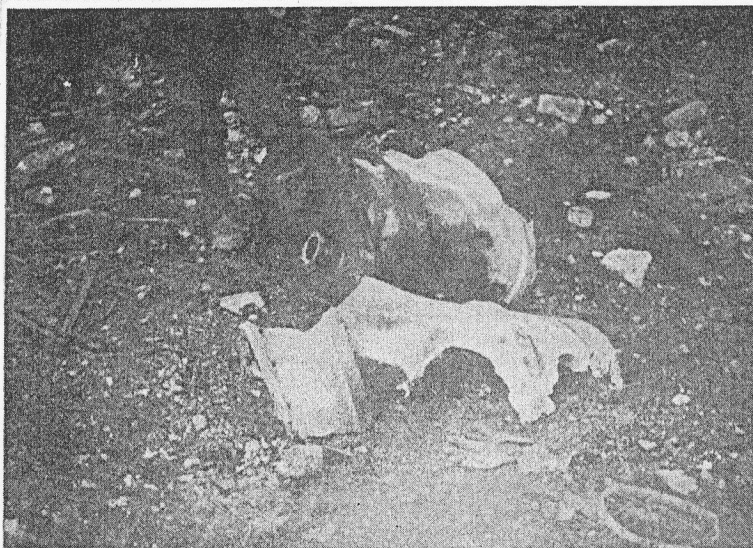
23. A wrecked aluminum storage can at Site No. 21. This can holds more than the other one.

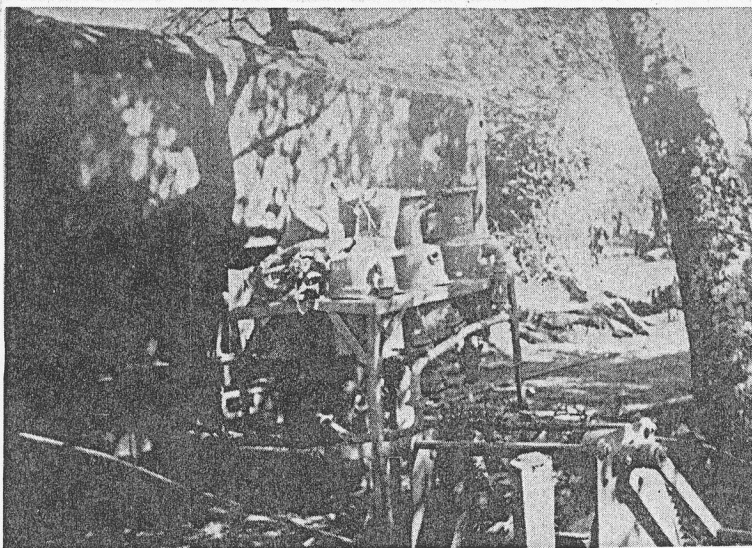
24. Filler system at Site No. 18. The purpose of this apparatus is not fully known. It is possible that the smaller "one dose cans" are filled here.

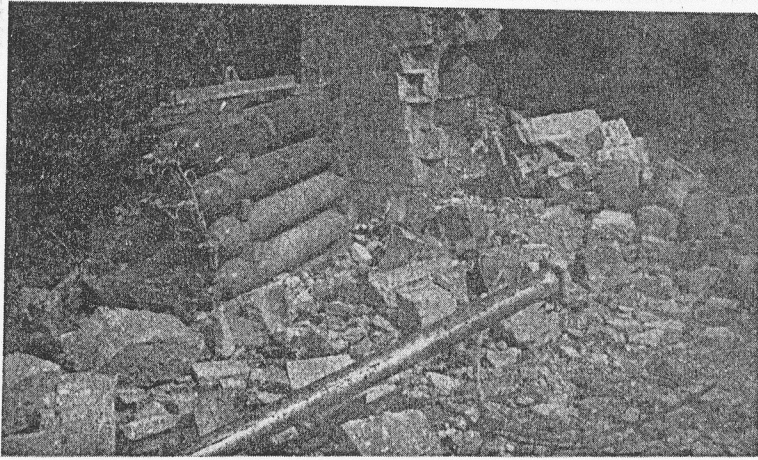
25. Nest of compressed air cylinders. This apparatus may be part of a system for recharging the air cylinders.

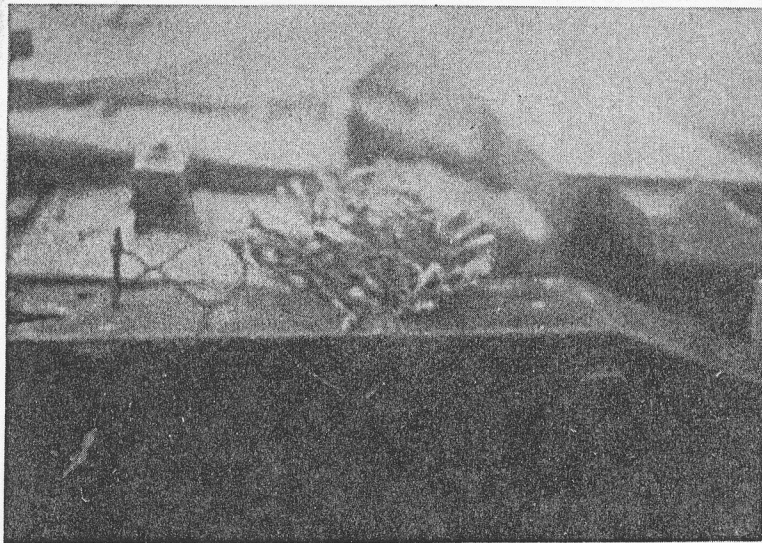
26. Bundle of wire suspension loops for holding the pipe valve adjacent to the slit in the tube. As the piston moves through the tube these loops are scraped off. It is necessary for the crew to suspend the pipe valve with these wire loops after every launching. A single loop from the bundle is shown at the left. Each time a robot is launched the piston falls at a distance of from one to two kilometers from the site. It is retrieved and used again. Due to its light weight, the saddle only goes a distance of from 100 to 200 meters.

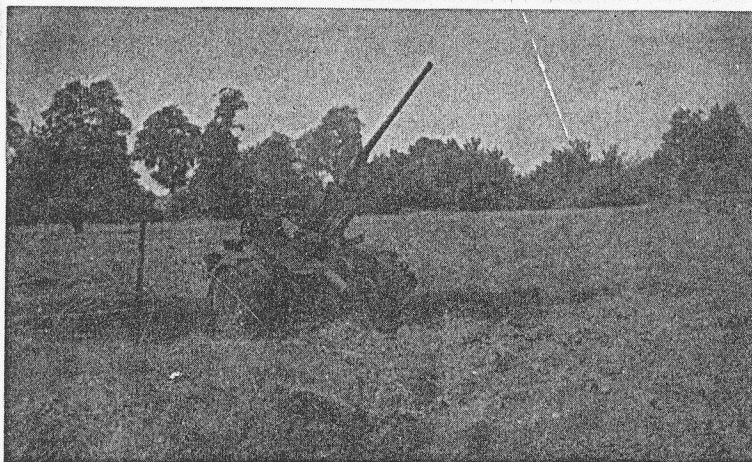
27. Abandoned German anti-aircraft gun at site No. 18. The French say that the Germans only had about two hours in which to leave sites 17 and 18. They made frantic efforts to hide or destroy the equipment but could not do much in such a short time. There was a large store of anti-aircraft ammunition on the site. Anti-aircraft guns were also left at site No. 17.

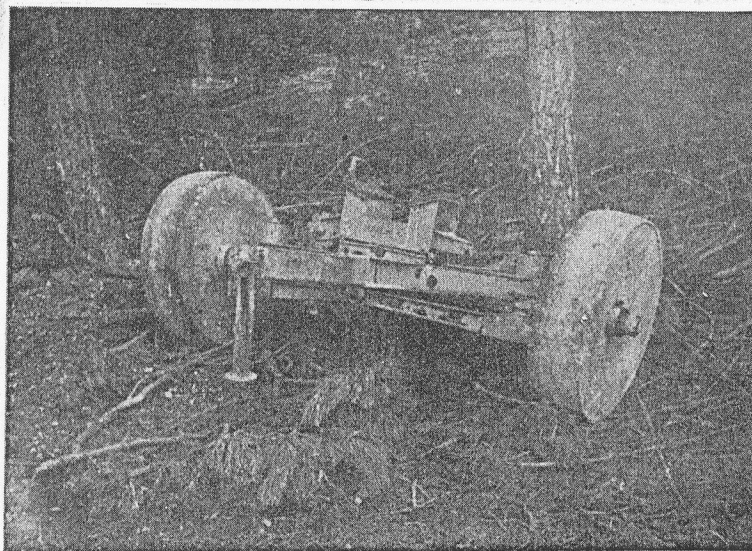
28. One of the road carts used in transporting the robots and gun sections at site No. 17.

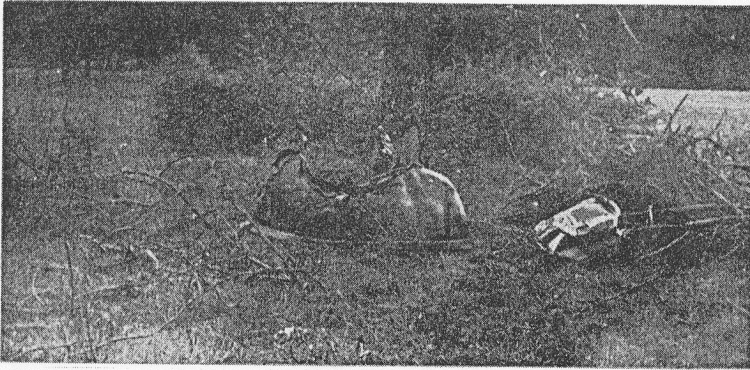
29. Wreckage of a V-1 at Site No. 3: Near all sites which had been used, there were wrecks of V-1s. The French say that  $\frac{1}{3}$  of all robots launched failed to fly properly. They say that often the fuel tanks fail and the robot burns. In some cases the robot turned 180 degrees and landed behind the site.

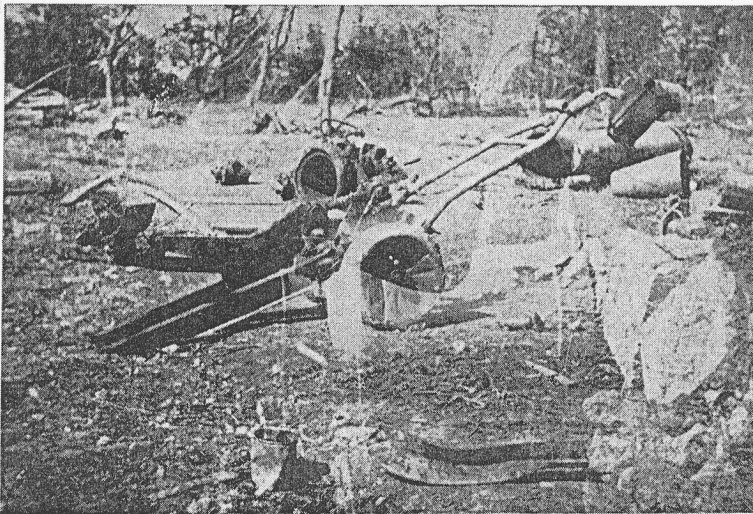
30. V-1 wreck at Site No. 18. This is a double exposure. The faint outline of an aluminum can for hydrogen peroxide may be seen in this picture.

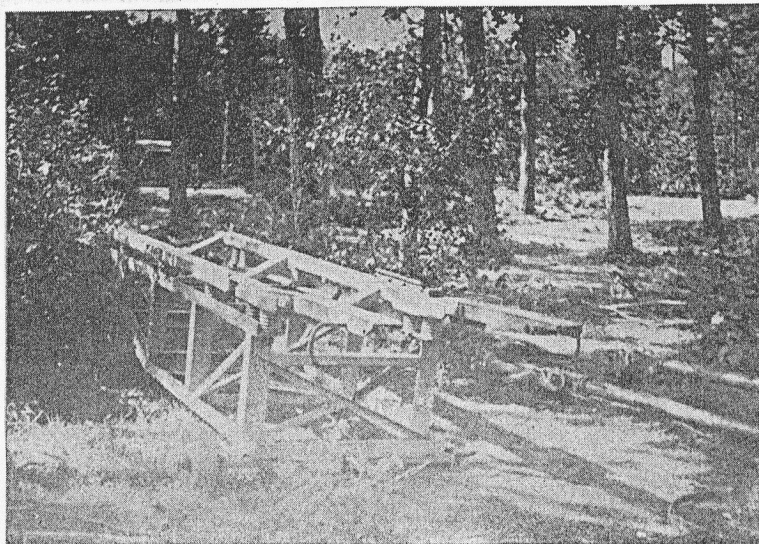
31. Loading truck for placing robots on the ramp. The extensions in the foreground are adjustable to correspond to the height of the ramp.

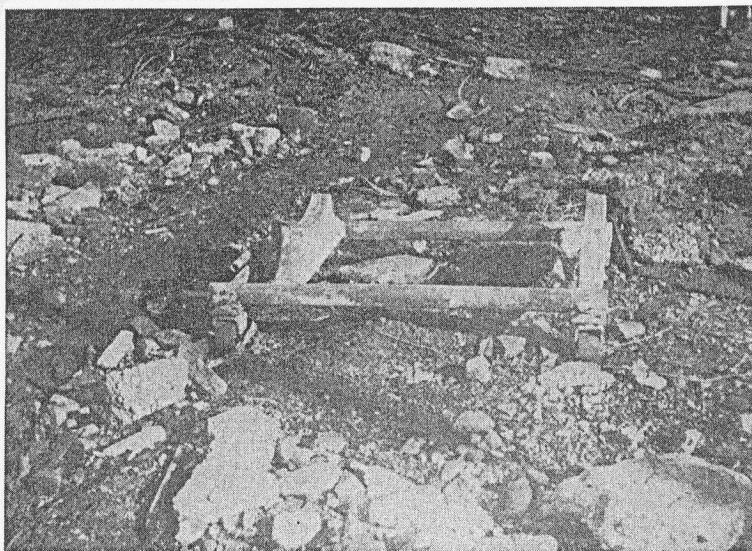
32. A small truck at Site No. 21. The purpose of this truck is not known.

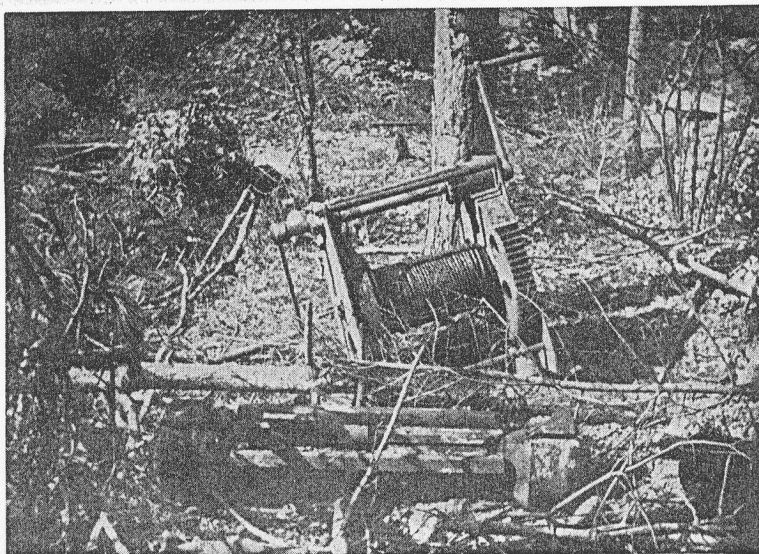
33. Wench for large crane hoist. At each site there was a large crane which runs on rails spaced about 14 feet apart. These rails extend the full length of the ramp and the crane is high enough to use at the muzzle end. Some cranes were made of steel and some of wood. The crane was used in construction and repairs. Note the piston lying in the foreground.

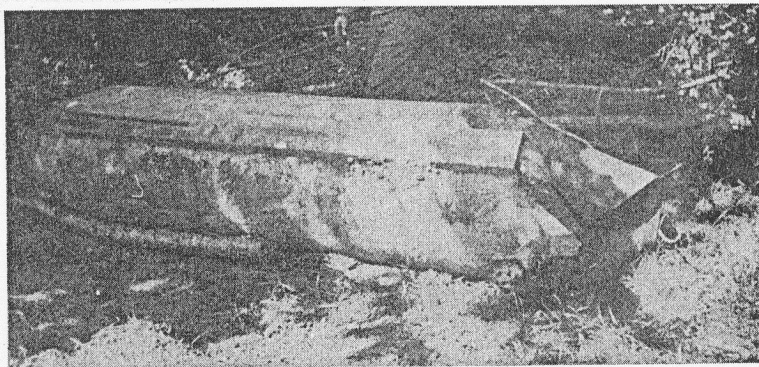
34. Rear view of practice projectile at Site No. 18. Note groove for the piston fin. This is the same type of groove as on the robot. It is assumed that the projectile had the same weight as the robot and that it was used to test the launching equipment.

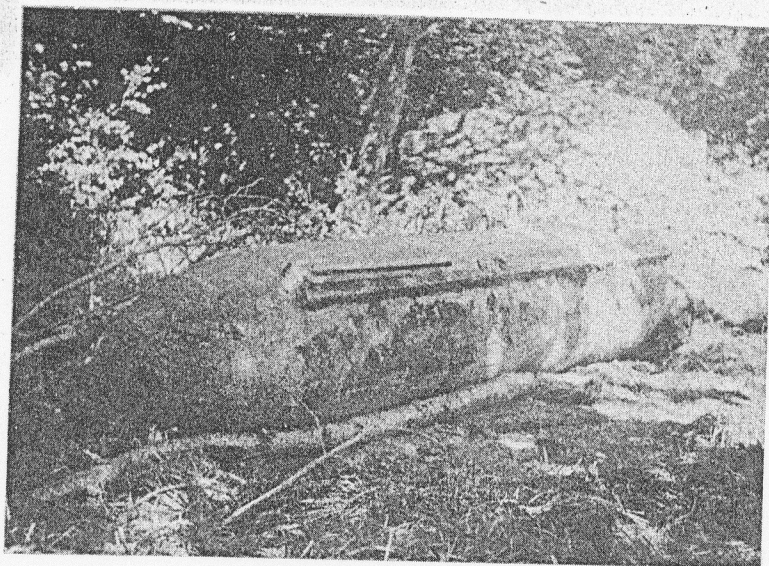
35. Front or nose view of the practice projectile. These projectiles may have had fins.
