MANUSCRIPT REPORT NUMBER 112

1968 ARCHAEOLOGICAL EXCAVATIONS
AT FORT BEAUSEJOUR

1970 ARCHAEOLOGICAL EXCAVATIONS
AT FORT BEAUSEJOUR

PARKS CANADA

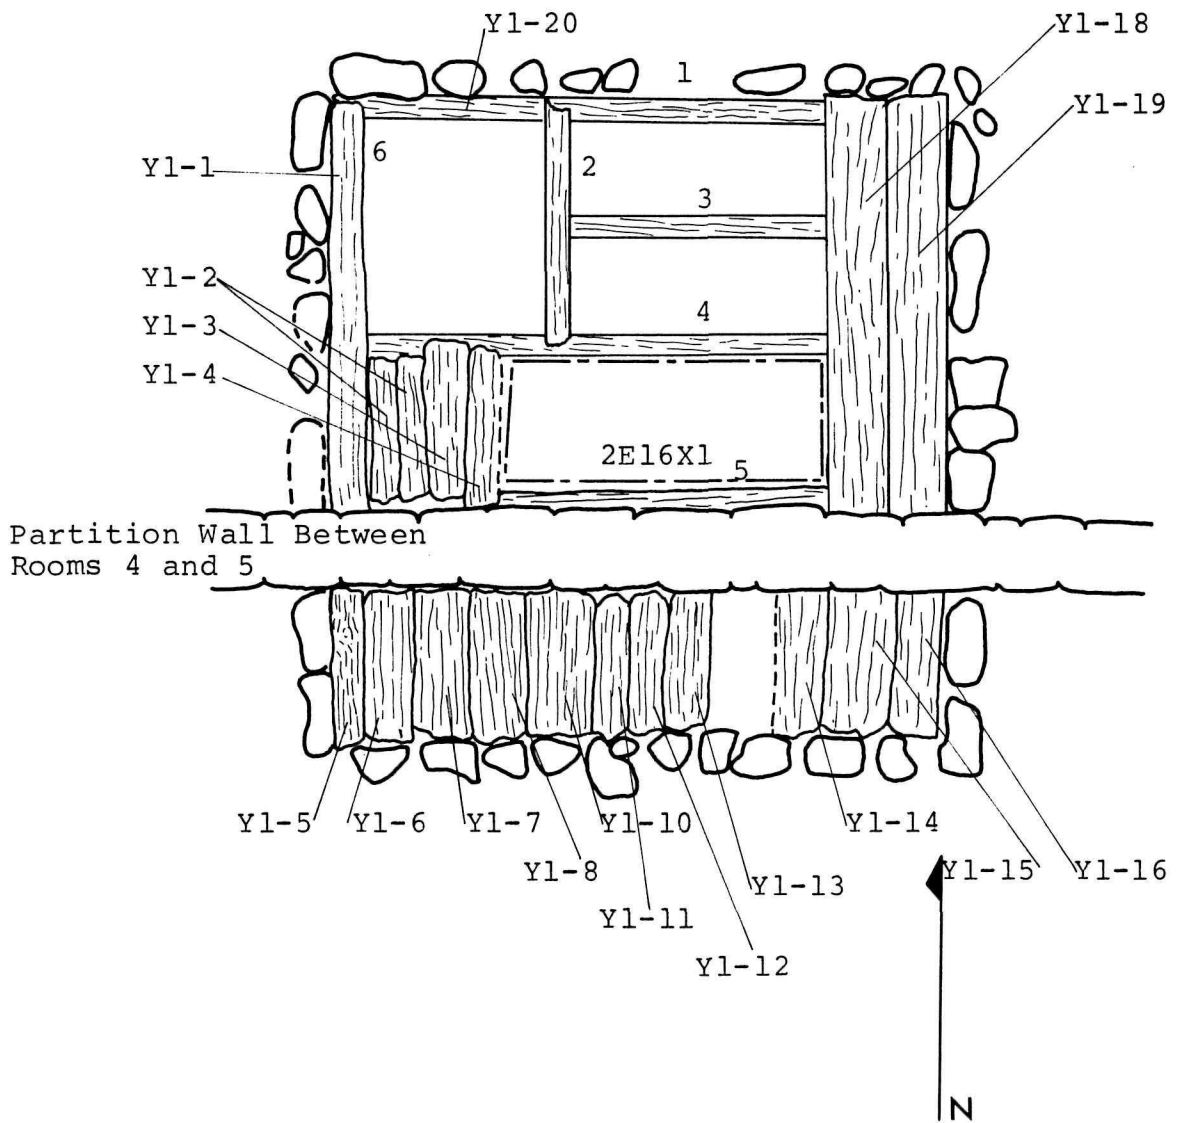
FIGURE 3

Diagram of the planking of 2E16Y1 showing the slope of the planking and the partition wall between Rooms 4 and 5, not to scale, looking east.

The floor of the structure consists of twenty planks or fragments of planks, running north-south. Planks Y1-5 to Y1-16, located south of the partition wall slope deeply to the North (Fig. 3). Those on the north side of the partition are not sloped. It appears that part of the flooring was looted, and when the Men's Barracks was built, the partition wall was either placed directly on the floor or a foundation trench was smashed through the floor. Either action would explain the slope. The second hypothesis seems preferable, because the weight of the wall would have buckled the floor north of the partition equally with that south of the partition.

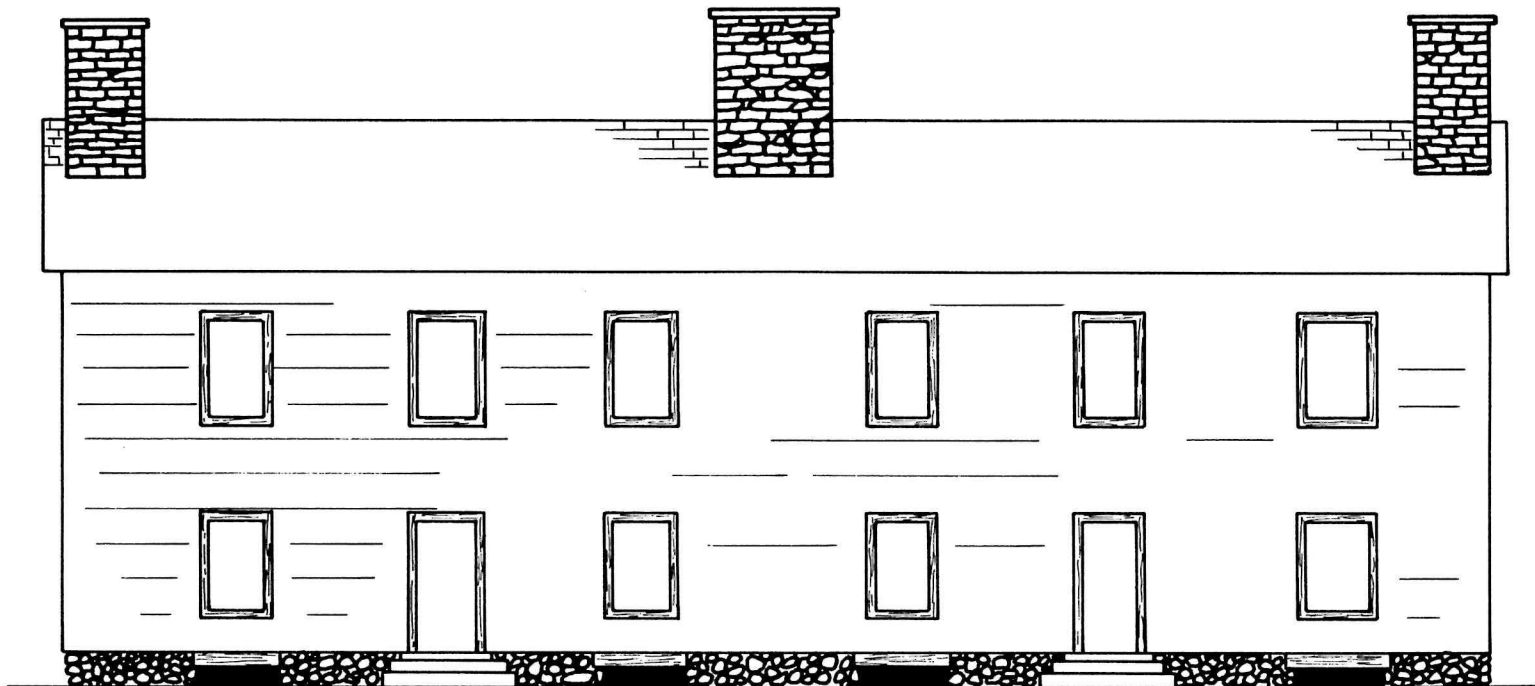
FIGURE 8

Elevation view of a tentative reconstruction of the 2E16 Mens Barracks, facing east, not to scale.

From the remains found in the excavation of 2E16 in 1966-1968, it is possible to describe the building that was the last to stand on this site. It clearly had three chimneys and six rooms in the basement, one of which was a kitchen. At the time of the original excavations in 1966, Rooms 2 and 5 were designated as storerooms (Coleman 1966: 30). This was likely partially the case, but I believe that the rooms served principally as halls containing the stairways to the ground floor. This arrangement would have provided equal access to the larger, more usable rooms on either side of Rooms 2 and 5 and would have avoided the obvious disadvantages of having a stairway in one of the larger rooms. A similar arrangement probably existed in the French Officers' Barracks built in 1754 (Nadon 1966: k: 7; Appendix 5). As storerooms only Rooms 2 and 5 would have been inconveniently narrow, but as stairhalls they are a good width and would have provided storage space under the stairs. Parts of the stair structures, recognizable as such, would have disappeared almost completely or have been easily removed.

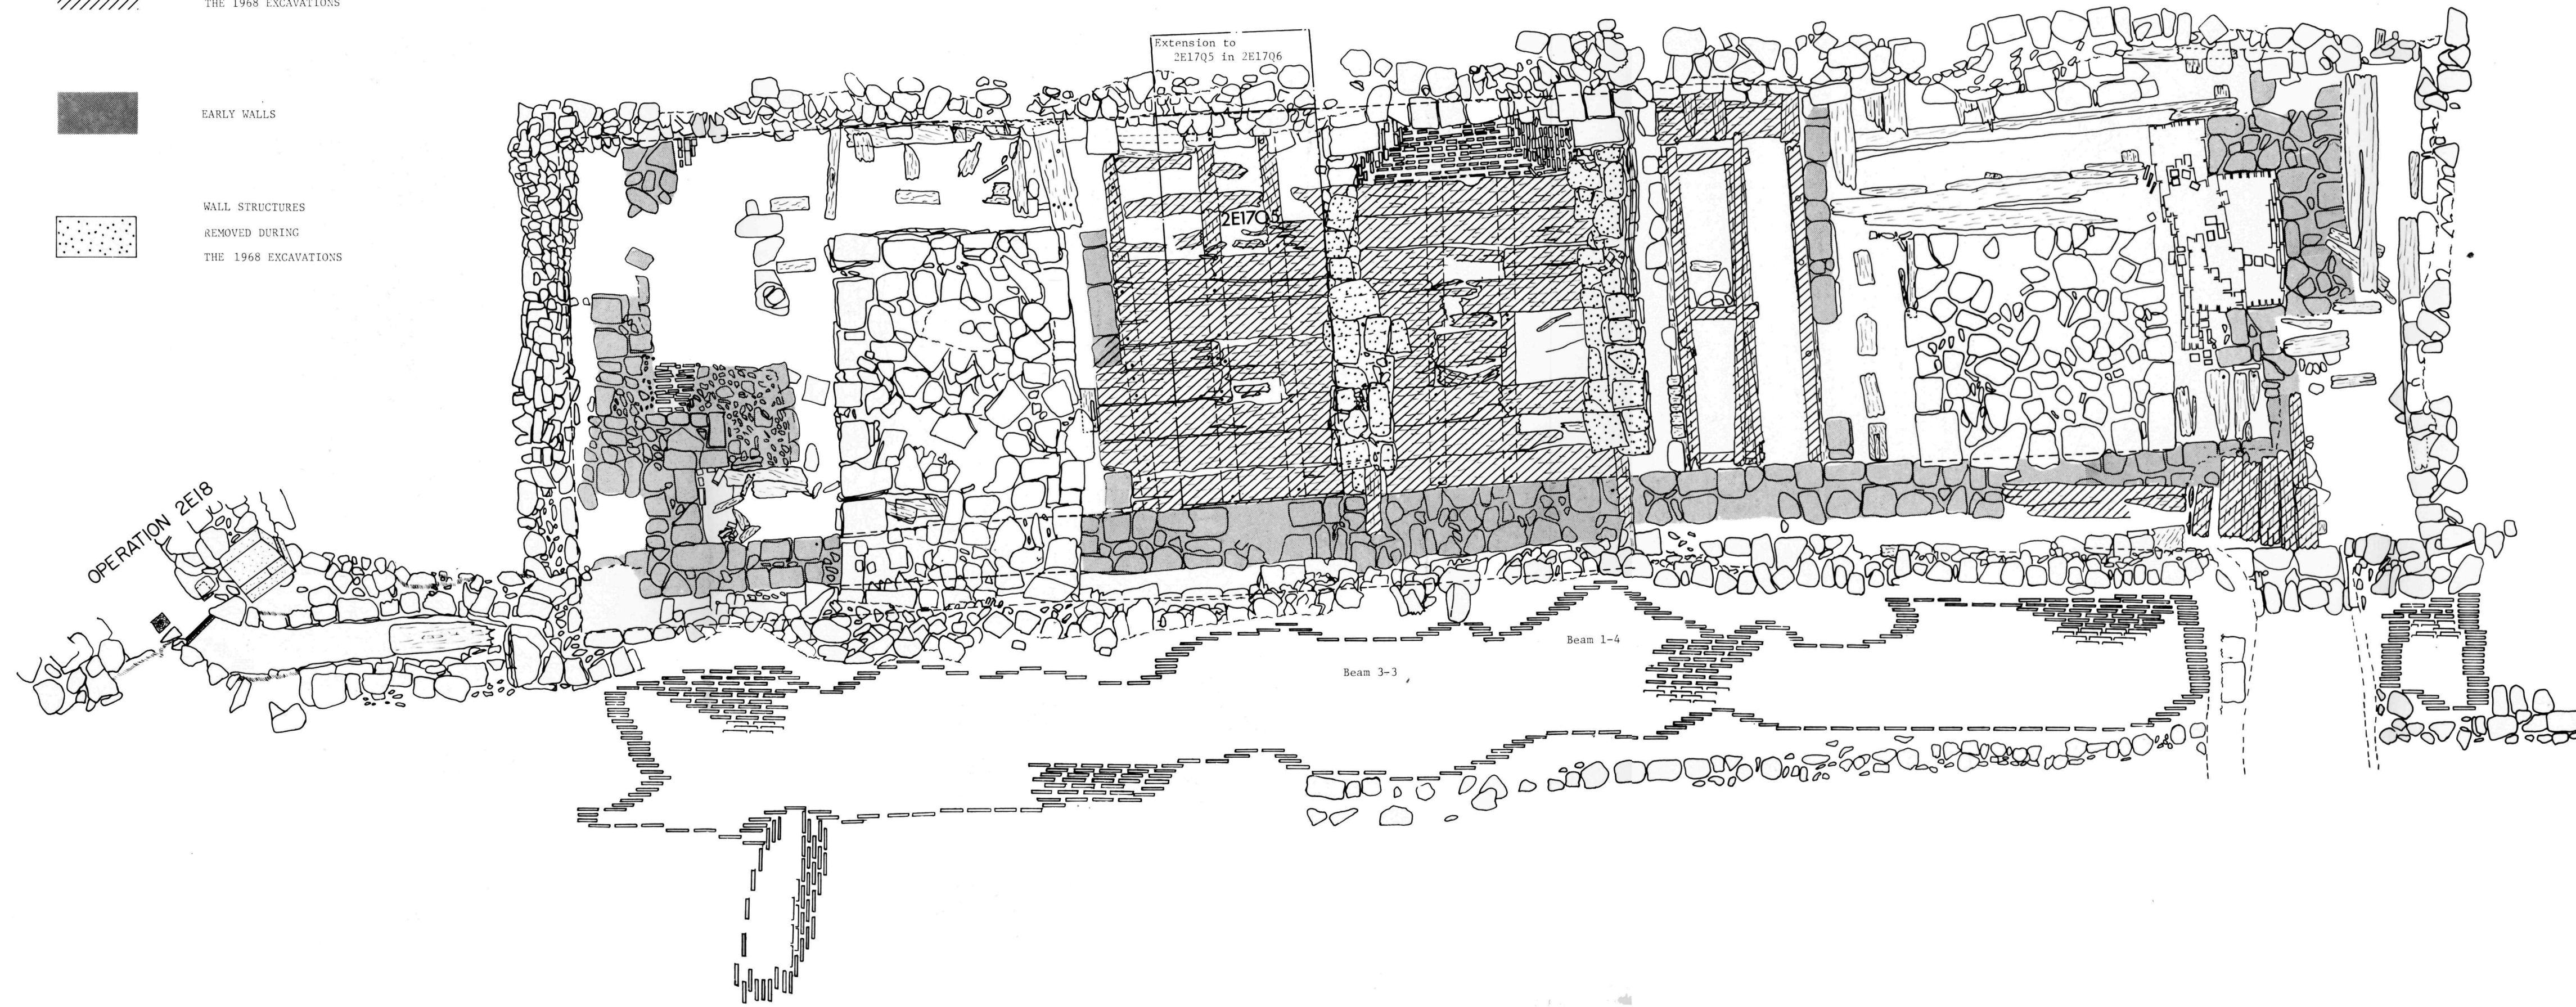
Figure 9

FORT BEAUSEJOUR N.B. SITE 2E	
PLAN OF OFFICERS' BARRACKS	
OPERATION 2E17

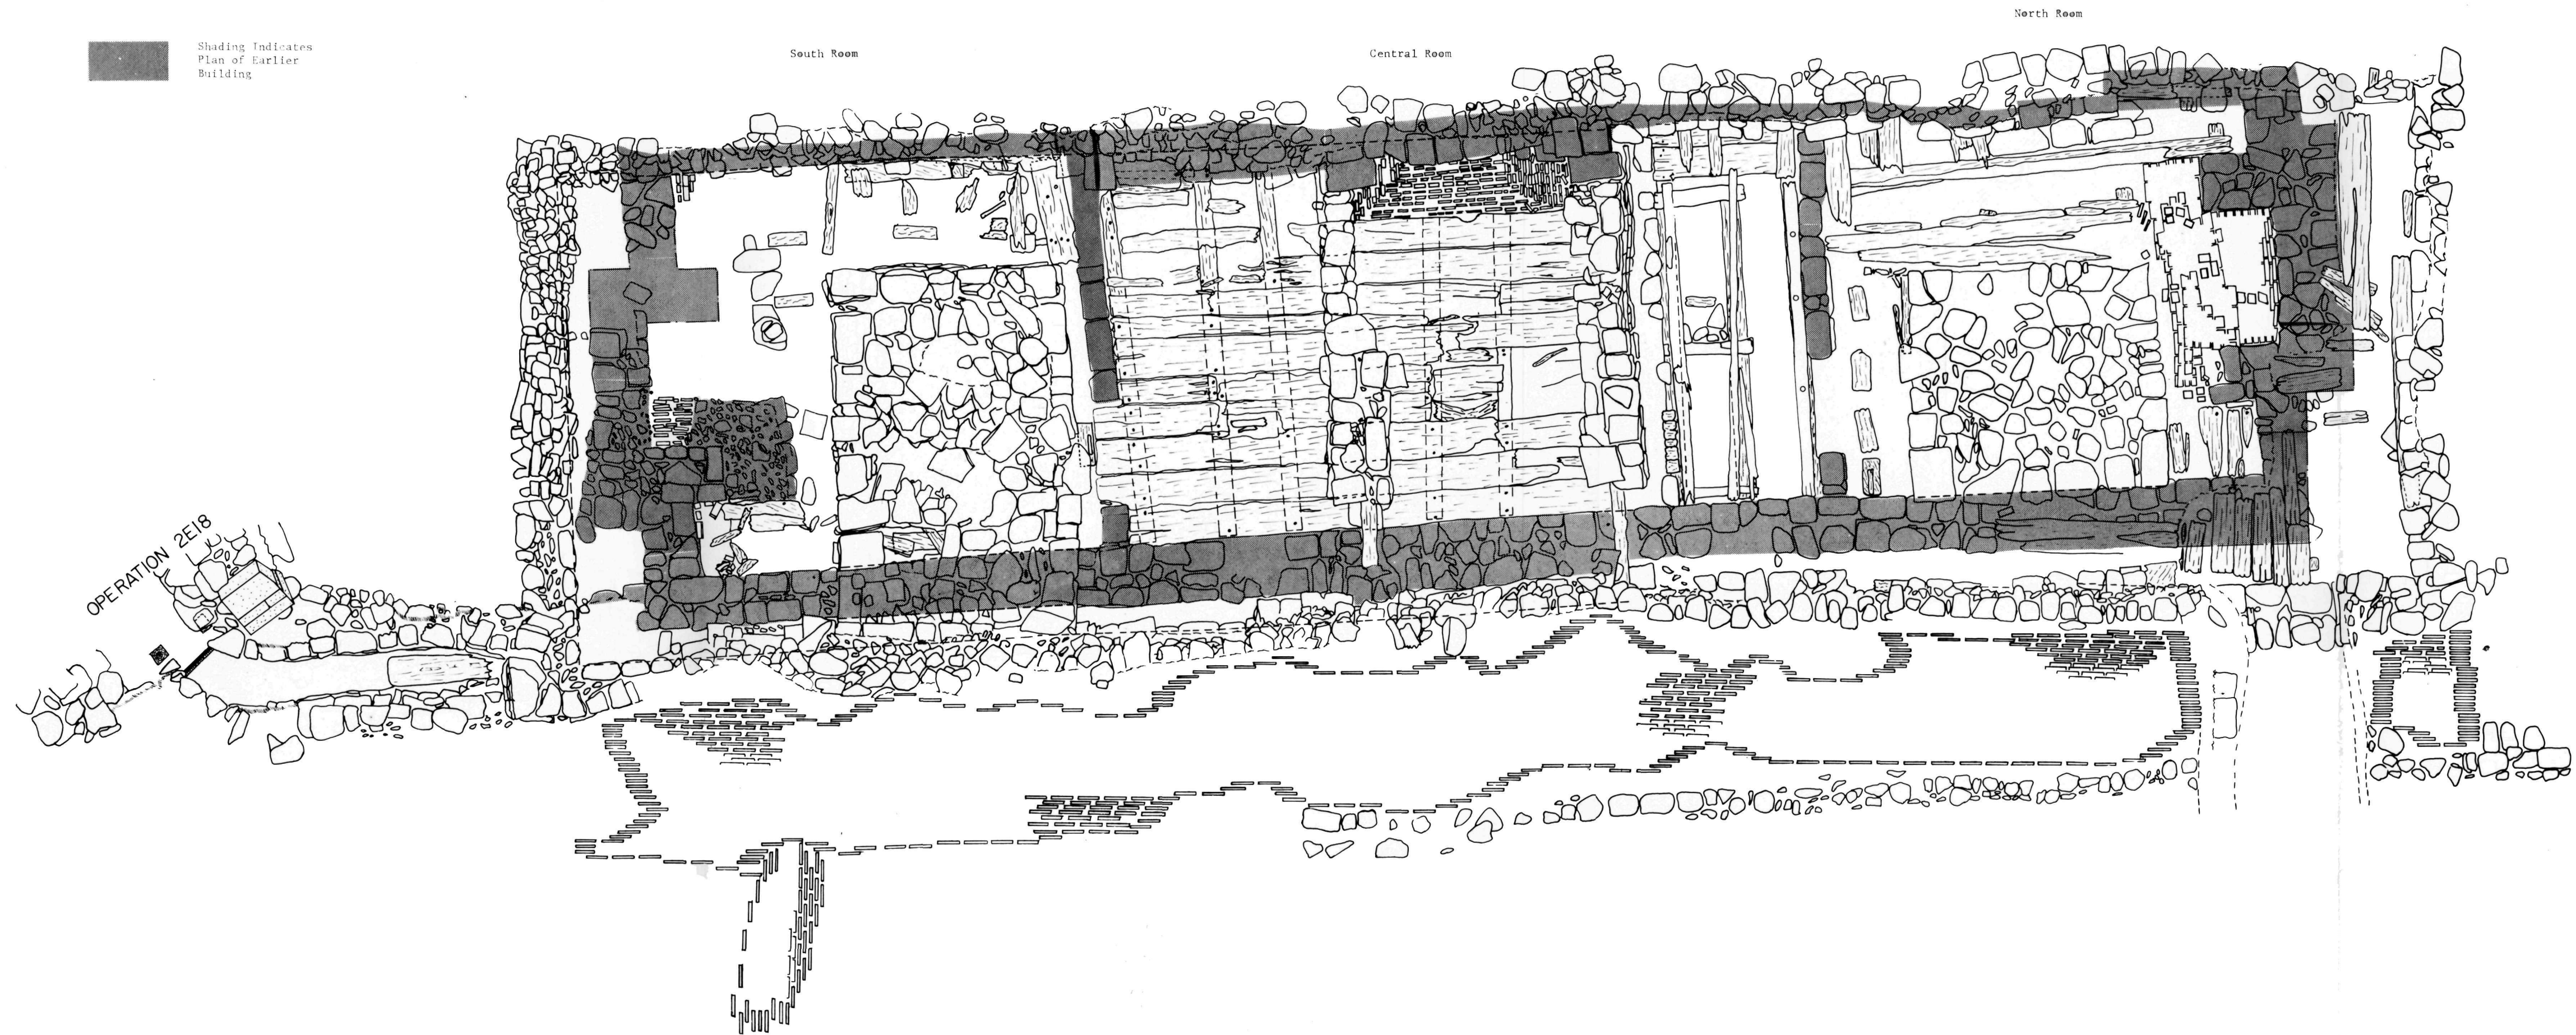
10 Plan of the basement of the earlier building
on the site of 2E17 Barracks. (2E-67-102-5)

Shading Indicates
Plan of Earlier
Building

During the 1966-1967 excavations of the 2E17 Officers' Barracks, three stone walls, forming the north, east and south foundation walls of an earlier structure, were located within the boundaries of the barracks (Fig. 11; MacDonald 1967: 2-29). The purpose of the 1968 excavations was to ascertain the relationship of these walls to each other and to the later structure; to locate the west wall of the earlier building; and to excavate below the level of this building and test for the presence of earlier structures.

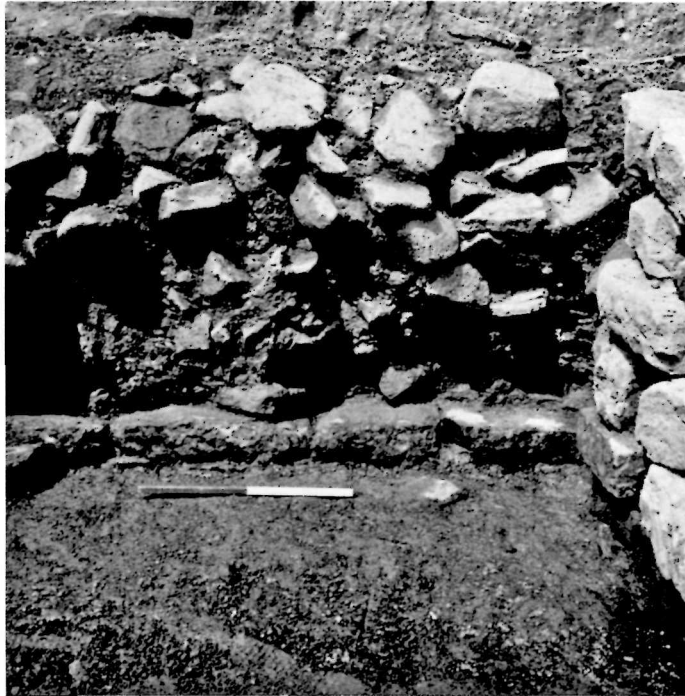
11 2E17Q5. View of the west wall of the earlier structure.
Camera facing west. 2 ft. scale aligned north-south (2E-3183 X).

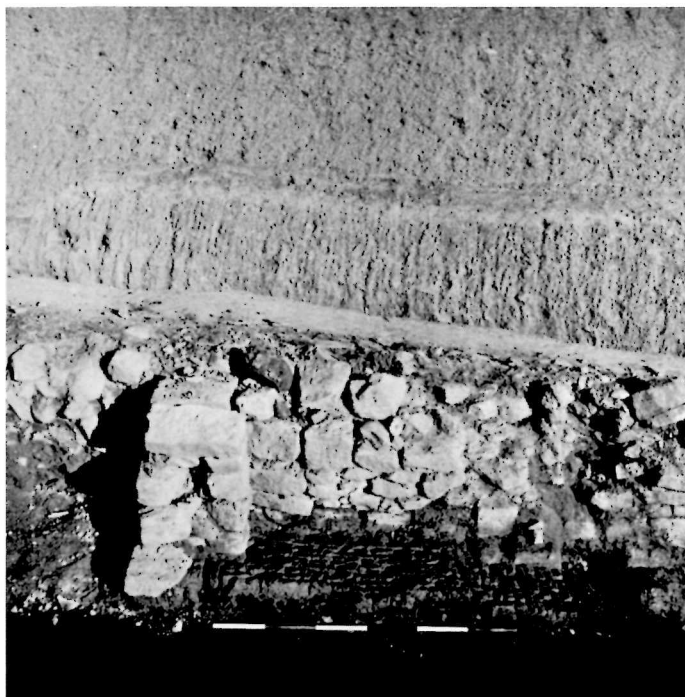
12 2E17Q5. Fireplace on the west wall of the barracks.
Camera facing west. 6 ft. scale aligned north-south (2E-3306 X).

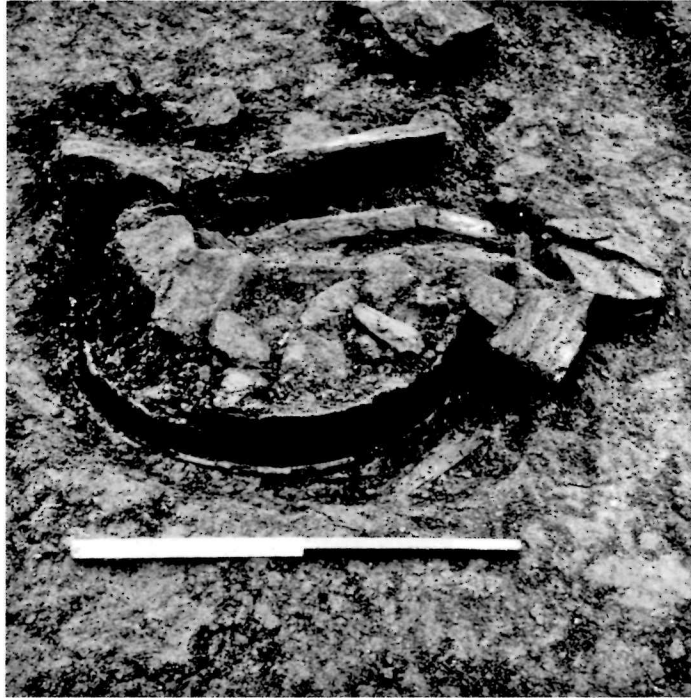
13 Barrel 2E17Q5-1. Camera facing east. 2 ft. scale aligned north-south (2E-3176 X).

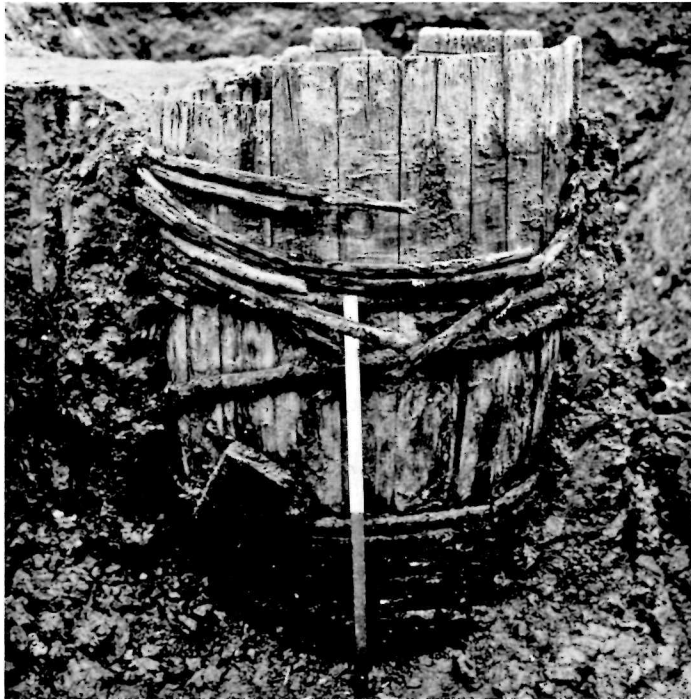
14 2E17Q6. Overall shot of barrel. Camera facing east. 2 ft. scale vertical (2E-3242 X).

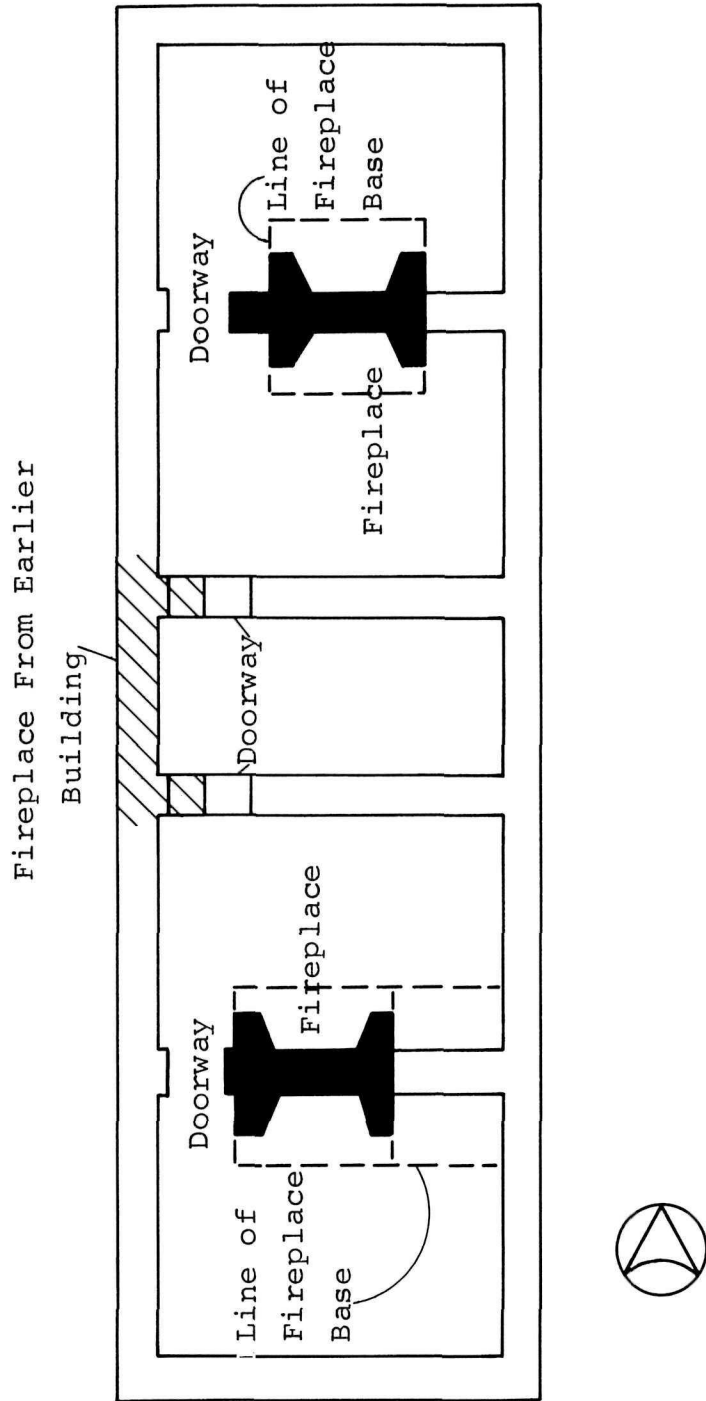
FIGURE 15

A tentative reconstruction of the ground floor plan of the 2E17 Barracks, not to scale.

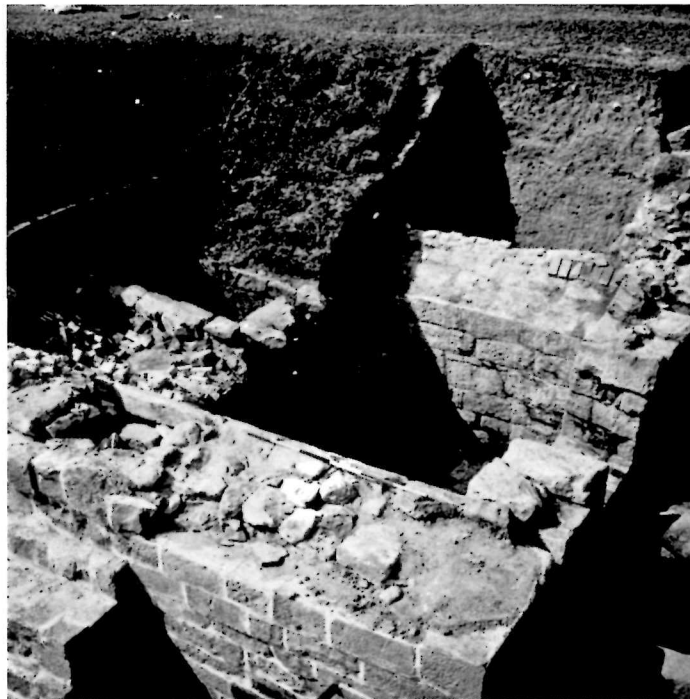
16 Post excavation shot of 2E12F, showing the concrete lintel and the top of the masonry steps into the casemate. Camera facing northwest. 6 ft. scale on top of south wall (2E-1528 X).

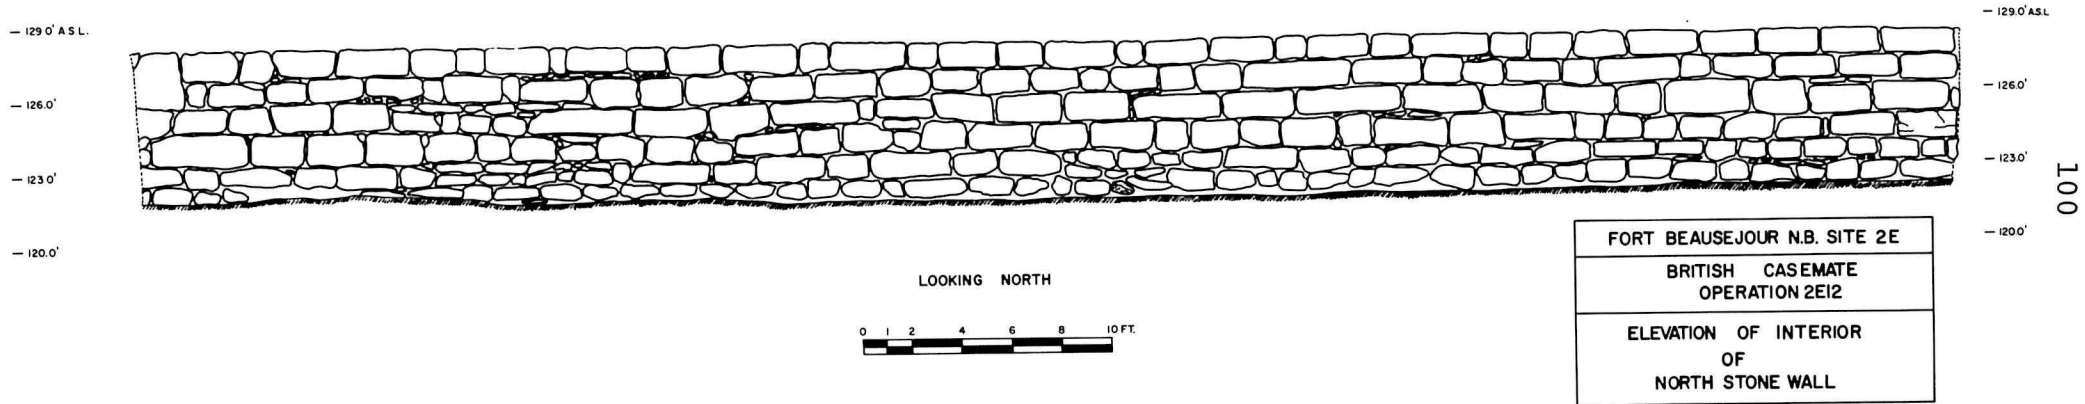
19 North face elevation view (2E12). 2E-68-102-15

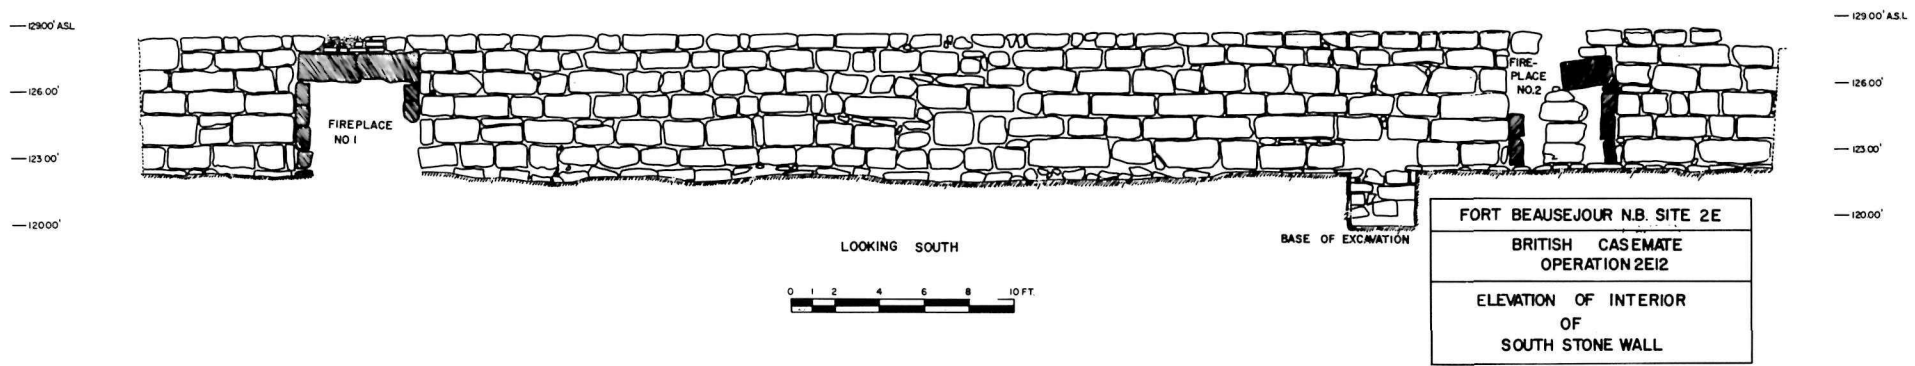
20 South face elevation view (2E12). 2E-68-102-20

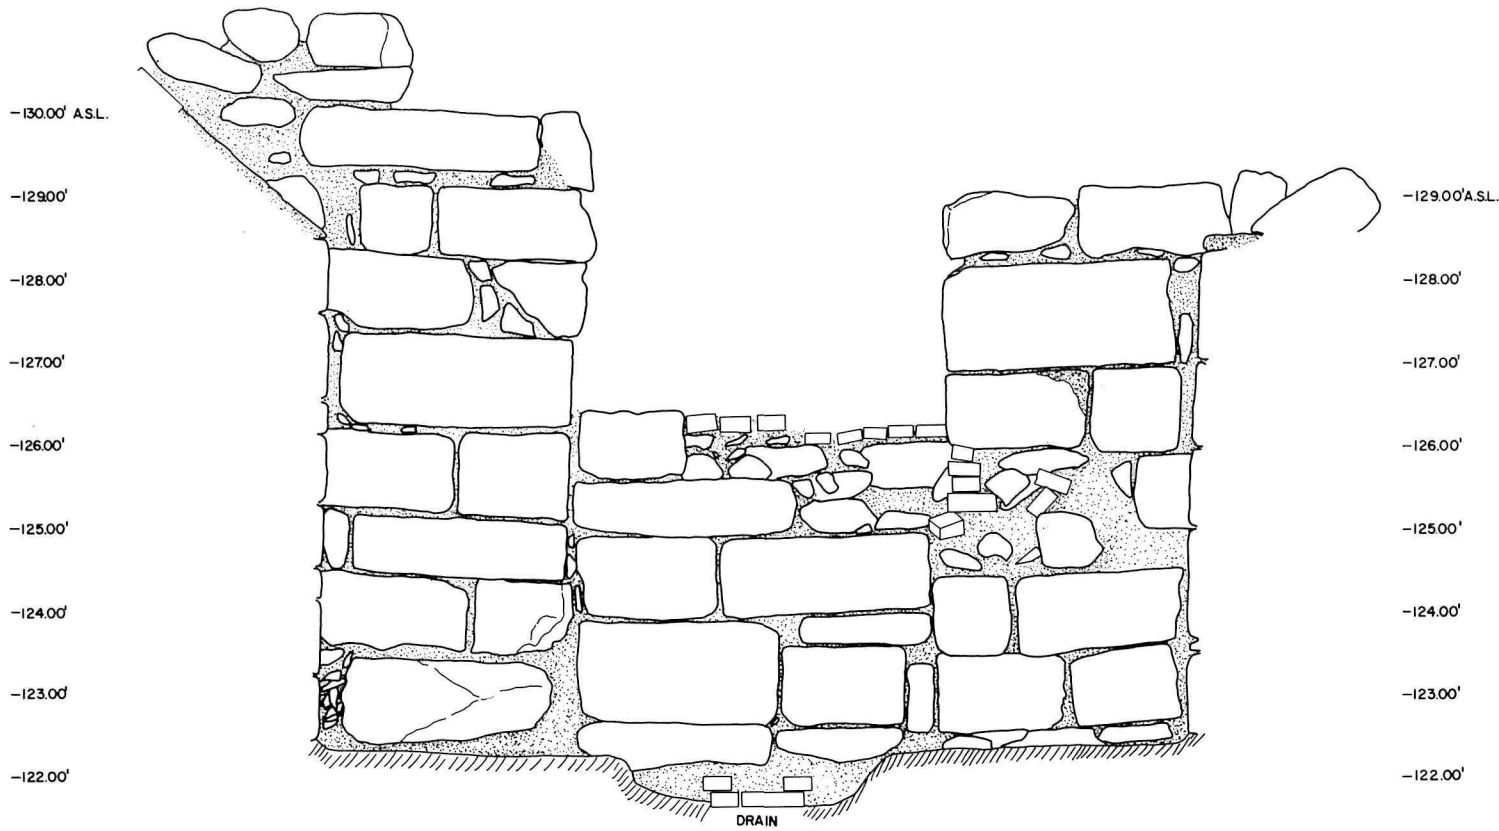
FORT BEAUSEJOUR N.B. SITE 2E
INTERIOR ELEVATION OF EAST WALL BRITISH CASEMATE OPERATION 2E12
0 1 2 FT

01 East face elevation view (2E12), 2E-68-102-30

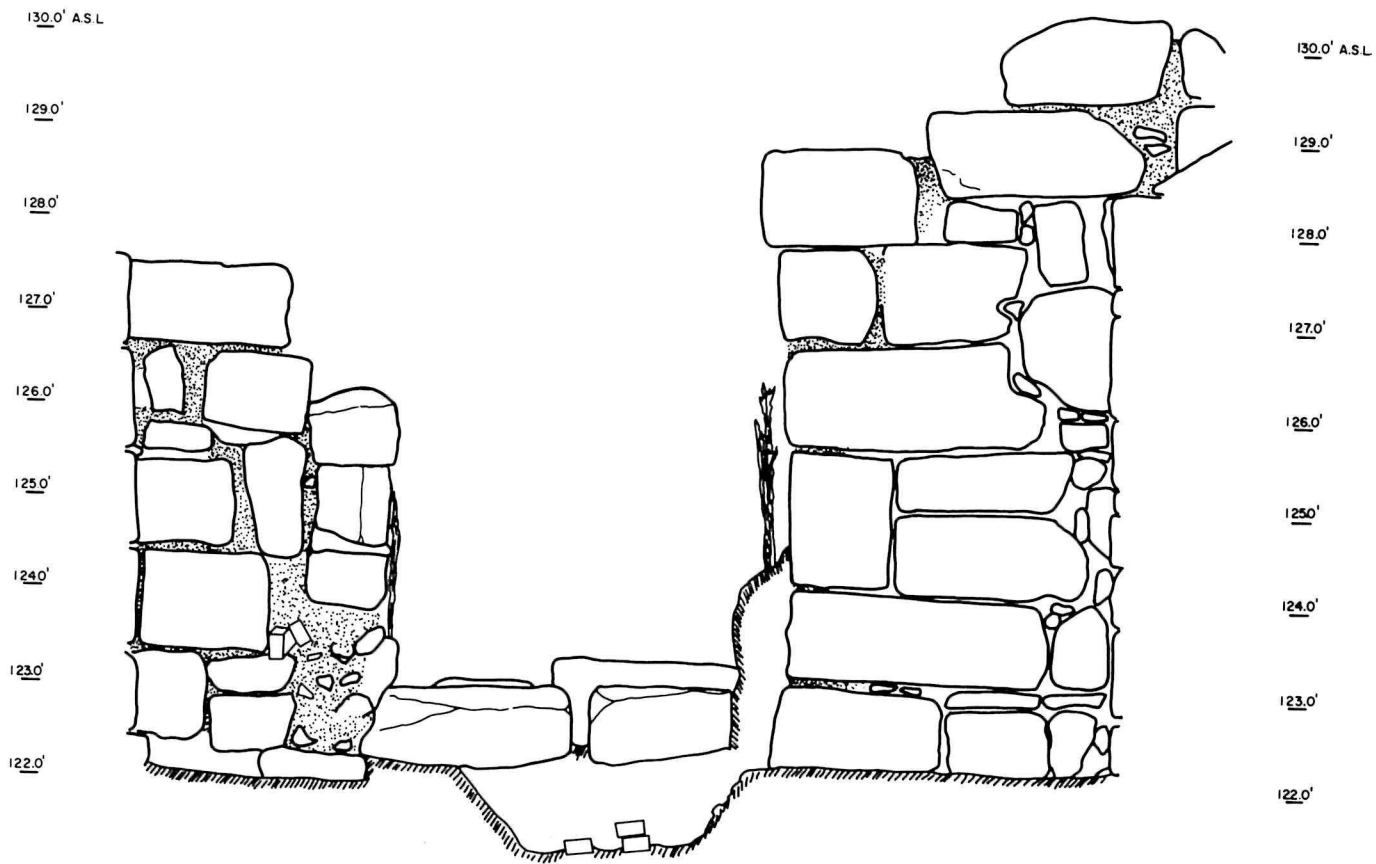
FORT BEAUSEJOUR N.B. SITE 2E
 INTERIOR ELEVATION OF WEST WALL
 BRITISH CASEMATE
 OPERATION 2E12

22 West face elevation view (2E12). 2E-68-102-14

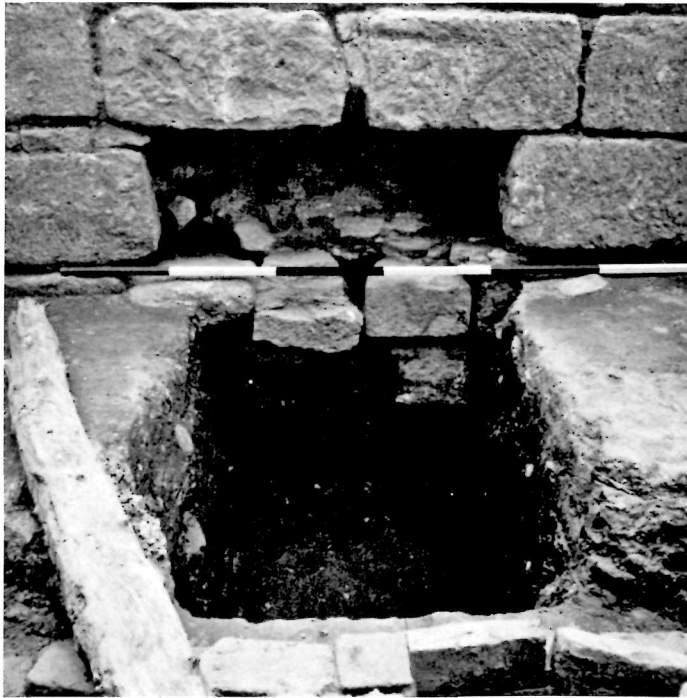
23 2E12Q6. Post excavation shot showing the open space in lower right corner of excavation which is the inlet of drain No. 1, and the difference in construction between the upper and lower parts of the south wall of the casemate. Camera facing south. 6 ft. scale aligned east-west (2E-2062 X).

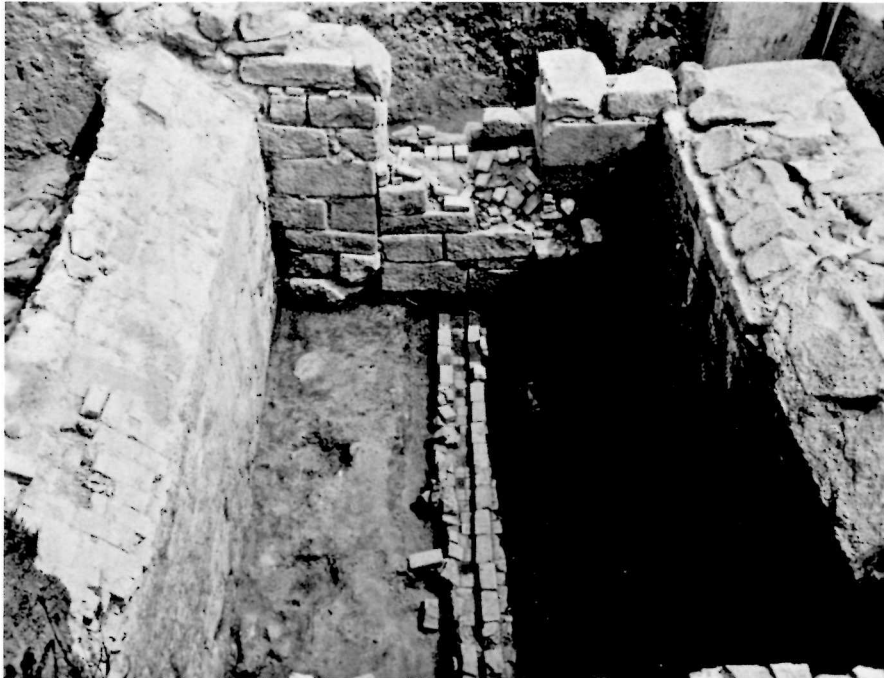
24 2E12. General view of the east end of the British Casemate, showing the abutting below the window, the brick drain, the spring of the arch on the north and south walls. Camera facing east. No scale (2E-181 B).

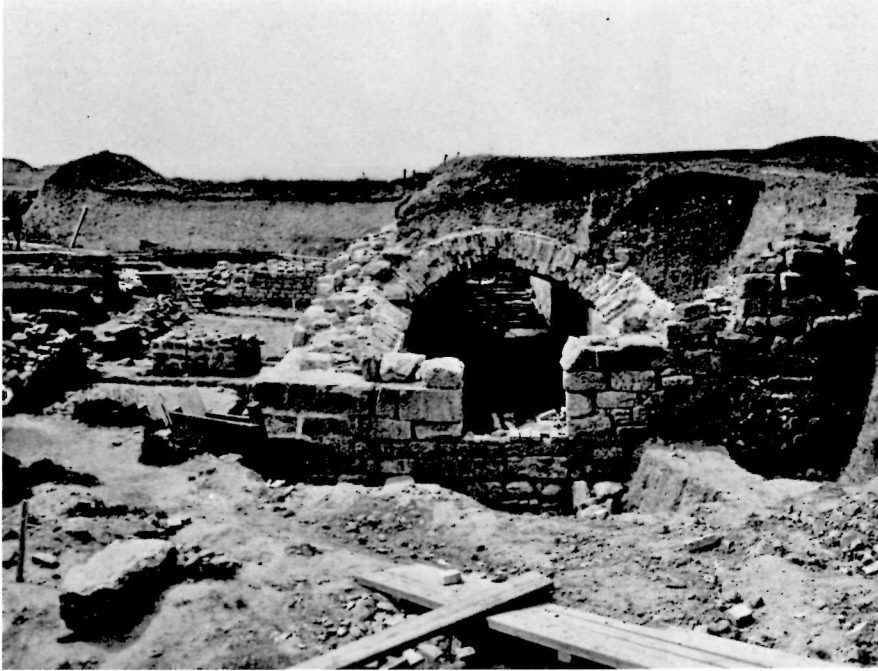
25 2E12. General view of the east end of the British Casemate showing the abutting below the window and of the extension to the main east wall of the casemate and the bonding of the east wall to the south wall. Camera facing west. No scale (2E-180 B).

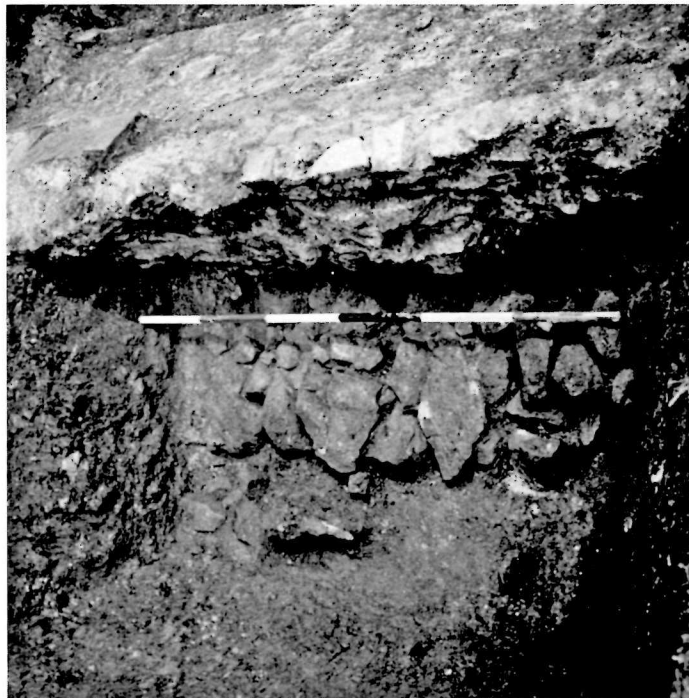
26 2E12F5. Post-excavation shot showing wall north of the north wall of the casemate. Camera facing down and east. 6 ft. scale aligned east-west (2E-1499 X).

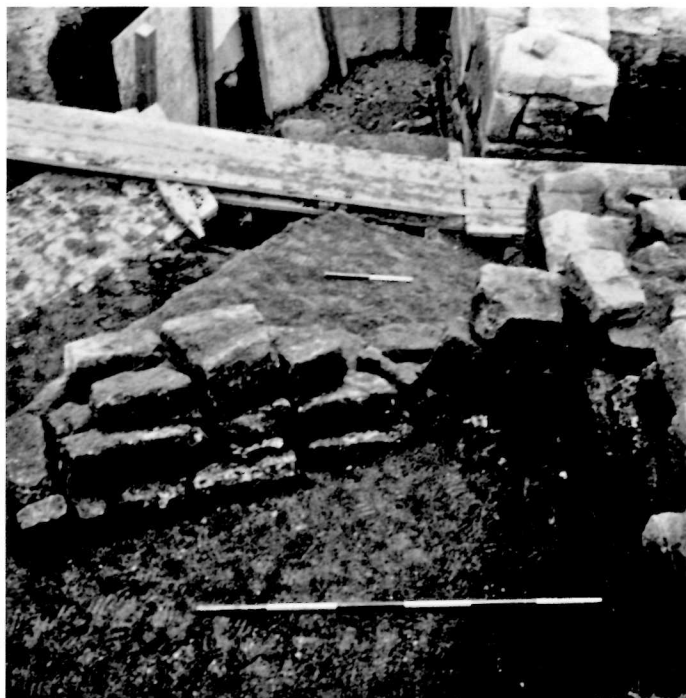
27 2E12F21. Post-excavation shot showing the rubble found east of the casemate. Camera facing south. 6 ft. scale aligned east-west (2E1498 X).

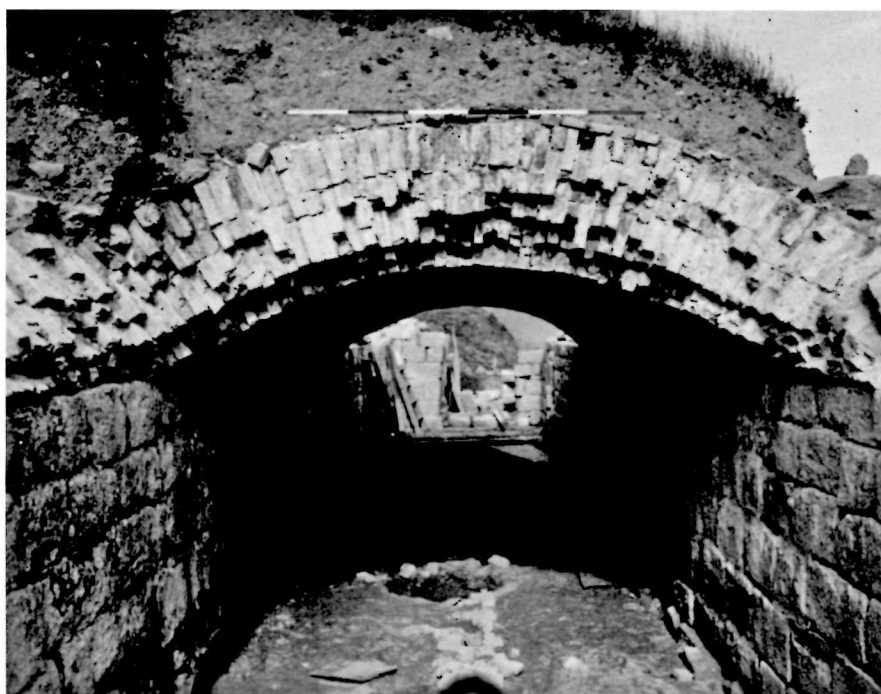
28 2E12. View of the east end of the casemate. Camera facing west. 6 ft. scale aligned north-south (2E-186 B).

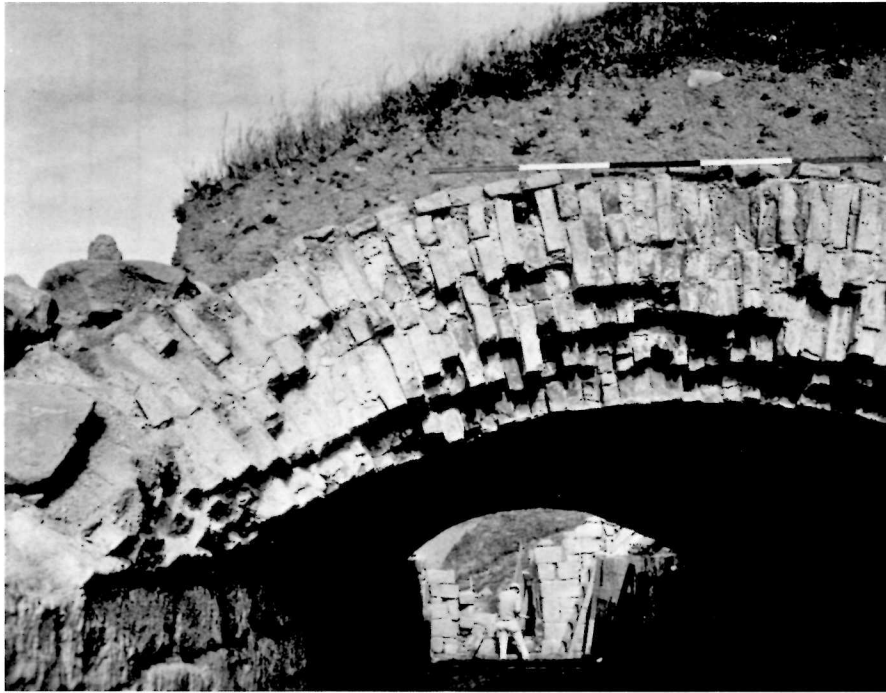
29 2E12. View of the south half of the east end of the vault, showing rubble above arch. Camera facing west. 6 ft. scale aligned north-south (2E-184 B).

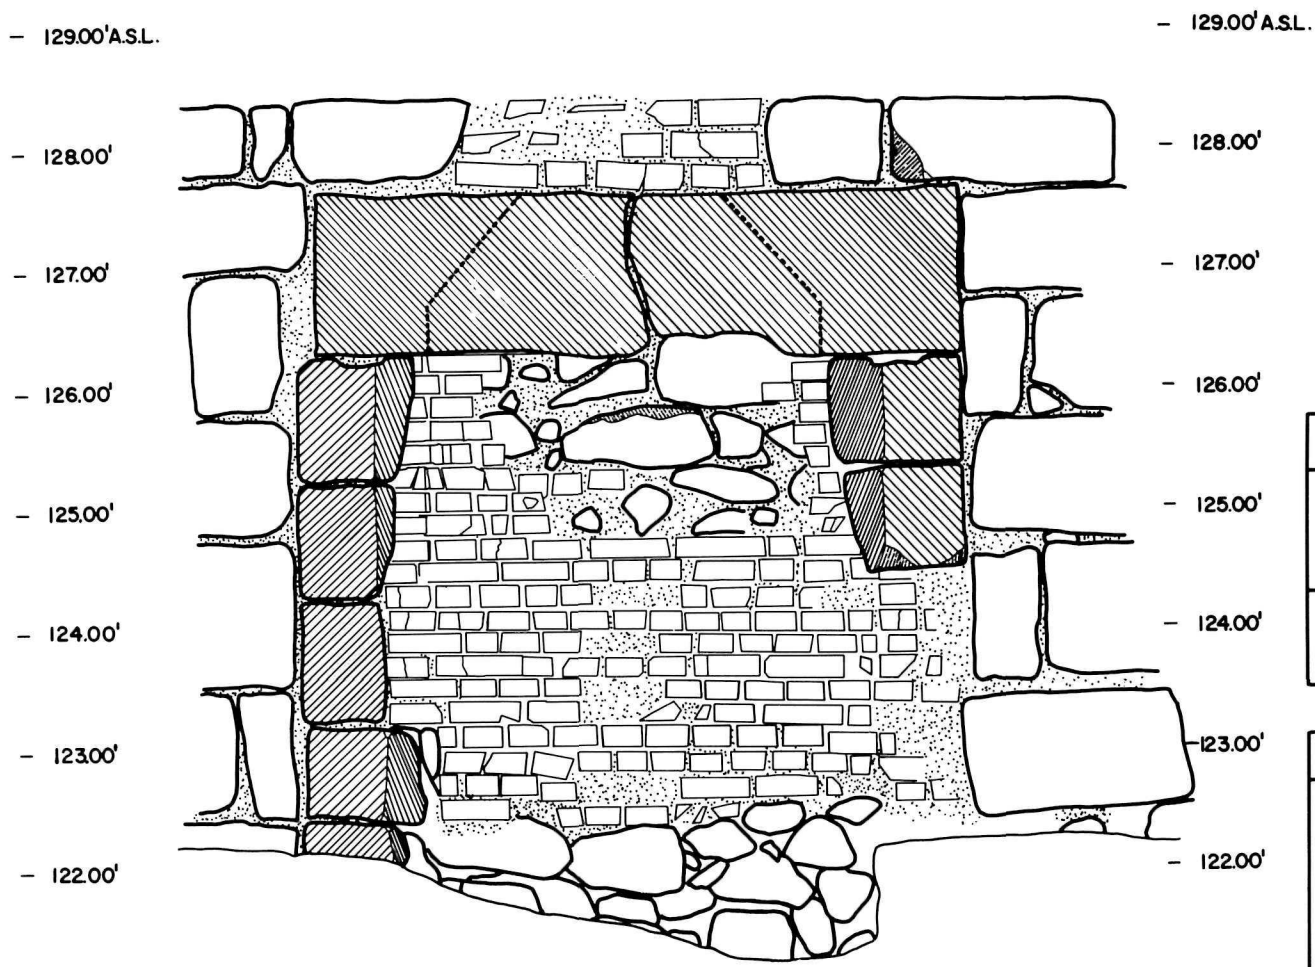
FORT BEAUSEJOUR N.B. SITE 2E
 ELEVATION OF EAST FIREPLACE
 BRITISH CASEMATE
 OPERATION 2E12

30 Elevation drawing of fireplace at east end of casemate, operation 2E12. 2E-68-102-28

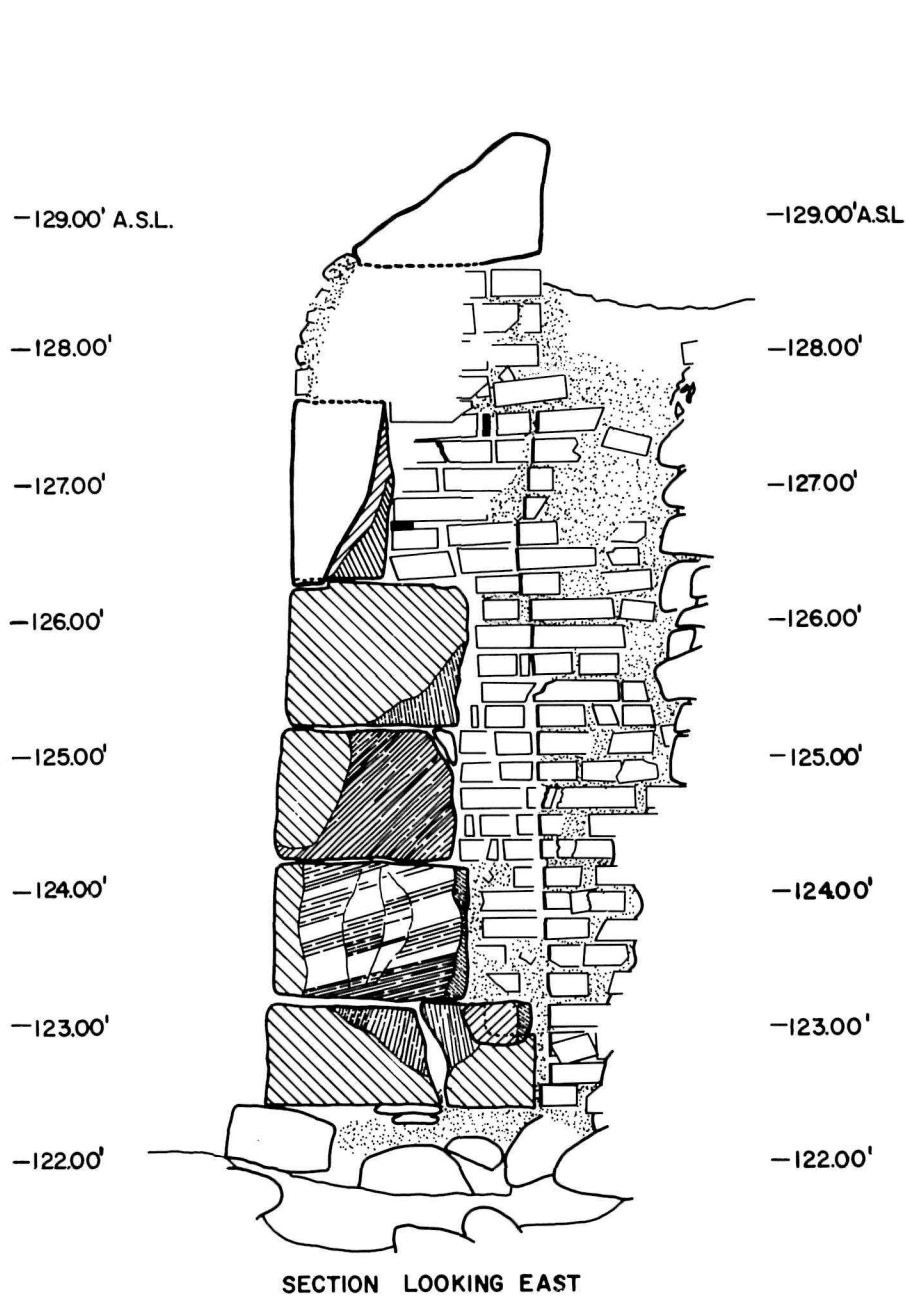
FORT BEAUSEJOUR N.B. SITE 2 E
SECTIONS OF EAST FIREPLACE BRITISH CASEMATE OPERATION 2E12
