MANUSCRIPT REPORT NUMBER 112

1968 ARCHAEOLOGICAL EXCAVATIONS
AT FORT BEAUSEJOUR

1970 ARCHAEOLOGICAL EXCAVATIONS
AT FORT BEAUSEJOUR

PARKS CANADA

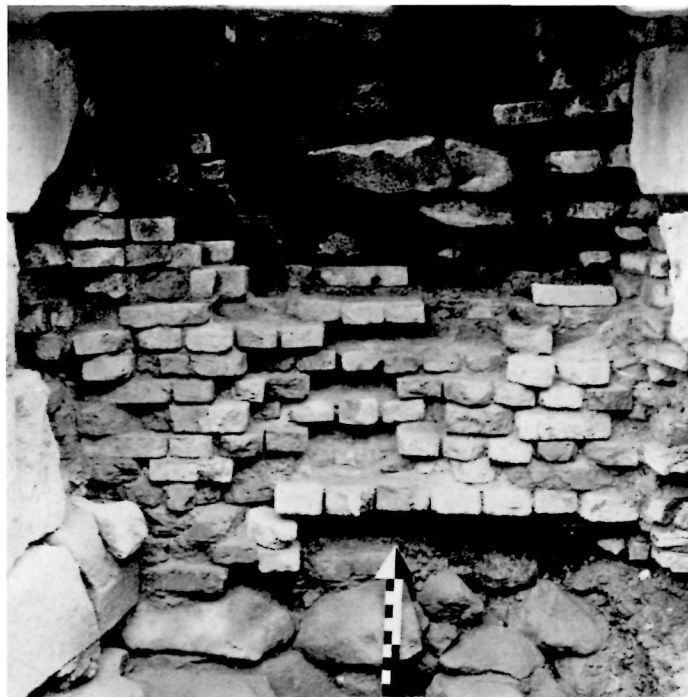
33 2E12. View of the back wall of the fireplace at the east end of the casemate, showing brick wall and rubble wall. Camera facing south. 1 ft. scale vertical (2E-3152 X).

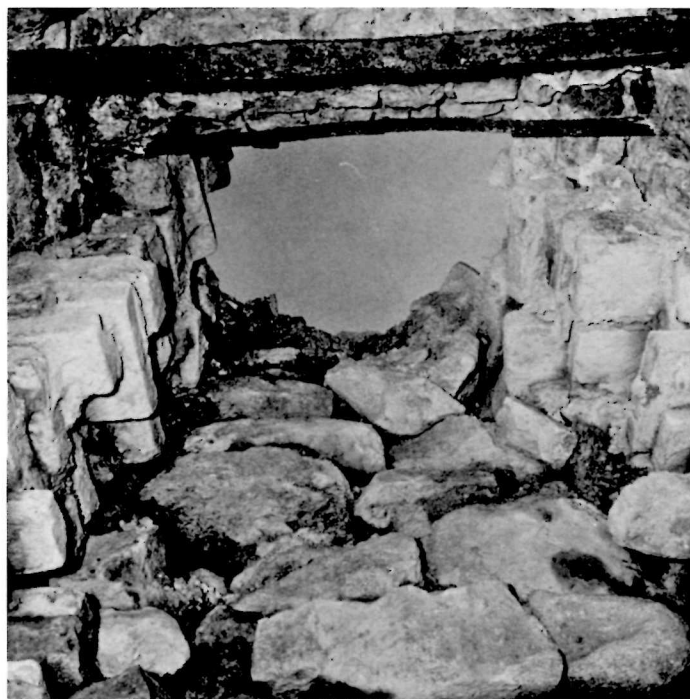
34 2E1?. View of the east fireplace in the casemate showing the top of firebox and metal braces. Camera facing up. No scale (2E-3154 X).

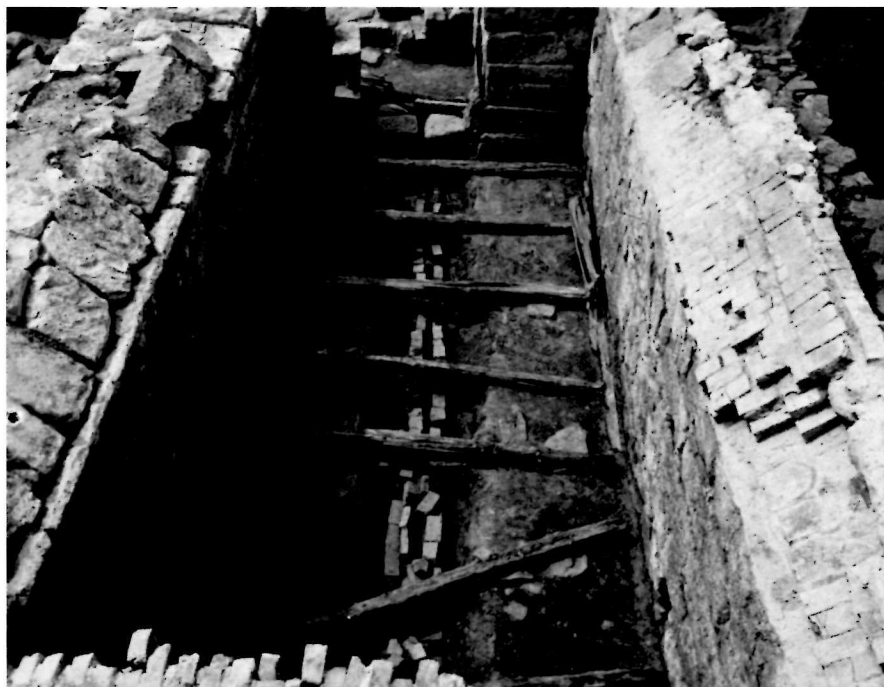
37 2E12. General view of the west end of the British Casemate, showing the brick drain and the floor structure. Camera facing west (2E-179 B).

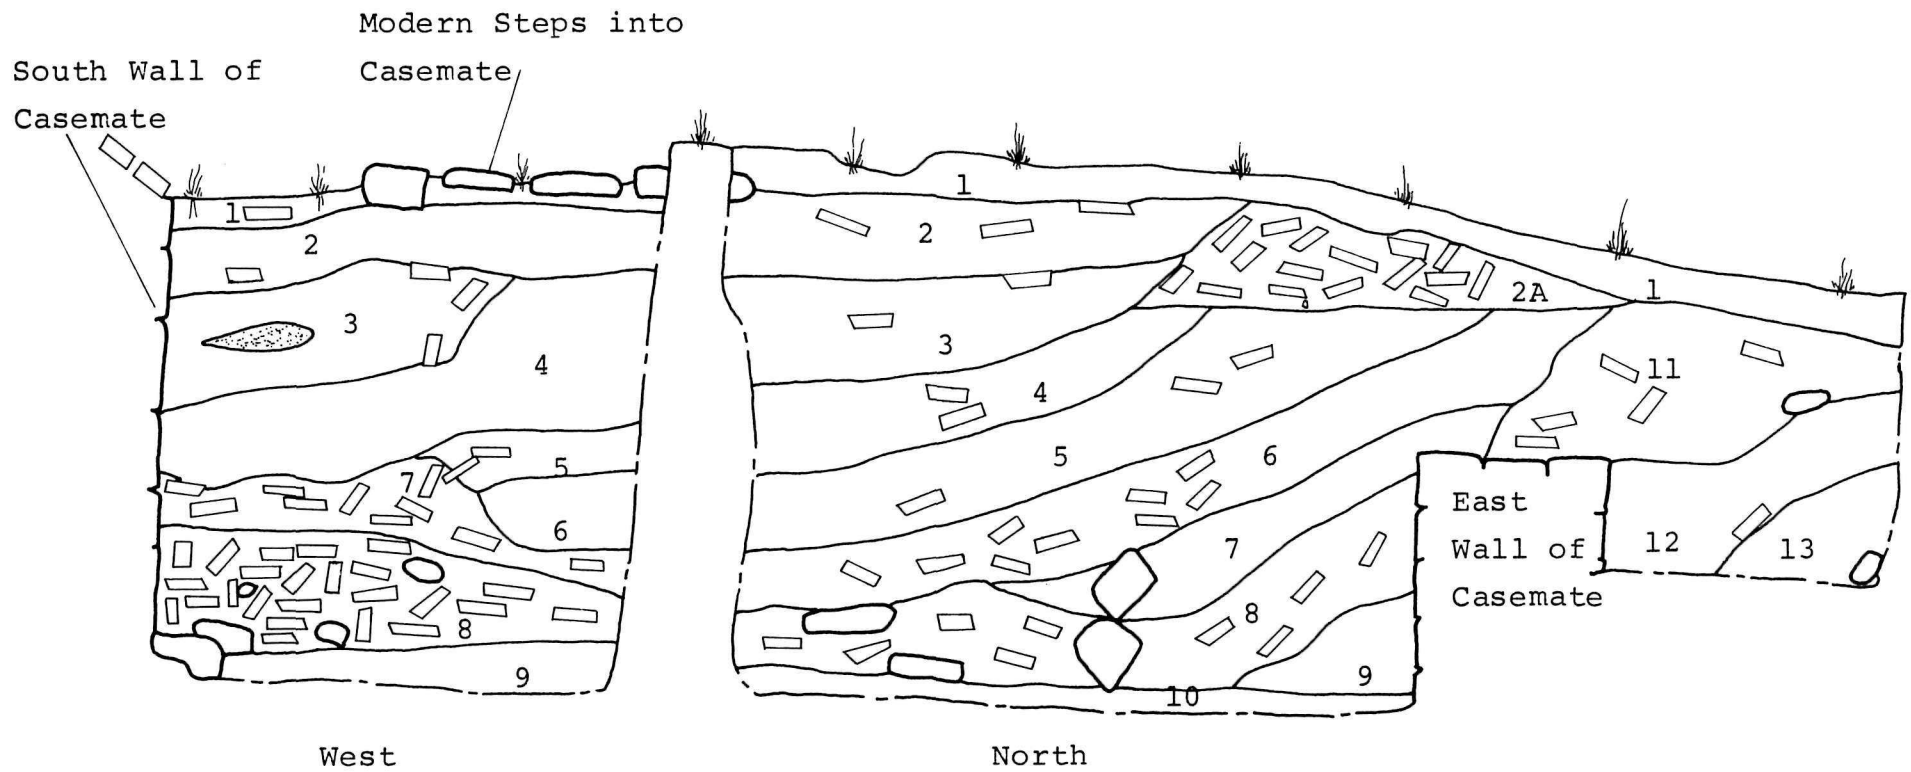
FIGURE 38

Soil Stratigraphy Layers of the West and North
Faces of 2E12B

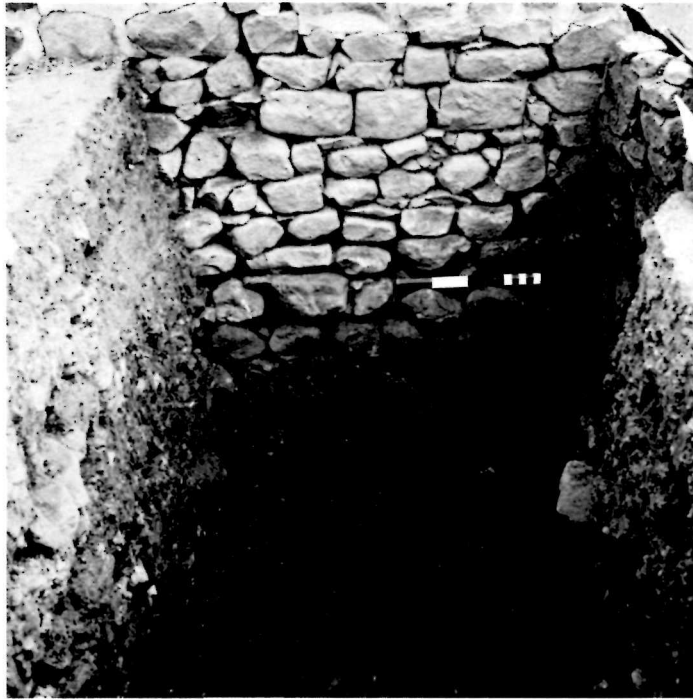
40 2E20R1. Post-excavation shot showing the east side of the west wall of 2E20J. Camera facing east. 2 ft. scale aligned north-south (2E-3224 X).

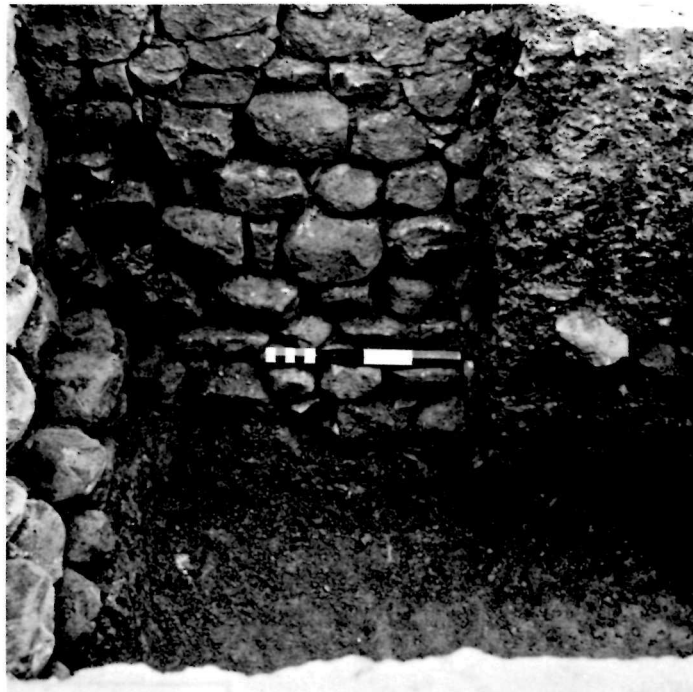
41 2E20R1. Post-excavation shot showing the south side of the north wall of 2E20M. Camera facing south. 2 ft. scale aligned east-west (2E-3226 X).

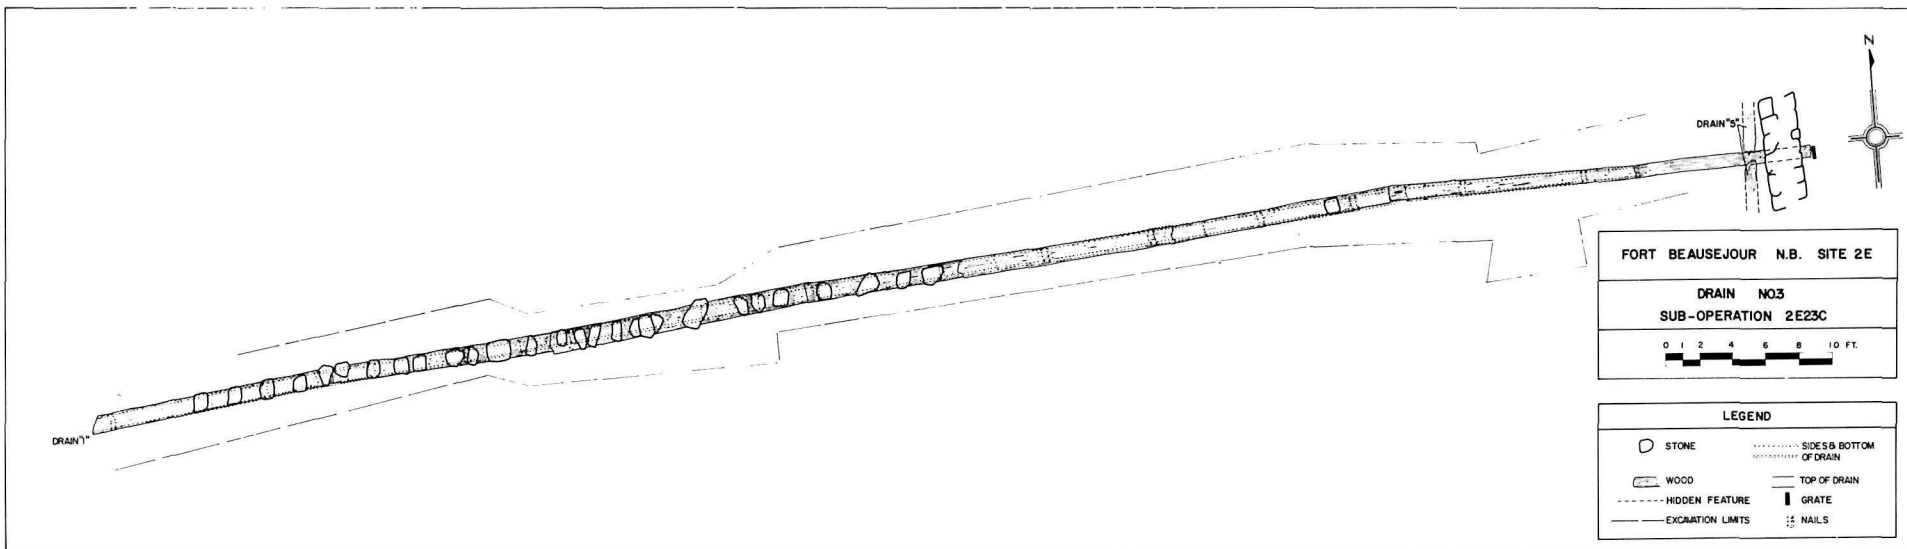
3 Site plan of Drain 3, suboperation 2E23C (2E-68-102-6).

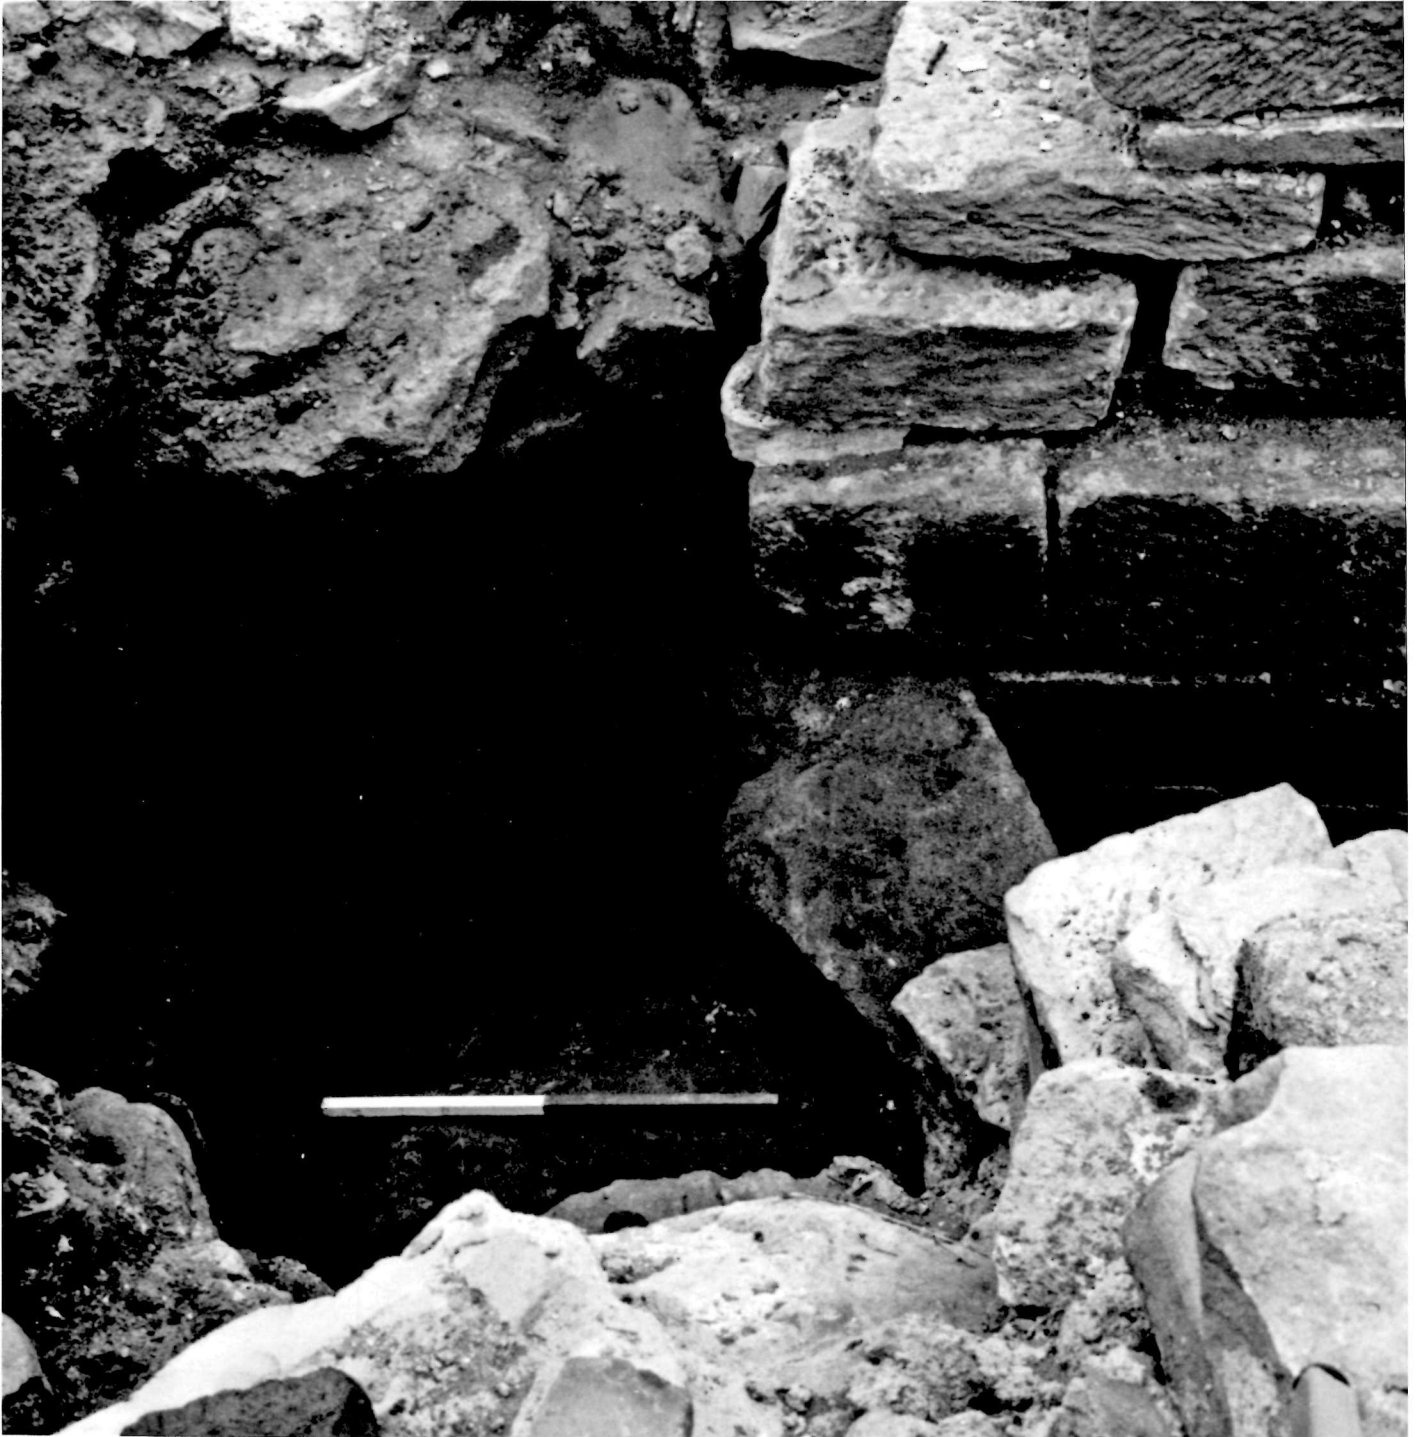
4 Post-excavation view of the wooden drain, with the camera facing west. Included is a two foot scale north-south at right angles to the north wall of 2E22L (2E-3543 X).

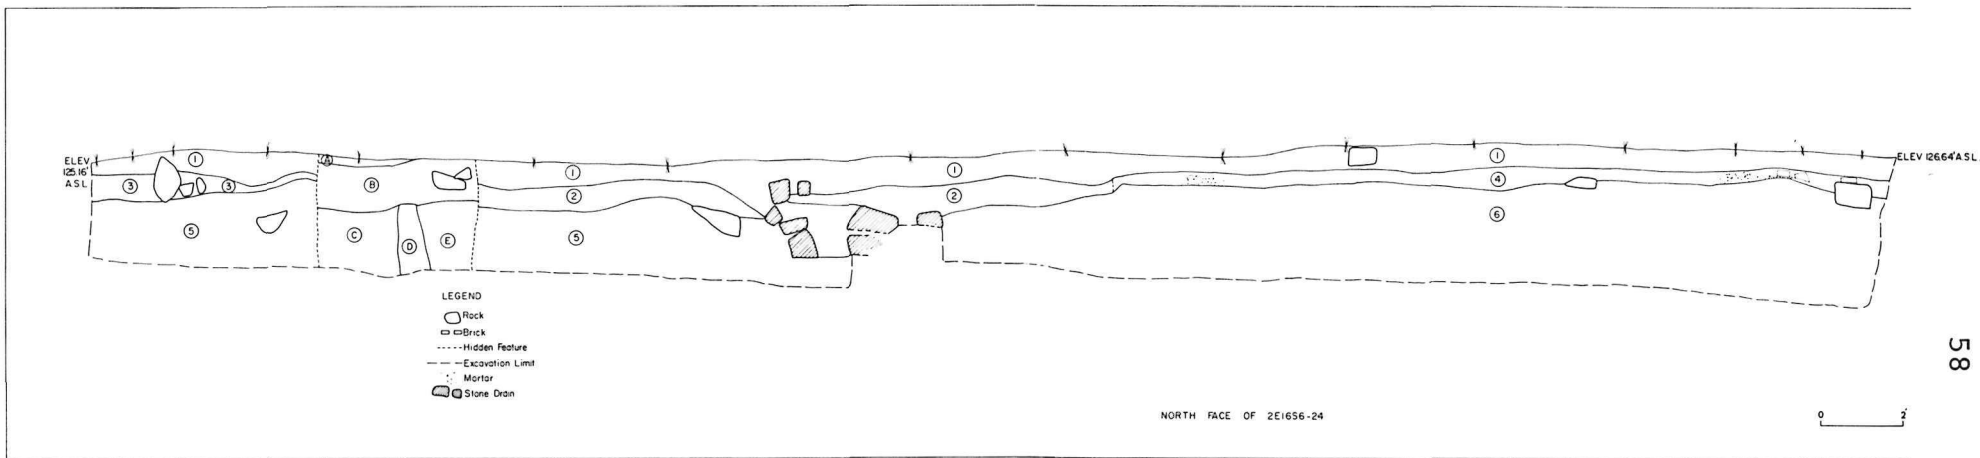
6 The soil layers of the stratigraphic cross-section along the north face of sub-operation 2E16S. 1, 7.5 YR 4/2 dark brown loam, sod layer; 2, 7.5 YR 4/4 dark brown clay with loam and sand, many artifacts; 3, 7.5 YR dark brown loamy clay, small stones and some mortar detritus and charcoal, some artifacts; 4, 10 YR 3/4 dark yellowish brown loam with clay, brick and mortar detritus in varying concentrations with some charcoal and wood fragments; 5, 7.5 YR 4/4 brown sandy clay; 6, 5 YR 4/4 reddish brown sandy clay, some small stones. A, 7.5 YR 4/2 dark brown with intrusions of black, partially formed sod layer. B, 10 YR 3/4 dark yellowish brown, sandy clay, intrusion on 7.5 YR 4/4 brown, mortar detritus, some modern artifacts. C, 10YR 3/4 dark yellowish brown, sandy clay, mortar and brick detritus, stone detritus. D, 7.5 YR 4/4 brown sandy clay. E, 10 YR 3/4 dark yellowish brown, sandy clay with intrusions of black, mortar and brick detritus. (2E-71-102-5)

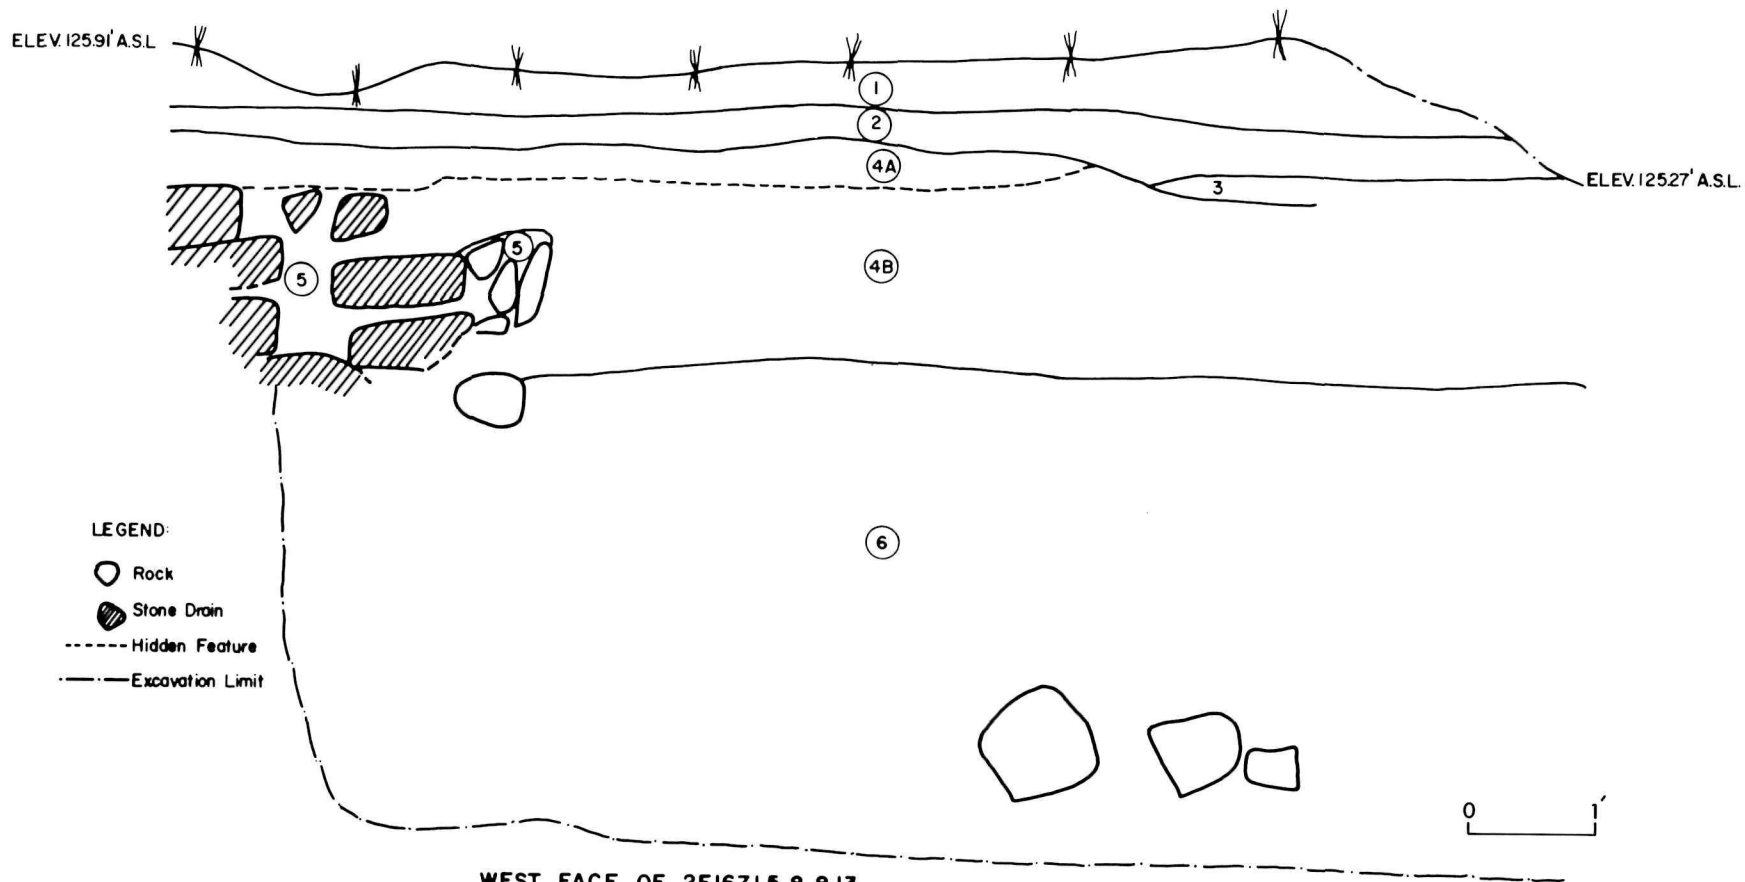
- 7 The soil layers of the stratigraphic cross-section along the west face of lot 2E16Z1, 5, 8, 8₂, 13
 1, 10 YR 3/4 dark yellowish brown loam, sod layer; 2, 10 YR 3/4 dark yellowish brown loamy clay,
 some burnt wood and some artifacts; 3, burnt wood; 4a, 10 YR 4/4 dark yellowish brown sandy
 clay, small pebbles; 4b, 10 YR 3/4 dark yellowish brown, very sandy clay, small stones; 5,
 7.5 YR 4/4 brown, very sandy clay; 6, 7.5 YR 4/4 brown, sandy clay (2E-71-102-3).

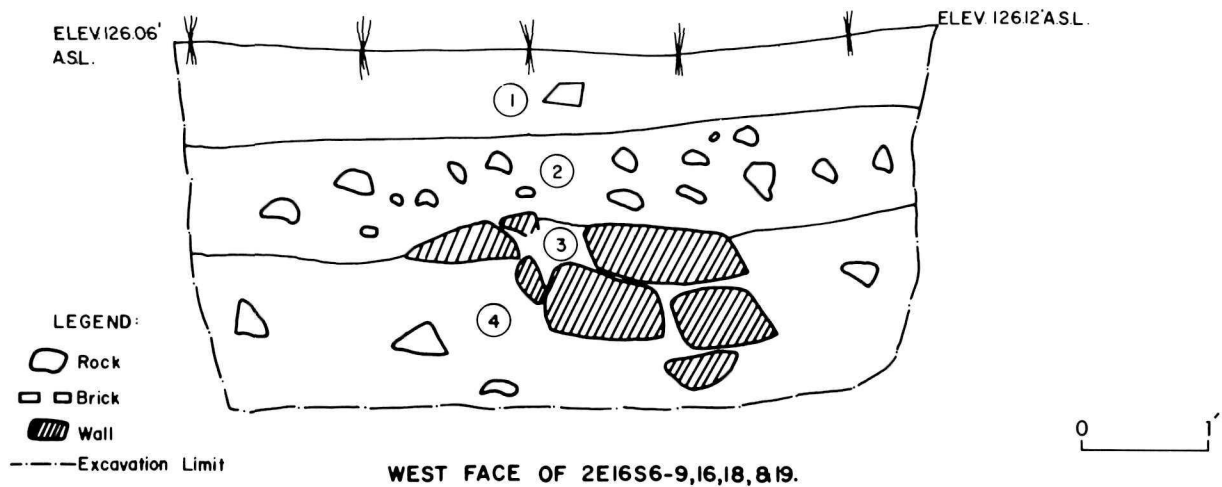
- 8 The soil layers of the stratigraphic cross-section along the west face of lot 2E16S19.
- 1, 7.5 YR 4/2 dark brown loam, sod layer; 2, 7.5 YR 4/4 brown loam with clay, small stones and artifacts, some wood fragments; 3, 7.5 YR 4/4 brown loamy clay with sand, no stones; 4, 7.5 YR 4/4 brown, sandy clay, some stones (2E-71-102-3).

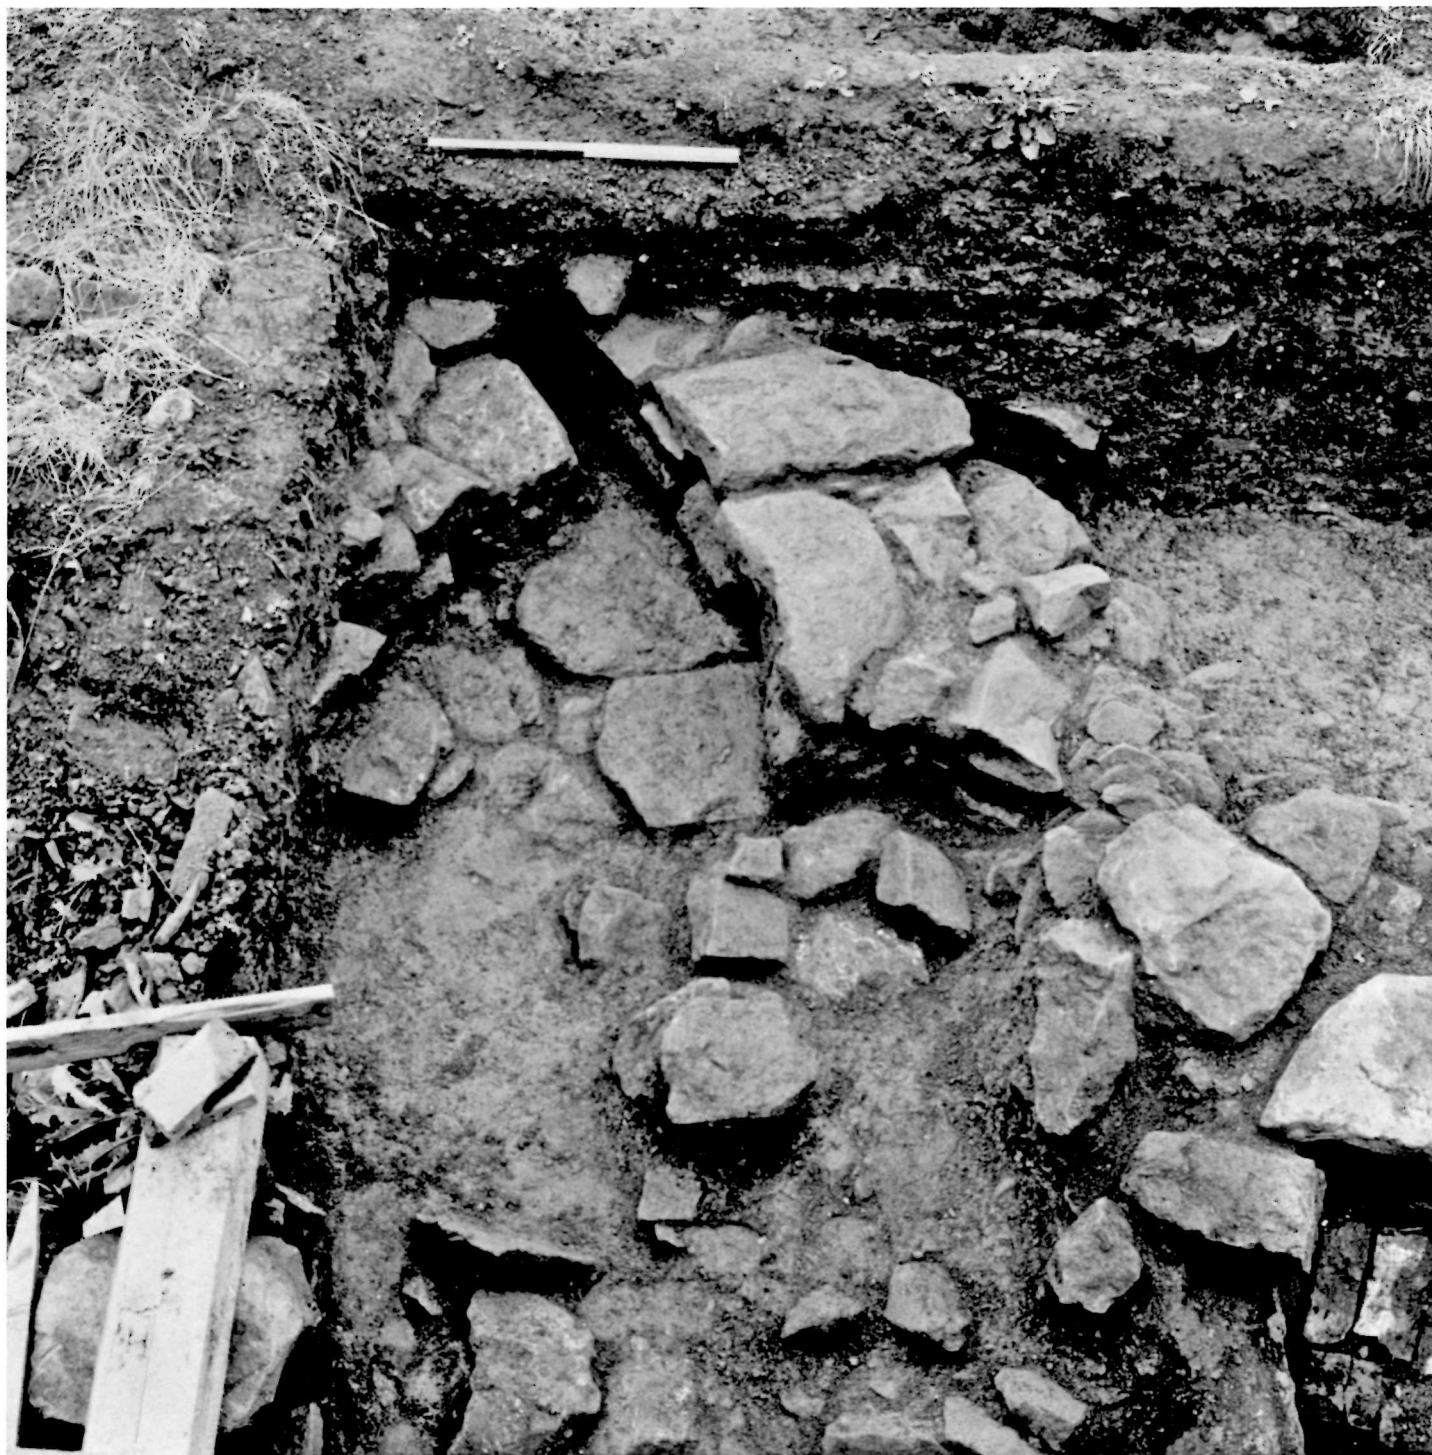
9 Post-excavation shot of 2E16Z5 showing the stone drain, camera facing west, with a two foot scale north-south. (2E-3579 X).

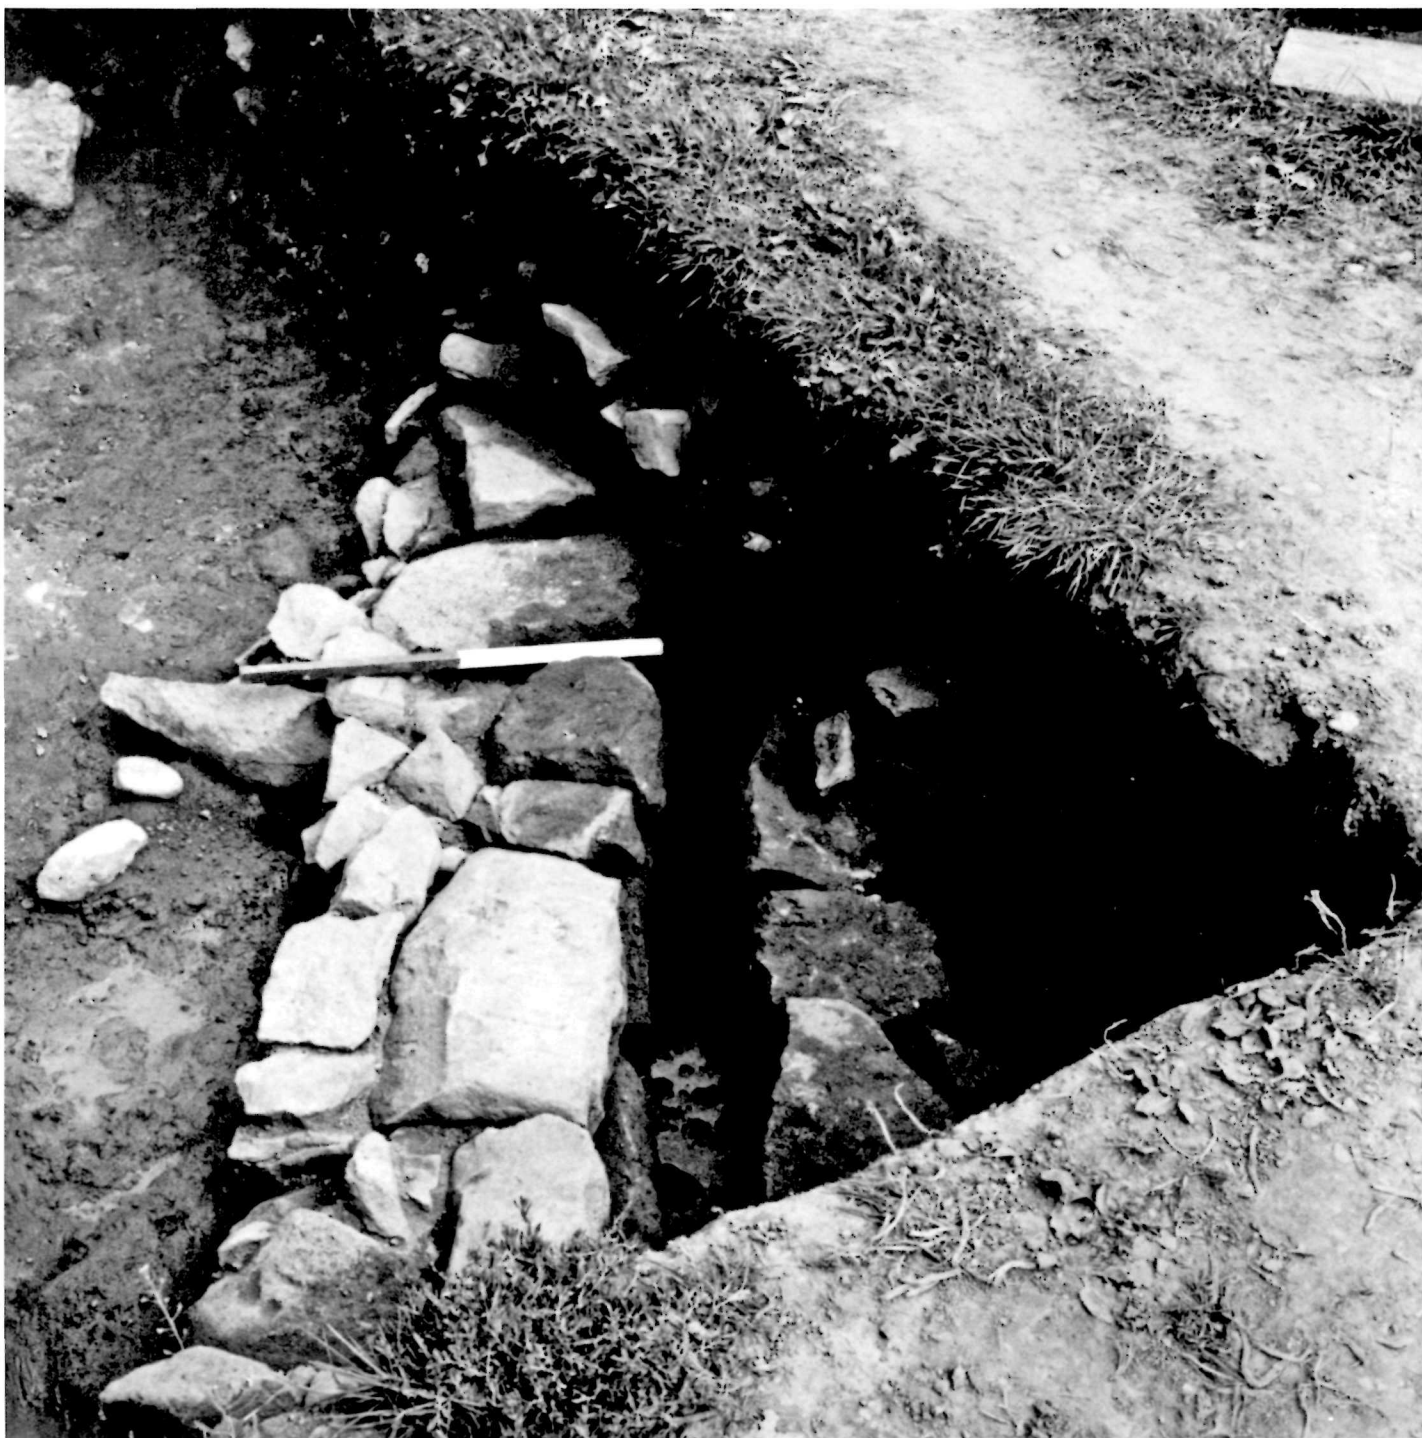
10 Post-excavation shot of the stone drain in 2E16S16 camera facing east, with a two foot scale north-south (2E-3588 X).

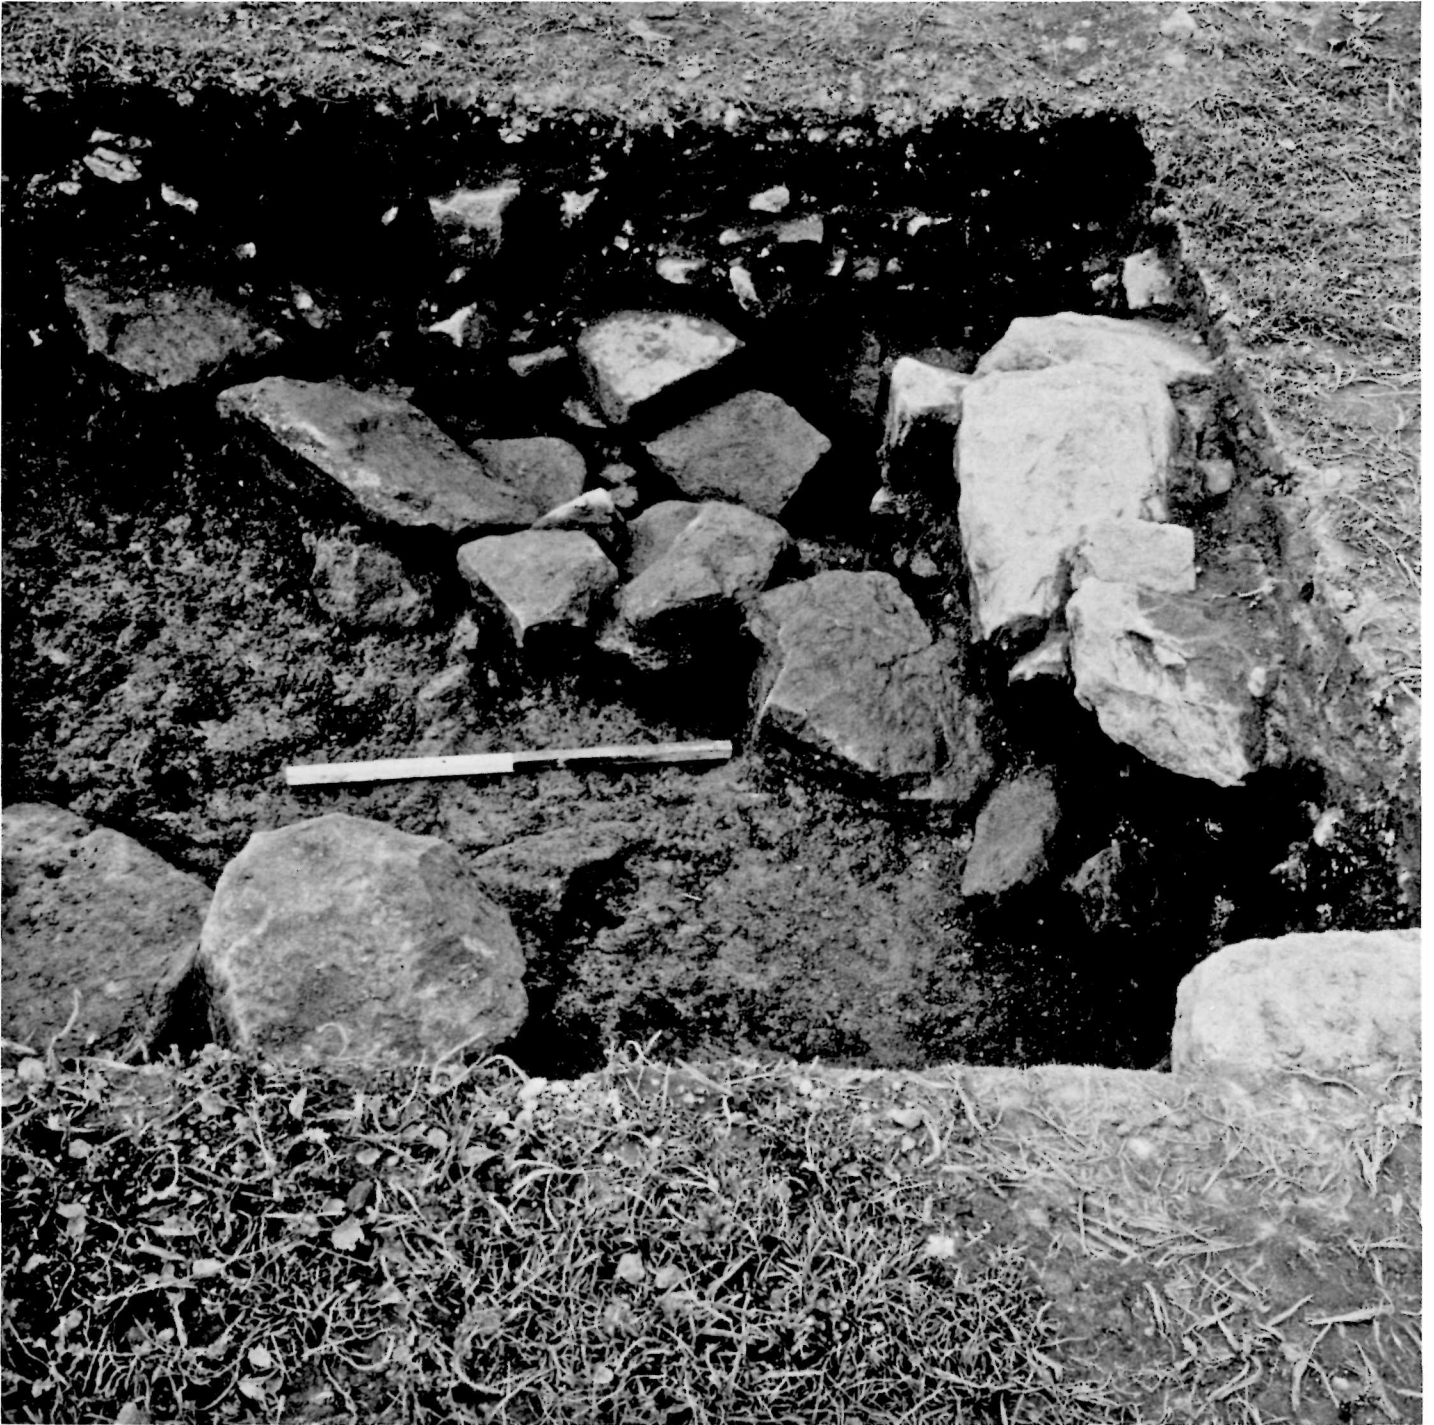
11 Post-excavation shot of the stone drain in 2E16S20, camera facing north-west, with a two foot scale northeast-southwest (2E-3594 X).

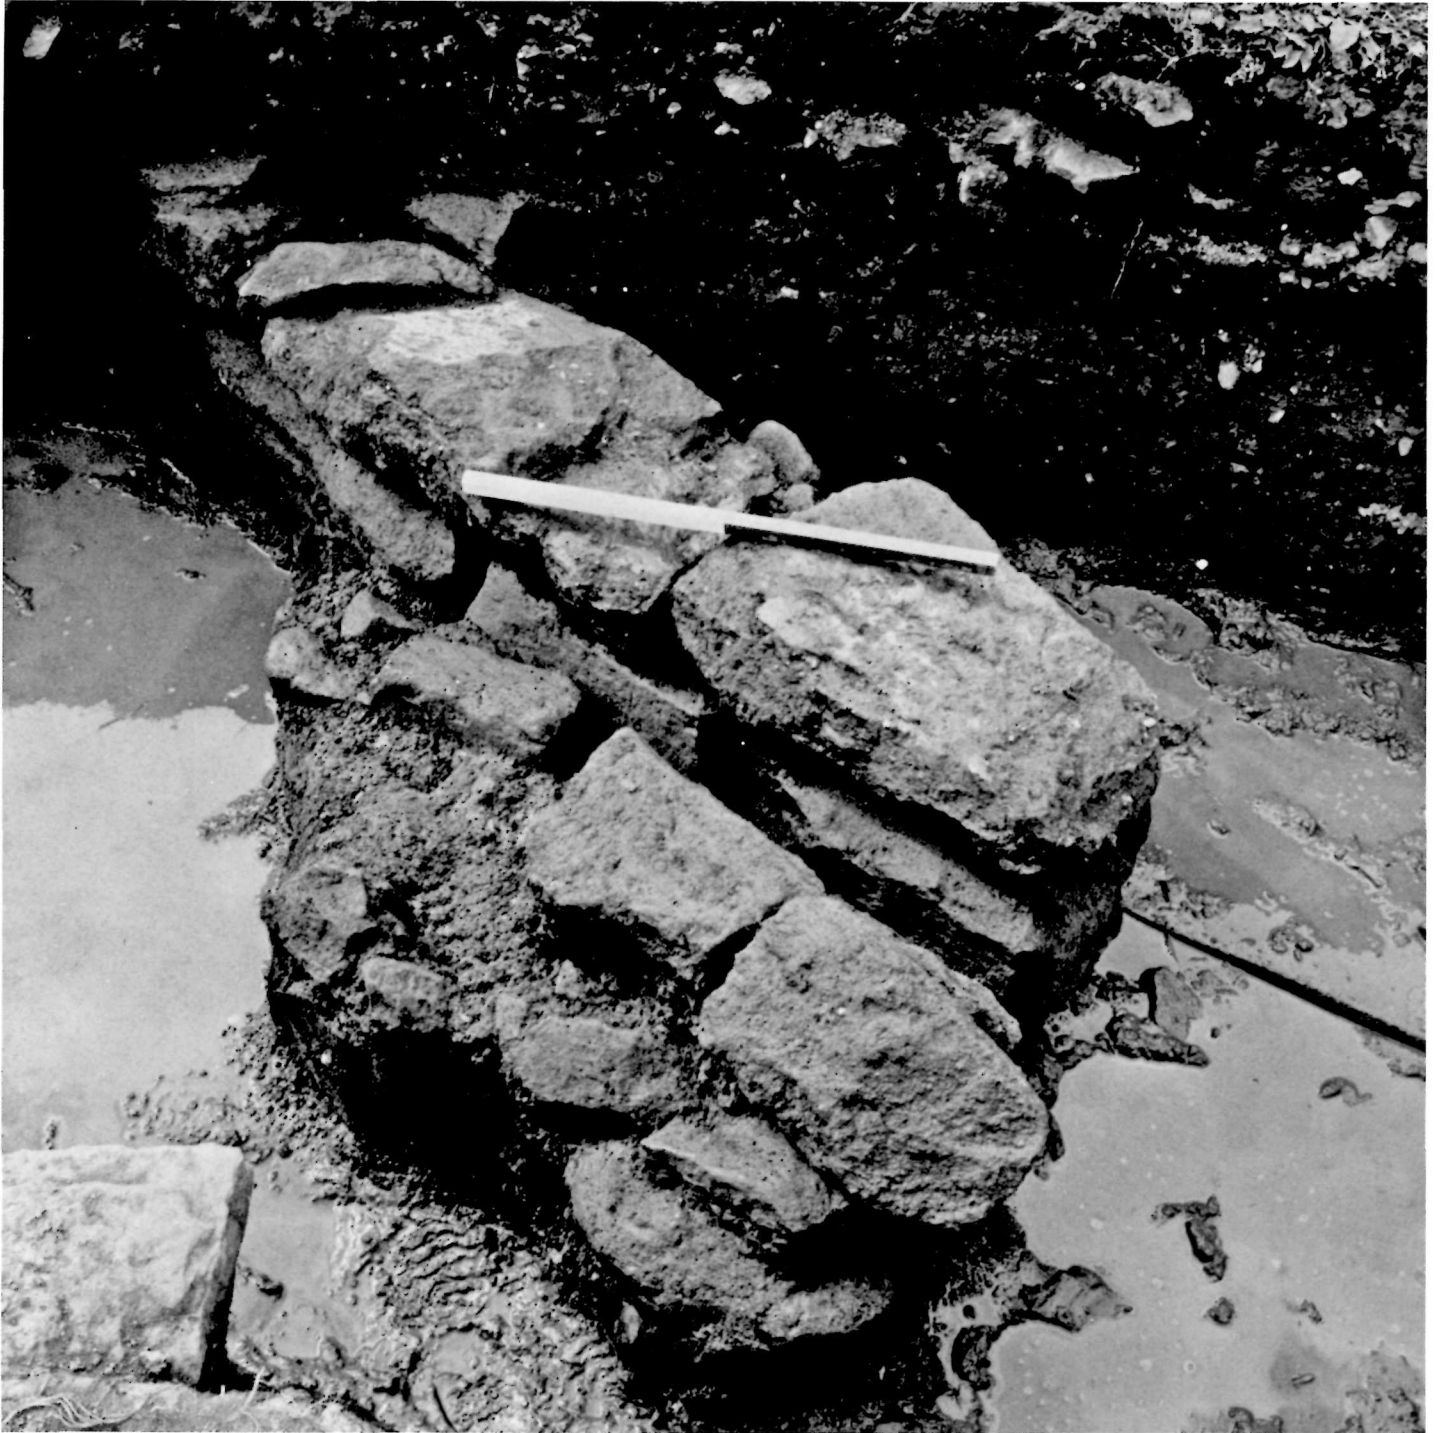
12 Post-excavation shot showing the stone drain in 2E16S24, with the camera facing north-west. There is a two foot scale northeast-southwest (2E-3598 X).

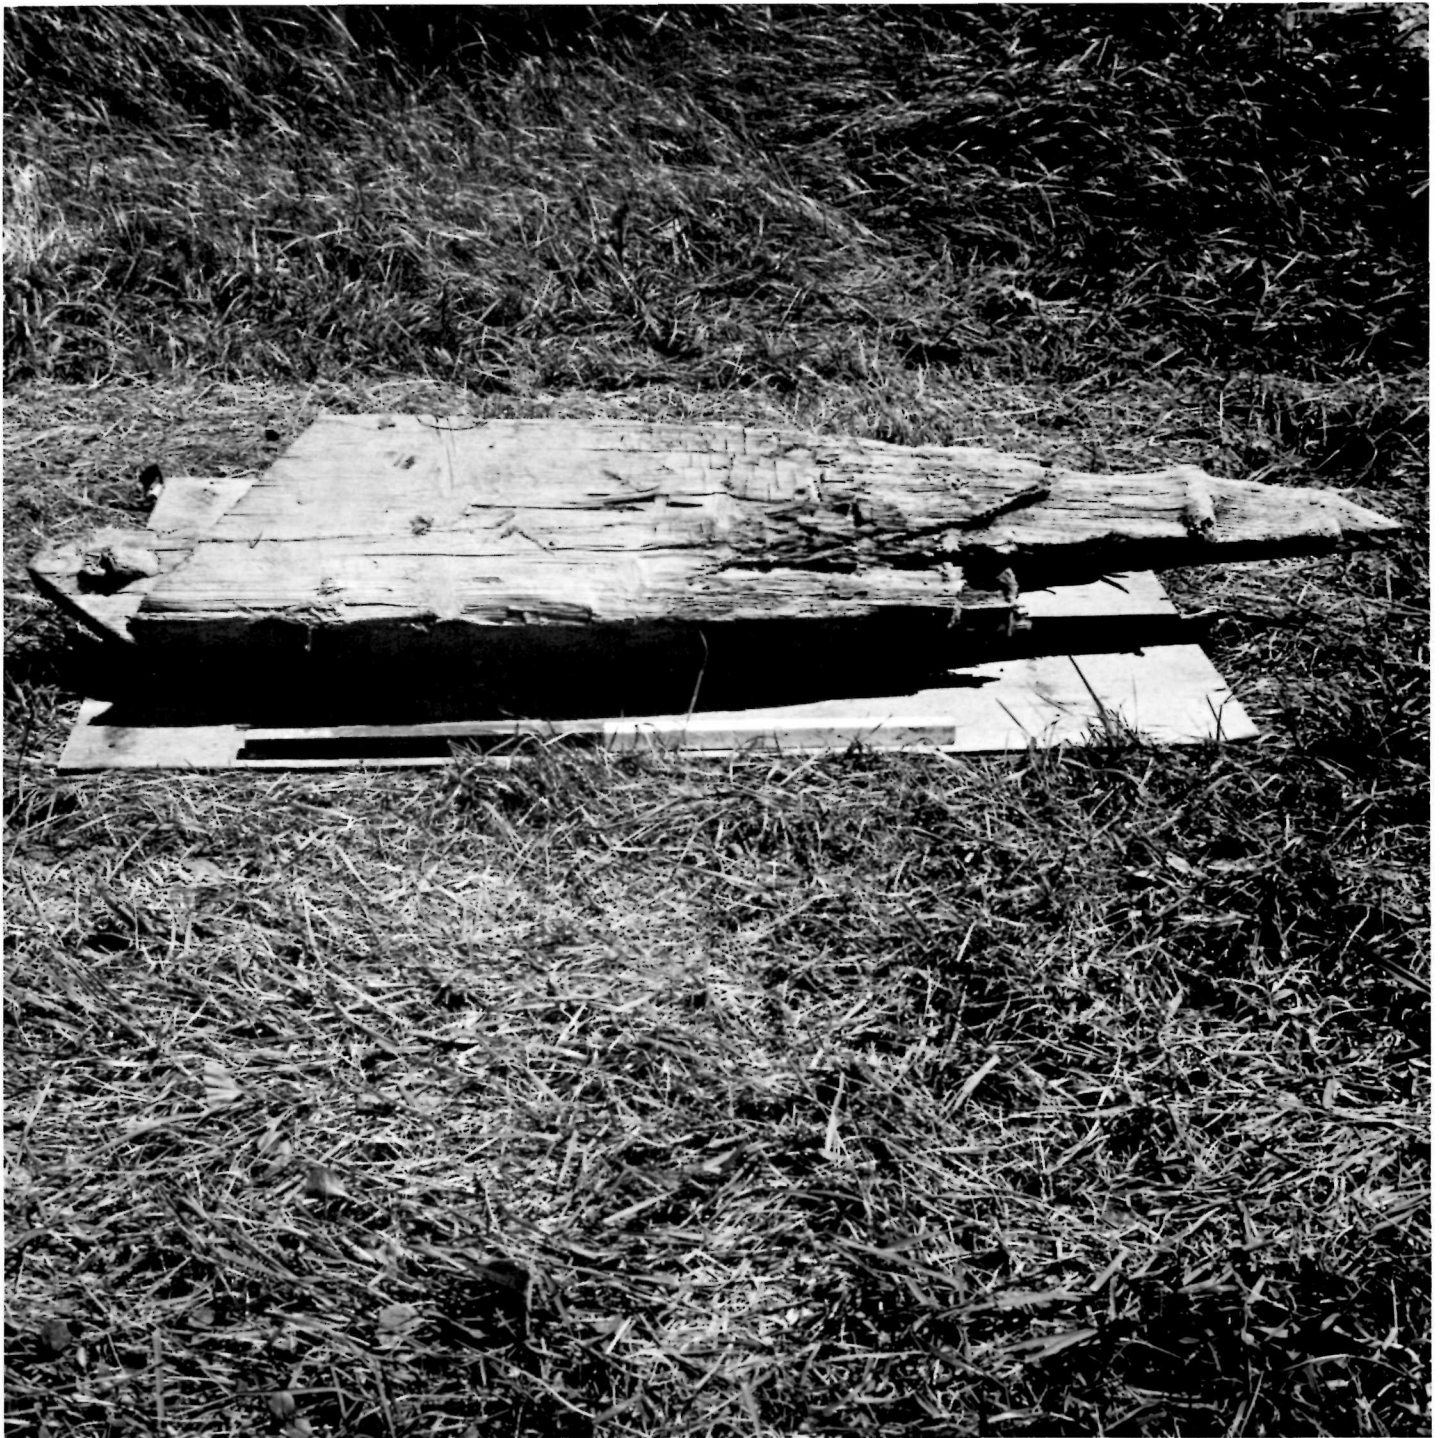
13 Post-excavation shot of artifact 2E27A23-1, a wooden post, with camera facing east, and a two foot scale north-south (2E-3519 X).
