MANUSCRIPT REPORT NUMBER 112

1968 ARCHAEOLOGICAL EXCAVATIONS
AT FORT BEAUSEJOUR

1970 ARCHAEOLOGICAL EXCAVATIONS
AT FORT BEAUSEJOUR

PARKS CANADA

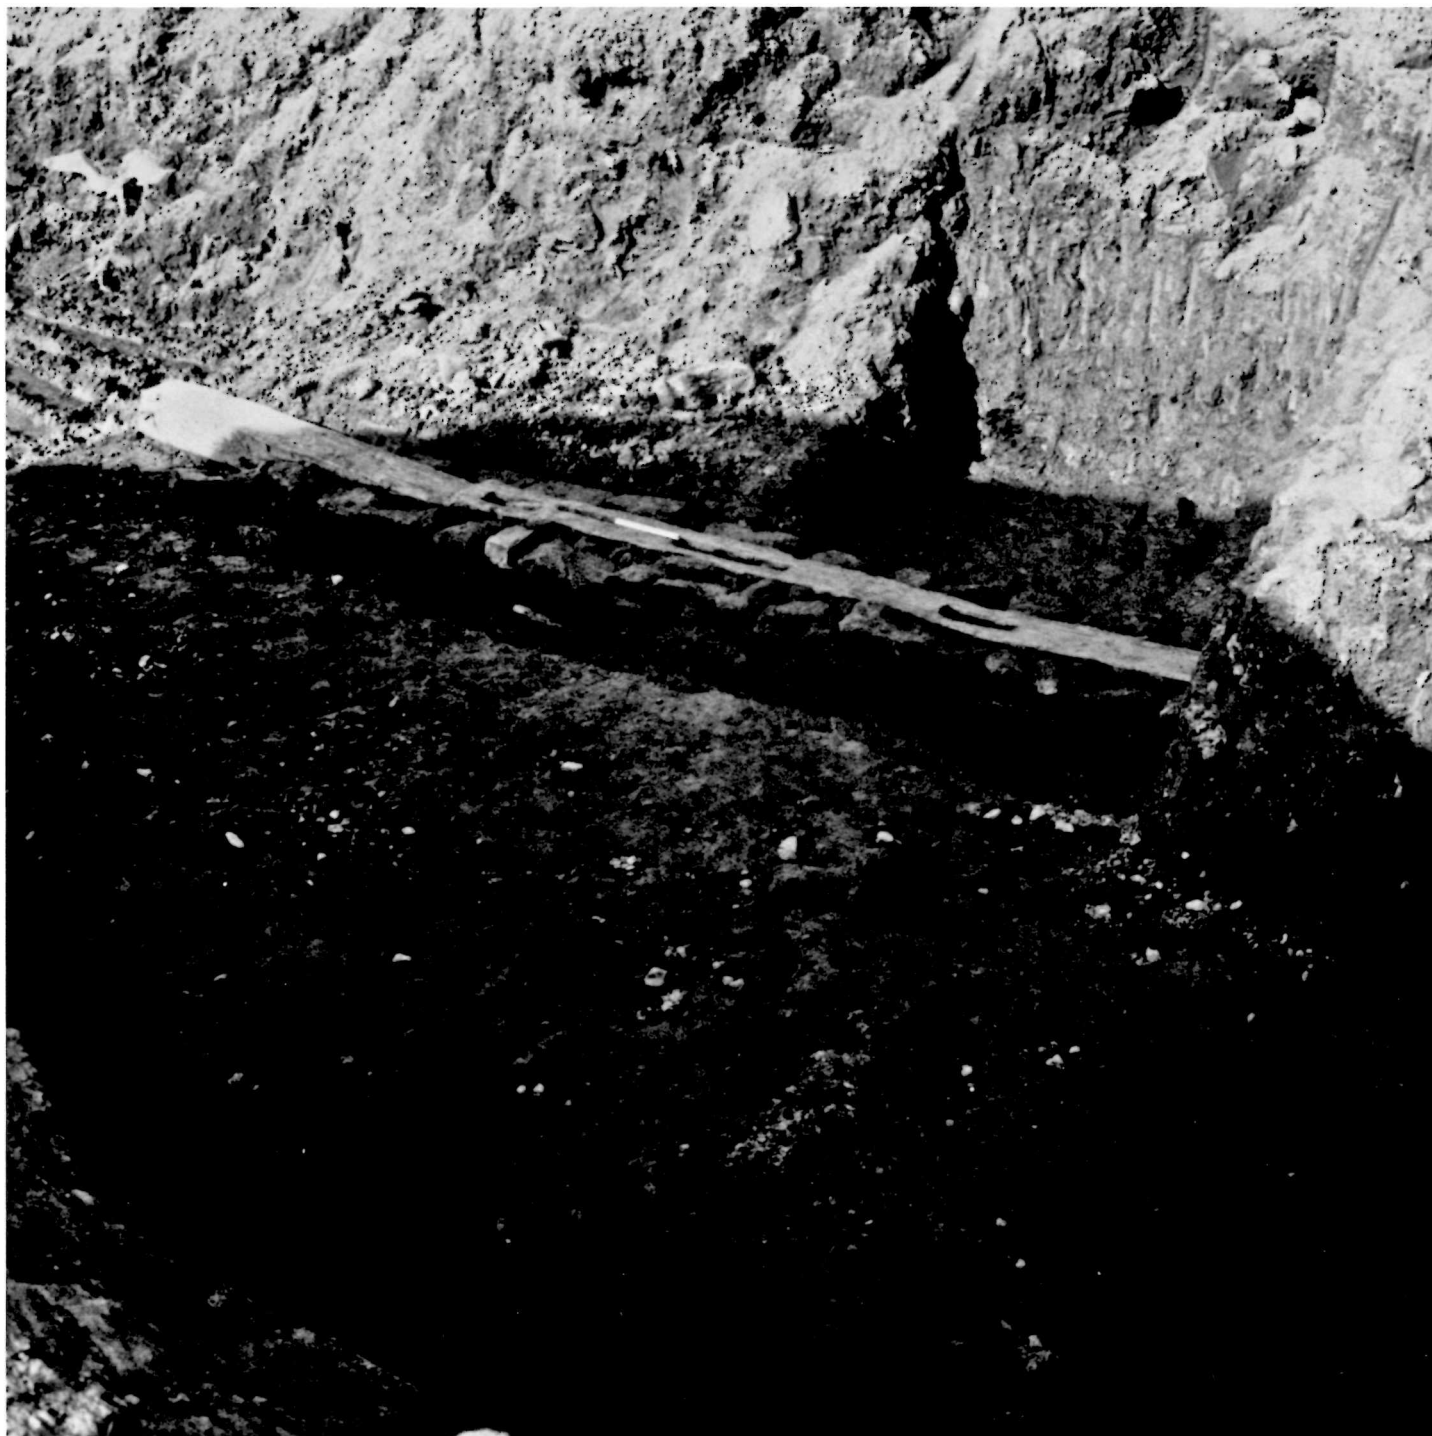
14 Post-excavation view of 2E26X1 showing the two beams and the stone bracing walls. The camera is facing southeast, and there is a two foot scale aligned east-west (2E-3530 X).

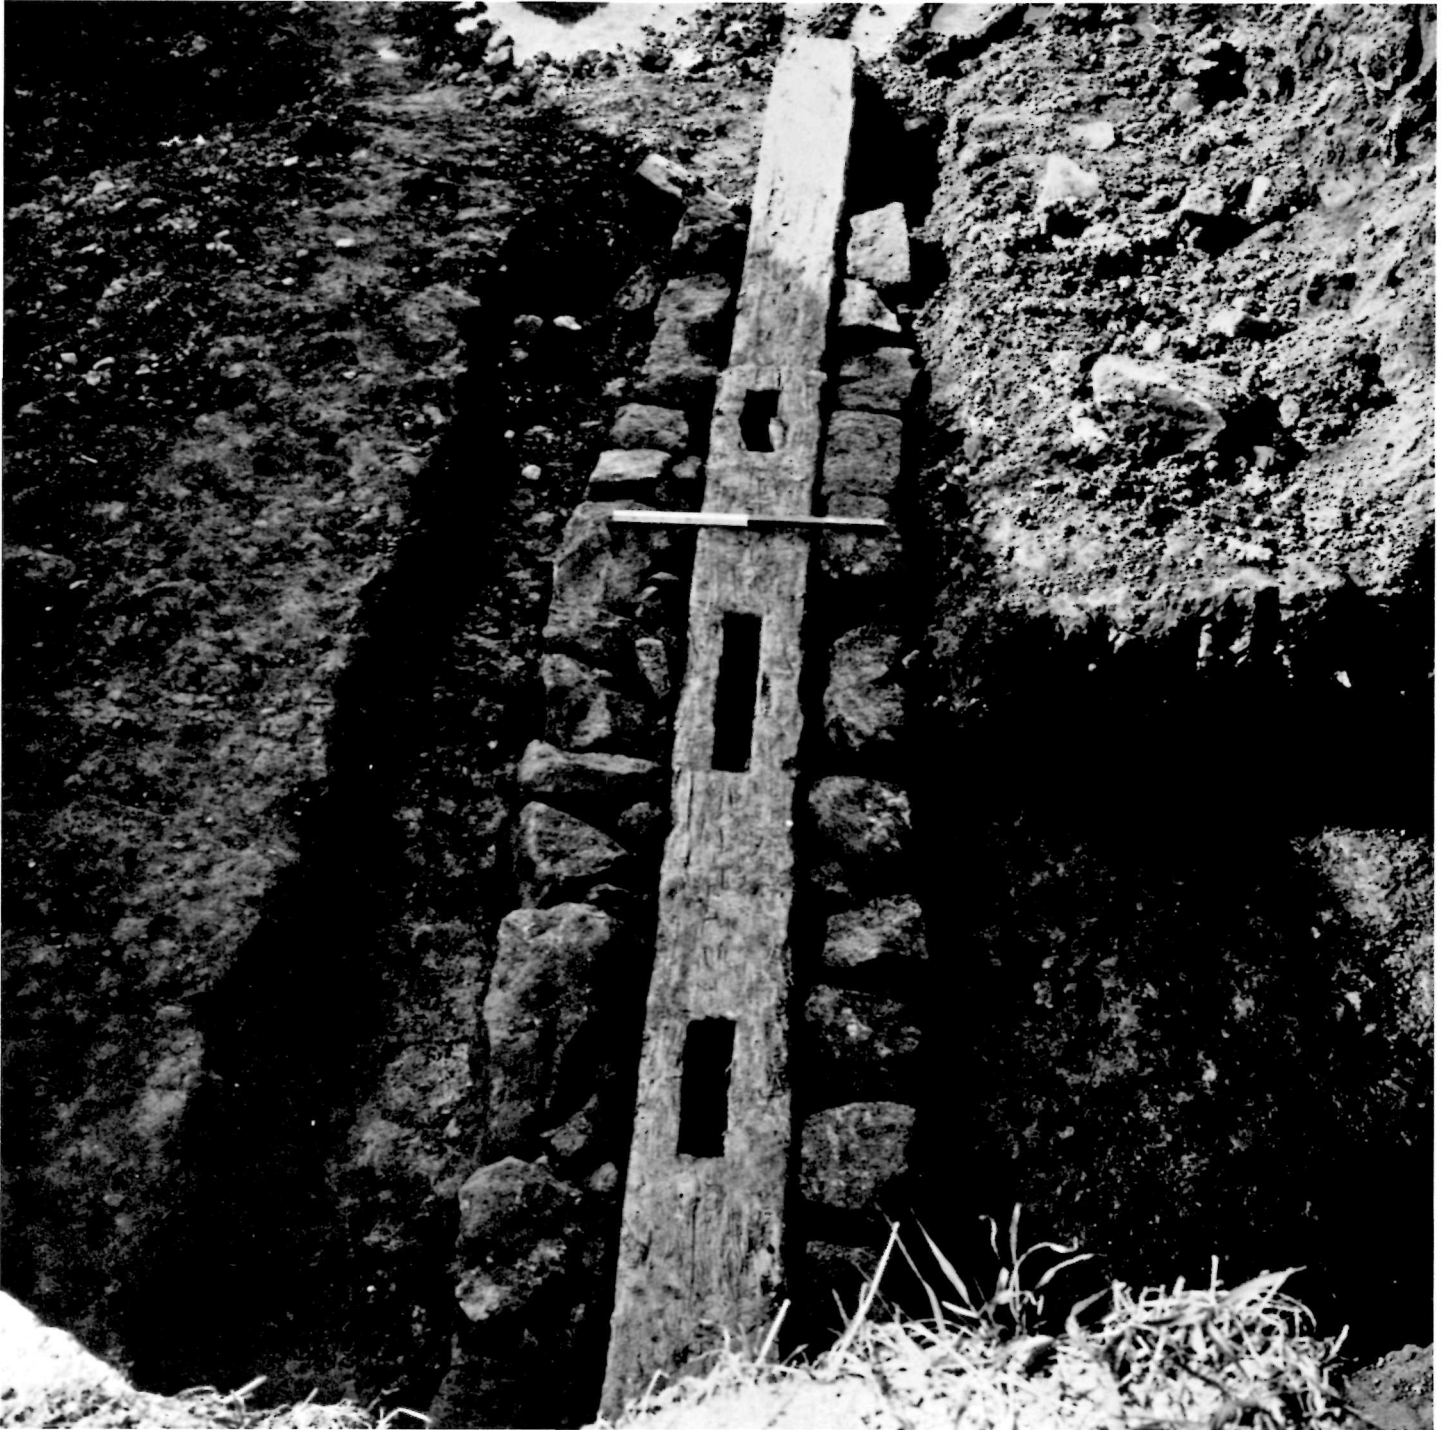
15 Post-excavation view showing the two beams in 2E26X1, camera facing east. There is a two foot scale north-south (2E-3531 X).

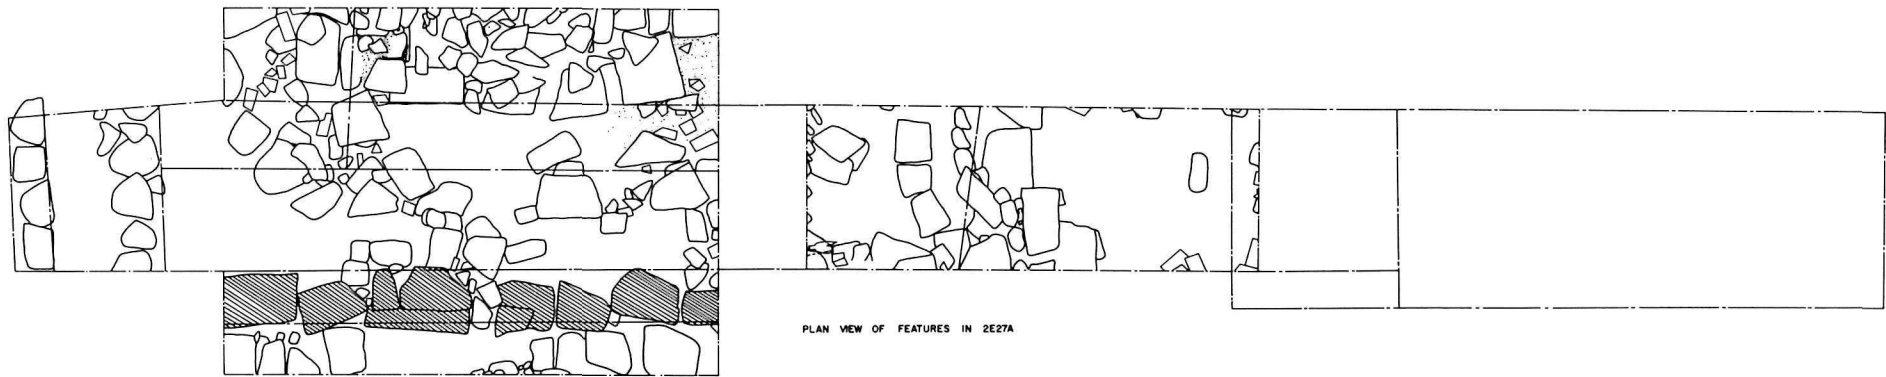
16 Plan of the features located in 2E27A (2E-71-102-4).

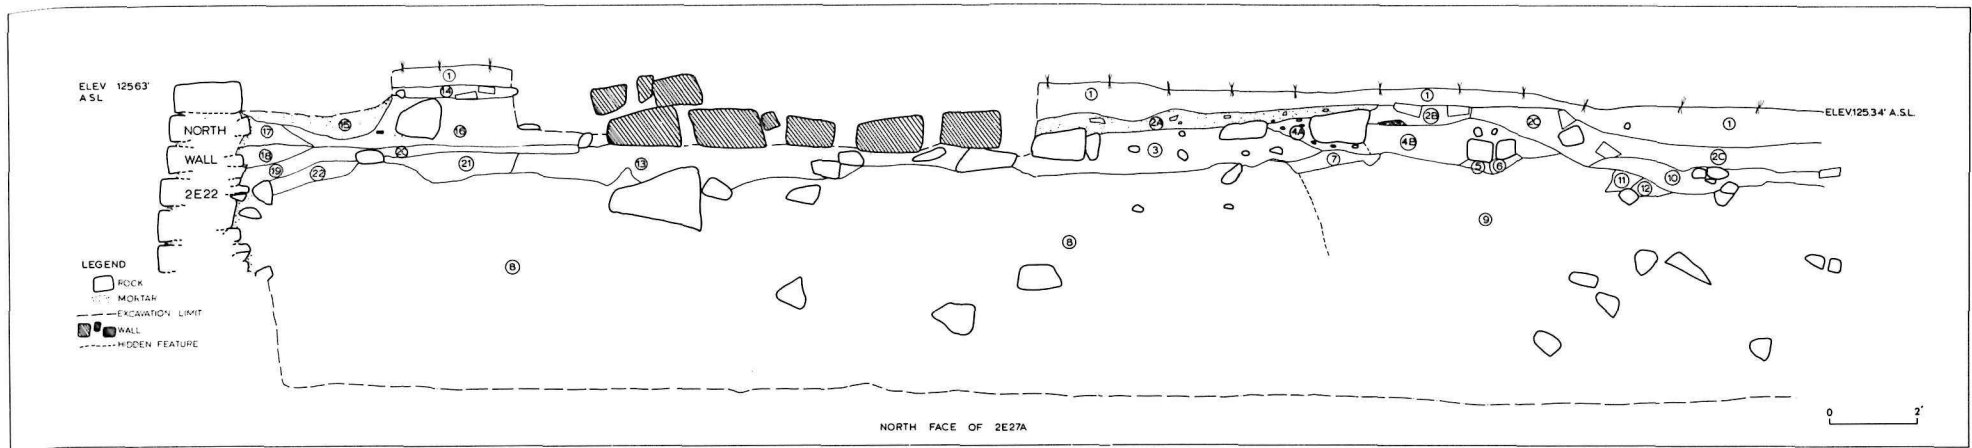
- 17 The soil layers of the stratigraphic cross-section along the north face of suboperation 2E27A.
- 1, 7.5 YR 3/2 dark brown sod layer, loam; 2a, 7.5 YR 3/2 dark brown, loamy clay, dens mortar and brick detritus; 2b, 7.5 YR 4/2 dark brown loamy clay, mortar and brick detritus; 2c, 7.5 YR 4/2 dark brown loamy clay; 3, 7.5 YR 4/4 brown sandy clay; 4a, 7.5 YR dark brown, very sandy clay, small stones; 4b, 7.5 YR 4/4 brown, sandy clay; 5, 5 YR 4/3 reddish brown, sandy clay; 6, 7.5 YR 4/4 brown medium sand; 7, 5 YR 4/3 reddish brown, very sandy clay; 8, 5 YR 4/4 reddish brown clay with some small stones; 9, 5 YR 3/3 dark reddish brown, very sandy clay; 10, 7.5 YR 4/2 dark brown, loamy clay; 11, 7.5 YR 5/6 strong brown, medium to coarse sand with clay; 12, 10 YR 5/8 yellowish brown medium to coarse sand with clay; 13, 7.5 YR 5/6 strong brown, medium sand; 14, 7.5 YR 4/2 dark brown loam with clay, some mortar detritus; 15, 7.5 YR 4/2 dark brown loam, dense whitish mortar detritus; 16, 7.5 YR 4/2 dark brown, sandy and loamy clay; 17, 7.5 YR 4/4 brown, slightly sandy clay; 18, 5 YR 4/3 reddish brown sandy clay; 19, 5 YR 3/4 dark reddish brown sandy clay, some charcoal fragments; 20, 10 YR 3/4 dark yellowish brown loam with clay, wood and charcoal fragments; 21, 7.5 YR 5/4 brown medium sand with clay; 22, 7.5 YR 4/4 brown medium sand with clay (2E-71-102-6).

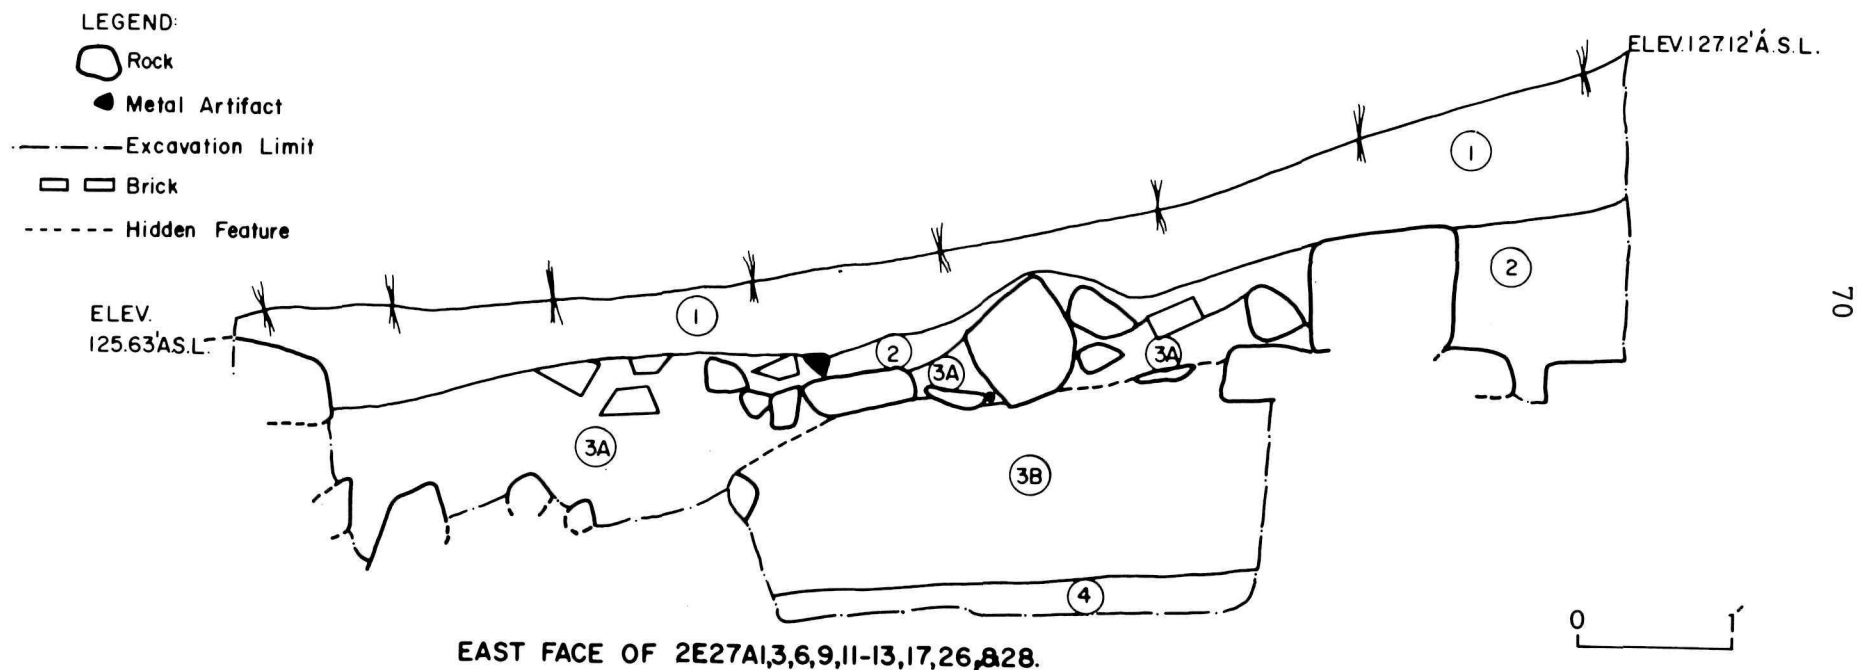
18 The soil layers of the stratigraphic cross-section along the east face of lots 2E27A3, 2E27A9, 2E27A11, 2E27A17, 2E27A26 and 2E27A28. 1, 7.5 YR 3/2 dark brown loam, sod layer; 2, 7.5 YR 4/2 dark brown, sandy and loamy clay; 3a, 7.5 YR 4/4 brown, medium sand with clay; 3b, 7.5 YR 5/4 brown, medium sand with clay; 4, 5YR reddish brown sandy clay with some small stones (2E-71-102-2).

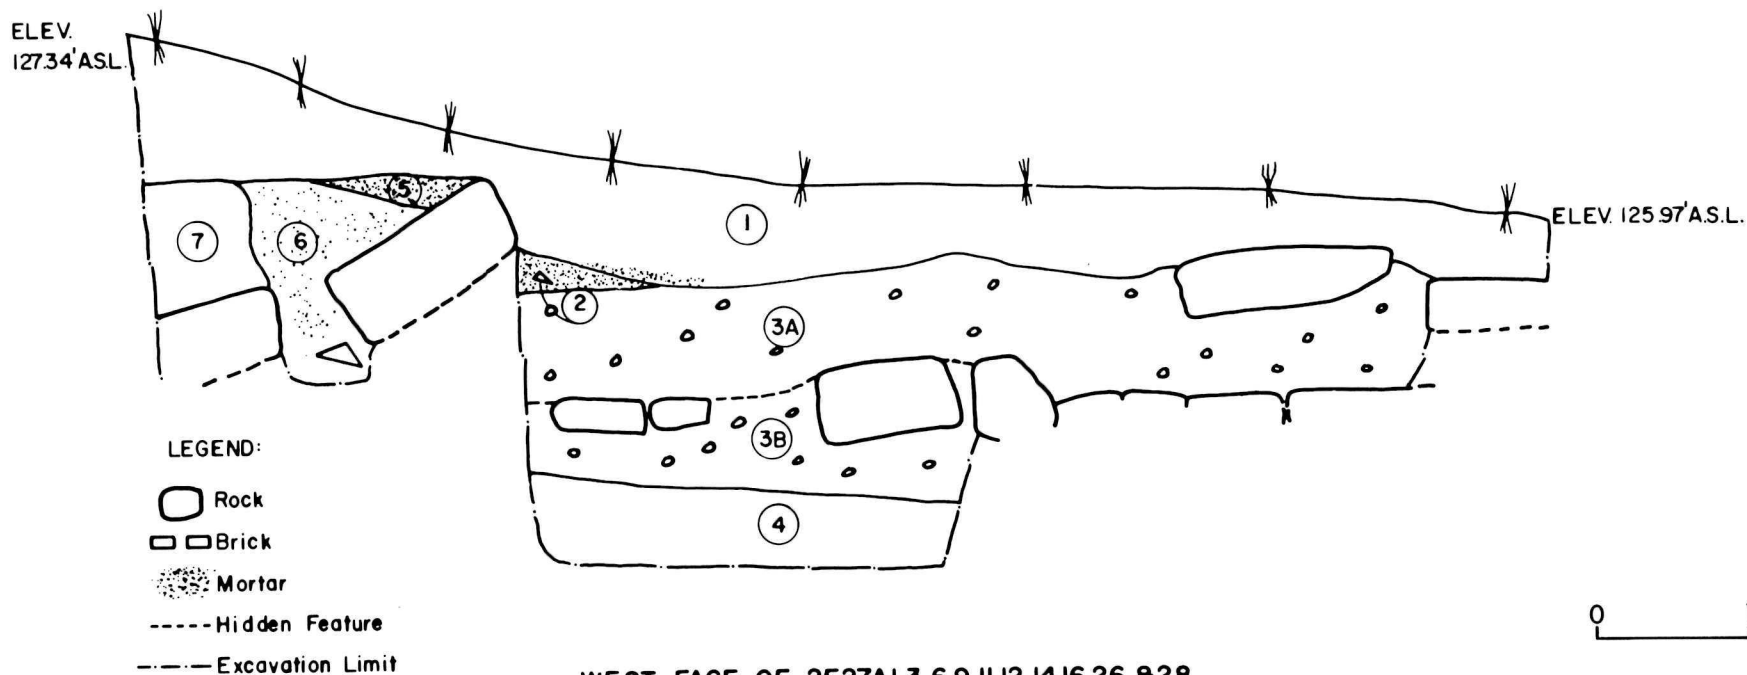
19 The soil layers of the stratigraphic cross-section along the west face of lots 2E27A9, 2E27A11, 2E27A16 and 2E27A28. 1, 7.5 YR 4/2 dark brown loam, sod layer; 2, 10 YR 3/4 dark yellowish brown loam, dense yellow and white mortar detritus with some brick detritus; 3a, 7.5 YR 4/4 brown sandy clay, small pebbles; 3b, 10 YR 3/4 dark yellowish brown sand with clay; 4, 10 YR 4/4 dark yellowish brown medium sand; 5, 10 YR 3/4 dark yellowish brown loam, dense mortar detritus; 6, 10 YR 3/4 dark yellowish brown, dense yellowish mortar detritus with some brick detritus; 7, 10 YR 3/4 dark yellowish brown loam with clay (2E-71-102-2).

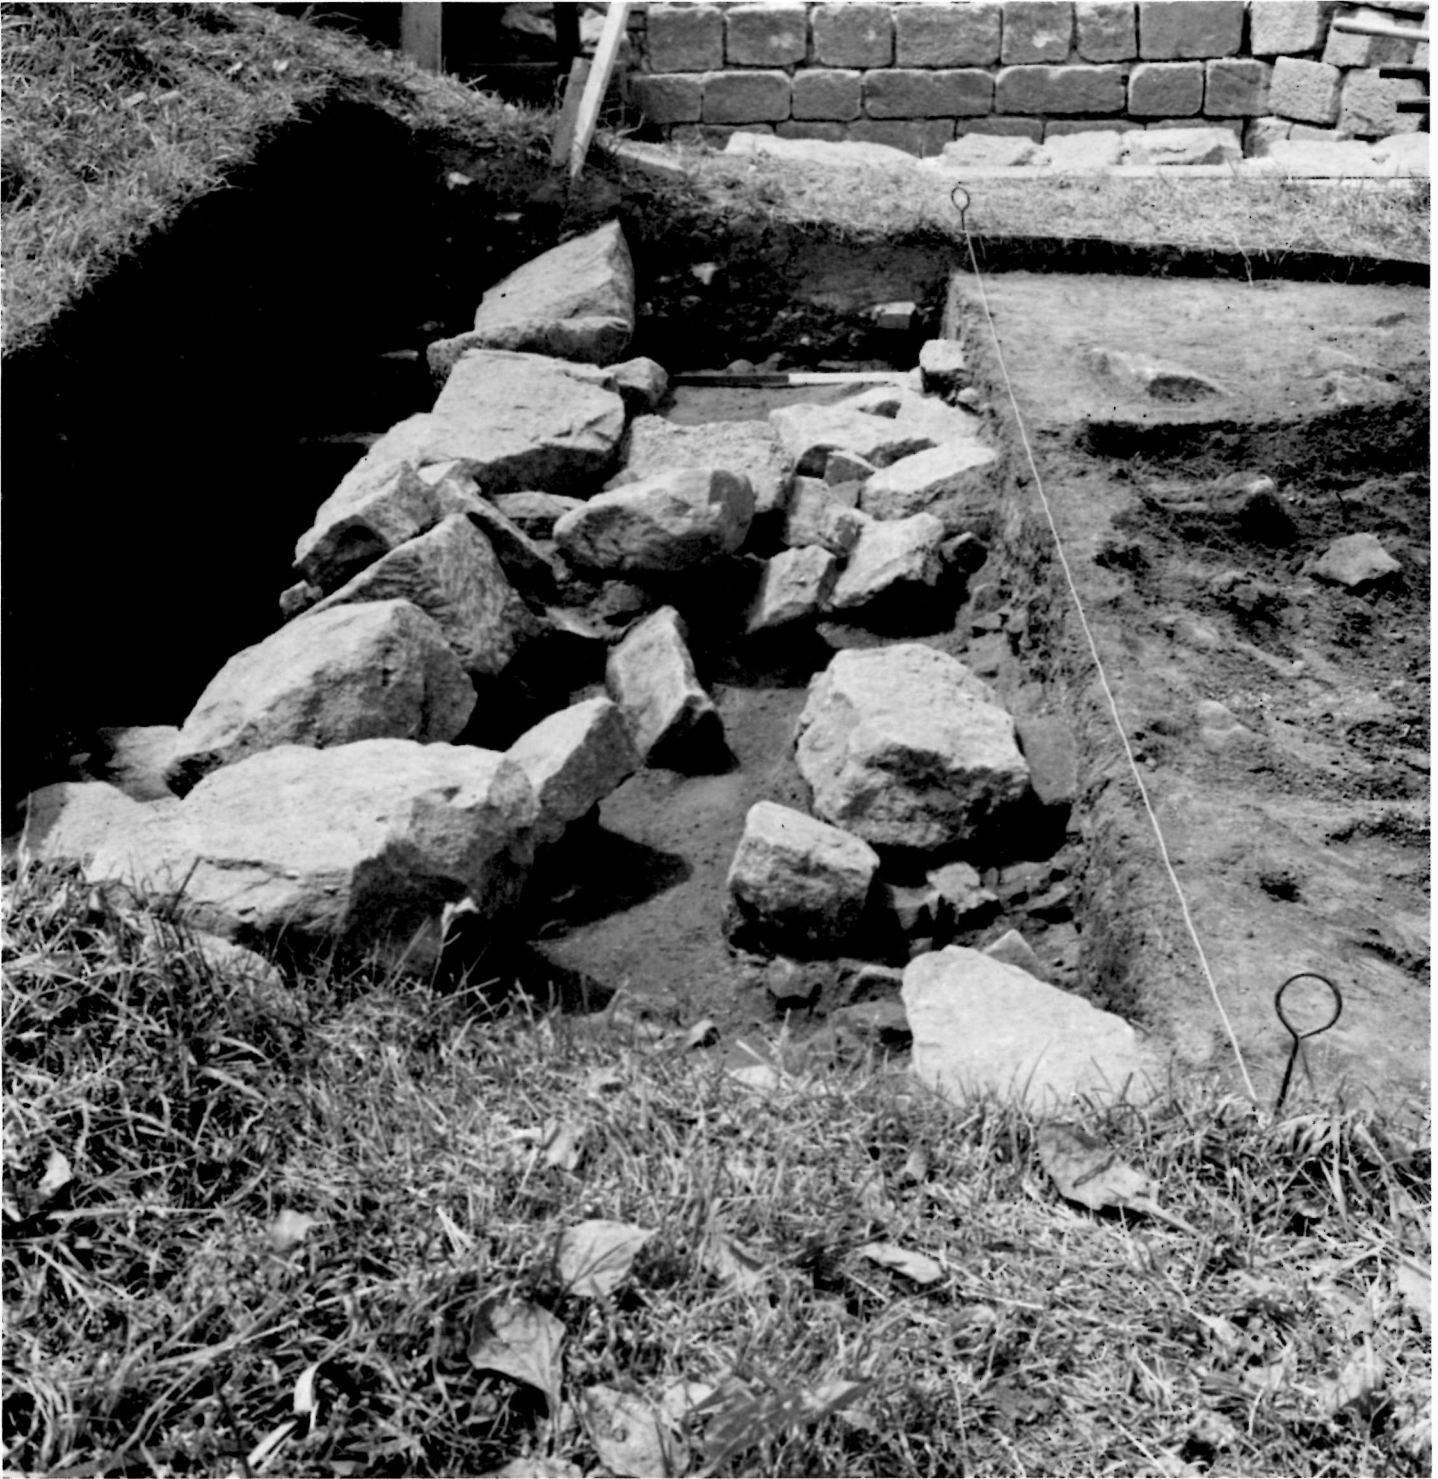
20 Post-excavation view showing the wall located in lot 2E27A3, with the camera facing west. There is a two foot scale north-south (2E-3504 X).

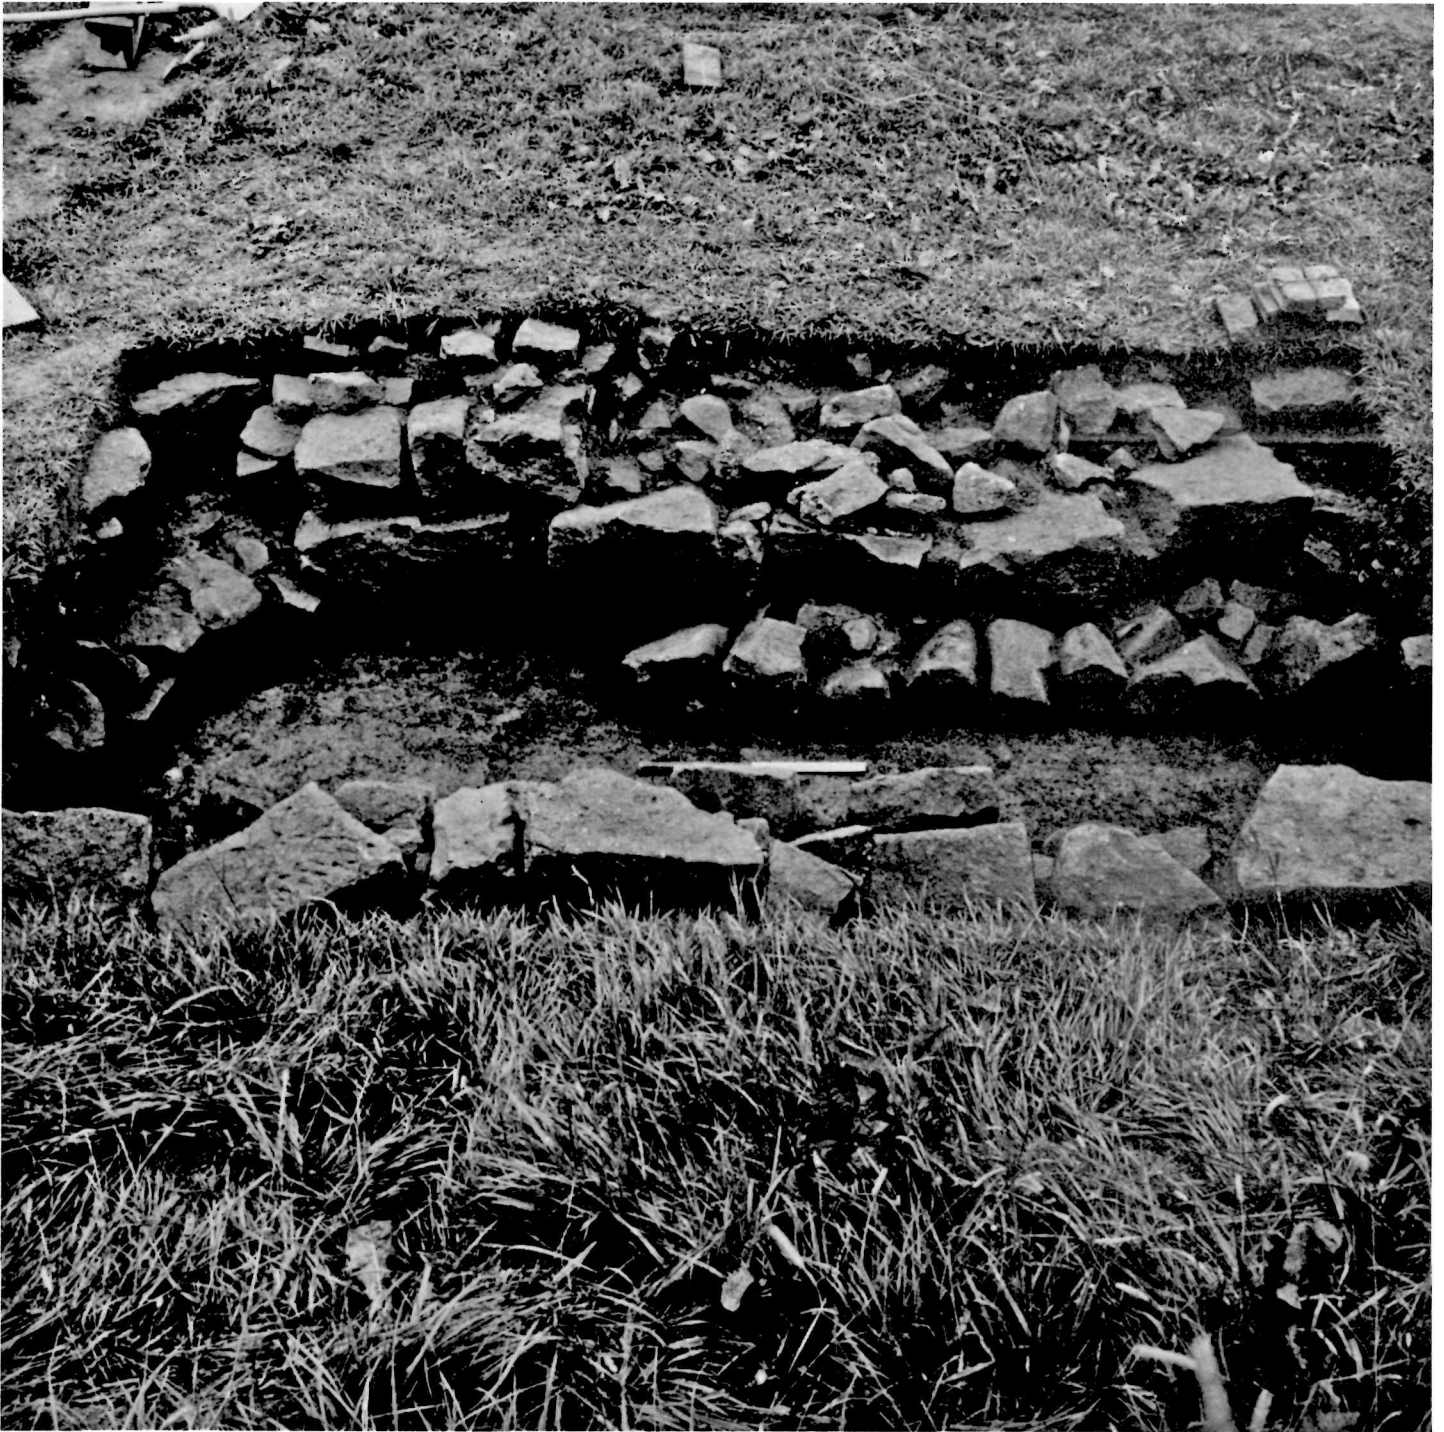
21 Post-excavation view showing the wall found in lots 2E27A16 and 2E27A17, camera facing north. There is a two foot scale east-west (2E-3522 X).

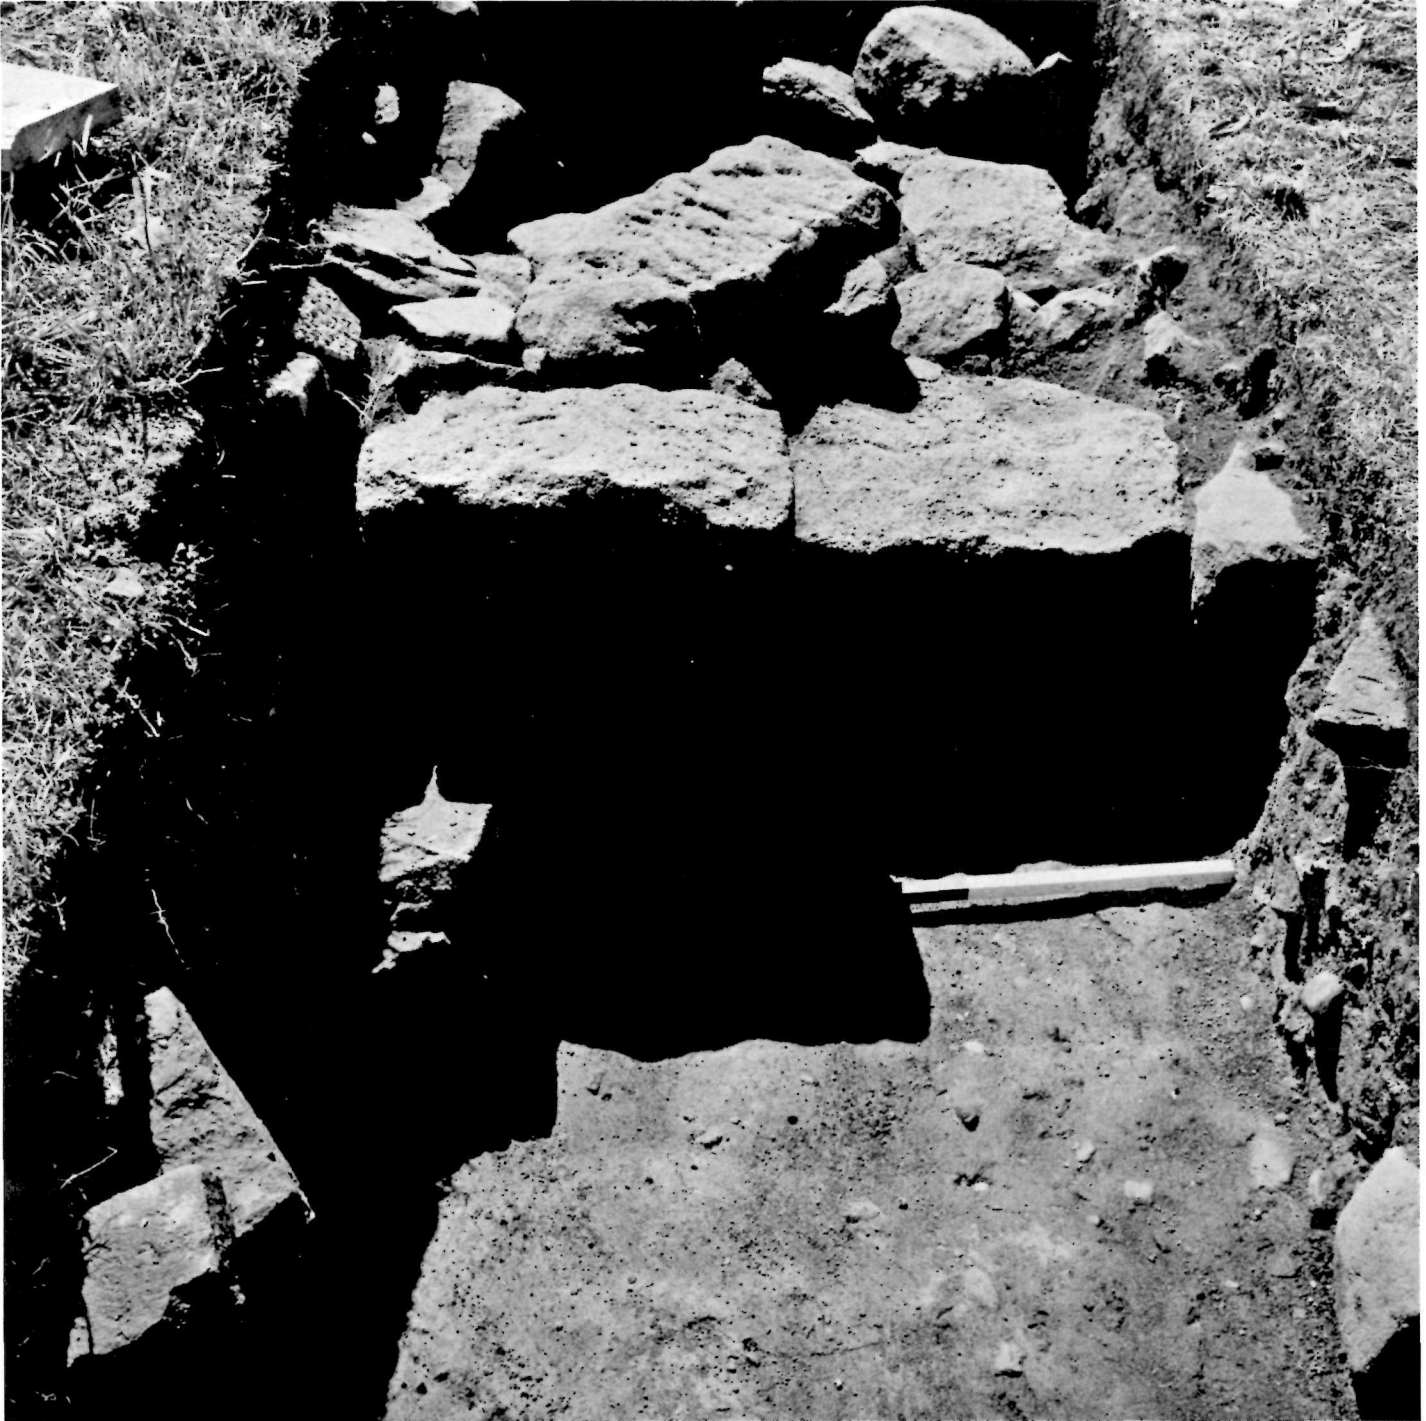
22 Post-excavation view showing the wall in 2E27A22, camera facing west with a two foot scale north-south (2E-3509 X).

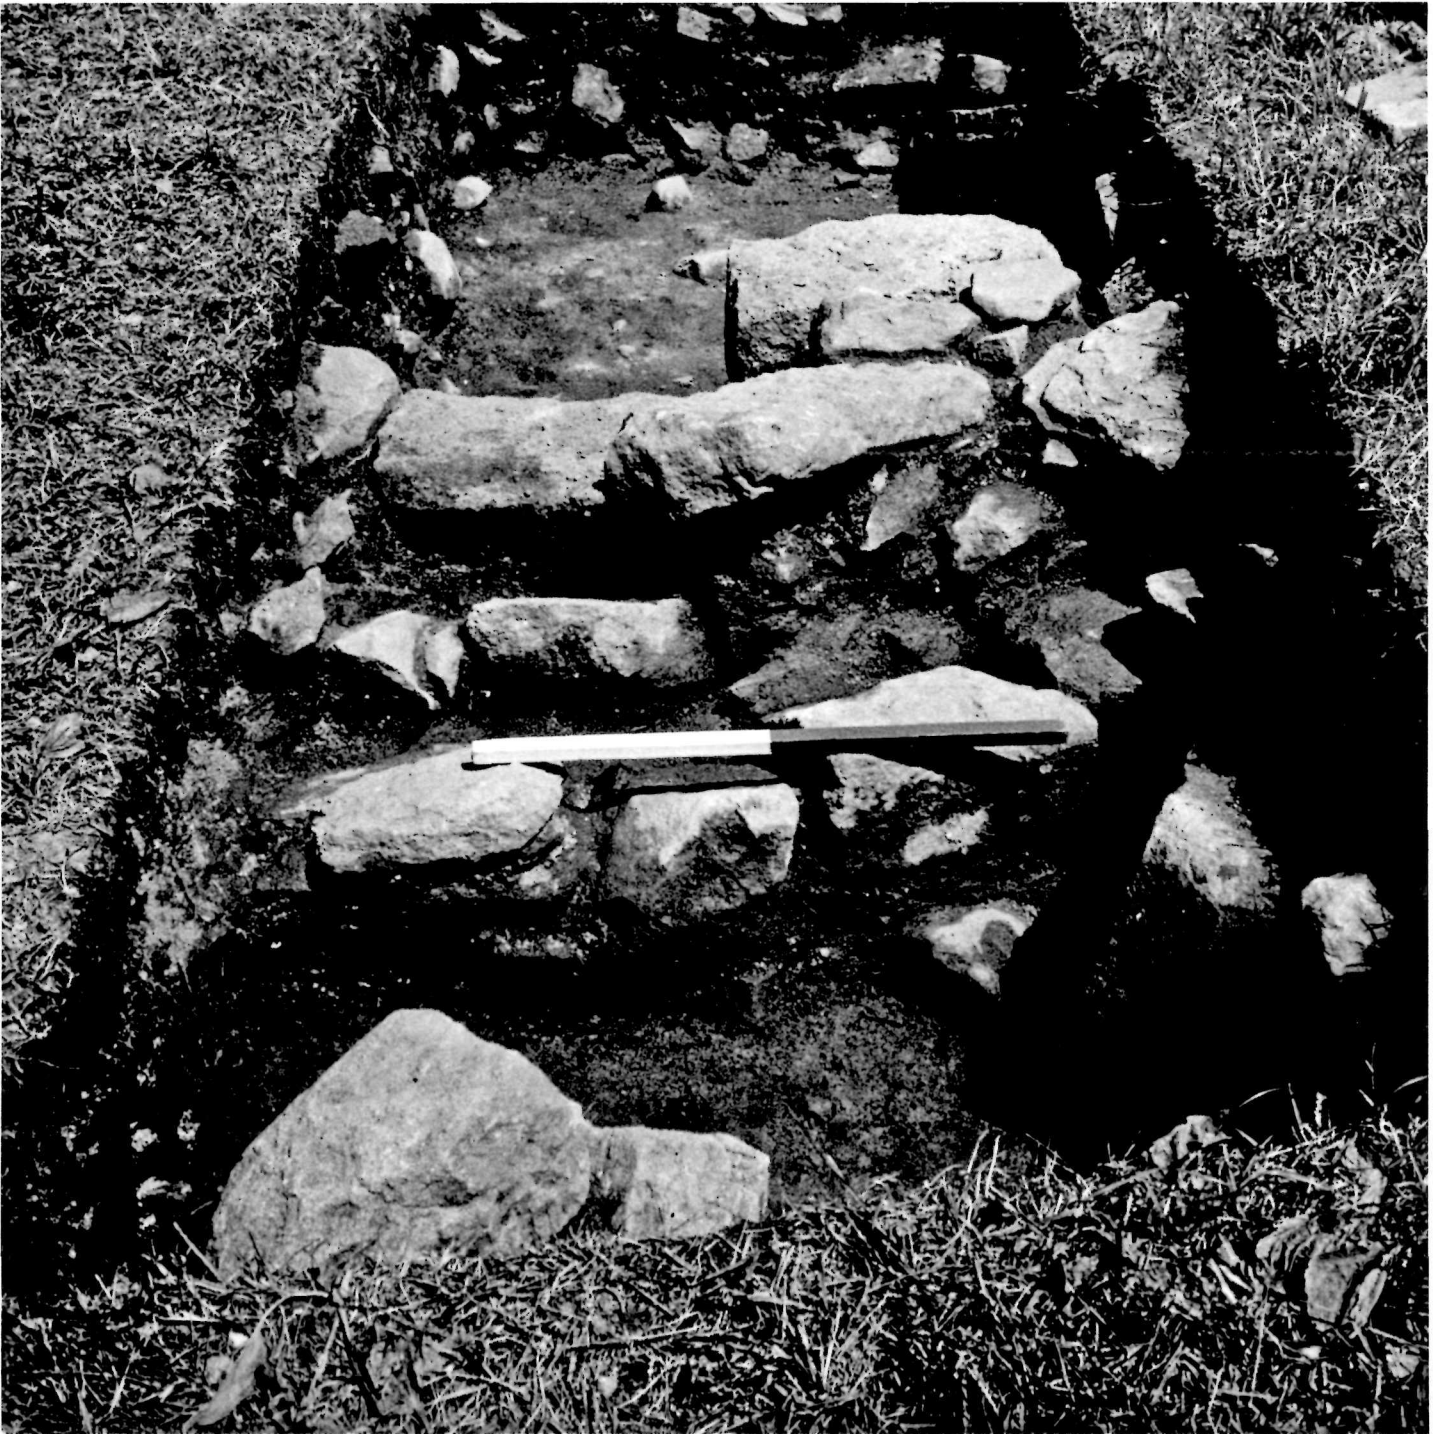
23 Post-excavation view showing the wall in 2E27A24 with the camera facing east. There is a two foot scale north-south (2E-3609 X).
