1967 EXCAVATION OF THE
PRINCE FREDERICK BASTION 2E20 AT FORT BEAUSEJOUR

by
Winnie Frohn
(1968)

1967 EXCAVATION IN THE PRINCE FREDERICK BASTION
AND MEN'S BARRACKS AT FORT BEAUSEJOUR

by
E. Frank Korvemaker
(1972)

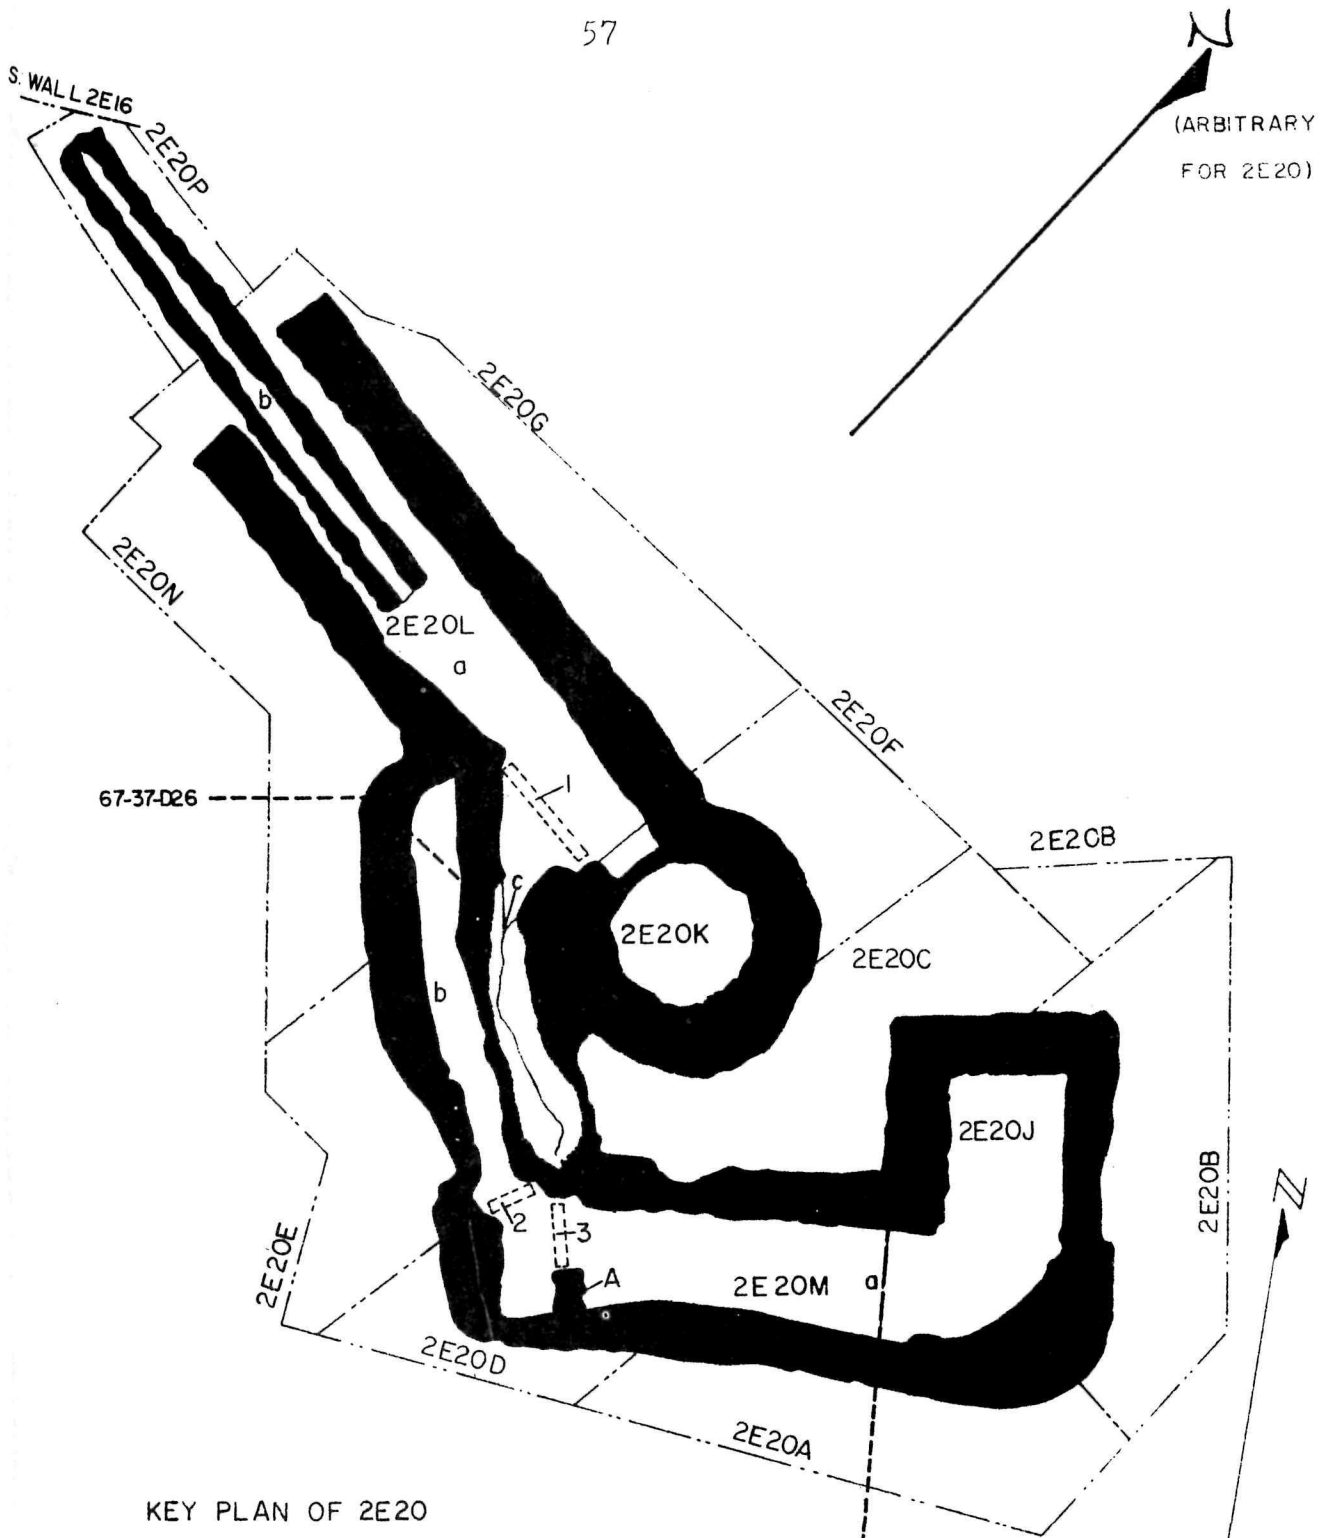
KEY PLAN OF 2E20

- A WALL A
- 2E20J CASEMATE
- 2E20M a SOUTH ARM OF CURVED PASSAGEWAY
- 2E20M b NORTH ARM OF CURVED PASSAGEWAY
- 2E20M c DRAIN
- 2E20K WELL
- 2E20L a STRAIGHT PASSAGEWAY
- 2E20P b DRAINWAY
- 1,2,3 DOOR SILLS
- CROSS SECTIONS

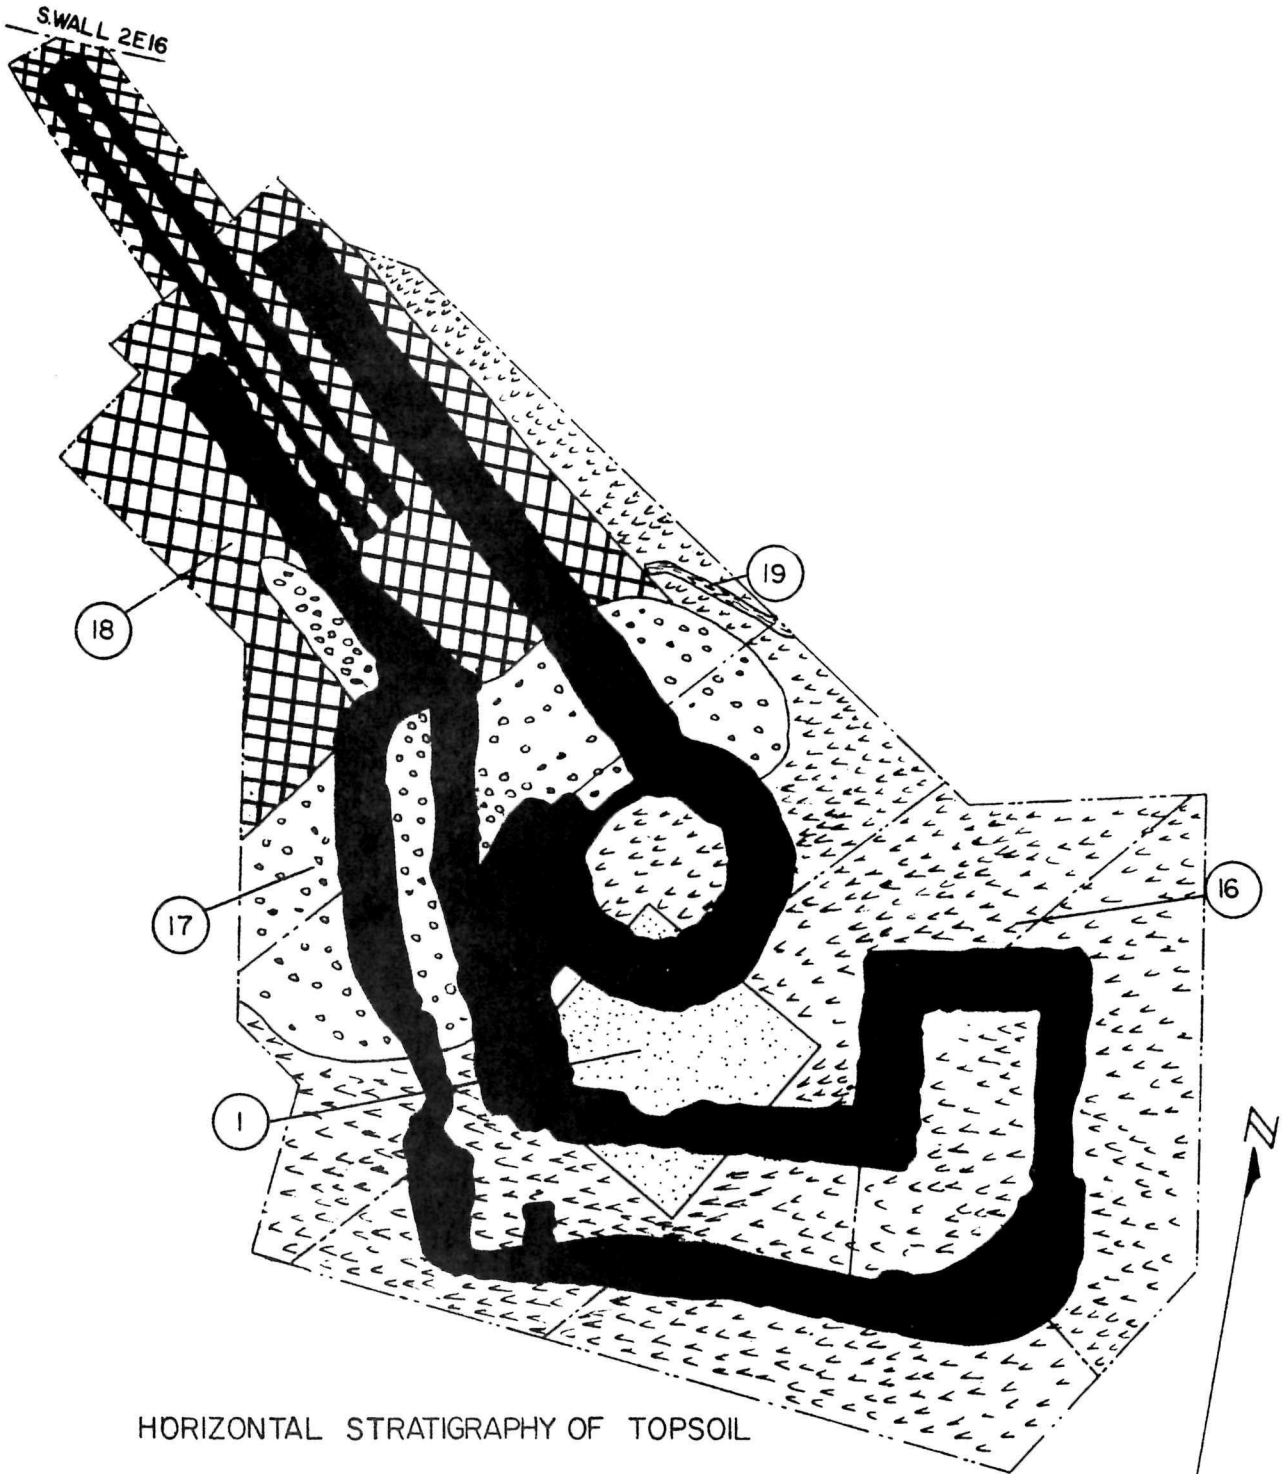
FIG. 4

HORIZONTAL STRATIGRAPHY OF TOPSOIL

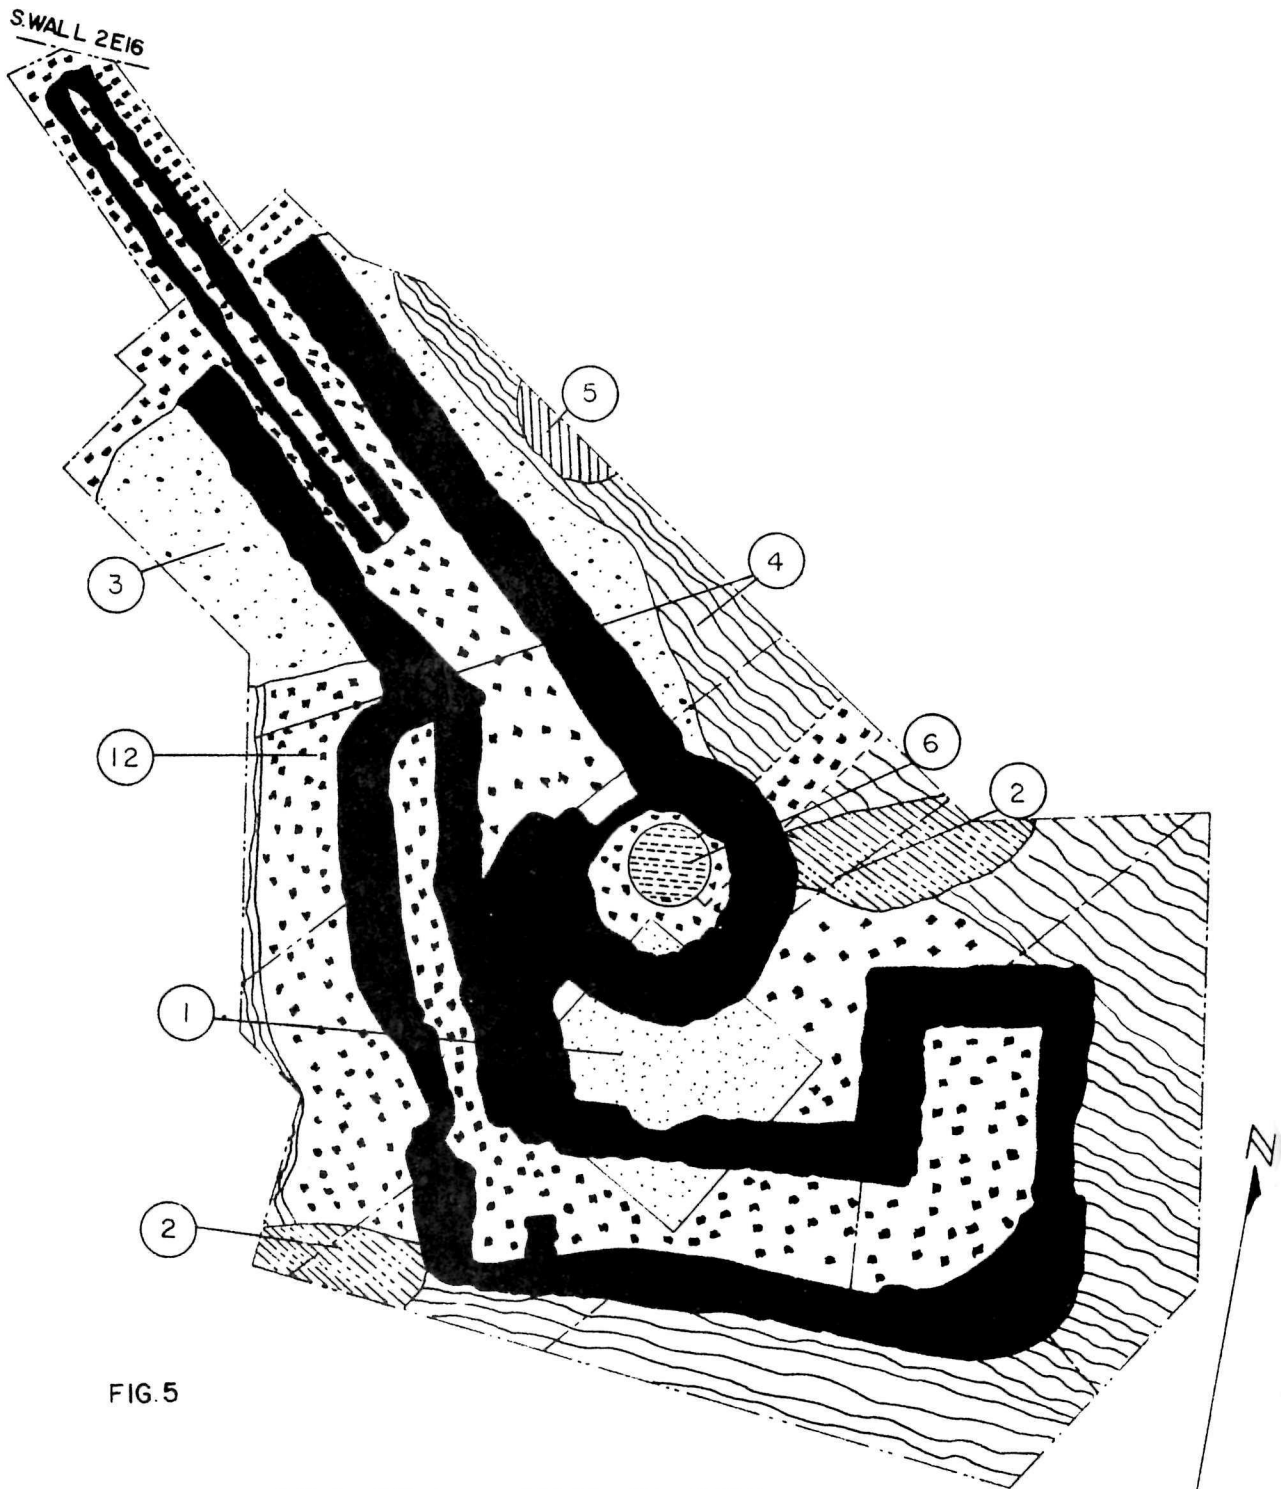
FIG. 5

SOILS BELOW TOPSOIL IN 2E20

- 12 Dark reddish brown sandy loam (5yr; 3/4)
- 3 Dark brown silty loam (2.5yr; 4/4); dark brown sandy clay (7.5yr; 3/2) plus stones
dark brown sandy loam (7.5yr; 3/2) plus charcoal pieces; dark brown sandy loam (7.5yr; 3/2)
- 4 Dark brown sandy loam (7.5yr; 4/4)
- 5 Mixture of many soils (soils 10 on x-s: 67-37-22 A & B)
- 6 Mixture of soils (soils 4 on 67-32-D5)
- 1 John Rick's 1962 Test Trench
- 2 Rock pile

The layer below the topsoil was, in general, dark reddish brown sandy loam (5 YR; 3/4), becoming more clay-like with increasing depth (Fig. 5, Table 1). Inclusions consisted of decayed wood, black in colour, often field stones of varying sizes, and sometimes bricks, whole or broken, sometimes patches of mortar detritus, and sometimes patches of reddish-brown sandy loam (5 YR; 4/4) or dark

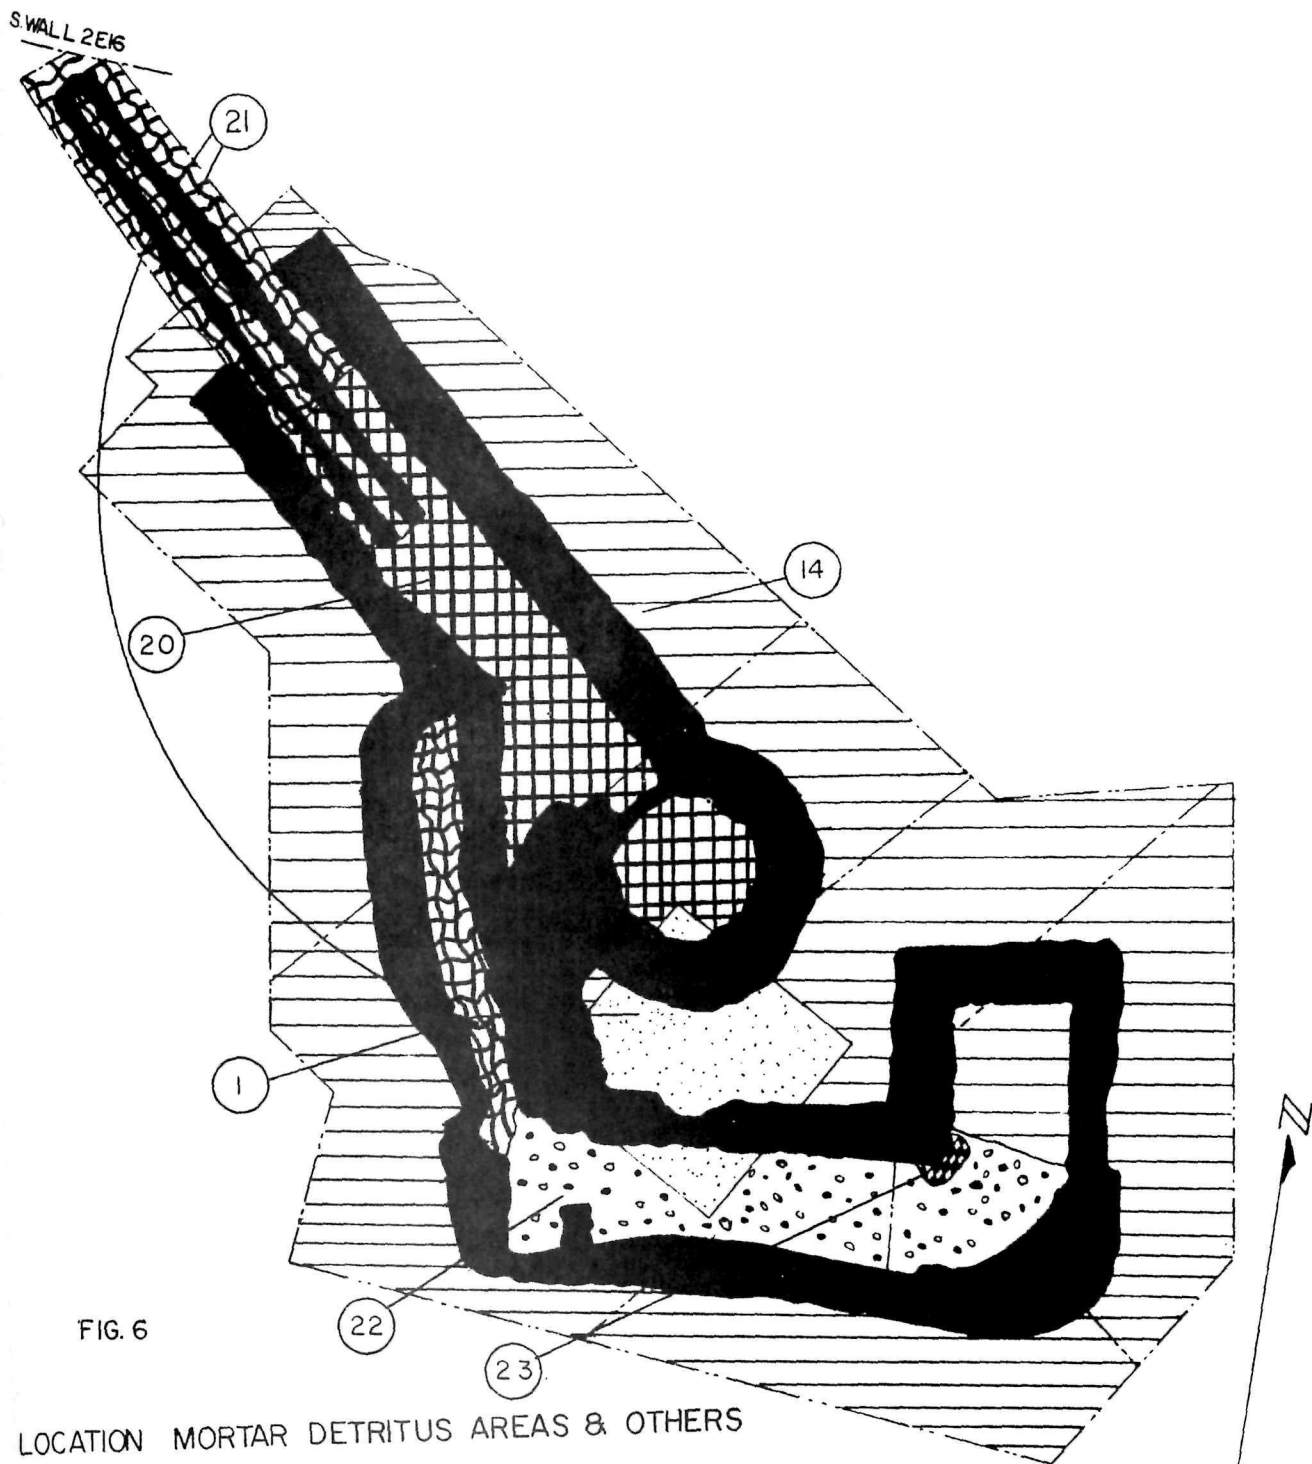
FIG. 6

LOCATION MORTAR DETRITUS AREAS & OTHERS
 BETWEEN ELEVATIONS OF APPROX. 132'-127' A.S.L.

- KEY:
- 20 Mortar detritus area
 - 21 Less concentrated mortar detritus area (thin layer, 0.01'-0.09') (underneath is dark reddish brown sandy clay (5yr; 3/4))
 - 1 1962 excavation: mixture of dark brown loam (7.5yr; 4/4), dark reddish brown sandy loam (5yr; 3/4), dark brown loam (7.5yr; 4/2), yellowish red sandy loam (5yr; 4/6), black loam (5yr; 2/1), dark reddish brown sandy clay (5yr; 3/4), & field stones
 - 14 Dark reddish brown sandy clay (5yr; 3/4)
 - 22 Mixture of dark reddish brown sandy clay (5yr; 3/4) & yellowish red loamy sand (5yr; 4/6)
 - 23 Concentration of nails & strong brown clay (7.5yr; 5/6)

In 2E20L, below Layer 2, was found a layer of soil with a high concentration of mortar detritus (Figs. 6, 11; and 67-37-D3a and b, -D6, - D11). This layer partly covered the area above the walls of 2E20L, though usually it did not go down to touch the walls, where, at this point, it usually was .01' thick gradually increasing until it had a thickness of approximately 1.5' in the middle of 2E20L. The concentration of mortar detritus became less dense and in a much thinner layer 7' from the west end of the south wall of 2E20L to the west end of the same wall. There were two kinds of mortar detritus: (3a) a heavily concentrated layer was found particularly in the area joining 2E20M and 2E20L. On the 2E20M side the mortar detritus ended very abruptly, just leaving a thin band approximately .05' wide (Fig. 7; 67-37-D10a,b). The mortar detritus layer seemed to slope from 2E20M into 2E20L. (3b) a less concentrated layer of mortar detritus, similar to that found at the west end, was found under the heavy concentration. In this layer the artifacts were not very frequent; however, there were many brick fragments, shell, and decomposed wood.

Where the west wall of 2E20J joins the north wall of 2E20M, an area was found consisting of strong brown clay (7.5 YR; 5/6) and a concentration of nails (Fig. 6, 13). The soil stain first appeared at the elevation of 128.75' ASL in the west part and at 128.2' ASL in the east part. The layer was very thin, approximately .05', then there was a layer of partially decomposed wood, approximately .02' thick, and then a layer of yellowish-red clay (5 YR; 5/8) with numerous nails (Fig. 13). Below this layer (approximately .05' thick)

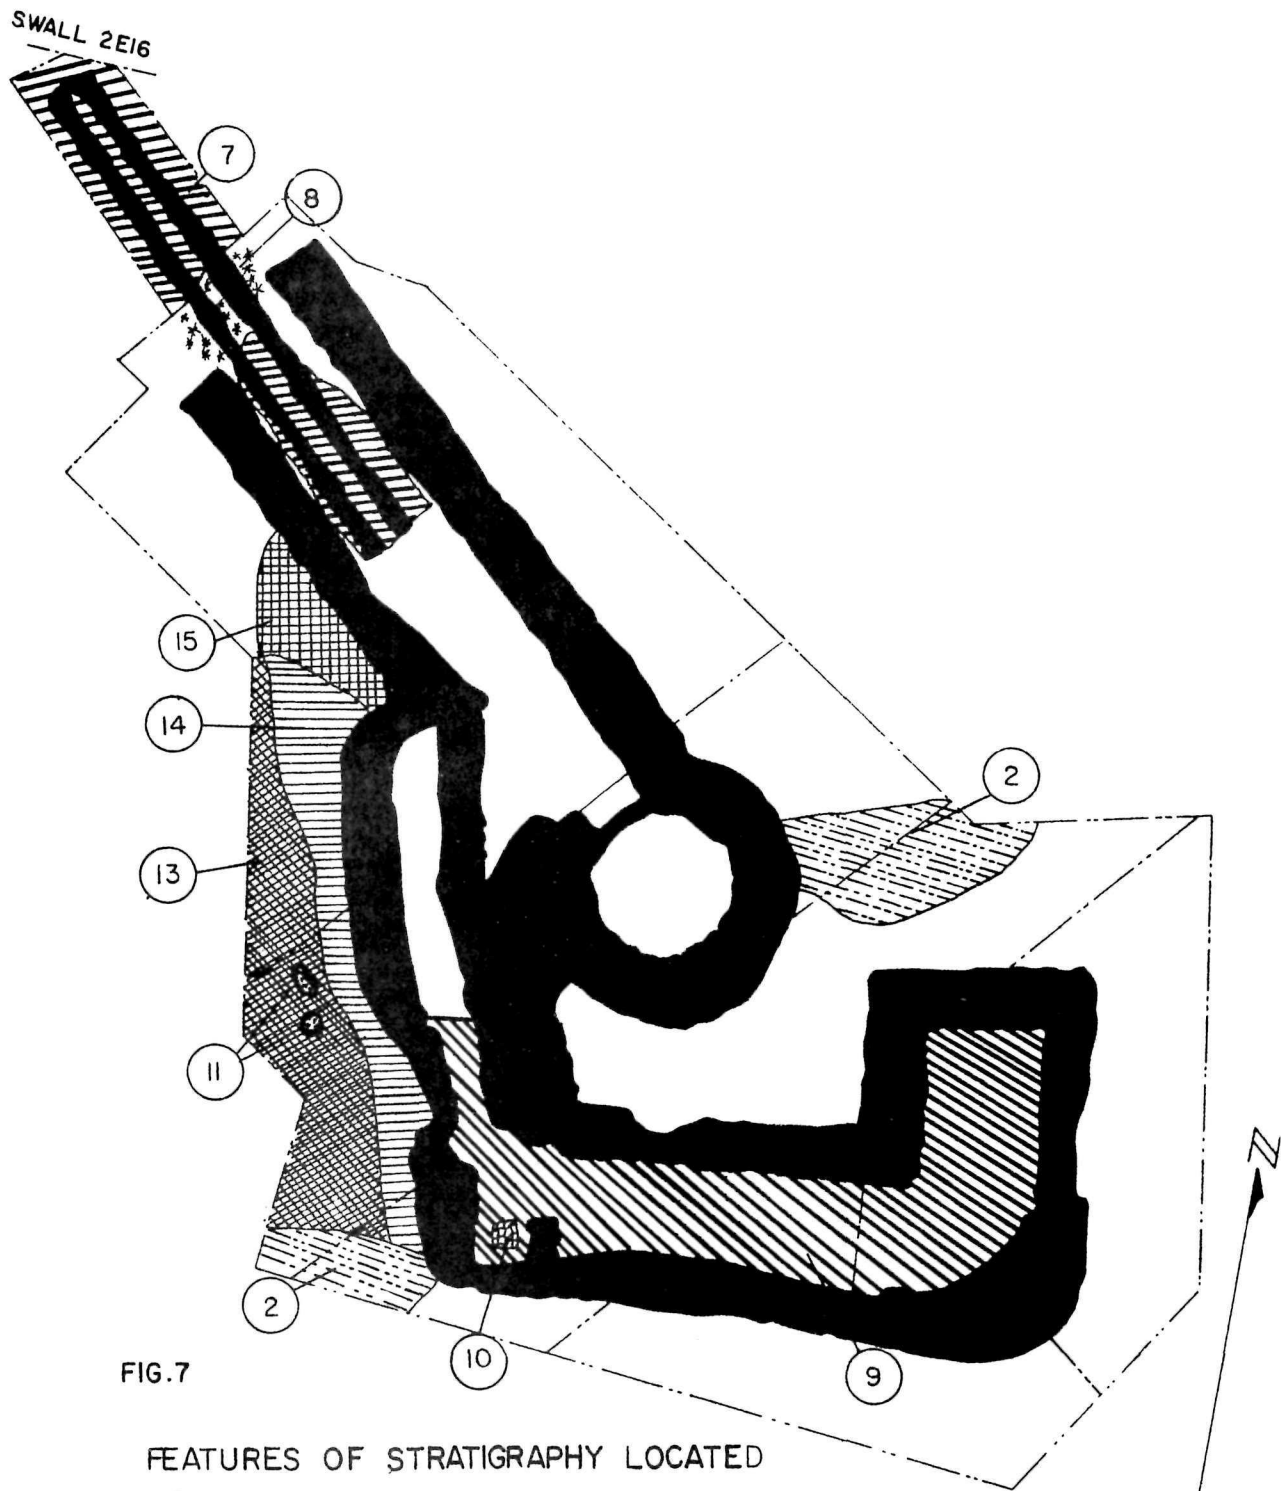
FIG.7

FEATURES OF STRATIGRAPHY LOCATED

This layer is the same as that of Layer 12 of the rest of 2E20M. It was found on the cobblestone floor base and also in the extreme western part of the south arm of 2E20M, where there was no cobblestone floor base (Fig. 7).

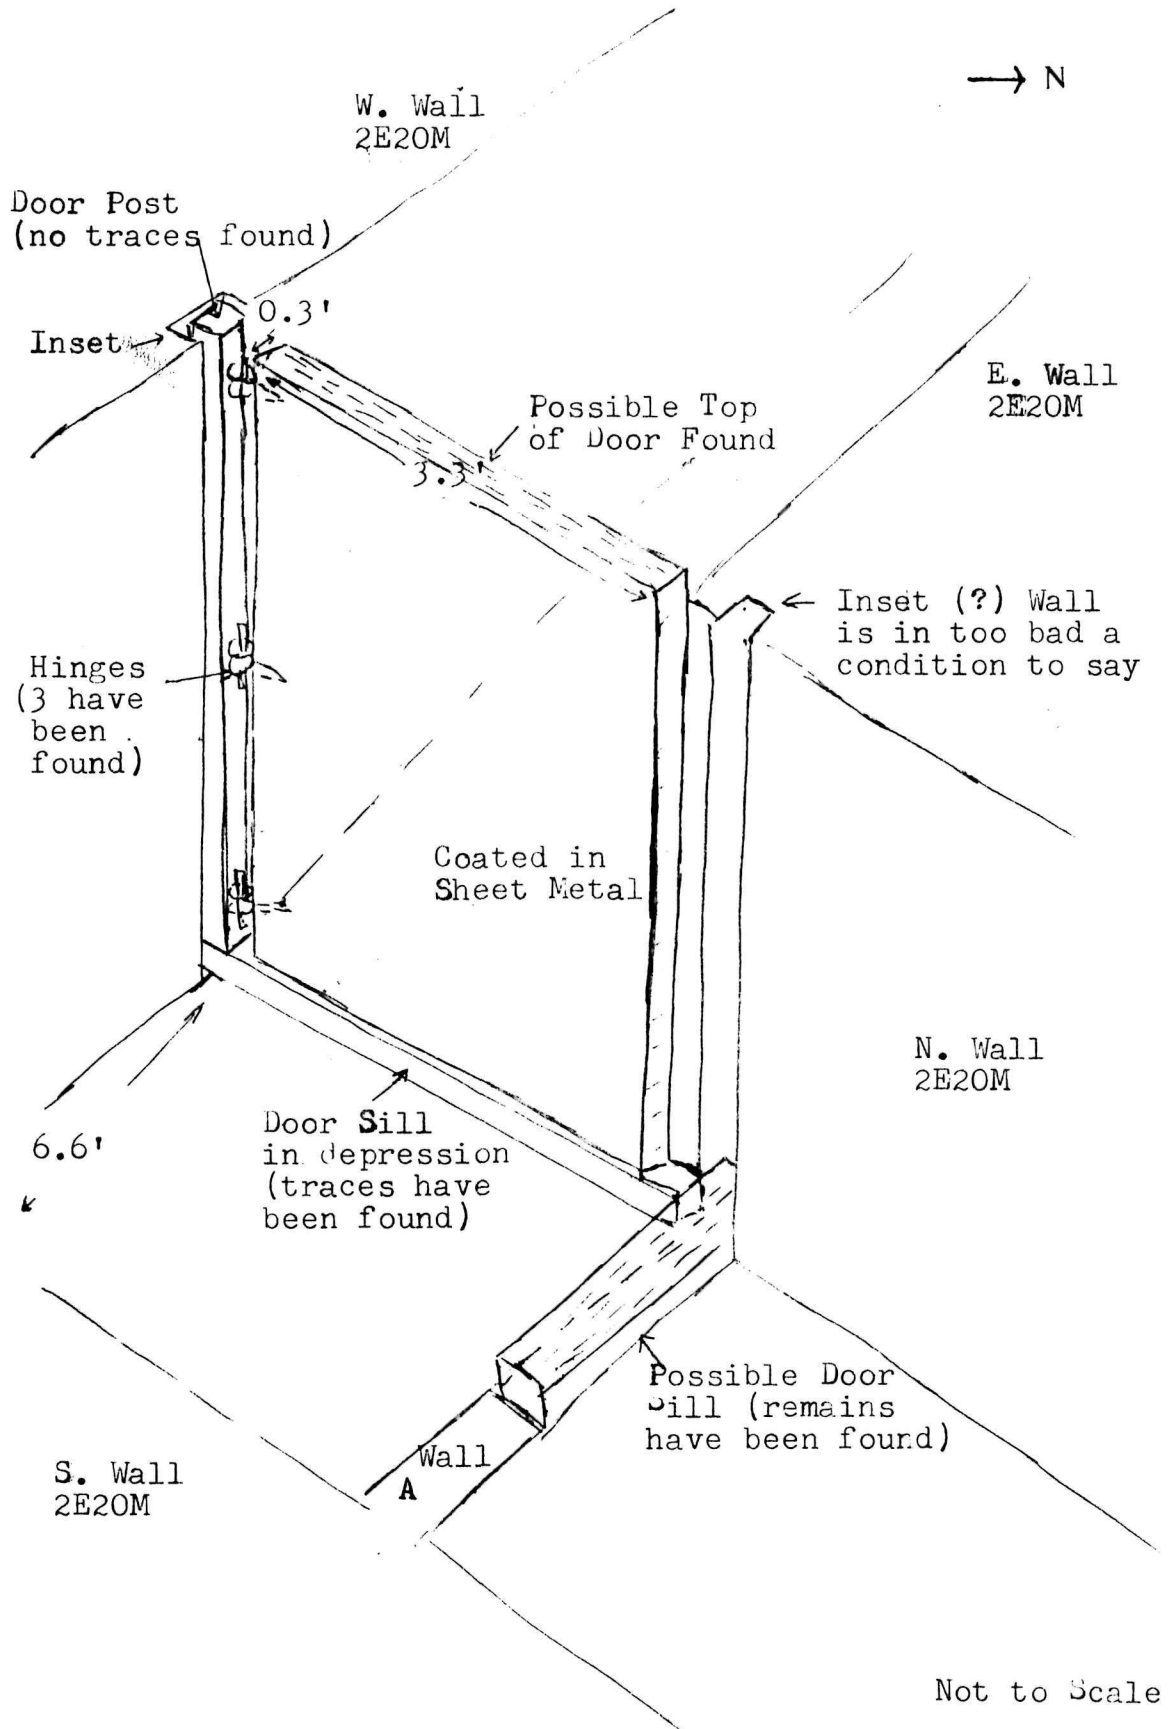
Fig. 8 Reconstruction of possible door (2E20M8).

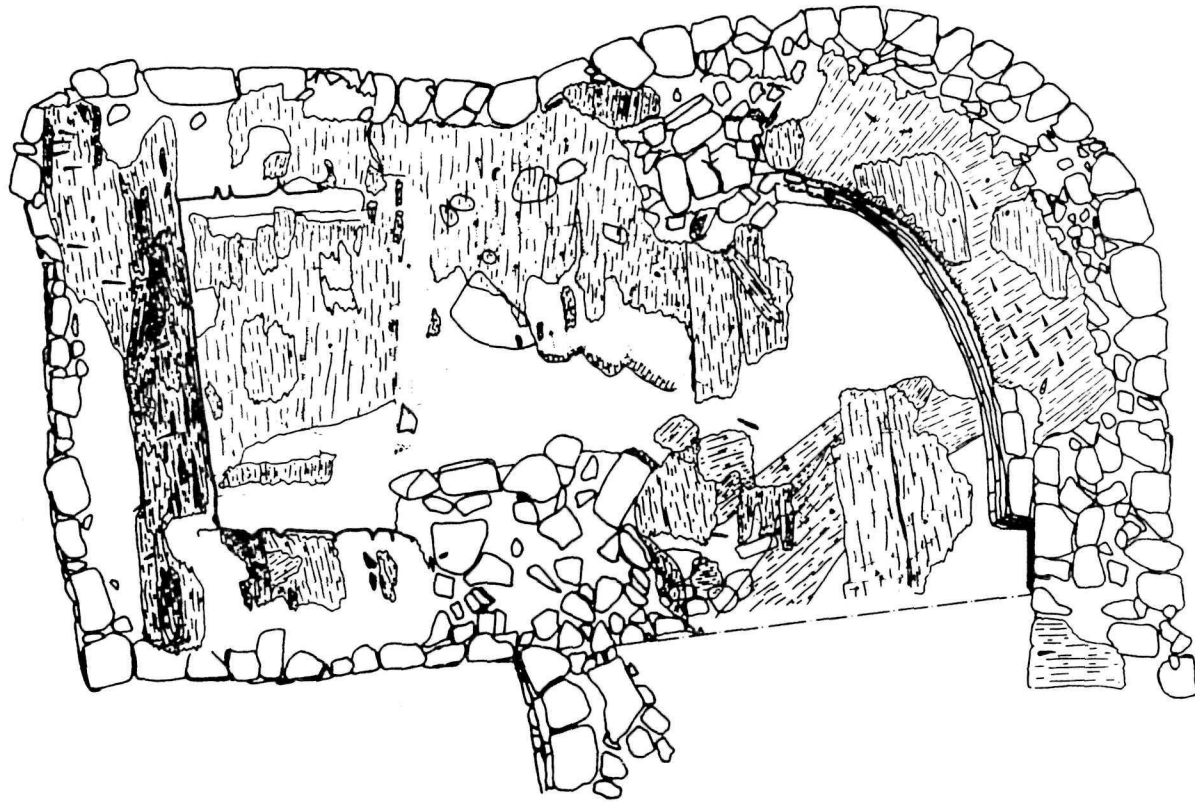
Fig. 9 Plan of 2E20J roof (2E-67-102-12).

CASEMATE ROOF PLAN
SUB-OPERATION 2E20J

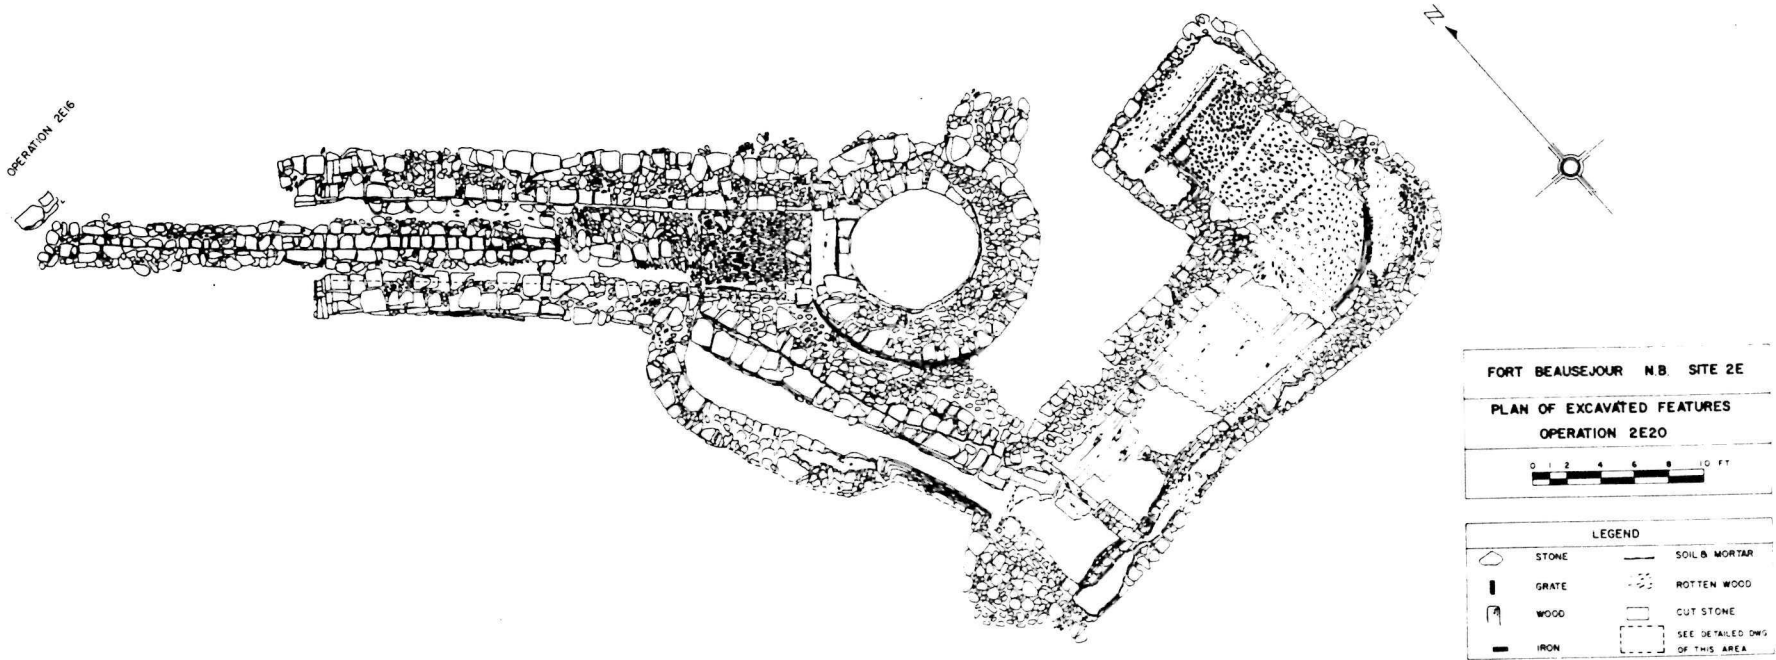
Fig. 10 Plan of 2E20 excavation (2E-67-105-11).

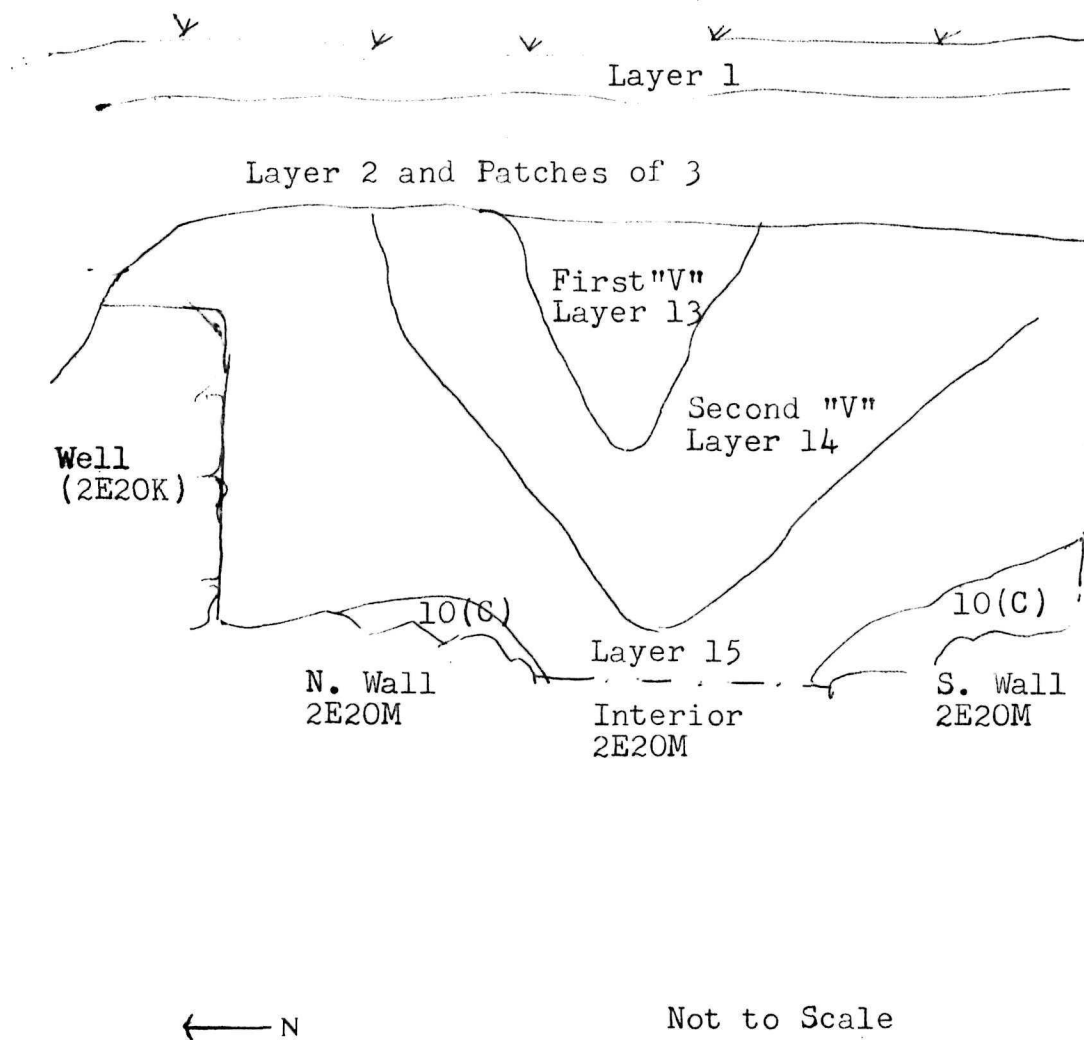
Fig. 11 Diagram of "V" of layers 13 and 14 above south arm of 2E20M.

This layer was directly below Layers 2 and 3. It consisted of a mixture of dark brown, sandy loam (7.5 YR; 4/4 or 7.5 YR; 4/2) and strong brown, sandy loam (7.5 YR; 5/6). This mixture was found directly above the middle of the structures, where the roof would probably have collapsed. The mixture formed a "v" shape (Fig. 11). On both sides of this "v", the soil became Layer 14.

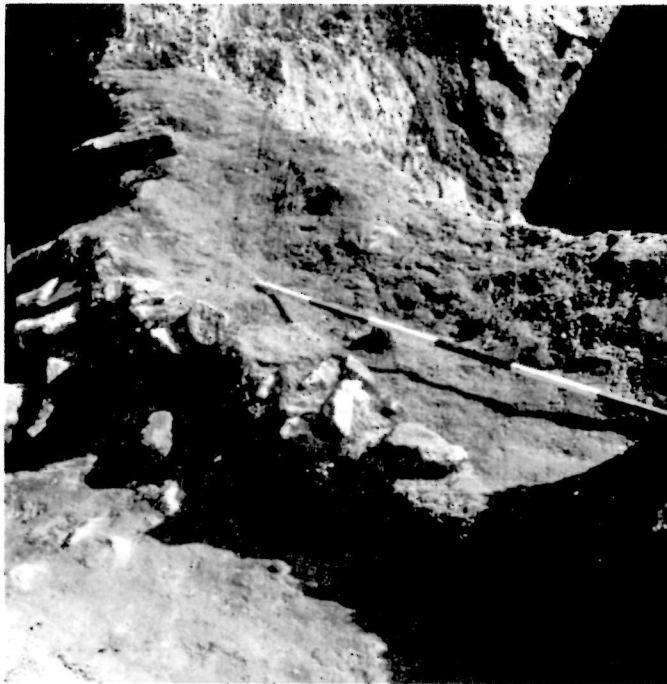
Fig. 12:(2E-173 X)

At the bottom of the mortar layer at the entrance to 2E20M from 2E20L. Camera is facing southeast. Scale: 6' rod. Notice abrupt end of layer to the south, gradually sloping north and down.

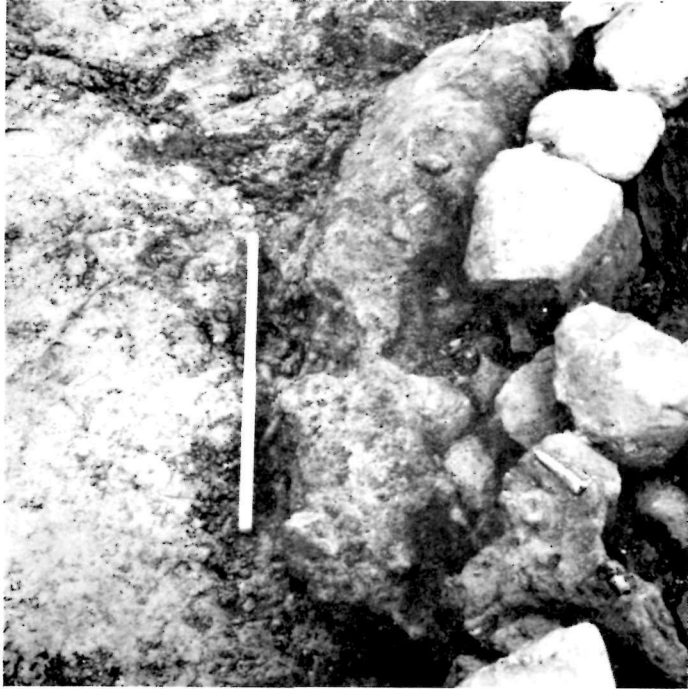
Fig. 13a: (2E-270 X).
 First layer of soil stain and nails at 2E20J-M.
 junction. Camera is facing southwest. 2' scale.
 A is north wall of 2E20M; B is west wall of 2E20J.

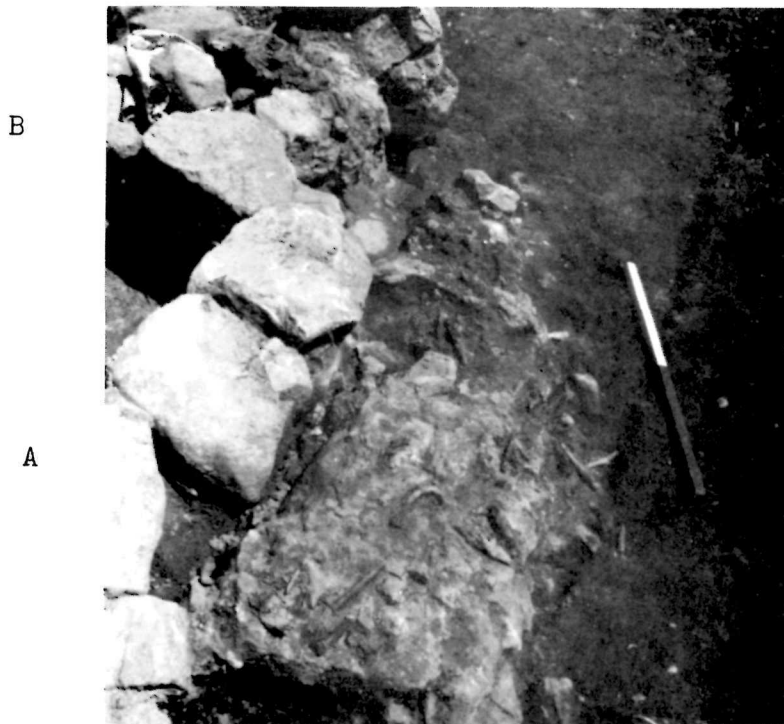
Fig. 13b: (2E-455 X)
 Second layer. Camera facing northeast. 2' scale.

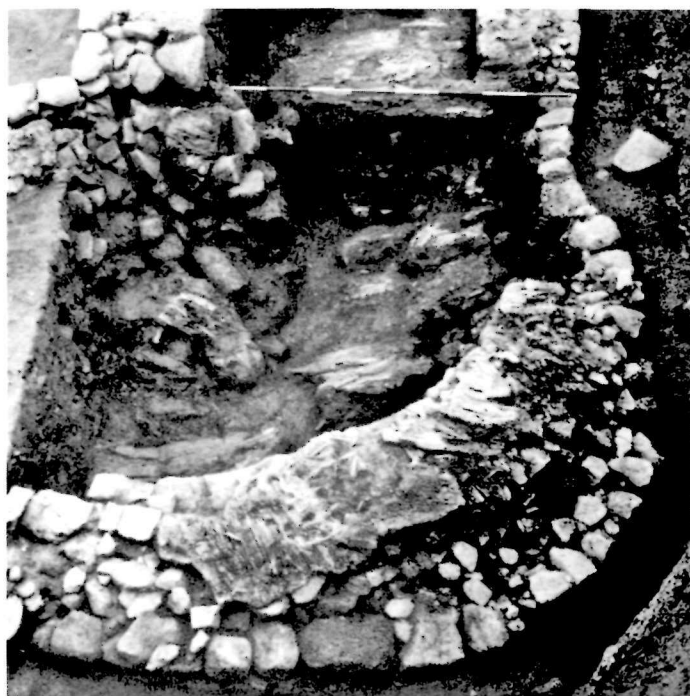
Fig. 14: (2E-464 X)
The casemate (2F20J) showing remains of
wooden roof. Camera is facing north. 8'
scale.

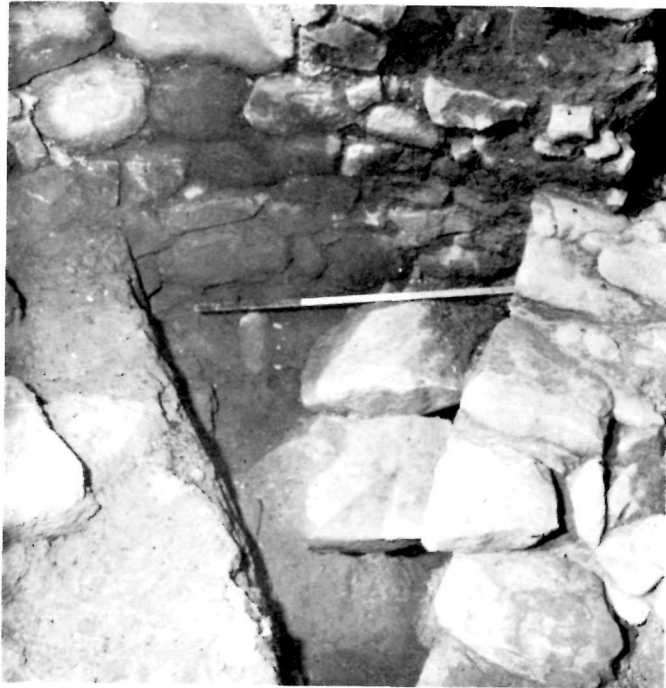
Fig. 15: (2E-622 X)
The drain (A); the west wall of 2E20M in back-
ground and the continuation of the east wall
of 2E20M to the left. Camera is facing west. 3'
scale.

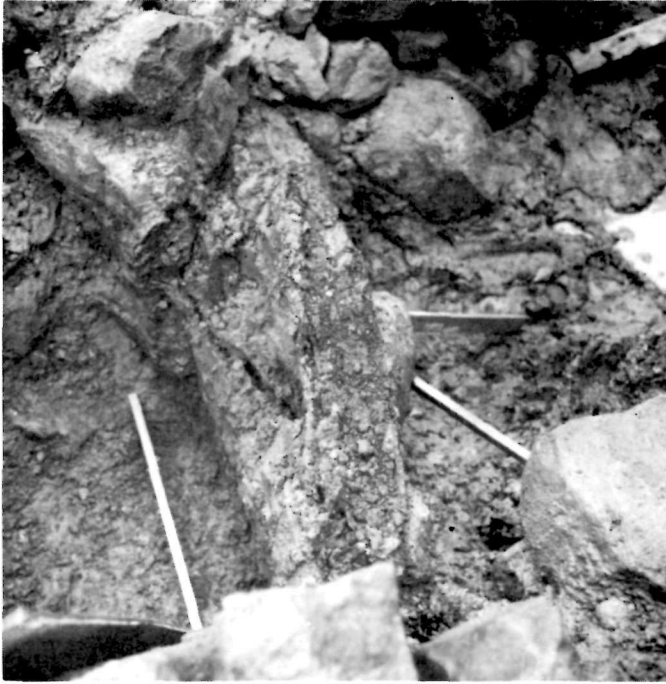
Fig. 16: (2E-697 X)
The top of the door of Sill #2 on Fig. 2. The camera is facing northeast. 2' scale.

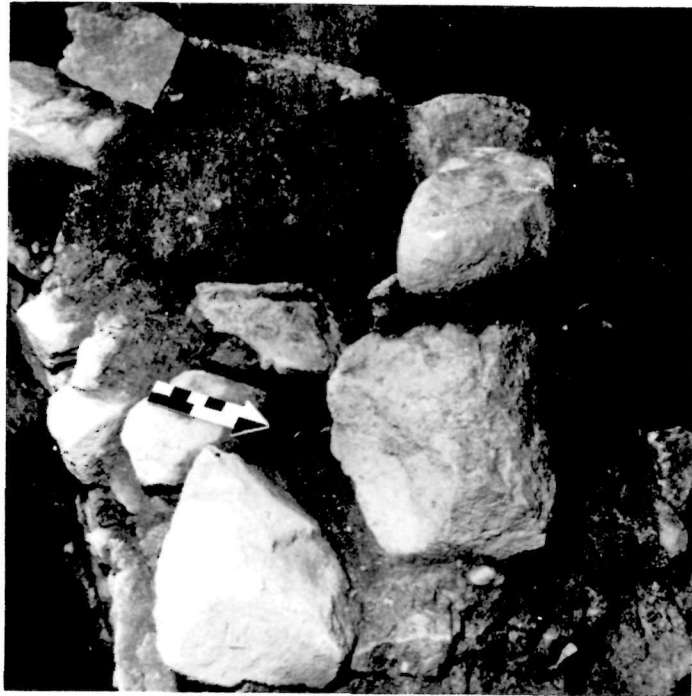
Fig. 17: (2E-621 X)
The north end of the west wall 2E20M. The north
arrow is 0.5' long. Camera is facing southwest.

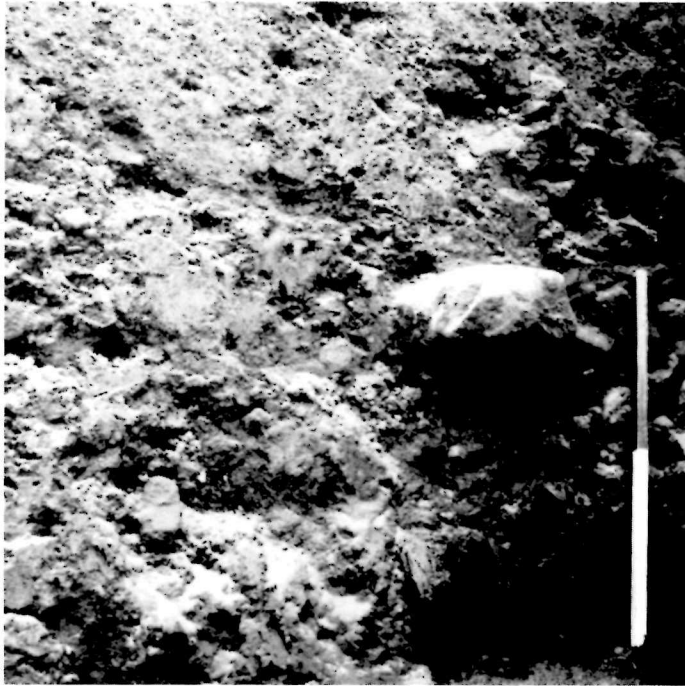
Fig. 18: (2E-382 X)
Example of the remains of the palisade found. 2'
scale. Camera is facing south. Palisade is in the
south wall of 2E20A.

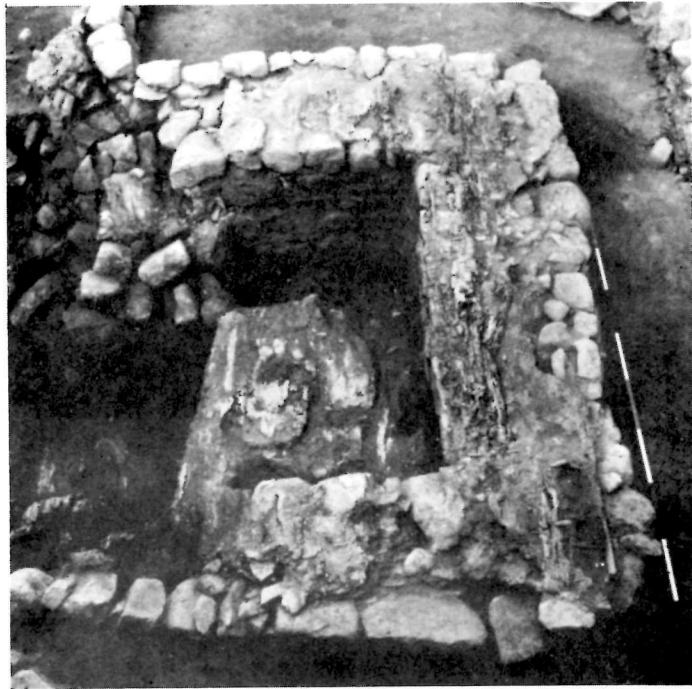
Fig. 19: (2E-462 X)
The north part of the casemate 2E20J. The interior still has wooden roof remains. Camera is facing west. 8' scale. North wall; most of east and west walls extant to original height.

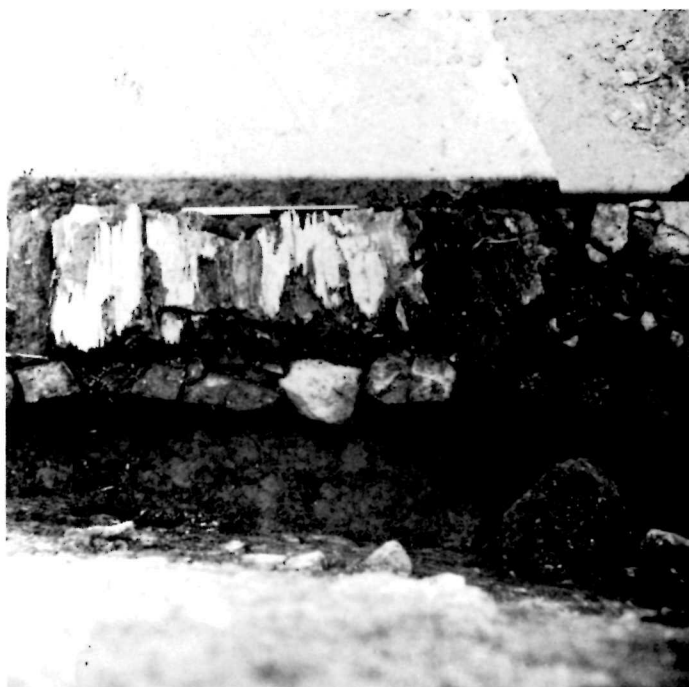
Fig. 20: (2F-461 X)
Remains of wooden roof on south wall of
2F20M. 2' scale. Camera is facing down and
slightly north.

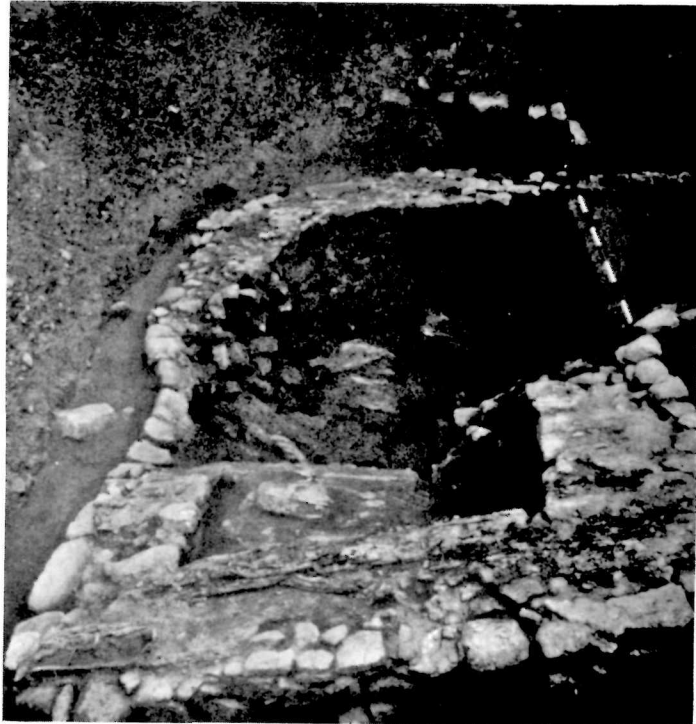
Fig. 21: (2E-539 X)
The casemate 2E20J. Notice the third "face"
of the curve. 8' scale. Camera is facing
south. Arrows indicate curve.
