1967 EXCAVATION OF THE
PRINCE FREDERICK BASTION 2E20 AT FORT BEAUSEJOUR

by
Winnie Frohn
(1968)

1967 EXCAVATION IN THE PRINCE FREDERICK BASTION
AND MEN'S BARRACKS AT FORT BEAUSEJOUR

by
E. Frank Korvemaker
(1972)

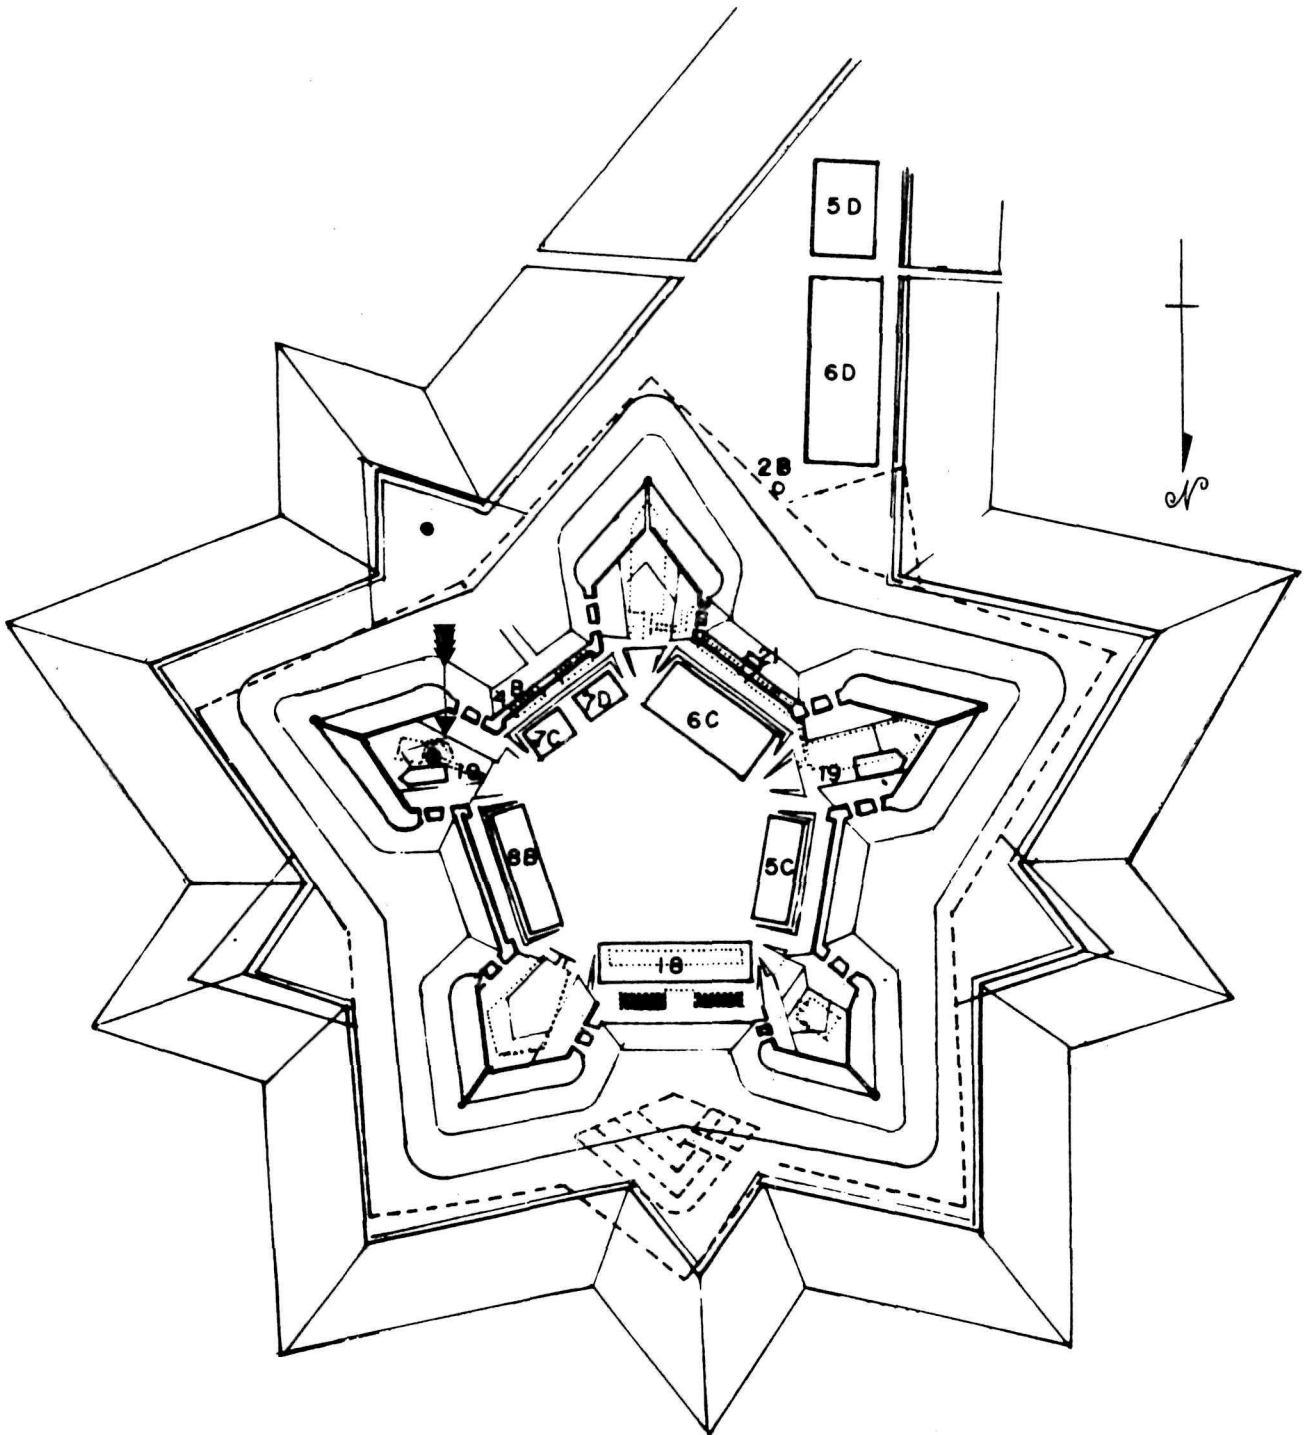
1 British plan of Fort Beauséjour (1755 - 1778) showing a casemate, well, and two passageways in the Prince Frederick Bastion. No scale.

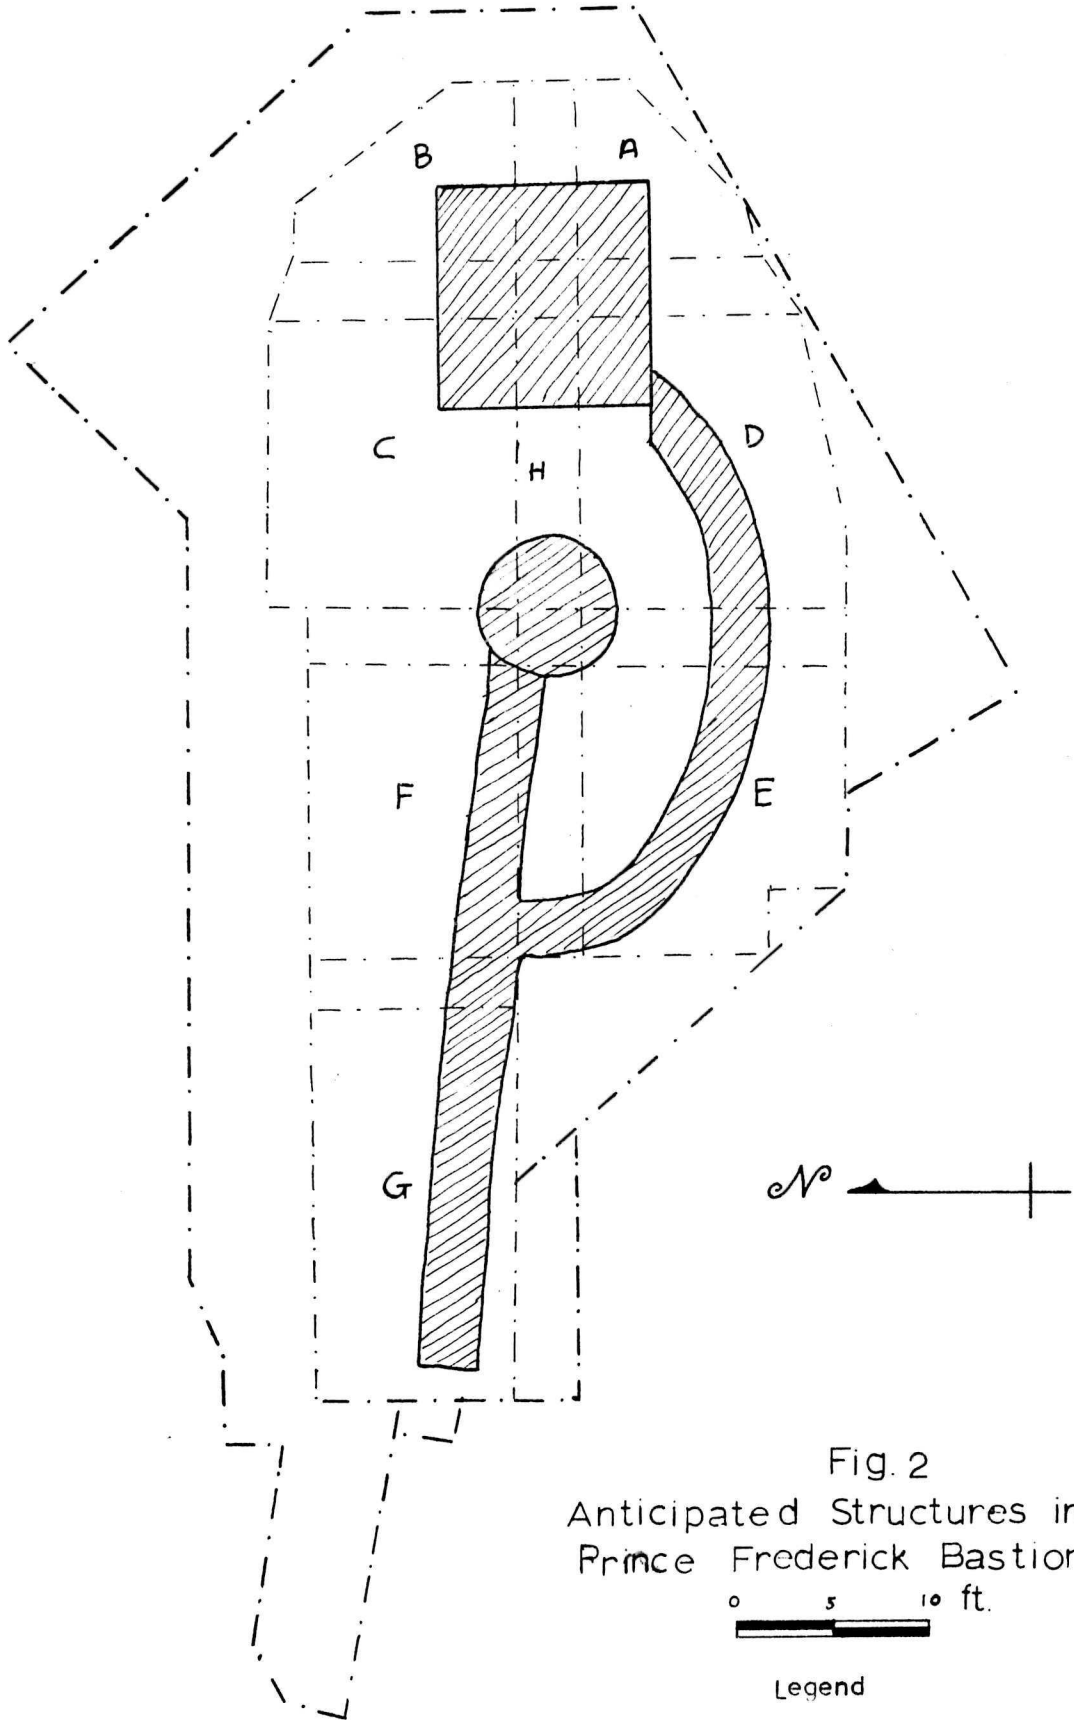
Fig. 2
Anticipated Structures in
Prince Frederick Bastion

Figure 2 shows the location of the original trenches with the structures in their theoretical positions, as well as the extended trench boundary. Figure 3 shows the structures which were actually uncovered and their locations within the revised trench layout.

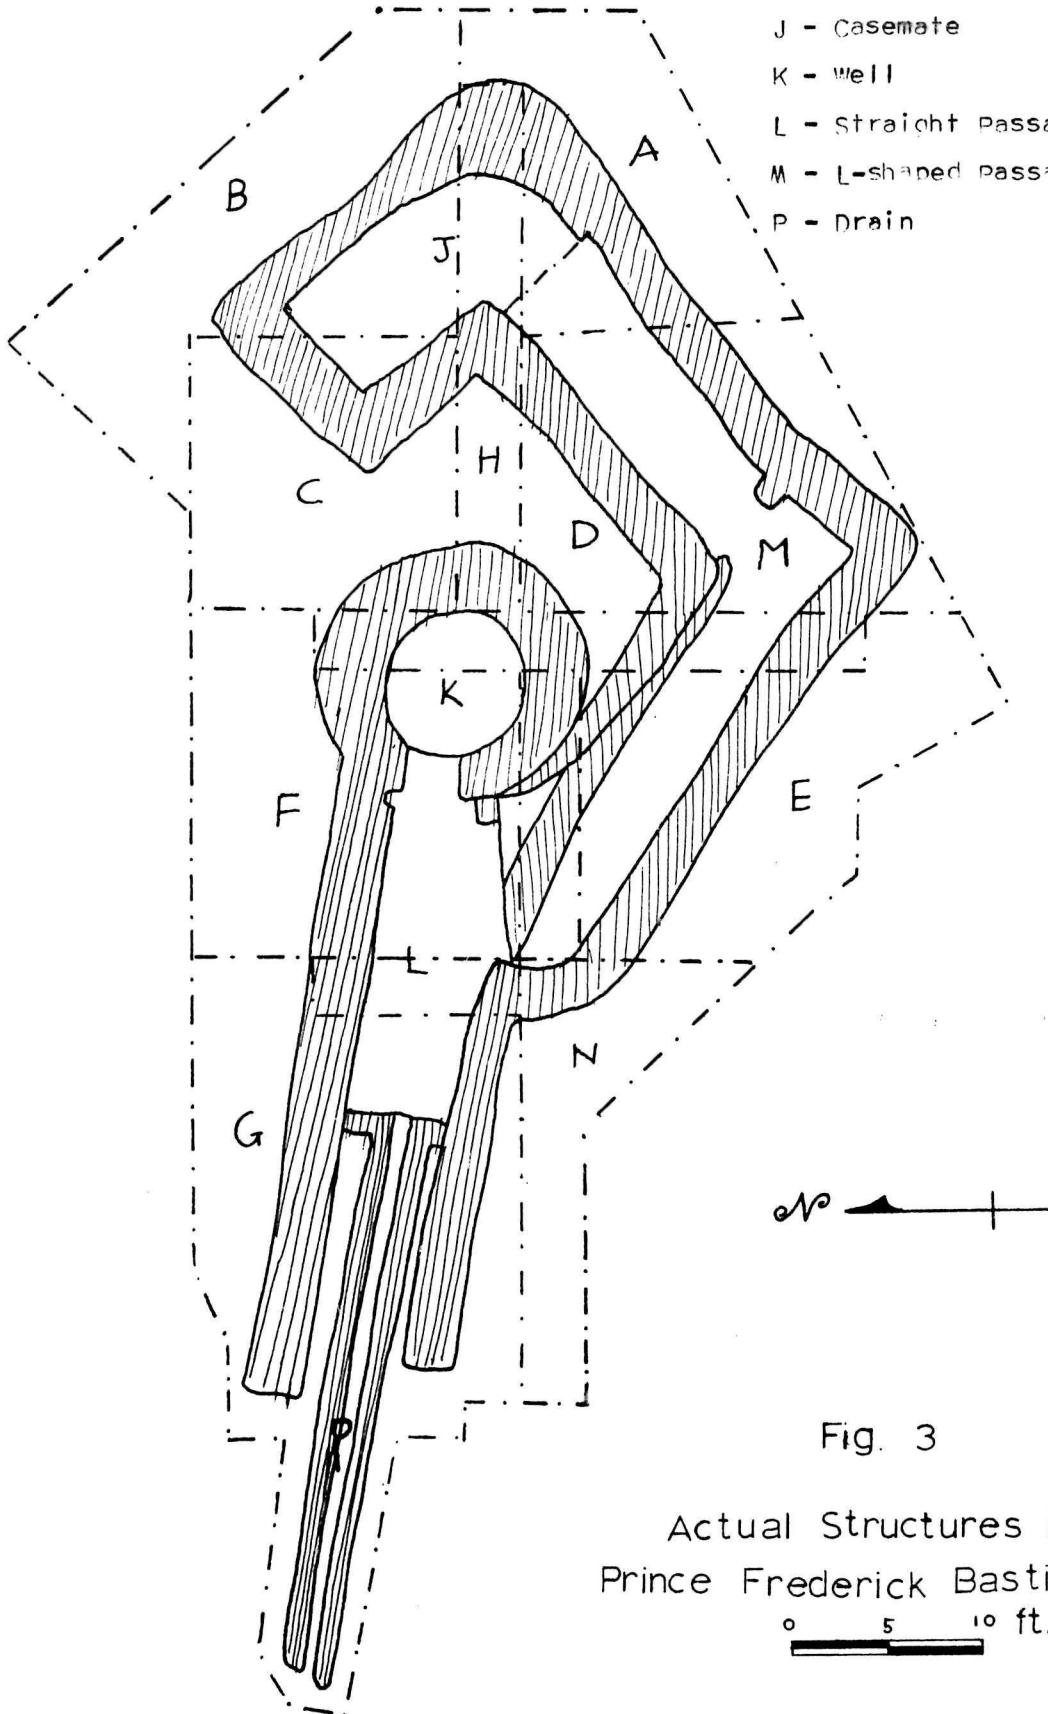
Fig. 3

Actual Structures in Prince Frederick Bastion

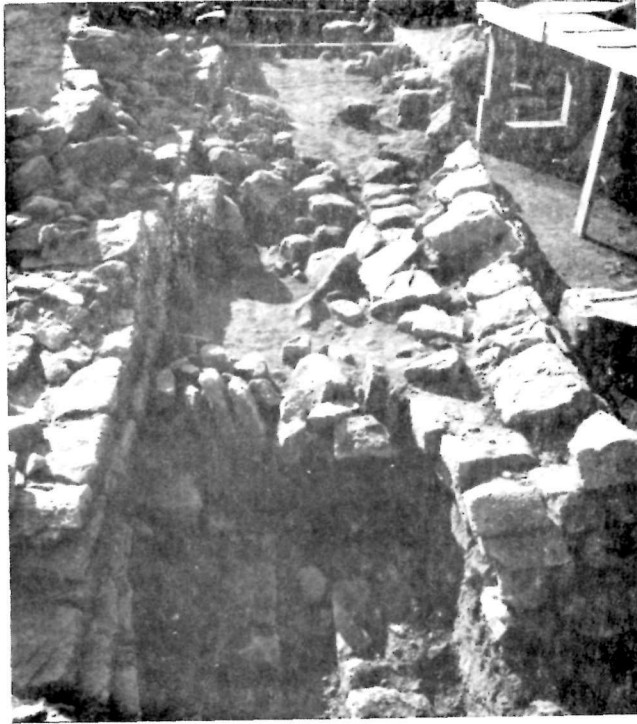
Fig. 7 - 2E20L: View of stones forming separation in straight passageway and part of collapsed wall behind it. Note also quoin stones at entrance to passageway. Facing E. 6' scale (2E-491-x).

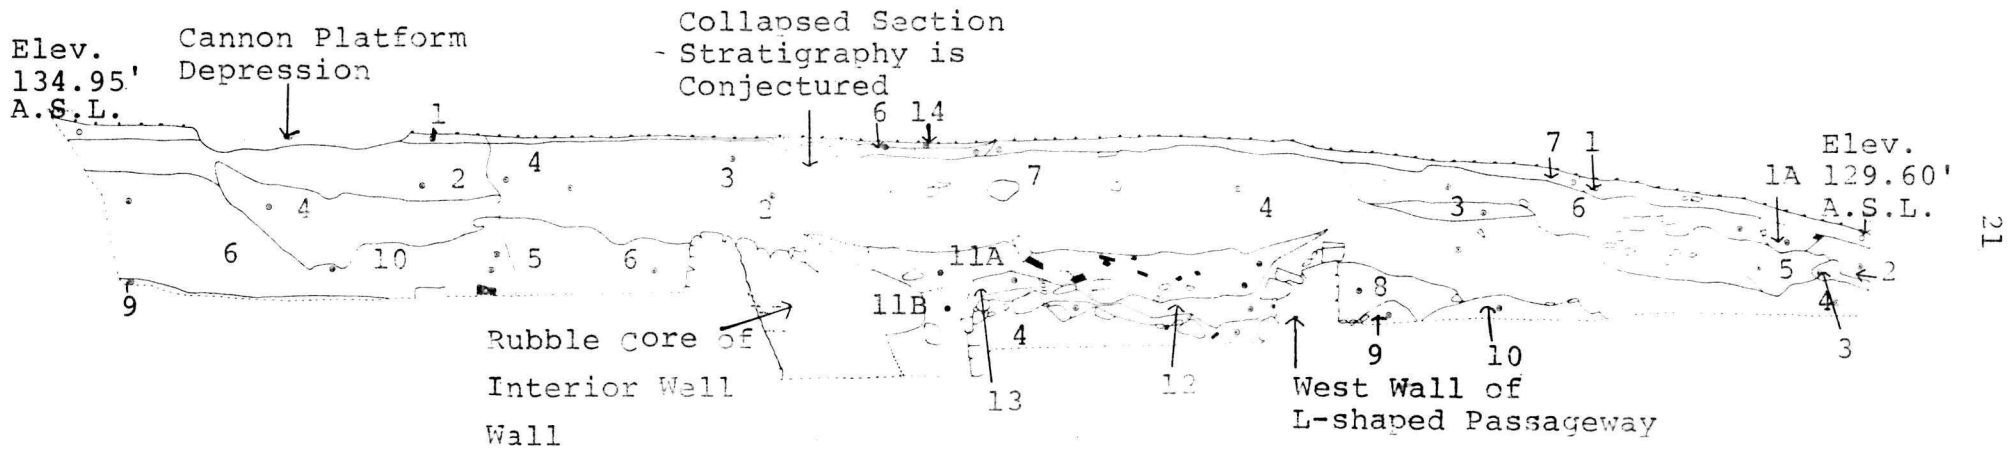
Fig. 8

Note: Depression in the top soil by the salient angle was caused by a cement gun platform.

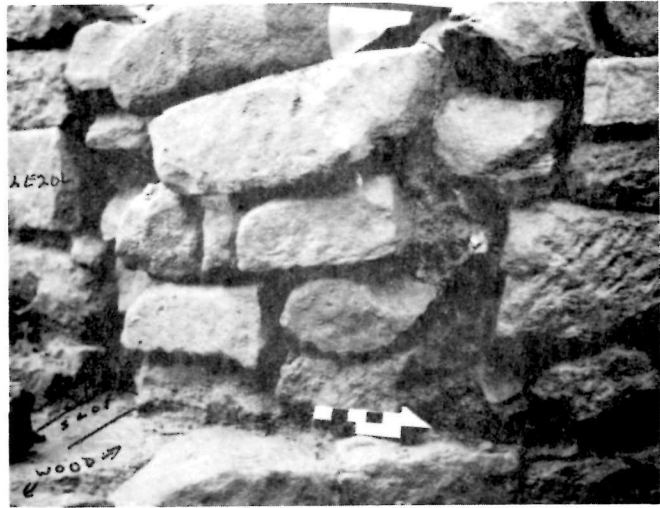
Fig. 10 - 2E20K: View of north side of well entrance showing break in the construction plus stone slot. 6" scale, Facing North. (2E-136-M)

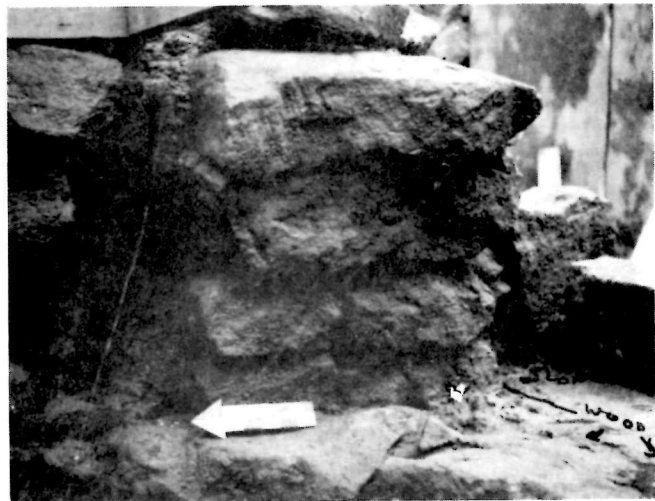
Fig. 11 - 2E20K: View of south side of well entrance showing break in the construction plus stone slot. 6" scale, Facing Southwest. (2E-137-M)

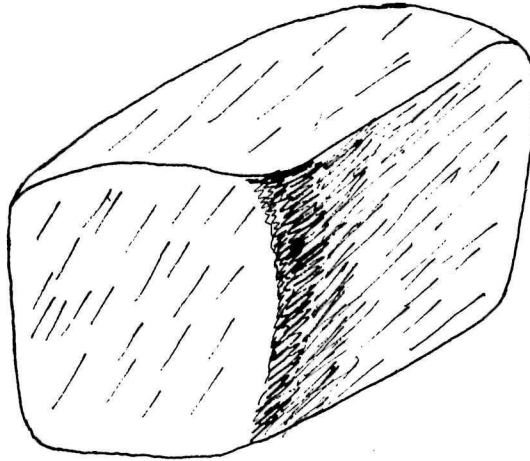
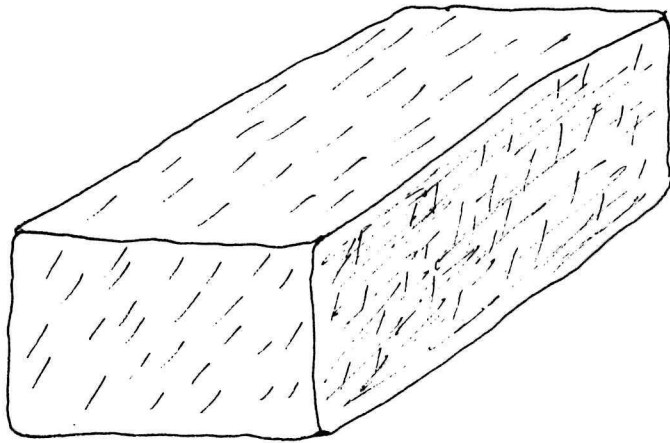
Fig.12 Rounded and Squared
Stones - no scale

Rounded Stone of the Well (2E20K)

Squared Stone of the Straight
Passageway (2E20L)

In a similar fashion the top two courses of the interior face of the well wall appear to have more of the sharp edge characteristics than the round edge ones, and hence might suggest a possible reconstruction of the entire top of the well after the British takeover in 1755.

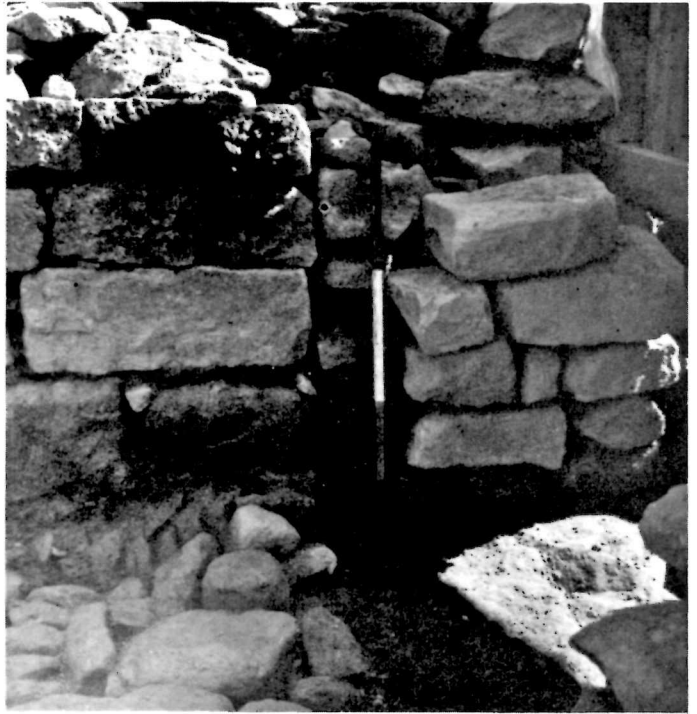
Fig. 13 - 2E20L: View of abutted joint between the north passageway wall and the well entrance. Facing North. 3' scale. (2E-586-X)

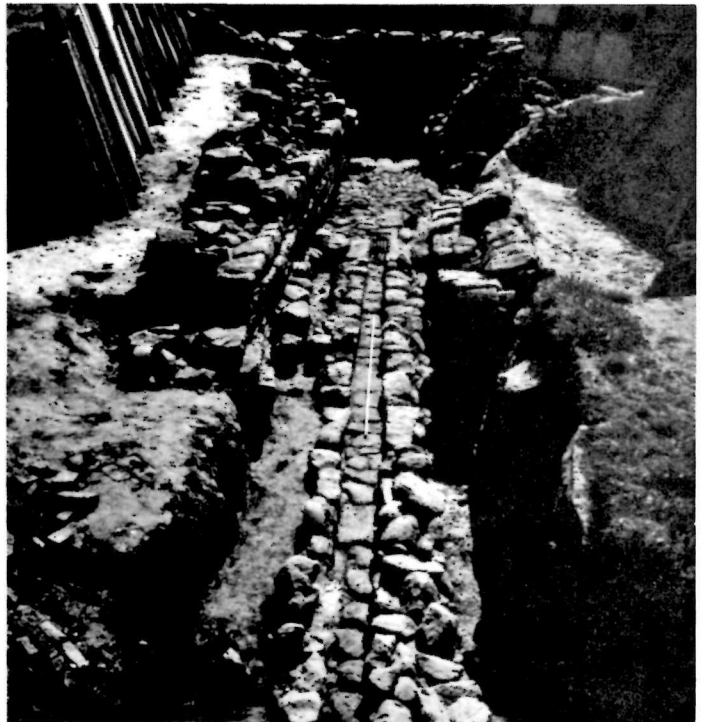
Fig. 14 - 2E20L: View of passageway entrance showing stones jutting out by the interior face of the north wall. 6' scale. Facing East. (2E-718-X)

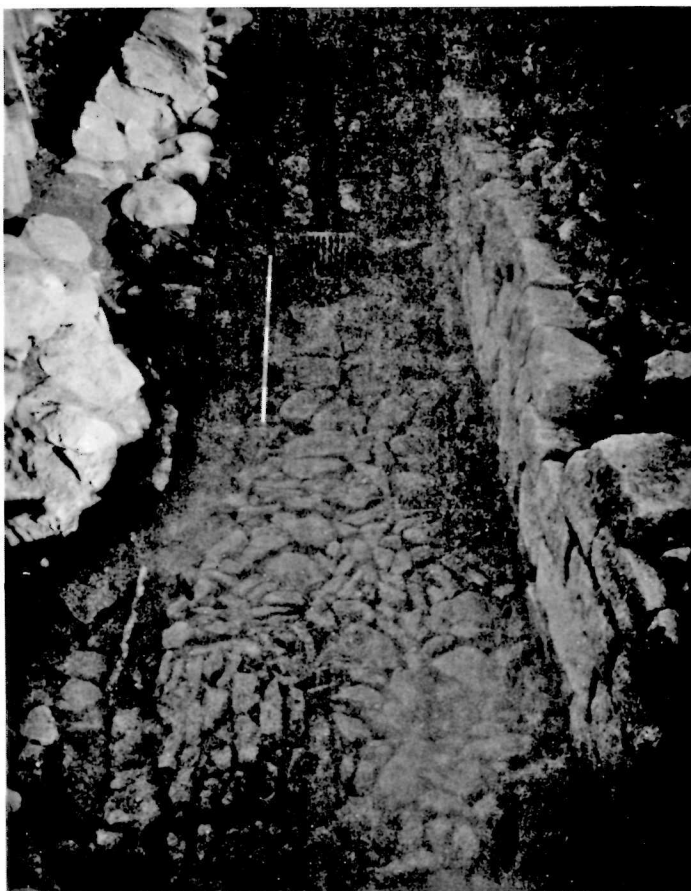
Fig. 15 - 2E20L: View of west half of the cobblestone floor with metal section by stone groove in bottom left corner. Facing West. 6' scale.(2E-71-B)

The size of the cobblestone does not appear to have been chosen for any particular pattern, nor are they very flat - as would be expected. This floor does, however, appear to have been constructed in two basic sections. The western part, consisting primarily of larger, flat stones, contains stones varying in size from 0.7' by 0.6' to 1.0' by 0.6'. The eastern portion - which lies almost directly in front of the L-shaped passageway - consists mainly of narrow long stones, many of which lay in an east-west direction. Average size of these stones is 0.9' by 0.3'. The photos of this floor in Figures 15 and 16 clearly show the distinction between the two sections.

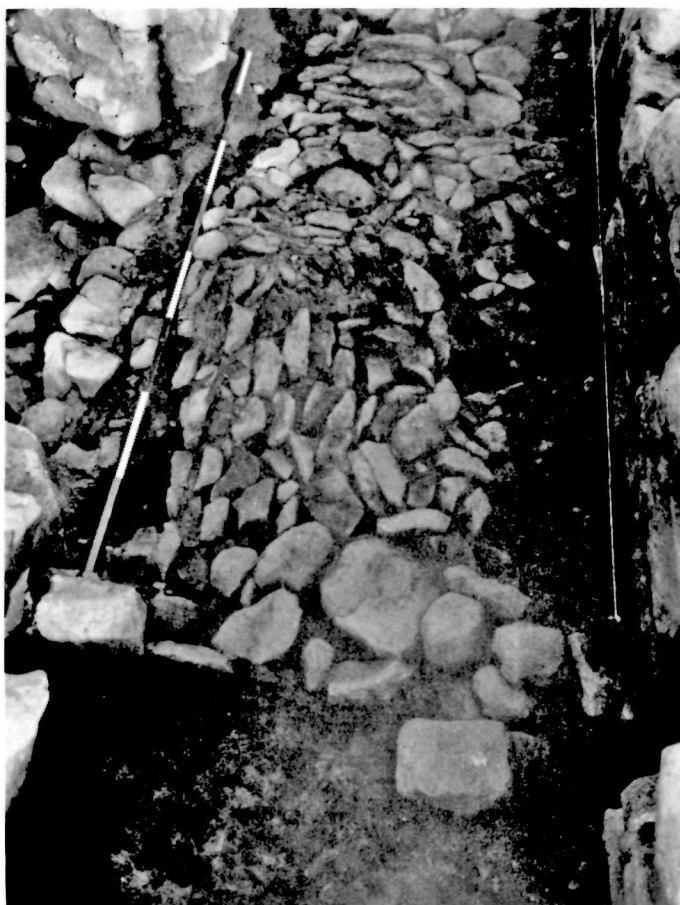
Fig. 16 - 2E20L: View of east half of the cobblestone floor with well entrance in the foreground. Facing West. 8' scale.(2E-72-B)

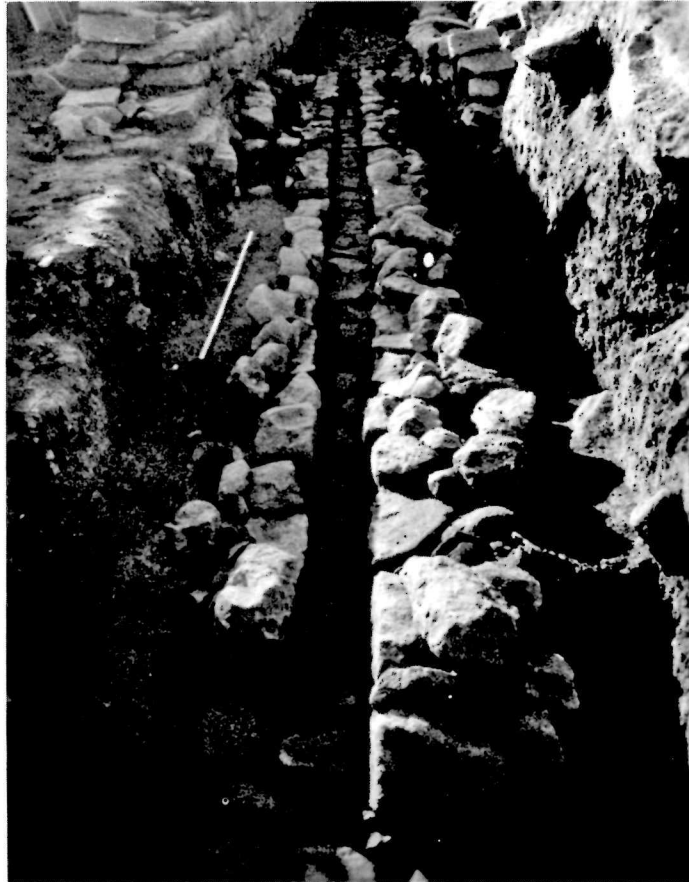
Fig. 17 - 2E20P: View of the drain, looking East. 6' scale. (2E-70-B)

Although no worked or shaped stones appear to have been used for the base of the drain, it is quite flat. The stones in the centre of the drain base tend to be square in shape, whereas the stones at the ends tend to be more irregular in formation. The average size of the square stones was 0.7' by 0.7' as opposed to 0.6' by 0.6' for the irregular ones. There is a 0.44' slope in the drain, going from 125.63' A.S.L. at the east end by the grate to 124.19' A.S.L. at the west extremity by the Men's Barracks (2E16).

The east end of the drain is blocked off by an iron grate. This grate has six vertical square bars (spaced 0.08' apart) welded to a single flat piece of metal. The entire grate protrudes 0.1' above the top of the drain, and the base - because it continued below the cobblestone floor - was not excavated. Two large stones, located at each side of the drain's east end, block off the cobblestone floor from the area beside the drain, thus forcing all water to leave the floor via the drain.

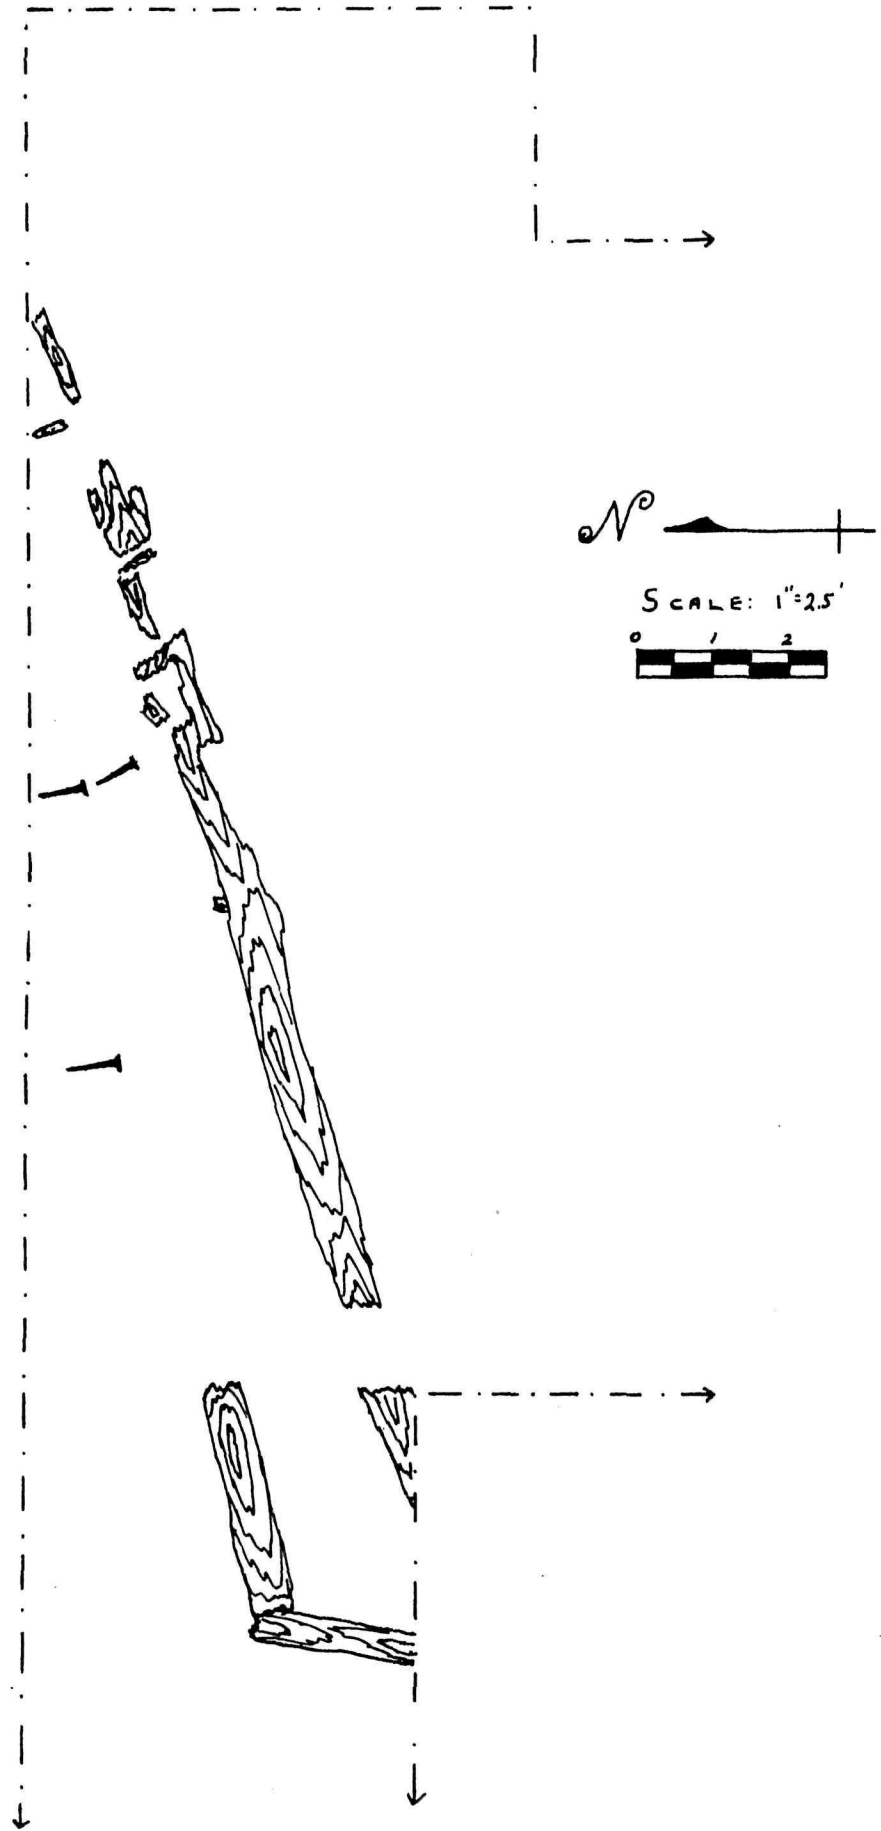
Fig.18

Gun Platform or Traverse

Unfortunately too little of the wood was actually uncovered to make an accurate reconstruction of this feature - or even to positively identify it. Possibly the information of this structure could be combined with that of a gun platform found in the Prince Henry Bastion and with traces found in the Prince Edward Bastion (See Field Drawings: 2E66-8-4 and 2E-66-33-2). However, even a combination of these three drawings still presents a very sketchy picture for any reconstruction attempt.

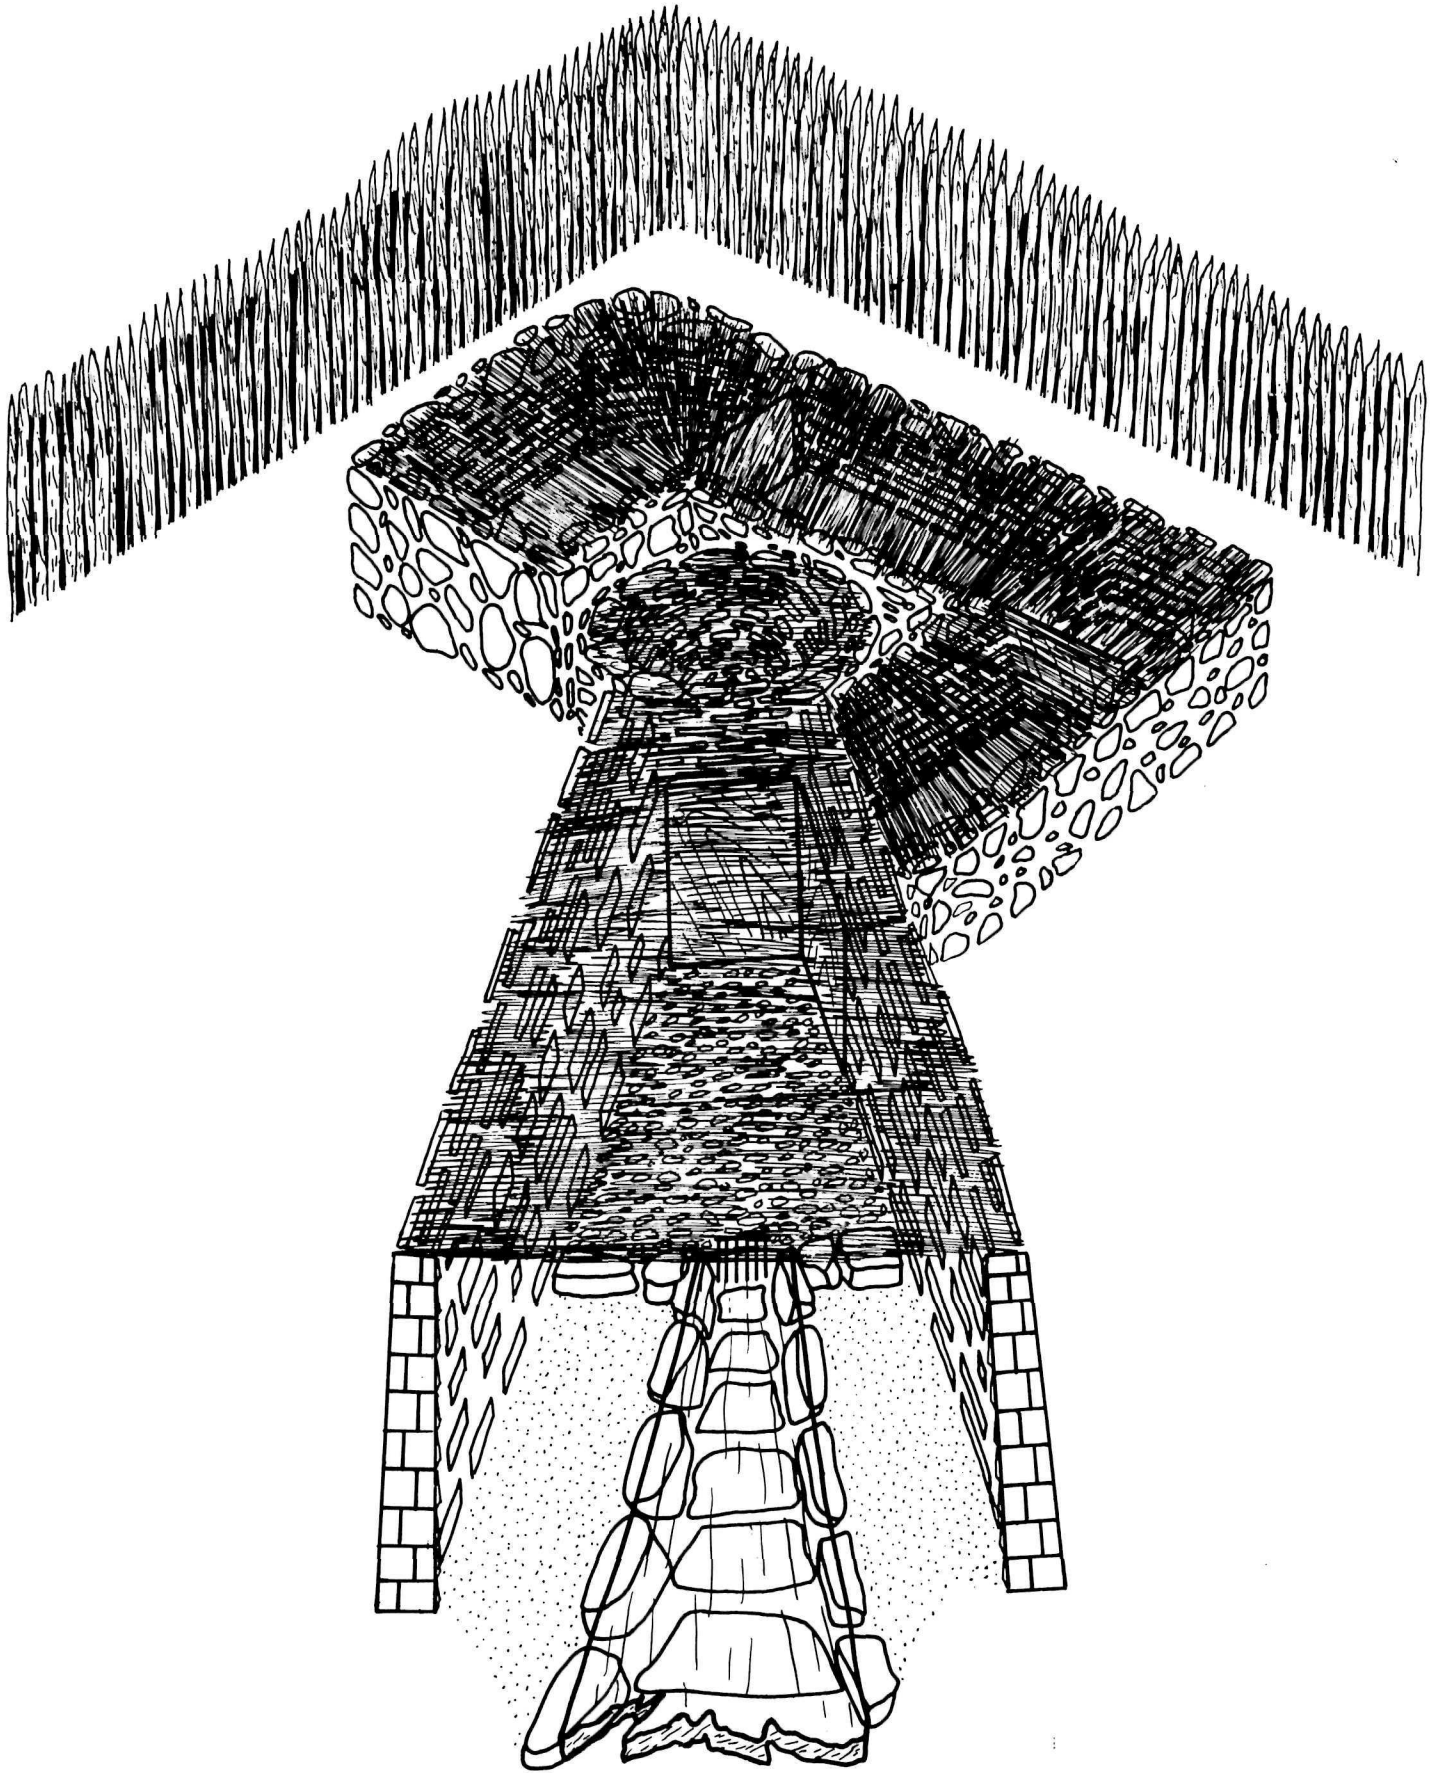
Fig.19 Reconstruction View of Casemate, Well, and Passageways in the Prince Frederick Bastion. Looking East- not to scale

In conclusion, therefore, reconstruction of the Prince Frederick Bastion would be highly possible, despite certain difficulties. These difficulties may possibly be overcome by additional excavation in the bastion, by continued research in the Archives and possibly even by excavation of the Prince William Bastion. In any event, the discovery of the stone passageways, well, casemate and drains in this bastion has added appreciably to the knowledge of the history and architecture of Fort Beausejour.

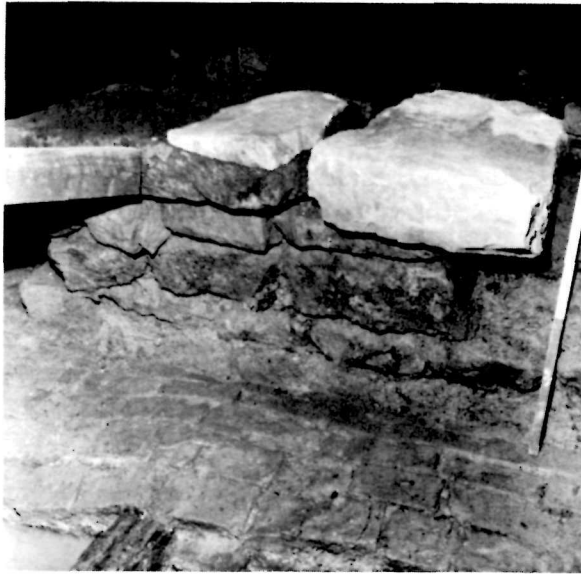
Fig. 20 2E16B- Photo of Oven Front
in Room I of the Men's Barracks.
(2E-606-X)

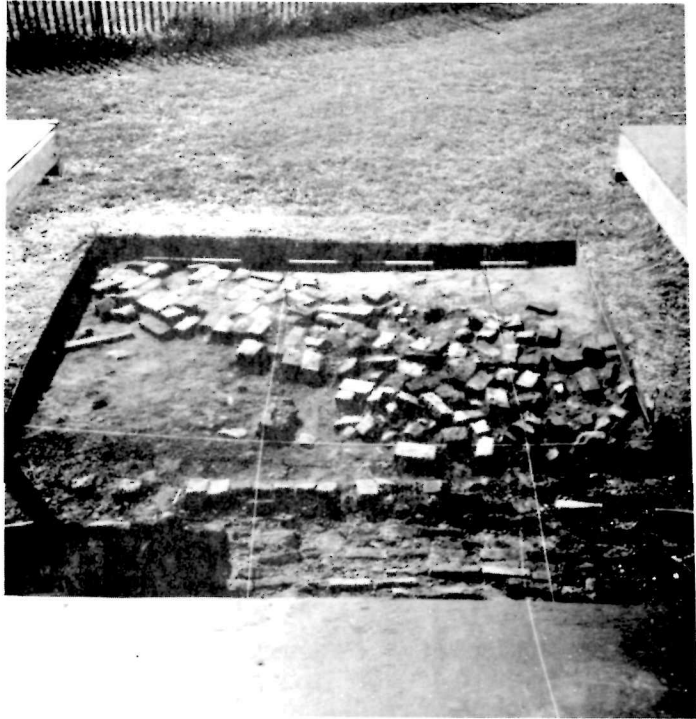
Fig. 22 - 2E16T4: View
of brick feature found
in test trench. Looking
West. 8' scale.
(2E-529-X)

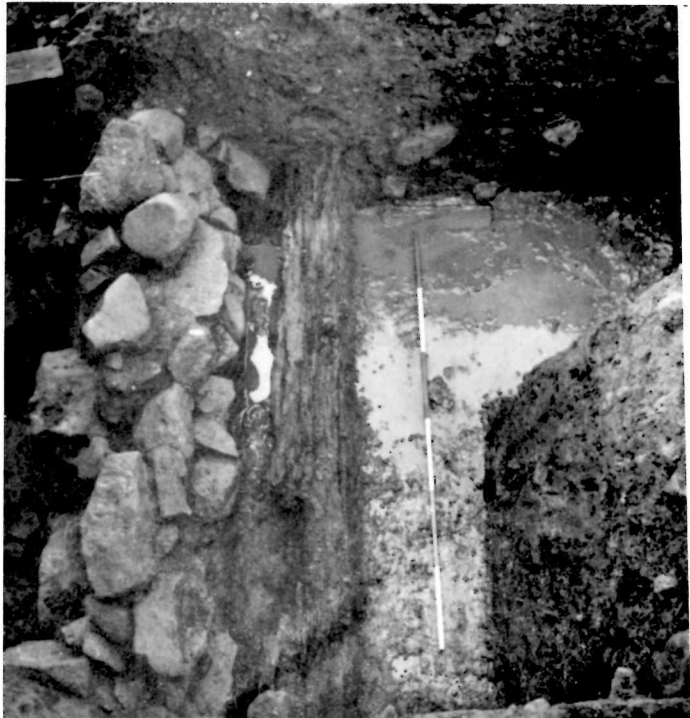
Fig. 23 - 2E16U4 & 5:
View of wood beam in
test trench plus
exterior face of west
wall of Men's Barracks.
6' scale. Looking South.
(2E-560-X)

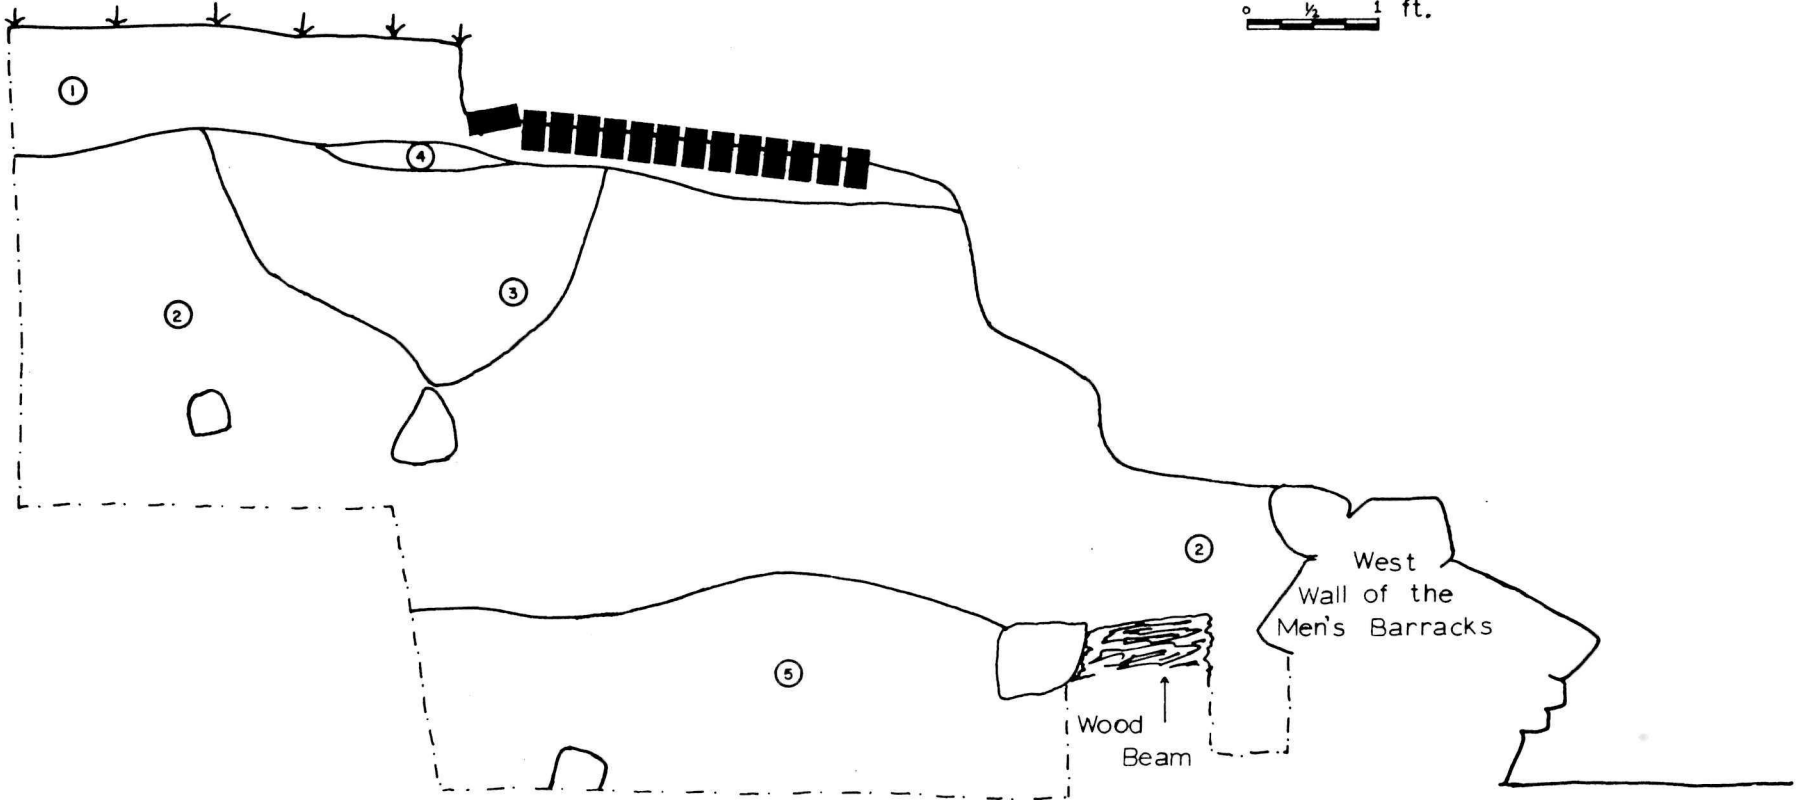
Fig. 24
2E16U - North Face
0 1/2 1 ft.

Figure 24

This drawing shows the north wall of the test trench dug west of the Men's Barracks to uncover the west face of the building wall. The stratigraphy is as follows:

Frederick Bastion. However, the walls of the Officer's Quarters (2E17-- another building in this fort) are from 1.8' to 2.3' thick, and so it is probable that the 2.0' thick wall of the Men's Barracks is the complete wall.

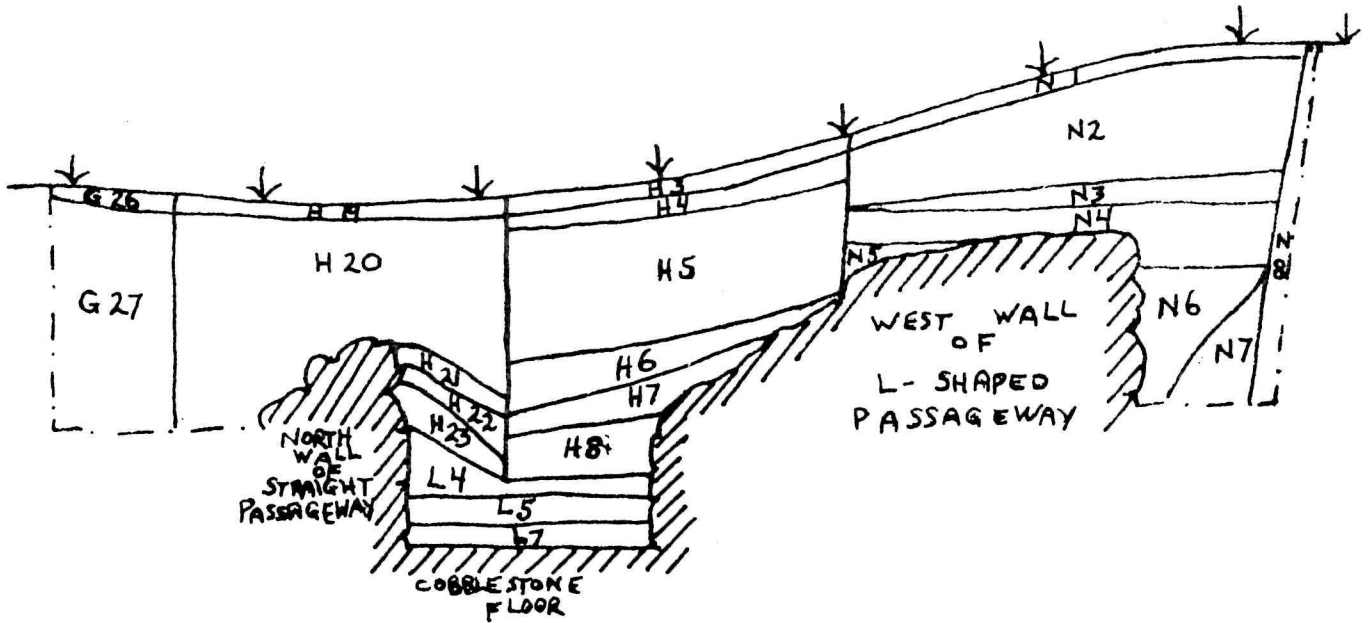
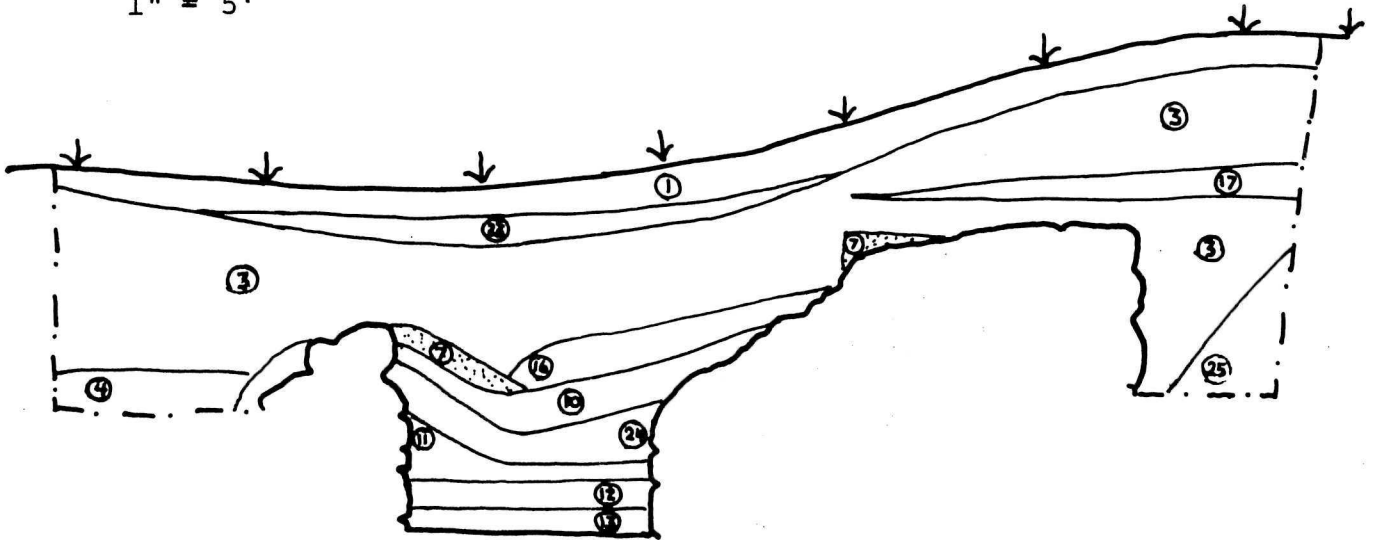
Section Through CD

Looking East

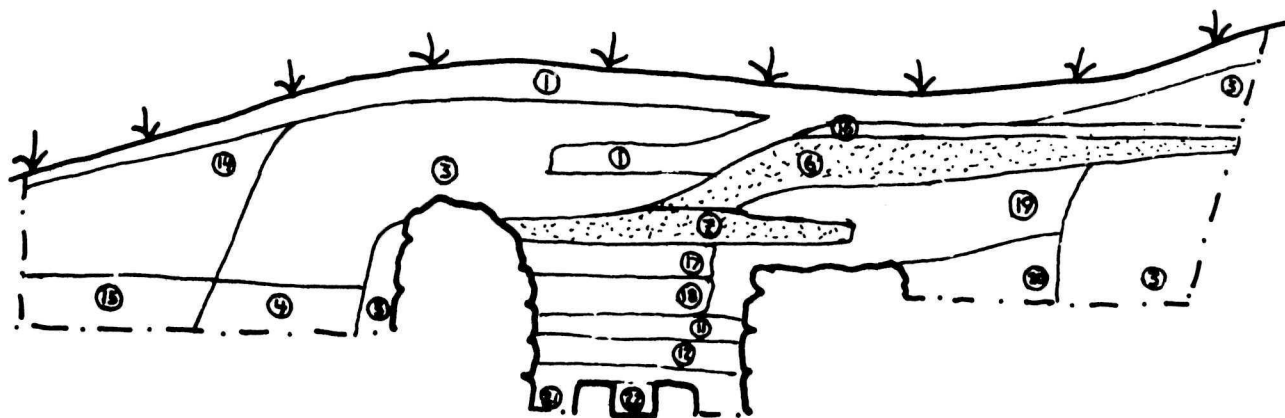
Section Through EF Looking East

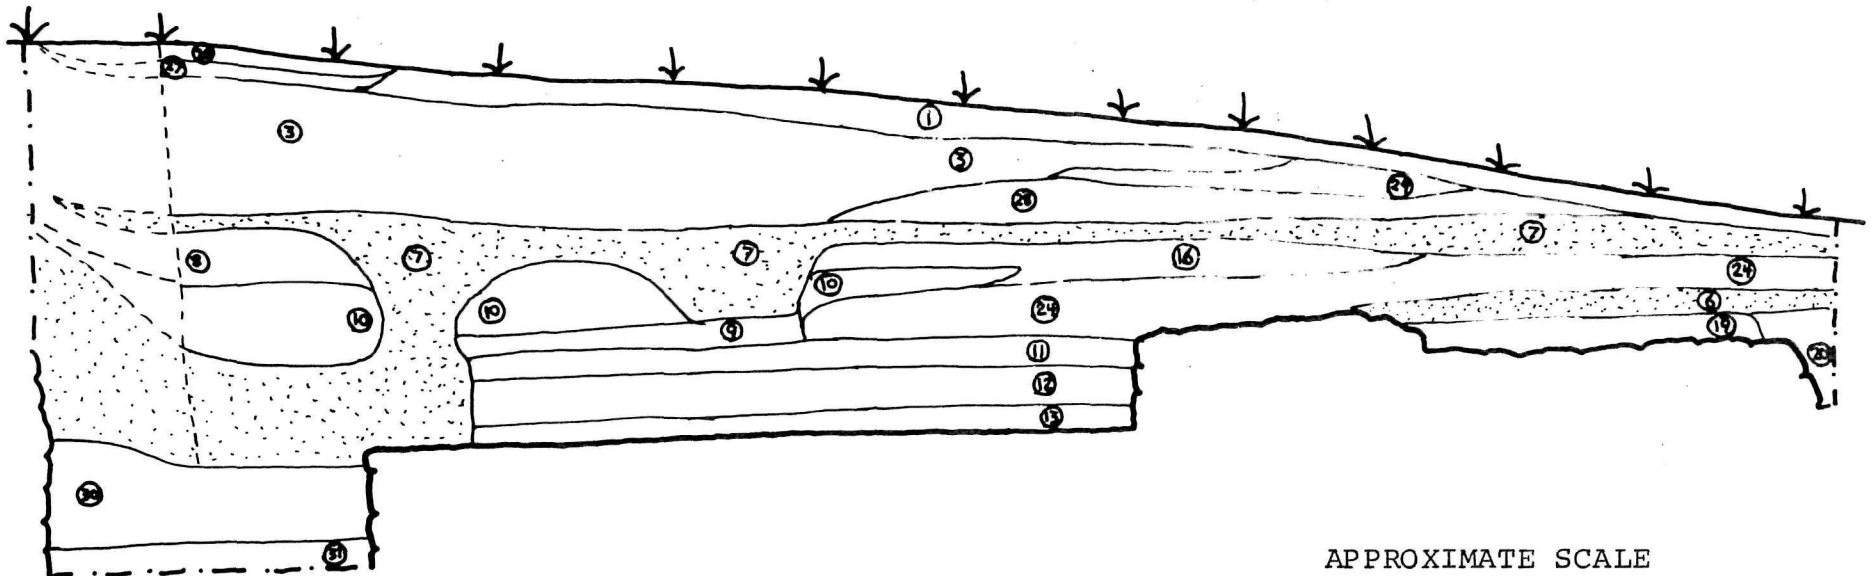
Section Through GH

Looking South
