1967 EXCAVATION OF THE
PRINCE FREDERICK BASTION 2E20 AT FORT BEAUSEJOUR

by
Winnie Frohn
(1968)

1967 EXCAVATION IN THE PRINCE FREDERICK BASTION
AND MEN'S BARRACKS AT FORT BEAUSEJOUR

by
E. Frank Korvemaker
(1972)

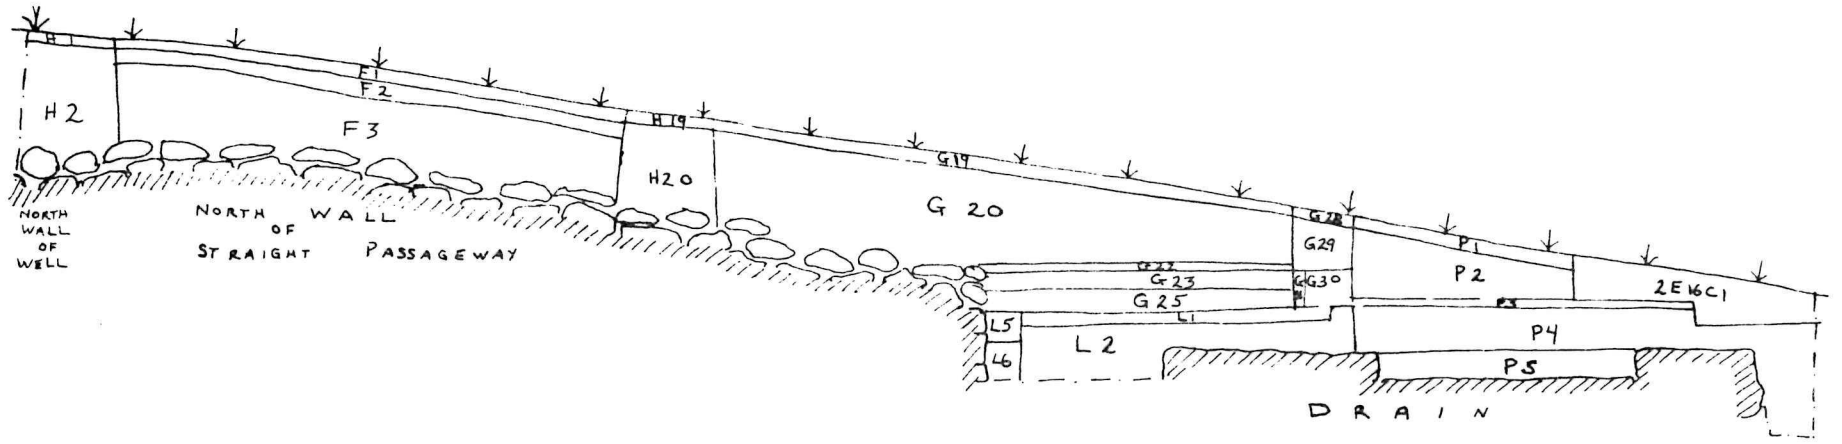
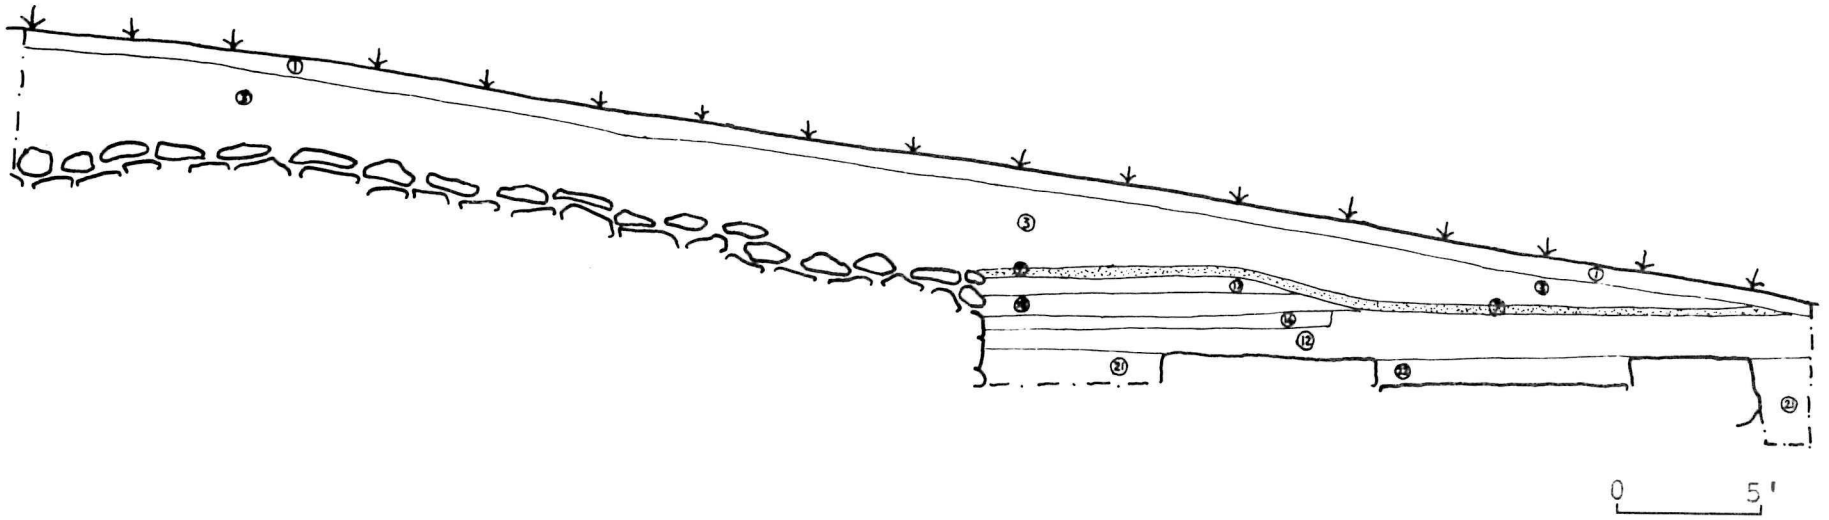
Section Through JK Looking South
