MANUSCRIPT REPORT NUMBER 130

MISCELLANEOUS REPORTS ON FORT WELLINGTON, ONTARIO

PARKS CANADA

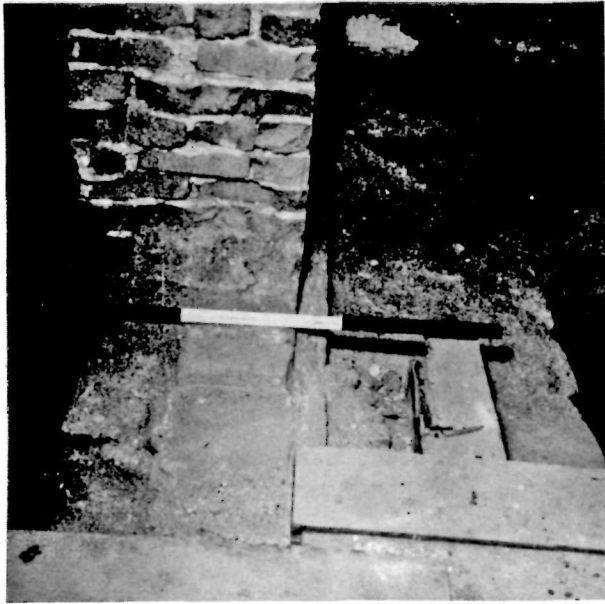
29. OPS.13-14: Brick dividing wall and sill in section. View east.

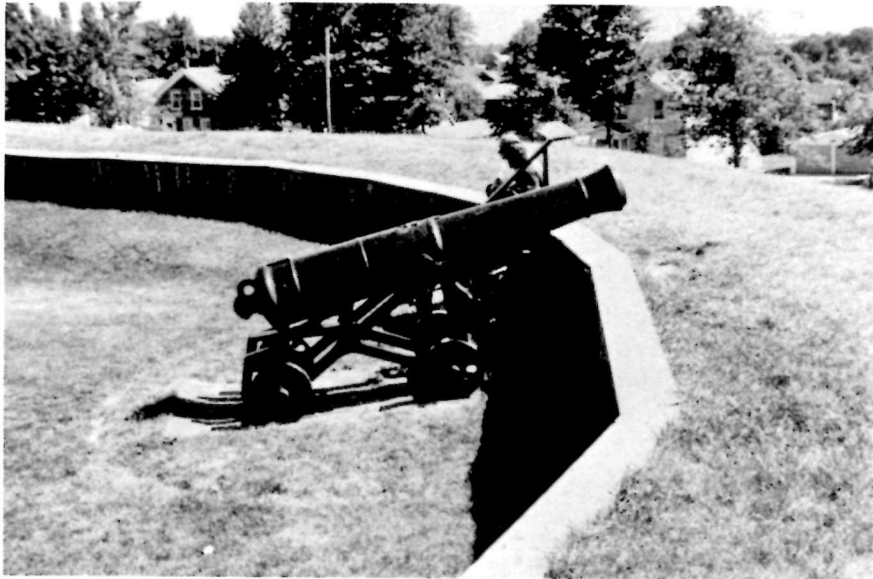
1. Southeast gun position before excavation.  
The pintle can be seen beneath the barrel  
of the cannon in front of the carriage.  
The rear racer is evident as a crop-mark.

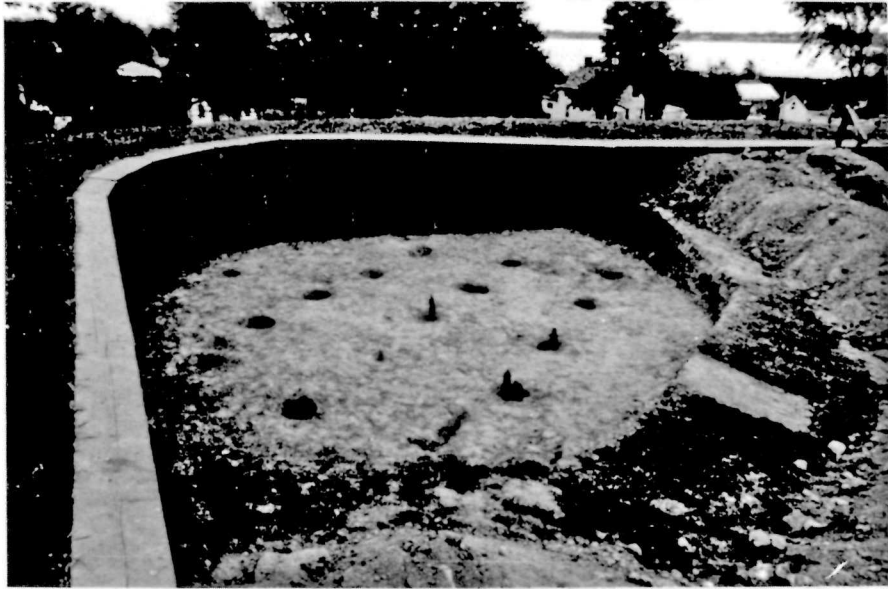
7,8. Two views (from west, and from rear) of the northeast gun platform after excavation.

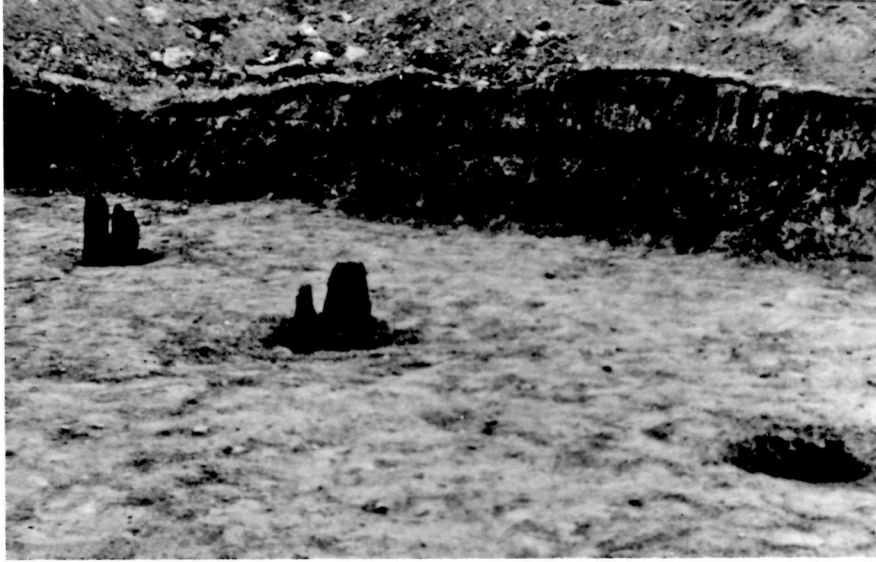
9. Two of the posts of the northeast gun platform still in position, and in the section to the back, the layer of gravel possibly marking the height of the platform.
10. The palisade put in about eight years ago can be seen to be in a very poor condition, especially below present ground level.

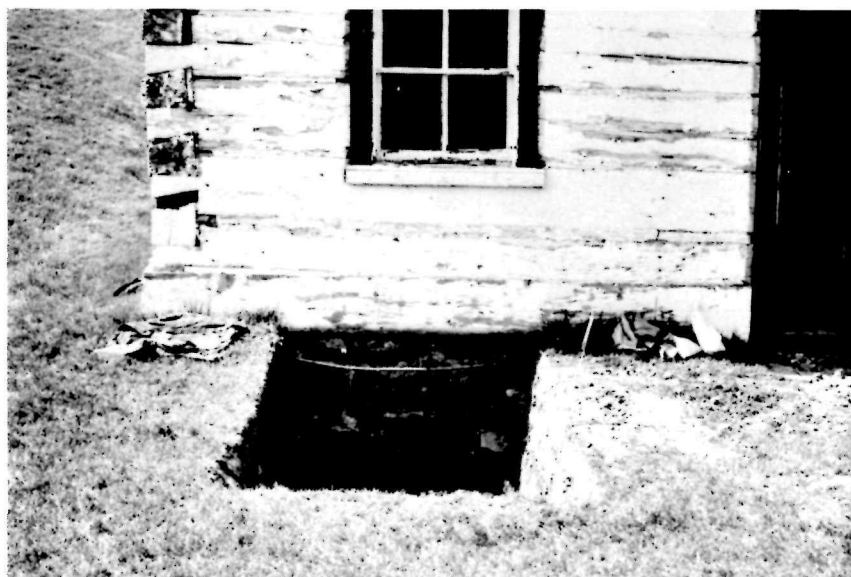
21. Guardhouse operation 15A view south of foundation of Guardhouse showing building sleeper, 1 foot concrete, and rubble stone foundation.

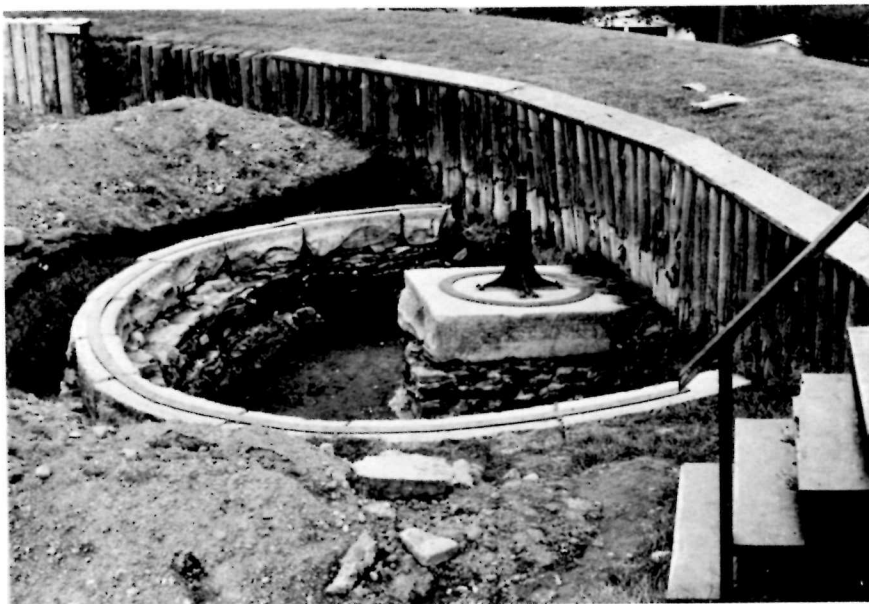
Fig. 11. 2H33. The southeast gun position after completion of excavation. The view is to the northeast with no scale present. 4 Oct. 1968. 2H-319 M.

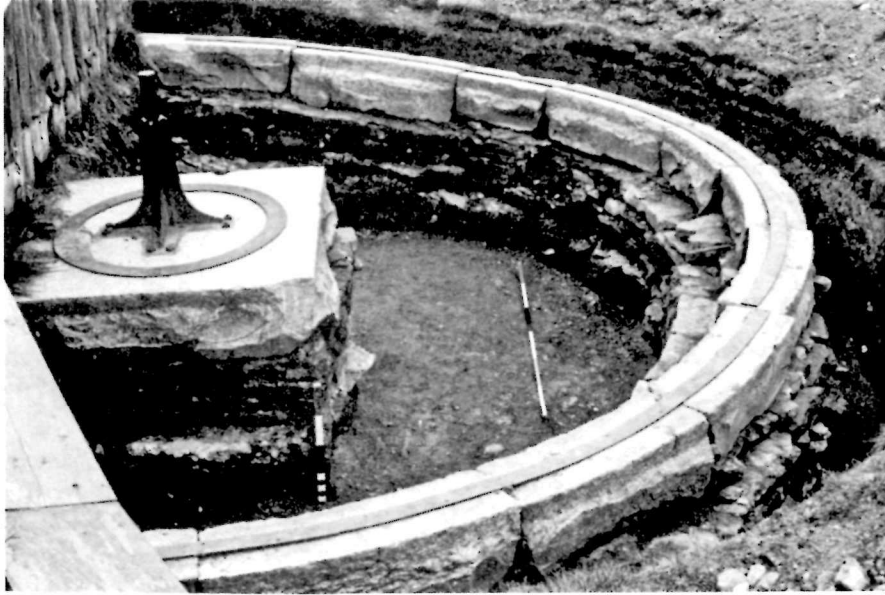
Fig. 12. 2H33. The southeast gun position after completion of excavation showing the general detail of the entire position. The view is to be the south with the 6' scale oriented N-S, and the 2' scale oriented up-down. 4 Oct. 1968. 2H-312 M.

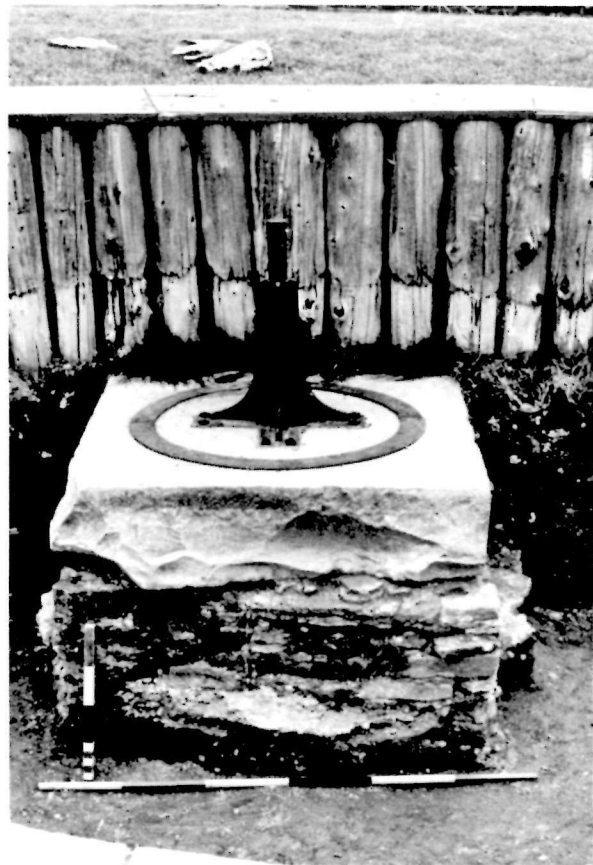
Fig. 15. 2H33. The southeast gun position after completion of excavation showing the details of the pintle foundation, block and race as well as the cast-iron pintle. The view is from the side looking east with the 6' scale oriented N-S and the 2' scale up-down. 4 Oct. 1968. 2H-313 M.

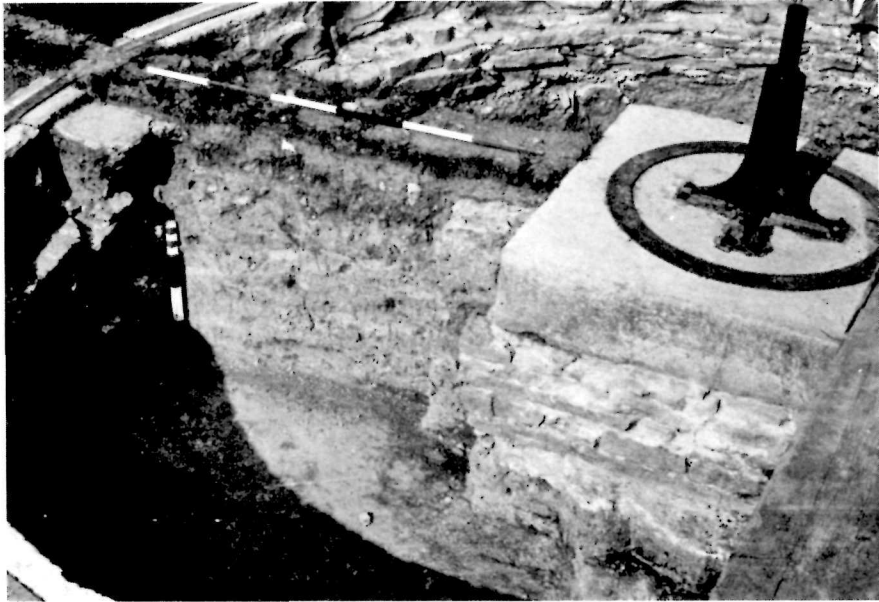
Fig. 16. 2H33. The southeast gun position during excavation showing the stratigraphy of the position. The view is to the northwest with the 6' scale oriented E-W and the 2' scale up-down. 30 Sept. 1969. 2H-296 M.

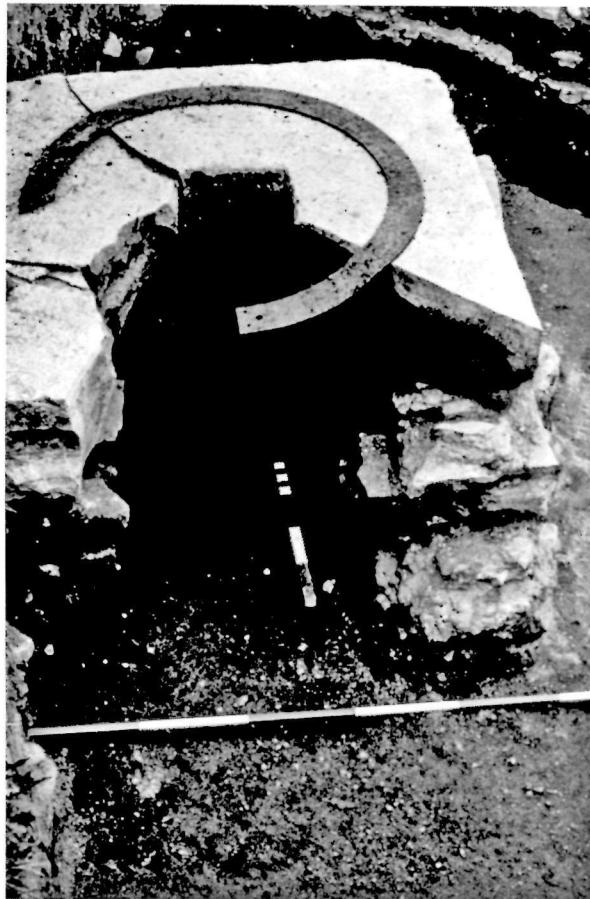
Fig. 19. 2H31. The southwest gun position after completion of excavation showing the detail of the damage to the pintle foundation, block, and track. The view is down and to the north with the 6' scale oriented E-W and the 2' scale N-S. Oct 1968. 2H-320 M.

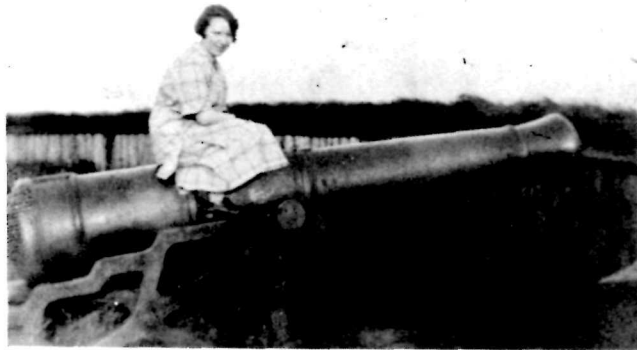
Fig. 24. (2H-1 B) 2H31. Southwest gun position. Circa 1924-1928 showing the protruding muzzle of the cannon utilized as the pintle prior to its removal in 1928 by Mr. Walter Webb. Photo courtesy of Mr. Webb. Woman is Mrs. Webb. Mounted gun is a British 24 pounder. Photo is looking south.
