MANUSCRIPT REPORT NUMBER 144

1966 EXCAVATIONS IN PRINCE EDWARD BASTION  
AND THE OFFICERS' QUARTERS  
FORT BEAUSEJOUR, NEW BRUNSWICK

1967 EXCAVATIONS IN THE OFFICERS' QUARTERS  
FORT BEAUSEJOUR, NEW BRUNSWICK

PARKS CANADA

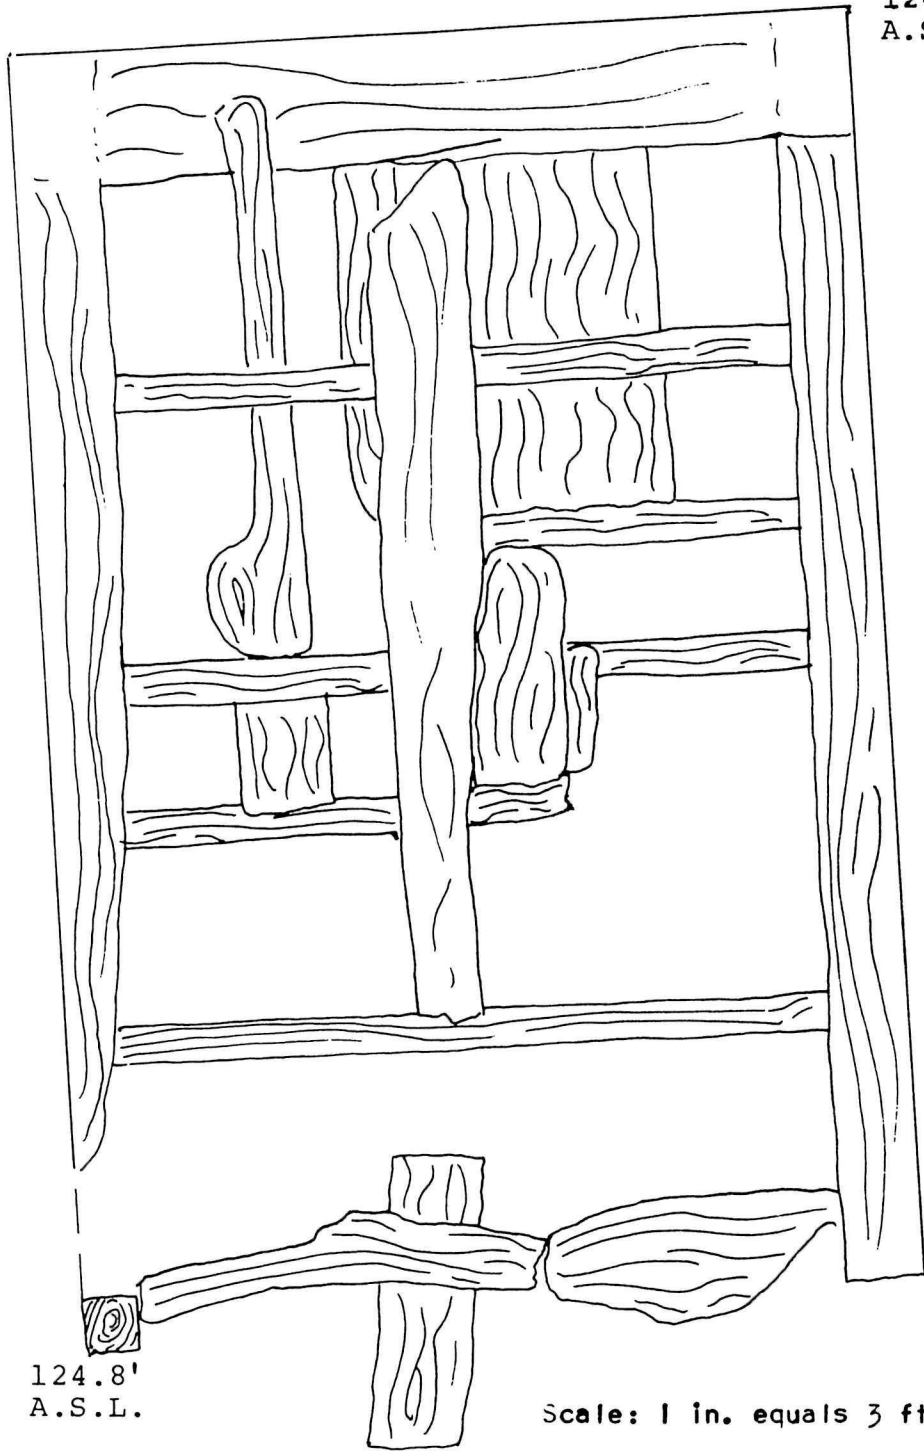
Fig. 3 -- Plan of French Powder Magazine (Sub. Op. 2E11N) floor.

The presumed floor of the Powder Magazine was very poorly preserved. Three complete and parts of three incomplete sleepers were found. These boards oriented in an east-west direction, are 0.6' wide, an average of 2' apart, and 0.55' deep. The sleepers rest on sterile soil.

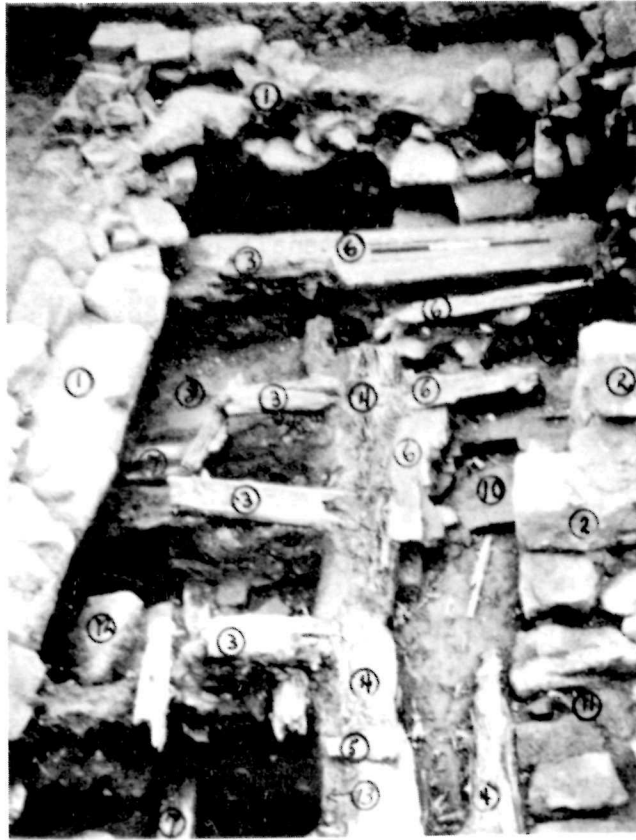
2E17A

Nous avons localisé dans cette sous-opération le coin nord-ouest de la résidence des officiers. J'écris ce rapport au moment où cette tranchée pose le plus de points d'interrogation. Il semble y avoir deux et peut-être trois planchers et éventuellement d'autres structures ainsi que le montrent les photos de la page suivante.

Vue vers le nord:

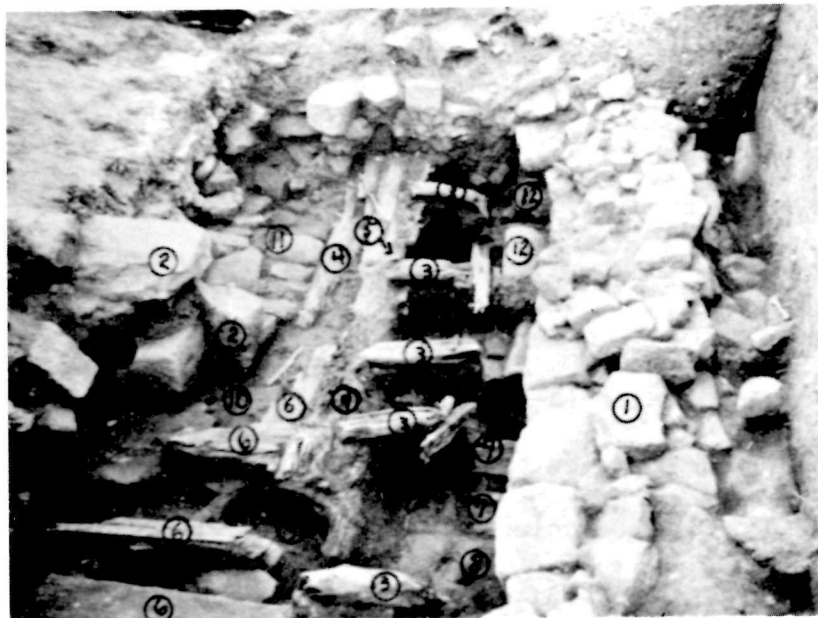
2E17A

Vue vers le sud.

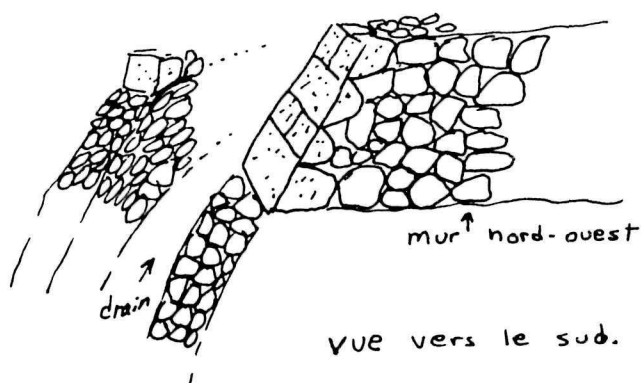
premier. Il est cependant en plus mauvais état et n'a qu'une seule pierre taillée. Les pierres ne sont pas liées par du mortier, mais il se peut qu'on ait utilisé de la glaise comme mortier. Le mur nord-ouest se termine à l'est avec des pierres taillées disposées en pente comme le montre 66-33-D11.

Le mur nord-ouest se termine donc avec des pierres taillées. Ce pendant sur le côté intérieur ou sud-est de ce mur les pierres sont équarries (faced stones), l'autre côté est mal façonné et inégal; le sol y était pierreux avec peu d'artifacts, par opposition au premier, entre les deux murs, où le sol était plus mou, sombre, avec beaucoup d'artifacts. On peut vérifier en consultant 66-33-D11. Il semble que les deux murs bordent un passage vers la casemate du Bastion du Duc de Cumberland, les côtés intérieurs devaient être exposés contrairement au côté extérieur qui devaient retenir le sol à la façon d'un mur de porerne. A l'état actuel des fouilles, ce n'est pas encore certain pour le mur sud-est mais ce l'est pour le côté nord-ouest du mur nord-ouest. Ce dernier s'appuie sur le rebord du drain, il ne peut donc pas être antérieur, mais le rebord du drain s'élargit à la rencontre de ce mur ce qui laisse croire qu'ils sont liés, chose d'autant plus probable que la pierre taillée est de style français et que le drain tourne pour semble-t-il passer entre les deux murs.

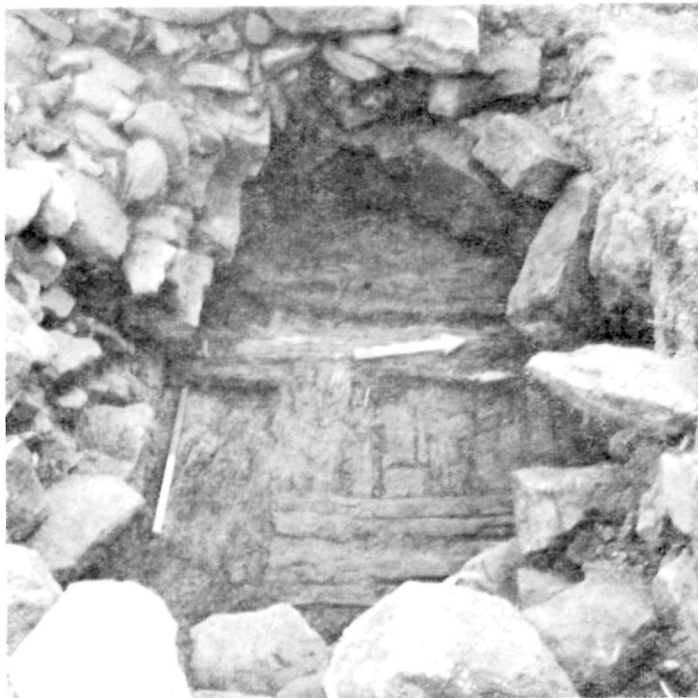
Fig. 2. (2E-1240 X) West portion of Room 1, 2E17L14, showing the remains of Floor 1. 2' scale aligned E-W along the south partition wall of the room.

A wooden floor, which will be termed level 1, covered the area of Room 1, with the exception of the stone base. The floor was not in good condition, but its character may be determined (Figs. 2, 3, 4, 5; also 67-48-D8; 66-33-D13; 67-7-407).

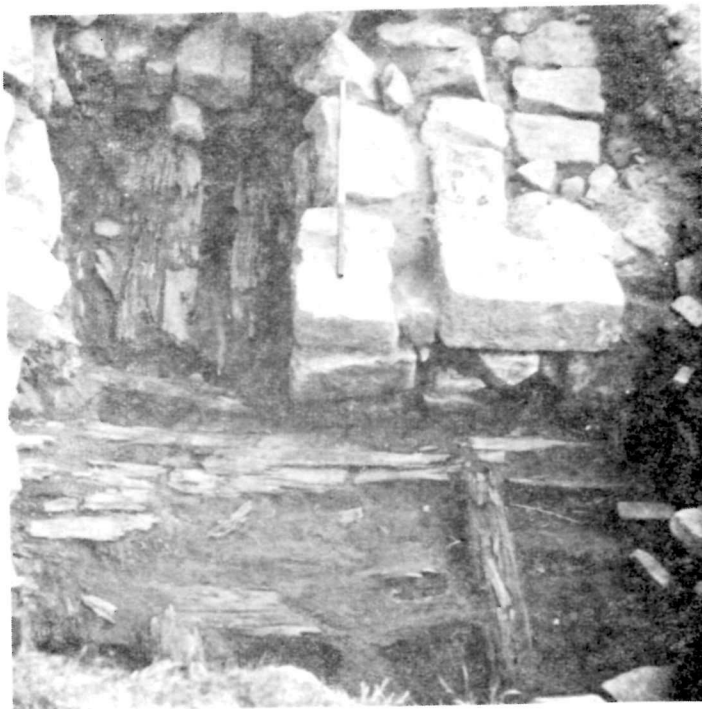
Fig. 3. (2E-1295 X) Detail of Floor 1 of Room 1, 2E17J12, at the SW corner area of the Officers' Barracks. 3' scale aligned N-S at the SW corner of the probable fireplace or oven base located in this room.

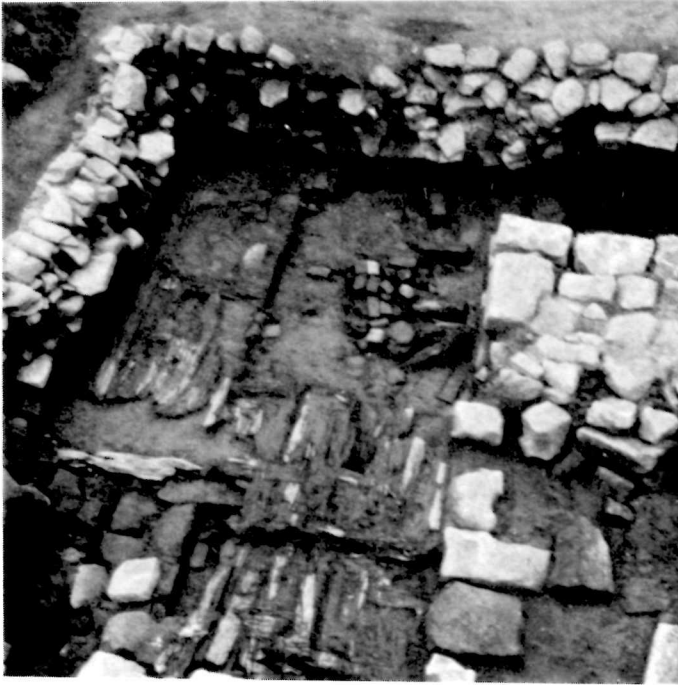
Fig. 4. (2E-531 X) 2E17J16, M14. General view of Room 1, looking west. Note remains of wood flooring and a portion of the earlier wall in the lower left portion of the photograph. Brick debris near the SW corner of the base.

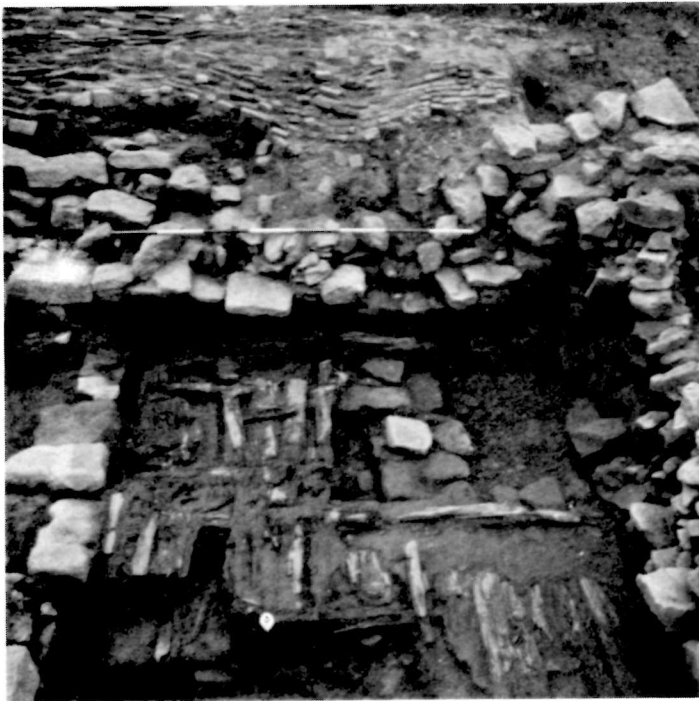
Fig. 5. (2E-534 X) Room 1, (2E17K5) facing East. 8' scale aligned N-S on top of the east barracks wall. Portion of earlier partition wall seen in the upper center of the room.

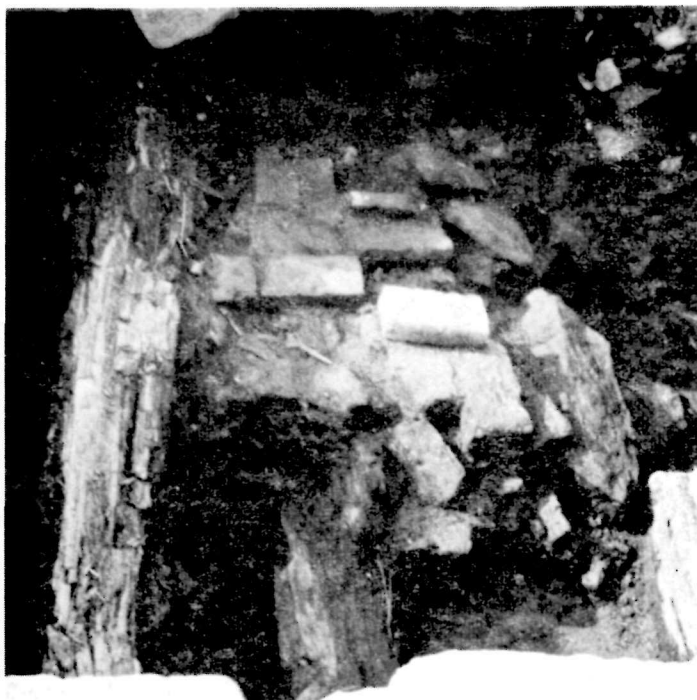
Fig. 6. (2E-1371 X) 2E17J. View of the sleeper beam overlying brick structure to the south of the fireplace base. No scale.

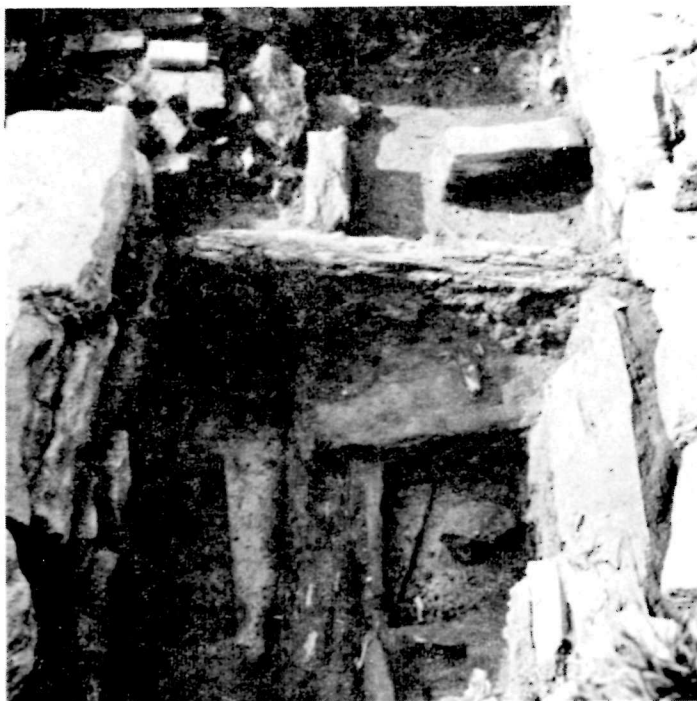
Fig. 7. (2E-1372 X) Detail of Floor 1 level, 2E17J, in the corridor between stone base (left) and west barracks wall (right).

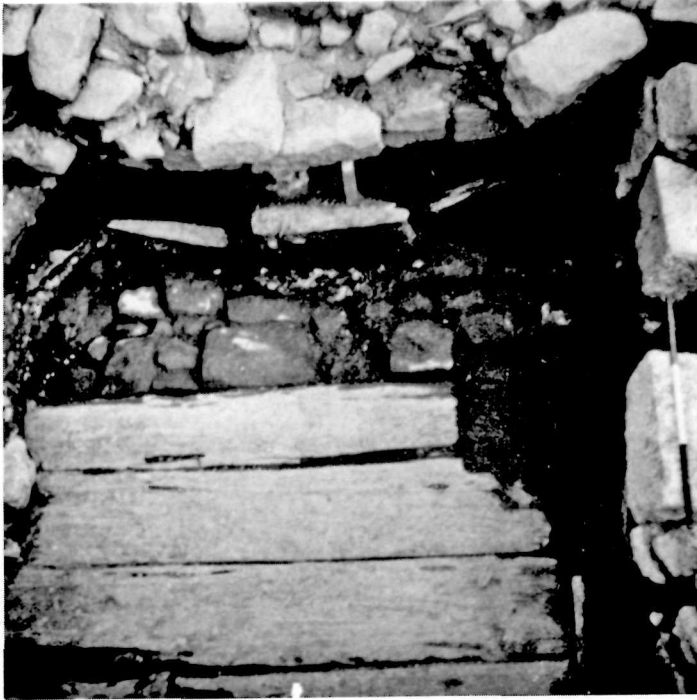
Fig. 8. (2E-1289 X) View of the east end of Room 2, 2E17G7, floor level. Note that planks of floor end at the edge of the earlier wall paralleling east barracks wall.

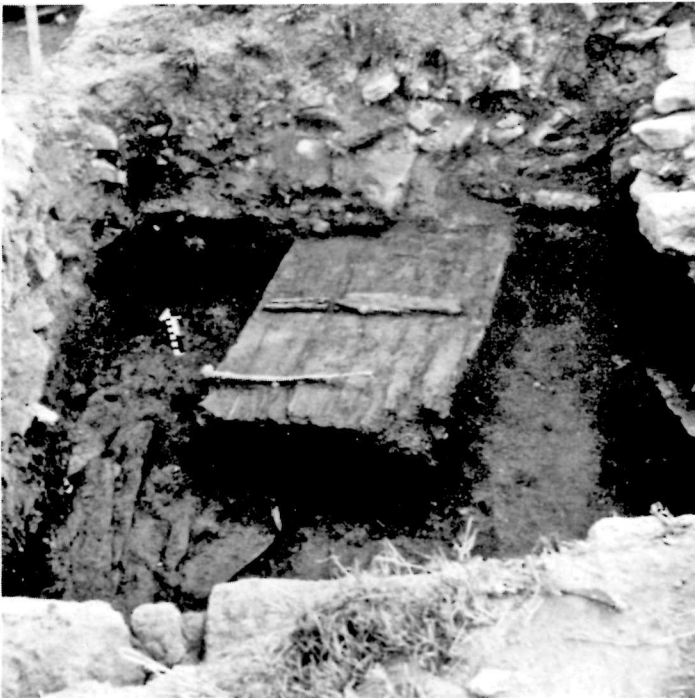
Fig. 9. (2E-1222 X) View of the west end of the trench in Room 2 showing the door, floor, and part of the walls. 1' North arrow.

A wooden door was found in 2E17G (2), below the collapsed wall rubble, by the north face and oriented in a NNE-SSW direction. It measures 3.2' E-W x 4.7' N-S and consists of four lengthwise (north-south) boards which are 0.15' thick and have an average width of 0.75'. A crossboard, 0.55' wide, is 1.6' from the north end of the door. Traces of nails are visible in the door boards under this crosspiece. An iron hinge (3), 0.2' wide and 1.95' long begins at the western side. An iron hook was found east of the cross-board. An iron handle, rounded in the middle but flat at both ends, was found in fill under the door. The handle is 0.65' long, and the flat parts have nails through them.

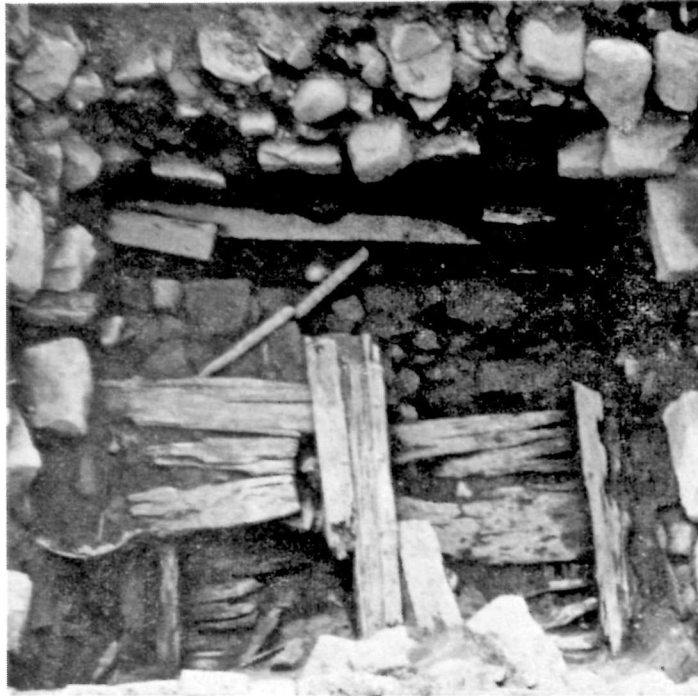
Fig. 10. (2E-1297 X) View of the east half of Room 4, 2E17C7, showing floor remains and earlier wall running N-S through the room at the east end. Note metal vessel and probable "pot hanger" in the lower left of the photograph.

In 2E17C, wood was found at various levels, from 118' ASL to 116.8' ASL. (1) A complete floor was later found. As in 2E17G, there are roughly-squared stones from the eastern edge of the planks up to 1' from the east building wall. These are at a point 117.2' ASL. There also seems to be another course below these stones. An iron basin and possible pot support (at 117.8' ASL) were found by the north face.

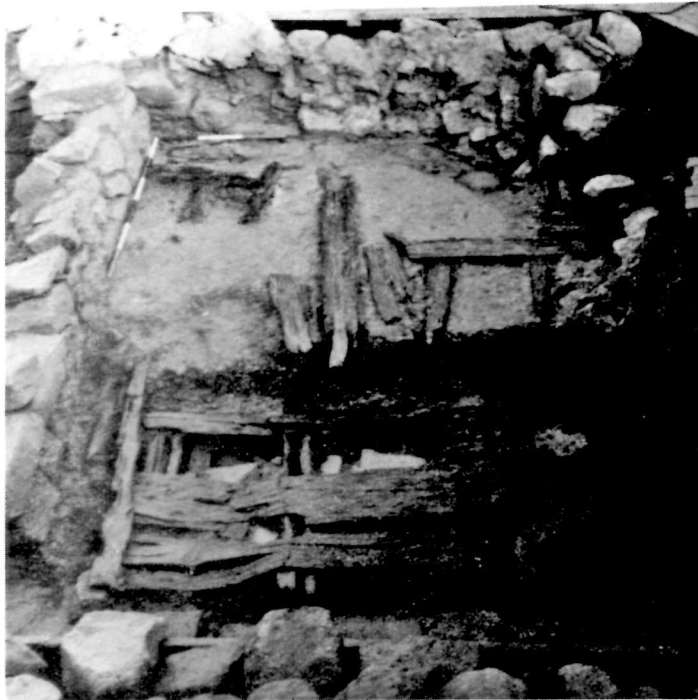
Fig. 11. (2E-558 X) General view of Room 4, facing west, partially excavated (2E17D4, C2). Flooring uncovered in the eastern portion of the room; doorway to Room 4 visible in the extreme lower left of the photograph. Portions of later floors are seen in the western half of the room above the better-preserved remains seen in the eastern half.

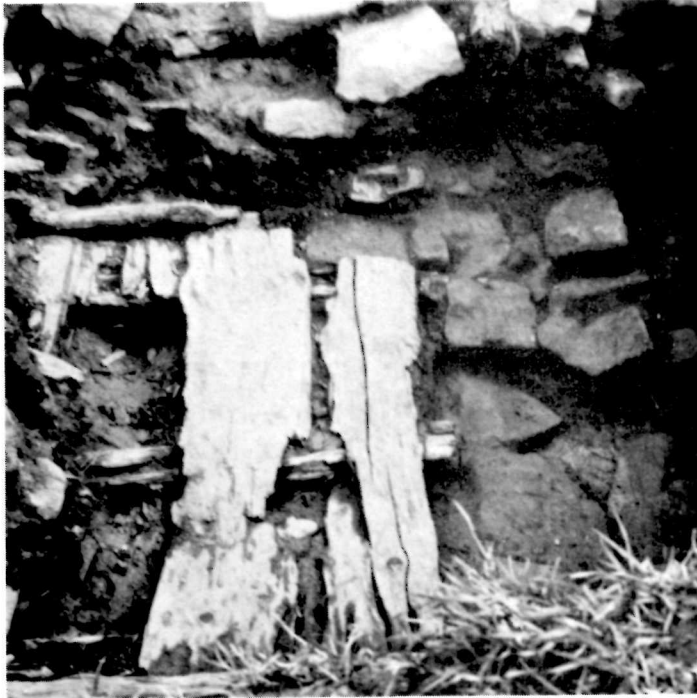
Fig. 12. (2E-1378 X) Detail of floor remains in Room 4, 2E 17C, looking North. Earlier wall top is visible along the right side of the photograph.

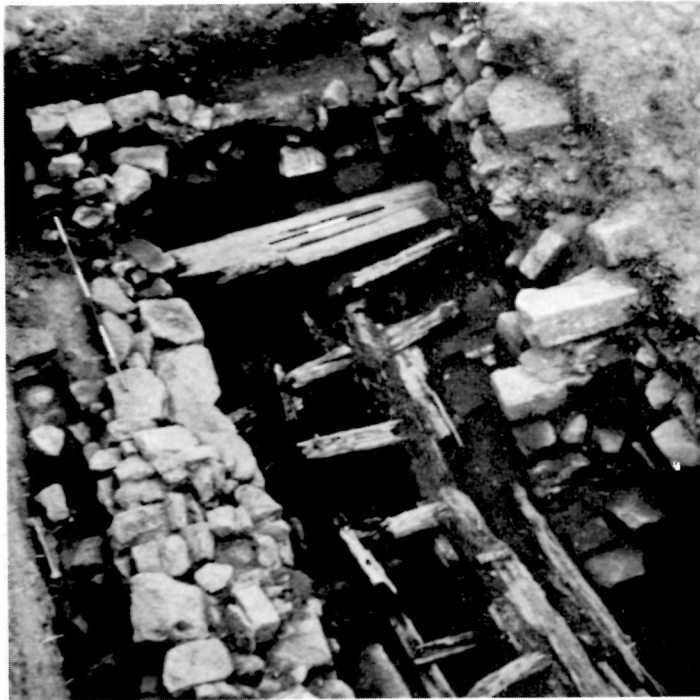
Fig. 13. (2E-1258 X) Overall view of the west half of Room 5, 2E17A, looking north. The northwest corner of the room is to the north of the 6' scale. Note various wooden remains along the west wall of the barracks.

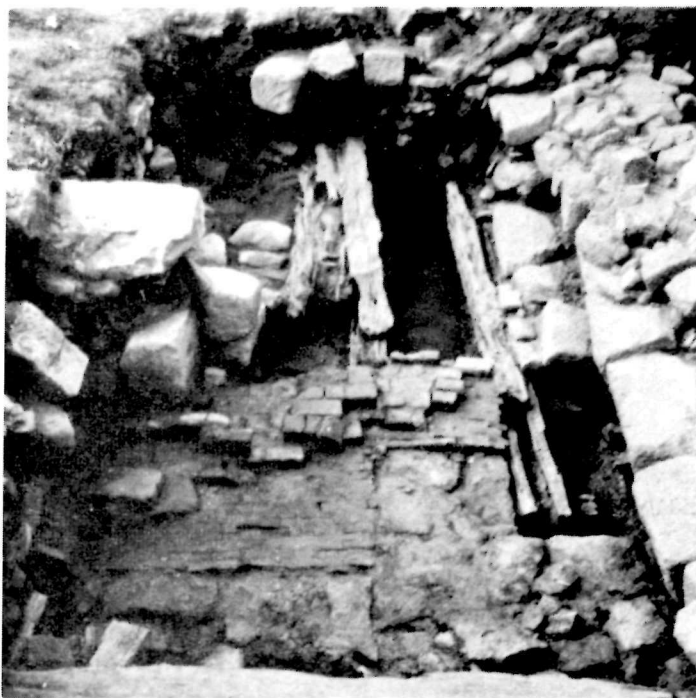
Fig. 14. (2E-1382 X) Detail of the west portion of Room 5, 2E17A, looking south. Brick fireplace hearth is in the lower part of the photograph abutting possible early wall in the right-centre foreground.

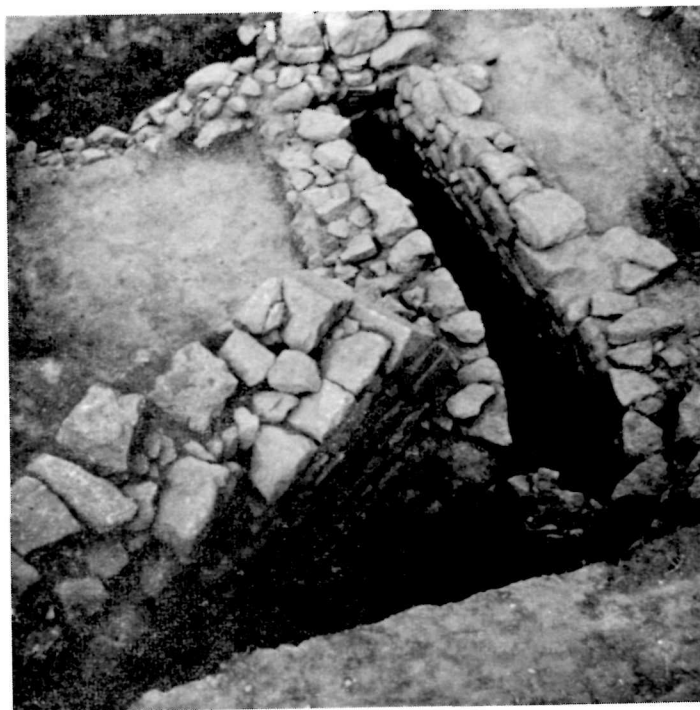
Fig. 15. (2E-1291 X) Overall view of the drain from the SE corner of the Officers' Barracks, 2E17L, N6,7,8, looking northeast from the masonry passageway leading to the Duke of Cumberland Bastion (2E18) and the Rrench timber casemate (2E18K) in that bastion.

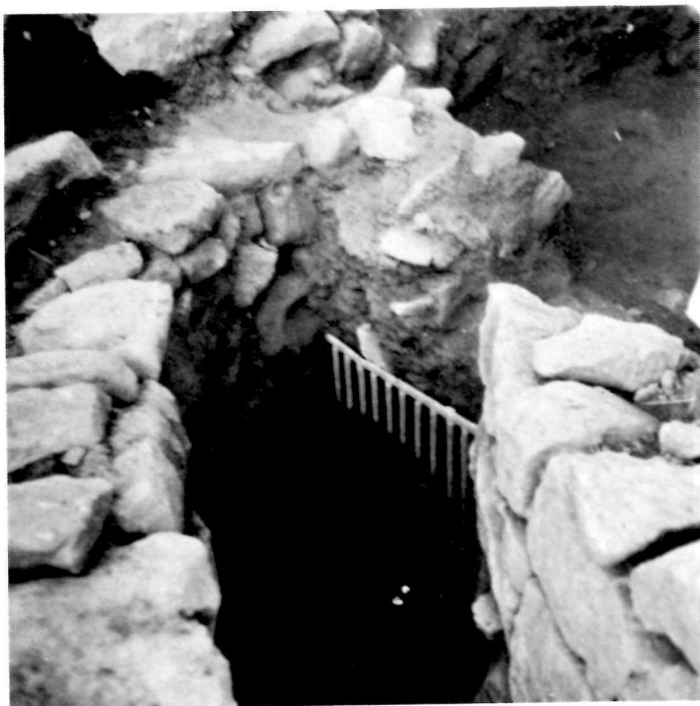
Fig. 16. (2E-1292 X) Detail of iron grate (2E17N8) at the southern terminus of the drain before it enters the passageway walls.

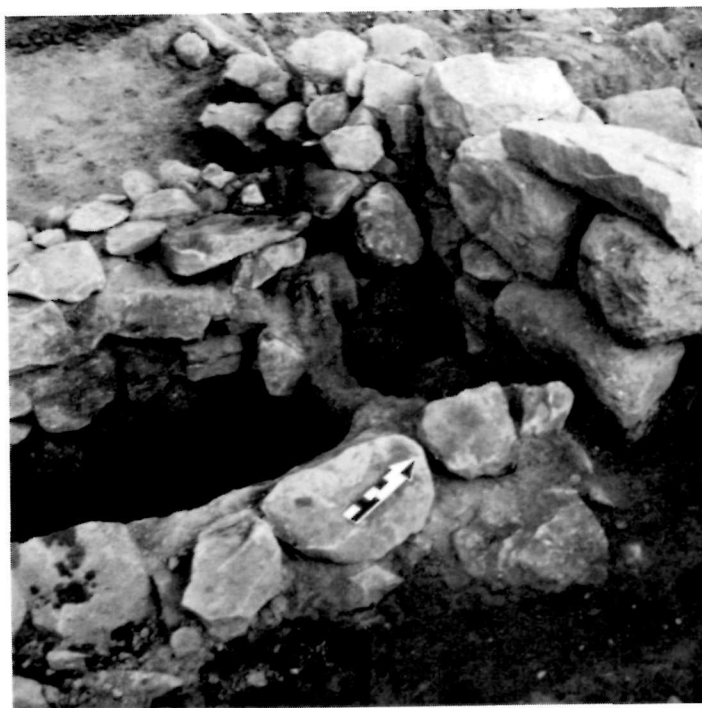
Fig. 17. (2E-1169 X) Masonry drain at the juncture with the SE corner exterior of Officers' Barracks (2E17L10). Note wood remains spanning the drain near the directional arrow.

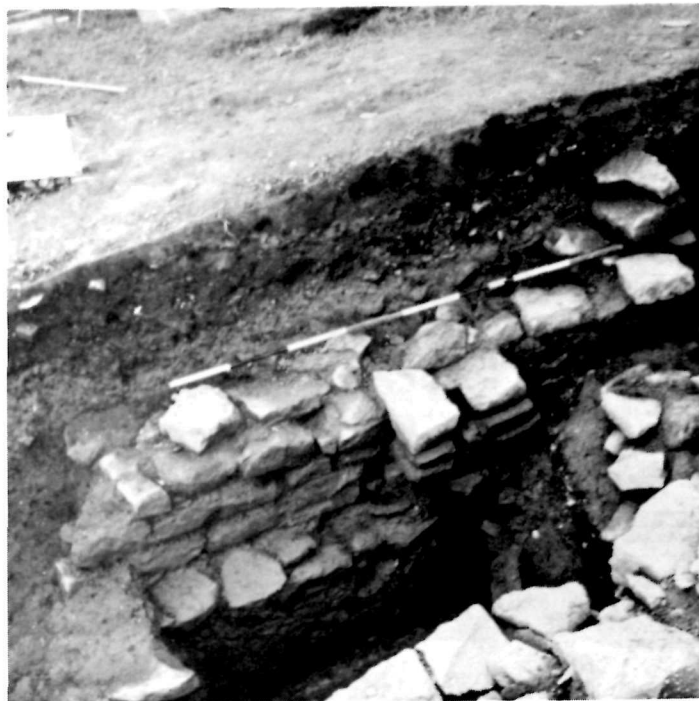
Fig. 18. (2E-103 X) Detail of portion of the south passageway wall, 2E17N13 and N14, to Duke of Cumberland Bastion (2E18). Note the "pilaster", a projection in the wall at the center of the photograph.

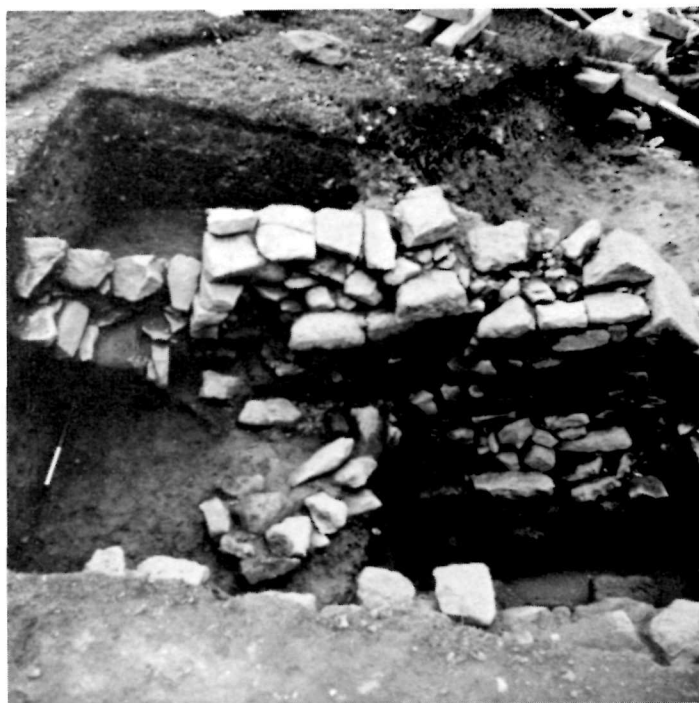
Fig. 19. (2E-104 X) Detail of the portion of the north passageway wall (2E17N13, 14, 15), showing the apparent constructional phases of the wall.

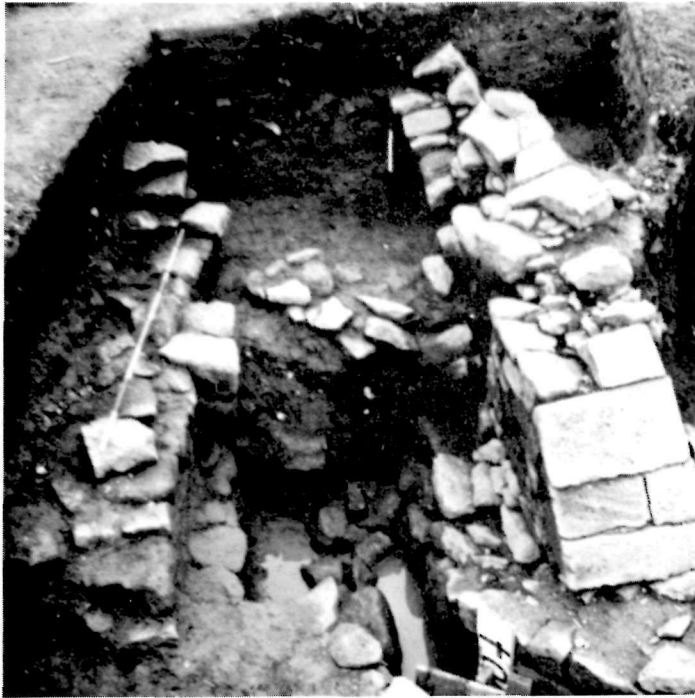
Fig. 20. (2E-101 X) View of the beginning of the passageway (2E17N13, 14, 15) at the parade square side, looking west. Cut stone terminus of the north wall of the passageway visible at the lower-right centre of the photograph.

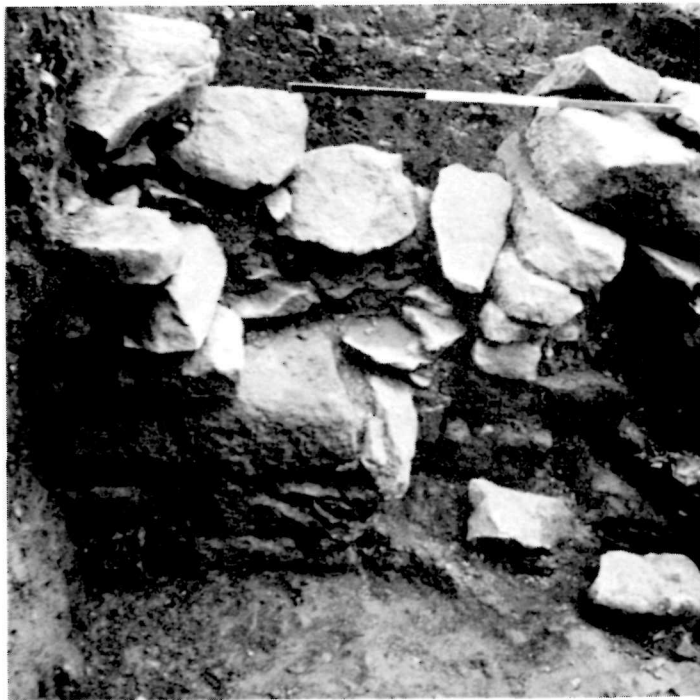
Fig. 21. (2E-105 X) Detail of portion of the north passageway wall showing two portions of the wall abutting (2E17N13) . Camera facing north.

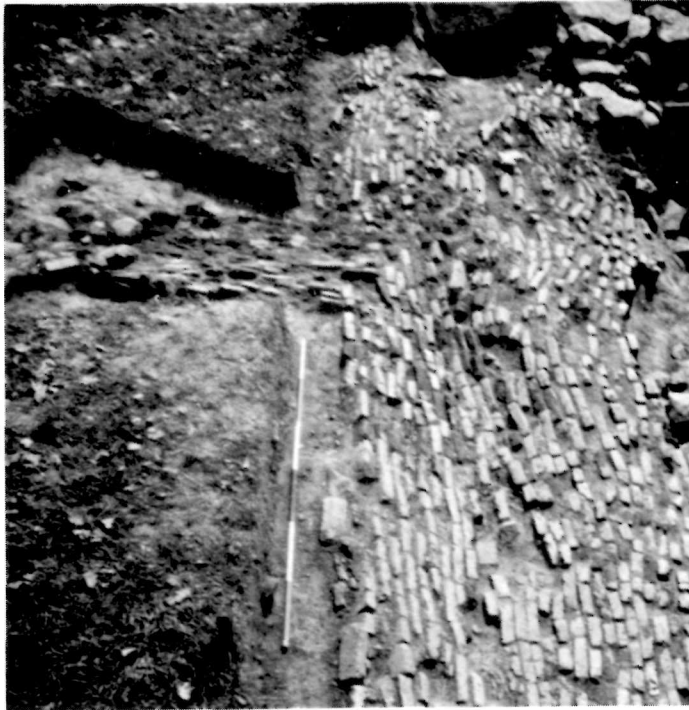
Fig. 22. (2E-337 X) Portion of brick walk/splash drain paralleling the Officers' Barracks on the east side, near the SE corner of the building. Brick surface drain leading to the parade square from the walk directly south of the 6' scale (2E17K2, 3).

There are rows of bricks in 2E17G, similar to those in 2E17C and 2E17L, which extend the width of the sub-op along the exterior of the east building wall. The bricks were part of a walk/drain; they were not found on the other sides of the building. (1)

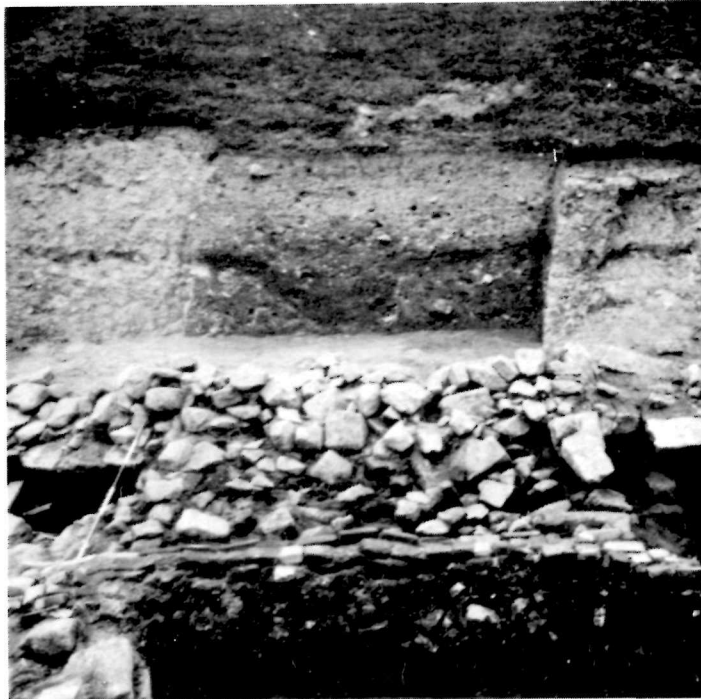
Fig. 23. (2E-394 X) View of the stratigraphy, facing west, in the west trench face of 2E17H2. Dipping layers possible indicate location of a sortie shown in the 1751 plan of the fort by Franquet.

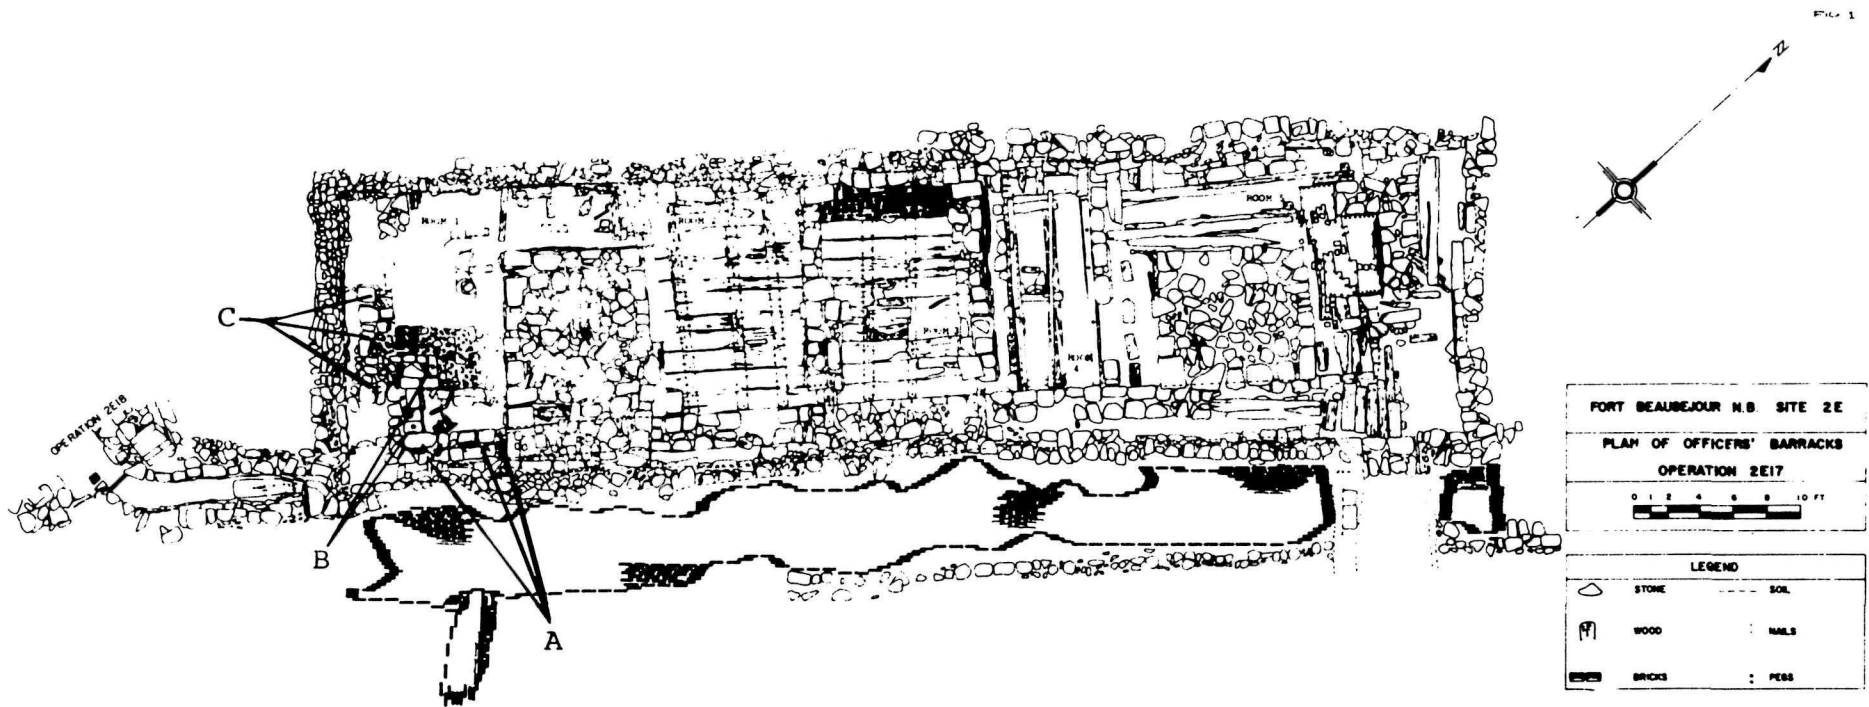
Fig. 1. Plan of Operation 2E17 showing: (A) north-south wall  
 (B) inner section  
 (C) north-south wall

Although there is no historical record of stone foundations, four stone foundation walls form the perimeter of the barracks building and represent its final stage of development (Fig. 1). The interior dimensions of the building are 17.8' EW x 68.6' NS. The walls are constructed of bonded, roughly squared field stones, held together with mortar, and are approximately 2.0' wide.

The south inner foundation wall (B, C, D of Figure 1) is parallel to the south barracks wall, but has an irregular shape similar to that seen on the 1752 plan.
