NATIONAL HISTORIC PARKS AND SITES BRANCH

MANUSCRIPT REPORT NUMBER 145

REPORT ON THE EXCAVATIONS OF OPERATIONS  
2E13 AND 2E19 AT FORT BEAUSEJOUR

Report on the Excavations of Operations 2E13  
and 2E19 at Fort Beauséjour, N.B., 1967.

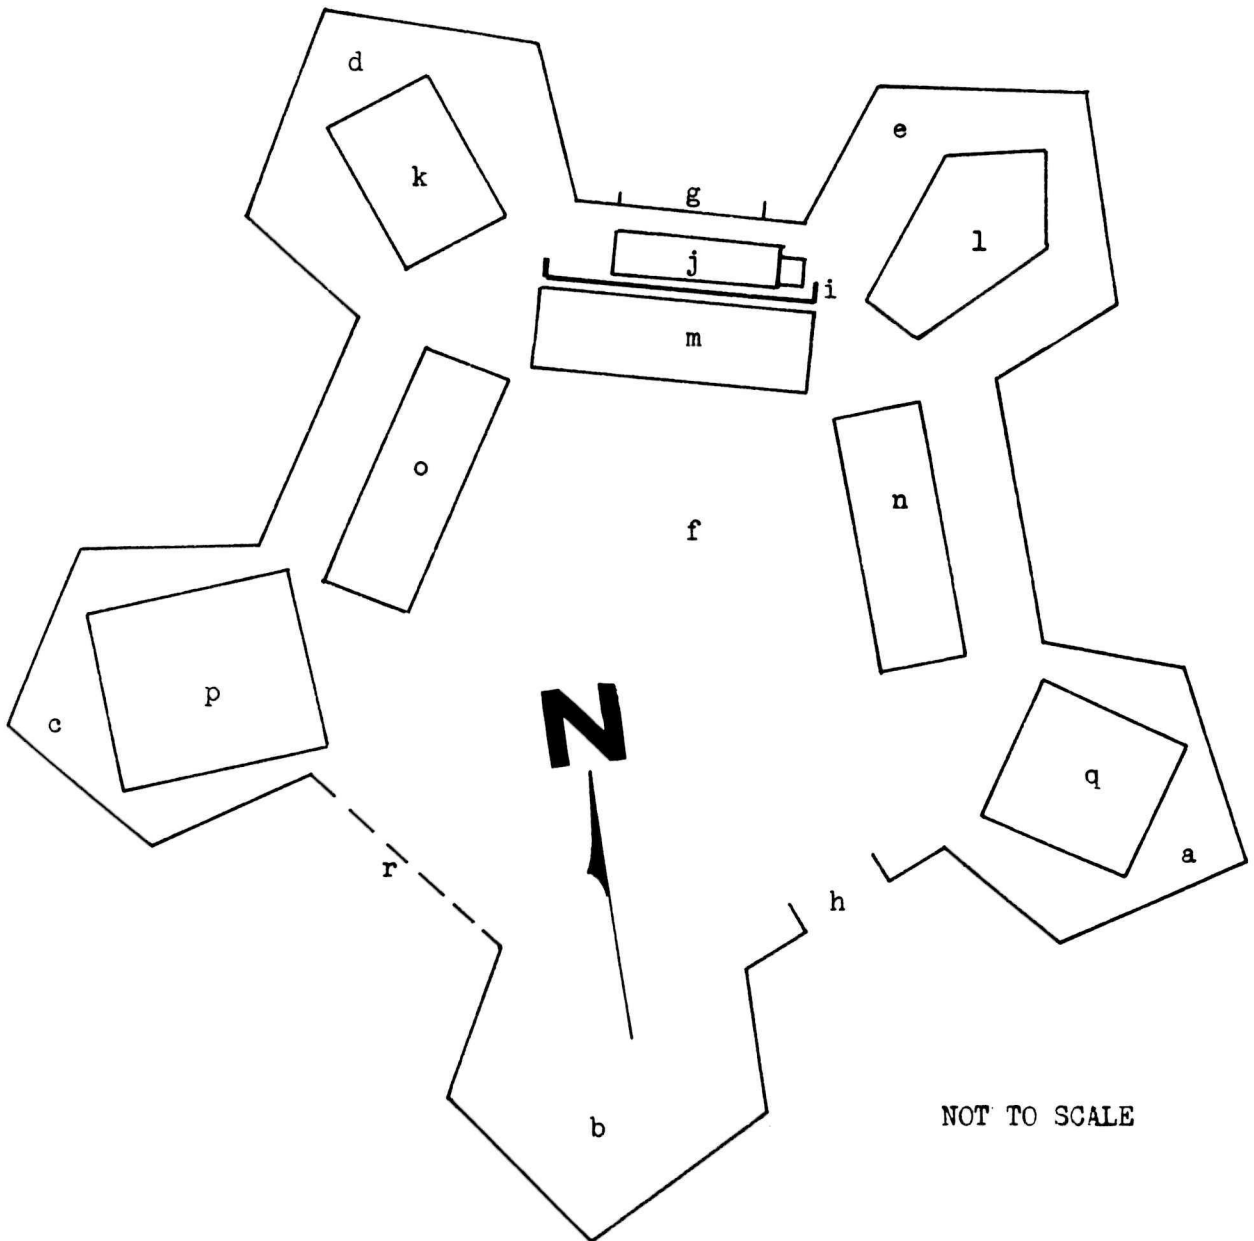
FIGURE 1. PLAN OF FORT BEAUSÉJOUR, NEW BRUNSWICK, 1967.

Fort Beauséjour has a pentagonal or star shape, formed by five earthen bastions with connecting curtain walls. The bastions were named Prince William, Duke of Cumberland, Prince Edward, Prince Henry, and Prince Frederick by the British, whose entrance was situated between Prince Frederick and Prince William bastions (Fig.1). It replaced the

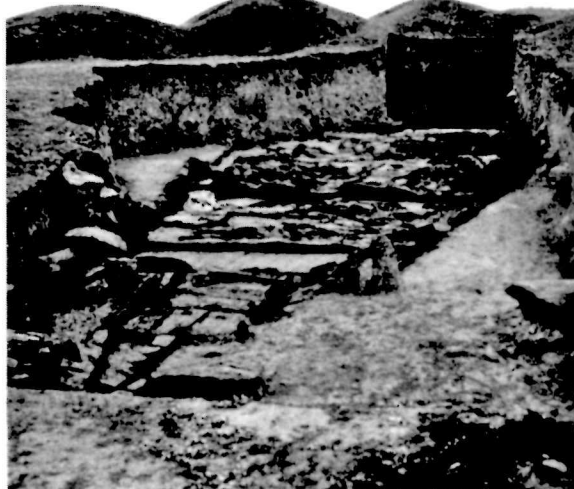
2E - 1363 X

Fig. 2. Photograph of operation 2E13 at the end of the 1966 field season, looking East.

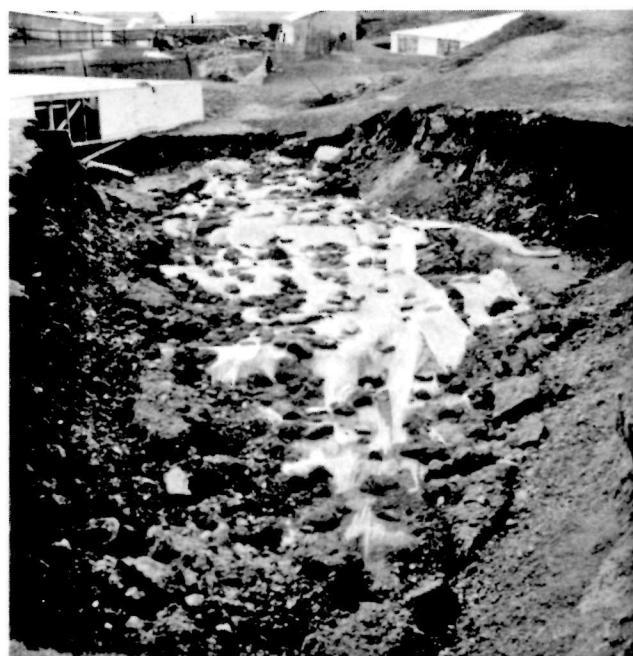
2E - 86 X

Fig. 3. Photograph of operation 2E13 at the start of the 1967 field season, looking West.

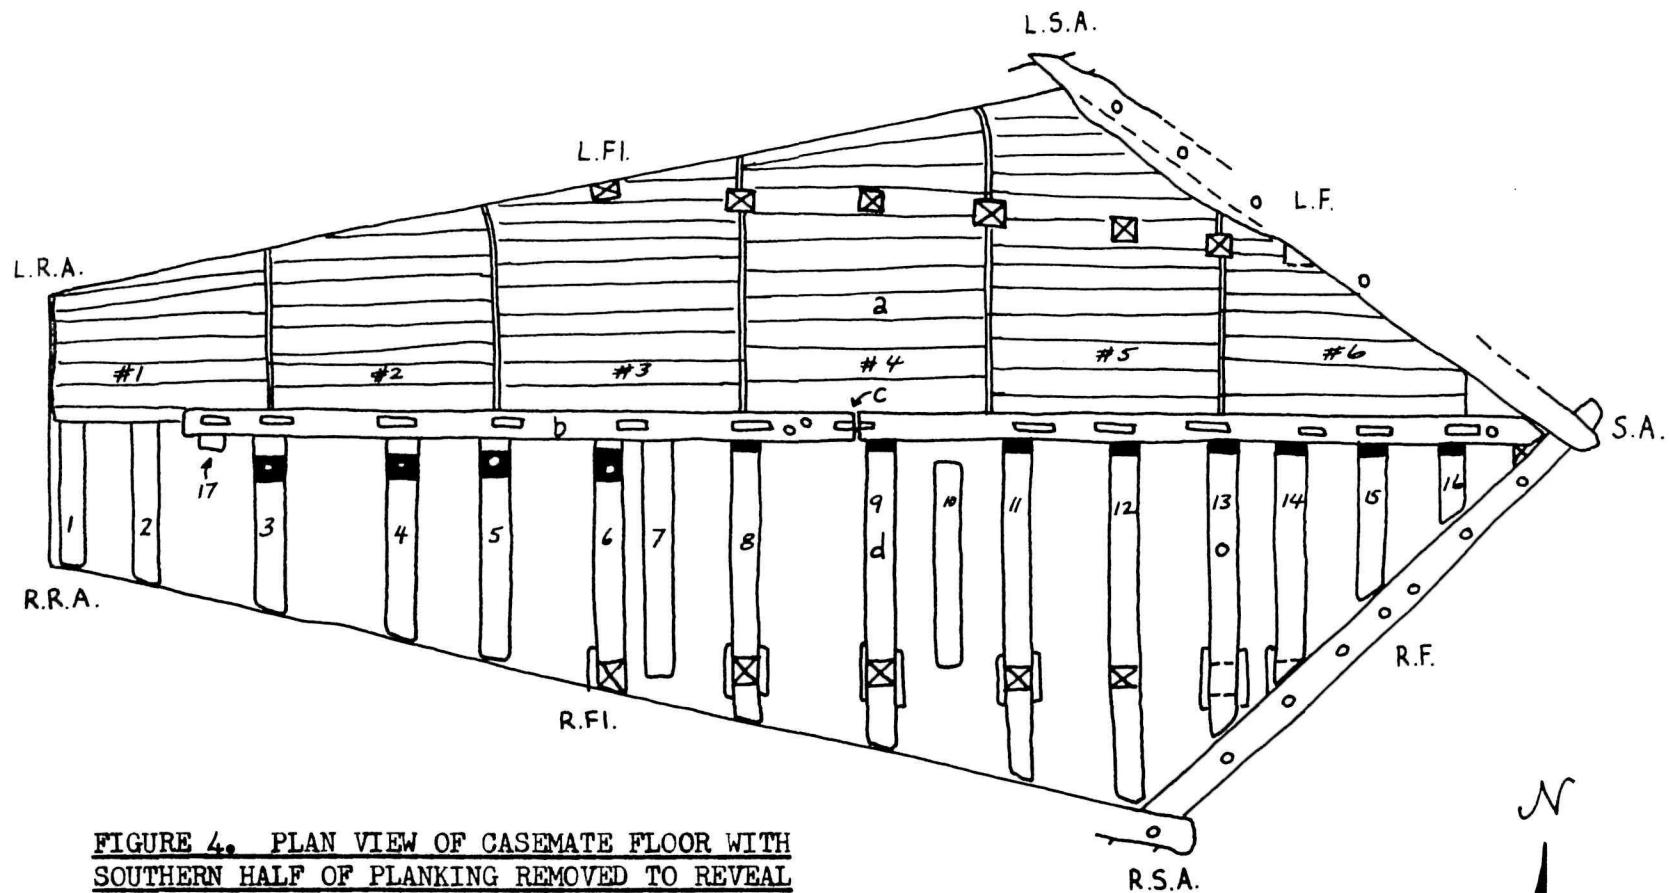
**FIGURE 4. PLAN VIEW OF CASEMATE FLOOR WITH SOUTHERN HALF OF PLANKING REMOVED TO REVEAL SUB-FLOOR CONSTRUCTION.**

Along the casemate center line, which runs between the salient angle and the short side mid-point, lies a beam termed the center floor beam. It rests directly on the sleeper beams and measures 0.9 feet wide, 0.45 feet thick, and 53.1 feet long. The beam is somewhat shorter than the casemate so that a gap of 5.6 feet exists between the west end of the beam and the short side of the casemate. The center floor beam is

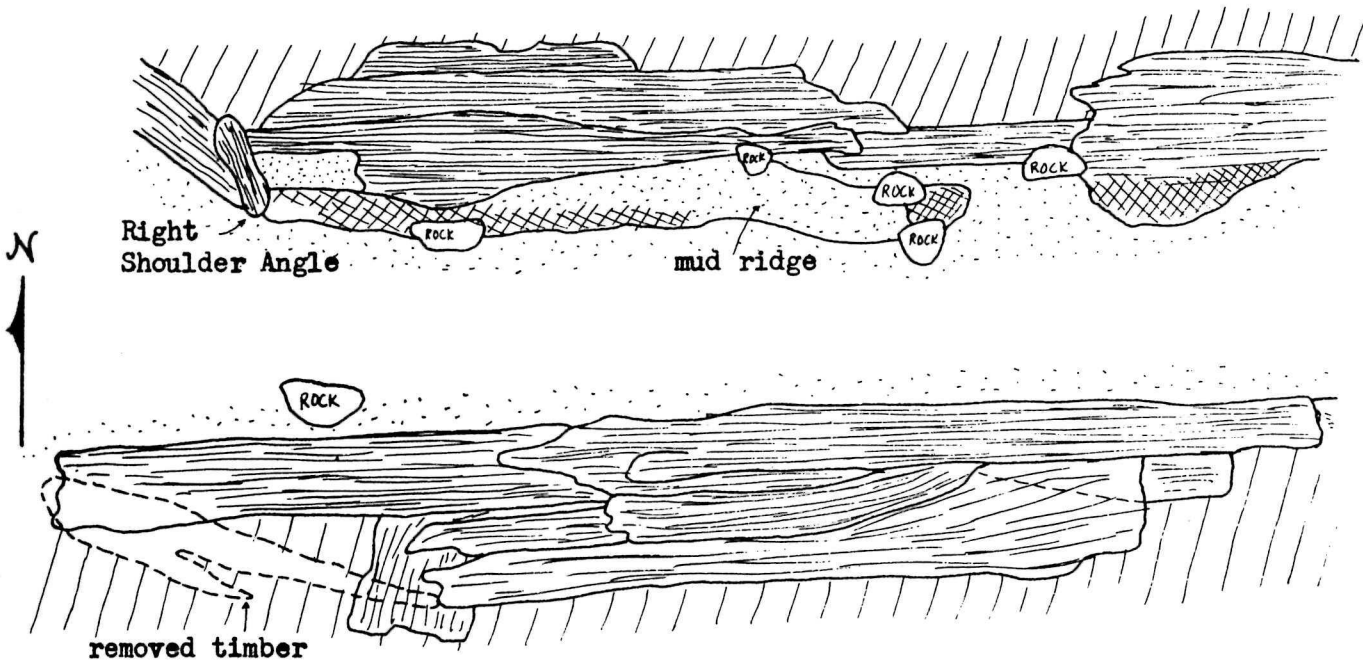
**FIG. 7. RIGHT AND LEFT FACE WALL TIMBERS PRIOR TO REMOVAL.**

Top illustration: right face wall timbers (2E13K6) plan view. Bottom illustration: plan view of left face wall timbers (2E13K4) with one timber removed. Neither drawing was made to scale. Dotted (stipled) areas indicate earth, crossed lines represent compressed wood chips and earth, wide diagonal lines indicate casemate floor area, close lines represent wood fibres.

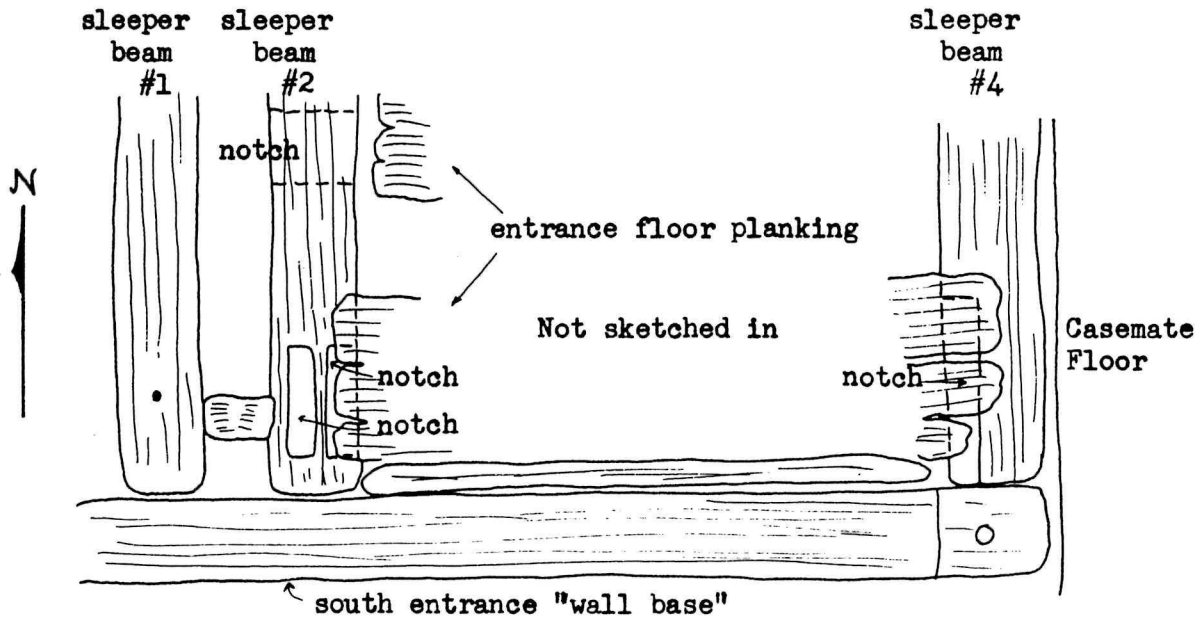
**FIG. 8. PLAN VIEW OF ENTRANCE, SOUTH SIDE.**

Figure illustrates the notching in the southern side of the wooden entrance. Open circle represents a dowel hole, full circle is a nail. Not to scale.

The wooden entrance measures 6.8 feet E-W and 6.0 feet N-S. It is located near the middle of the short west casemate wall. Nothing but a decayed floor or platform remains; there is little left of either wall or roof, if there was any to start with (Figs. 8, 12).

Four mortise notches other than those used with the posts are visible. Two are located in the second sleeper beam while there is one in both of the entrance wall timbers (Figs. 8, 12). All measurements read about 0.5 feet long and 0.15 feet wide. Broken off tenons remained inside the mortise notches so that no depth readings were available. An empty dowel hole (0.05 feet deep) was located in the middle of the south wall base timber, 0.33 feet from its eastern end.

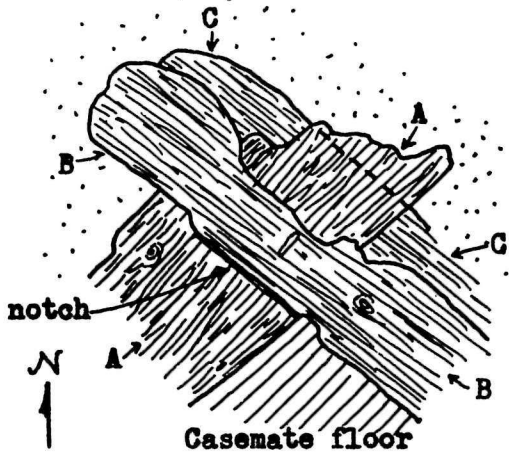
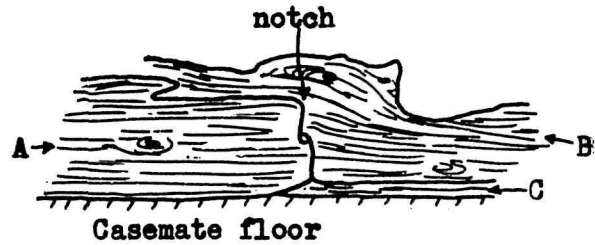
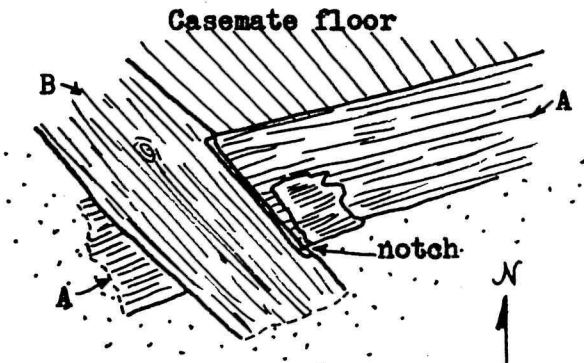
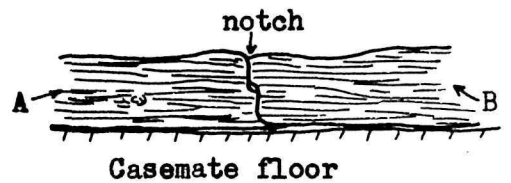
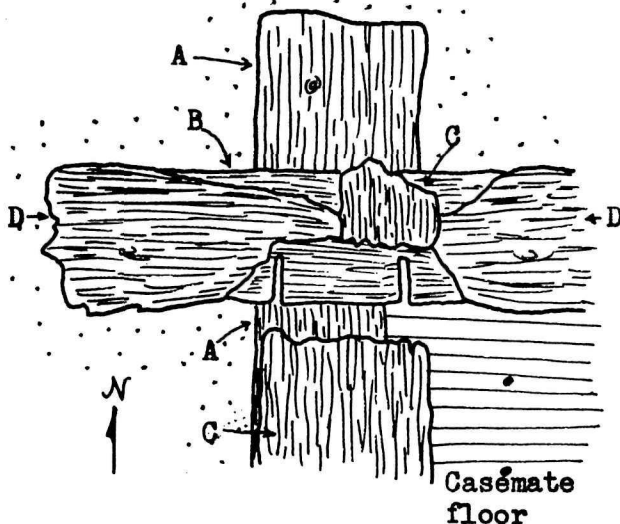
a. Plan view of left shoulder angle.

b. Side elevation of left shoulder angle, looking N.

c. Plan view of right shoulder angle.

d. Side elevation of right shoulder angle, looking S.

e. Plan view of left re-entrant angle.

**FIGURE 9. CROSS-HALVING JOINTS IN THE CASEMATE WALL TIMBERS.**

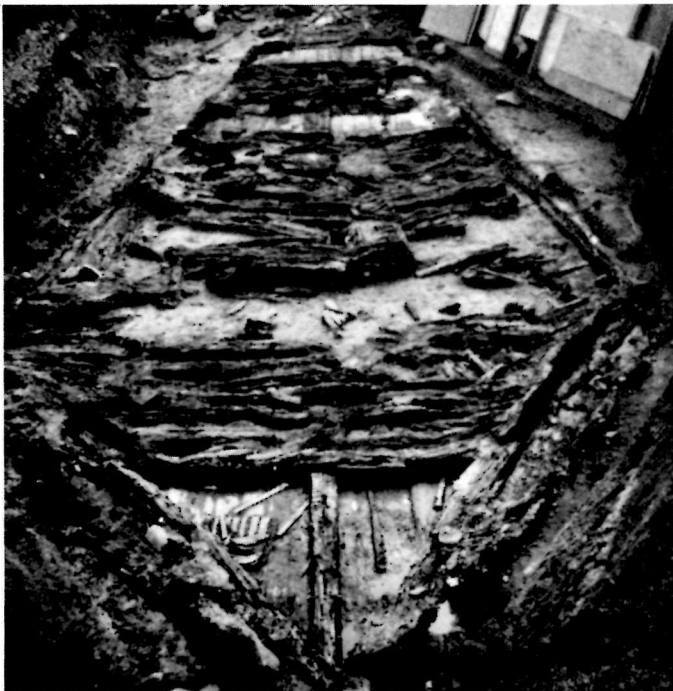
Fig. 10. Photograph of casemate roof after excavation, looking west.

The 1967 field season completed the roof excavation started in 1966. When fully exposed, it was apparent that the roof had been flat and NOT gabled as reported by Miss Coleman (1966). Nowhere were there indications of a pitched roof. No rafter timbers, which are characteristic of gabled roofs, were found nor was there any evidence of a center roof beam. Instead, a mass of rough logs were uncovered running north-south. They were unworked with only the branches trimmed off and no planks were visible. In some areas, noticeably between the two shoulder angles, the roofing remains were scarce for many of the roof timbers were missing while in other regions the logs were pressed together into a layer of wood fibre.

The most noticeable feature was the rough nature of the roof timbers. Many continued from one side of the casemate to the other with no break in the middle. Pitched roofs, even after collapse, display a crack or break in the roof timbers where the apex of the roof and the center roof beams (ridgepole) ran. Usually, two separate sets of timbers--one for each roof side--are used for pitched roofs but the excavated timbers did not have this dichotomy. It was quite evident that the original roof structure was flat and not gabled.

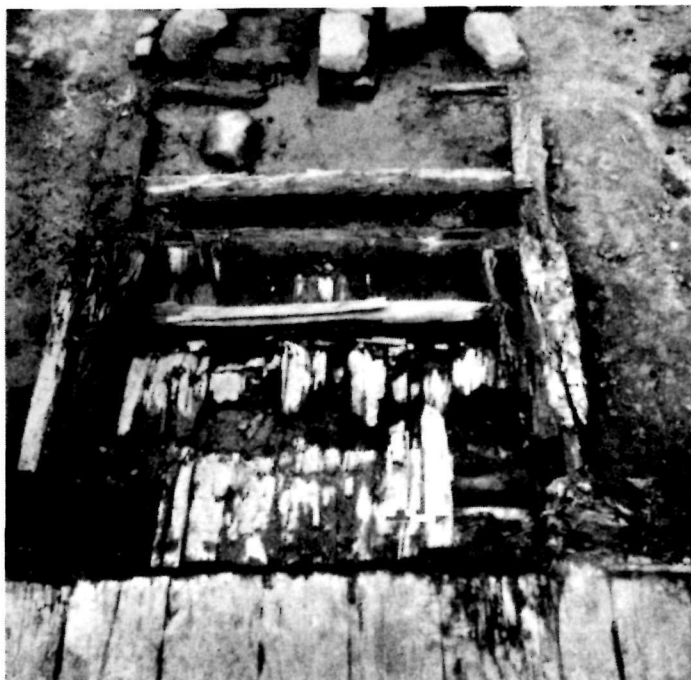
Fig. 11. Photograph of the stone drain and the wooden entrance, looking west.

(d) the casemate entrance: this section will include two different but related features. They are the wooden entrance proper which lies adjacent to the shortest side of the casemate and the stone drain which runs westward from the wooden entrance (Fig. 11).

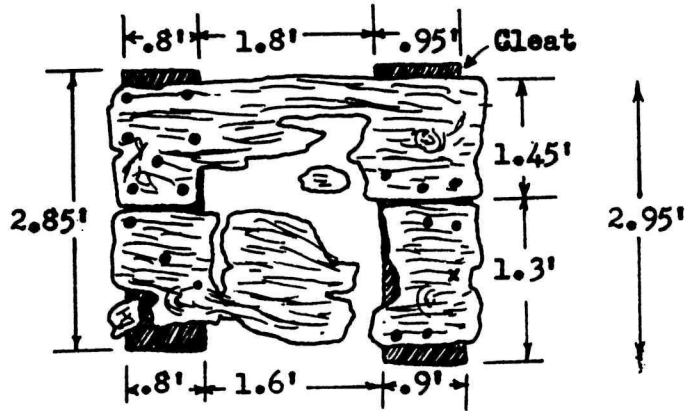
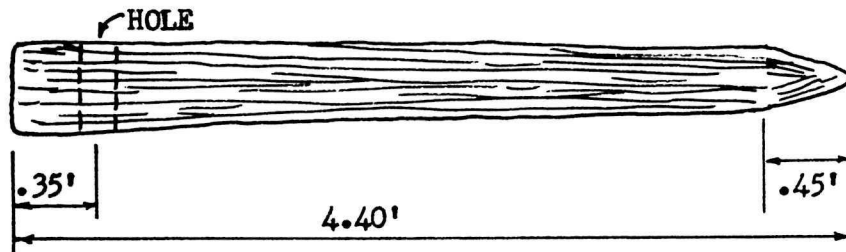
**FIGURE 13. THREE ARTIFACTS FROM THE CASEMATE, 2E13K.**

Top illustration: The possible door found near the left shoulder angle, plan view. Black dots represent nails; the "x" represents one nail which was found in the cleat only; the striped wood are the door cleats. Scale: 1" to 2'.

One of the possible tool "handles, which may be considered representative of all the "handles" uncovered, was measured. It was 2.65 feet long, 0.18 feet wide at its wide end, and 0.14 feet wide at the narrow end. The stick was not tapered; instead, it had a long slender shaft (0.14 feet thick) which suddenly widens into a thicker base. This was 0.6 feet long and 0.18 feet thick. A cross-section would reveal a roughly circular base and triangular shaft with the apex of this triangle located on the same side as the wider base (Fig. 13). These pieces of wood may have

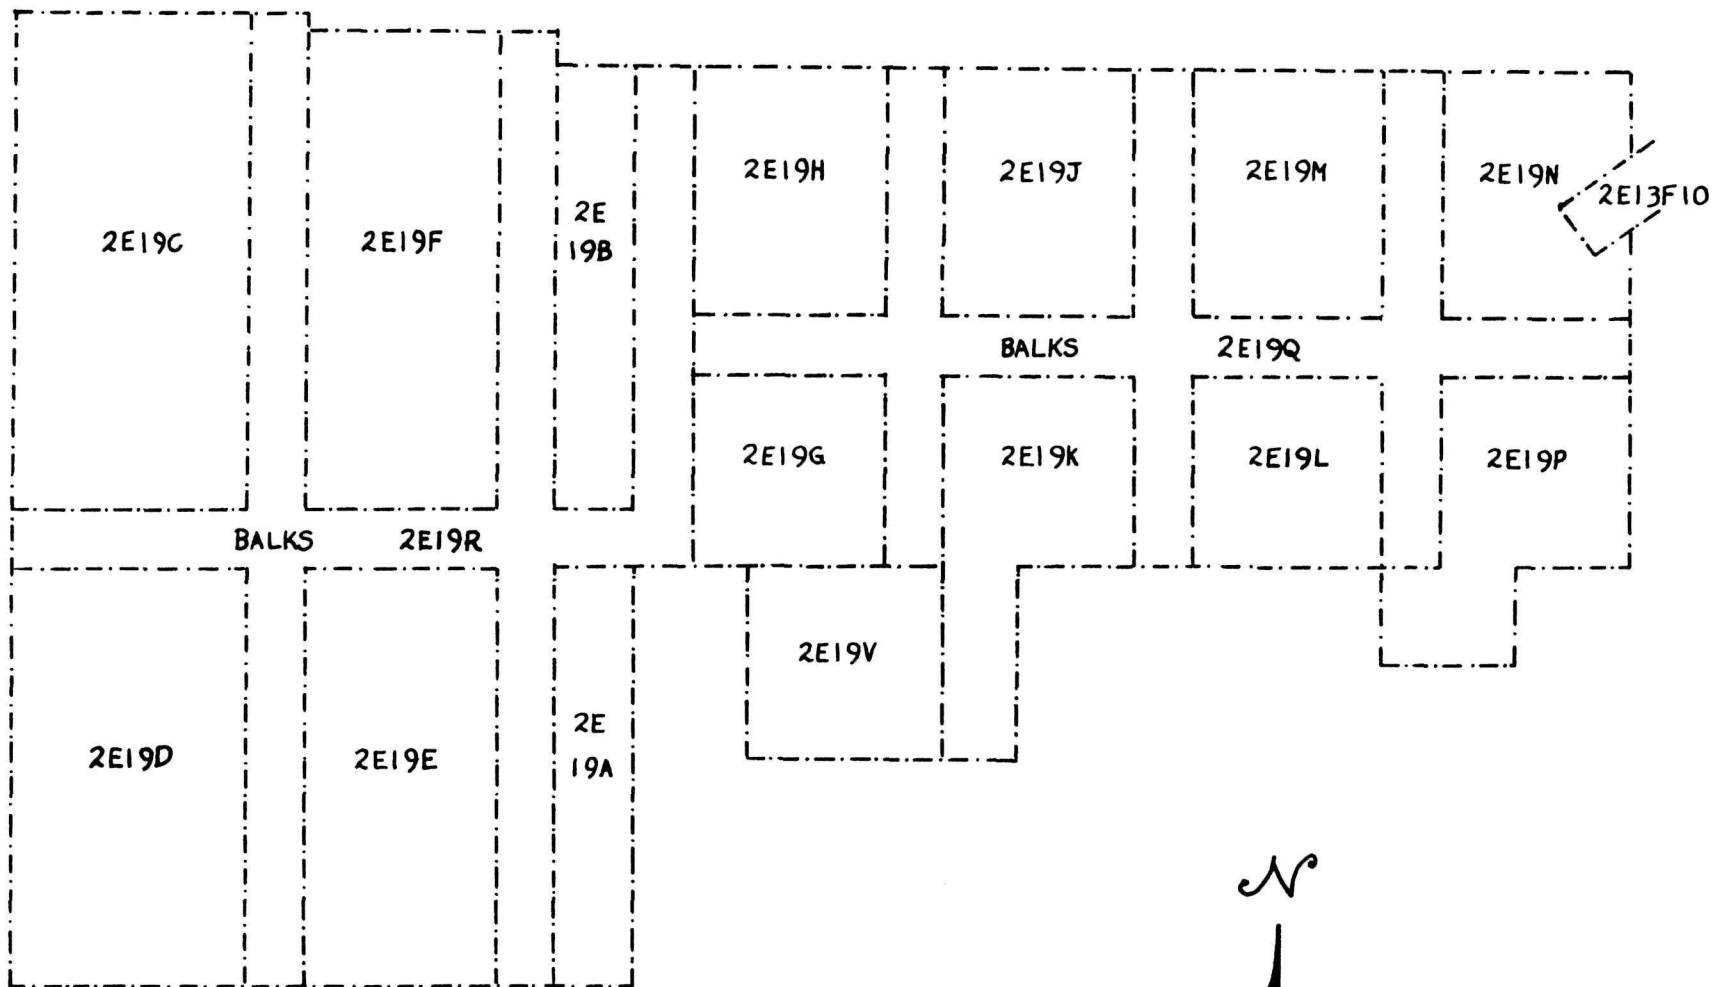
FIGURE 15. LOCATION OF TRENCHES IN OPERATION 19.

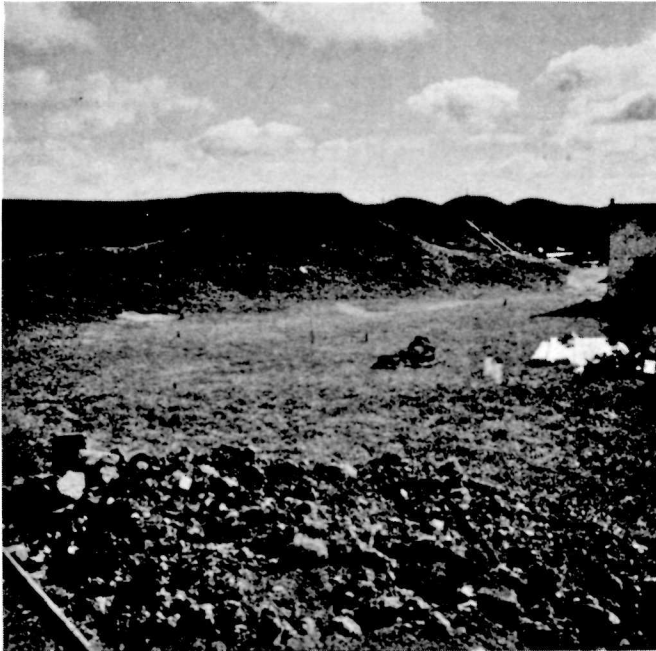
Fig. 16. Photograph of operation 2E19 before excavation, looking northeast. Operation 2E13 in right background.

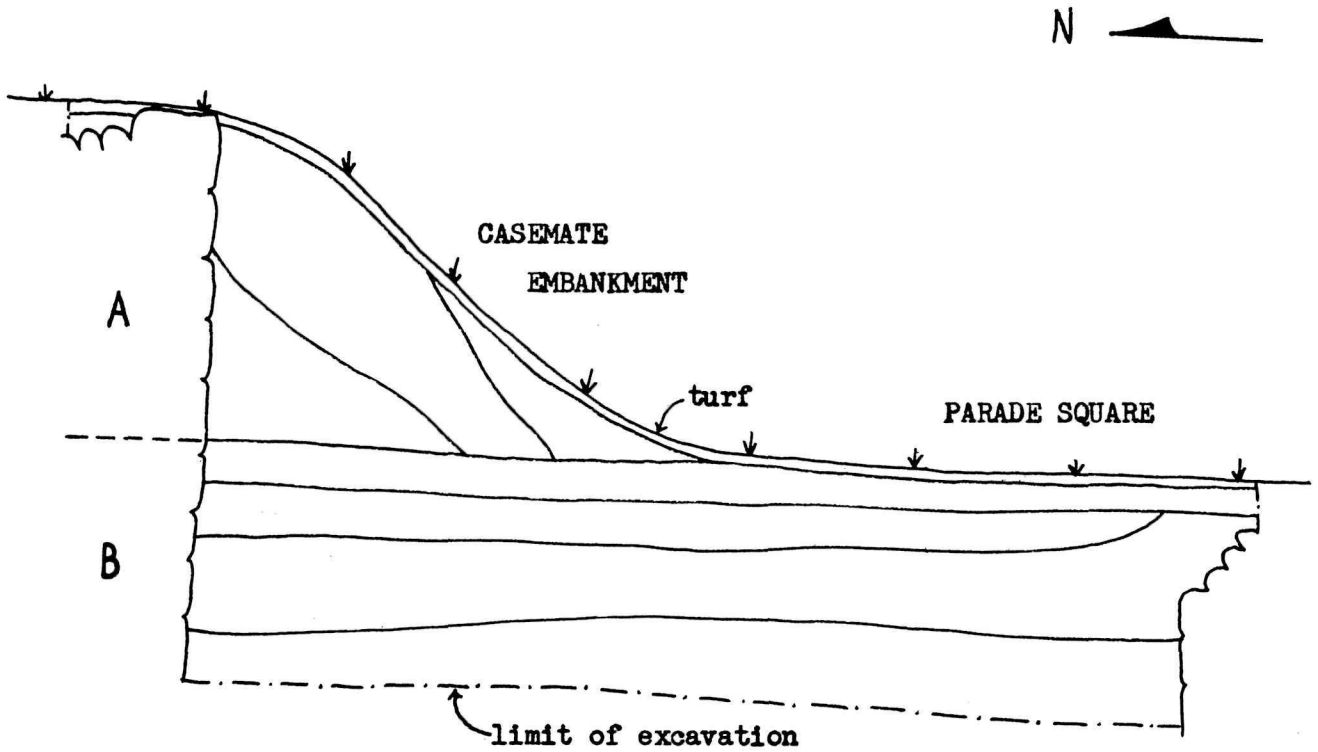
**FIGURE 18. IMAGINARY CROSS-SECTION THROUGH THE WIDTH OF OPERATION 2E19.**

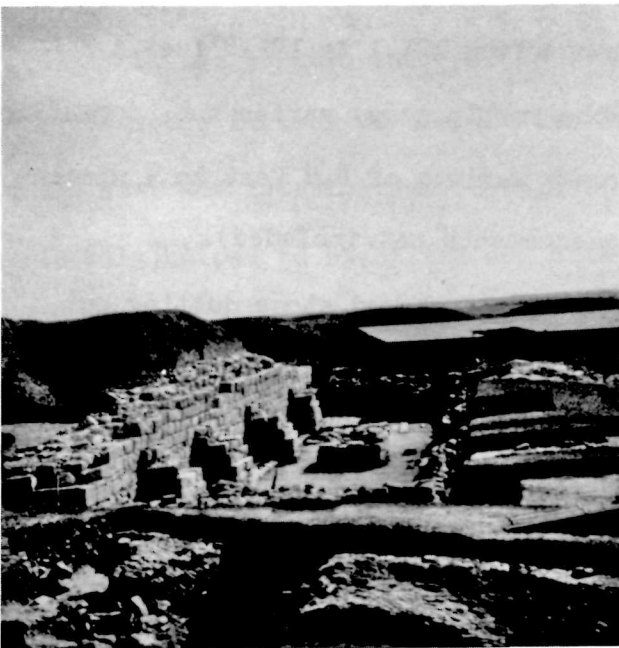
Fig. 19. Photograph of the North shaped stone wall, looking north. Note the four stone counterforts along south face of wall.

(b) North shaped stone wall: it is 79.7 feet long and is located approximately twenty feet to the north of the S. stone wall. This impressive wall, the longest and the highest in operation 19, consists of an interior face of shaped stone backed with a stone rubble core. The shaped stones are of various sizes but the majority of them are quite large, some being 2.5 feet long and one foot wide. Four bonded counterforts help support this massive wall; they will be discussed under heading number 2 entitled "counterforts".

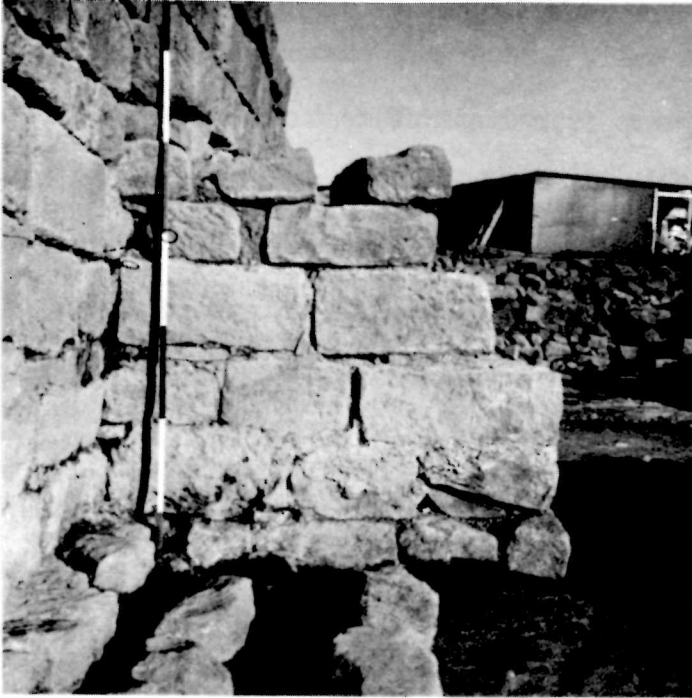
Fig. 20. Photograph of counterfort # 3, looking E .

feet (W) and 4.5 feet (E) and #4 is 3.5 feet (W) and 3.3 feet (E). No counterforts were, therefore, perfectly square, each feature being somewhat longer E-W than N-S. Counterfort #3 is the largest, #1 the smallest.

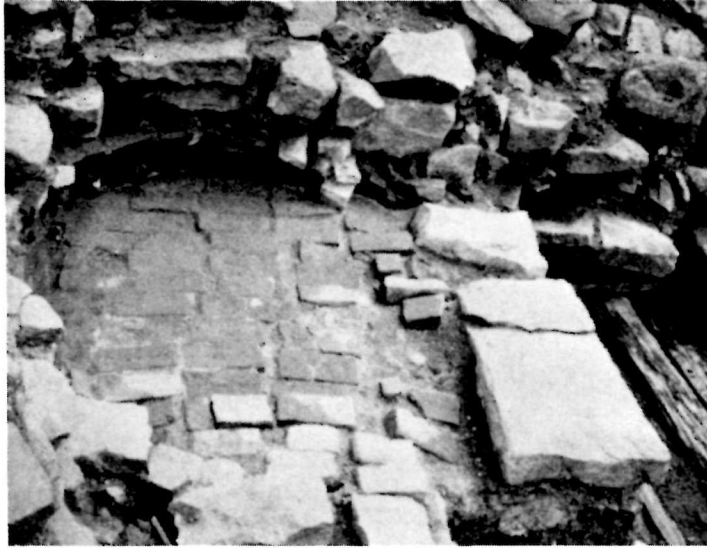
2E - 1299 - X

Fig. 1  
Brick floor and sides  
of oven, looking EAST

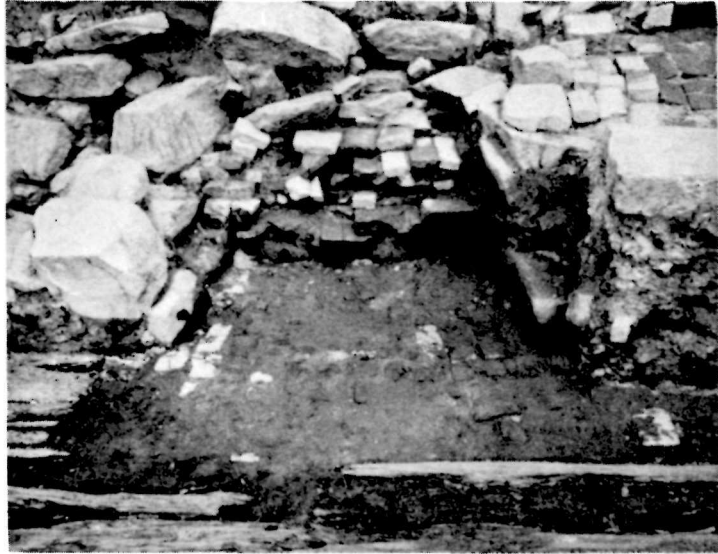
Fig. 2 -- Fireplace, facing north. Dots indicate base stones of the fireplace referred to in the text.

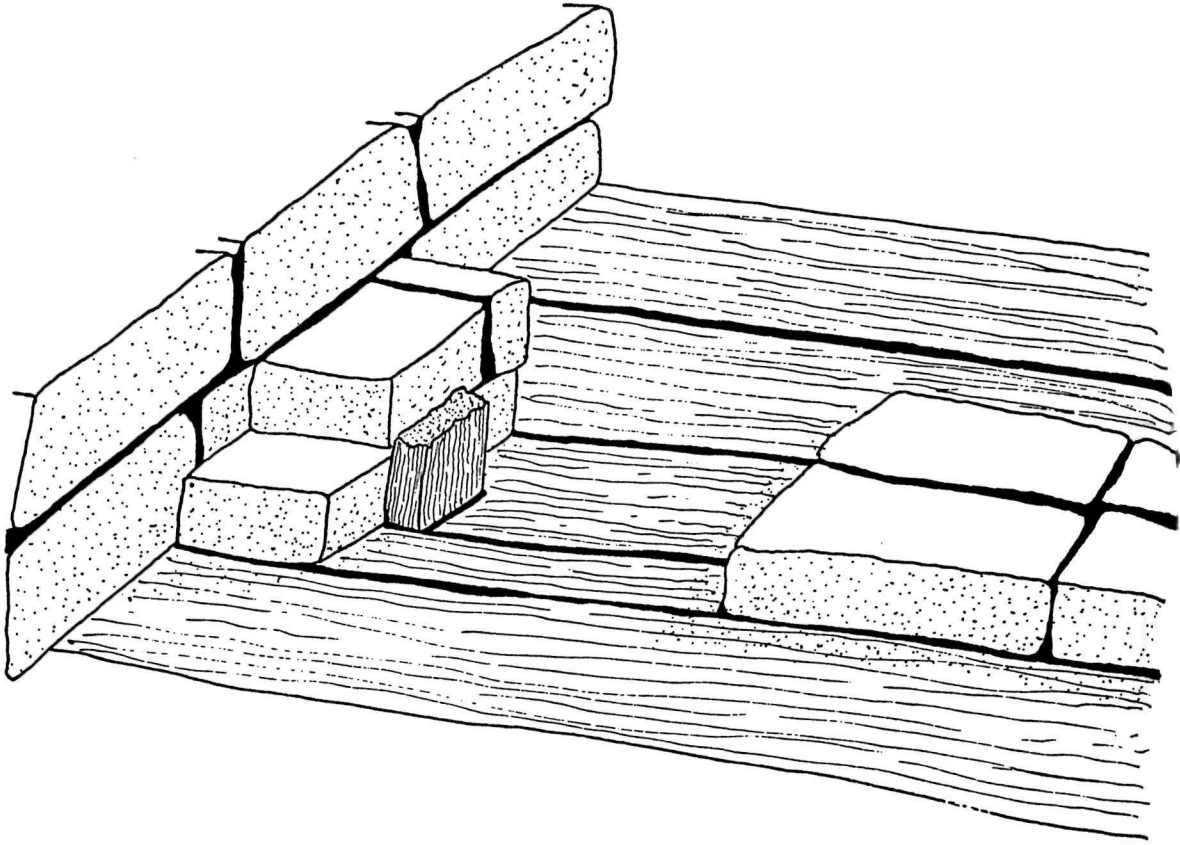
2E16 DOORWAY

DOOR 3 ALONE PRESENTED AN ADDITIONAL FEATURE. 2.6' EAST OF THE UPRIGHT WAS A RECTANGULAR MORTISE FOR A STUD MEASURING 0.35' EAST-WEST BY 0.25' NORTH-SOUTH. NO PART OF THE UPRIGHT BEAM REMAINED. THIS MAY HAVE BEEN THE LOCATION OF THE EAST HALF OF THE DOOR FRAME. HOWEVER, NO OTHER DOORWAY HAD THIS FEATURE.

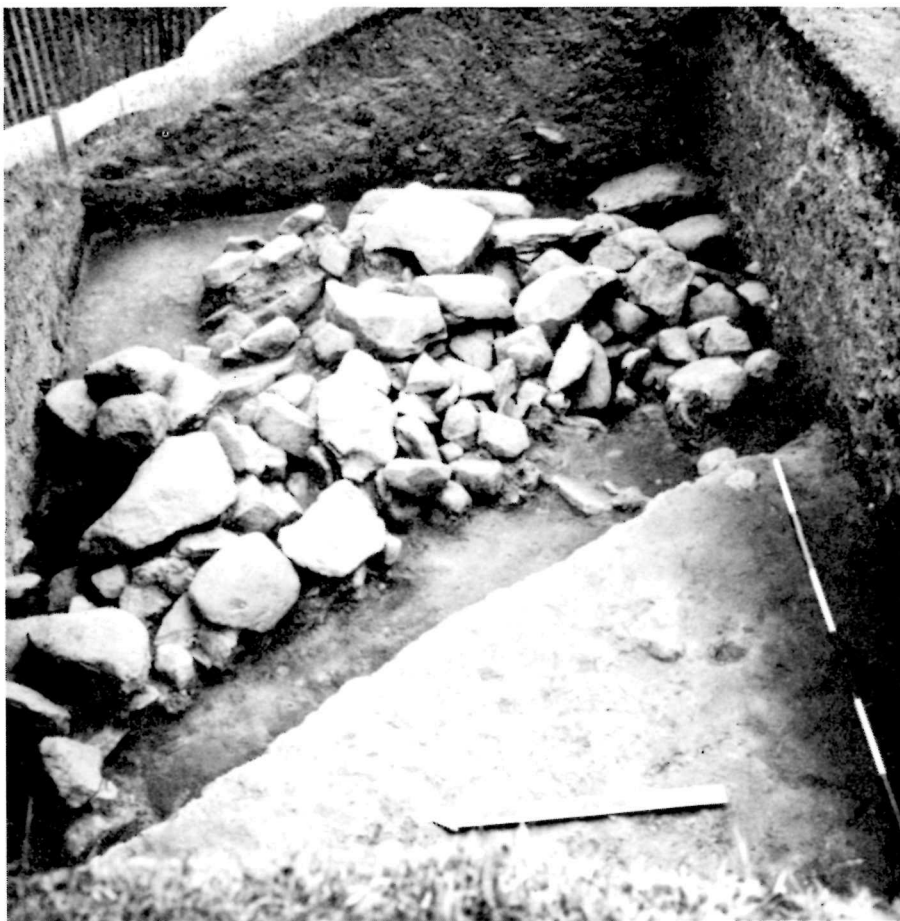
1

PLATE 1. (66 x 367). 2E13A. THIS IS A VIEW OF THE DRY RUBBLE REVETTING ON THE ESCARP OF PRINCE HENRY BASTION AT THE SALIENT ANGLE, LOOKING FROM THE PARAPET EAST TOWARDS THE DITCH. THE REVETMENT IS PARALLEL TO THE LEFT FACE OF THE BASTION. THE DARK REDDISH BROWN STRATUM WHICH CONTAINS THE STONES HAS BEEN REMOVED TO A GREATER DEPTH THAN THE REST OF THE FLOOR--THUS THE OBLIQUE LINE OF EXCAVATION IN THE MIDDLE OF THE PICTURE. NO ARTIFACTS WERE FOUND WITHIN THIS STRATUM. NOTE THAT THE STONES ARE NOT CUT OR LAID IN COURSES: THEY LOOK MORE LIKE FILL OR RUBBLE THAN LIKE A DELIBERATE WALL. PRESUMABLY THE REVETMENT WAS HASTILY BUILT.

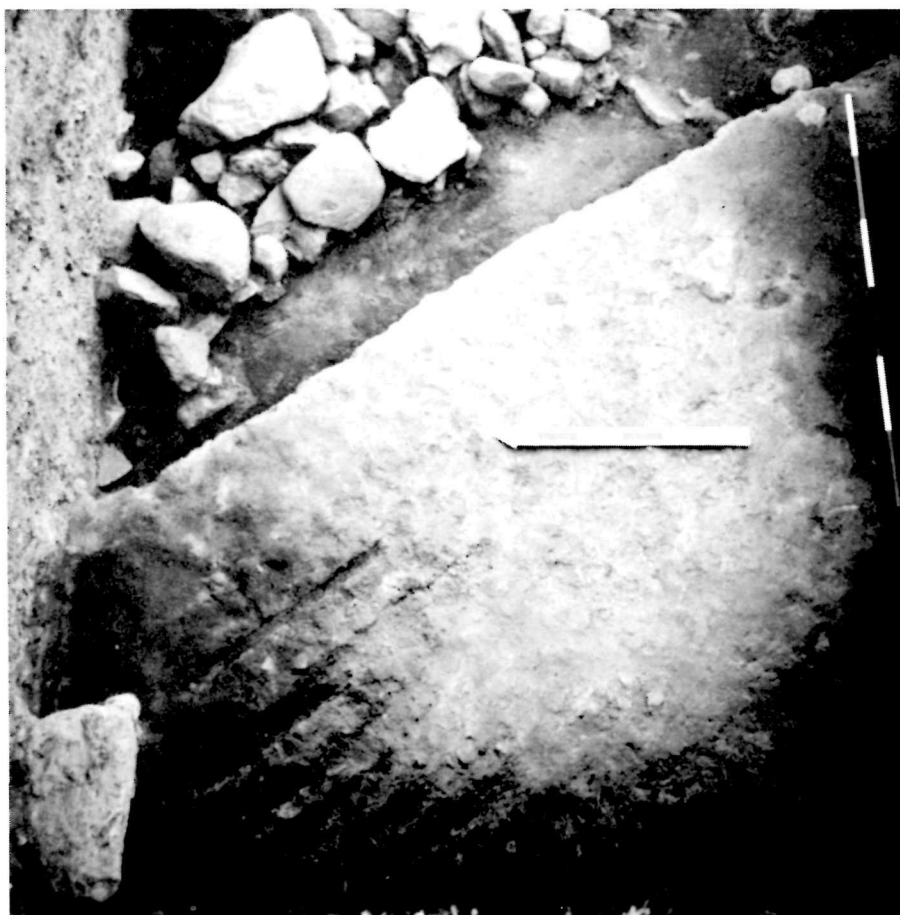
2

PLATE 2. (66 x 368). 2E13A. AGAIN, A VIEW FROM THE PARAPET OF PRINCE HENRY BASTION LOOKING EAST TOWARDS THE DITCH. THIS PHOTOGRAPH SHOWS THE PART OF THE SUB-OPERATION FLOOR WHICH IS CONCEALED IN PLATE 1. IN THE LOWER LEFT CORNER ARE SIX OF THE SEVEN HORIZONTAL POST HOLES MENTIONED IN THE TEXT: THEY ARE PARALLEL TO THE LEFT FACE OF THE BASTION, AND FORM ONE LAYER OF BONDING IN THE WOOD AND BEATEN EARTH STRUCTURE OF THE RAMPARTS. THE NORTH ARROW, WHICH IS THREE FEET LONG, SERVES AS A SCALE FOR THEM.

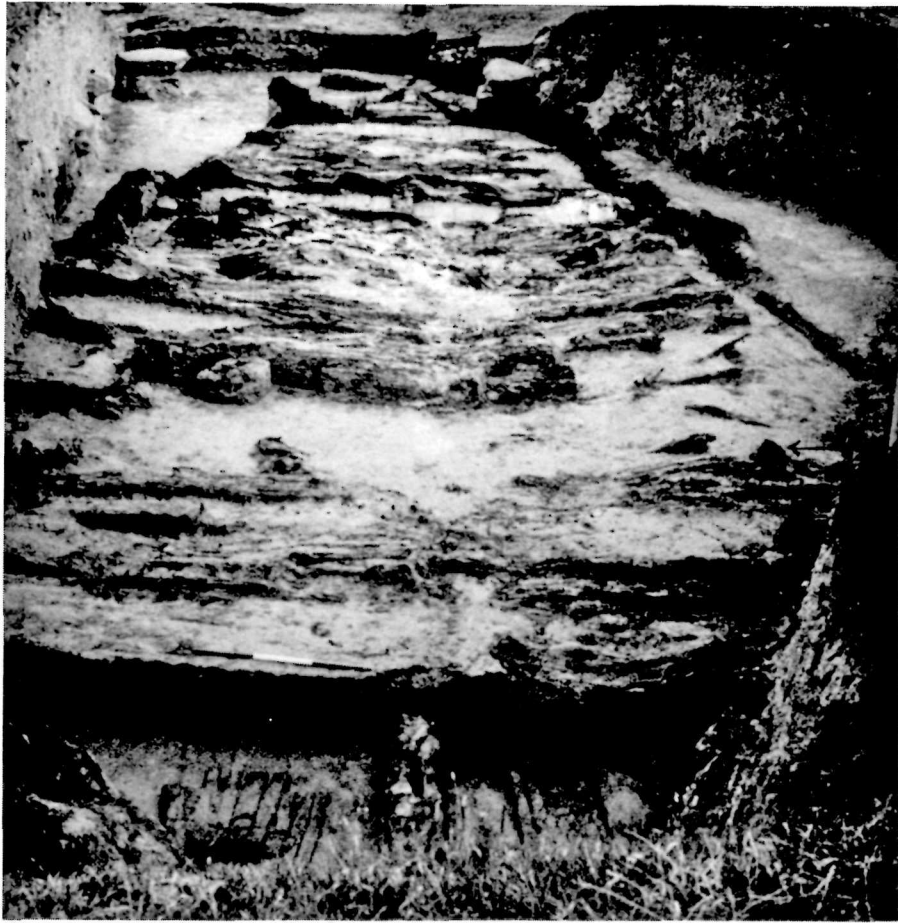
3

PLATE 3. (66 x 1058). 2E13K. THIS IS A TOTAL VIEW OF THE FRENCH CASEMATE IN PRINCE HENRY BASTION, FROM THE PARAPET LOOKING WEST TOWARDS THE PARADE SQUARE. MOST OF THE WOOD VISIBLE IS COLLAPSED ROOF: NOTE THAT, ALONG THE EDGES, VESTIGIAL SIGNS OF WALLS REMAIN. ALSO, IN THE RIGHT CENTER OF THE PICTURE, TWO OF THE THREE REMAINING UPRIGHTS ARE VISIBLE (INDICATED BY ARROWS).

THREE TRENCHES EXPOSING THE FLOOR CAN BE SEEN: IN THE FOREGROUND, WITH THE CENTER ROOF BEAM AND A COLLAPSED BARREL; IN THE MIDDLE BACKGROUND, WITH AN ANVIL, TWO BARRELS OF "FLUX", AND THE CENTER ROOF BEAM; AND BEFORE THE ENTRANCE IN THE BACKGROUND.

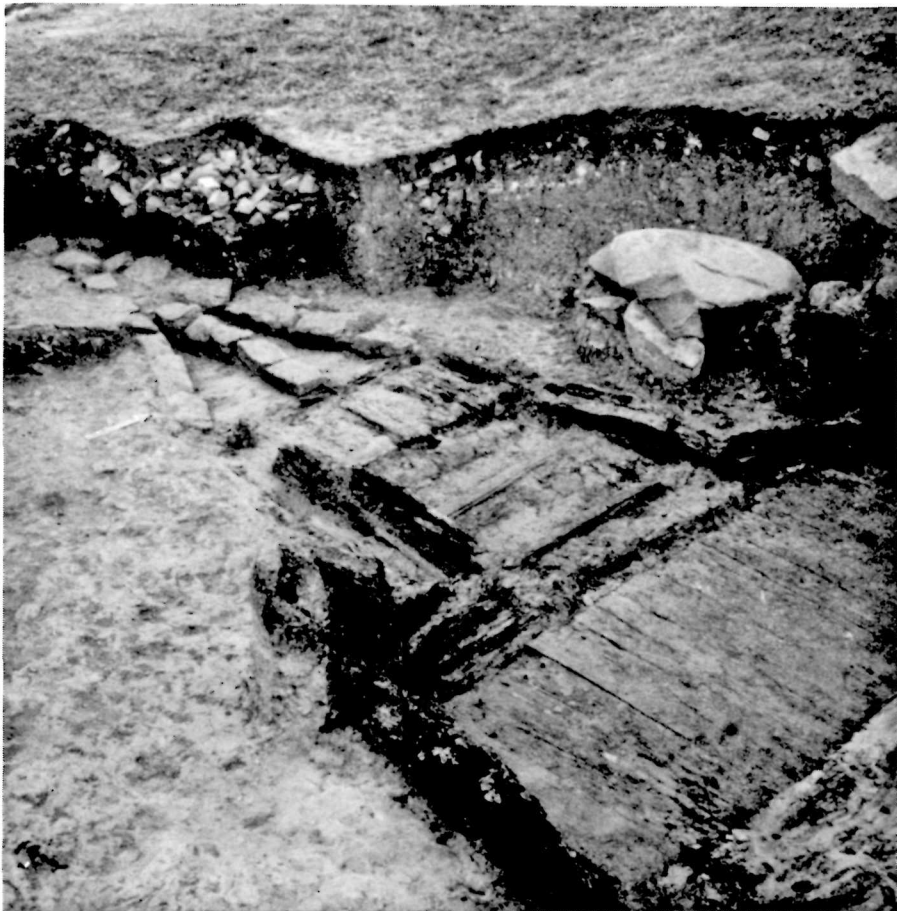
4

PLATE 4. (66 x 1059). 2E13K. HERE WE HAVE A DETAIL OF THE ENTRANCE TO THE FRENCH CASEMATE, LOOKING NORTHWEST FROM THE TERREPLEIN OF PRINCE HENRY BASTION. NOTE THE EXPOSED FLOOR OF THE CASEMATE, WITH ITS WELL-PRESERVED BOARDS AND NAILS, THE BEAM AND [NOW DISINTEGRATED] BOARD CONSTRUCTION OF THE ENTRANCE, AND THE PECULIAR STONE STRUCTURE LEADING AWAY FROM THE ENTRANCE. THE CENTER BEAM OF THE ROOF WAS NOT FOUND ON THE FLOOR AT THIS END OF THE BUILDING. BRICK RUBBLE IS SEEN IN THE UPPER LEFT CORNER OF THE PHOTOGRAPH.

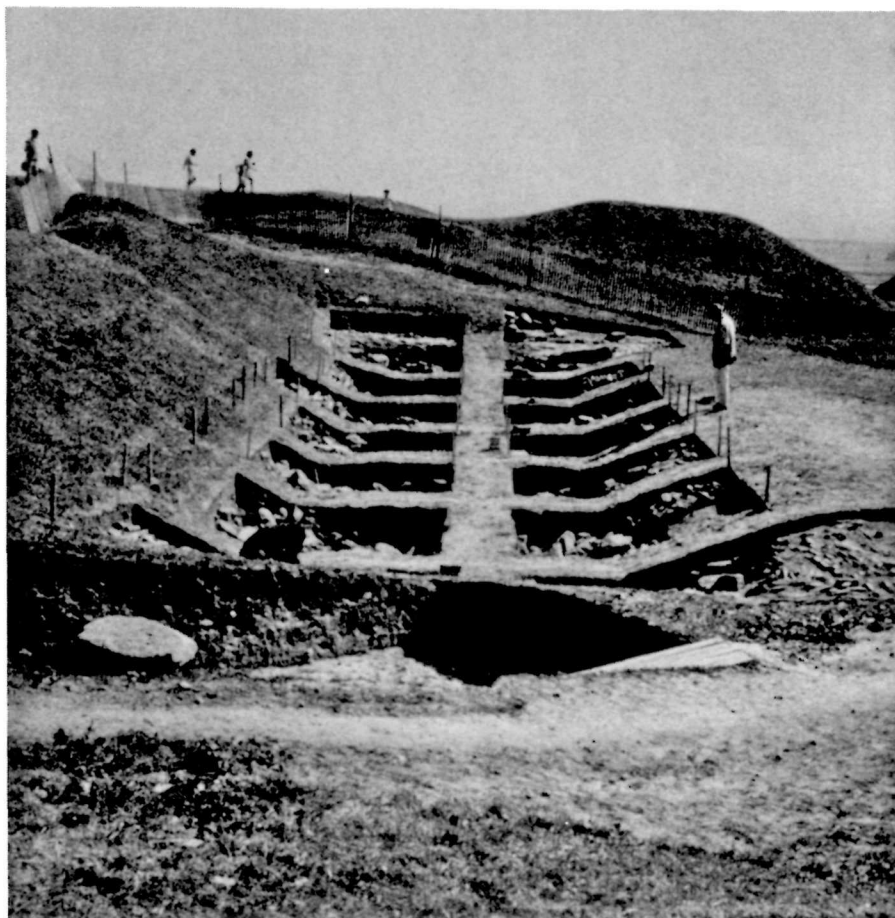
5

PLATE 5. (66 x 849). 2E16. THIS VIEW, LOOKING SOUTH FROM PRINCE HENRY BASTION, SHOWS THE MEN'S BARRACKS NEAR THE MIDDLE OF EXCAVATION. THE 14 MAIN TRENCHES (SUB-OPERATIONS 2E16A TO 2E16P) HAVE BEEN OPENED, AND NO BALKS HAVE YET BEEN REMOVED. BEFORE COMPLETION, THE TRENCHES ON THE RIGHT WERE EXTENDED FOUR FEET WEST TO EXPOSE THE BRICKS, AND THOSE ON THE LEFT WERE EXTENDED THREE FEET EAST FOR THE SAME PURPOSE.

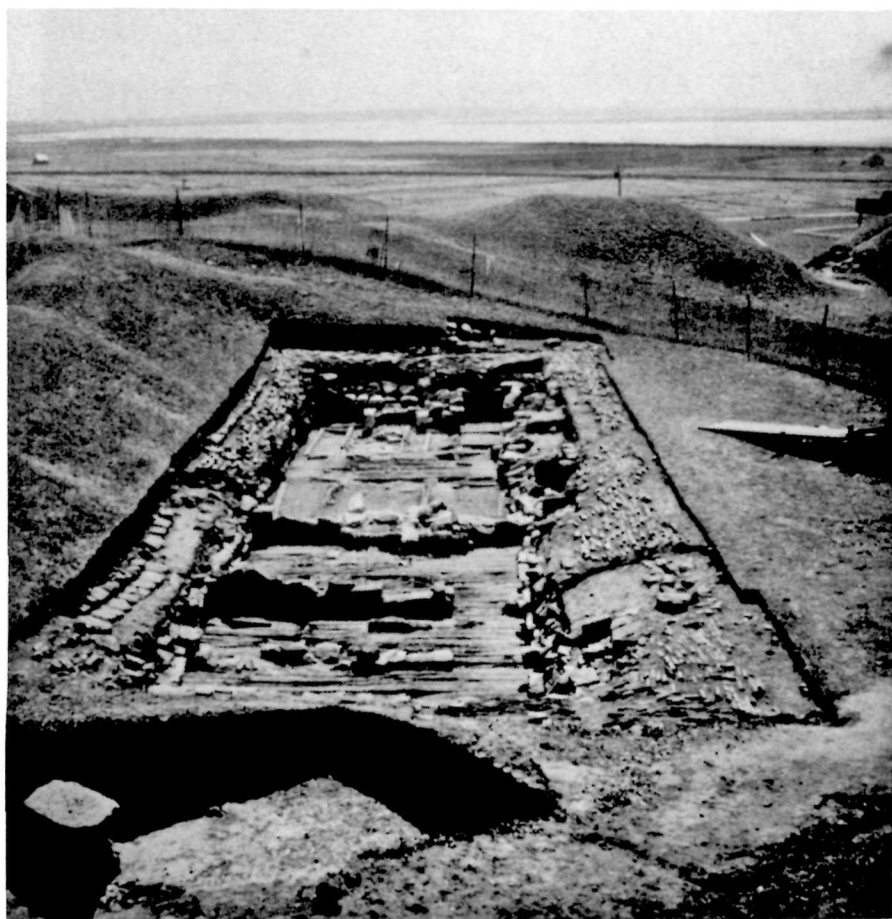
6

PLATE 6. (66 x 1043). 2E16. THE SAME VIEW AS PLATE 5, THIS PICTURE WAS TAKEN WHEN EXCAVATION IN THE MEN'S BARRACKS WAS COMPLETED BUT FOR THE TRACING OF THE DRAIN AT THE SOUTHWEST CORNER, AND THE CUT THROUGH THE FLOOR.

NOTE THE BRICK WALK, THE STONE REVETMENT ON THE LEFT, THE PARTITIONS, DOORWAYS (ON THE RIGHT), WINDOWS (ALSO ON THE RIGHT), AND TWO FIREPLACES--CENTRAL AND SOUTHERN.

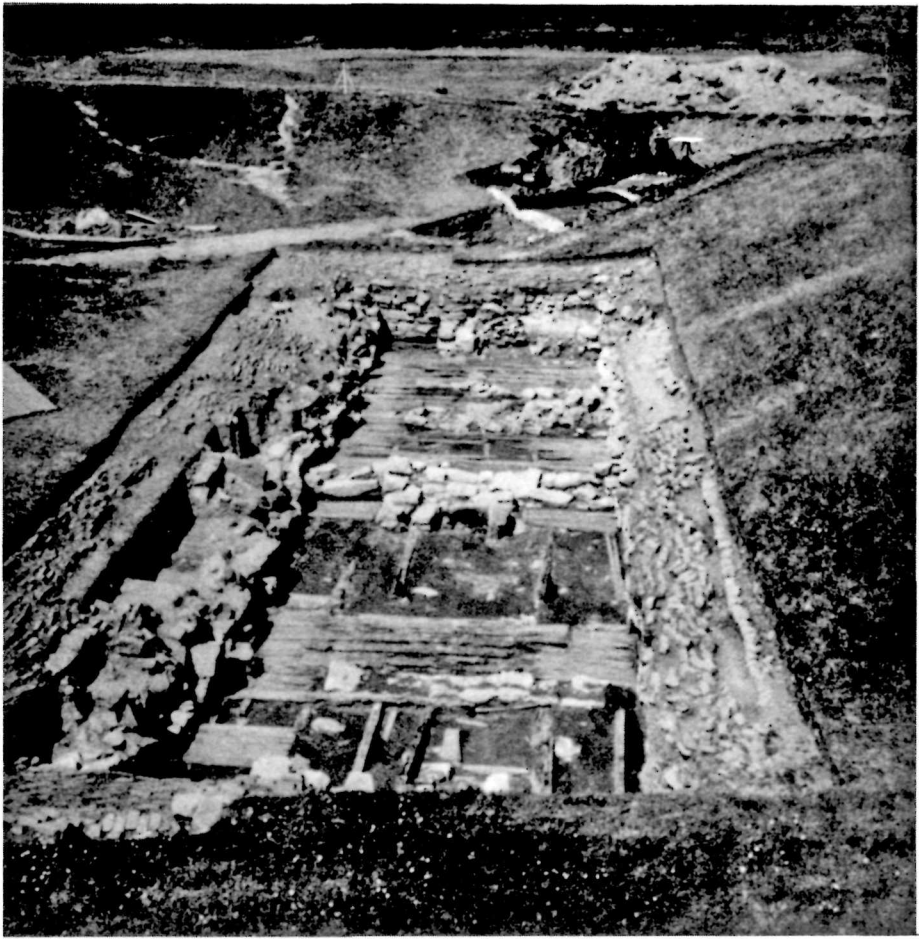
7

PLATE 7. (66 x 1045). 2E16. THIS WAS TAKEN AT THE SAME TIME AS PLATE 6, BUT LOOKS NORTH TO THE MEN'S BARRACKS FROM PRINCE FREDERICK BASTION. THE SAME FEATURES ARE VISIBLE, EXCEPT THAT THIS VIEW SHOWS THE NORTH FIREPLACE AND OVEN AS WELL.
