NATIONAL HISTORIC PARKS AND SITES BRANCH

MANUSCRIPT REPORT NUMBER 145

REPORT ON THE EXCAVATIONS OF OPERATIONS  
2E13 AND 2E19 AT FORT BEAUSEJOUR

Report on the Excavations of Operations 2E13  
and 2E19 at Fort Beauséjour, N.B., 1967.

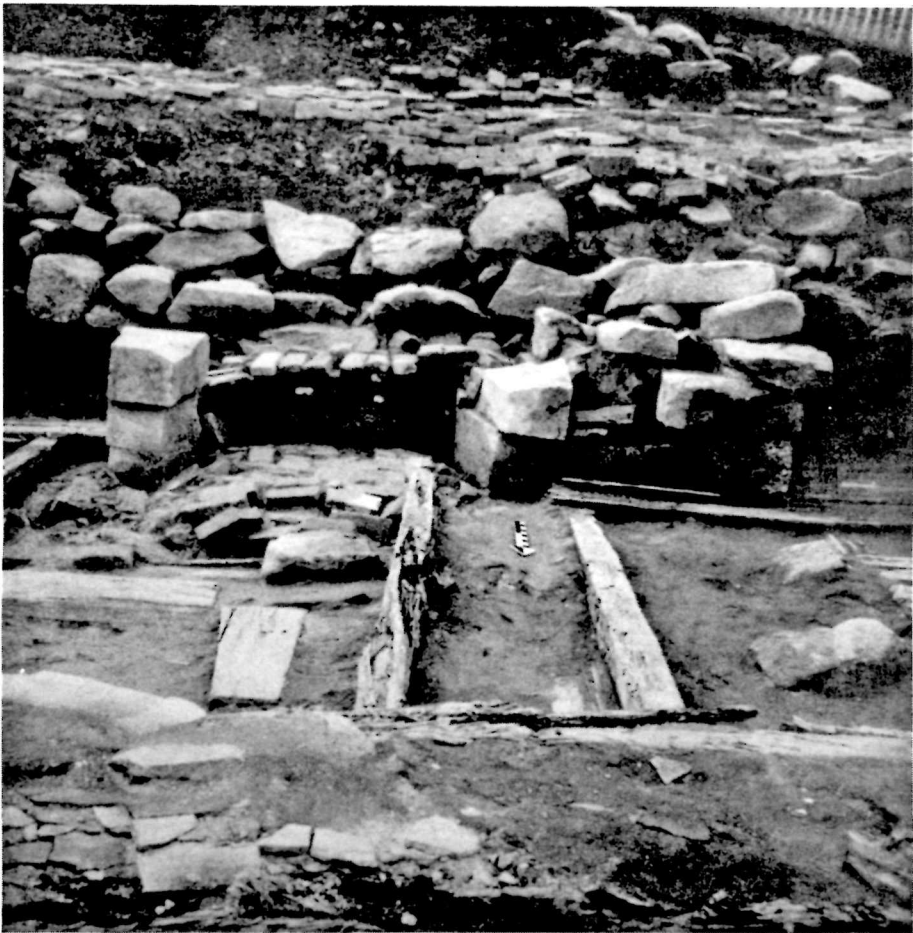
8

PLATE 8. (66 x 1018). 2E16. A CLOSE-UP OF THE SOUTH FIREPLACE (#4) OF THE MEN'S BARRACKS. IT SHOWS THE BACK AND FLOOR OF THE HEARTH, THE CUT STONE SIDES, THE WIDE WEST WALL OF THE FIREPLACE, AND THE RELATIONSHIP BETWEEN THE HEARTH AND THE WOODEN BASEMENT FLOOR.

THE SOUTH FIREPLACE CONSISTS OF A BRICK HEARTH (#4) AND BRICK OVER STONE BACK, EDGED BY TRAPEZOIDAL CUT STONES [SEE PLATE 8, APPENDIX I]. AGAINST THE FRONT, OUT OF PLACE, WAS FOUND A LARGE CUT STONE ENGRAVED:

THE BACK AT PRESENT CONSISTS OF ONE COURSE OF STONES 0.6' HIGH, TOPPED BY THREE TO FIVE COURSES OF BRICKS SET FOR THE MOST PART END-ON, FACE DOWN. EACH COURSE OVERLAPS THAT BELOW IT, YIELDING AN INWARD SLANT LEADING TO THE DEFUNCT FLUE WHICH WOULD HAVE BEEN ROUGHLY OVER THE CENTER OF THE FIREBOX. MORTAR REMAINS BETWEEN THE BRICKS AND STONES (UNLIKE THE FLOOR, WHERE MORTAR HAS DISINTEGRATED), AND SOME BRICKS RETAIN SLIGHT TRACES OF BURNING.

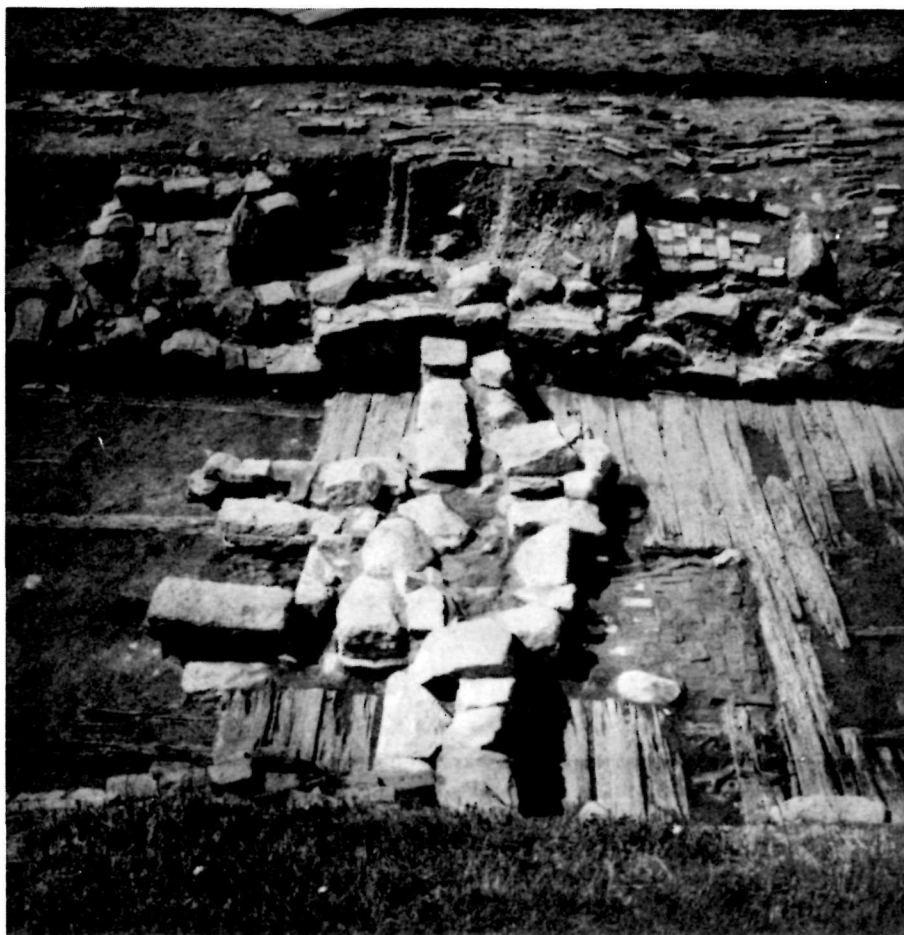
PLATE 9. (66 x 1041). 2E16. THIS PHOTOGRAPH LOOKS WEST TO THE CENTRAL FIREPLACE OF THE MEN'S BARRACKS. BOTH HEARTHS ARE VISIBLE, AS IS THE DOORLESS CENTRAL PARTITION DIVIDING THE TWO MAIN PORTIONS OF THE BASEMENT.

THE CENTRAL FIREPLACE IS NOT NEARLY AS WELL PRESERVED AS THE SOUTH ONE. ONLY ONE GOOD COURSE OF STONES REMAINS IN THE BODY OF THE STRUCTURE, AND THE WALLS OF BOTH HEARTHS HAVE BEEN VIRTUALLY REMOVED TO FLOOR LEVEL. THE FIREPLACE IS A 7.8' SQUARE ENLARGEMENT IN THE MIDDLE OF THE CENTRAL PARTITION [SEE DRAWING 7, APPENDIX II, AND PLATE 9, APPENDIX I]. VIRTUALLY NONE OF THE STONES FORMING IT ARE CUT, BUT MUCH MORTAR REMAINS AMONG THEM.

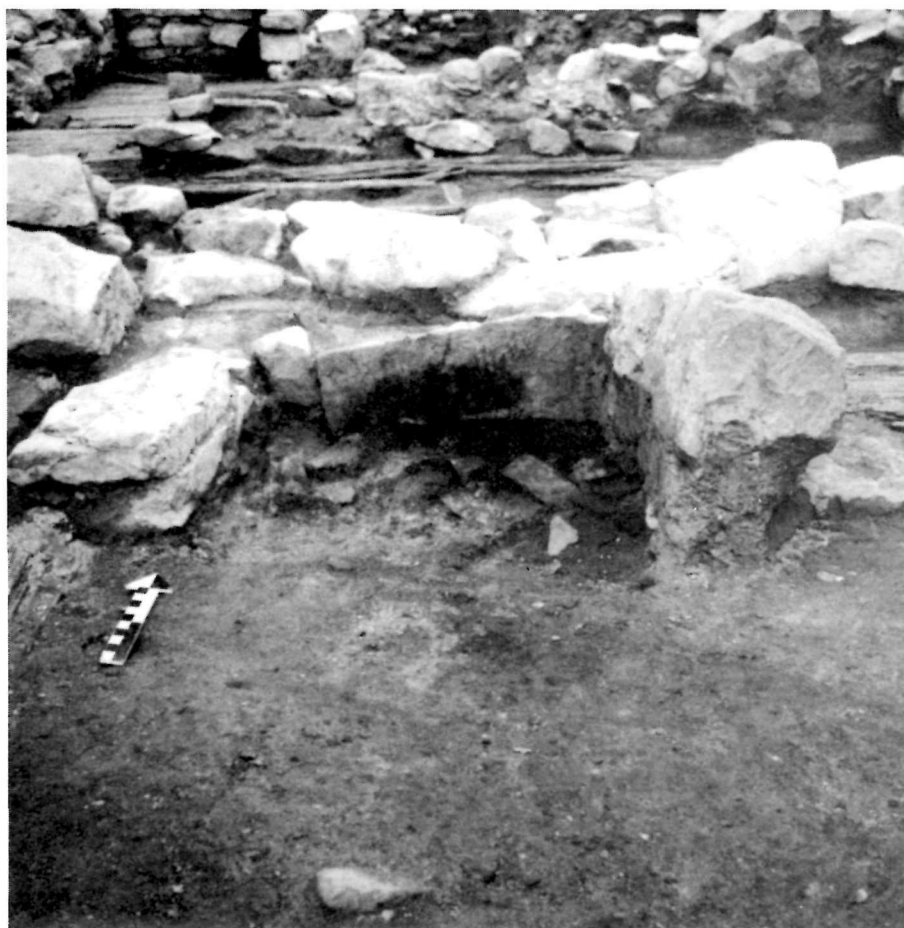
PLATE 10. (66 x 1016). 2E16. A CLOSE-UP OF THE SOUTH HEARTH (#3) OF THE CENTRAL FIREPLACE OF THE MEN'S BARRACKS. THIS HEARTH IS EXTREMELY POORLY PRESERVED. IT HAS NO FLOOR (THE BRICKS IN THE PHOTOGRAPH ARE APPARENTLY CHIMNEY RUBBLE), AND THE STONES ARE NOT WELL CUT. THE SIDE STONE ON THE RIGHT HAS SLIPPED OUT OF PLACE, AND SHOULD BE RESTING ON THE FLAT STONE BESIDE IT.

THE BACK OF THE HEARTH SHOWS MORE EVIDENCE OF BURNING THAN ANY OTHER HEARTH IN THE BARRACKS.

THE SOUTH HEARTH OF THE CENTRAL FIREPLACE (HEARTH 3) IS ANOTHER MATTER, ALMOST COMPLETELY DIFFERENT FROM HEARTHS 1, 2 AND 4. IT IS BADLY PRESERVED, AND IN FACT APPEARS TO HAVE BEEN POORLY BUILT. NONE OF ITS STONES--NOT EVEN THE SIDE WALLS--ARE CUT, AND IF IT EVER HAD A BRICK FLOOR, THE ONLY TRACE OF IT IS ROUGH, RANDOM BRICK RUBBLE EMBEDDED IN THE EARTH [SEE PLATE 10, APPENDIX 1].

THE TOP STONE THAT REMAINS OF THE EAST SIDE HAS MOVED INTO THE FIREBOX: PLATE 10 SHOWS THIS IN ITS DISTURBED POSITION, THOUGH IT SHOULD REST DIRECTLY ON THE STONE SEEN IMMEDIATELY EAST OF IT AT A LOWER ELEVATION. SIMILARLY, ALL TRACES OF WOOD FLOOR NEAR IT HAVE DISAPPEARED, BUT FOR ONE SLEEPER BEAM. I CANNOT EXPLAIN WHY THIS HEARTH ALONE SHOULD HAVE BEEN FOUND IN SUCH A BAD STATE OF REPAIR, OR WHY IT SHOULD APPEAR TO HAVE BEEN BUILT LESS CAREFULLY THAN THE OTHER THREE.

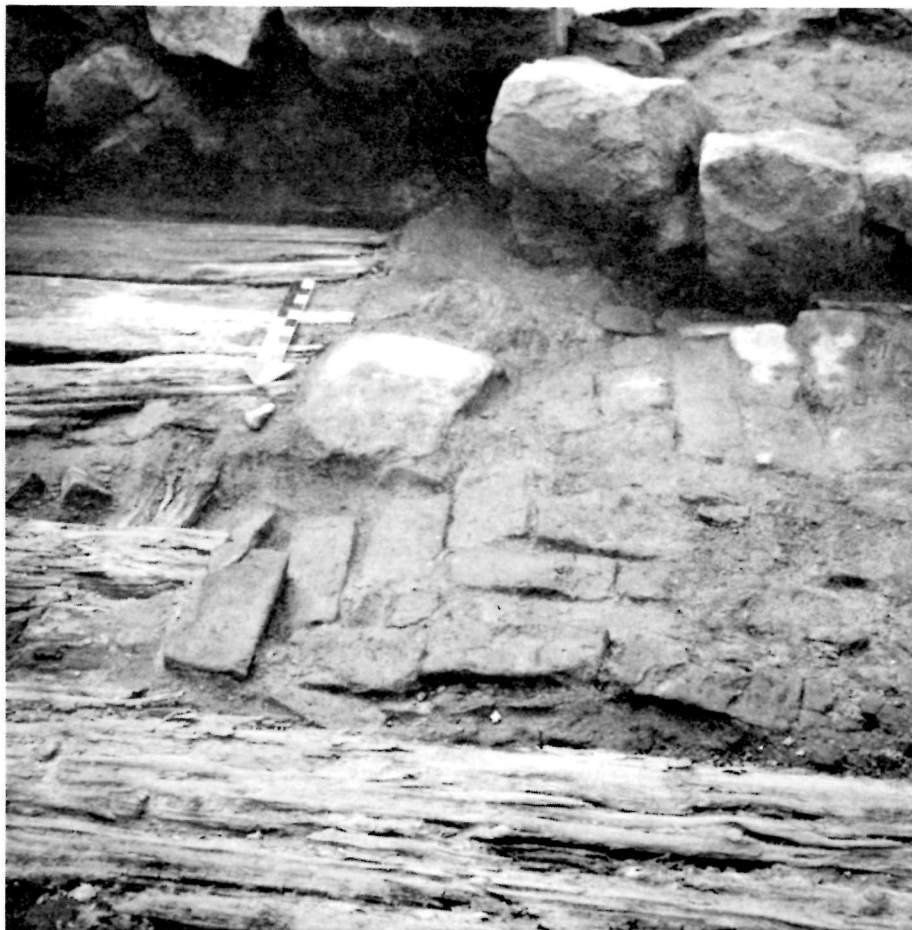
12

PLATE 12. (66 x 1014). 2E16. THIS IS A DETAIL OF THE BRICK FLOOR OF THE NORTH HEARTH OF THE CENTRAL FIREPLACE (NORTHEAST CORNER--SEE PLATE 11). THE BRICKS INTERLOCK TO FORM A CORNER.

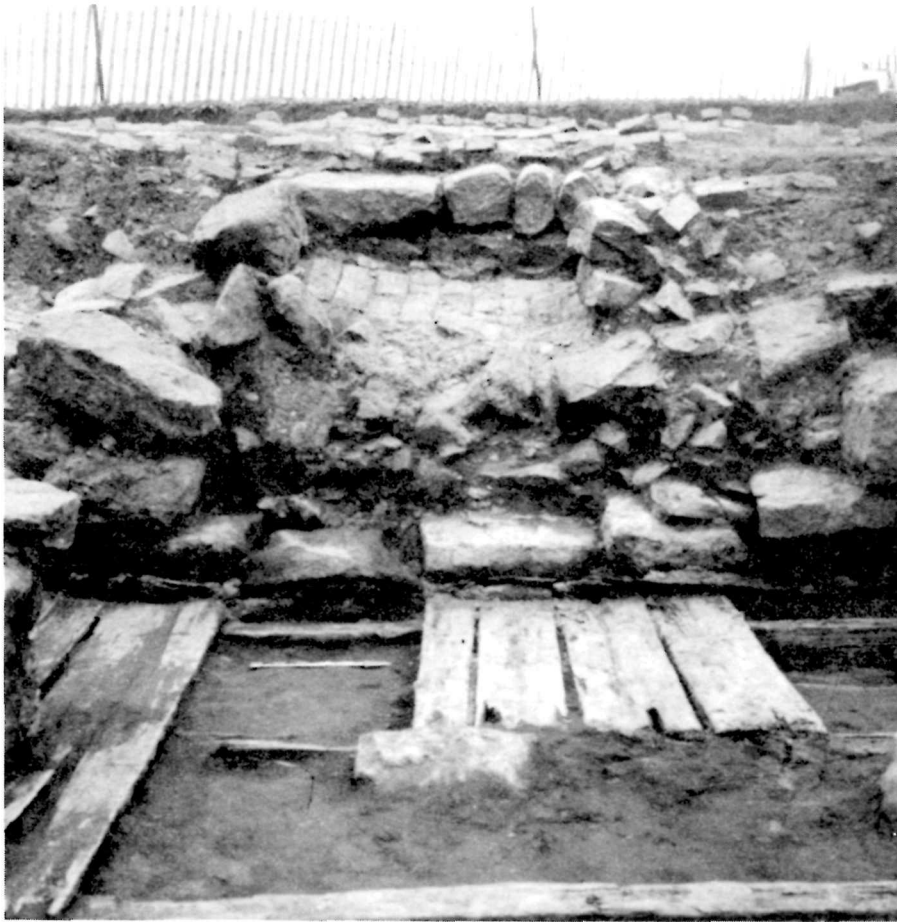
13

PLATE 13. (66 x 1021). 2E16. A WINDOW. (THIS PARTICULAR ONE IS WINDOW 4.) NOTE THE SLOPING BRICK FLOOR, THE COURSED STONE SIDES, AND THE WAY THE BUILDING WALL APPEARS TO HAVE BEEN SQUARED OFF AROUND THE WINDOW.

ON THE WEST SIDE OF THE BARRACKS, JUST BELOW THE PRESENT SOD LEVEL, ARE FOUR "WINDOWS". THESE ARE SQUARE BOX-LIKE STRUCTURES WITH STONE SIDES AND INWARD SLOPING BRICK BOTTOMS, PROJECTING OUT FROM THE MIDDLE OF THE MAIN BUILDING WALL TO THE INSIDE EDGE OF THE BRICK WALK [SEE PLATE 13, APPENDIX I].

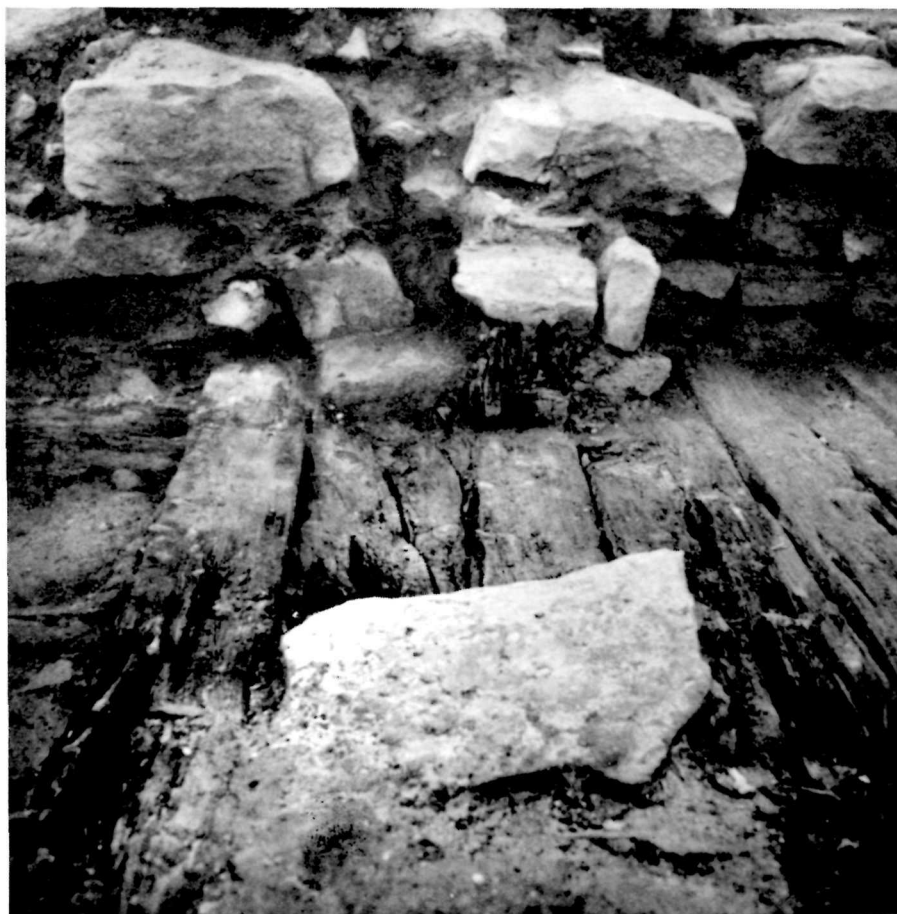
14

PLATE 14. (66 x 1050). 2E16. A DOORWAY. (THIS IS DOOR 4.) THE STONE IN THE FOREGROUND IS THE END OF PARTITION 5. BEYOND IT IS THE STONE PROJECTION AND A WOODEN UPRIGHT, PRESUMABLY SUPPORTS AND FRAME FOR THE HINGED SIDE OF THE DOOR.

AGAINST THE EAST FACES OF THESE STONE PLATFORMS, ON THE SOUTH HALF OF DOORS 1 AND 3 AND THE NORTH HALF OF DOORS 2 AND 4, ARE THE REMAINS OF 0.3' X 0.6' UPRIGHT BEAMS [SEE FIGURE 5 ON P. 32, PLATE 14, APPENDIX I, AND DRAWING 7, APPENDIX II].

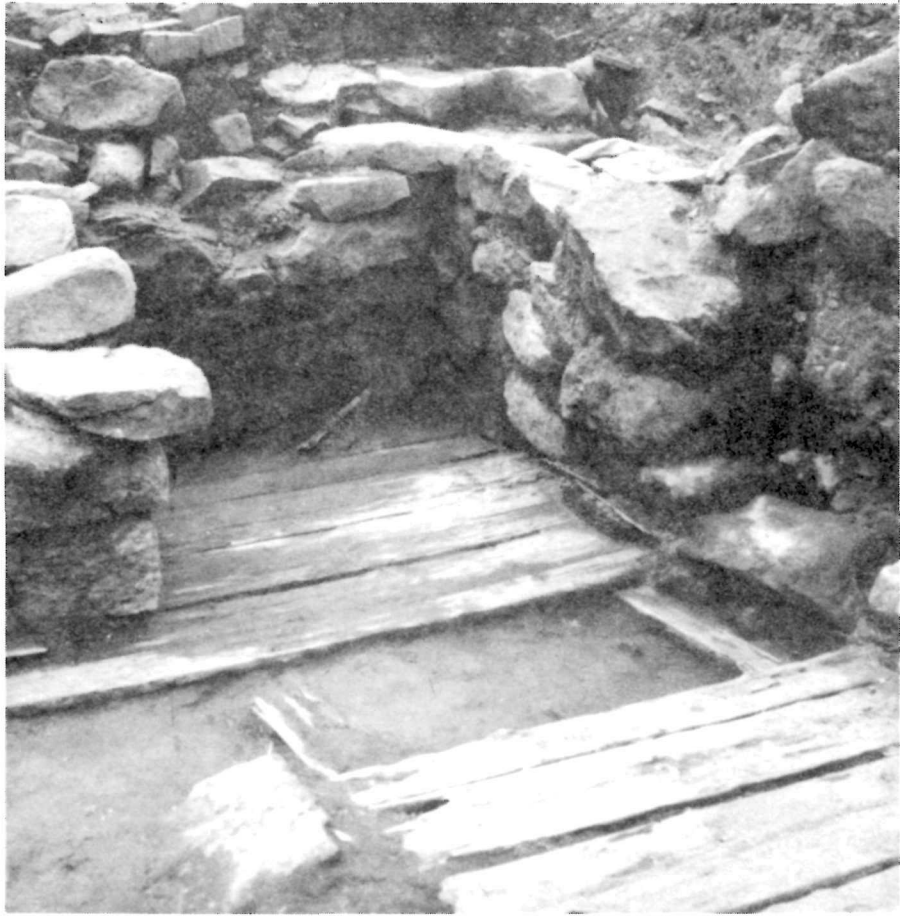
15

PLATE 15. (66 x 1020). 2E16. THIS IS A DETAIL OF A WELL PRESERVED PORTION OF THE WALL OF THE MEN'S BARRACKS: THE SOUTHWEST CORNER. FIVE GOOD COURSES CAN BE SEEN, ALTHOUGH THE TOP TWO HAVE SLIPPED IN A BIT. THE FLOOR IS WELL PRESERVED HERE, AND SOME BASEBOARD REMAINS.

MORTARED FIELD STONE SET IN REGULAR COURSES AND ROUGHLY FACED ON THE INSIDE. WE FOUND AT MOST FIVE COURSES (APPROXIMATELY 3.8' HIGH IN THE CORNERS, MAXIMUM ELEVATION 124.6' A.S.L.) AND MORE COMMONLY TWO COURSES (AVERAGE 1.5' HIGH, 122.3' A.S.L.) OF STONE REMAINING ABOVE FLOOR LEVEL [SEE PLATE 15, APPENDIX 1]. ORIGINALLY THE FOUNDATIONS WERE UNDOUBTEDLY HIGHER: SUFFICIENTLY SO, IN FACT, TO ACCOUNT FOR SOME 69 CUBIC YARDS OF STONE RUBBLE AND MORTAR WHICH COVERED THE ENTIRE FLOOR OF THE BARRACKS TO AN AVERAGE DEPTH OF  $1\frac{1}{2}$  FEET.

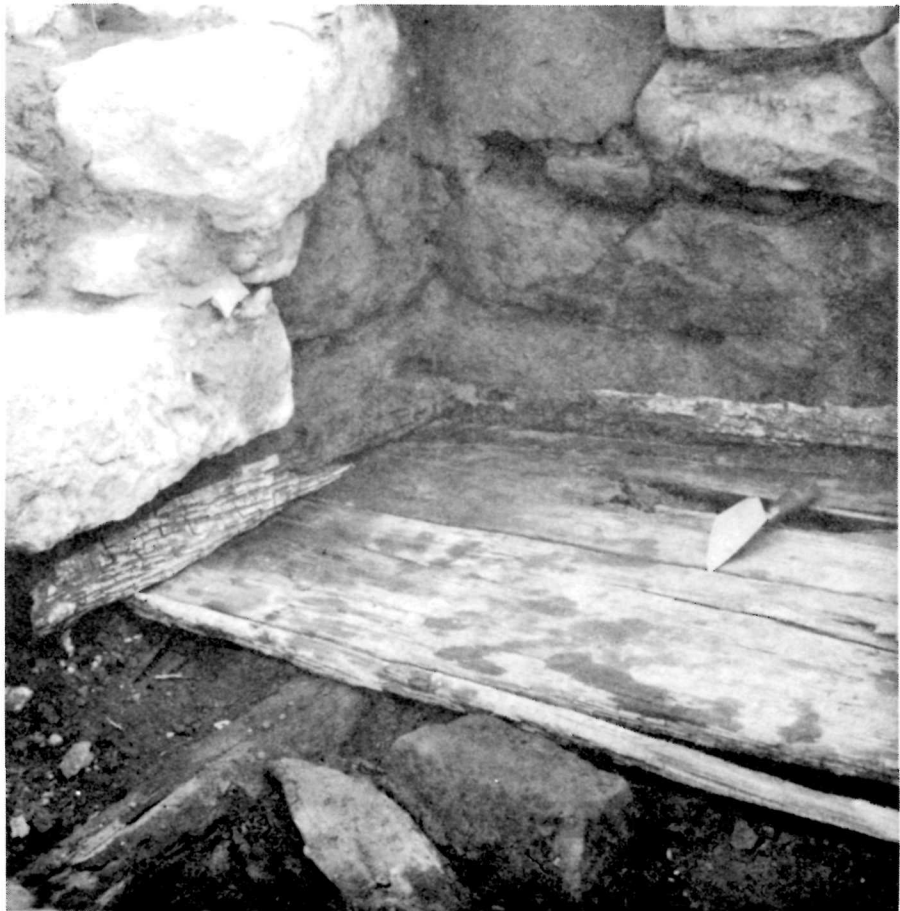
16

PLATE 16. (66 x 971). 2E16. HERE IS A DETAIL OF BASEBOARD AND FLOOR IN THE SOUTHEAST CORNER OF THE MEN'S BARRACKS. THE BASEBOARD RETAINS ITS ORIGINAL POSITION RELATIVE TO THE FLOOR, AND ONE OF ITS NAILS IS VISIBLE (ON THE LEFT). THE TROWEL SERVES AS SCALE. THIS IS THE SUBJECT OF THE SKETCH, FIGURE 6, P. 35.

THE BASEBOARD HAD BEEN SET ON EDGE AGAINST THE WALLS AND NAILED TO THE FLOOR. IT IS AT BEST 0.39' WIDE BY 0.04' THICK, ALTHOUGH IN MOST CASES IT IS SO POORLY PRESERVED THAT THE ORIGINAL DIMENSIONS CAN NOT BE DETERMINED [SEE PLATE 16, APPENDIX I].

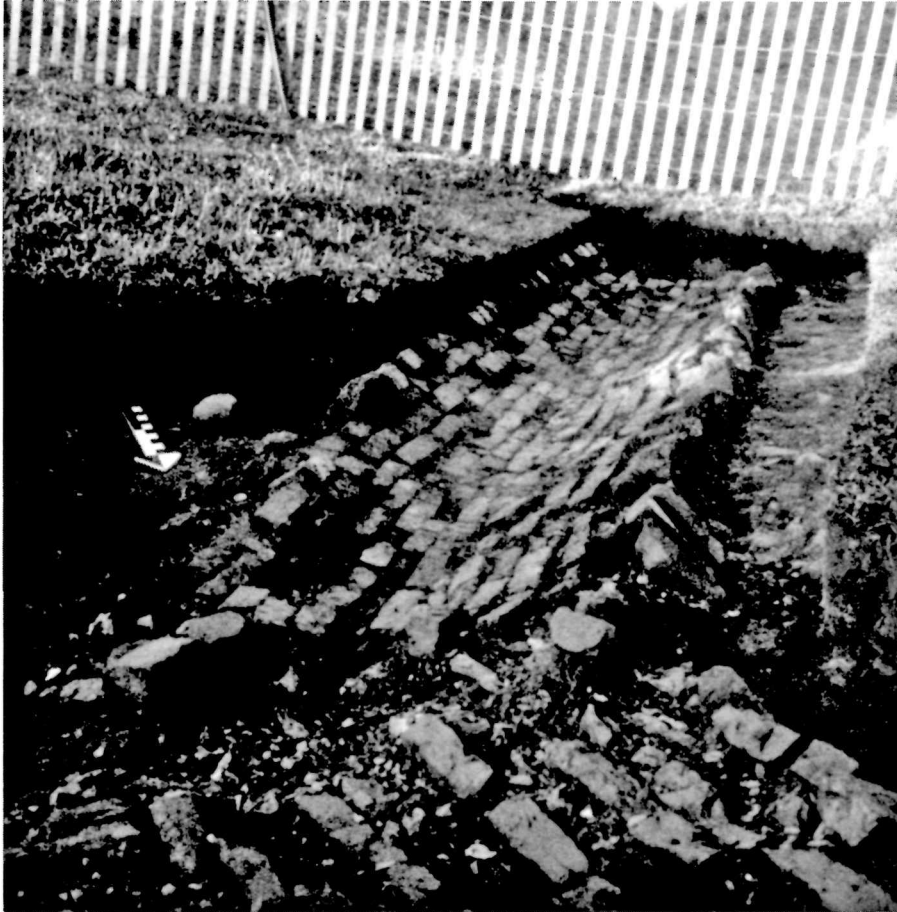
PLATE 17. (66 x 1047). 2E16. THIS IS THE BRICK DRAIN AT THE SOUTHWEST CORNER OF THE MEN'S BARRACKS, LEADING TOWARDS THE ENGLISH ENTRANCE TO THE FORT. NOTICE THAT THE BRICKS ARE SET ON EDGE, BOUNDED BY ROWS OF OBLIQUE BRICKS SET ON END, FORMING A SHALLOW TROUGH.

THE BACK EDGE OF THE EXCAVATION IS THE END OF THE DRAIN. AT THAT POINT THE DRAIN SEEMS TO HAVE BEEN CUT OFF, ALTHOUGH AS IT LIES IN THE TOPSOIL NO STRATIGRAPHIC EVIDENCE WAS FOUND TO PROVE THAT THIS HAS HAPPENED.

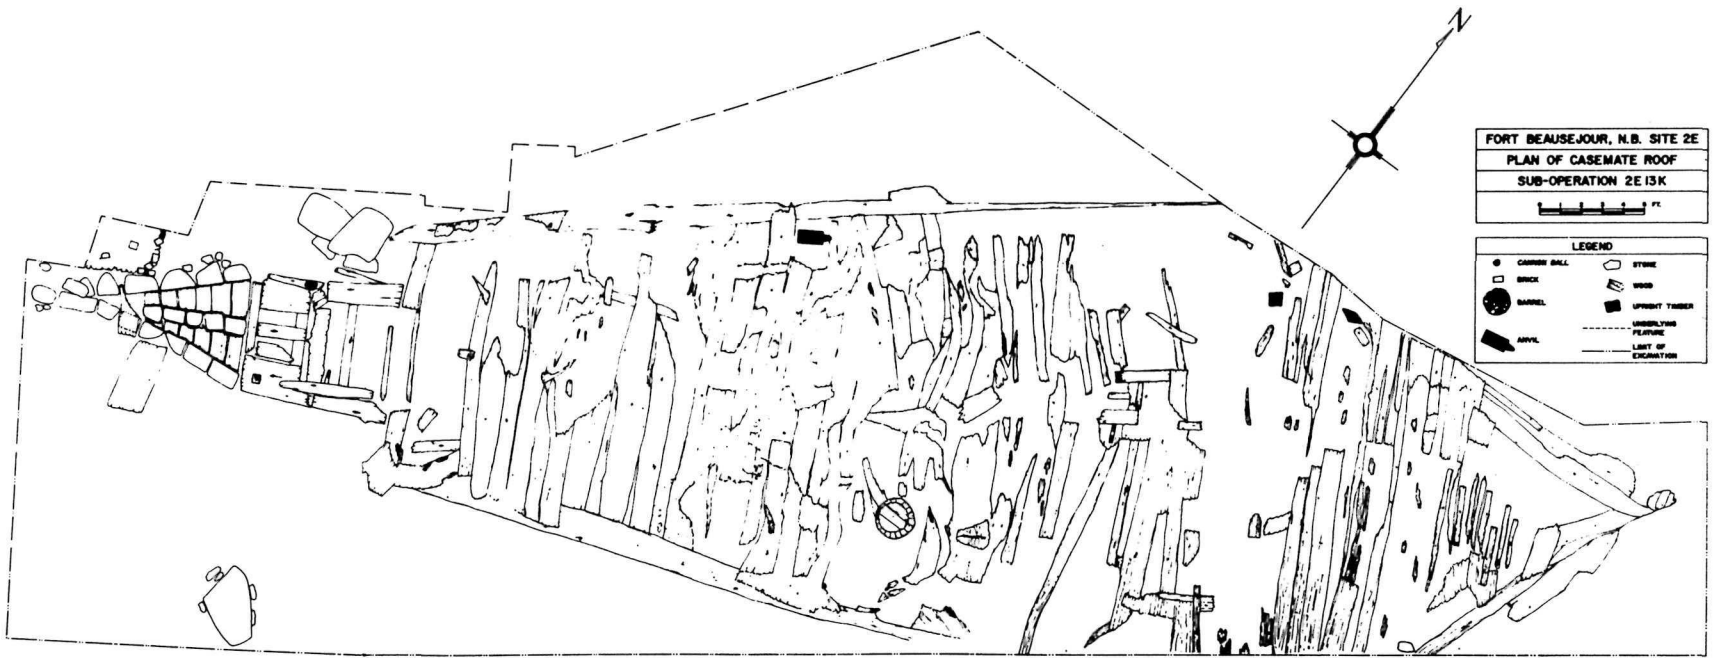
THIS IS A PLAN OF THE FRENCH CASEMATE, SHOWING THE WOOD OF THE ROOF AND THE ENTRANCE. THE DRAWING, WITH ITS KEY, IS SELF-EXPLANATORY, SO NO COMMENT IS NEEDED HERE.

FORT BEAUSEJOUR, N.B. SITE 2E  
 PLAN OF CASEMATE ROOF  
 SUB-OPERATION 2E 13K

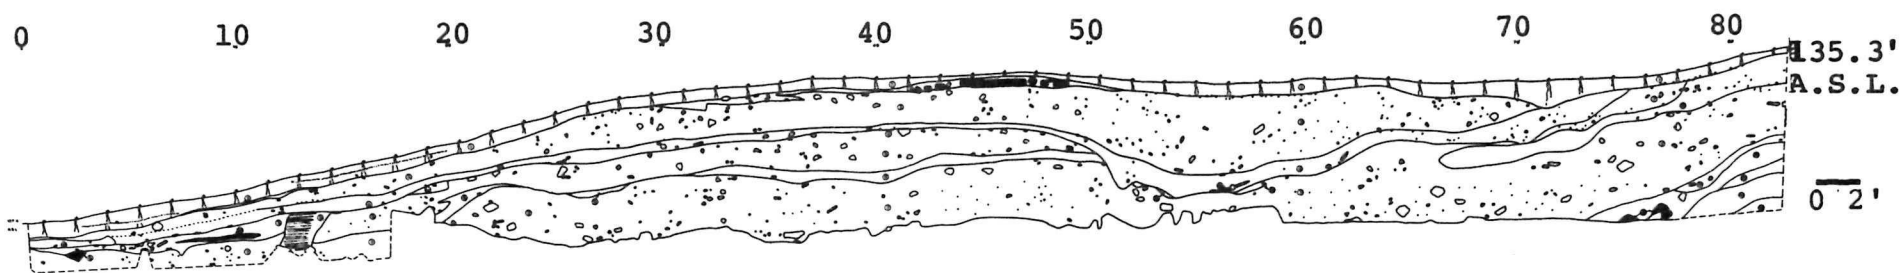
Drawing 5. 2E13G, D, C. Longitudinal Cross-Section (Looking North)

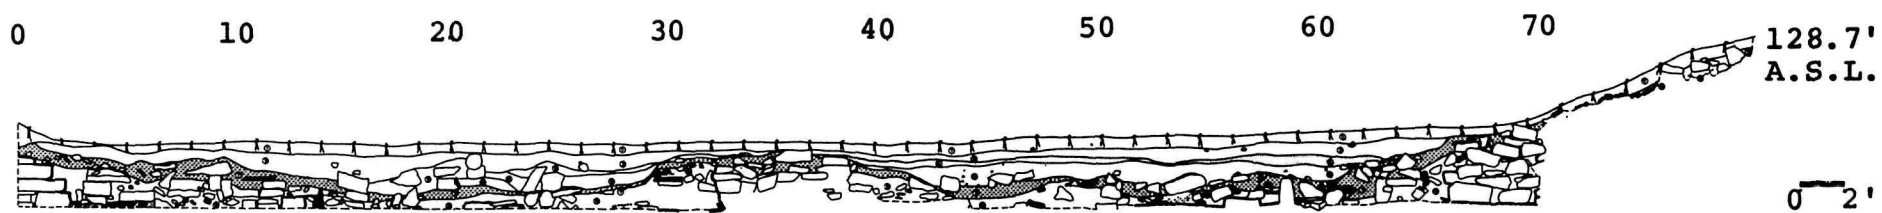
Drawing 8. 2E16 Longitudinal Cross-Section (Looking East)
