NATIONAL HISTORIC PARKS
AND SITES BRANCH

THE FORT AT COTEAU-DU-LAC:
FOUR REPORTS

(1977)

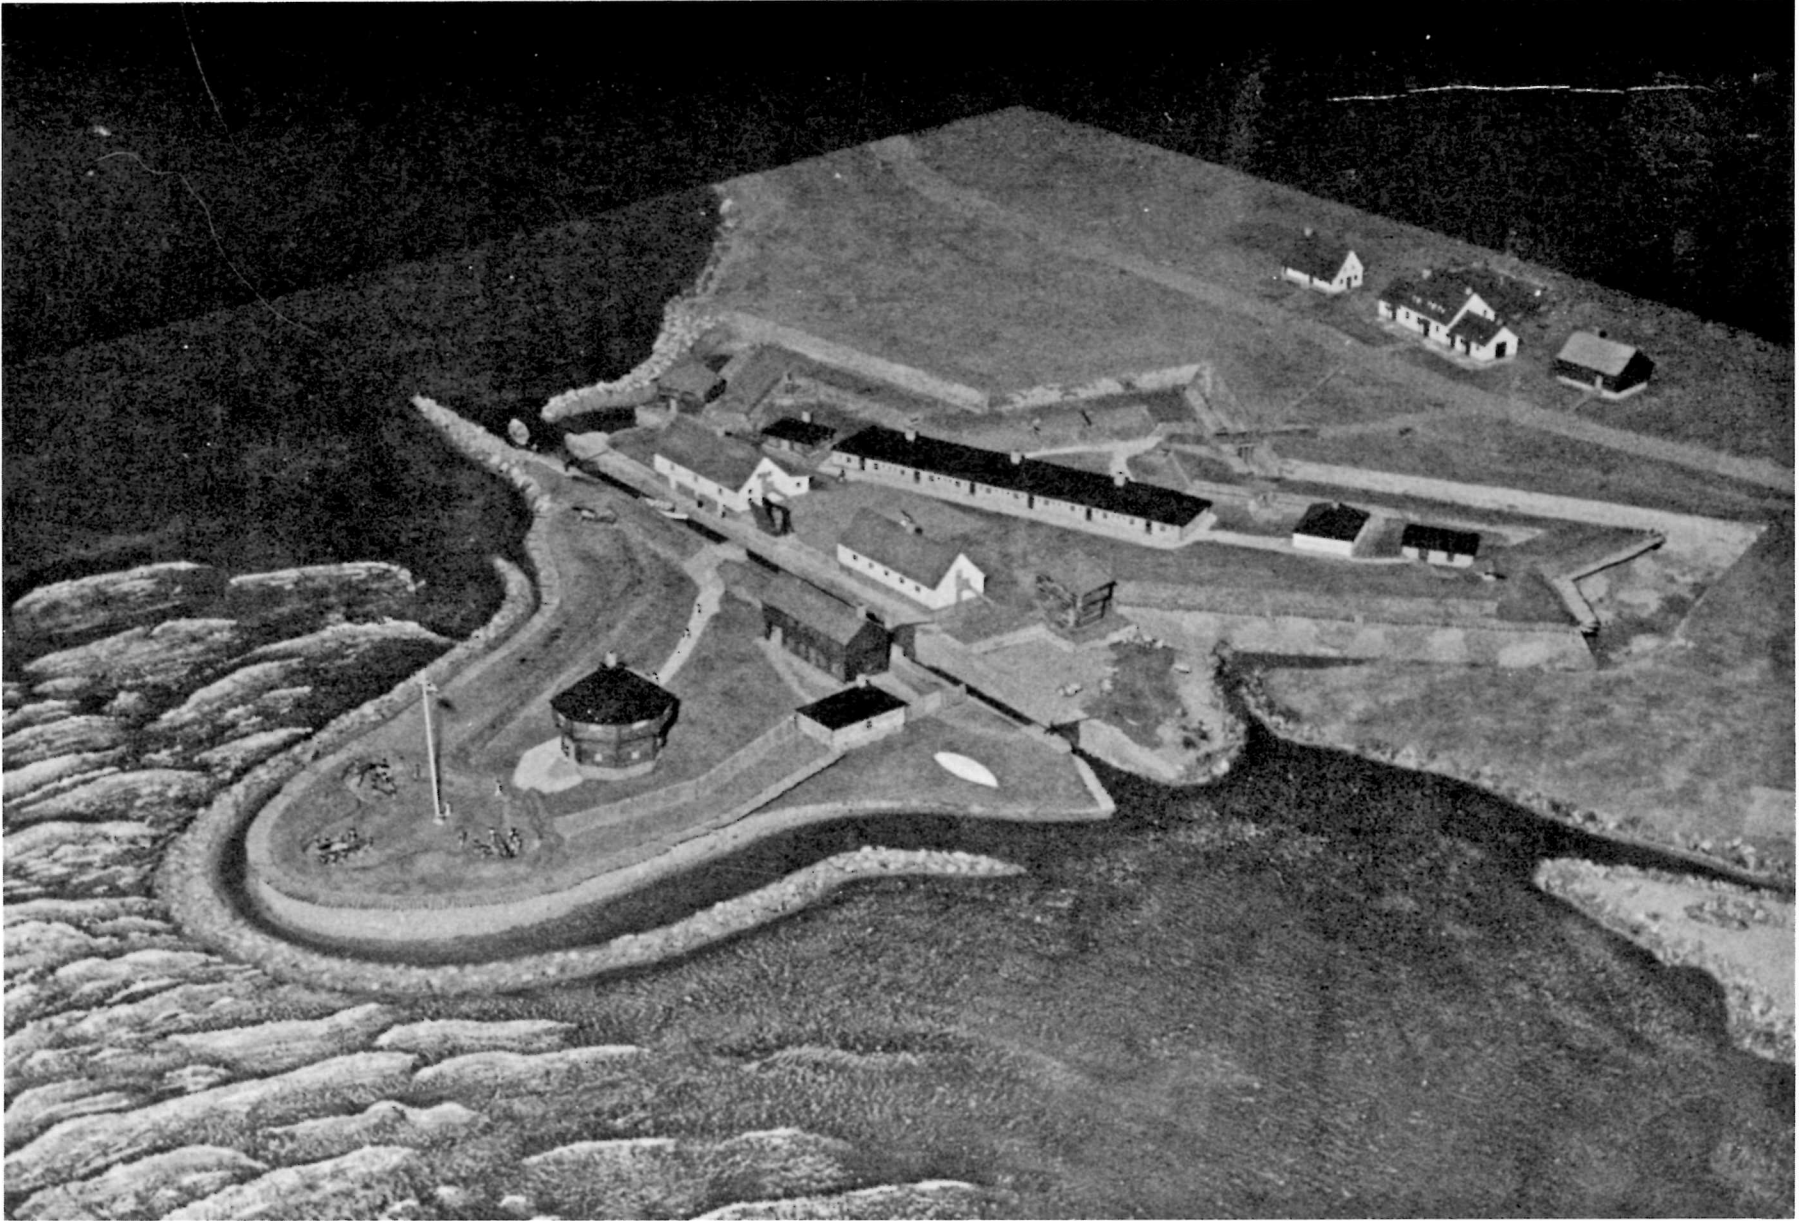
- 3 A model of the fort at Coteau-du-Lac. The model, based on historical and field data, represents the fort between 1815 and 1823. This model has been installed at Coteau-du-Lac to serve as an interpretive and explanatory aid to visitors. Because the model was constructed before all data were available, it is incomplete, if not inaccurate in some details. (Model by Cecil Gorman.)

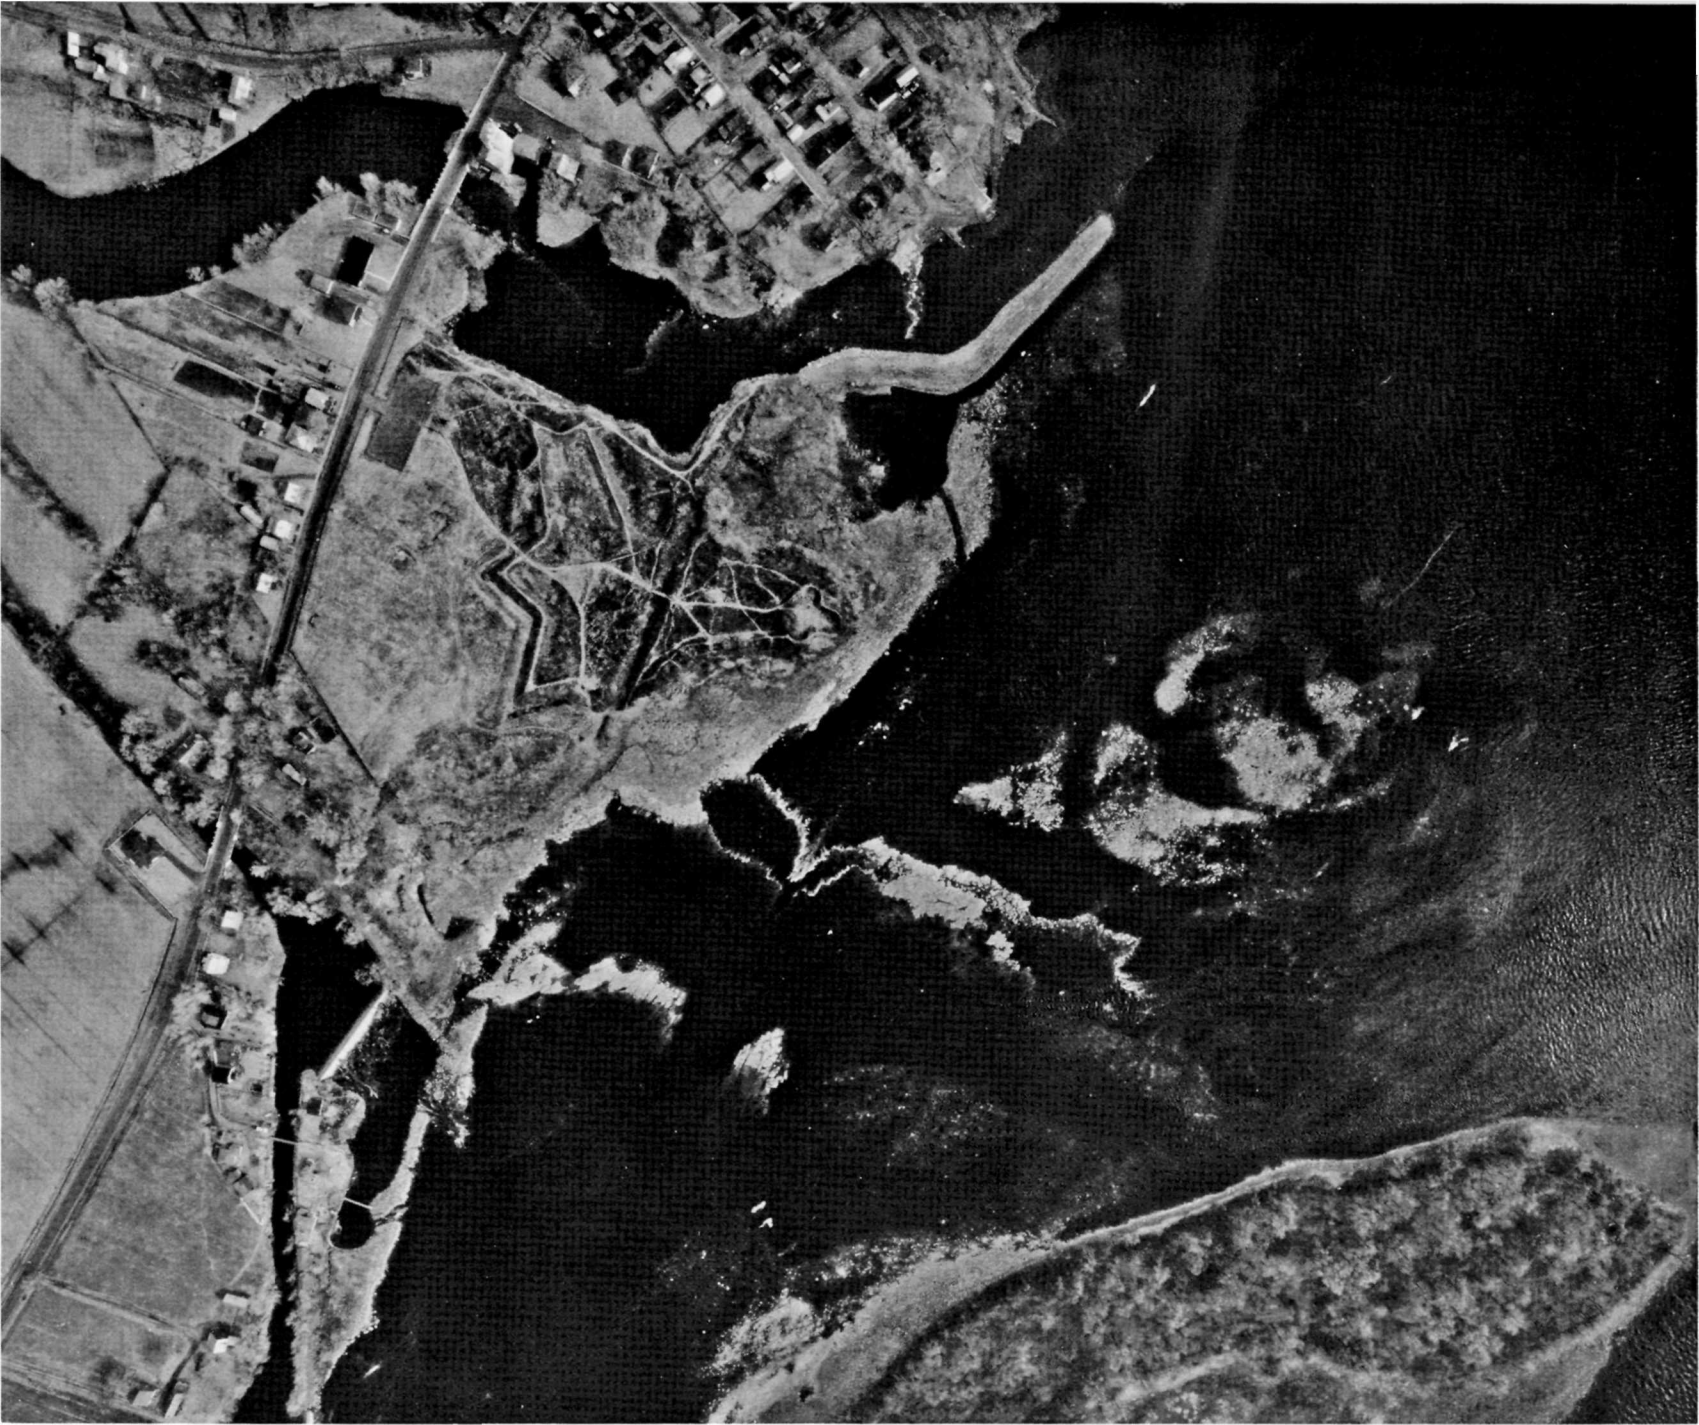
- 11 The fort at Coteau-du-Lac, aerial view before excavation. The St. Lawrence River and part of Prisoner's Island are visible in the upper right (south) of the photograph. Note the rapids between the fort and the island. The water level was much higher during the historic period. To the left of the photograph are the Delisle River and the modern village of Coteau-du-Lac. (Department of Mines and Technical Surveys.)

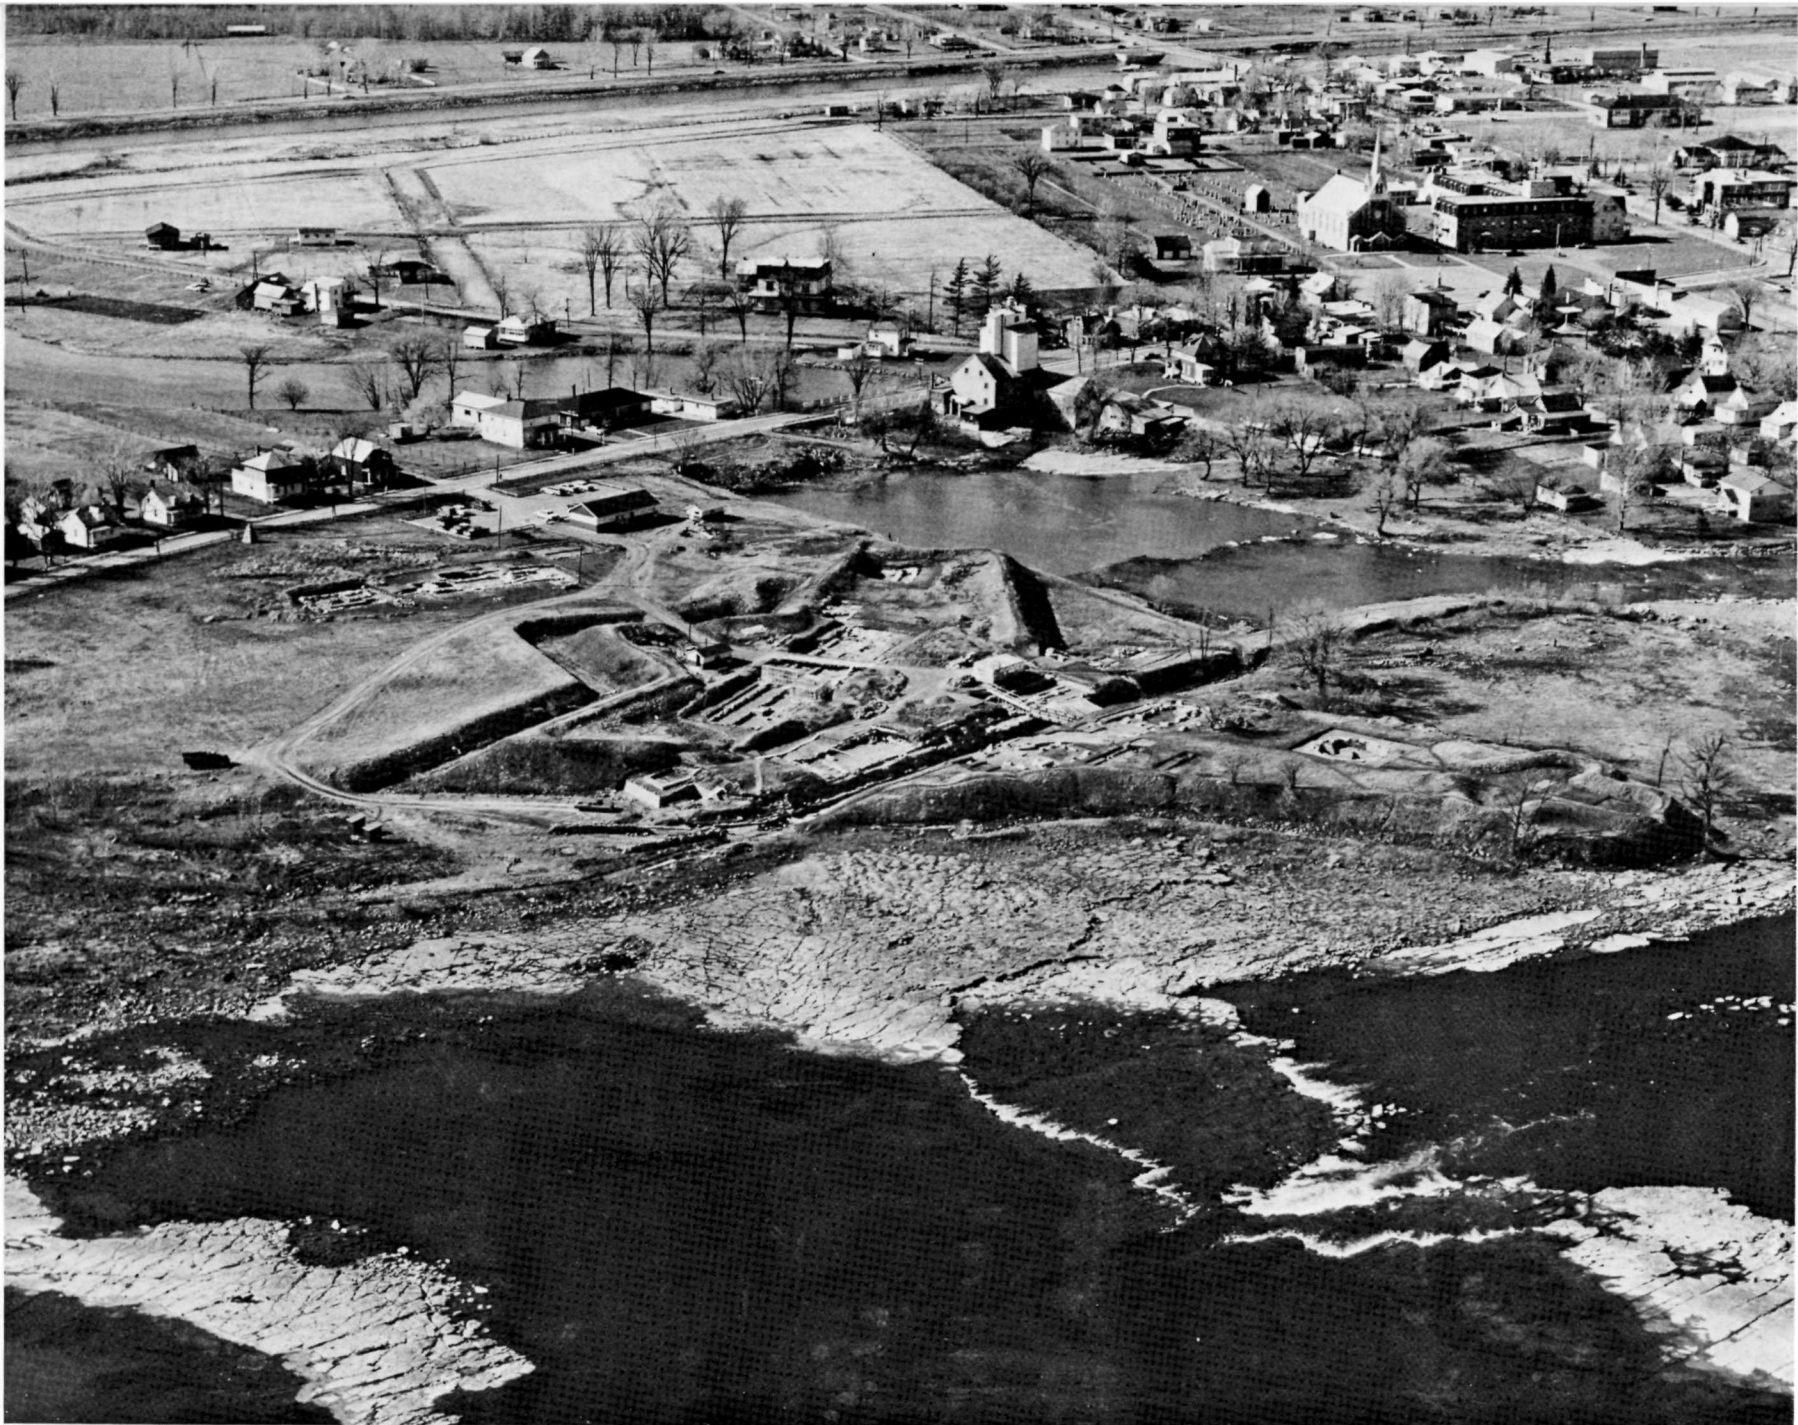
13 Aerial view of Coteau-du-Lac, looking north. An early stone quarry is visible in the foreground. The later Soulanges Canal runs along the upper part of the photograph.

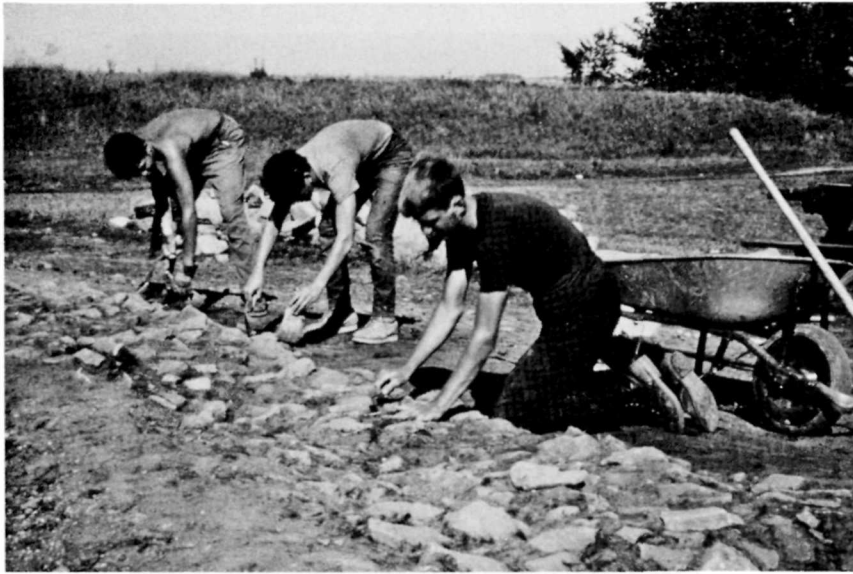
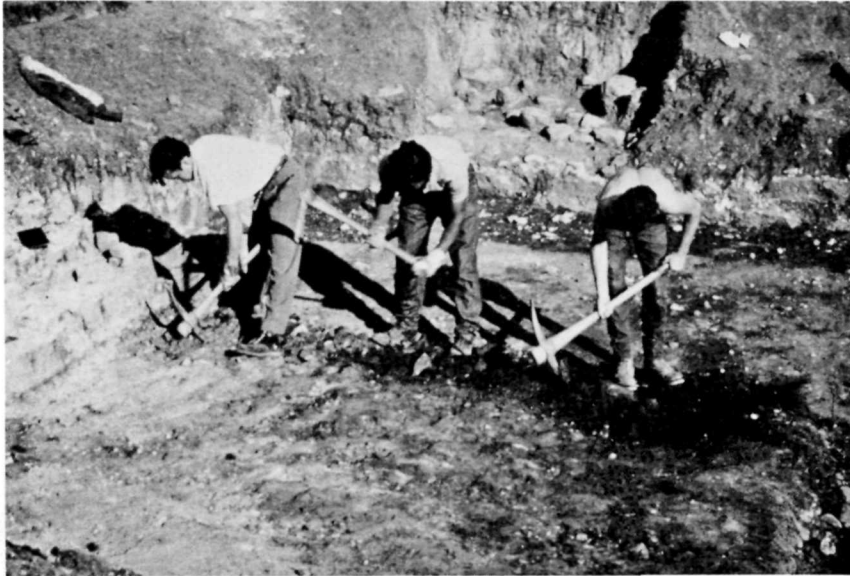
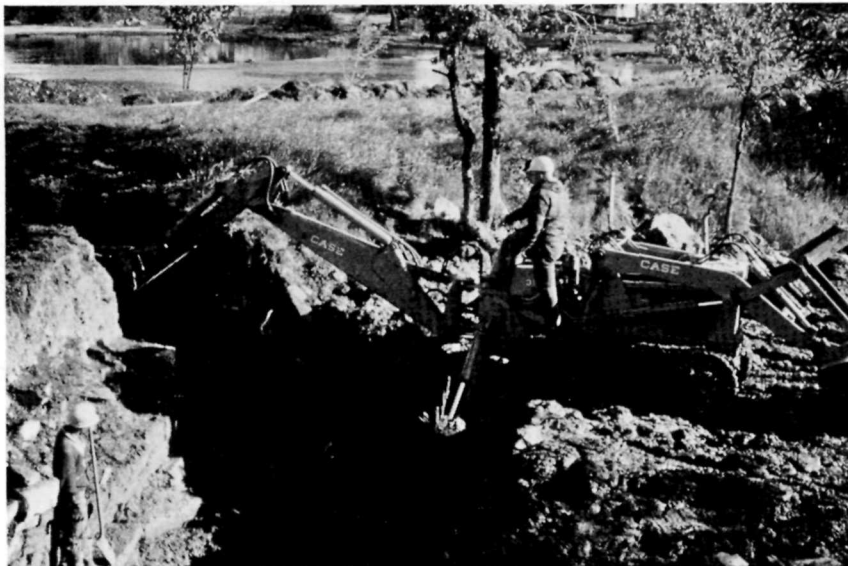
- 18 Excavation techniques. Workers cleaning the walkway on the east side of the commanding officer's quarters. Trowels and whisk brooms were used to excavate those features which could not be uncovered by pick and shovel.
- 19 Excavating the cellar of the commanding officer's quarters with pick and shovel.
- 20 Excavating the north end of the canal with a backhoe. This machine was used in the canal to excavate below the prevailing water table.

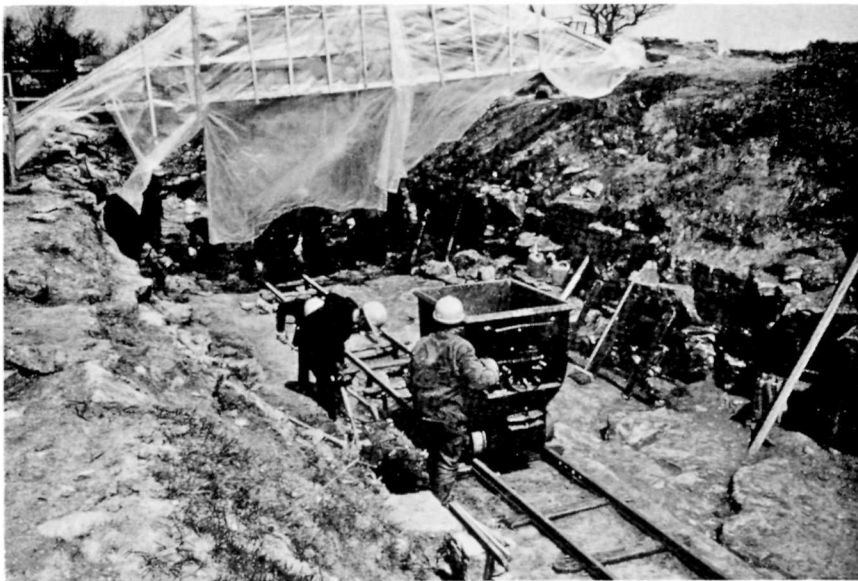
22 Two dump-cars and a flatbed car were used successfully in the excavation of the canal. Note the portable shelter extended over the excavation area.

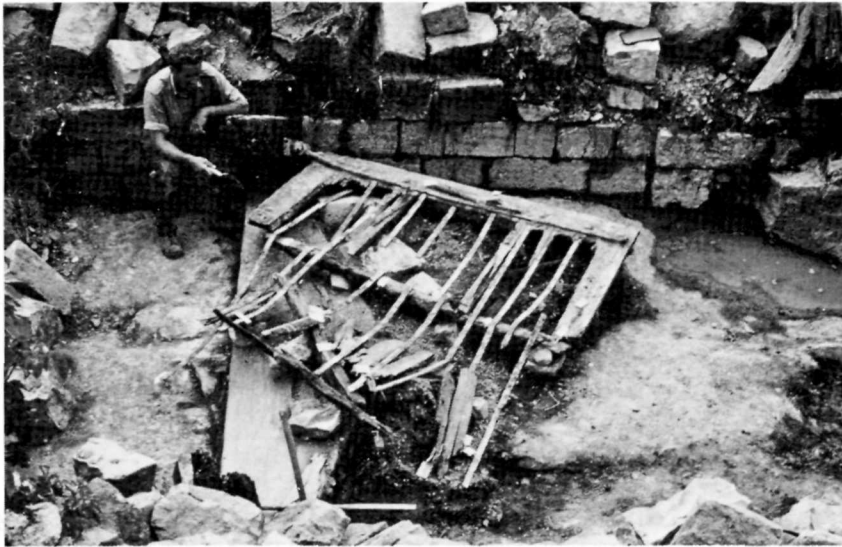
30 The gate sill at the south end of the canal after removal of the gate. The well-faced and squared stones of the wall and the altered bedrock to the south are also visible.

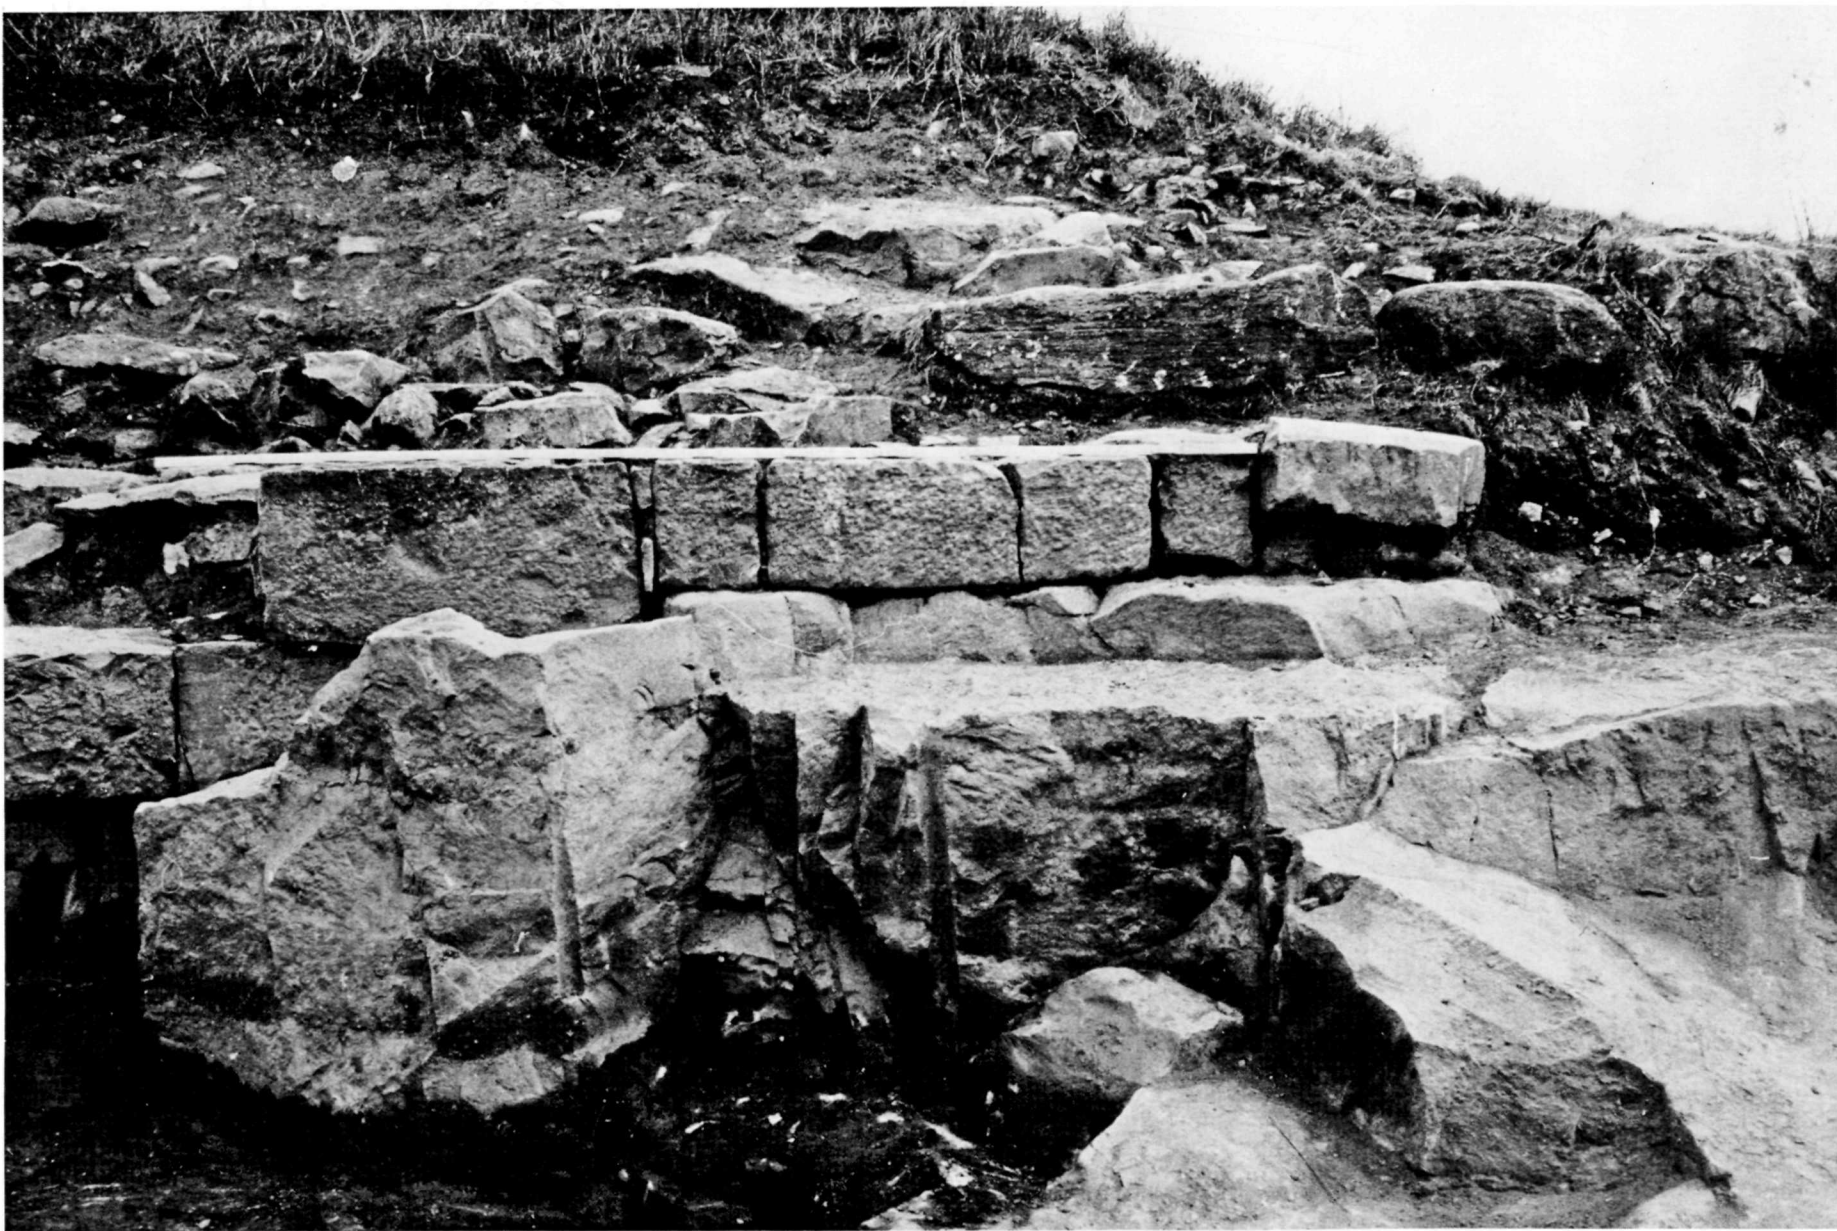
- 33 A section of the west canal wall near the south gate showing a basal course of well-faced and dressed stone laid on a section of bedrock. The vertical striations in the bedrock are due to drilling for blasting.

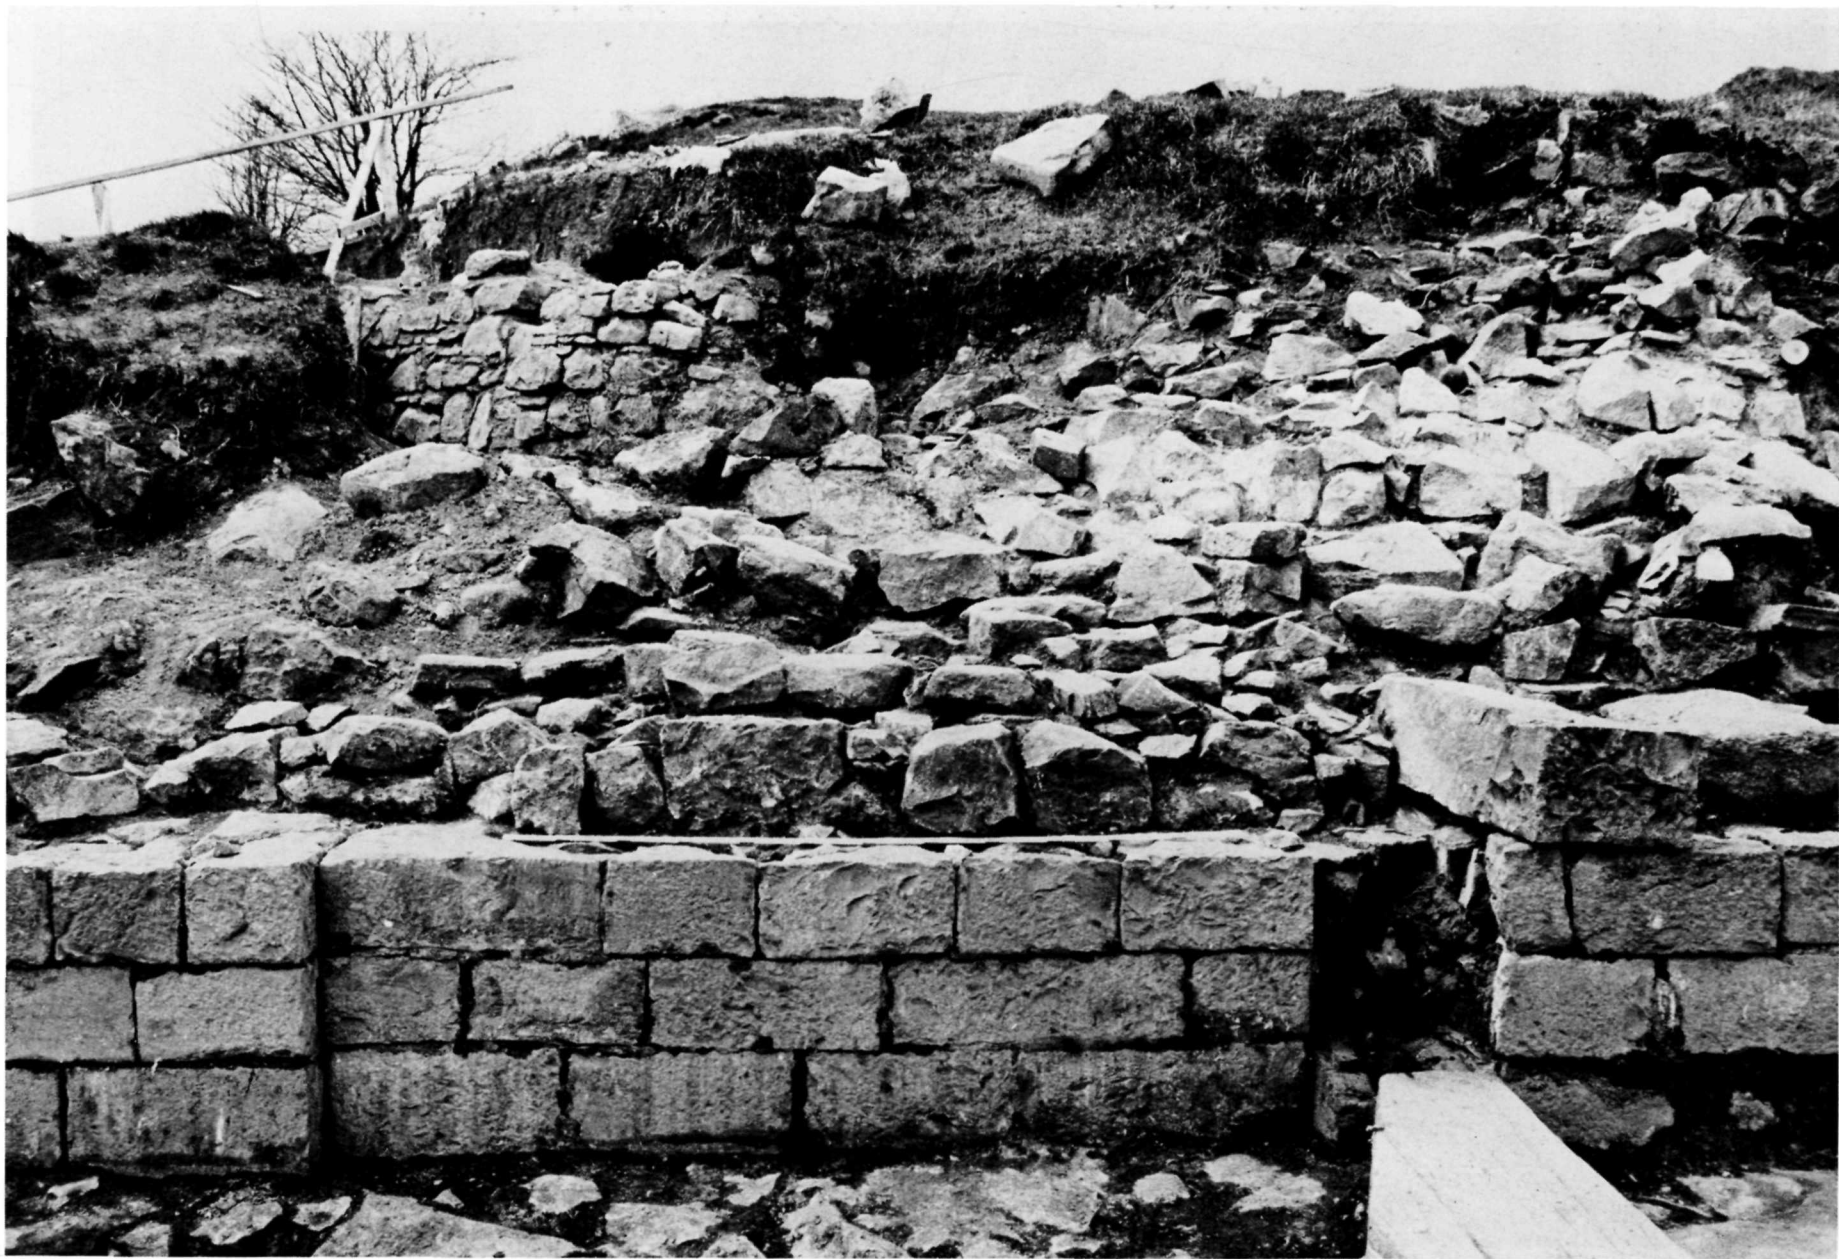
34 A section of the west canal wall at the south gate showing the well-squared and faced masonry forming the gate pier, the junction of the sill and the masonry, and the gate recess in the pier. The stone rubble in the immediate background provided fill for the pier. The masonry feature in the background to the left is the end of the retaining wall leading from the south blockhouse platform toward the canal.

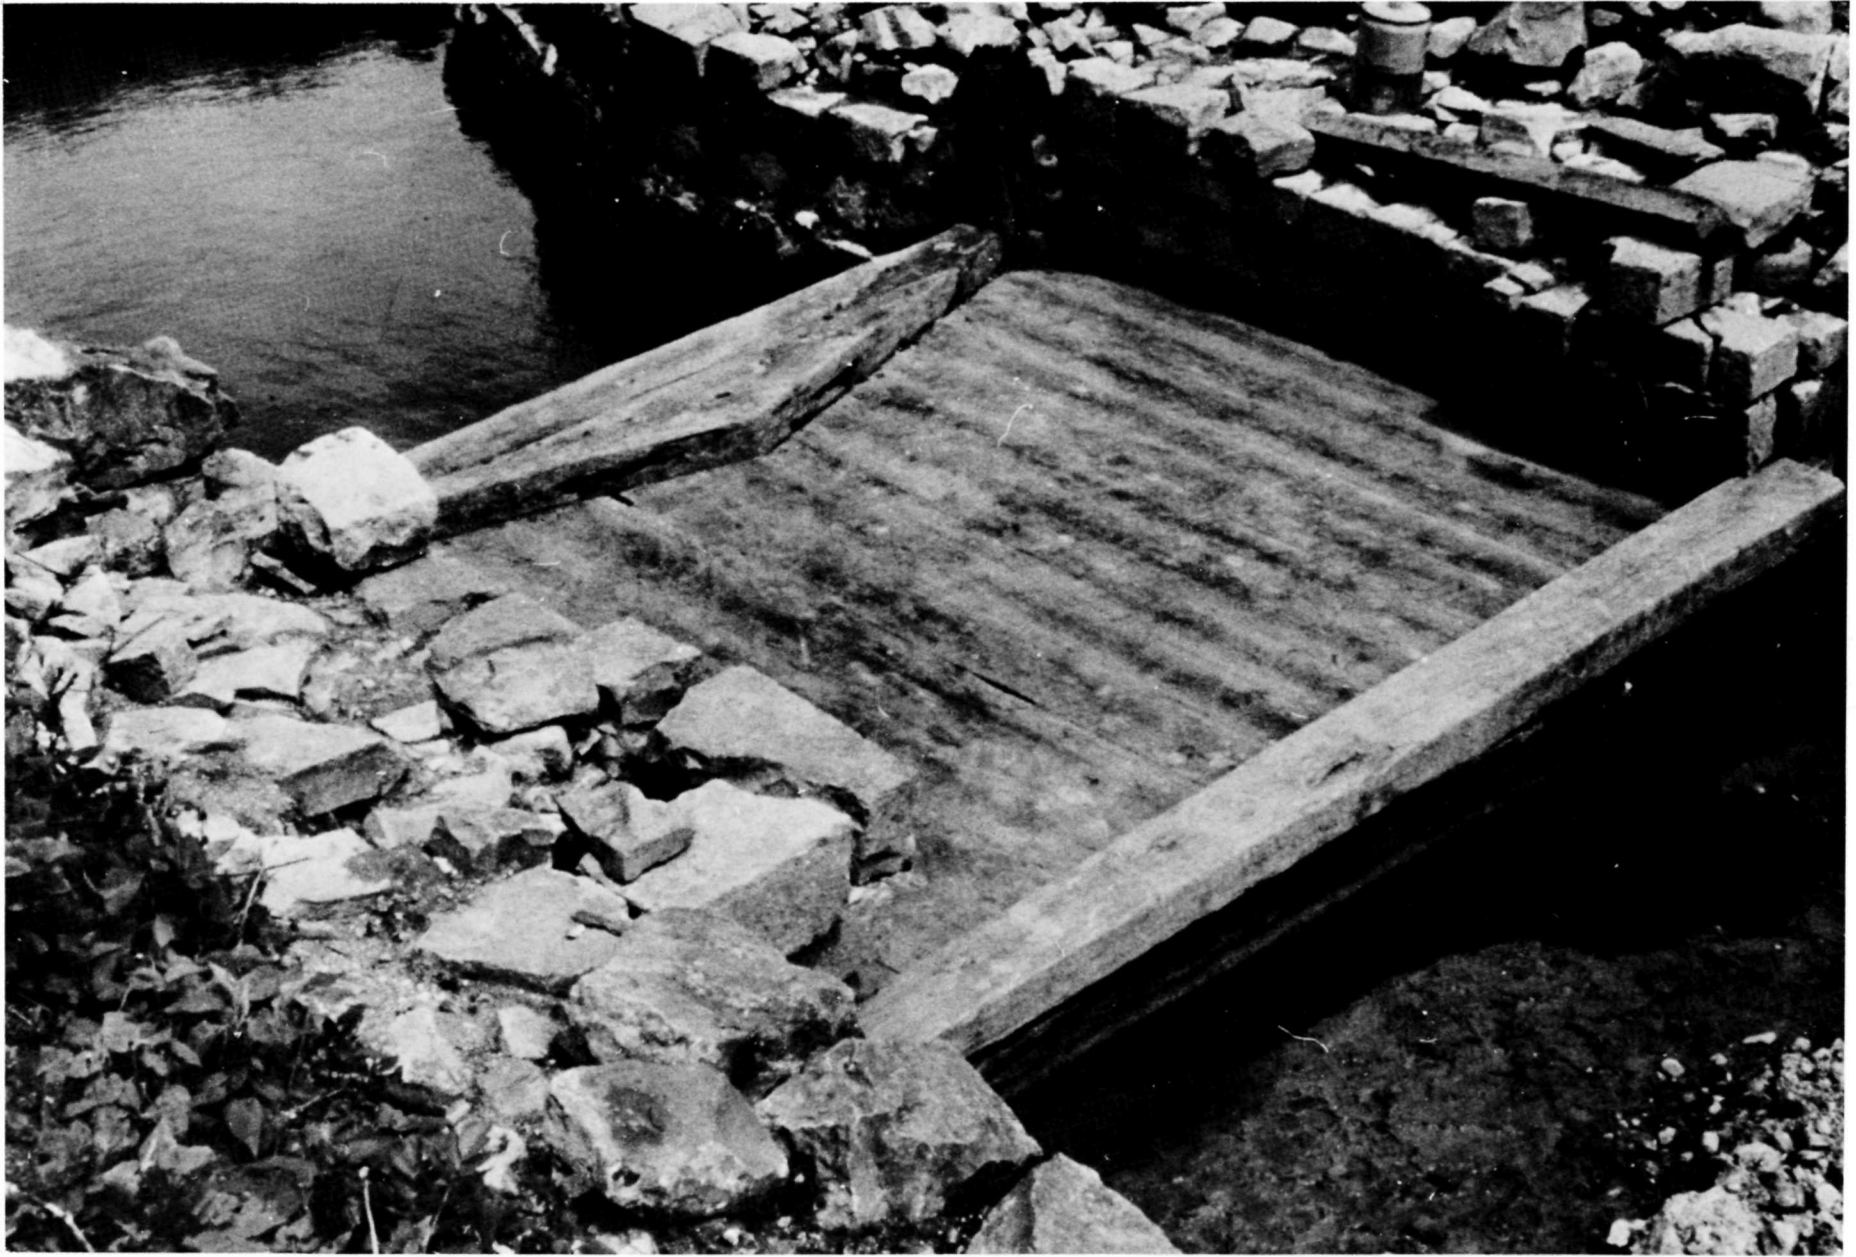
36 The north lock gate showing the triangular sill and the apron.

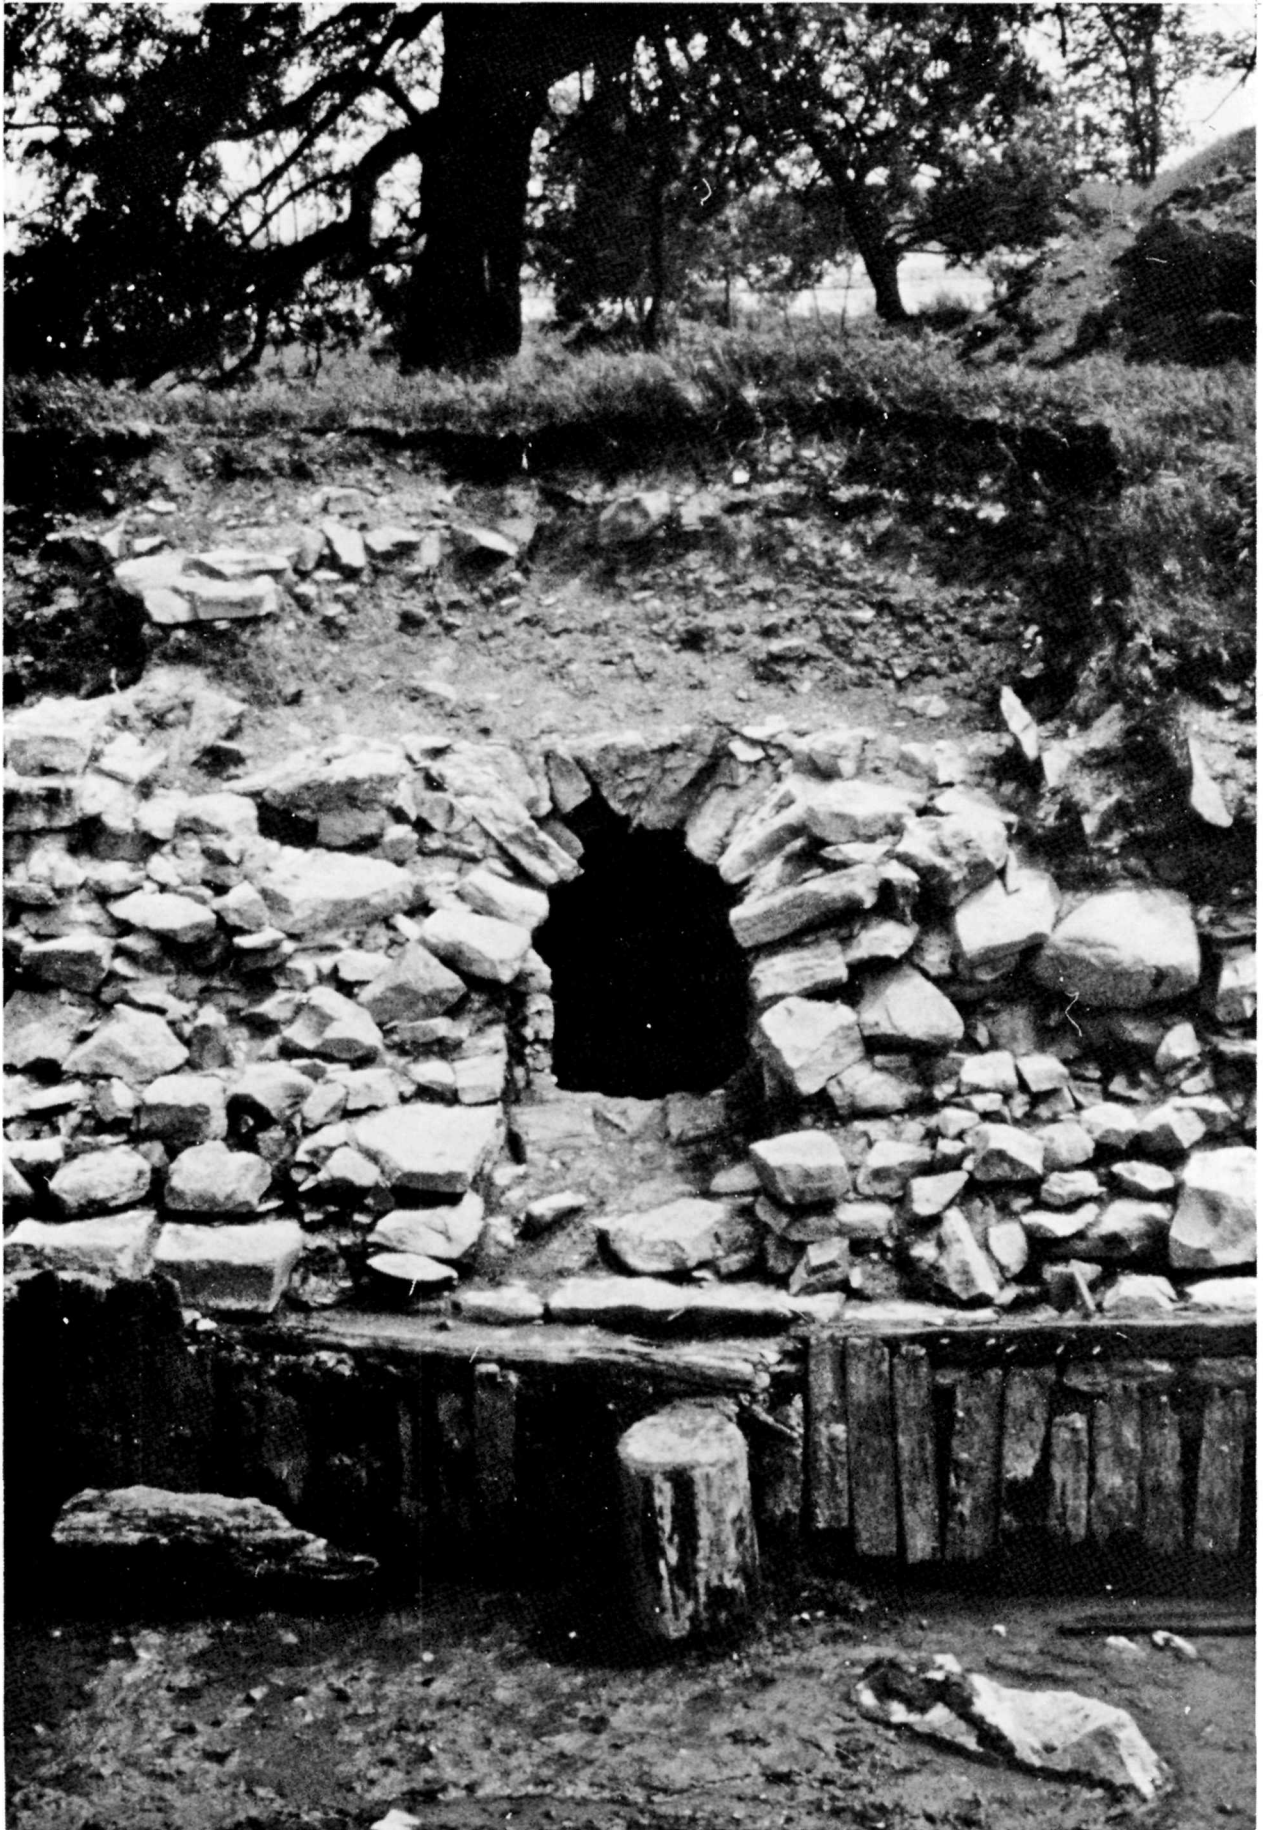
- 37 A section of the east wall showing the entrance to the drainage tunnel and the vertical plank lining of the north lock of the canal. In the foreground is one of the two round posts found at opposite sides of the canal.

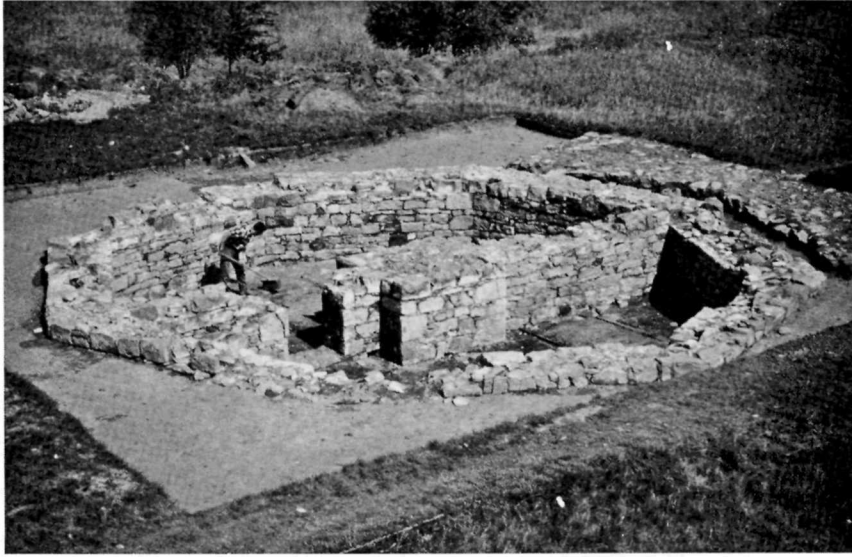
41 The octagonal blockhouse after excavation, looking northeast. A section of the stone walkway can be seen to the right of the foundation.

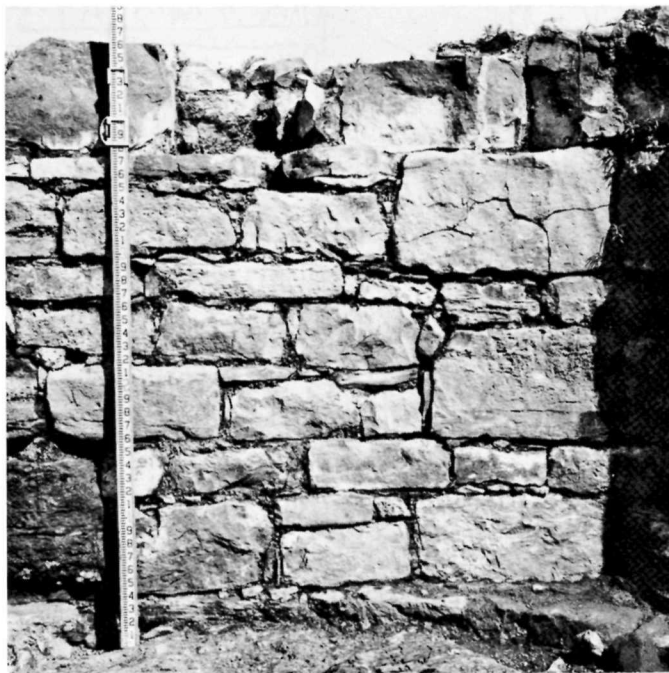
42 A section of the wall dividing the cellar of the octagonal blockhouse, showing the worked masonry.

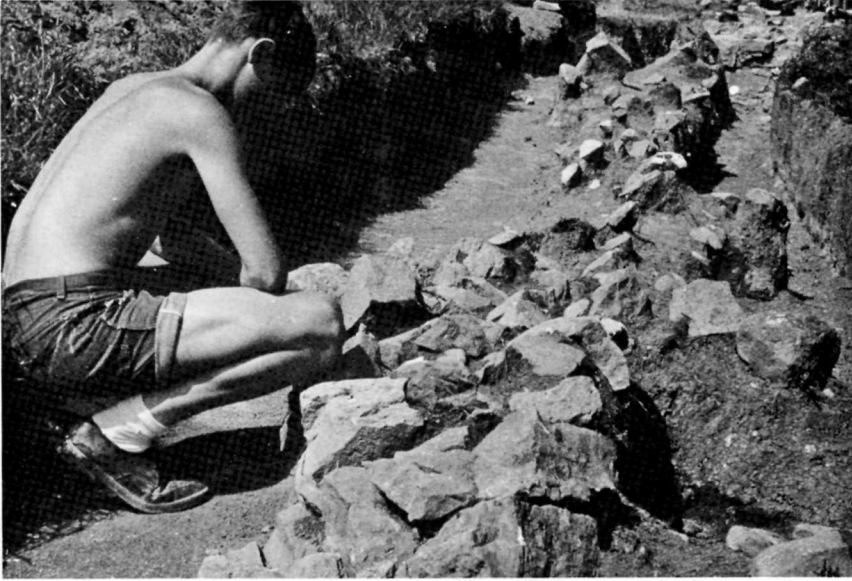
- 47 Palisade north of the octagonal blockhouse, looking northwest. The stones used to support the posts may be seen in the foreground.

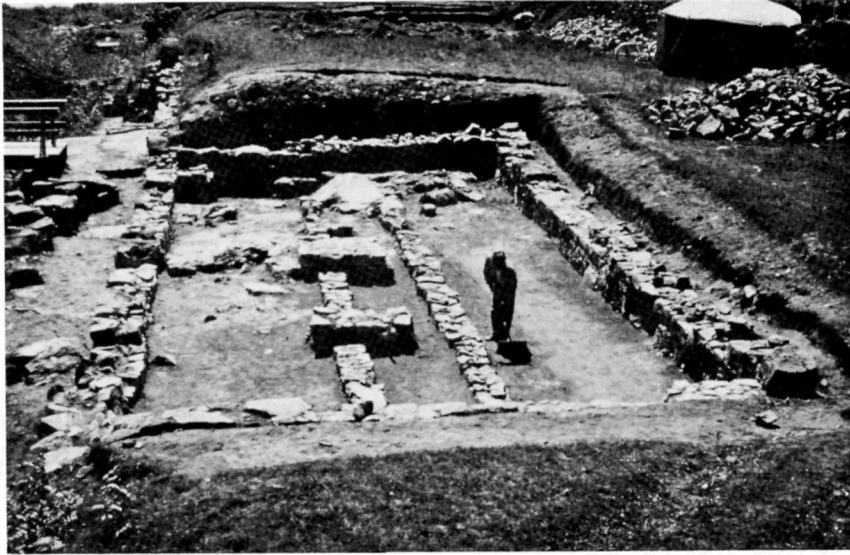
- 53 The storehouse/temporary officers' quarters after excavation, looking south. The two masonry bearing walls in the middle of the structure supported the partitions of the first floor and the plank flooring joists. The masonry feature at the centre of the photograph is a hearth base. The use of the other rectangular masonry feature is not known.

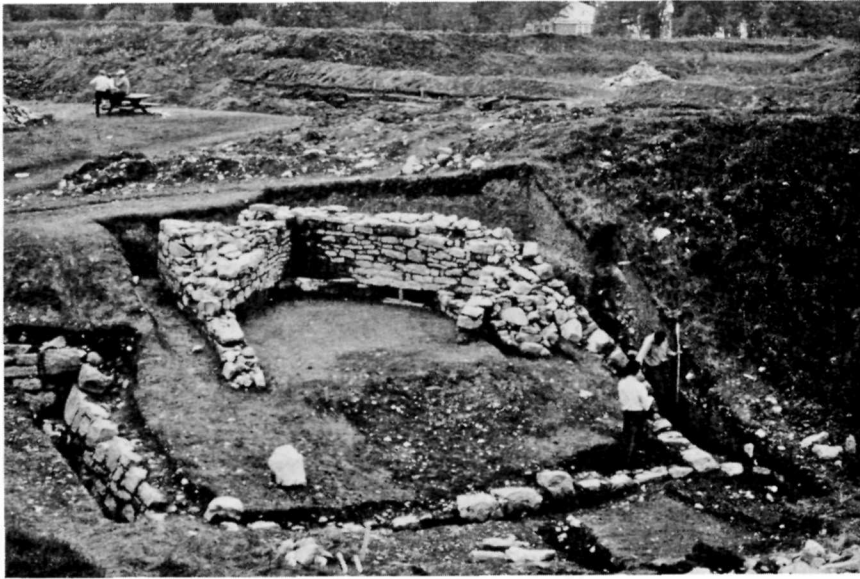
- 61 North blockhouse after excavation, looking southwest. Although the base course of the north retaining wall of the platform still stands, the north foundation wall of the building itself is missing completely. The remains of the wooden shed built against the base of the platform retaining wall are visible in the right foreground.

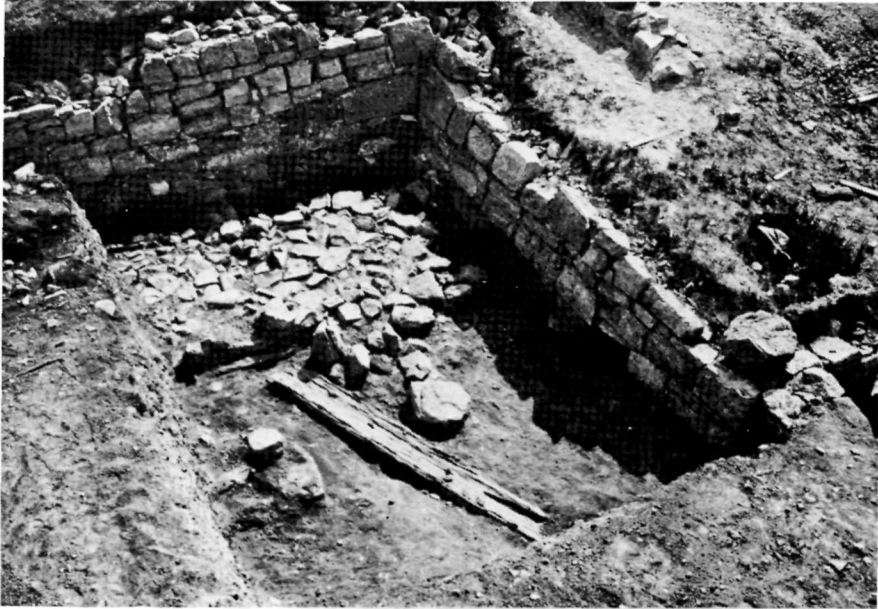
- 64 Temporary kitchen or ox shed. The stones at the bottom of the photo may have been the flooring of either a kitchen or a shed for oxen; both structures were located in the same area. The wooden panel may also have been part of one of the two buildings. To the right of the photo is the east retaining wall of the north blockhouse platform. In the background is the retaining wall between the north blockhouse and the west side of the canal.
