NATIONAL HISTORIC PARKS
AND SITES BRANCH

THE FORT AT COTEAU-DU-LAC:
FOUR REPORTS

(1977)

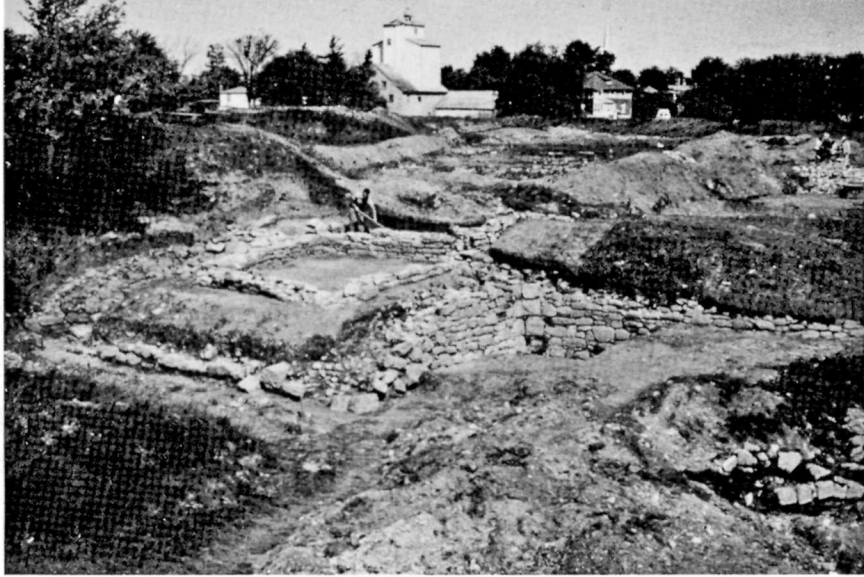
- 66 The south blockhouse after excavation, looking north. Note the extensive quarrying of the south platform retaining wall. To the right is a section of the retaining wall which curves toward the canal and the storehouse/gunshed.

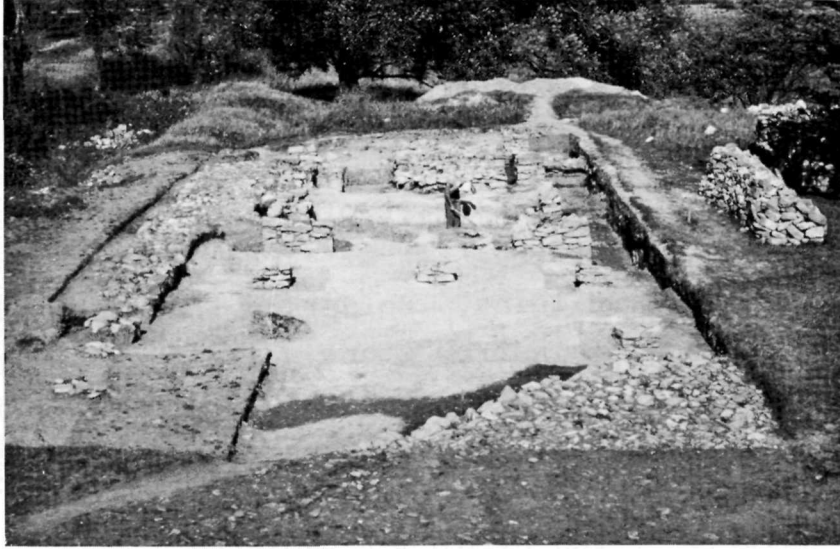
70 The hospital after excavation, looking north. A narrow walkway is shown to the west of the structure and in the right foreground is a section of the principal walkway which extends from the east bridge abutment to the octagonal blockhouse.

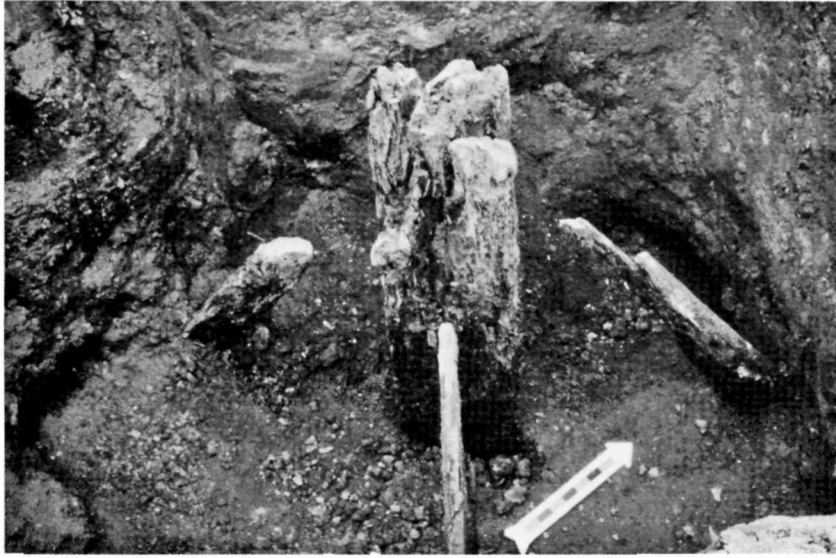
73 Cloverleaf bastion flagstaff. The base and supports of the flagstaff during excavation. The arrow points north and bears a scale in tenths of a foot.

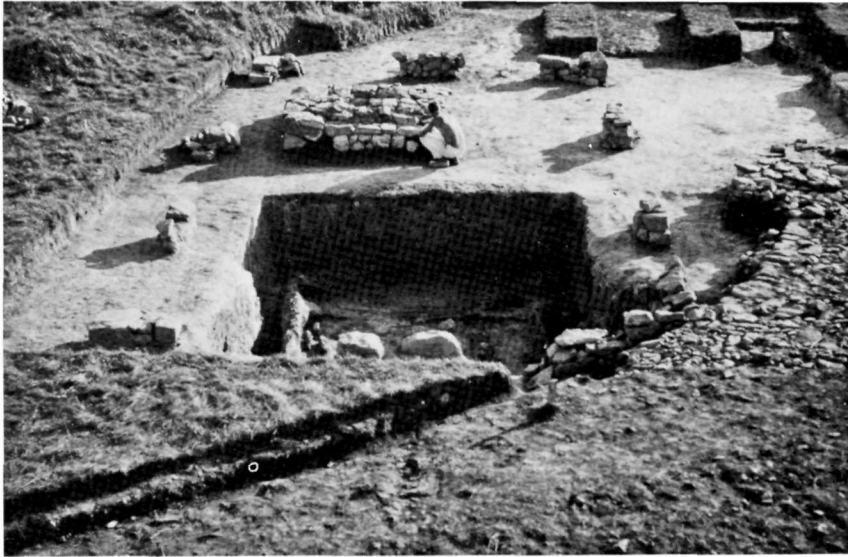
- 78 The hospital/master carpenter's quarters after excavation, looking south, showing features of the foundation. The stone hearth base is visible in the upper centre of the building and the logs and planks at the bottom of the cellar are visible in the lower centre. To the right is a section of the walkway leading from the east bridge abutment to the octagonal blockhouse.

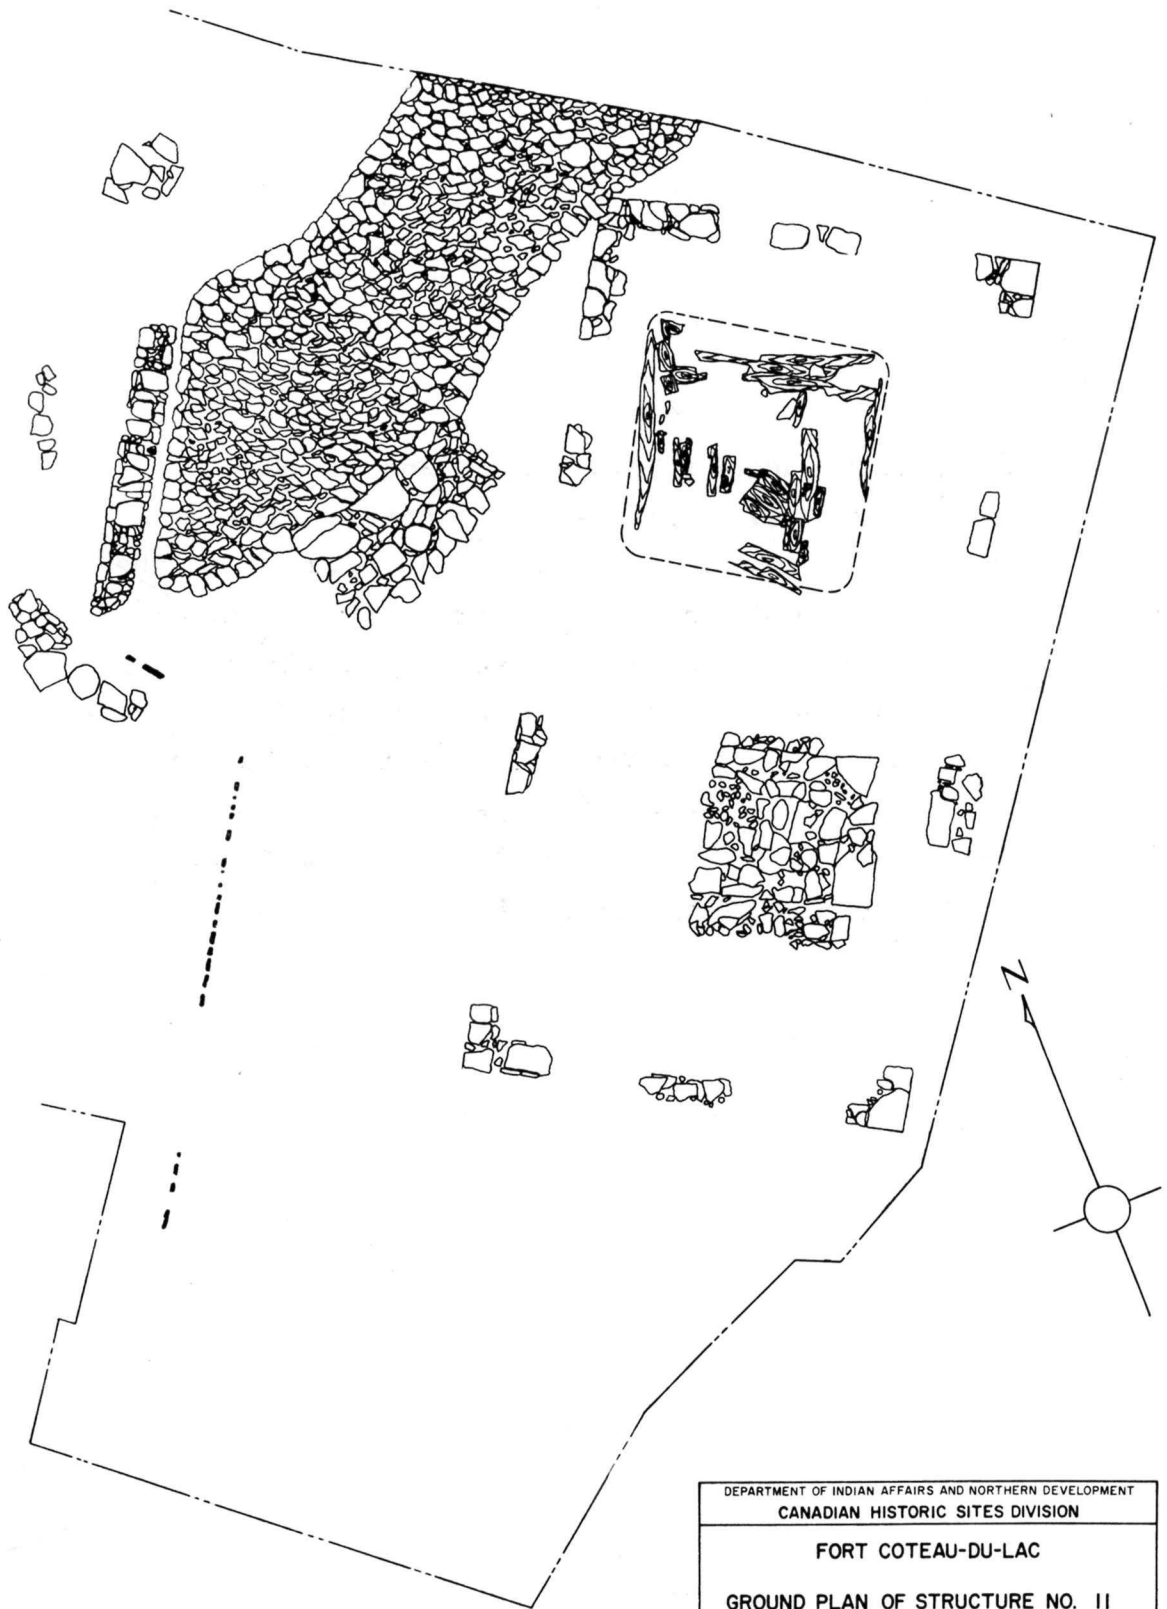
DEPARTMENT OF INDIAN AFFAIRS AND NORTHERN DEVELOPMENT	
CANADIAN HISTORIC SITES DIVISION	
FORT COTEAU-DU-LAC	
GROUND PLAN OF STRUCTURE NO. 11	
HOSPITAL- MASTER CARPENTERS' QUARTERS	
DRAWN BY M. L.	SCALE 0 1 2 4 6 8 10 FT.
DATE DEC. 1965

- 79 . Plan of the hospital/master carpenter's quarters showing the masonry foundation, the hearth base and the cellar and its planking. The linear feature to the east is the remains of a plank fence. The east bridge abutment is to the northwest of the building and the walkway leading from it to the octagonal blockhouse runs toward the northeast. A stone approach leading to the entrance of the hospital/master carpenter's quarters abuts the south side of the main walkway. (Plan by Michel Lapierre.)

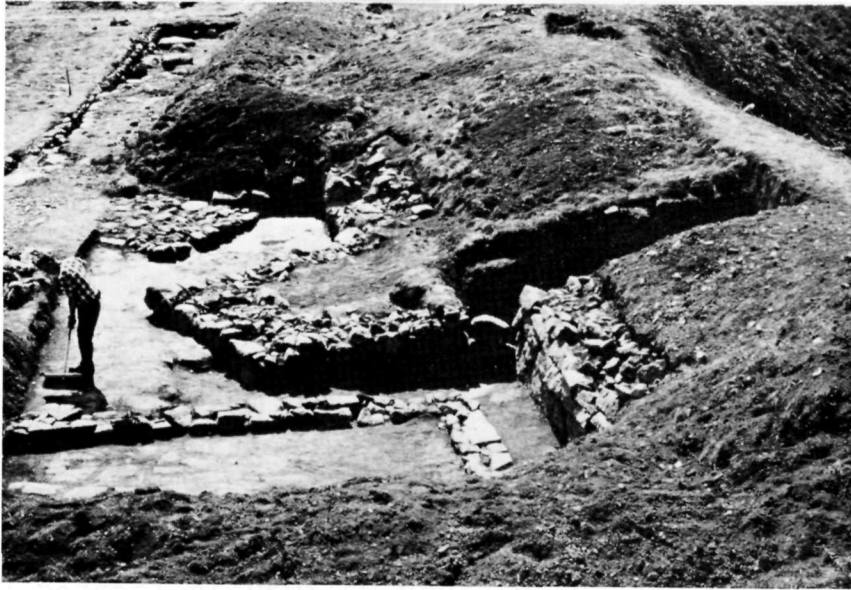
81 Gun platform after excavation, looking south. The southwest corner of the guardhouse is visible in the foreground. To the right of the guardhouse is the masonry retaining wall of the earthworks. To the west of the gun platform is an exploratory trench excavated in an unsuccessful attempt to find an early entrance to the fort.

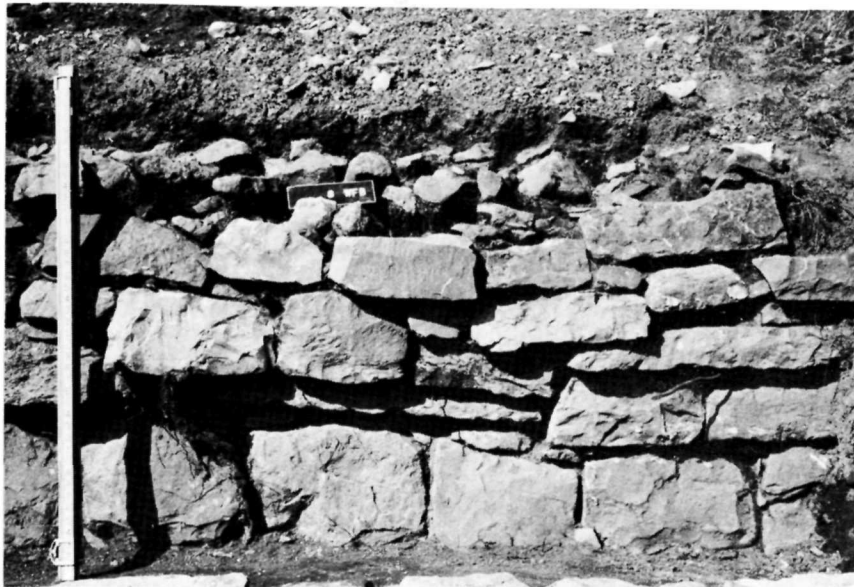
82 Masonry retaining wall; part of the earthworks retaining wall to the north of the gun platform.

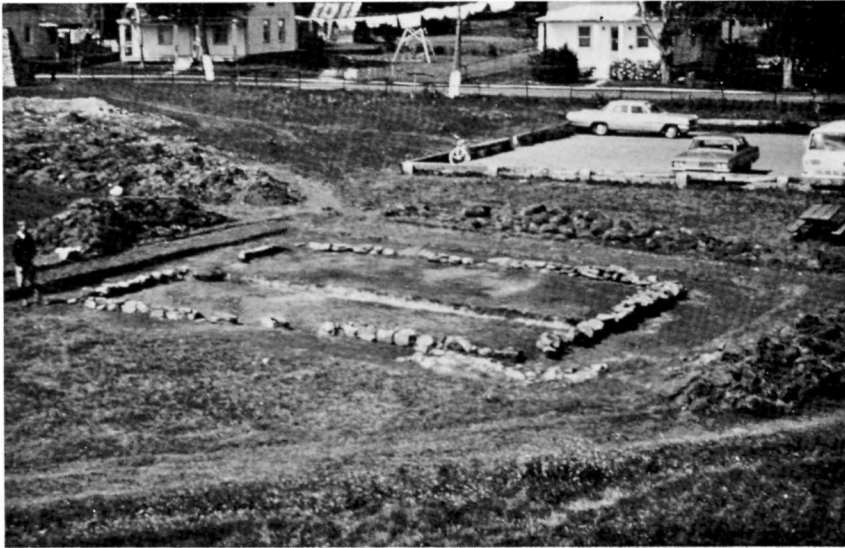
- 86 Barracks/carpenter's shop/stable after excavation, looking southwest, showing the stone foundations and entrances. The trench at the centre of the building was excavated in an unsuccessful attempt to find an earlier structure.

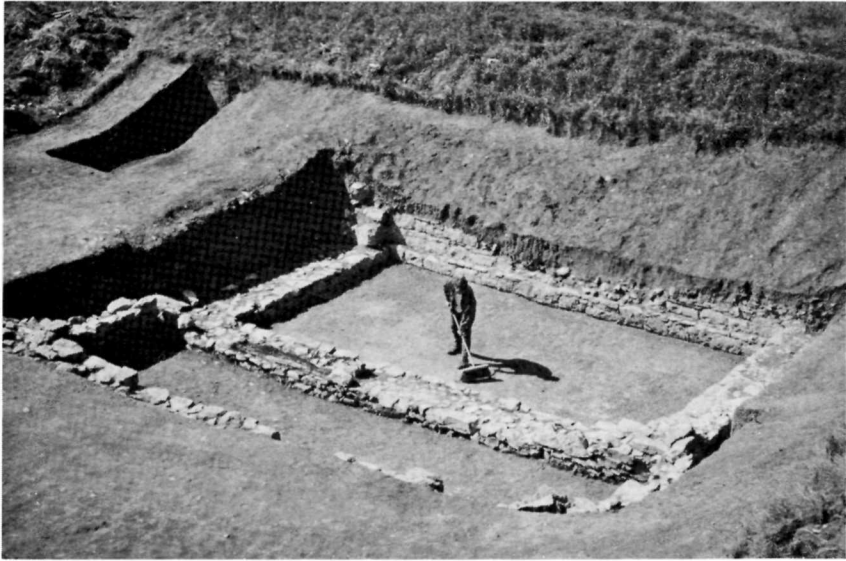
89 Powder magazine after excavation, looking west. The west wall was not completely excavated to prevent further erosion of the earthworks. The plank door sill is located near the south end of the centre wall. The trench to the left of the photograph was excavated to establish whether the masonry retaining wall associated with the gun platform extended further to the north, but no traces of the wall were found in the vicinity of the powder magazine.

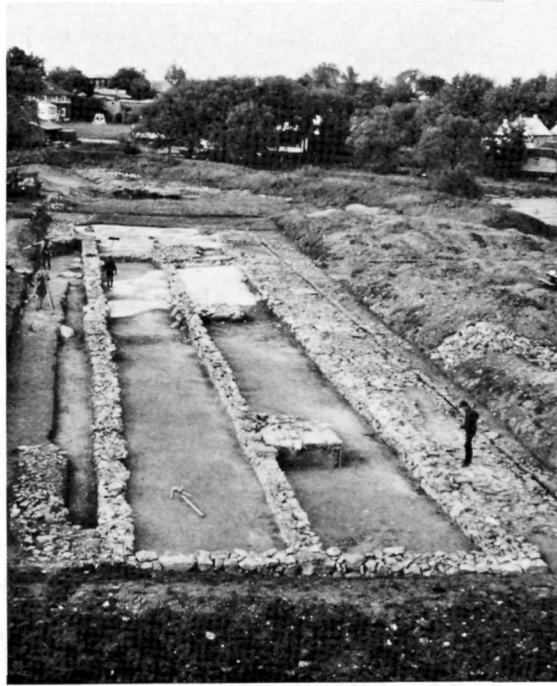
93 The stone barracks after excavation, looking north. Note the hearth bases, the central masonry bearing foundation and the walkway and drain on the east side of the structure. A fragment of walkway is visible in the lower left foreground.

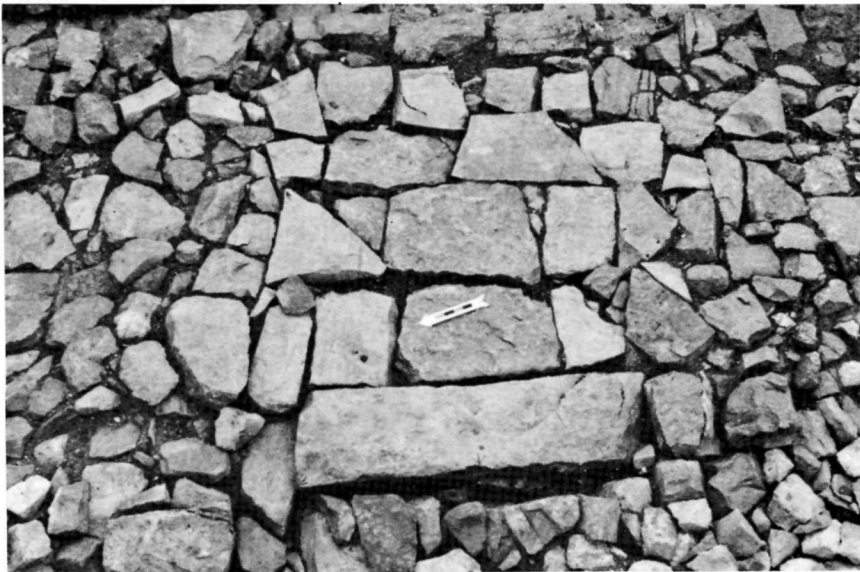
94 A section of an elevated walkway in front of one of the entrances to the stone barracks. The scale on the north arrow is in metric feet.

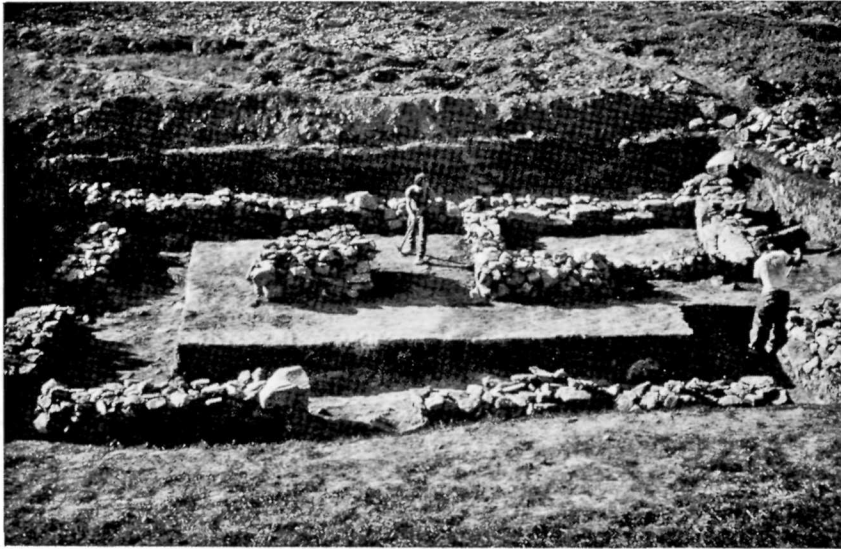
- 98 Commissariat officer's quarters/church after excavation, looking west. Note the small cellar in the upper righthand corner of the structure and the two masonry hearth bases at left and right centre of the photograph.

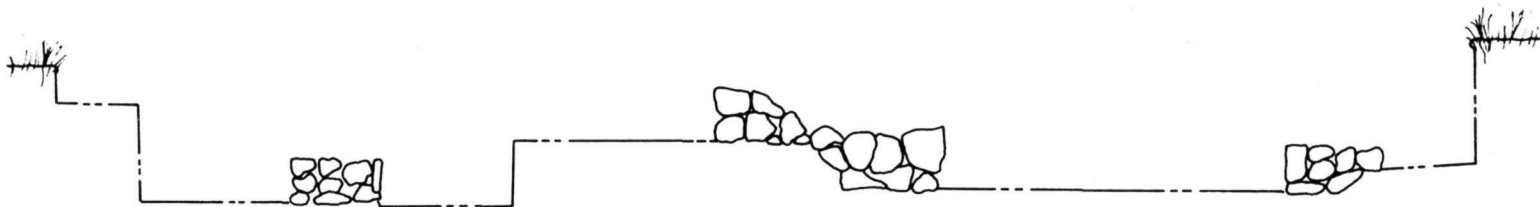
100 North-south and east-west sections of the commissariat officer's quarters/church, showing the masonry foundations and what are thought to be hearth bases. (Sections by Michel Lapierre.)

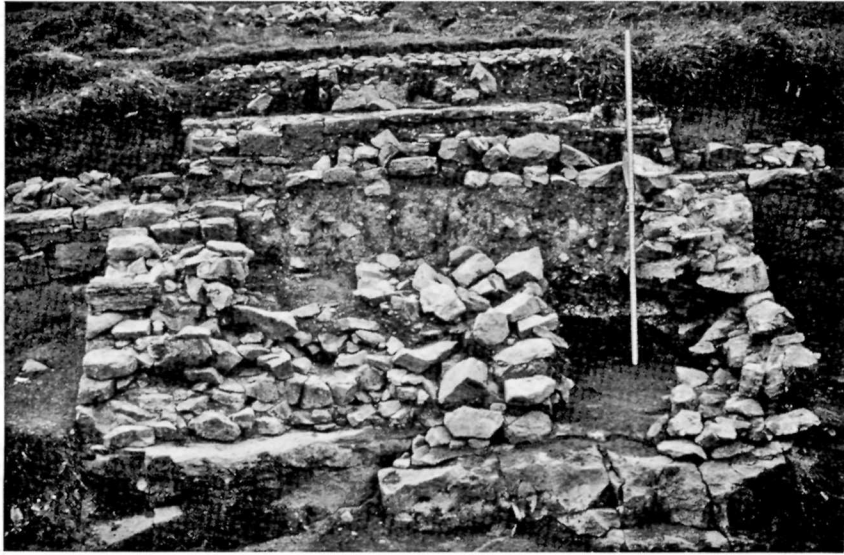
101 Western bridge abutment after excavation. In the upper background is the edge of the stone walkway.

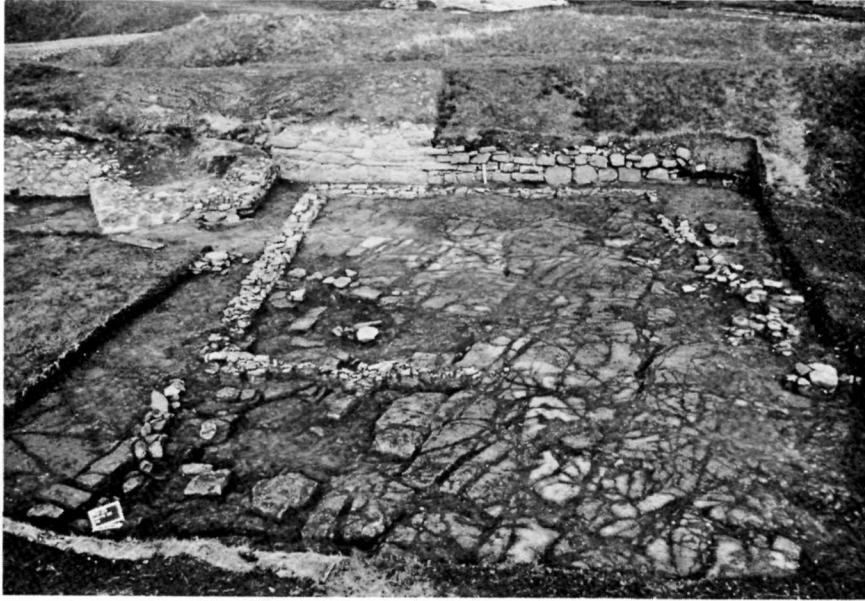
- 105 Guardhouse after excavation, looking west. Note the fragmentary condition of the foundation in the foreground and at right. In the background to the left is the gun platform and on each side of it are stone retaining walls at the foot of the earthworks. Note also the bedrock.

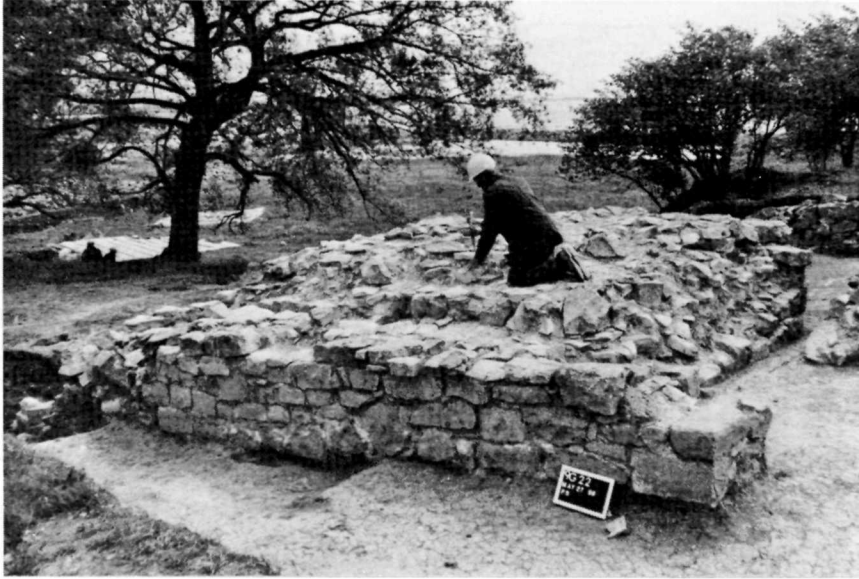
108 The bake house after excavation looking east. Note the gaps in the wall on the south side. The worker is cleaning the top of the hearth base.

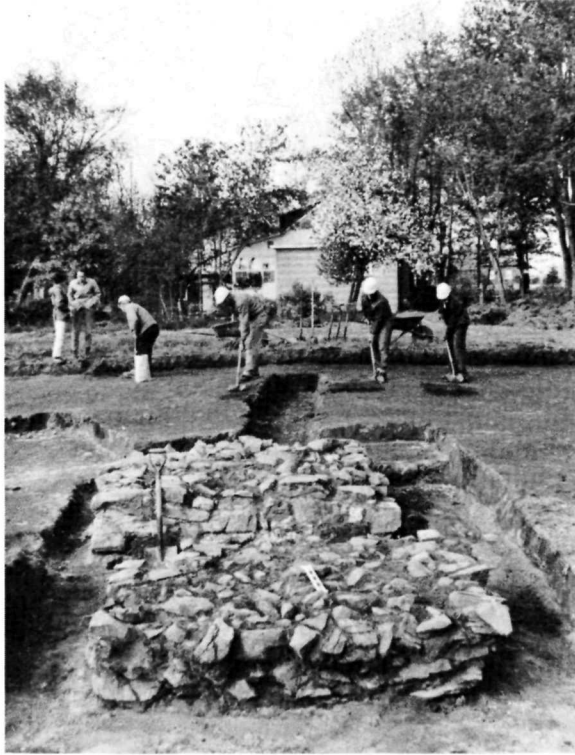
111 Barracks master's quarters, looking southwest. The two masonry hearth bases in the foreground illustrate the irregular placement of the unworked stones used in their construction.

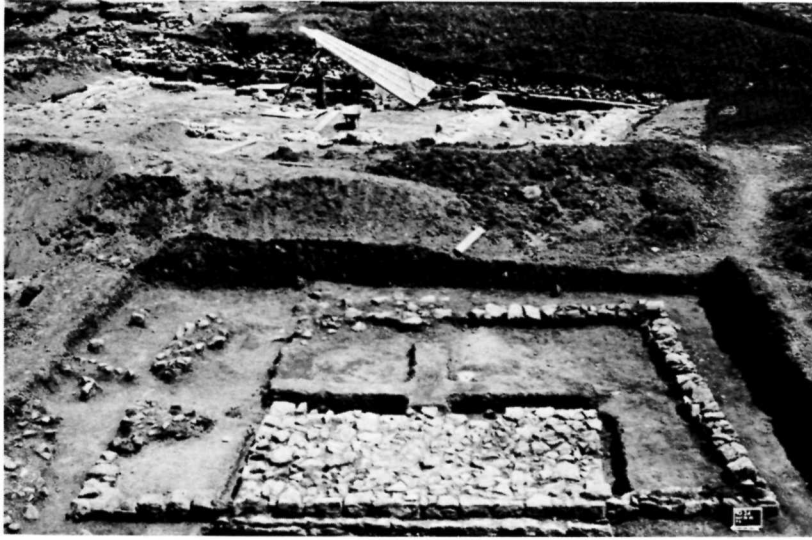
114 Cooking house after excavation looking east, showing the foundations and the base of the cooking apparatus. The T-shape in the centre of the structure is a baulk. In the background, the storehouse/gunshed is undergoing consolidation.

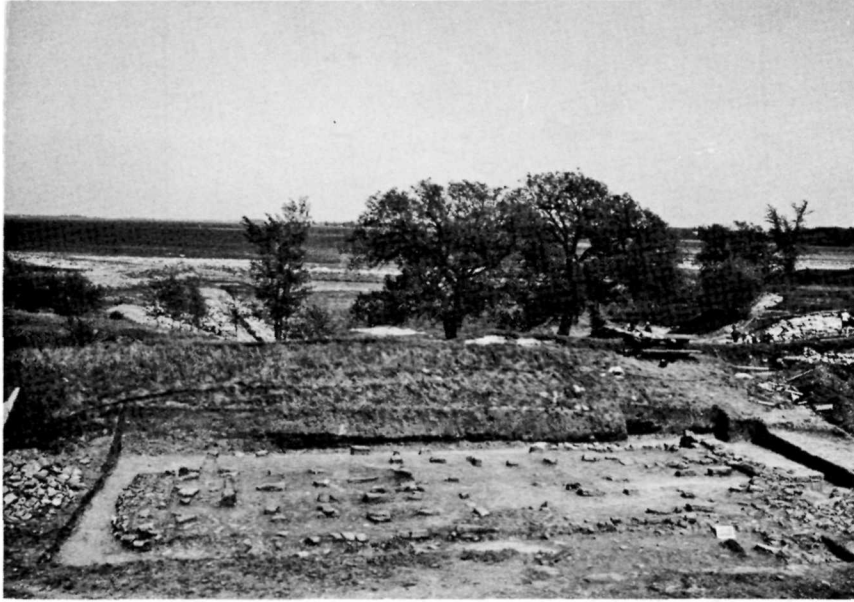
116 The barracks/store after excavation, looking east. The masonry hearth base and foundation wall are to the right of the foundation. Single stones are used to support the floor joists. At the left are the remains of a stone walkway abutting the north end of the structure.

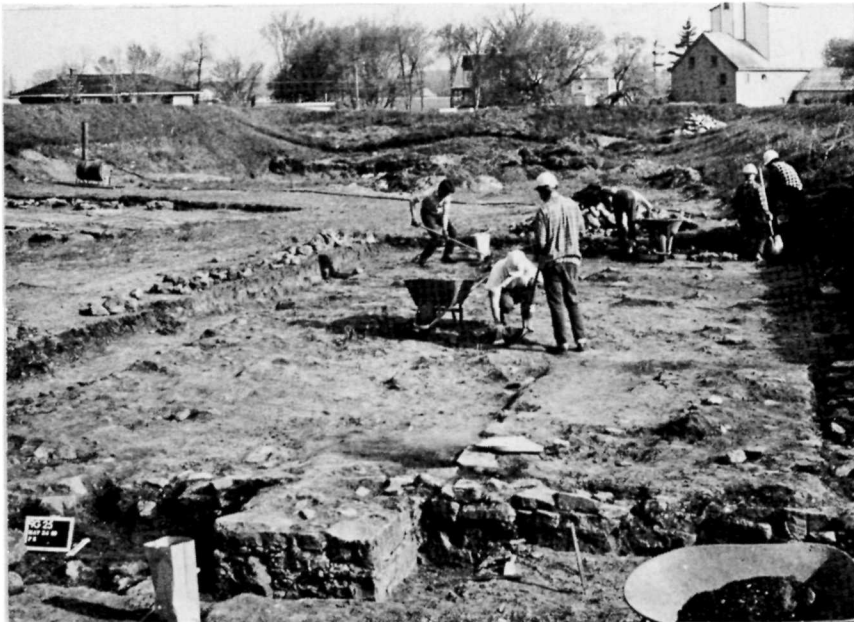
117 The barracks/store during excavation, looking north. Note the masonry hearth base and the north foundation wall in the foreground.

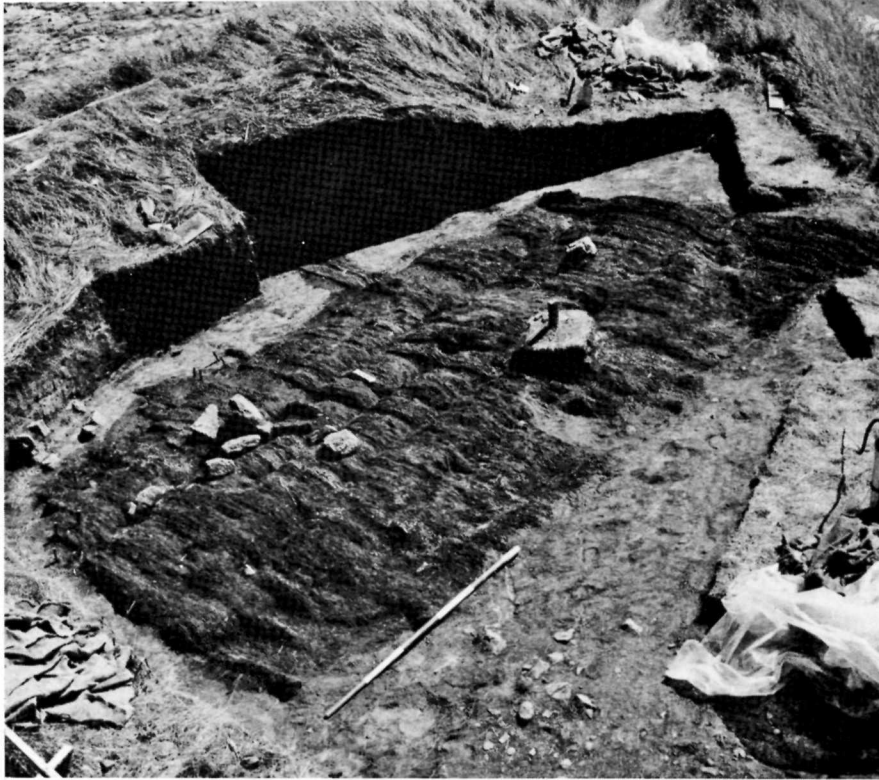
119 Southeast gun platform after excavation, looking south. The uneven configuration of the platform is caused by the sunken areas where the sleepers have rotted. The nails which held the rail in place are visible at the left of the photograph. The unexcavated area at centre is not part of the gun platform but a surveying stake.

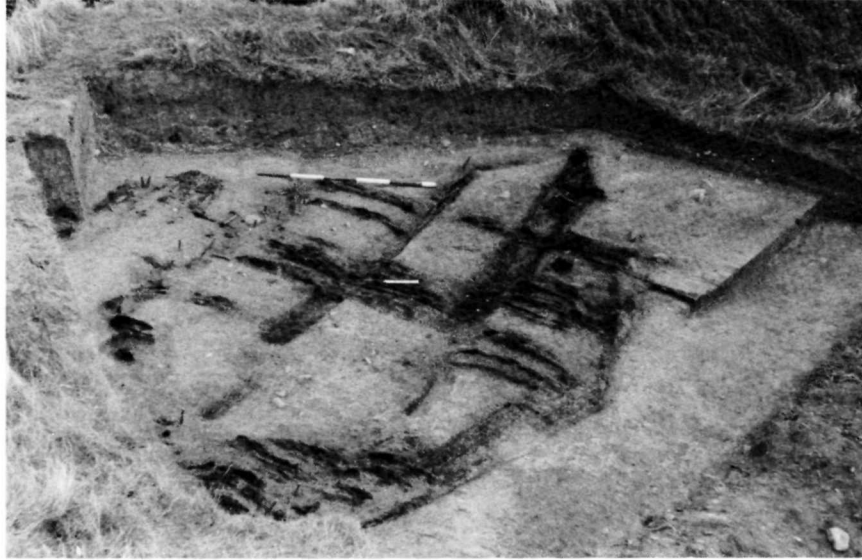
121 Northwest gun platform after excavation, looking east, showing the sunken areas where the sleepers have rotted and the nails protruding from the rotted platform planks.

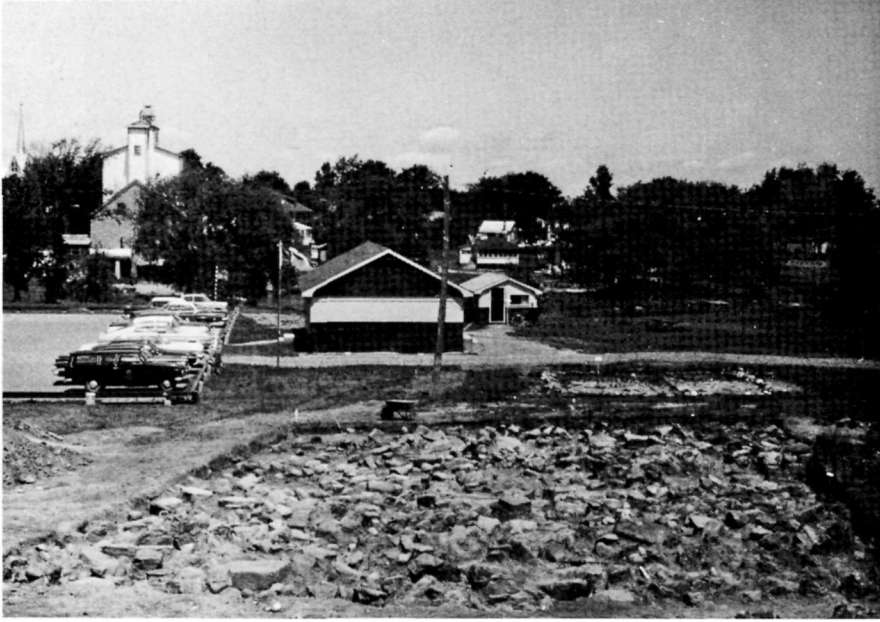
125 Officers' servants' quarters, looking northeast. Excavation did not reveal any remains of this structure, or of other structures located here according to plans of the fort. Only a large quantity of randomly distributed unworked stones were uncovered, as well as a refuse area.

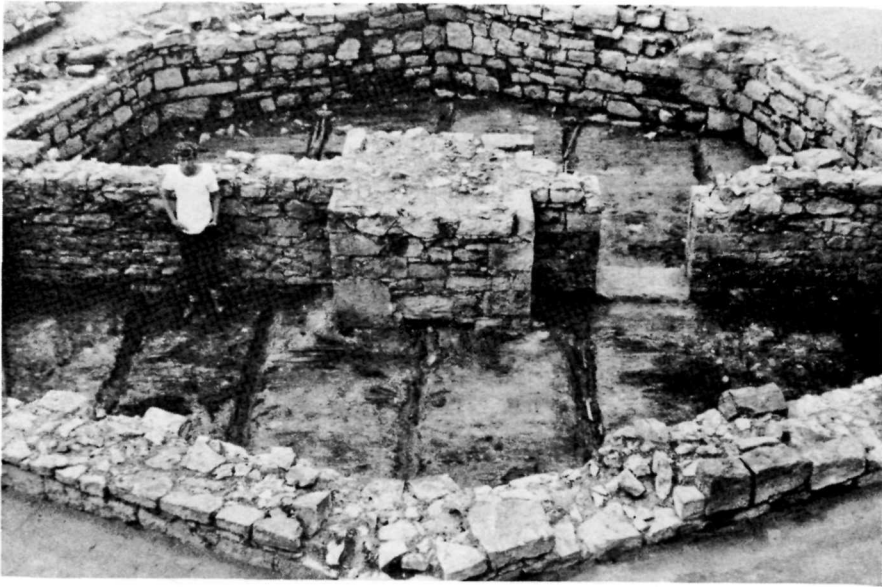
132 The octagonal blockhouse: general view of excavation
from north.

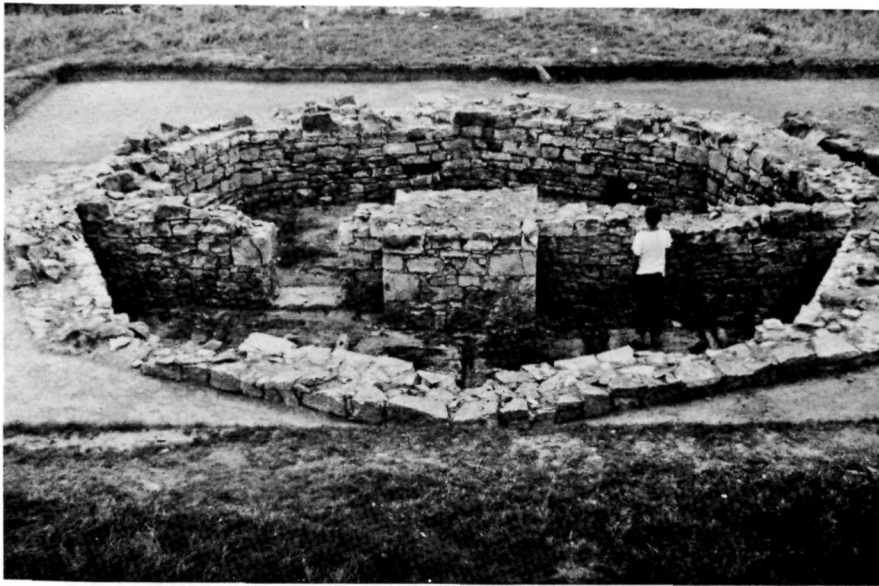
133 The octagonal blockhouse: general view of excavation
from south.

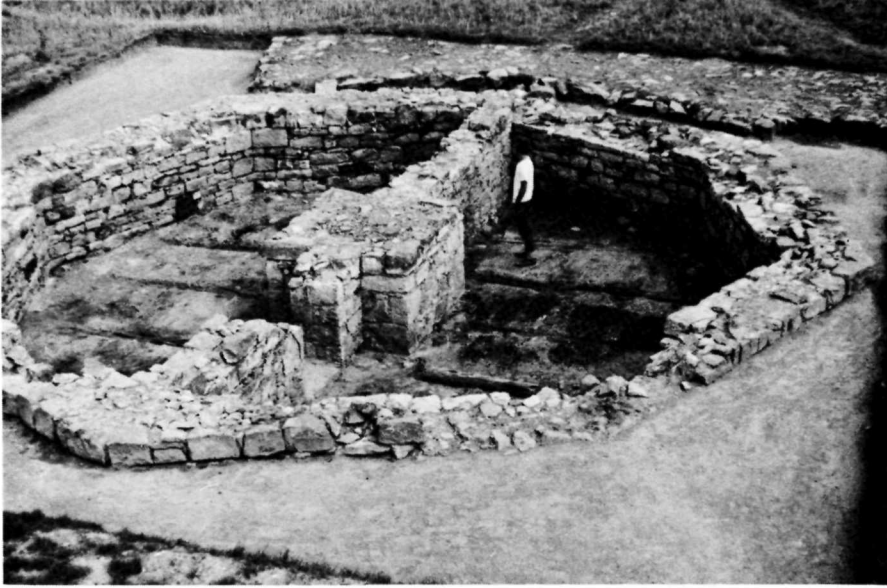
134 The octagonal blockhouse: general view of excavation from west.

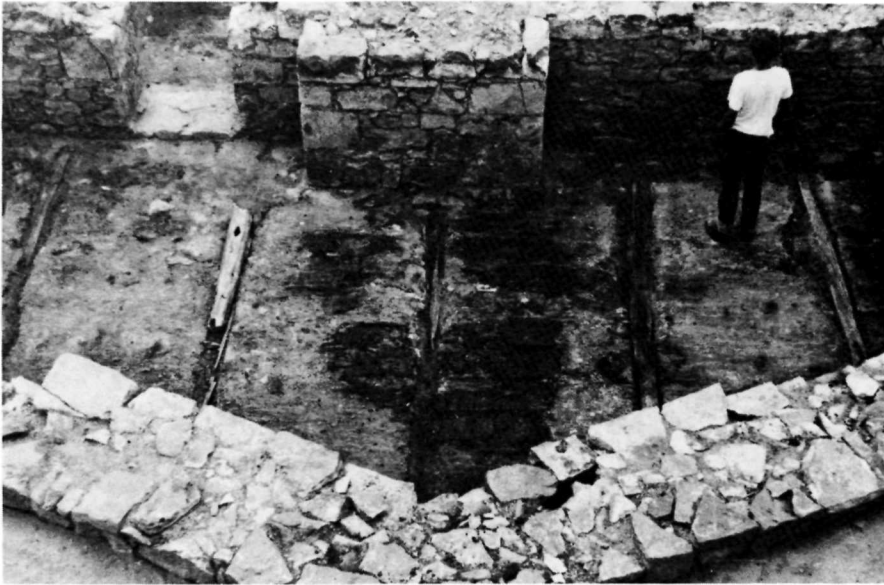
135 The octagonal blockhouse: detail of flooring on southwest side of cellar.

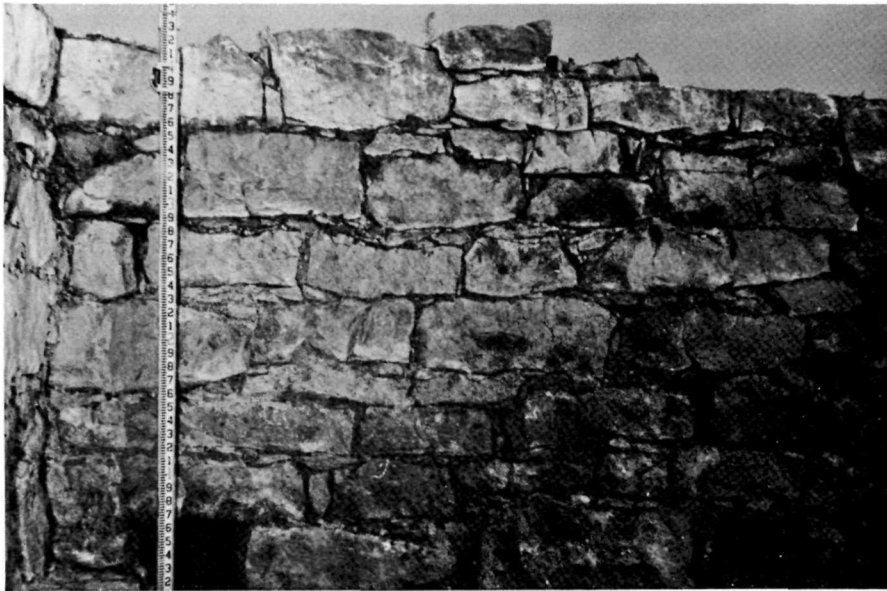
137 The octagonal blockhouse: central bearing wall to east of hearth base.

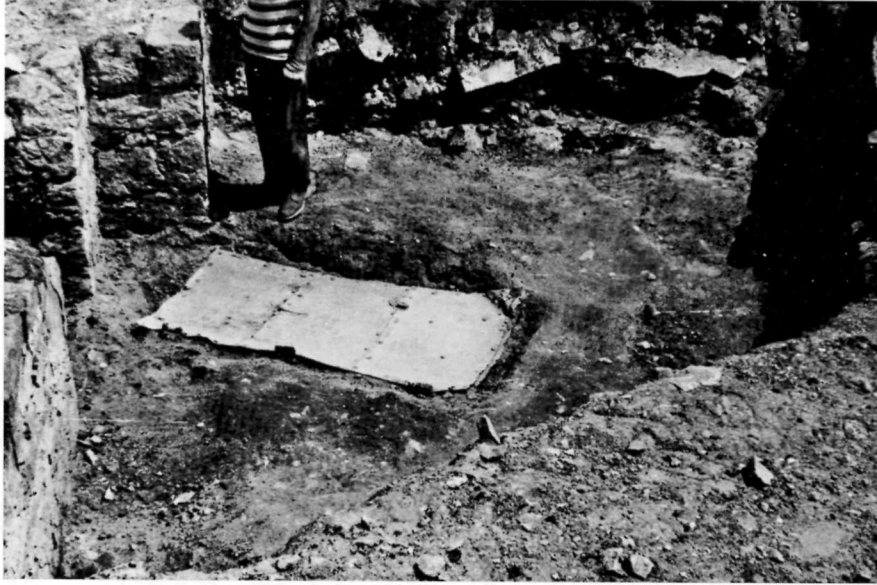
138 The octagonal blockhouse: magazine door in situ. Note the metal panels.
