THE HALIFAX CITADEL, 1906-51

THE CANADIAN PERIOD

by Brenda Dunn

1977

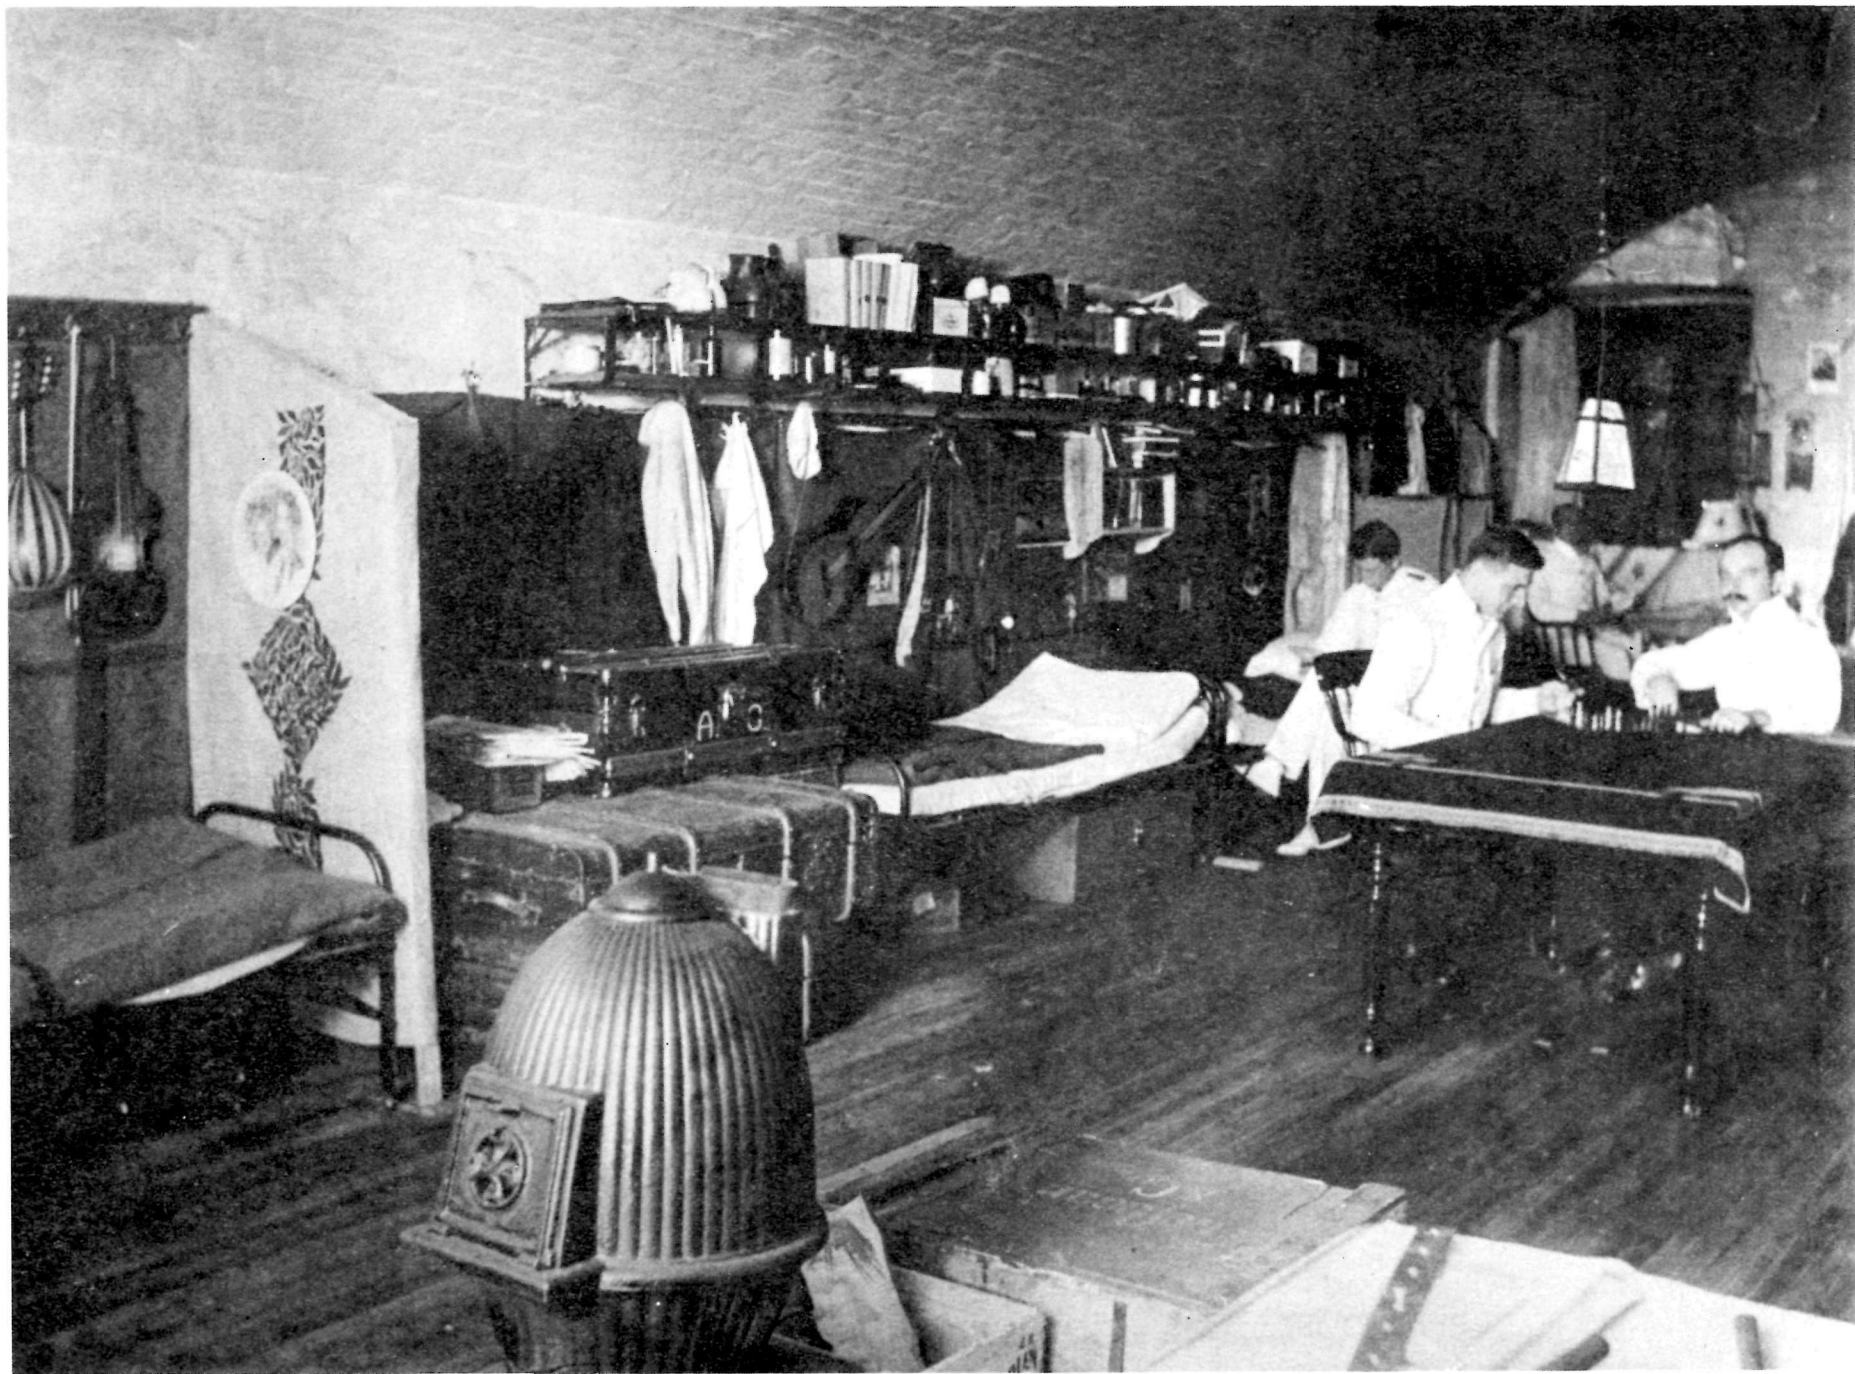
- 1 One of the Cavalier casemates occupied by the prisoner-of-war camp during World War I. (Public Archiyes of Nova Scotia.)

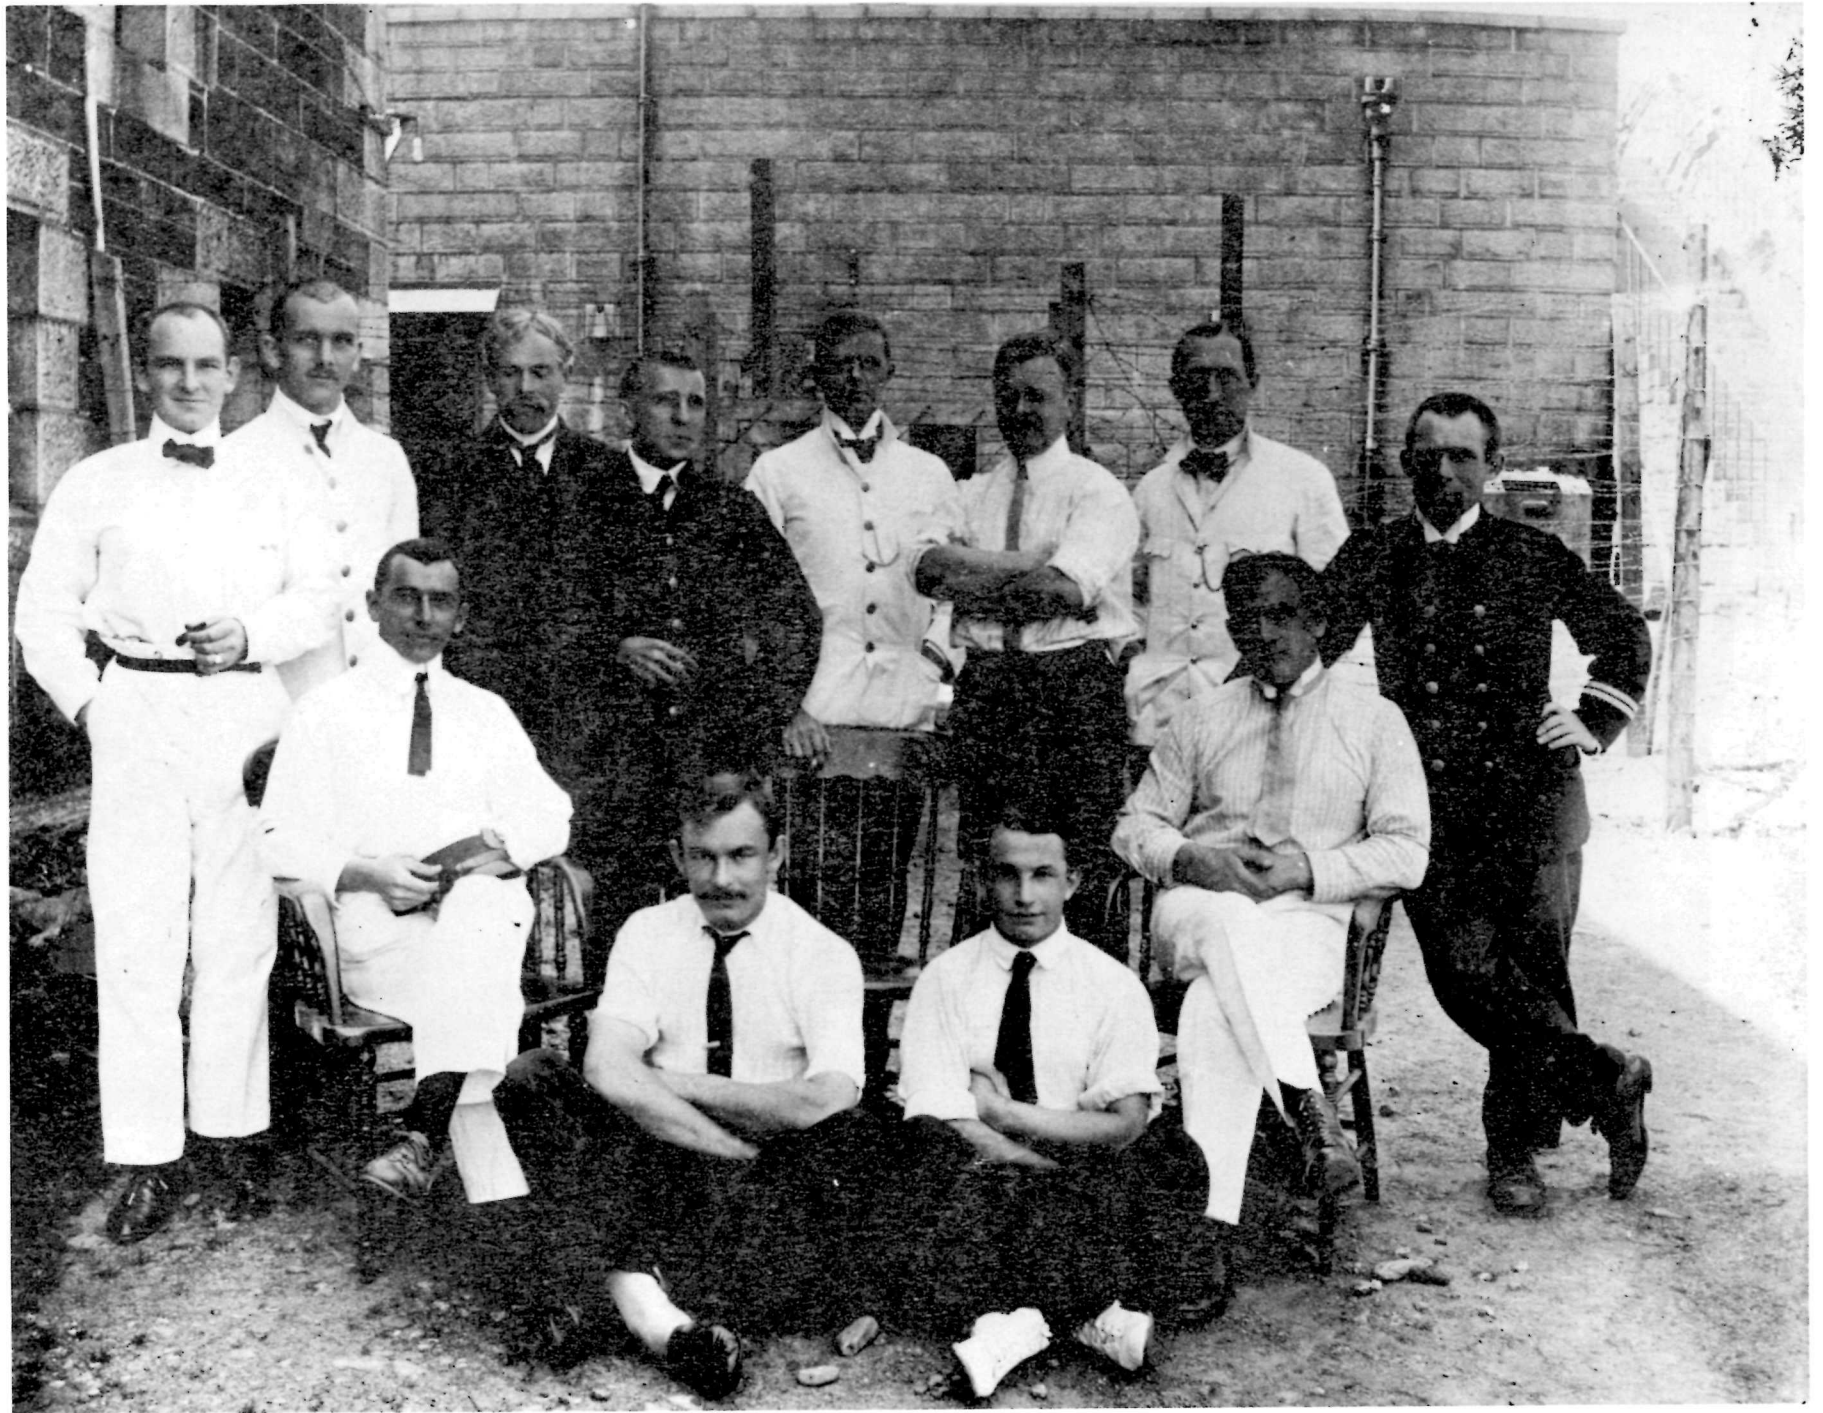
- 3 Prisoners of war posing at the north end of the Cavalier, circa 1915.  
Some of the men are also seen in the Cavalier casemate in figure 2.  
(Department of National Defence. Directorate of History.)

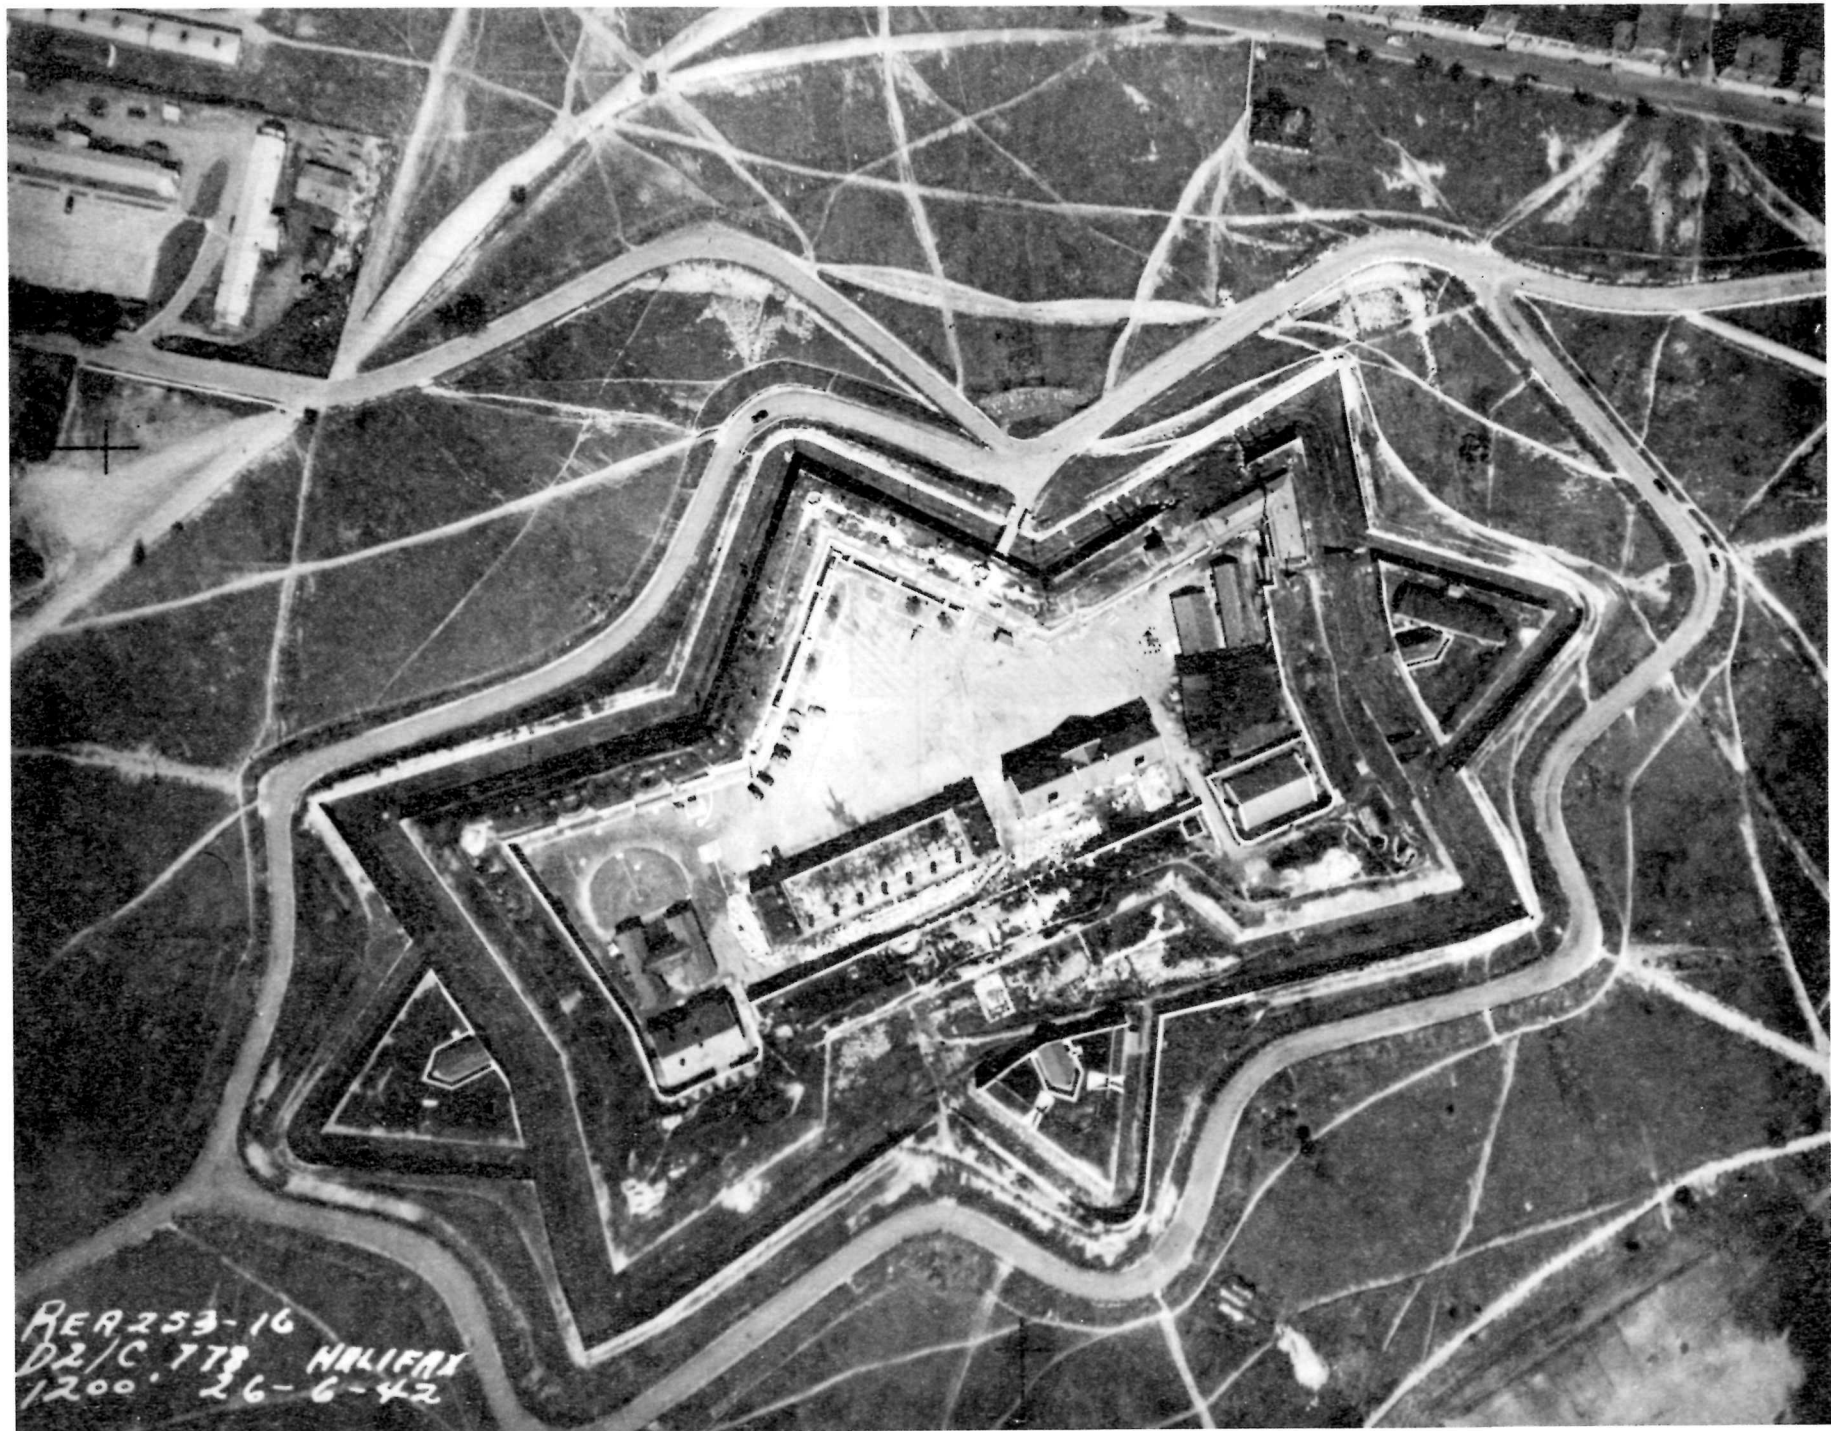
6      Aerial photograph of the Citadel, 1942. (Department of National  
Defence. C.F.B. Rockcliffe REA 253-16.)

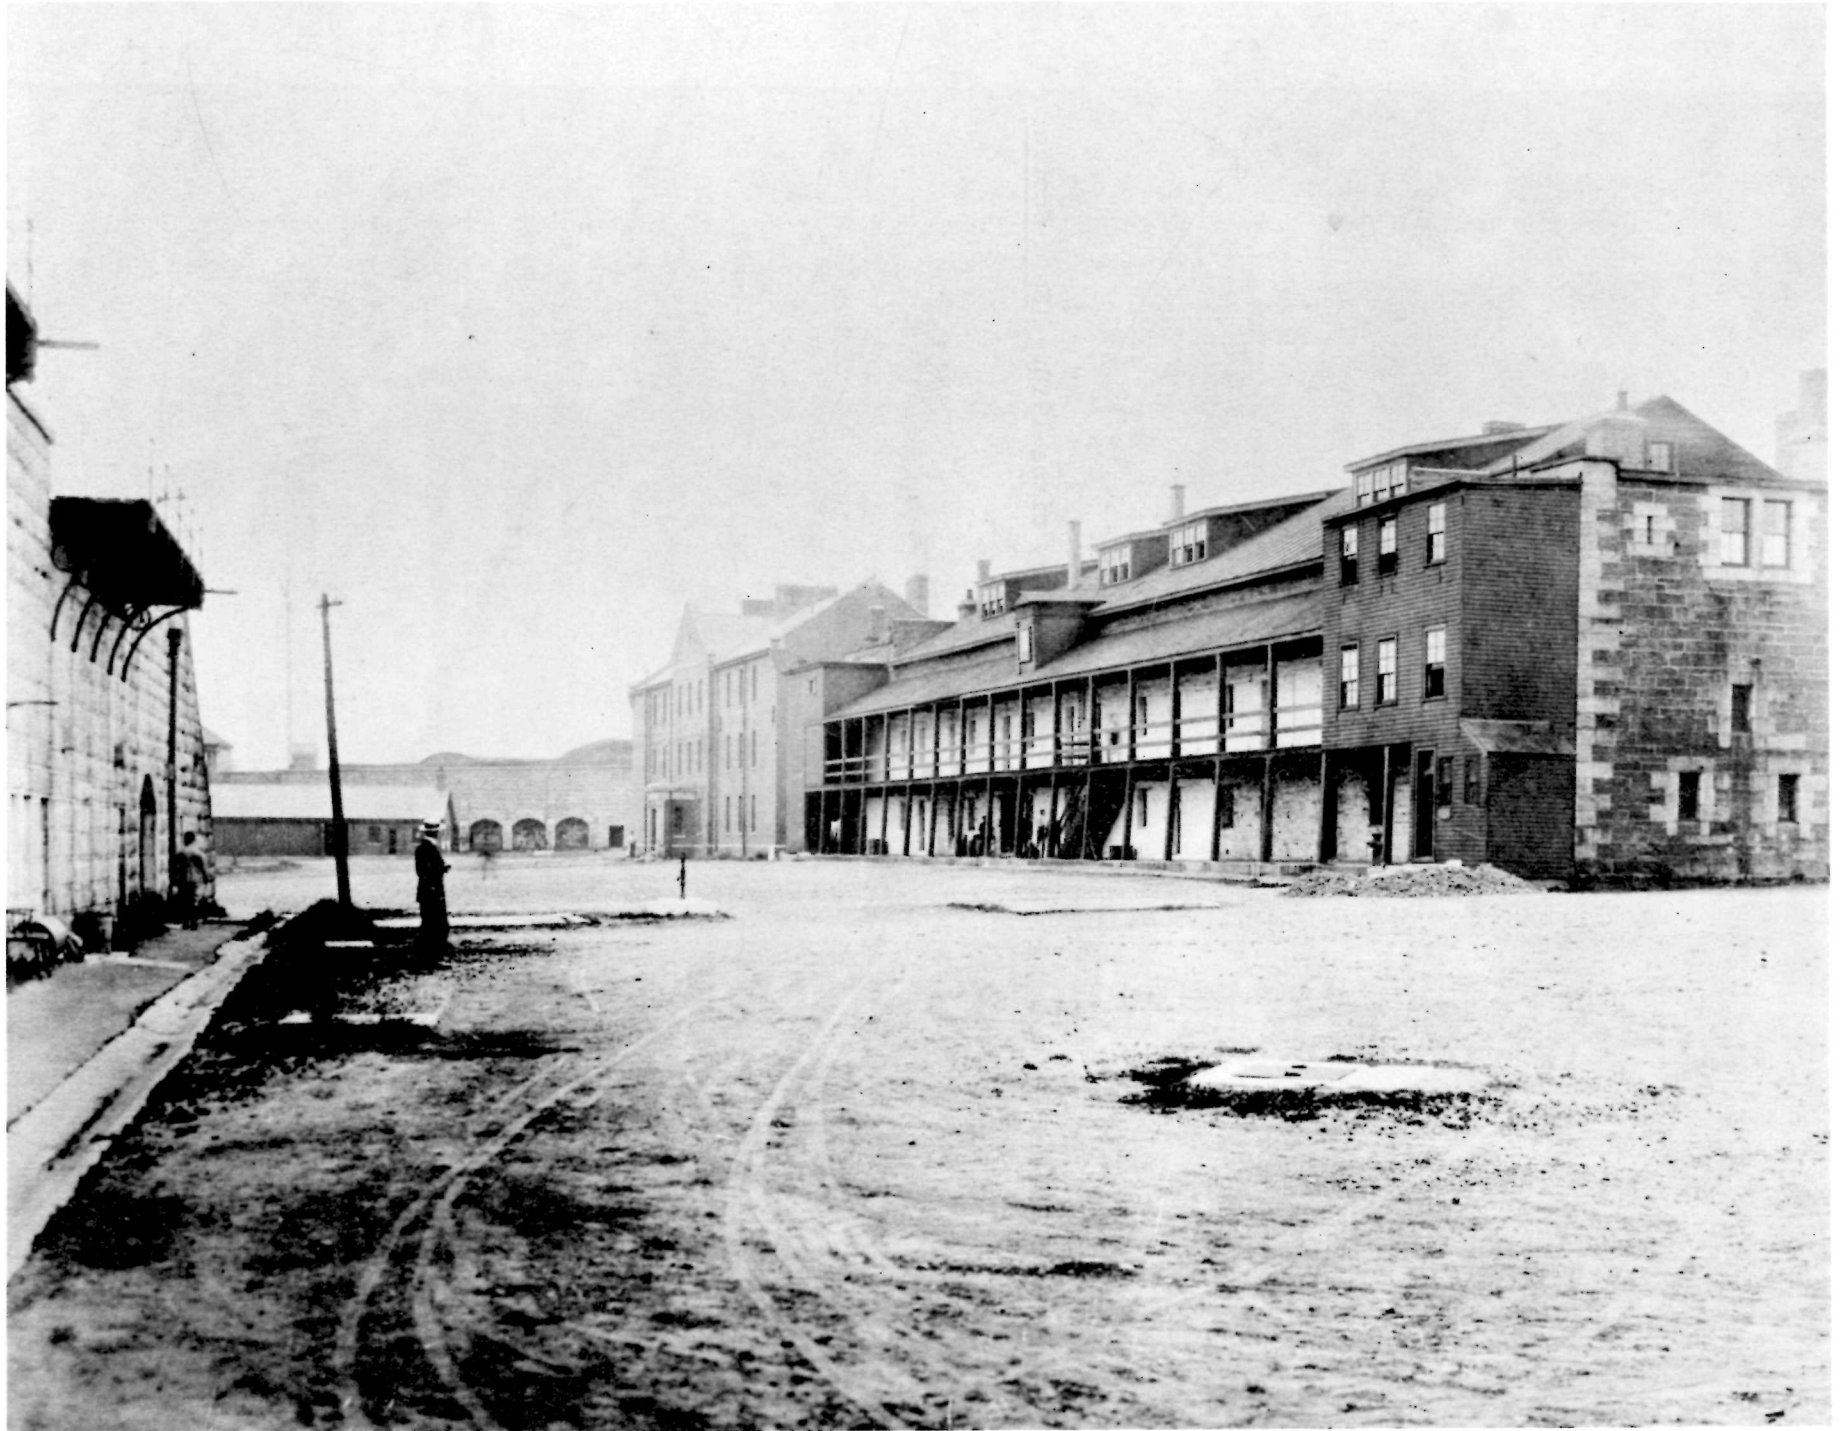
10 Photo of parade taken from the northeast salient, July 1928. In addition to raising the roof of the Cavalier, the Canadians had also re~~v~~atted the structure at the south end of the verandah and whitewashed or painted the east wall. The new building at the foot of the storm mast and the renovated front~~w~~all of casemate 31 are also seen ~~o~~n the photograph. (Nova Scotia Museum. P 170 28.121 (6295))

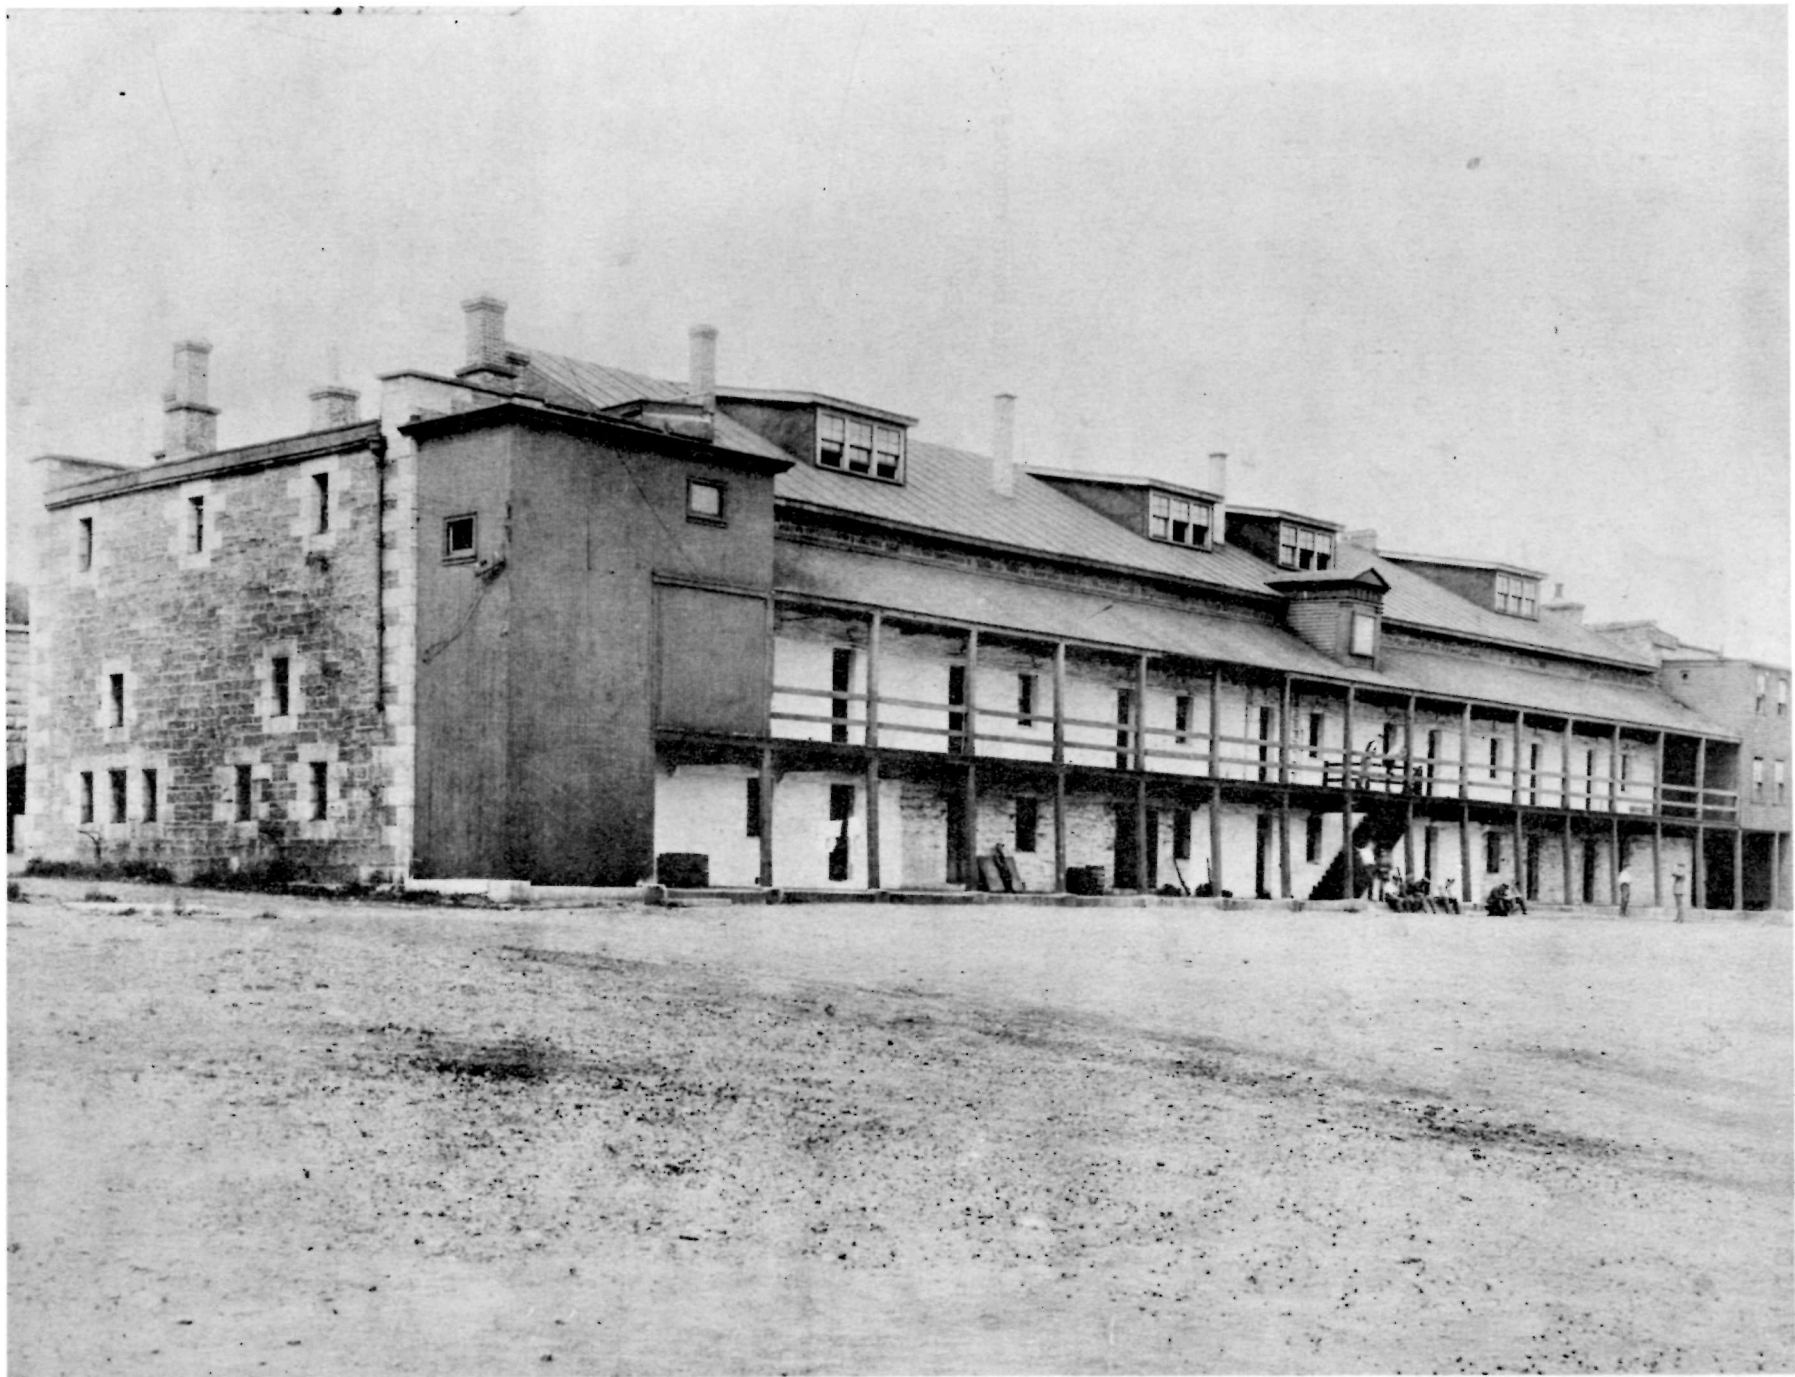
- 12      The Cavalier in 1928, after the construction of the third floor and the new roof. (Nova Scotia Museum, P 170 28.120 (6294), Gauvin and Gentzell, 4 July 1928.)

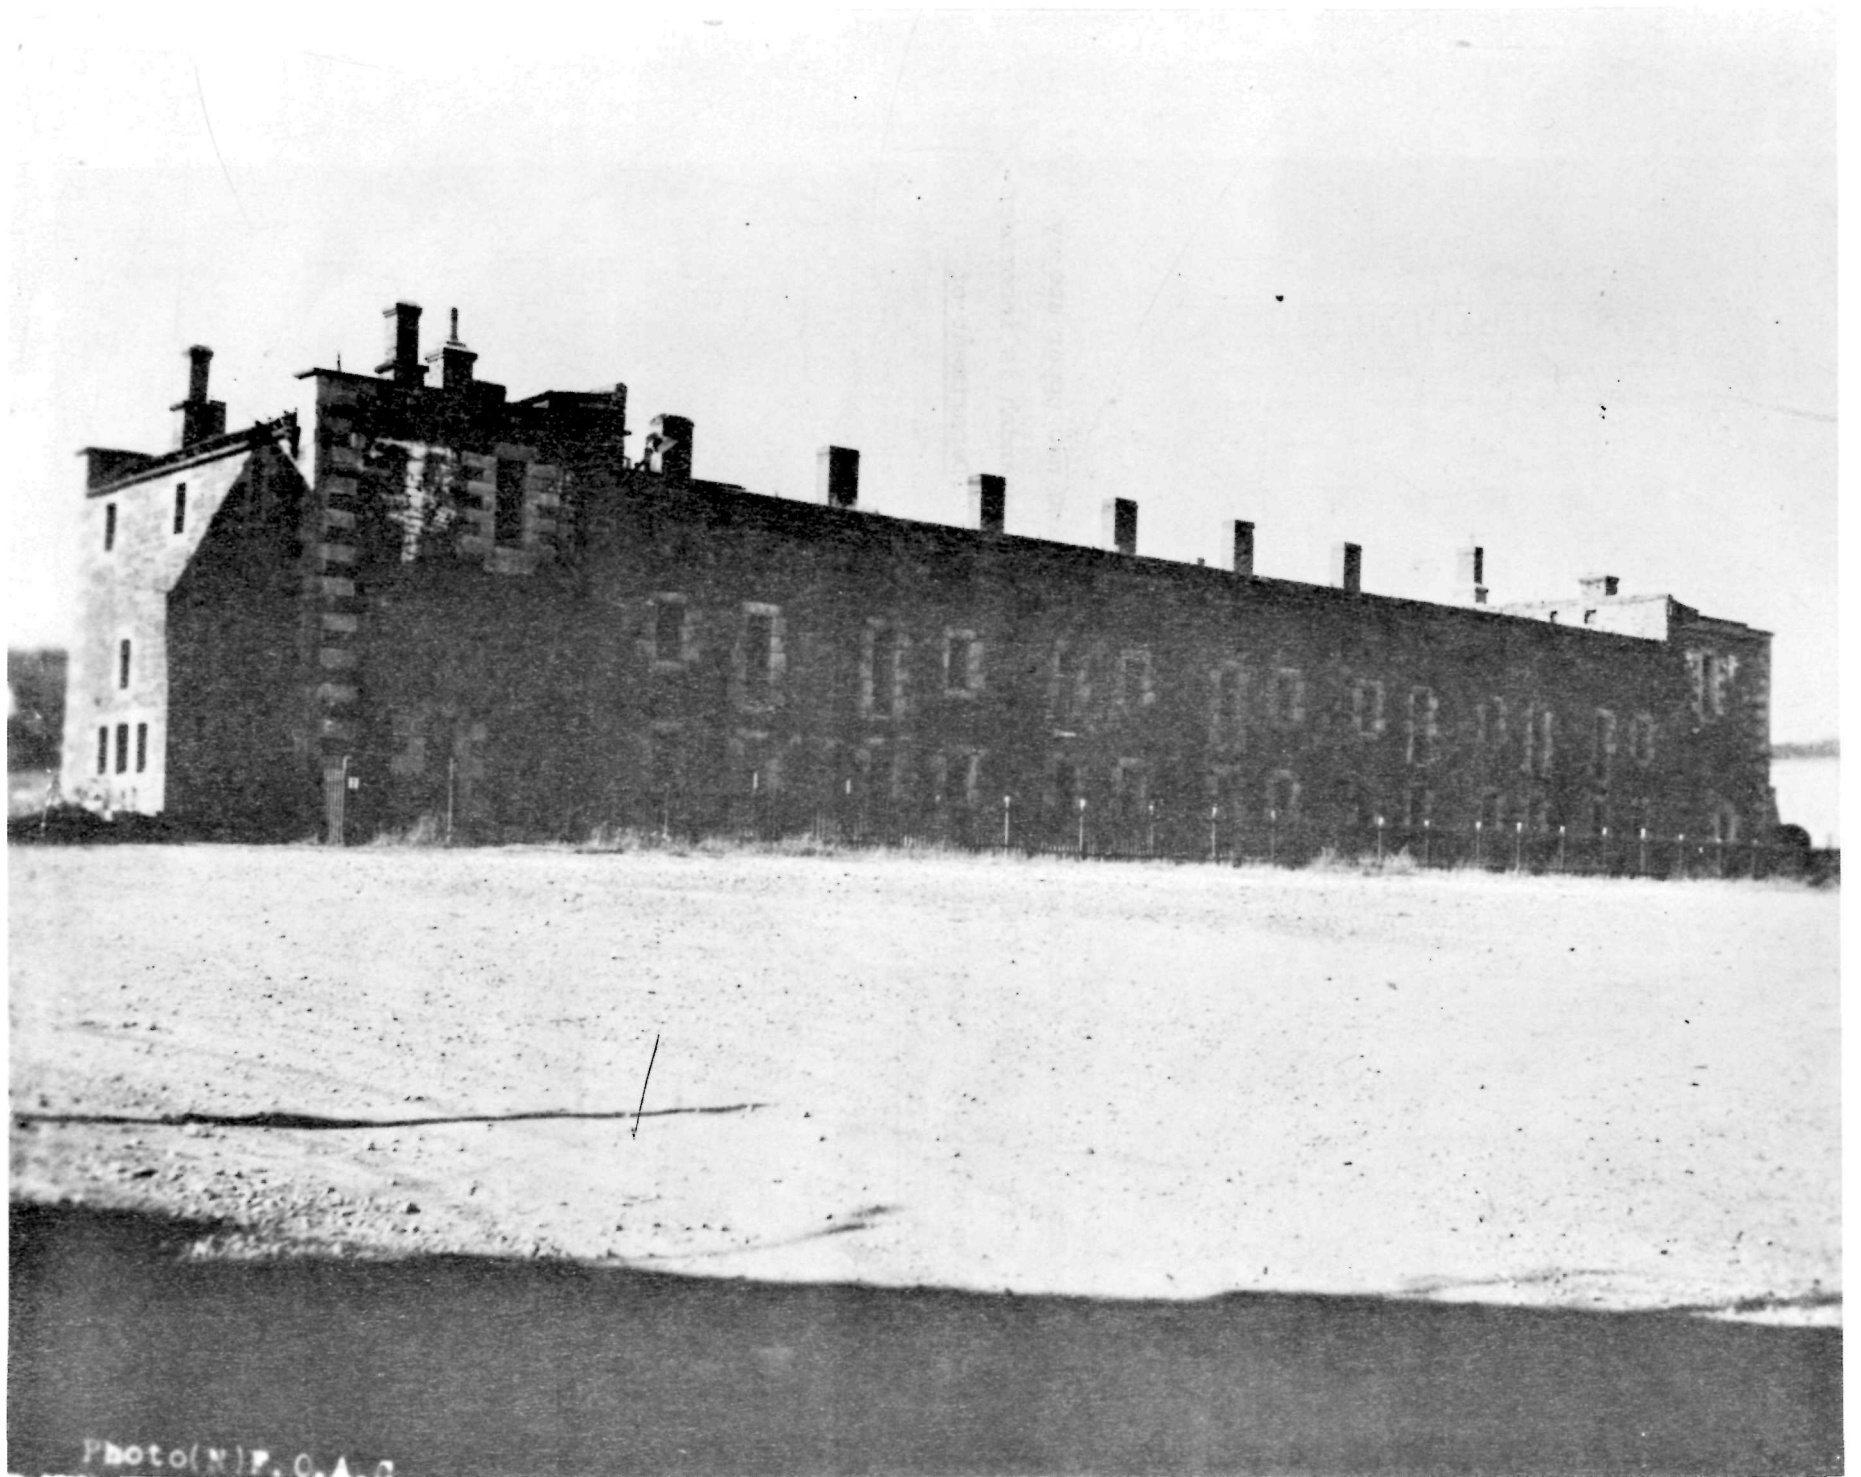
13      The Cavalier in 1950. The pitch roof and verandah had been removed.  
          (Public Archives of Canada. Massey Photo No. 2, HS - 12486)

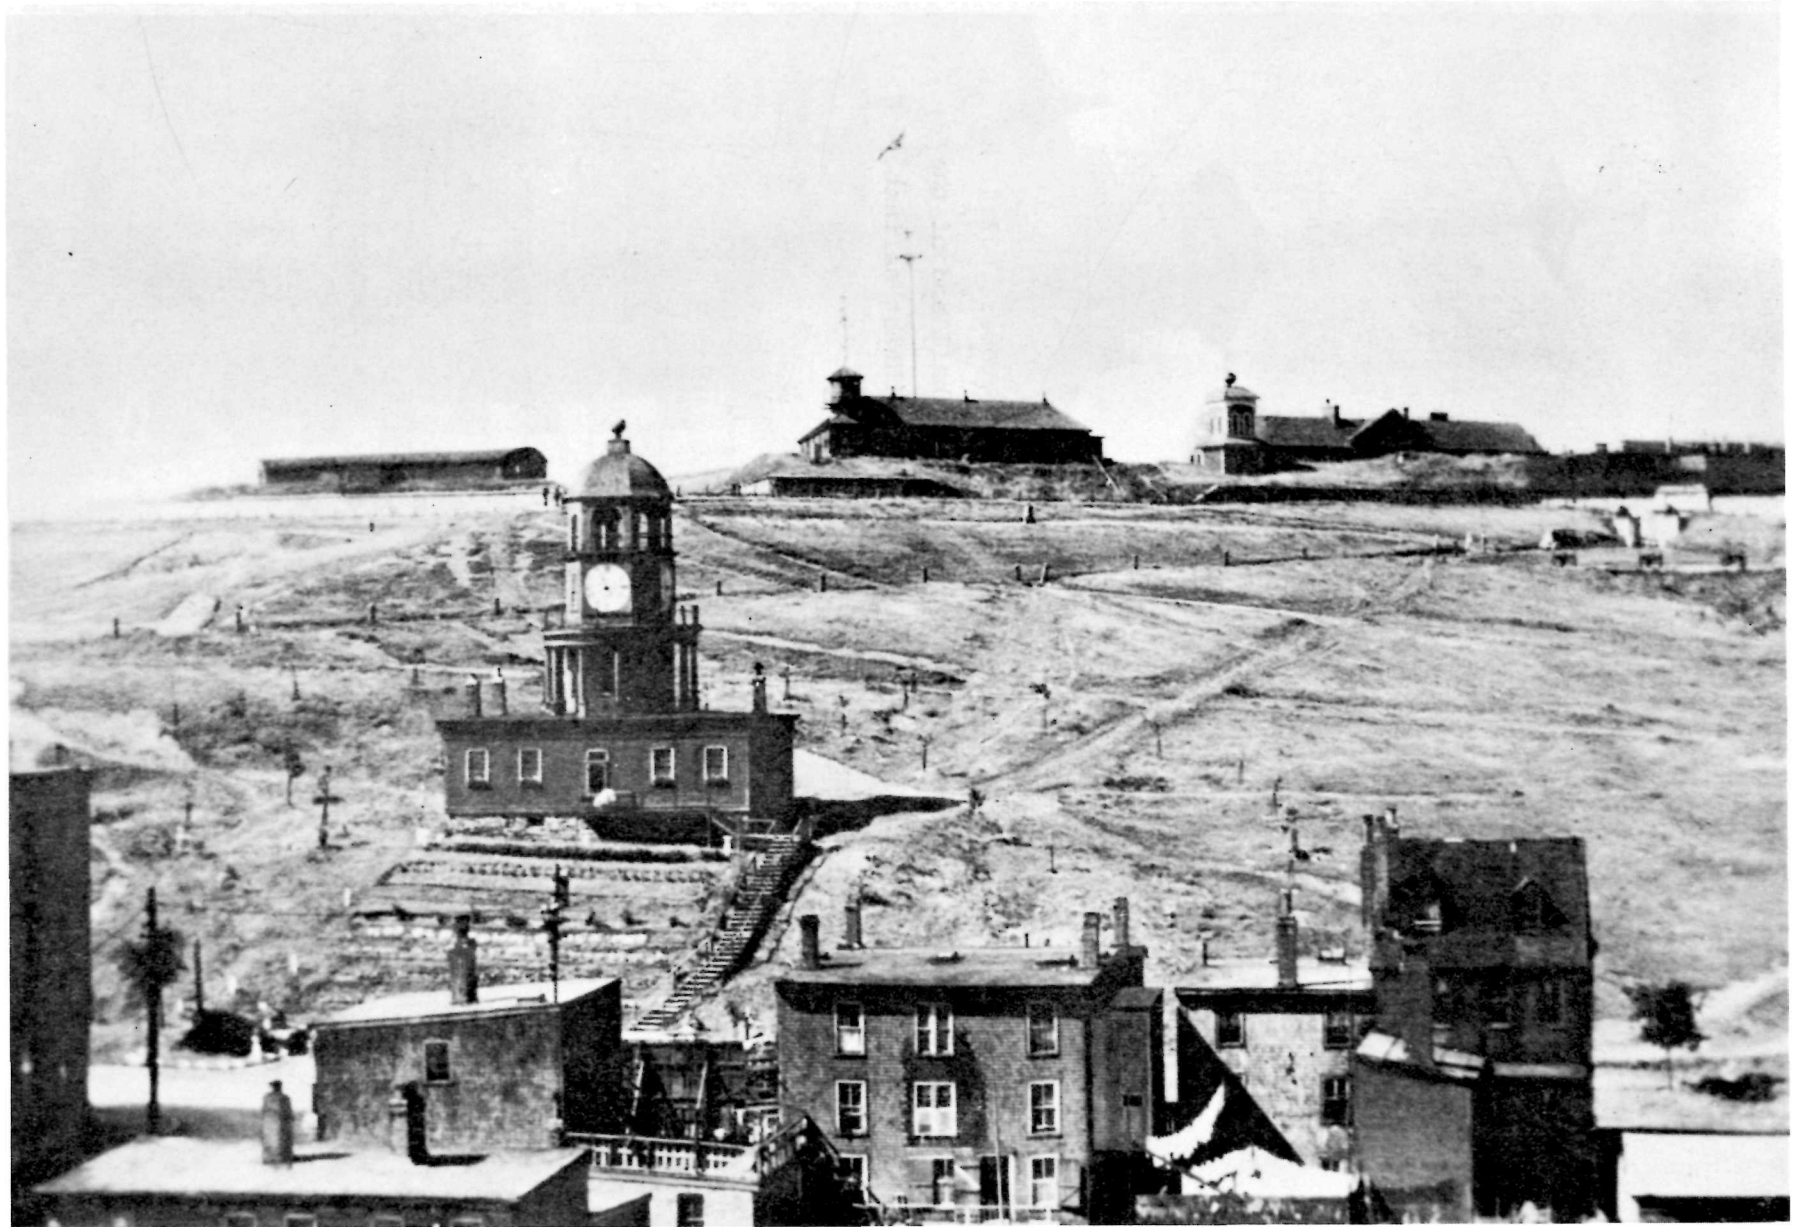
- 21 View of the east slope, circa 1929. The drill shed, signal station and time ball gave the east slope a distinctive appearance during the Canadian period. (Mr. Warren Schaffner and the Public Archives of Nova Scotia)

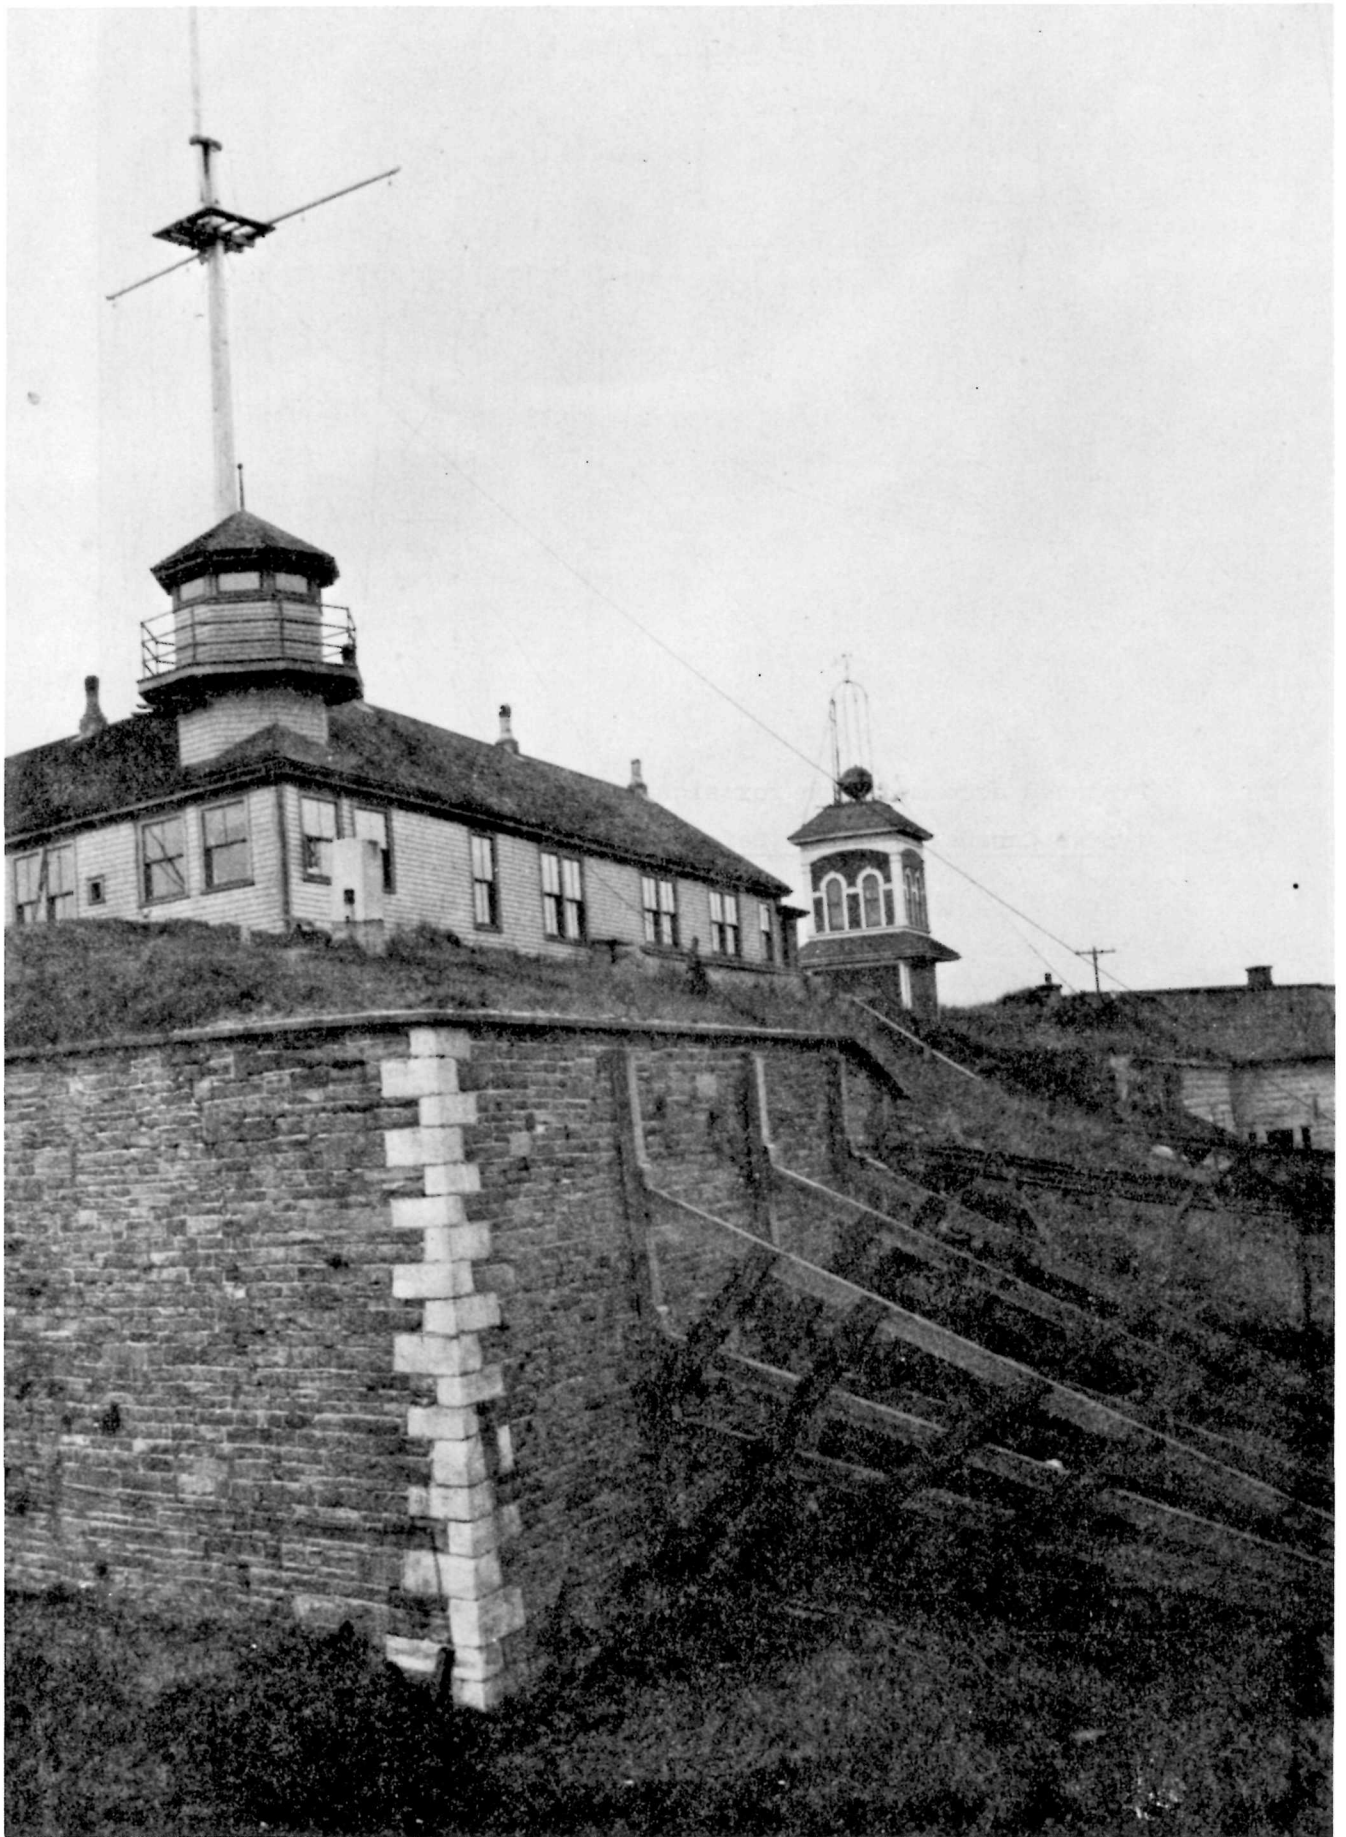
- 22 "The Citadel Walls in Halifax, Nova Scotia, 8 October 1927." A good photograph of the signal station and time ball and of the timber strutts supporting the escarp of the southeast salient. (Public Archives of Canada. PA-87819.)
