THE HALIFAX CITADEL, 1906-51

THE CANADIAN PERIOD

by Brenda Dunn

1977

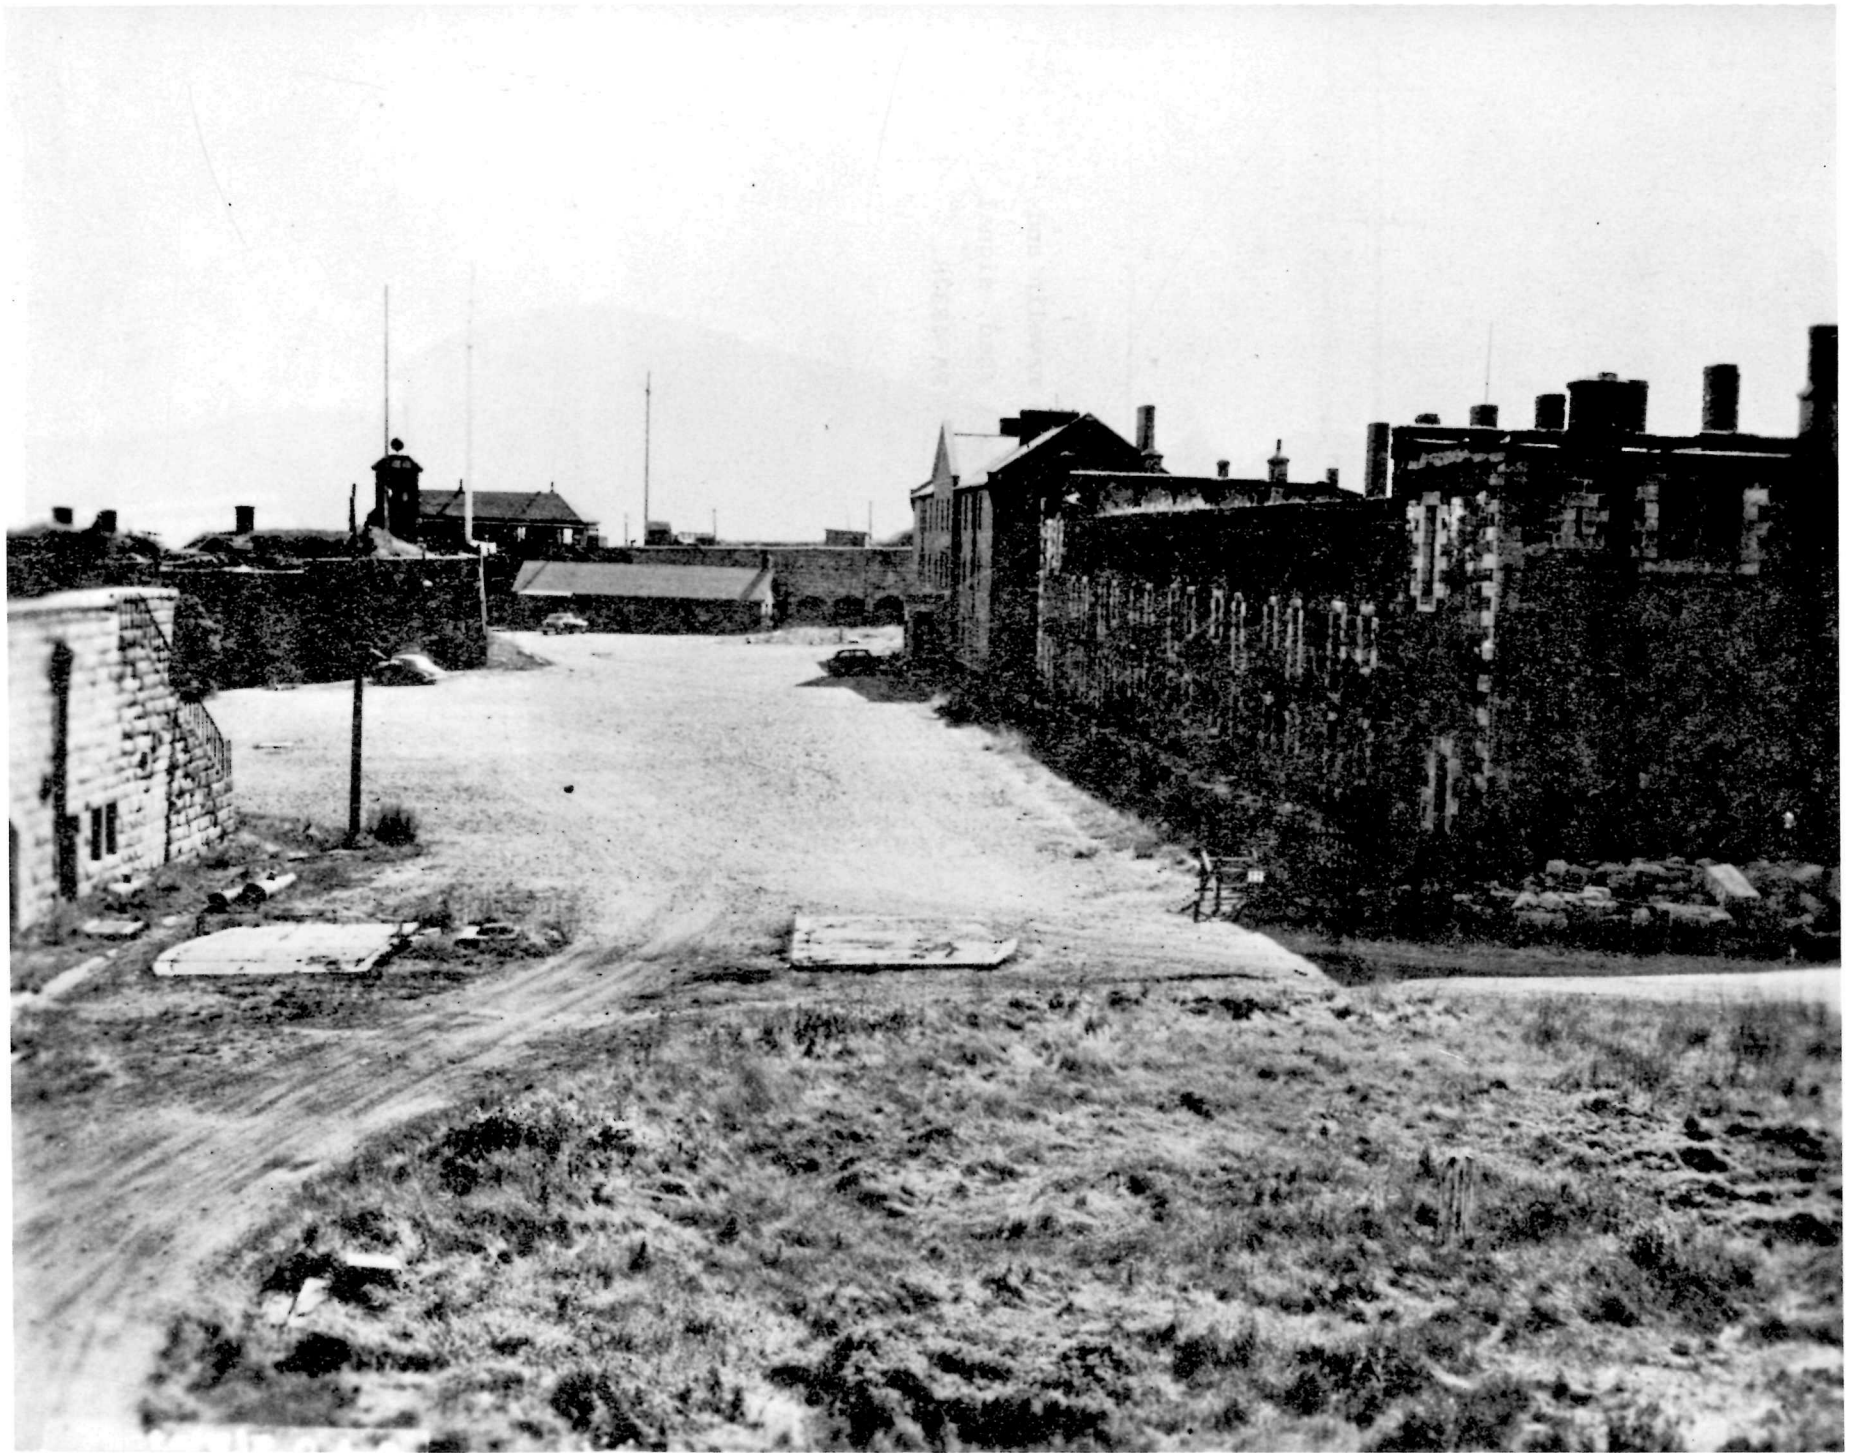
- 24 Photo of parade from northeast salient, 1950. Compare with figure 10. (Public Archives of Canada. Massey Photo No. 22, HS - 12483)

There is little obvious difference in the exterior of the building in photographs taken in 1928 and 1950. The change from slate to asphalt shingles can be noted. By 1950 there was a small roof extending over the east section of the north wall. (See Figures 10 and 24).

A small building appears on the south rampart of the southeast salient in several photographs between 1928 and 1950.<sup>55</sup> It does not appear on any plan. It was a square building and had a pitch roof with north and south slopes. It was located at the foot of the storm signal mast on the south rampart of the salient. (See Figures 10 and 24).

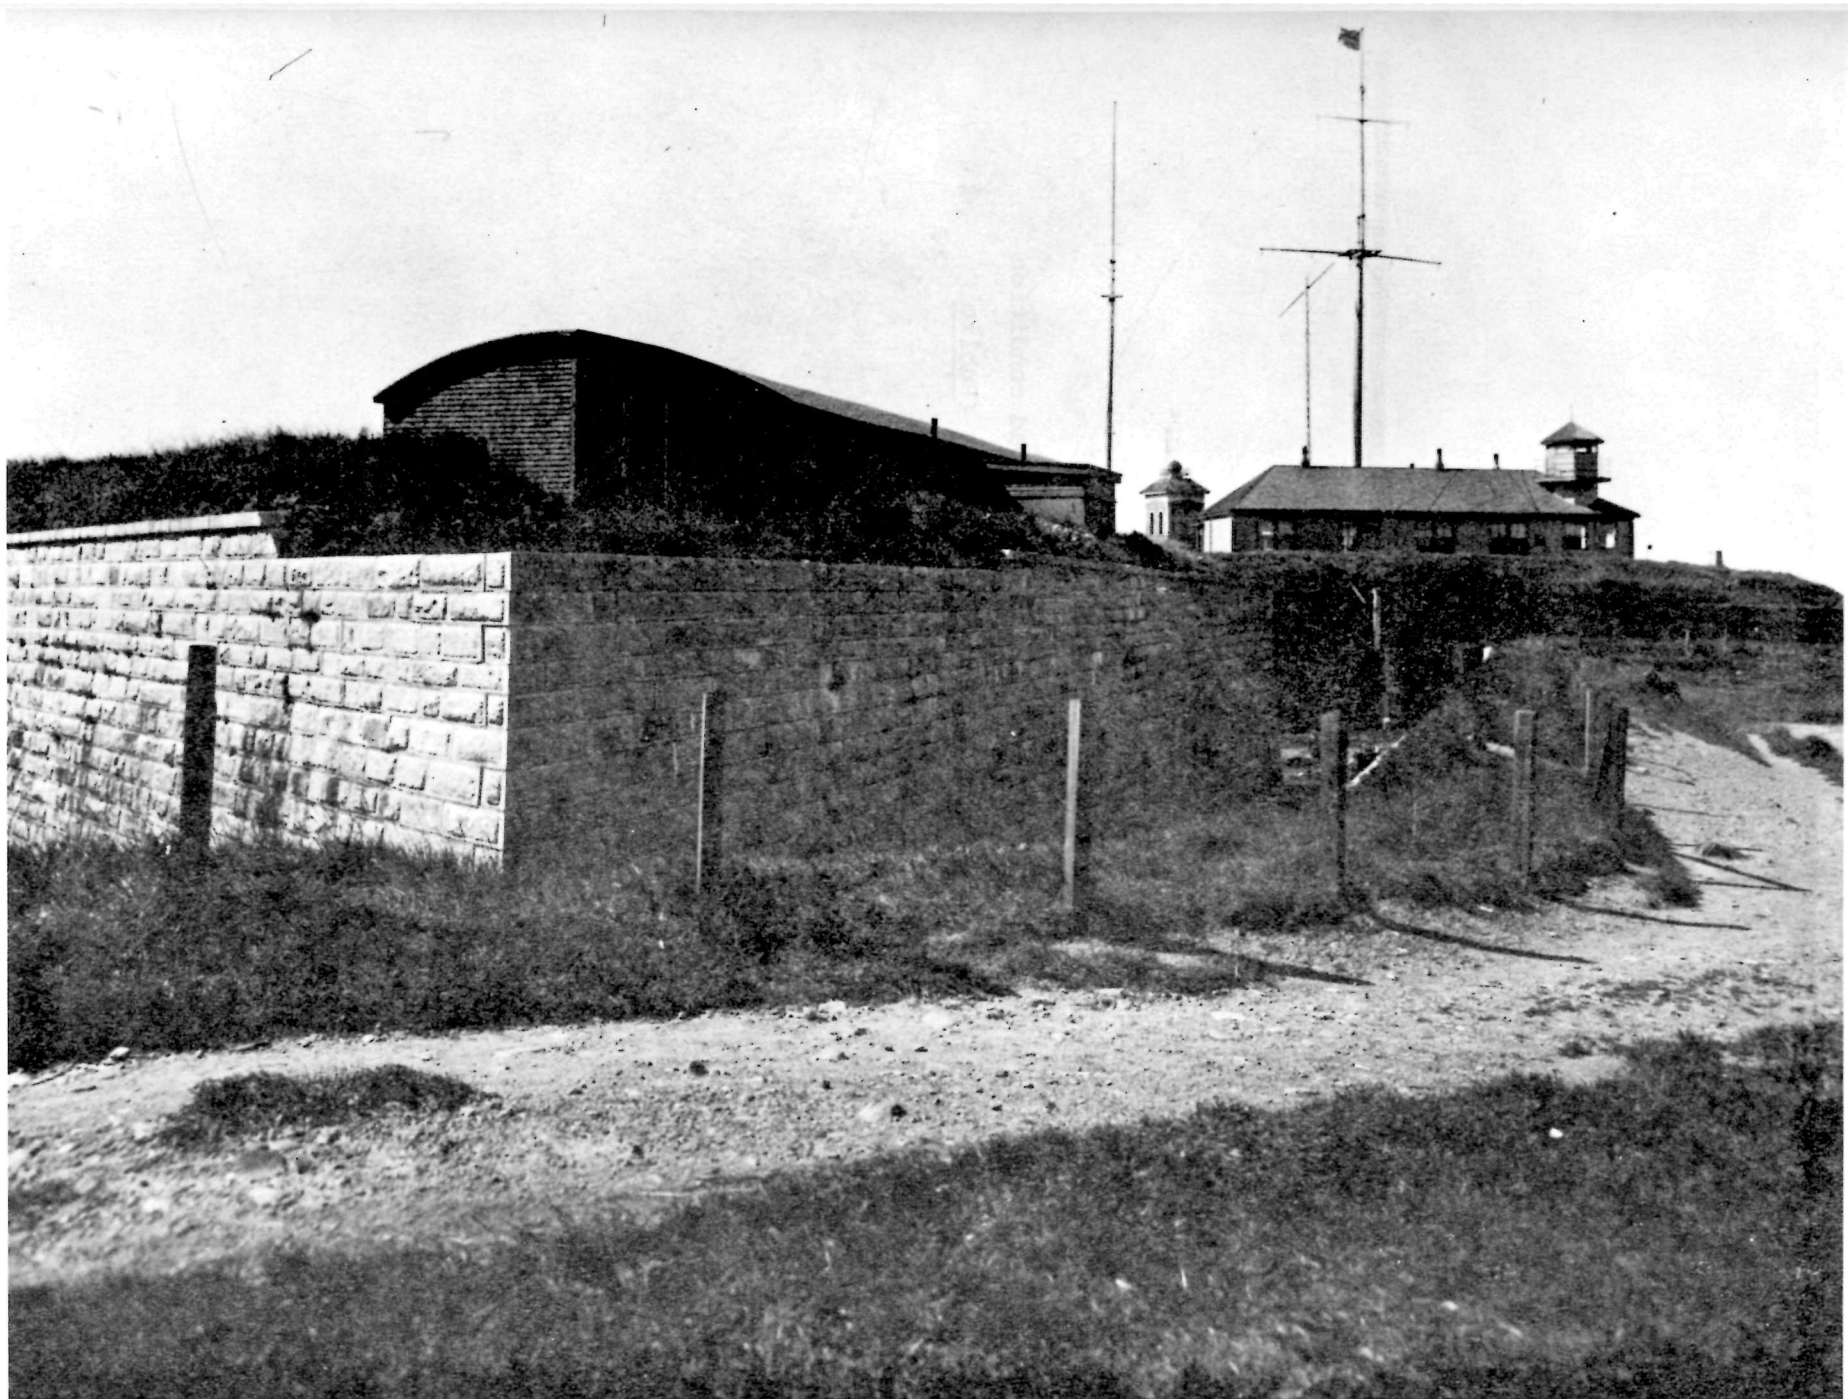
- 25 "Citadel and moat at Halifax, N. S." Photo of south mavelin and southeast salient from the glacis, showing the drill shed, signal station and time ball. (Public Archives of Canada. PA 48378. Department of Interior collection.)

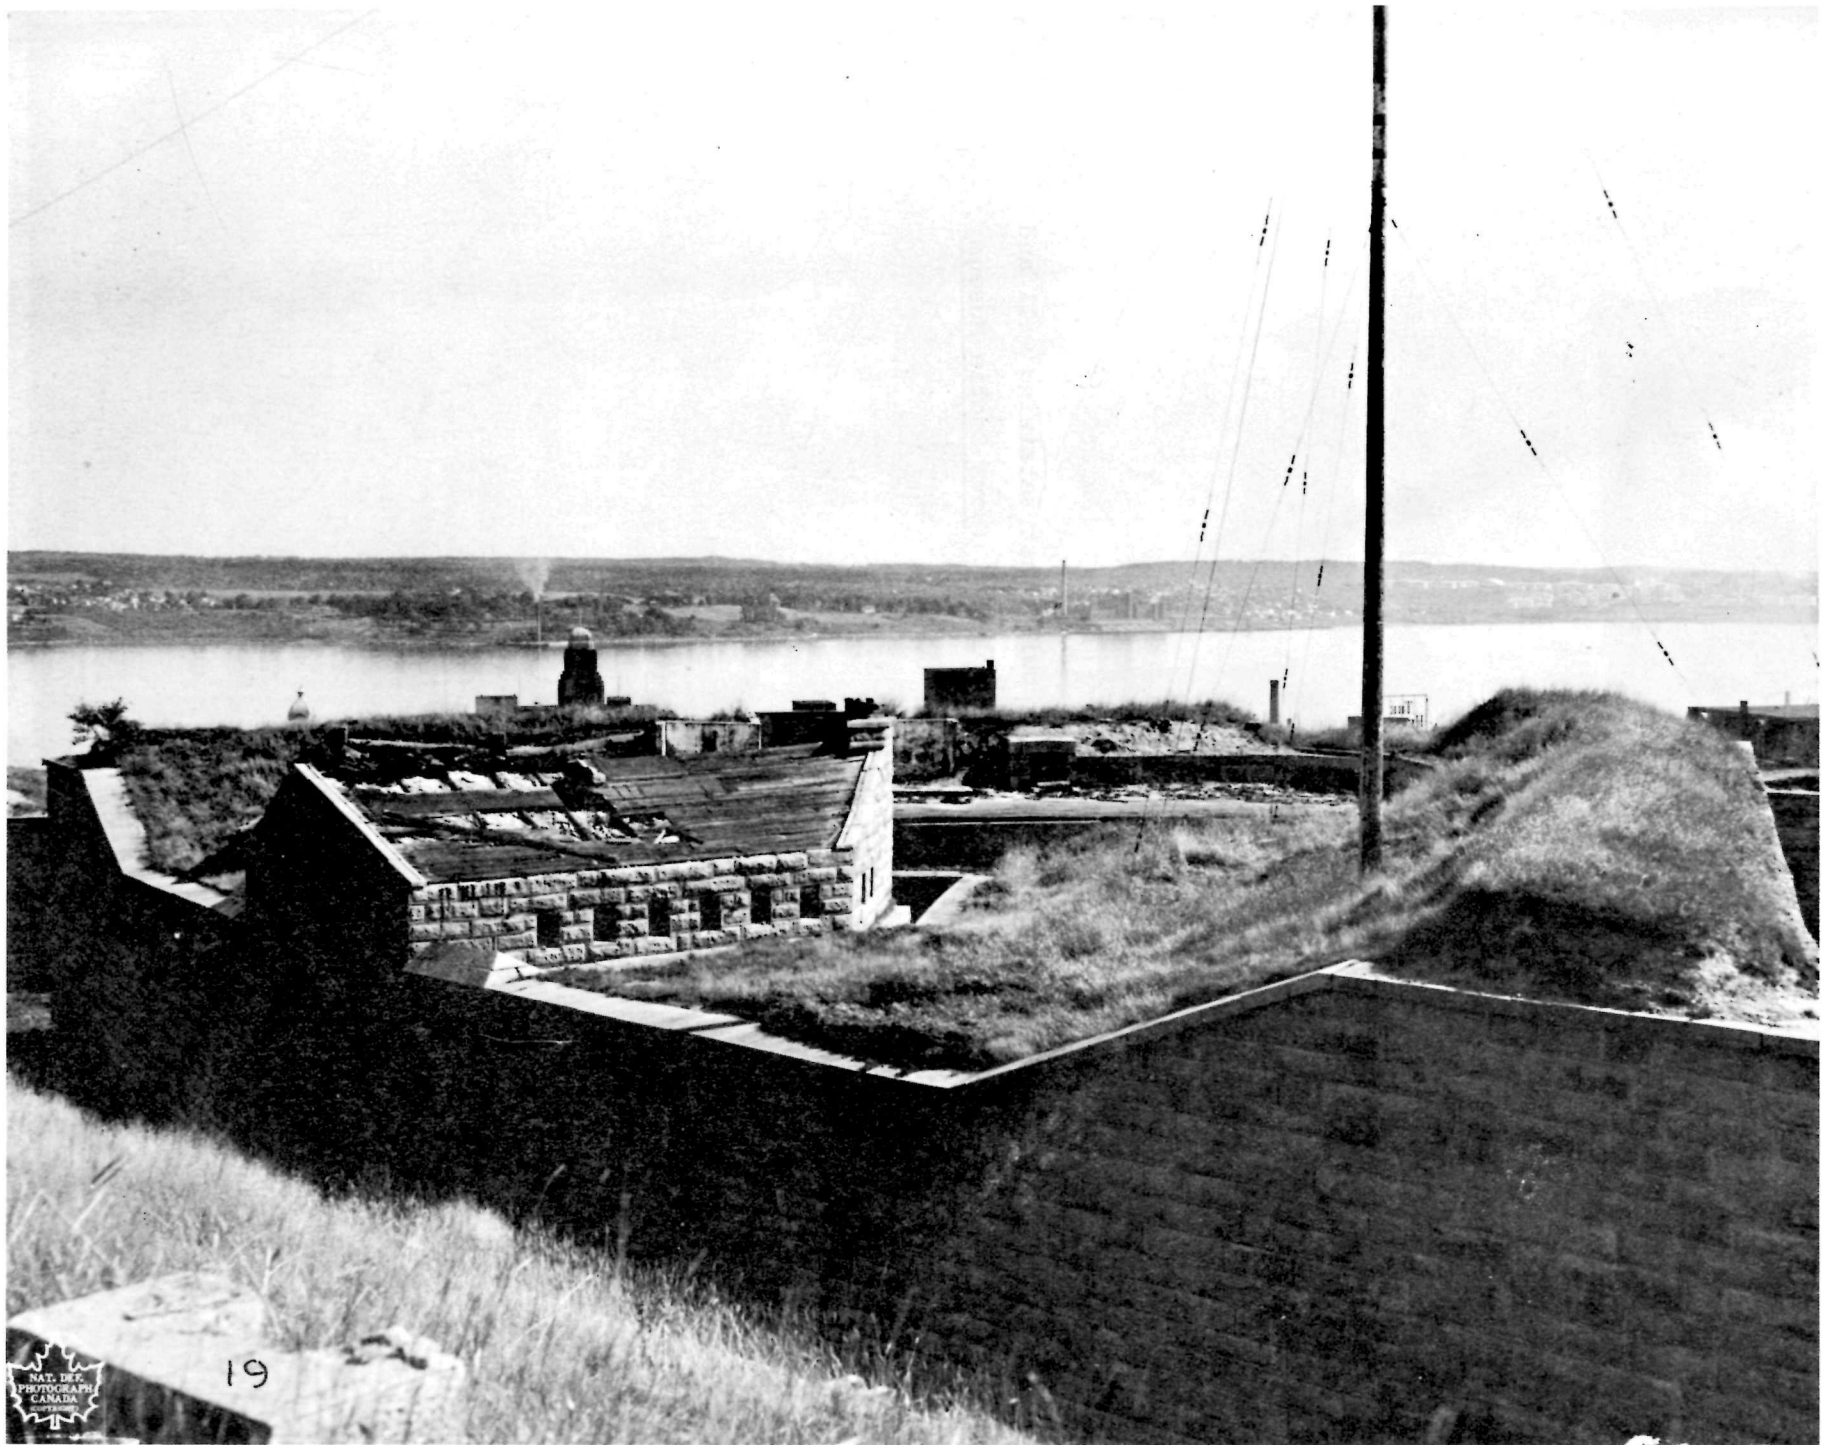
26 The south ravelin in 1950. The guardhouse was in bad condition and only the foundation of the drill shed remained. (Public Archives of Canada. Massey Photo No. 19, HS - 12480)

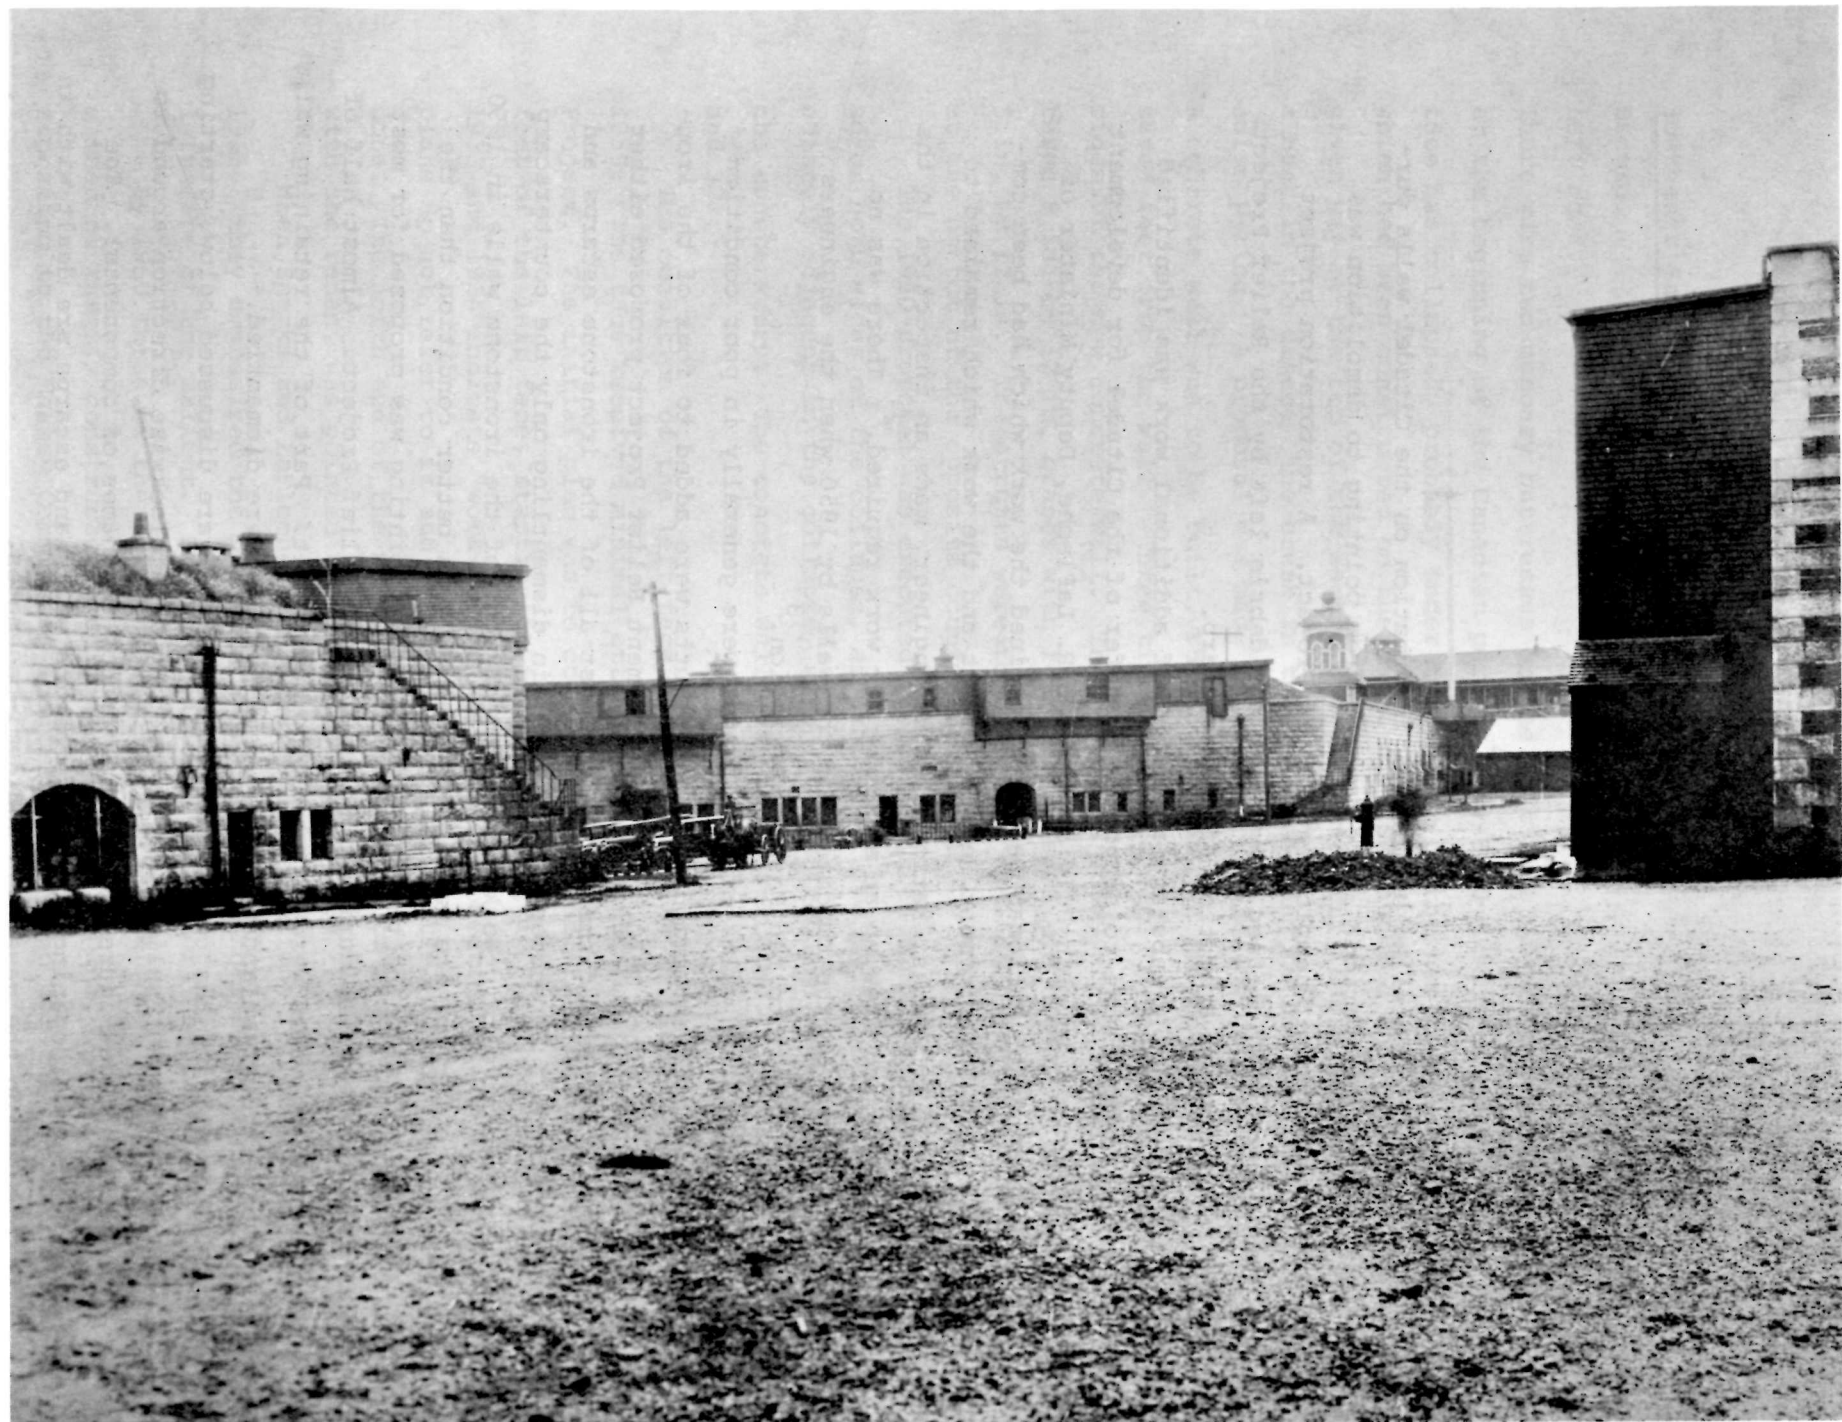
27 View from north end of parade, showing east retaining wall and buildings on the east rampart, July 1928. (Nova Scotia Museum, P 170 28.123 (6297).)

The time ball house was a two-storey structure, approximately ten ft. square at the base. The ground floor had a central door and two windows on the west wall. There were two steps at the door. A small overhanging roof was located between the ground floor and the first storey. There were two arched windows in each of the four walls of the first storey. The time ball apparatus sat on the main roof of the building.<sup>13</sup> (See Figures 22 and 27).

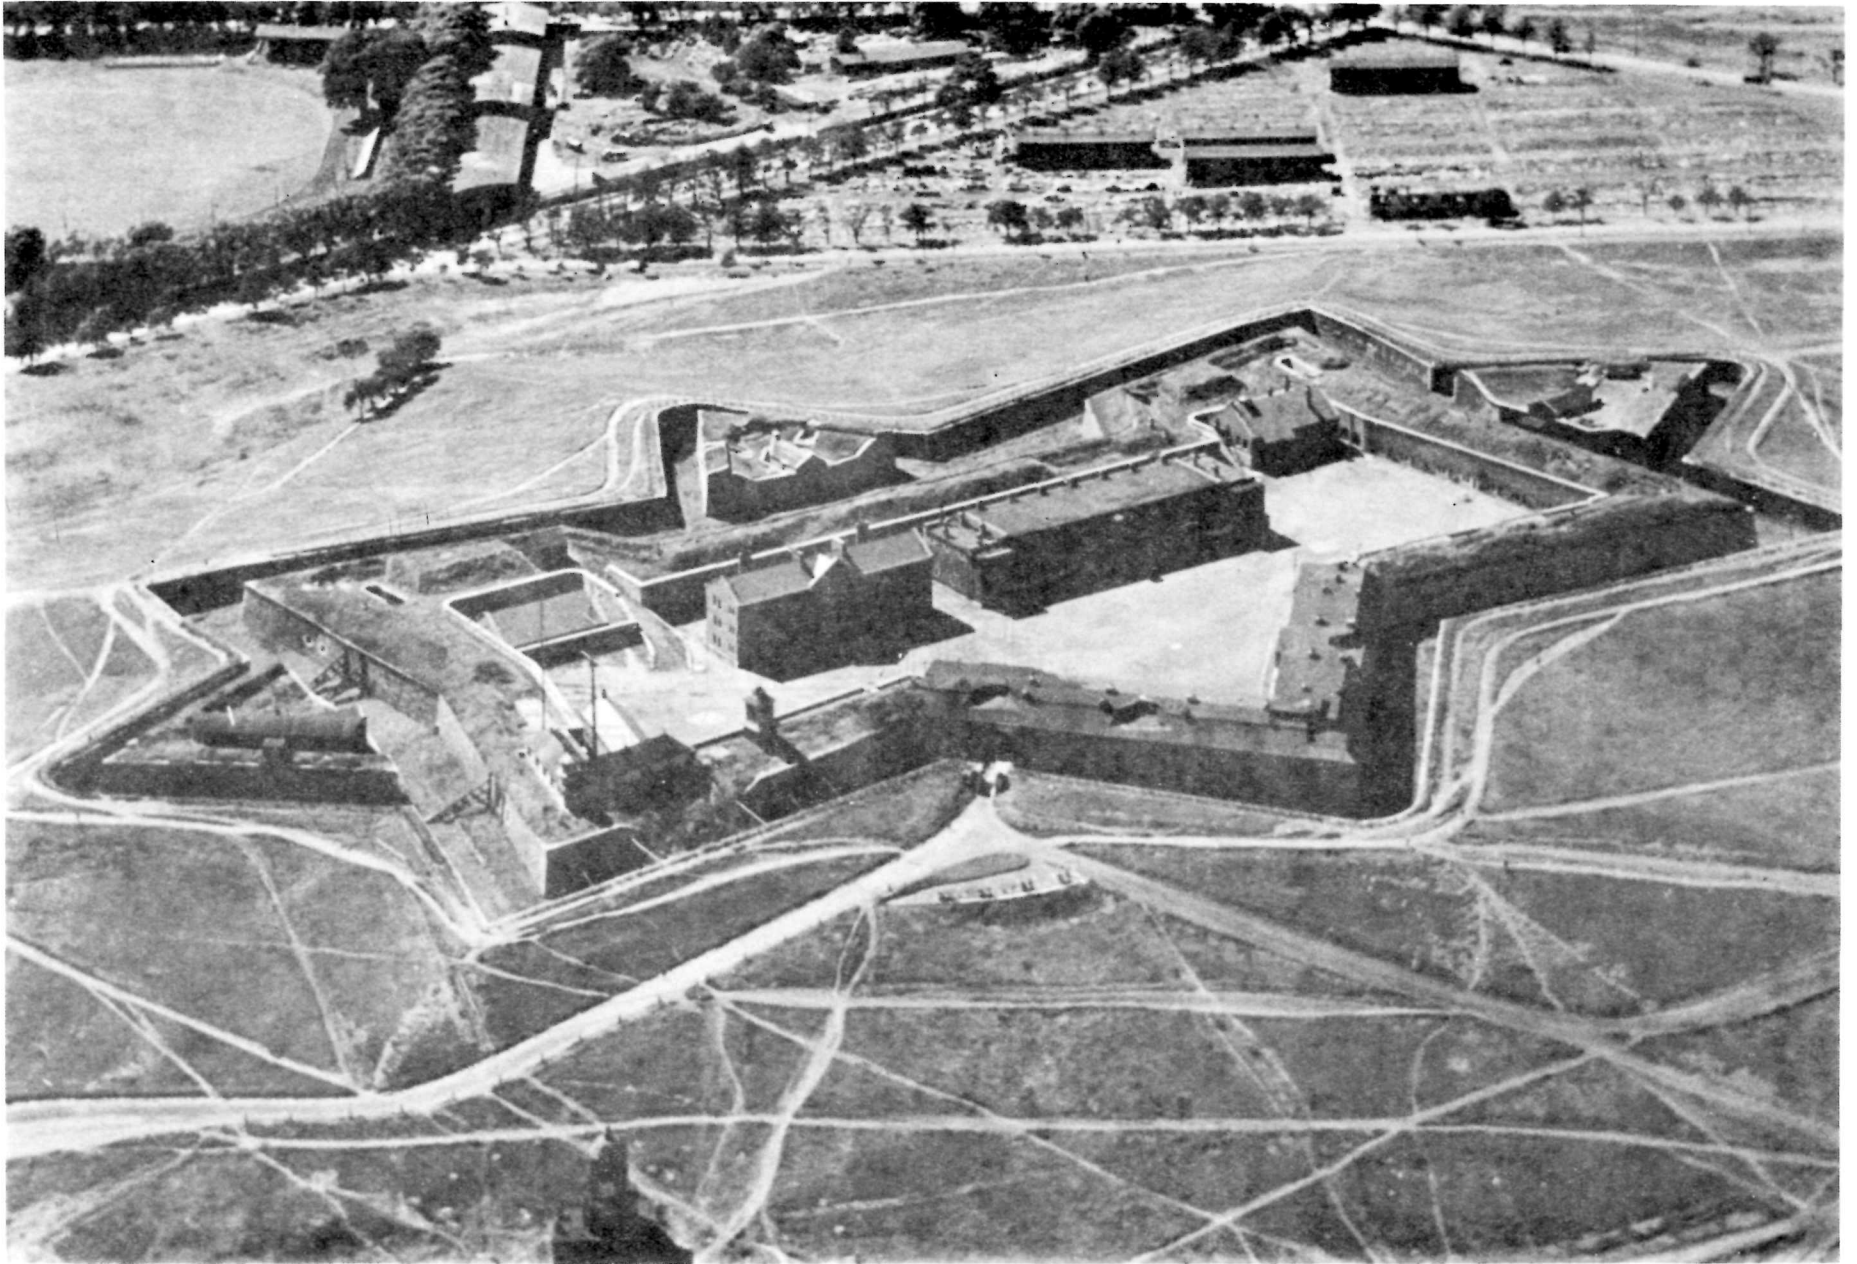
32 Aerial photograph of the Citadel taken by the Department of National Defence, 7 September 1923. (Public Archives of Canada, C - 8080)

The Brick Block was a three-storey brick building with a pediment and a pitch roof. (See Figures 10 and 32). Dimensions given for the building vary between 131 ft. 2 in. by 34 ft. and 130 ft. by 35 ft.<sup>101</sup> Because the Brick Block will be discussed in a report on the late British period, 1860 to 1906, only a brief outline of the structural details will be given here.

The 1920 proposal was executed in part. Three timber braces were placed on both sides of the collapse, as proposed. Two additional strutts, immediately adjacent to the collapse, spanned the ditch and were braced against the counterscarp. The concrete wall was not constructed. (See Figures 22 and 32).

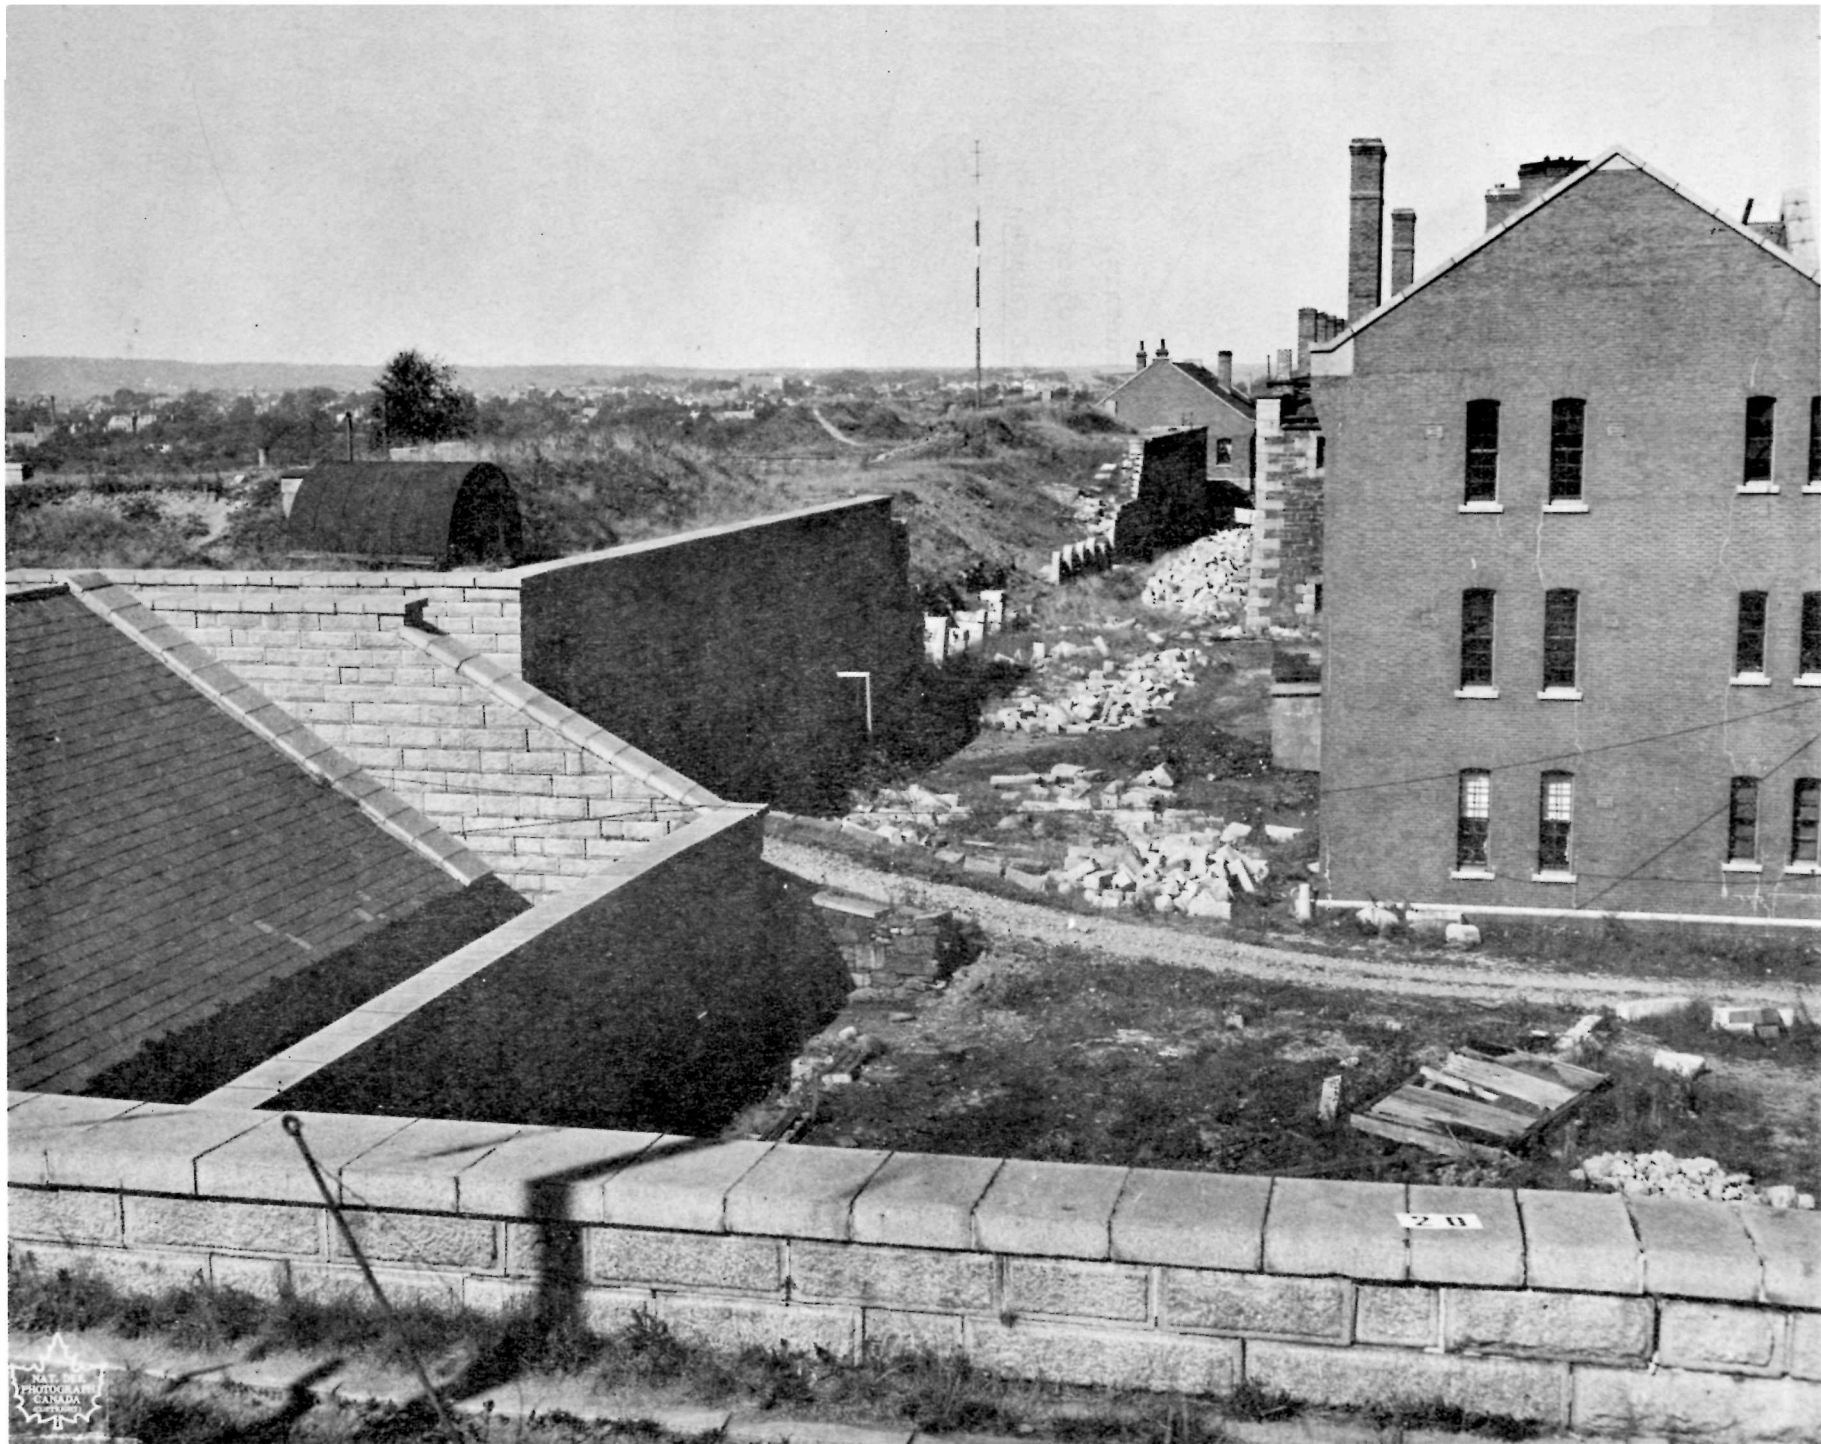
- 35 Photo of the west front taken from the terreplein of the southwest demi-bastion in 1950. Notice the quonset hut on the west curtain and the section of dismantled retaining wall. A mast belonging to the Maritime Broadcasting Company is seen on the northwest demi-bastion. (Public Archives of Canada. Massey Photo No. 20, HS - 12479)

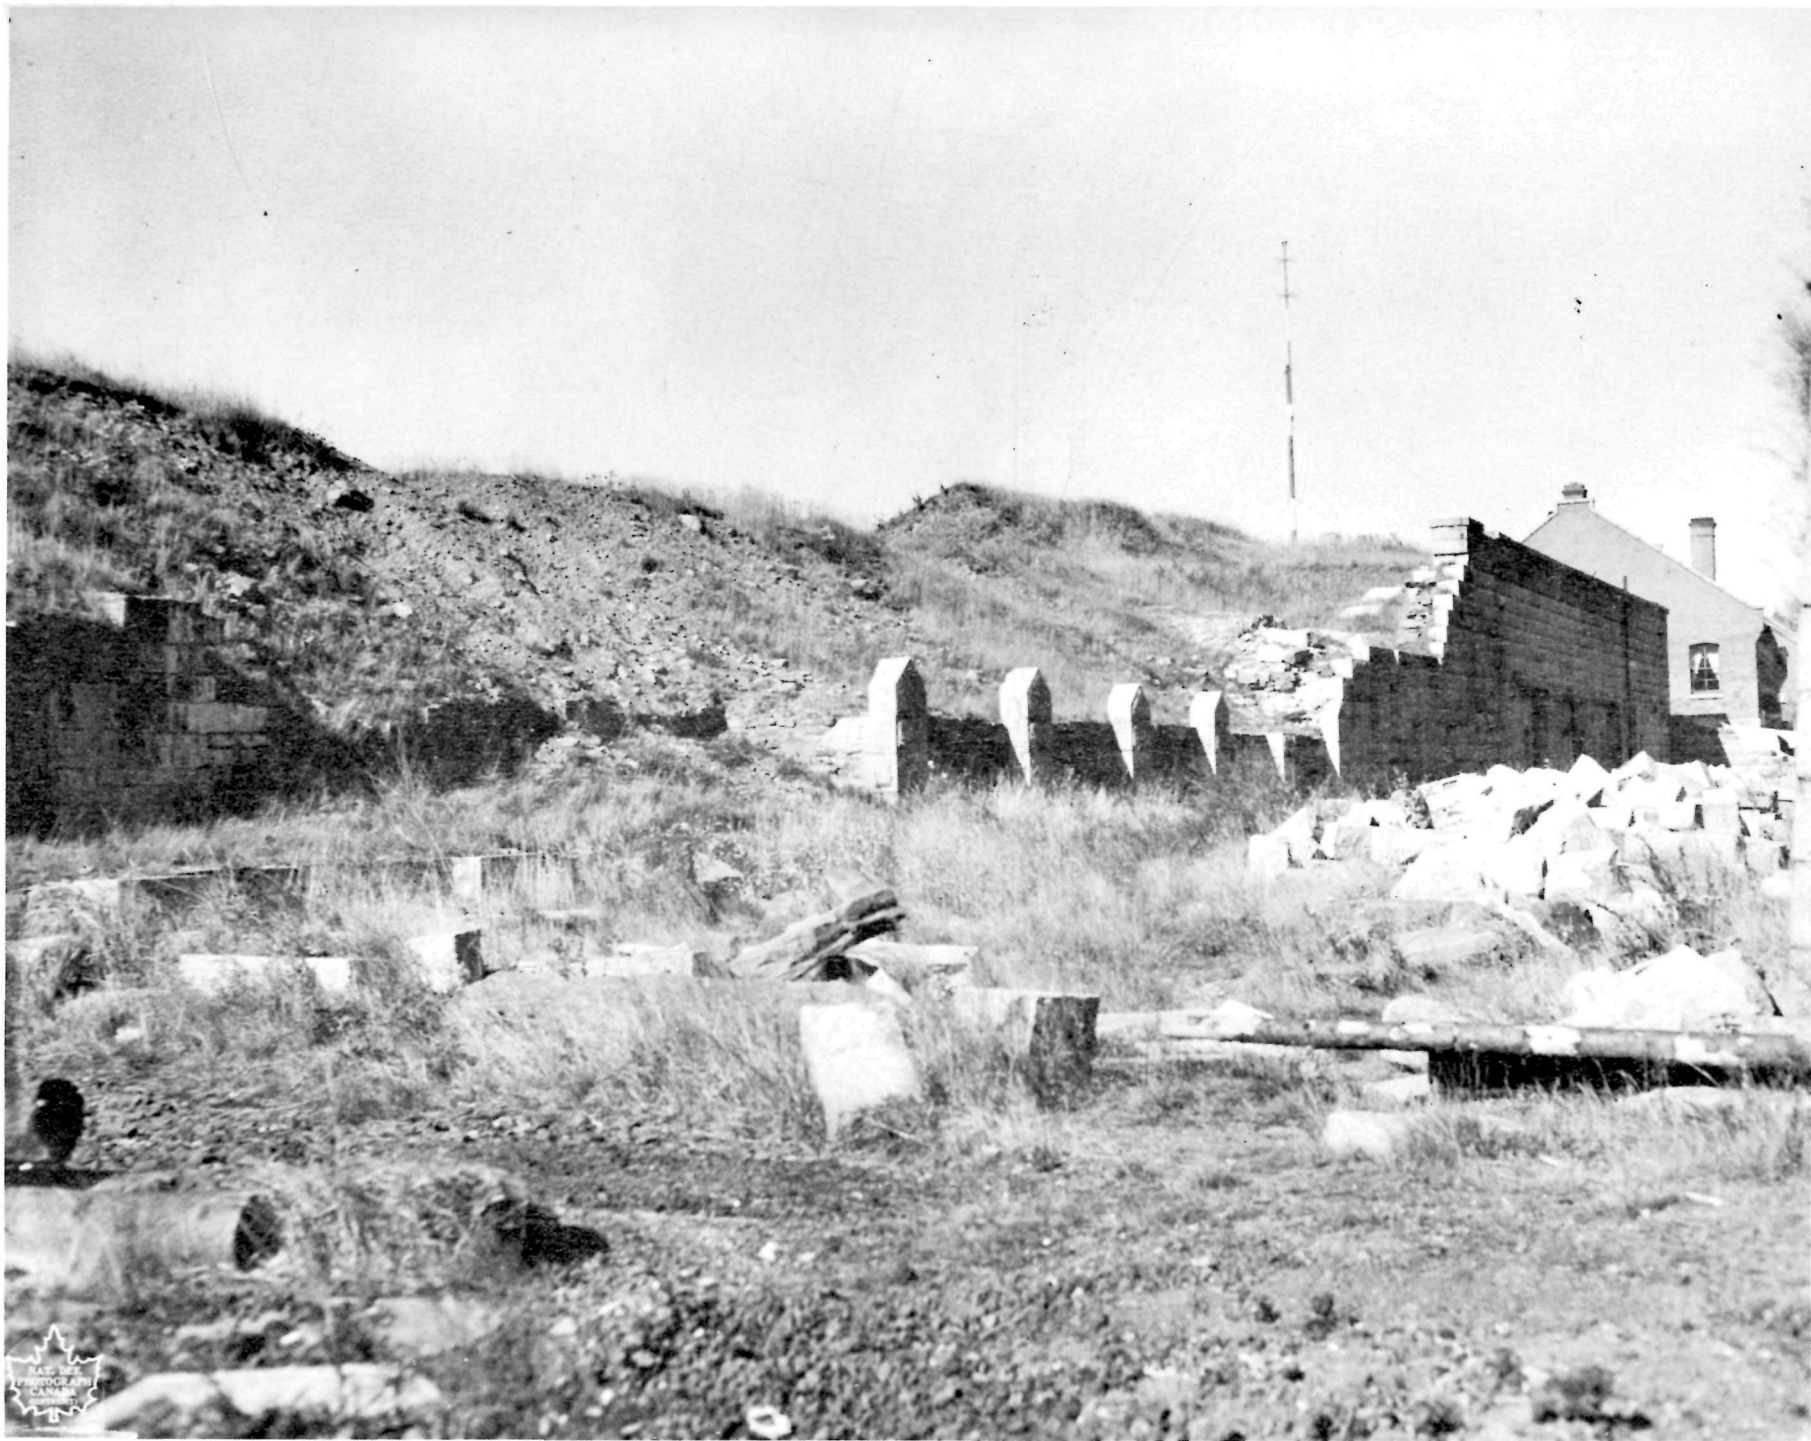
36 Close-up of the dismantled retaining wall of the west curtain, 1950. The restoration work of the Unemployment Relief Project is seen in demi-casemates 37 to 41. (Public Archives of Canada. Massey Photo No. 8, HS - 12493)

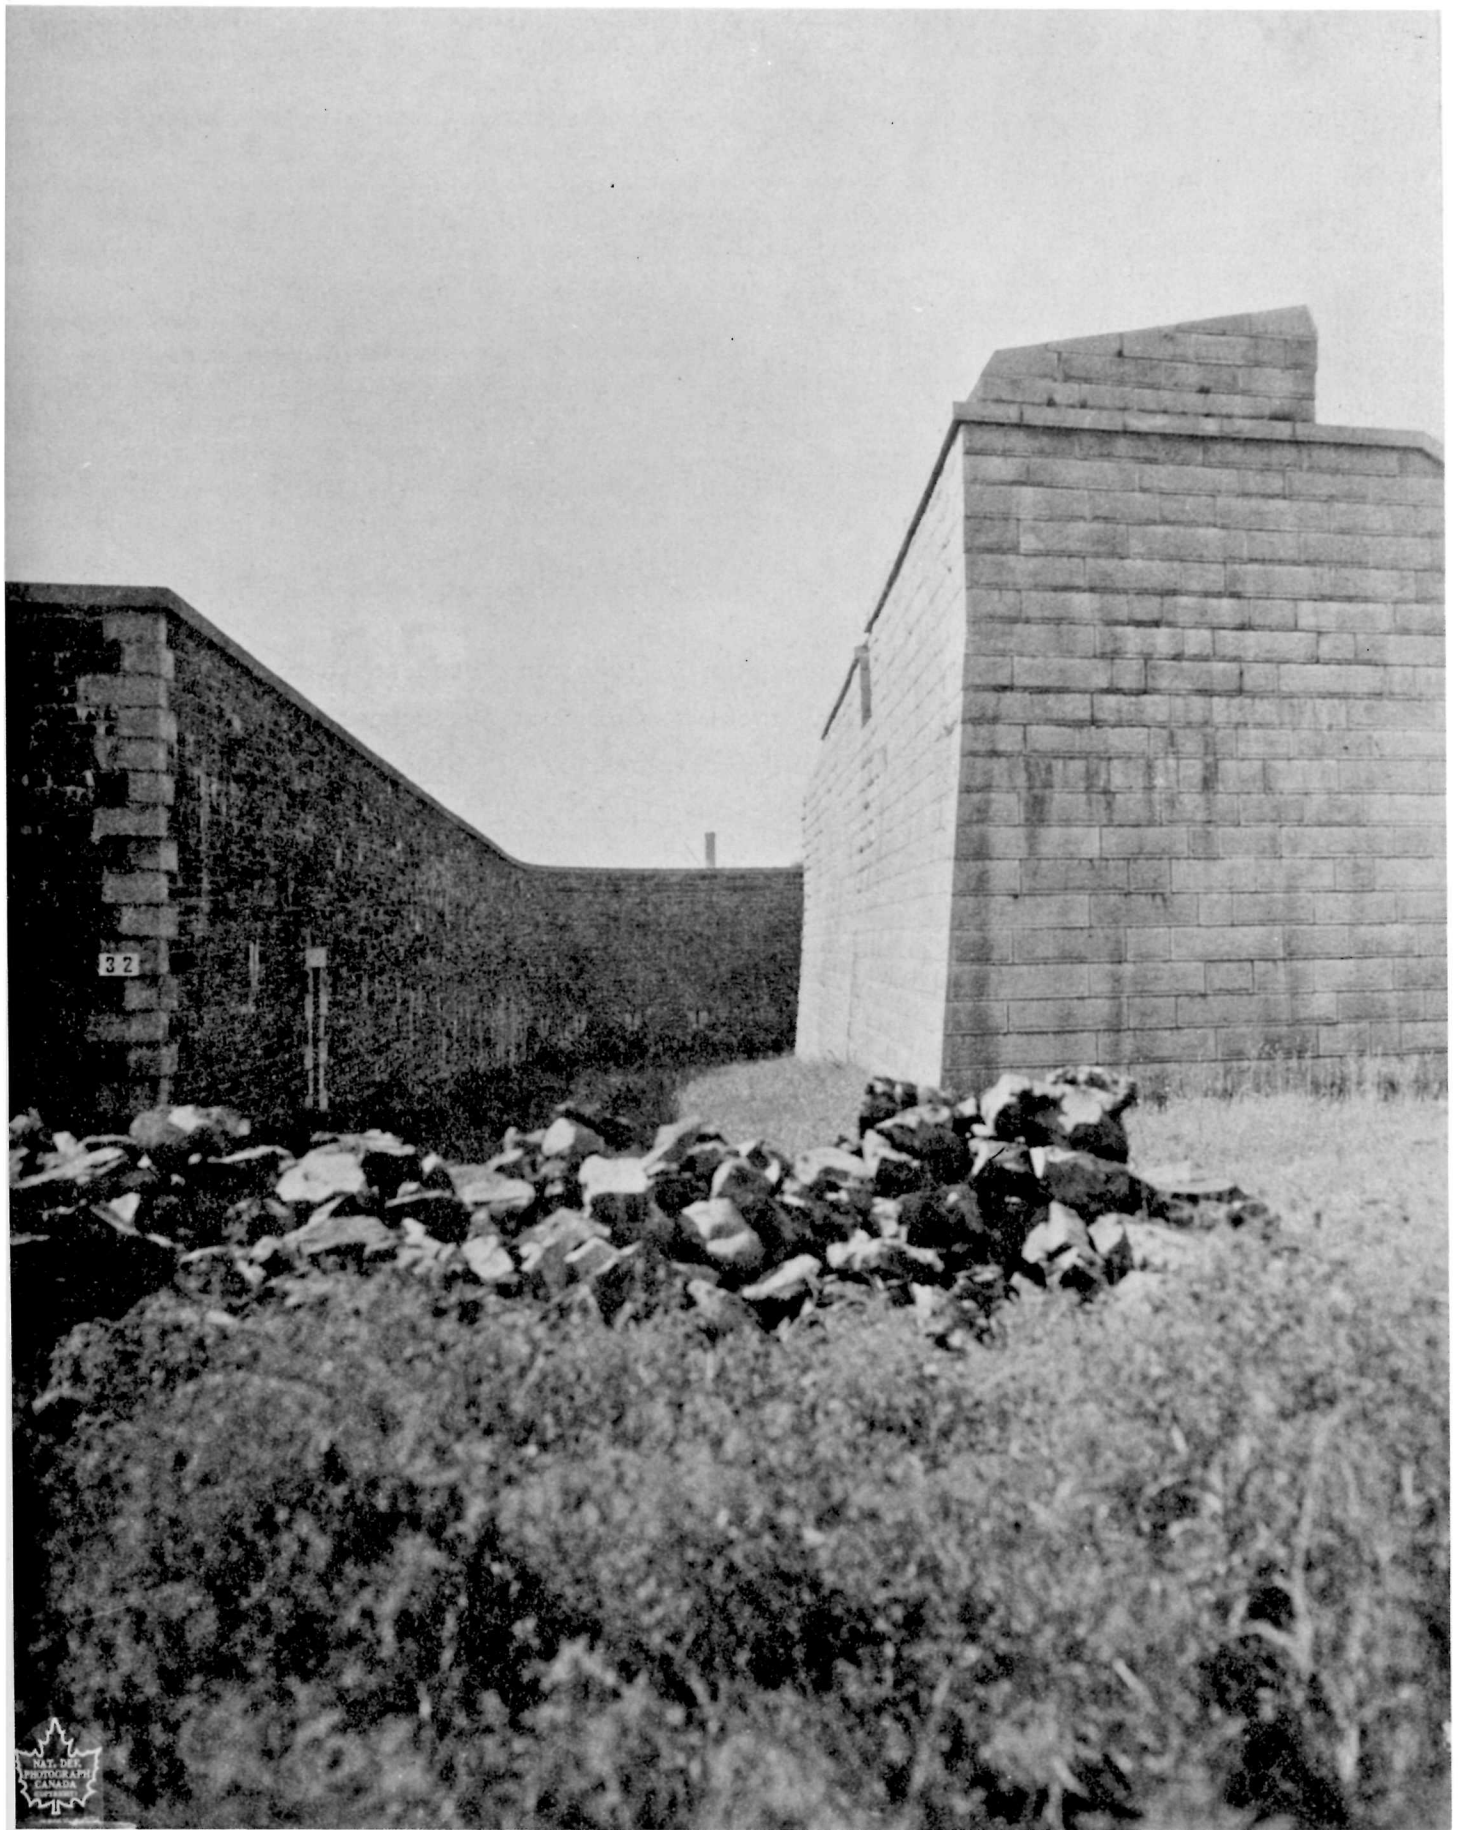
37 South counterscarp of the west ravelin, built during the second restoration project, 1938-40. (Public Archives of Canada. Massey Photo No. 32, 1950, HS - 12463)
