THE HALIFAX CITADEL, 1906-51

THE CANADIAN PERIOD

by Brenda Dunn

1977

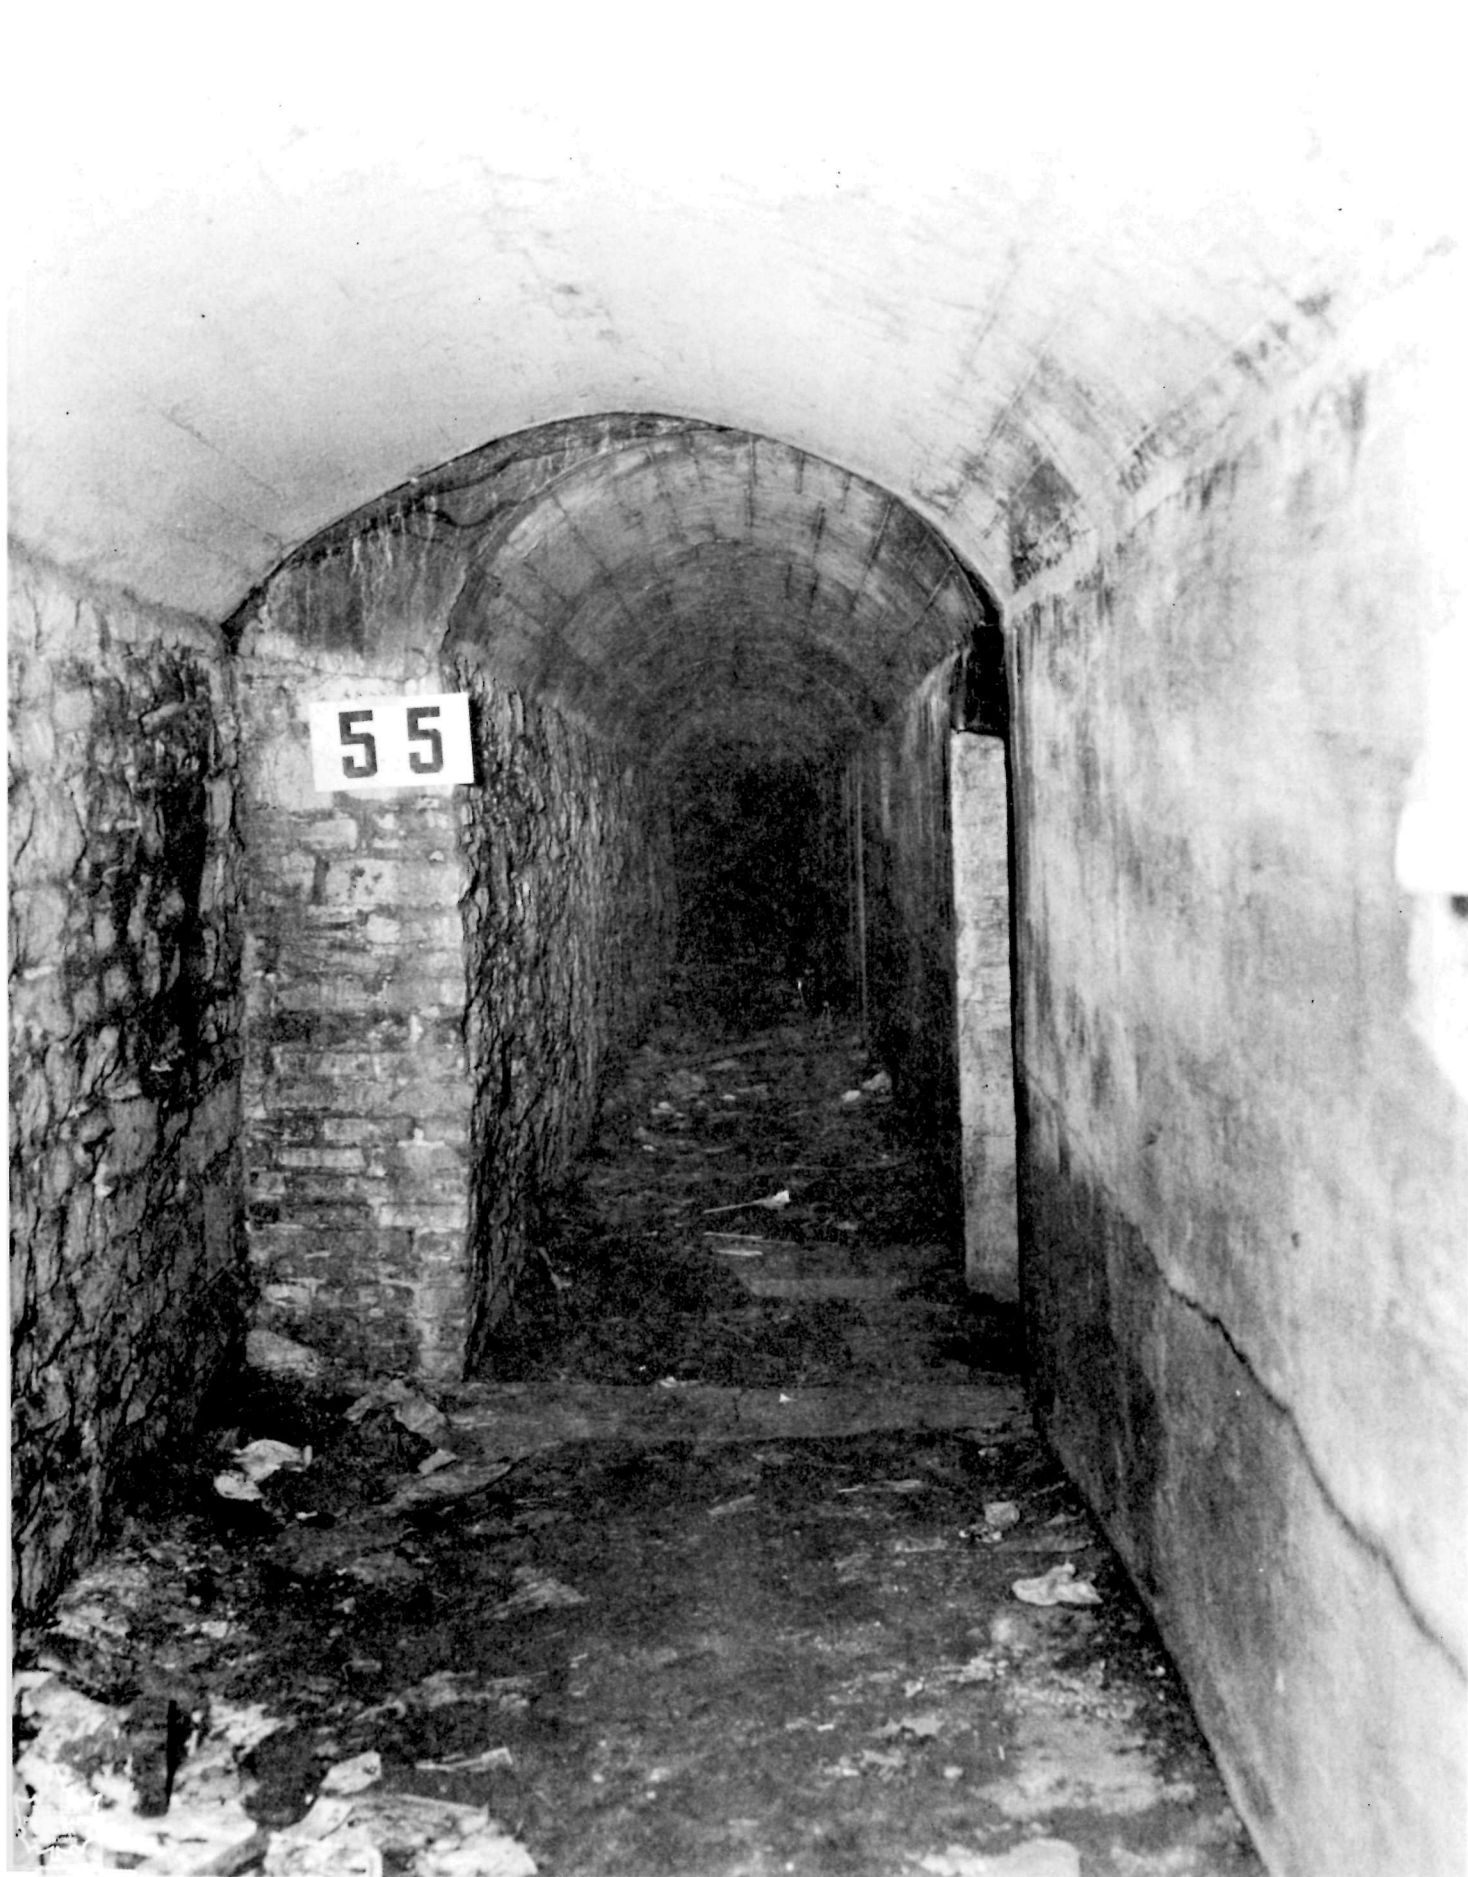
38 Photo of the musketry gallery in the reconstructed south counterscarp of the west ravelin, looking west from the corner with the southwest demi-bastion counterscarp, 1950. (Public Archives of Canada. Massey Photo No. 55, HS - 12454).

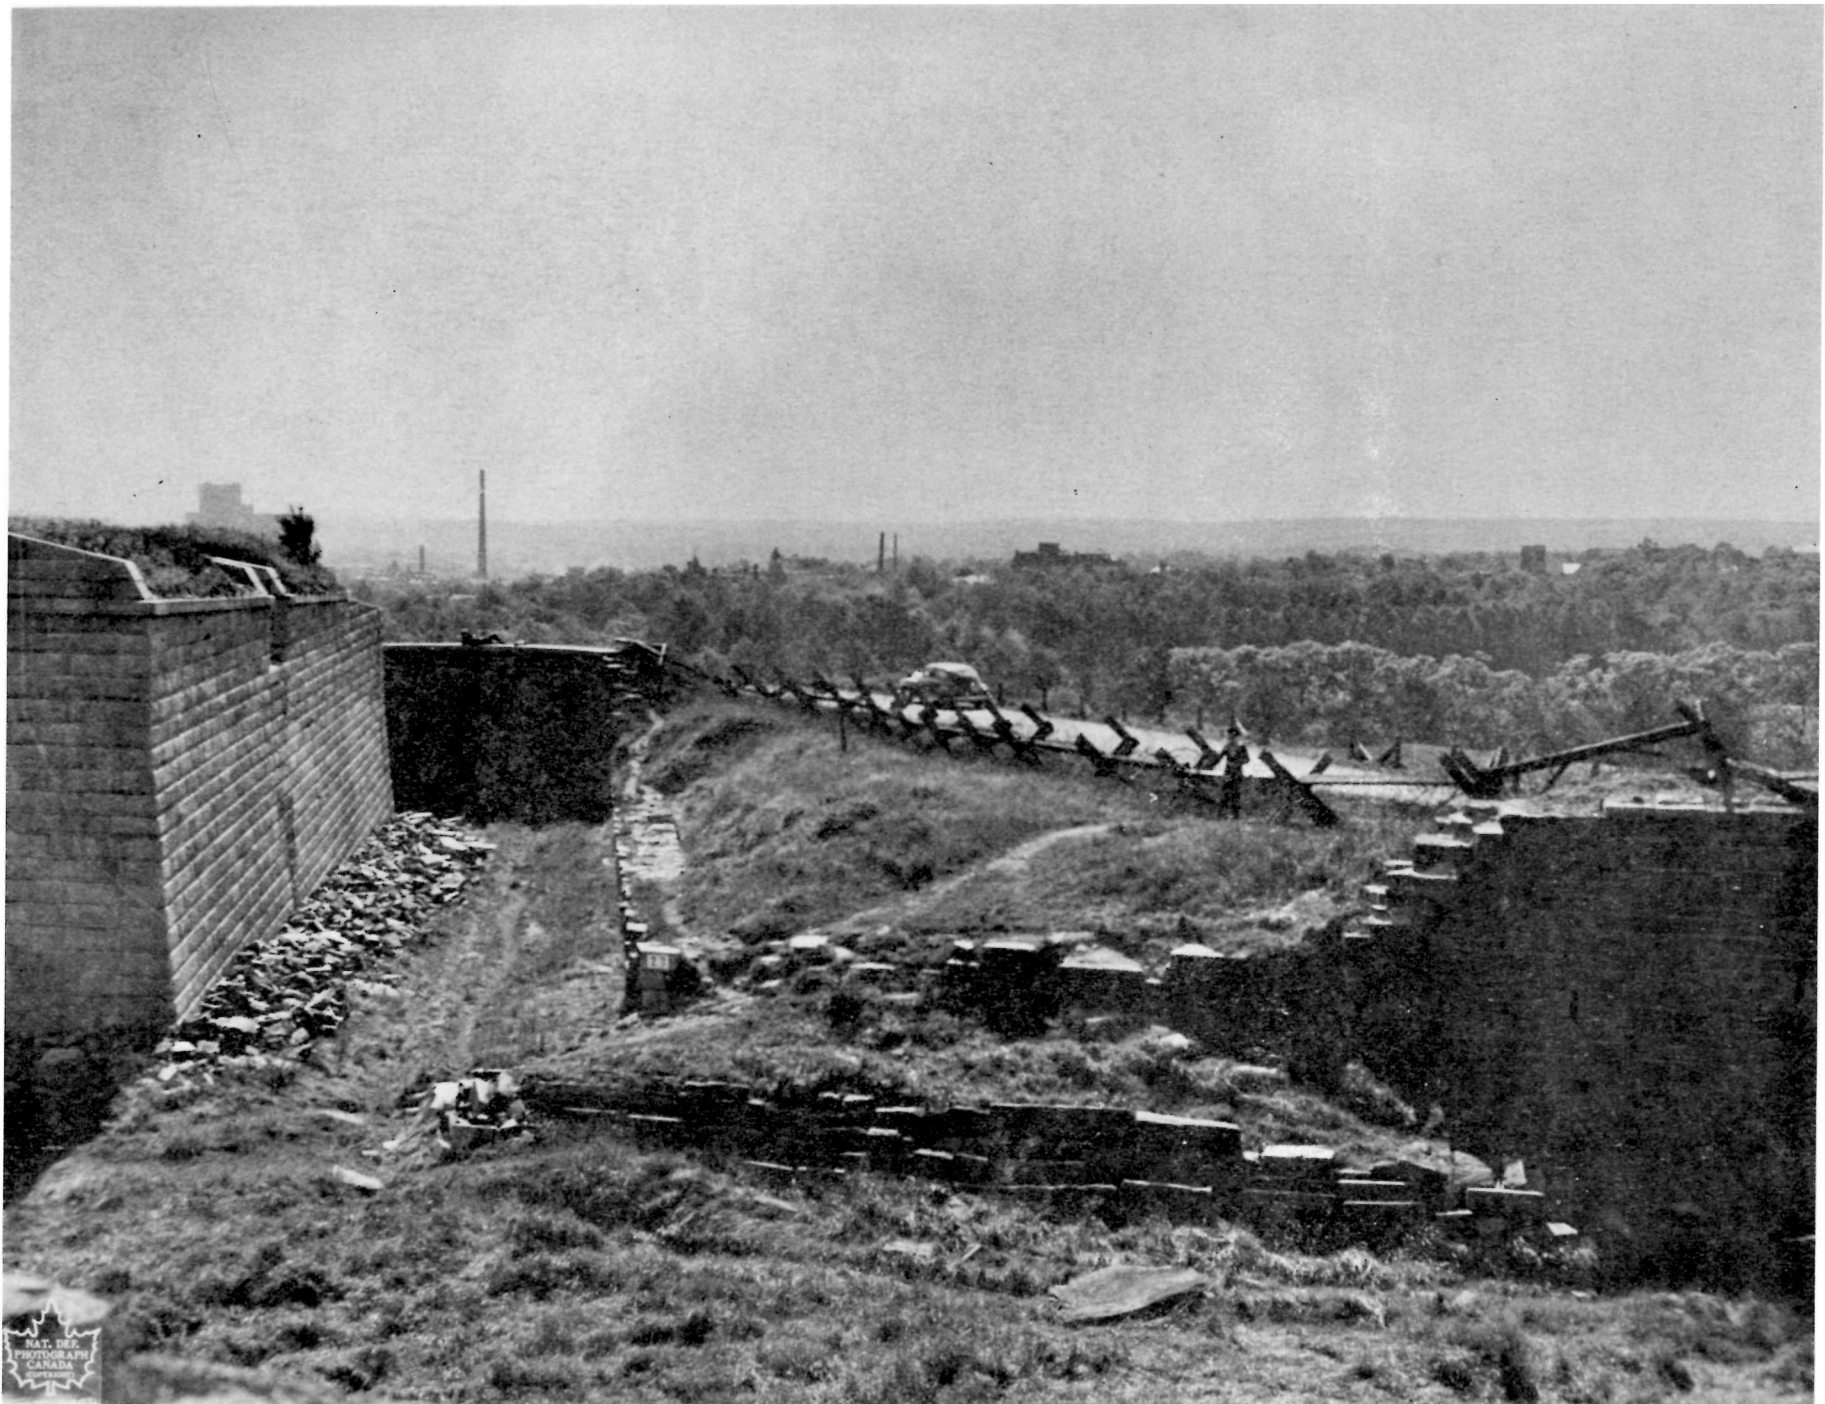
39 Dismantled counterscarp on the west front, showing the corner of the north counterscarp of the west ravelin and the west counterscarp of the northwest demi-bastion, 1950. The Unemployment Relief Project's practice of dismantling the top of the wall and piling the stones to form a bank at the bottom of the wall is seen in the photograph. (Public Archives of Canada. Massey Photo No. 27, HS - 12470).

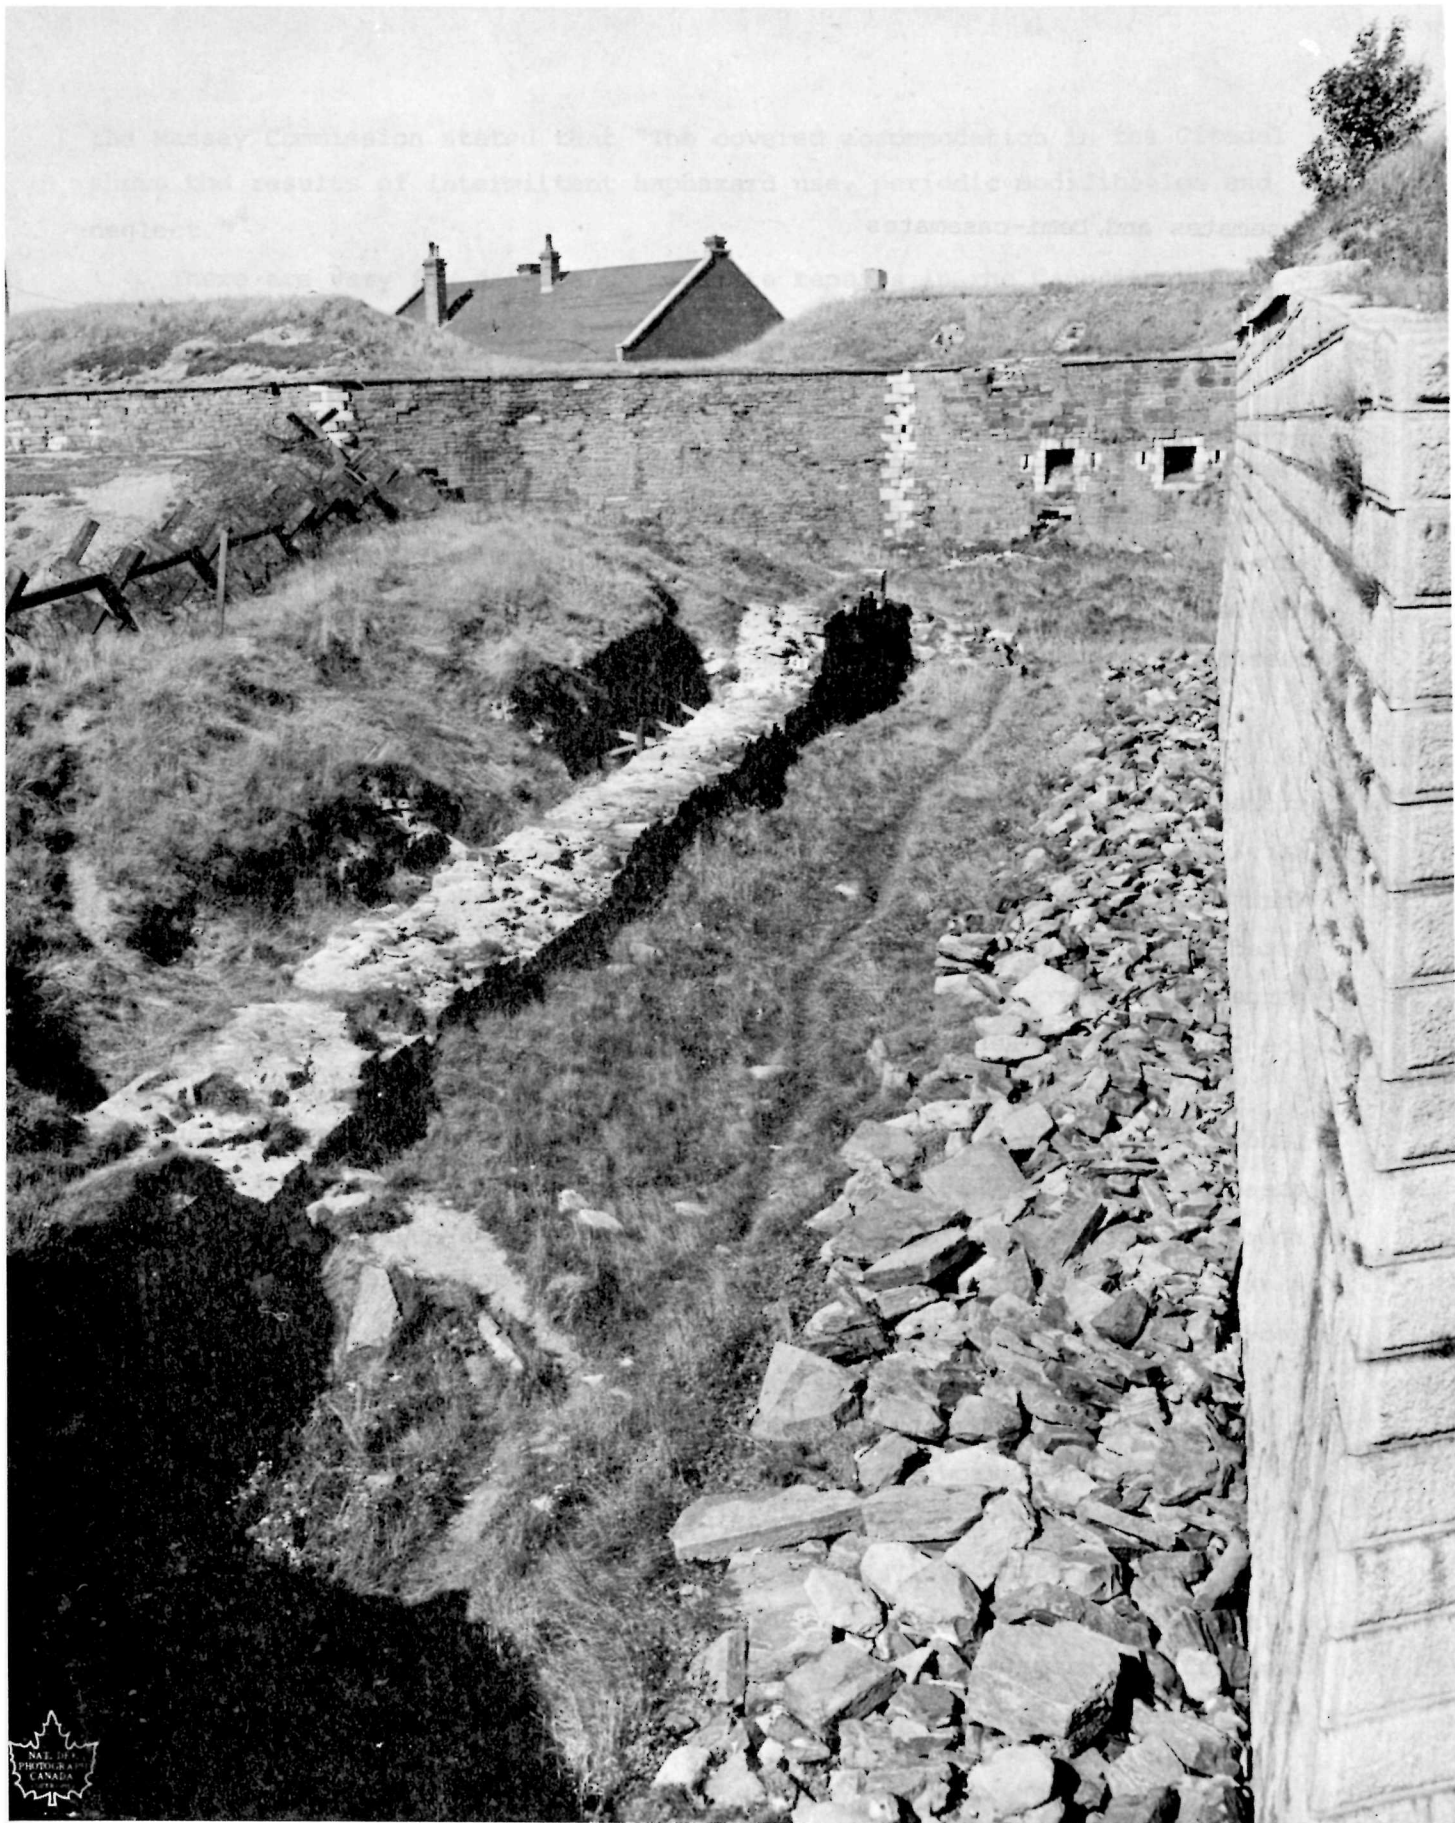
40 Photo taken from the salient angle of the west ravelin, showing the bad condition of a section of the escarp on the west front and the remains of a section of counterscarp dismantled by the Unemployment Relief Project. (Public Archives of Canada. Massey Photo No. 40, 1950, HS - 12496).
