MANUSCRIPT REPORT NUMBER 77

THE 1971 EXCAVATIONS AT FORT ST. JAMES

ENVIRONMENTAL STUDY OF FORT ST. JAMES

A Preliminary Report on the 1971 Archaeological
Excavations of Fort St. James, British Columbia.

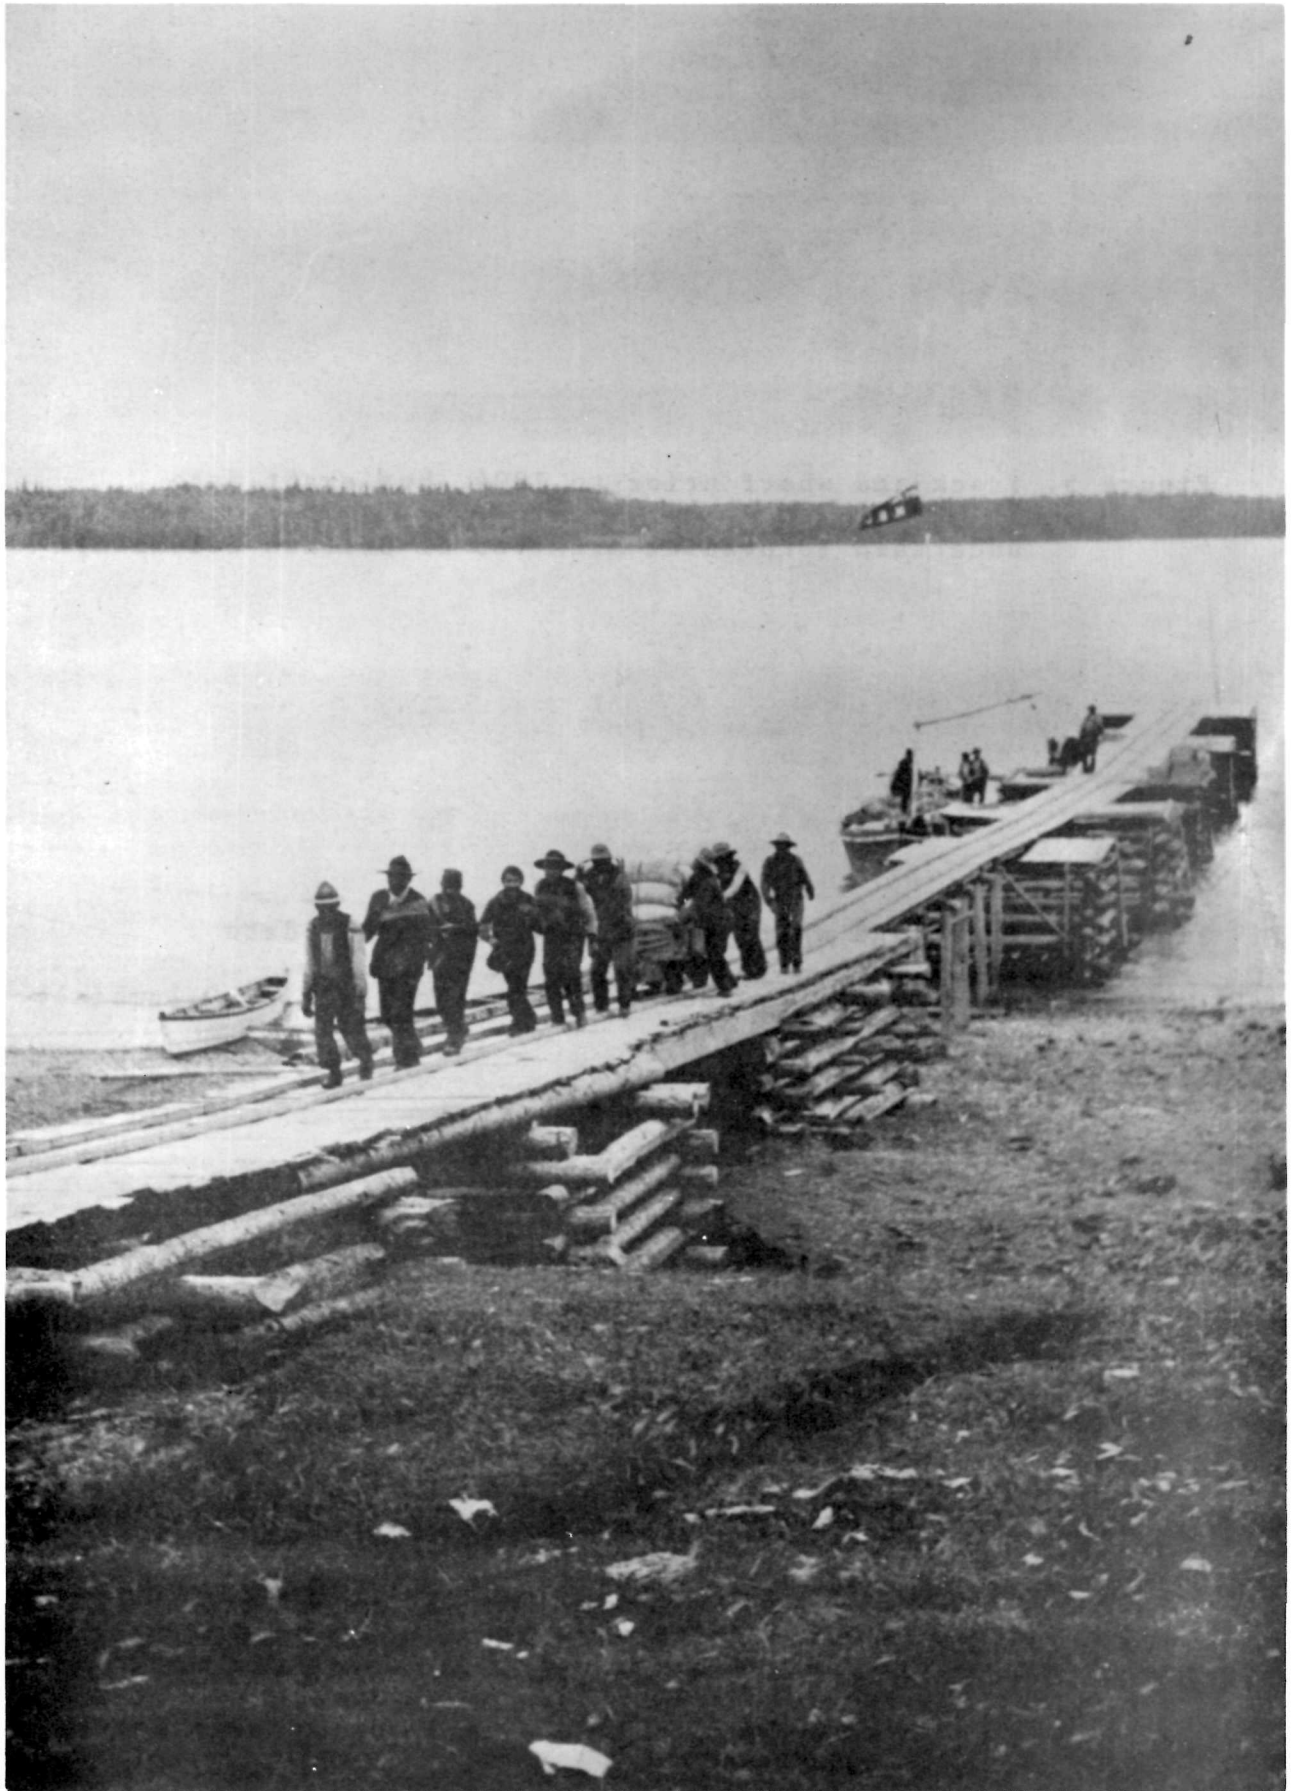
Figure 4. Towing the cart up from the lake to the
warehouse. (Provincial Archives of
British Columbia).

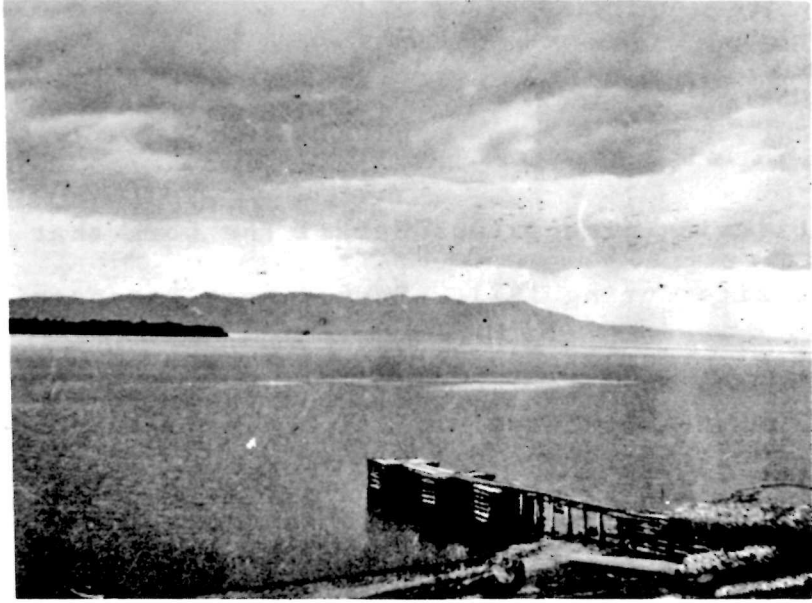
Figure 5. Track and wharf prior to 1904, but exact date uncertain (Provincial Archives of British Columbia).

The wharf and the track that extended from the warehouse out into Stuart Lake was constructed in 1894-95, they were extended again in 1904 and discontinued in 1916. This structure ran from the west end of the warehouse along the ground for 126 ft. where the first evidence of crib work appears. This crib work decreased the grade of the shore and from Figures 5 and 6 it was possible to determine that there were six or seven sets of cribbing. This figure does not include the last two piers which were added in 1904. By extrapolating from the

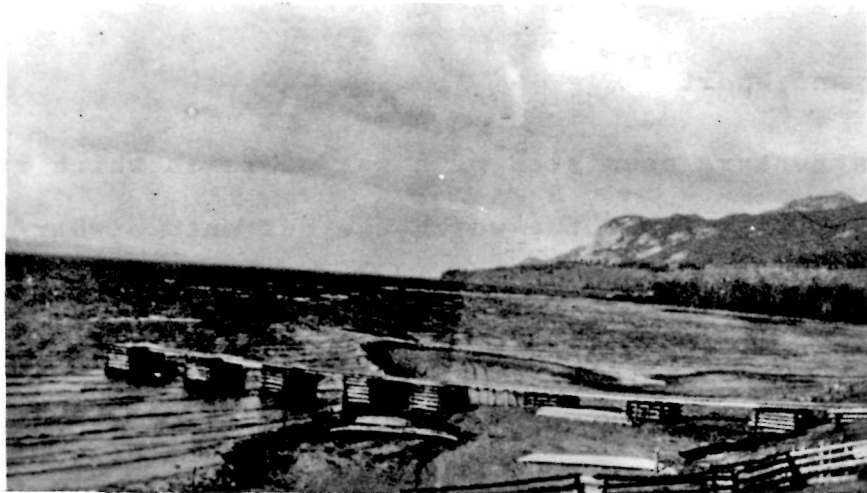
Figure 6. Track and wharf after 1904, but exact date uncertain (Provincial Archives of British Columbia).

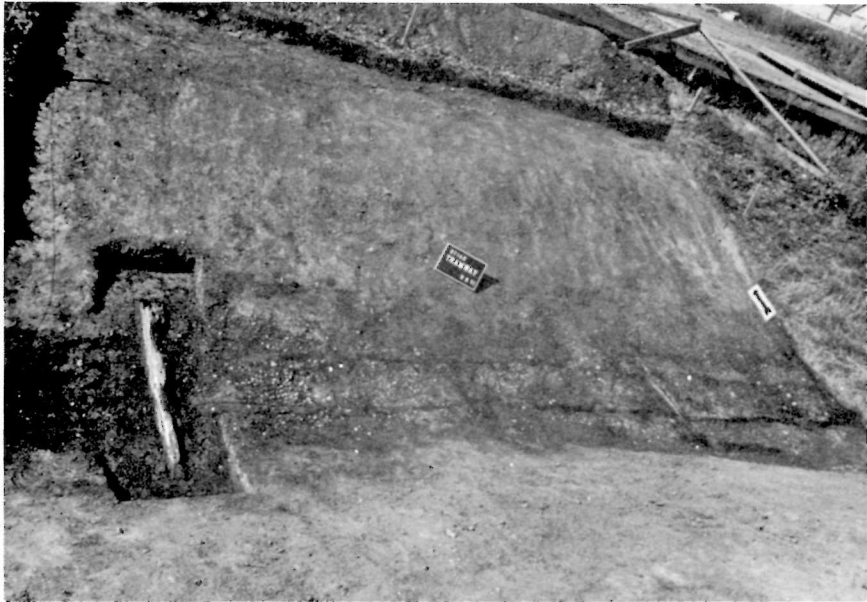
Figure 9. Sub-structure of the track in 3T1A after
Excavation, looking north. 3T-100M.

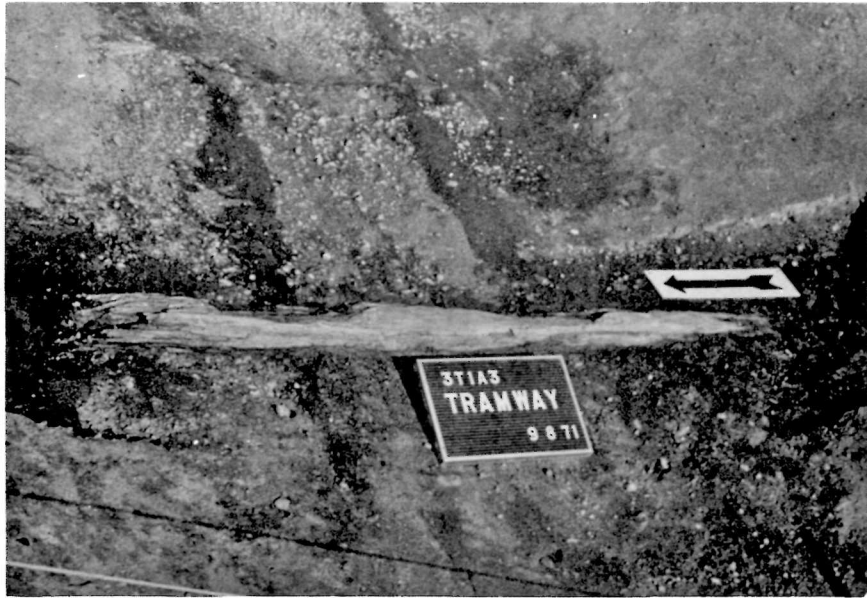
Figure 10. Support beam of the tram sub-structure. Note wear
marks on beam. 3T-103M.

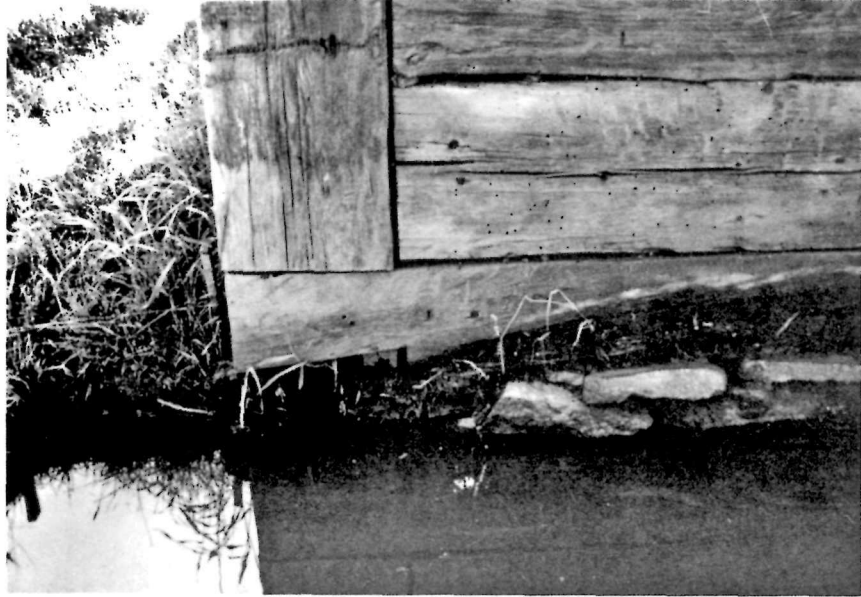
Figure 13a. Northwest corner of warehouse in sub-operation 3T1B. Western basal log is joined to northern basal log with a half dovetailed joint. Both logs have suffered considerably from decay. 3T-76 M.

The foundation for the warehouse (Figure 13) was composed of relatively flat limestone laid in double or triple courses depending on the sizes of the individual stones. These stones averaged about 1.0 ft. in width, but were undressed and showed very little regularity in size. They are unmortared and at intervals of 5 ft. or 6 ft. wooden sleepers projected through the foundation. These beams measured approximately 8 in. by 8 in. and were spaced at intervals that ranged from 5 ft to 7 ft. These beams ran beneath the wooden sill or base plate of the wall which rested on the stone foundation and their relationships with the floor joists of the warehouse and their length were unknown. They had an elevation of 2273.8 ft. MSL., and probably served to bind the stones of

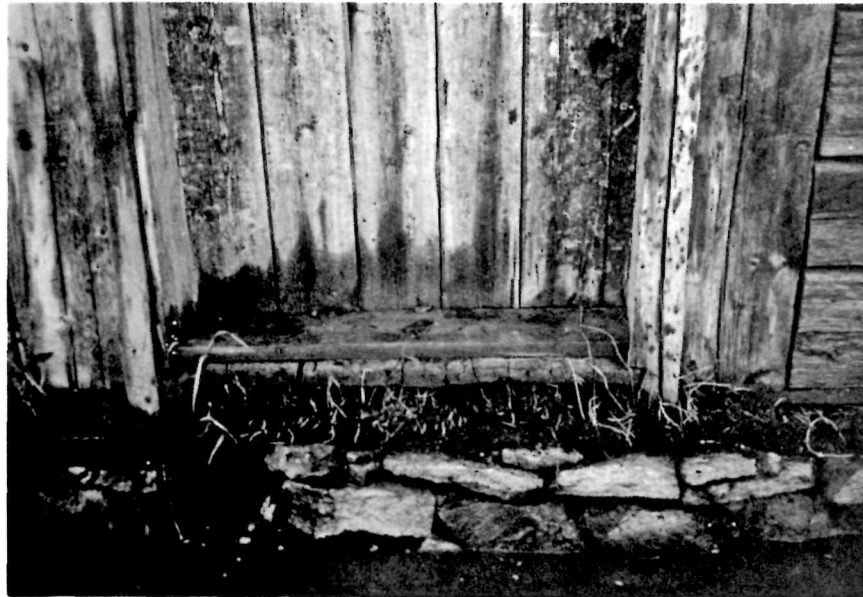
Figure 13b. Stone foundation beneath the western entrance to the warehouse in sub-operation 3T1B. Note the decayed sleeper beam below the left corner of the door frame. 3T-73 M.

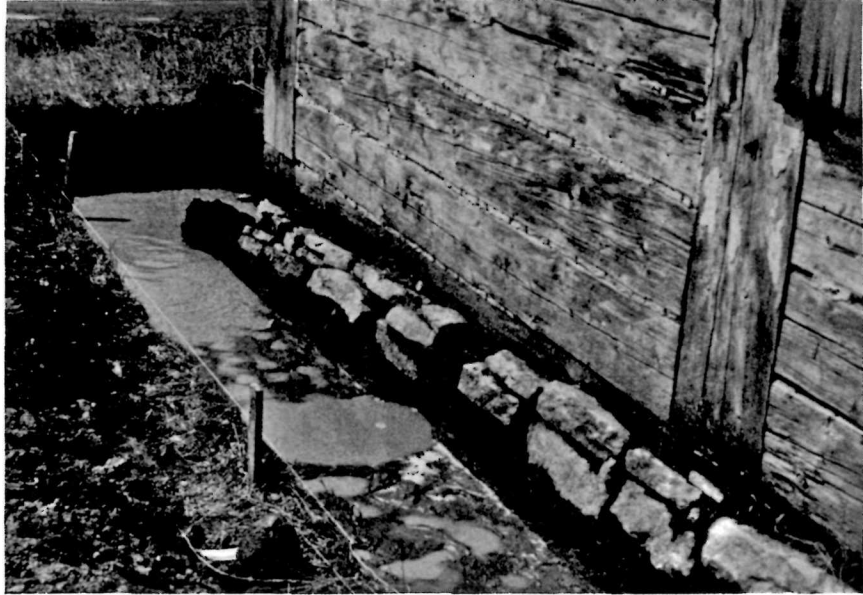
Figure 15. Double coursed limestone foundation of warehouse in 3T1C. Note the gap left by decaying sleeper beam and the rotted state of the bottom-most log. 3T-88 M.

The foundations of the building shown in Figure 15 along the south wall were quite similar to those found along the west wall of the building. Again it was composed of limestone laid in double or triple courses and the various sized stones were undressed. This stone foundation was topped with a wooden base plate and it was broken in several places with wooden sleepers placed at intervals of 5 ft. to 7 ft.

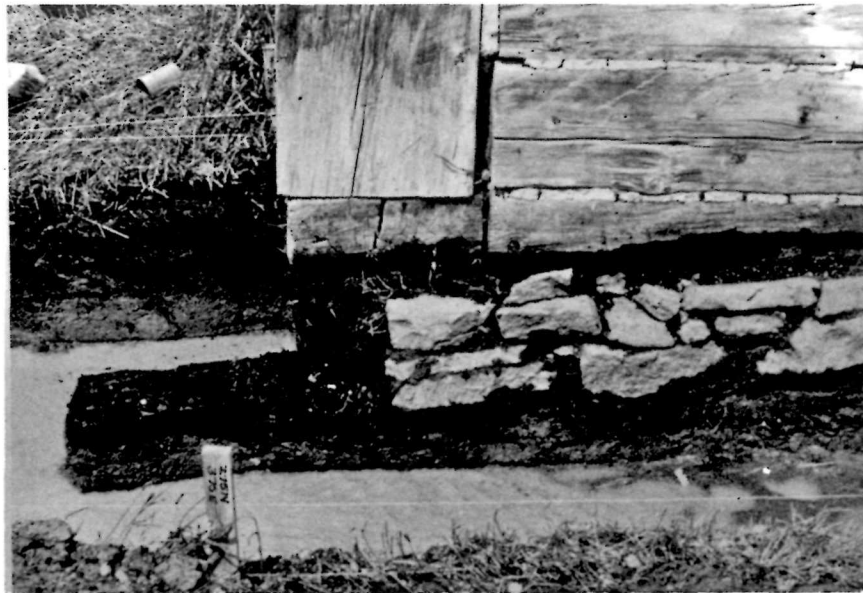
Figure 16. Southwest corner of the warehouse in 3T1C. Note the wooden member that extends out from the foundation and how the stone has slumped away from the foundation. 3T-85 M.

The foundation terminated at 0.8 ft. east of the southwest corner of the building and that corner was supported by an overlapping system of beams as shown in Figures 16 and 17. It was not bound by a half dovetailed joint which was the case with the northwest corner of the building. The stone foundation had also slumped downward about 0.4 ft., a circumstance due probably to the rotting of the lower support beam. An elevation taken on the top, or what was assumed to be the top of that beam, was 2273.5 ft. MSL. The top of the stone

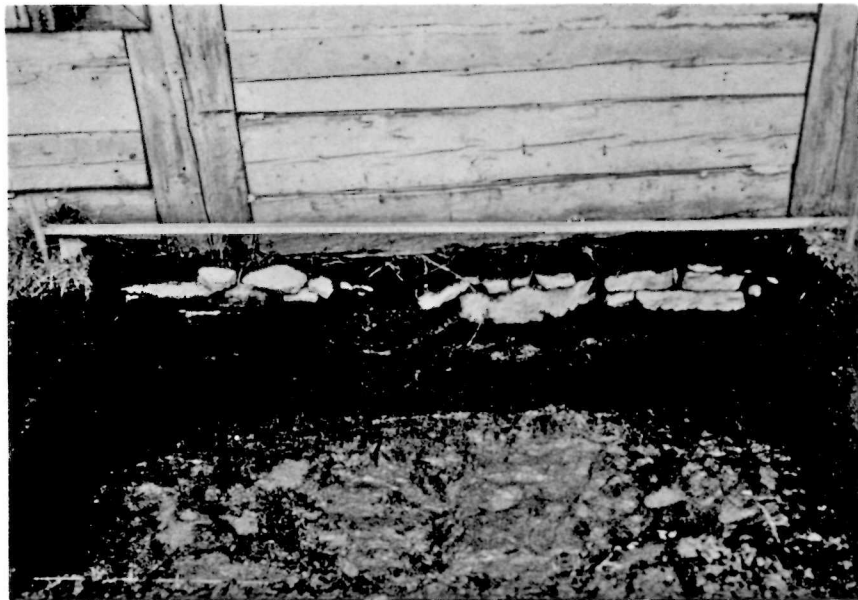
Figure 19. Ditch 3T1J3 and its relationship to the eastern wall foundation of the warehouse between 1295N-1300N. 3T-111 M.

used for the ditch which ran east and west across the trench between 1295N and 1300N. The relationship of this ditch to the warehouse foundation is illustrated in Figures 18 and 19. It can be seen in this profile that the ditch ran beneath the warehouse foundation, but it is uncertain as to whether or not the ditch pre-dates the warehouse. The ditch was slightly over 1.0 ft. in width and, again, rain prevented determining its exact depth, which was estimated to have been 2.7 ft. below ground surface. This ditch in places still retained fragments of wood and gave the impression that it might have been wood-lined. The evidence, however, was too fragmentary to be certain. A continuation of this ditch was found in 3T1F.

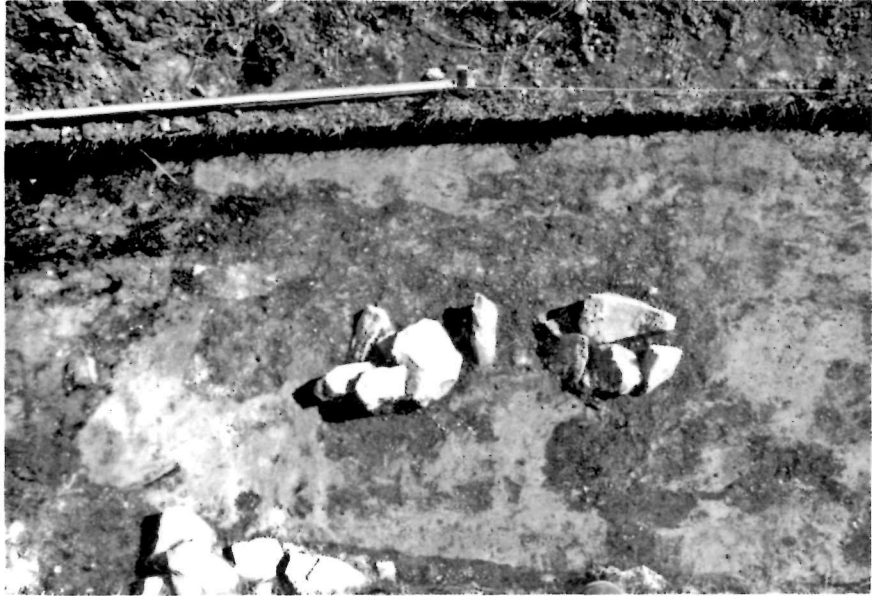
Figure 23a. Stone piers for support of staircase posts.
Photograph taken from the doorway of the fish
cache. 3T-103 M.

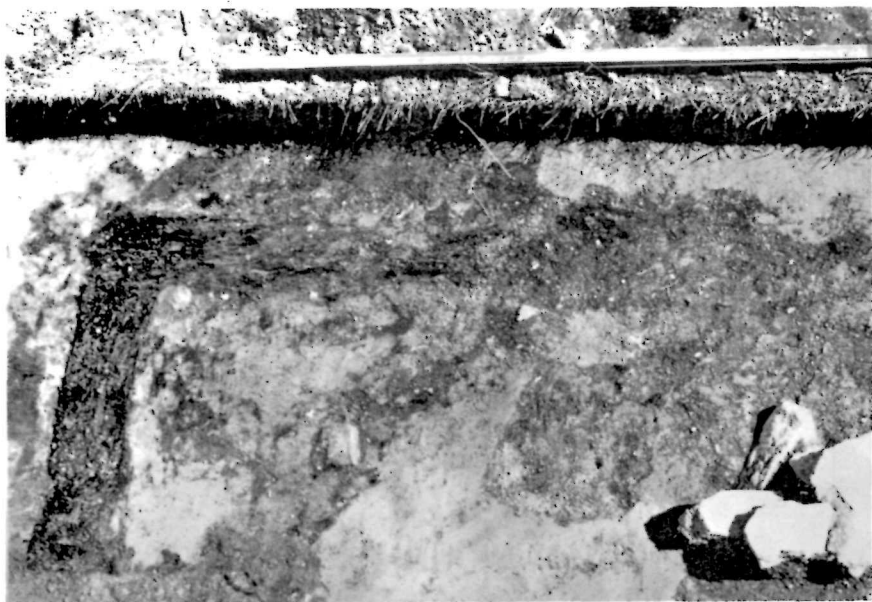
Figure 23b. Remnants of log structure that pre-dated the
fish cache as seen from the doorway of the
fish cache. 3T-105 M.

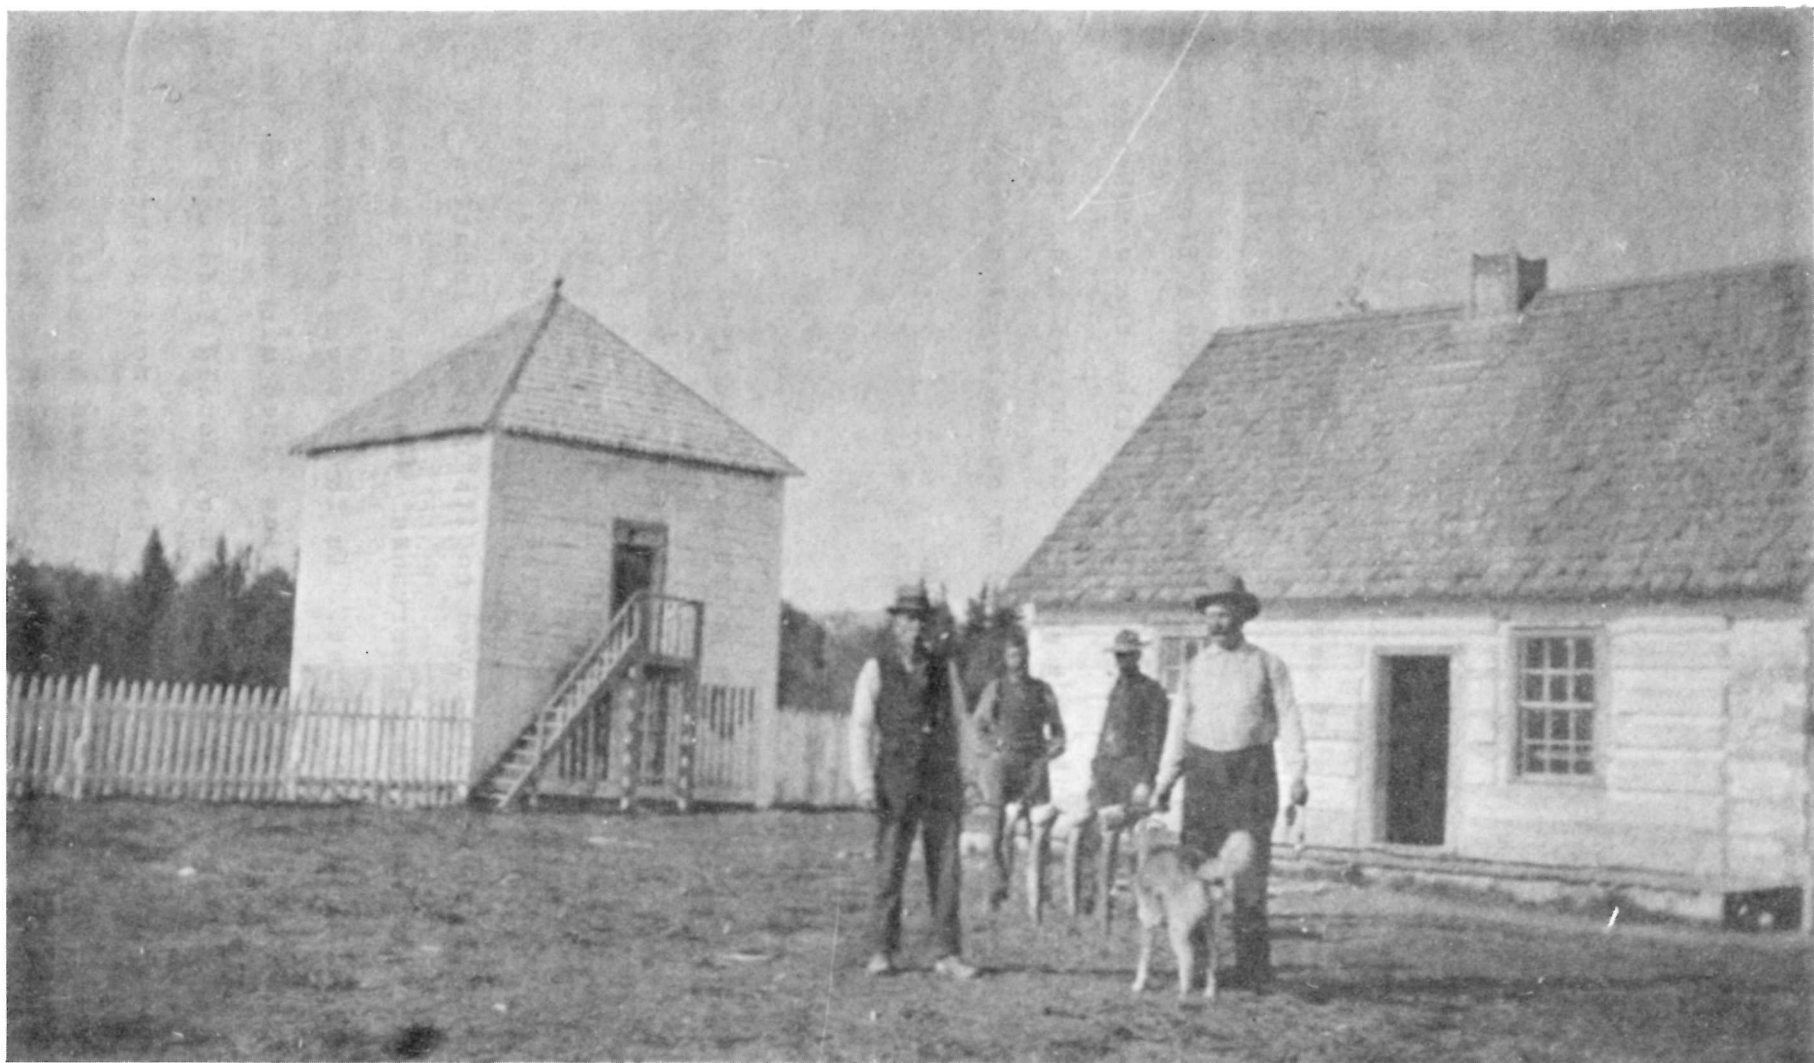
Figure 25. Stuart Lake Salmon, circa 1912. Men's house and fish cache in background. Note that the boardwalk in front of men's house does not extend past the ends of the building (Photograph courtesy of Mr. David Bunting).

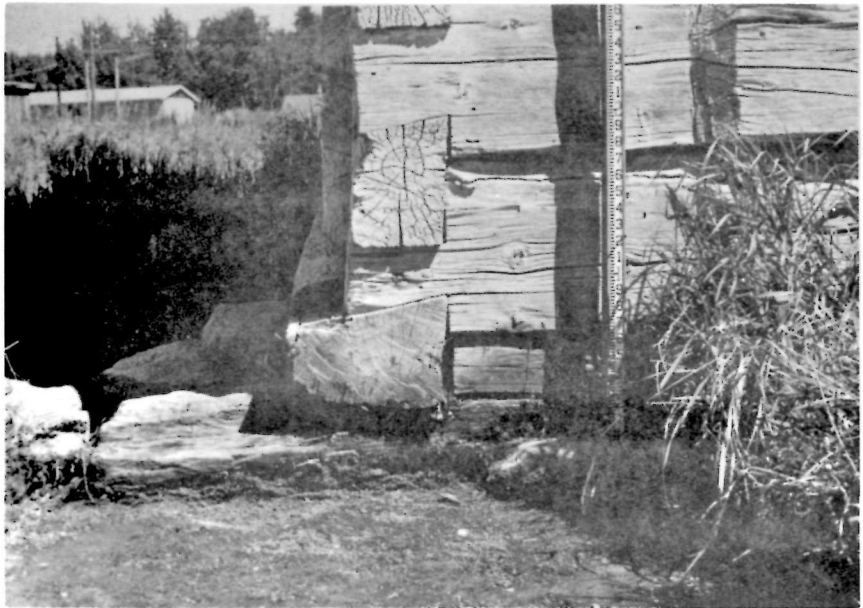
Figure 27. Northwest corner of Men's house as seen from the north. Note how sill is joined with a dovetailed lap joint. 3T-90 M.

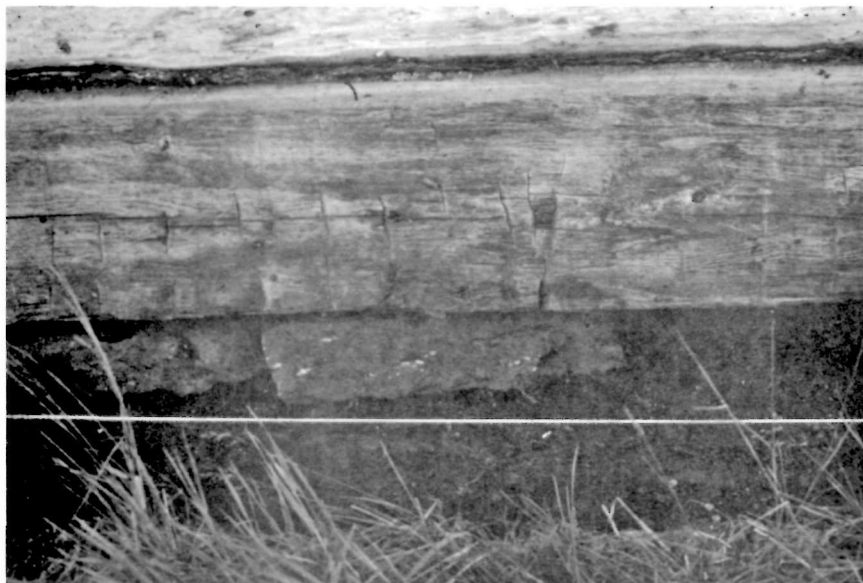
Figure 29. Stylized view of the northwest corner of the clerk's quarters (3T-72-102-10).

of notched log construction placed on a single coursed limestone foundation. These stones varied in length from 0.6 ft. to 1.0 ft. As can be seen in Figure 29 the foundation did not have a base plate as did the warehouse, but the log along the bottom of the west wall extended 1.3 ft. west of the structure's corner, and was unsupported by the stone work. This situation was similar to that of the warehouse in that the bottom log projects out from beneath the corner of the building, but in the case of the warehouse this lower log supported a base plate. Further excavation will determine whether or not this construction occurs at the other corners of the building.

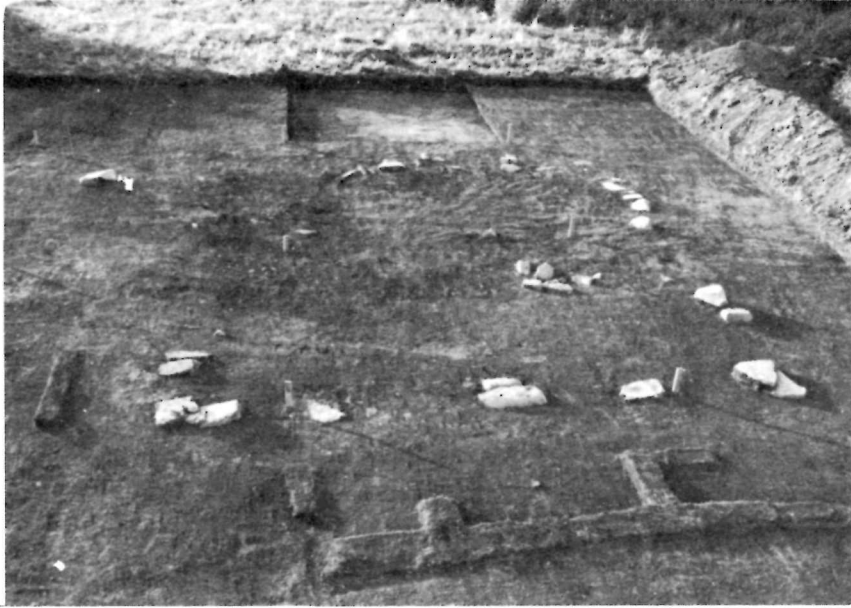
Figure 31. Interpreter's house excavation as seen from the south at the base of sub-operations 3T3A2 through 3T3R2. Note the wooden fence that has collapsed in the foreground. 3T-97 M.

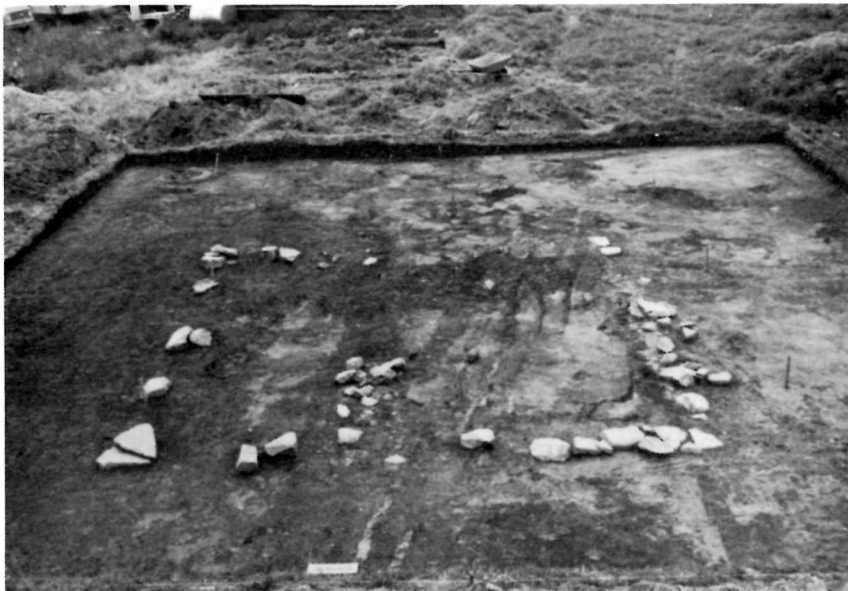
Figure 32. Interpreter's house excavation as seen from the east at the base of sub-operations 3TA3 through 3TR3. Note the plow furrows running from east to west across the excavation. 3T-96 M.

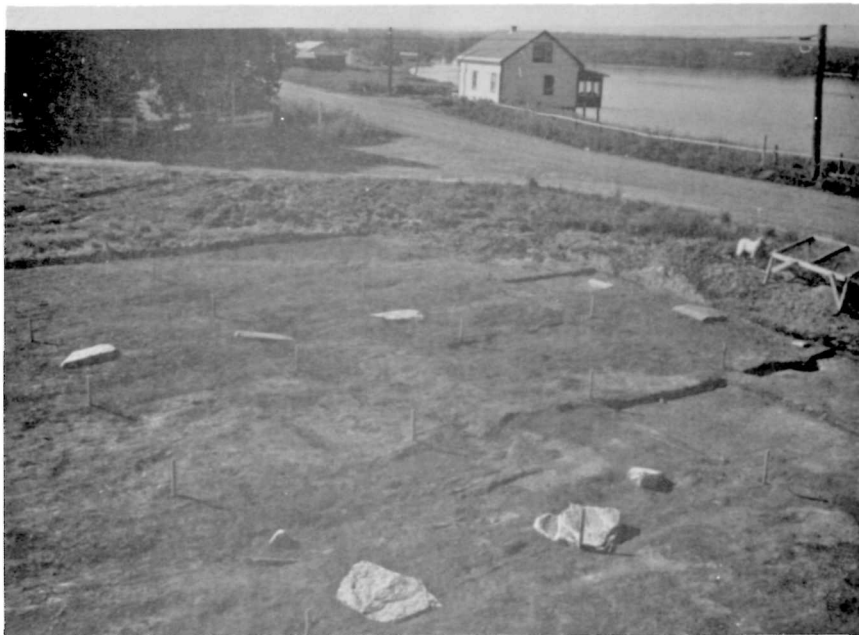
Figure 36. Eastern end of the 1920s-40s trade store site as represented by the large flat limestones. These stones bear no relation to the earlier store. 3T-106 M.

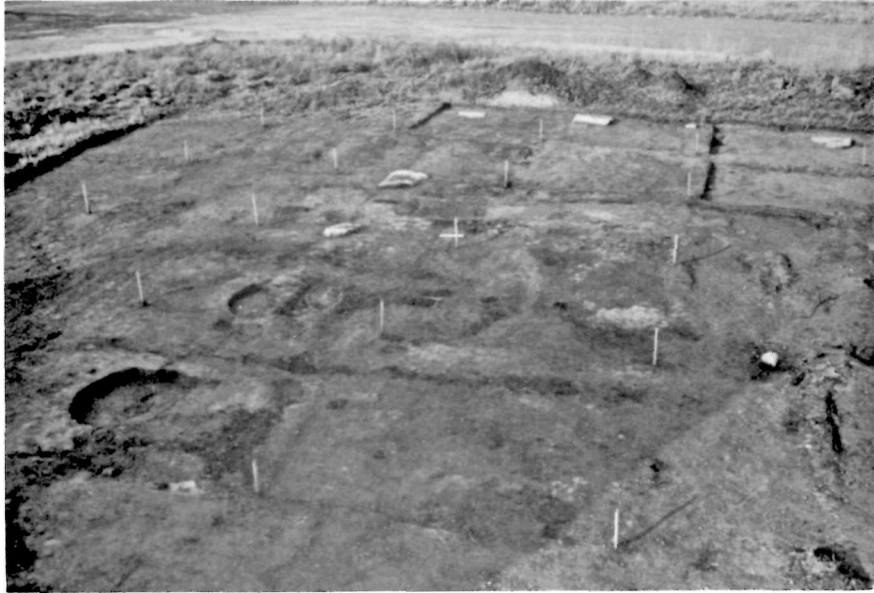
Figure 38. 1884-1919 trade store foundations seen from the east as represented by faint lines of charcoal and ash in the soil. 3T-123 M.

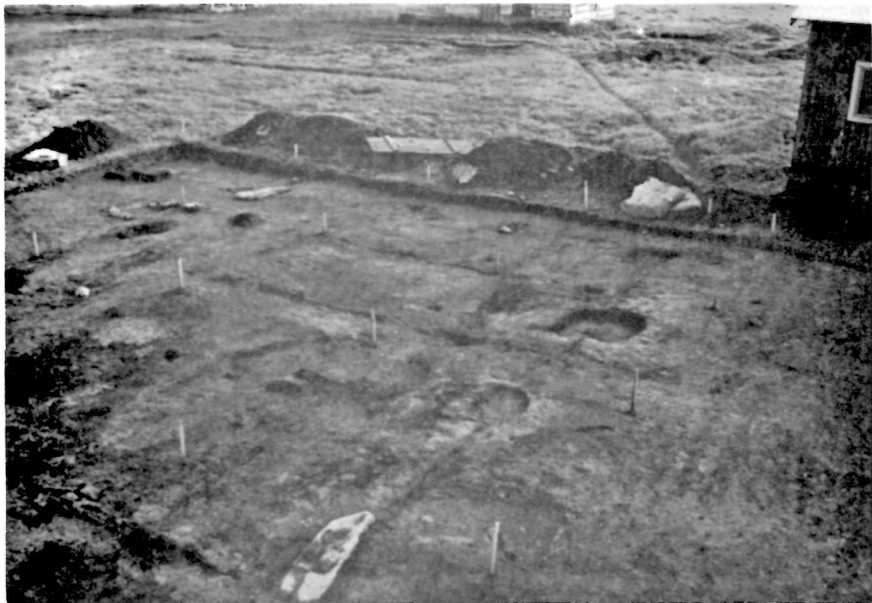
Figure 39. 1884-1919 trade store as seen from the southwest. Pits in excavation are sites of the foundation stones of the post-1920s store. 3T-115 M.

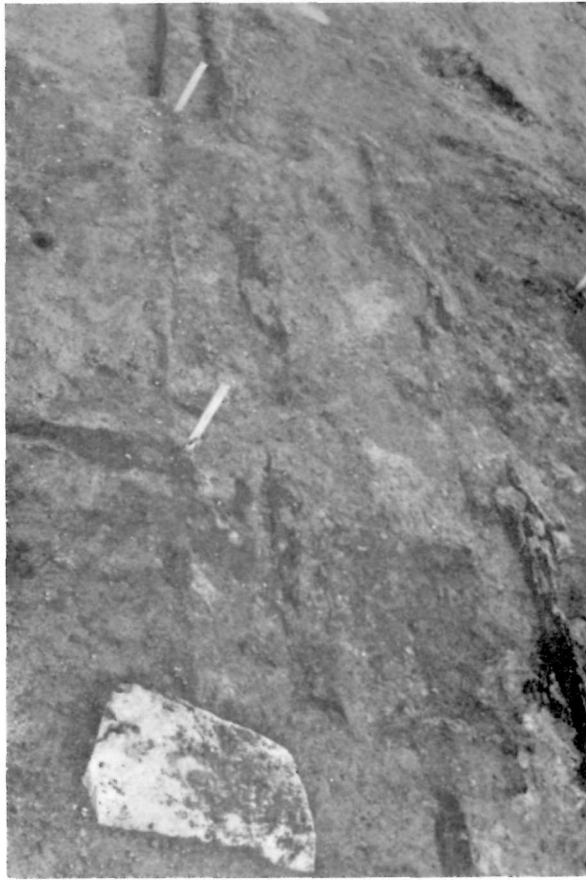
Figure 40. Charred timbers of the base plate of the 1884-
1919 trade store from the southwest.
3T-109 M.
