NATIONAL HISTORIC SITES SERVICE

MANUSCRIPT REPORT NUMBER 78

FORT HERCHMER, DAWSON:

PAST & PRESENT

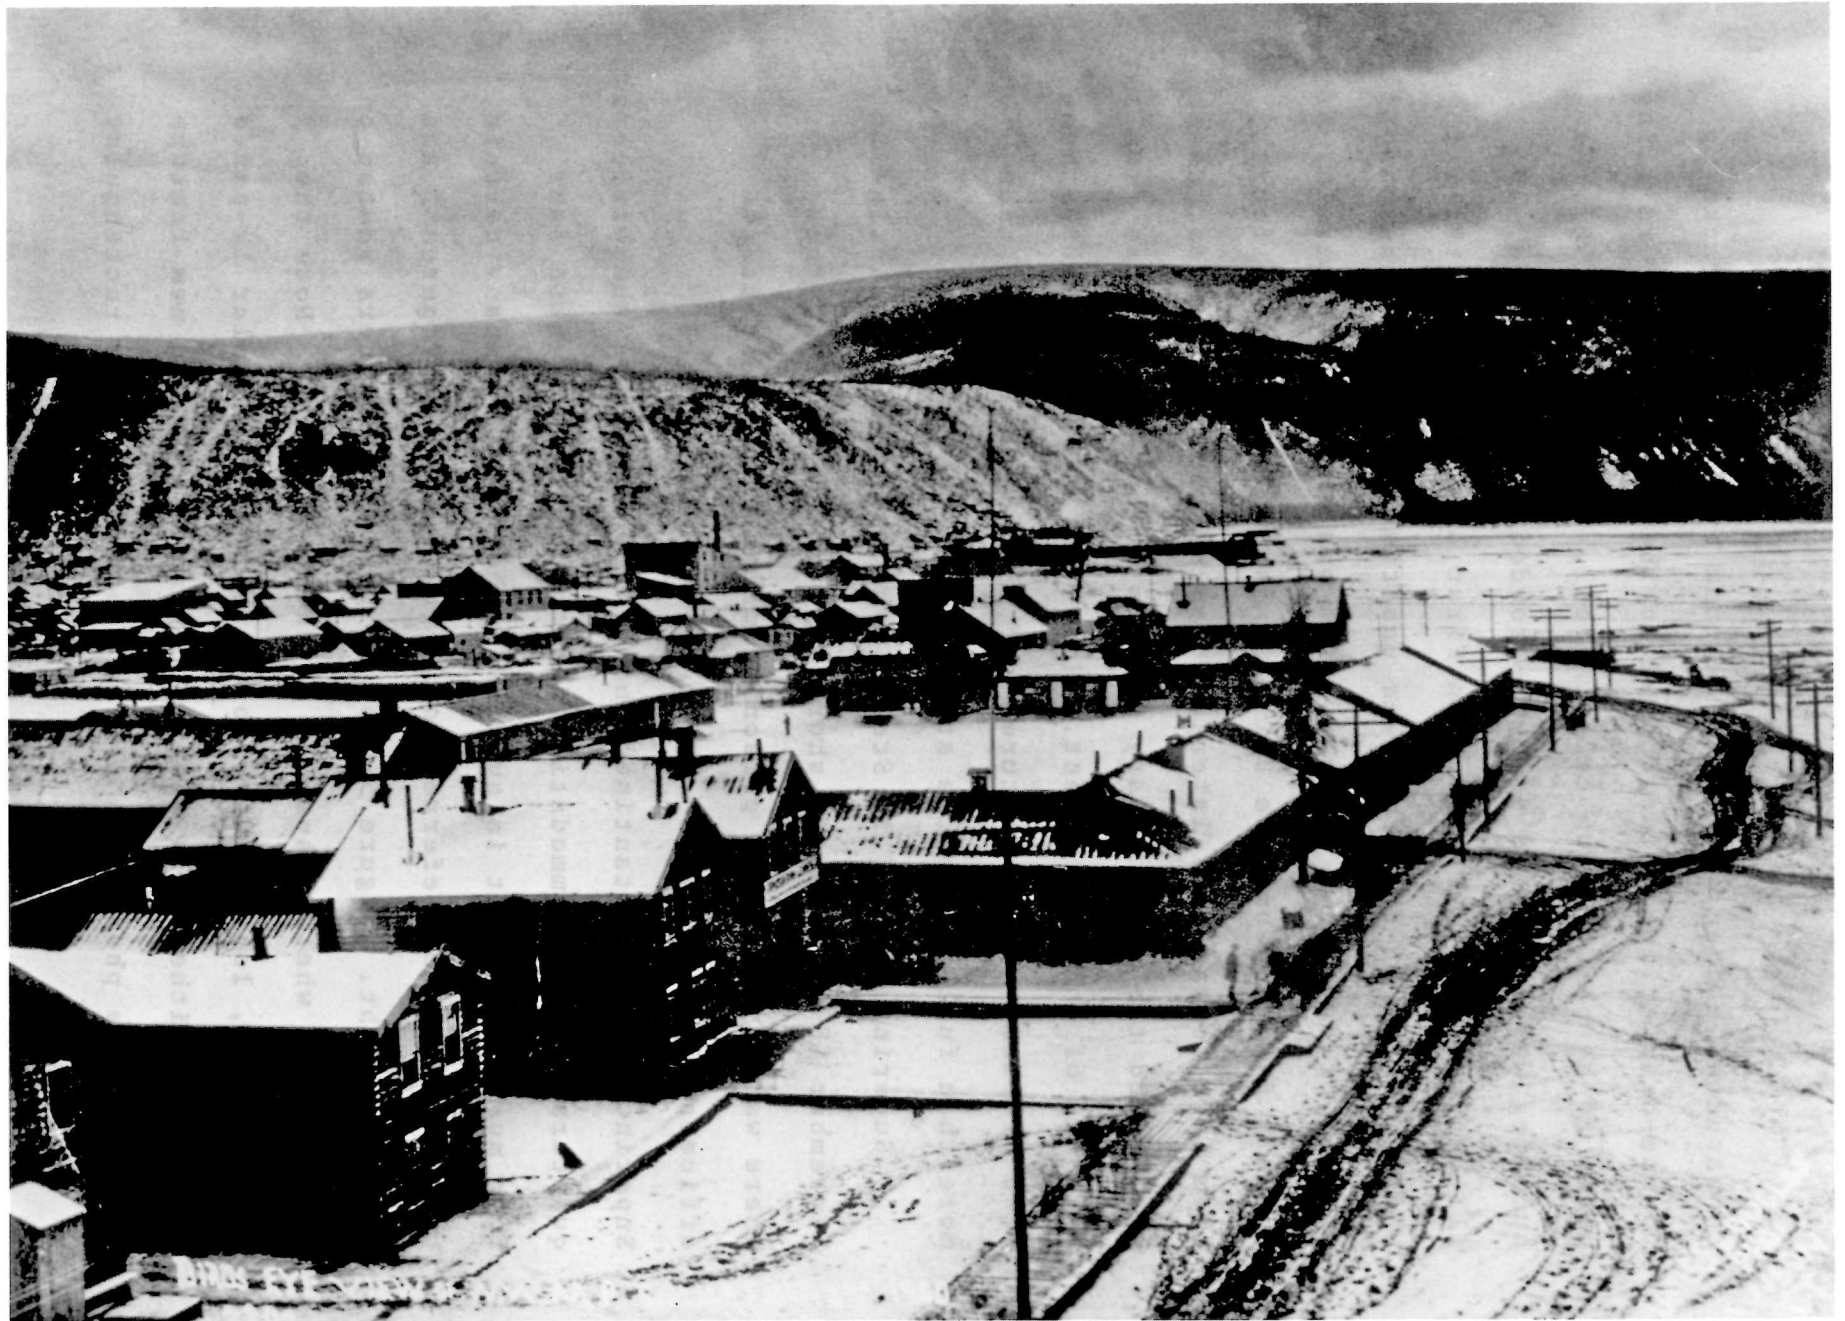
Fig. 4

Fort Herchmer, looking southeast, 1900
L-shaped building middle foreground is
the Guard-room cum Gaol. Yukon River
to the right.

constructed had so warped and shrunk by 1900 that cracks up to one-quarter inch wide opened in the partitions, permitting notes to be passed from cell to cell. As early as 1901 the building was condemned as over-crowded, a fire hazard, and ill-designed. Its fronting on First Avenue, one of the main thoroughfares of the town, was unsatisfactory from the point of view of security, and yet worse was the close proximity of the old Bank of Commerce Building (shown in Figure 4 fourth from left foreground) later used as an employees' mess, which overlooked the penitentiary section of the guard-house from a distance of only three feet. However, in 1898 and 1899 these were problems for the future, for the force had its hands more than full during the stampede.

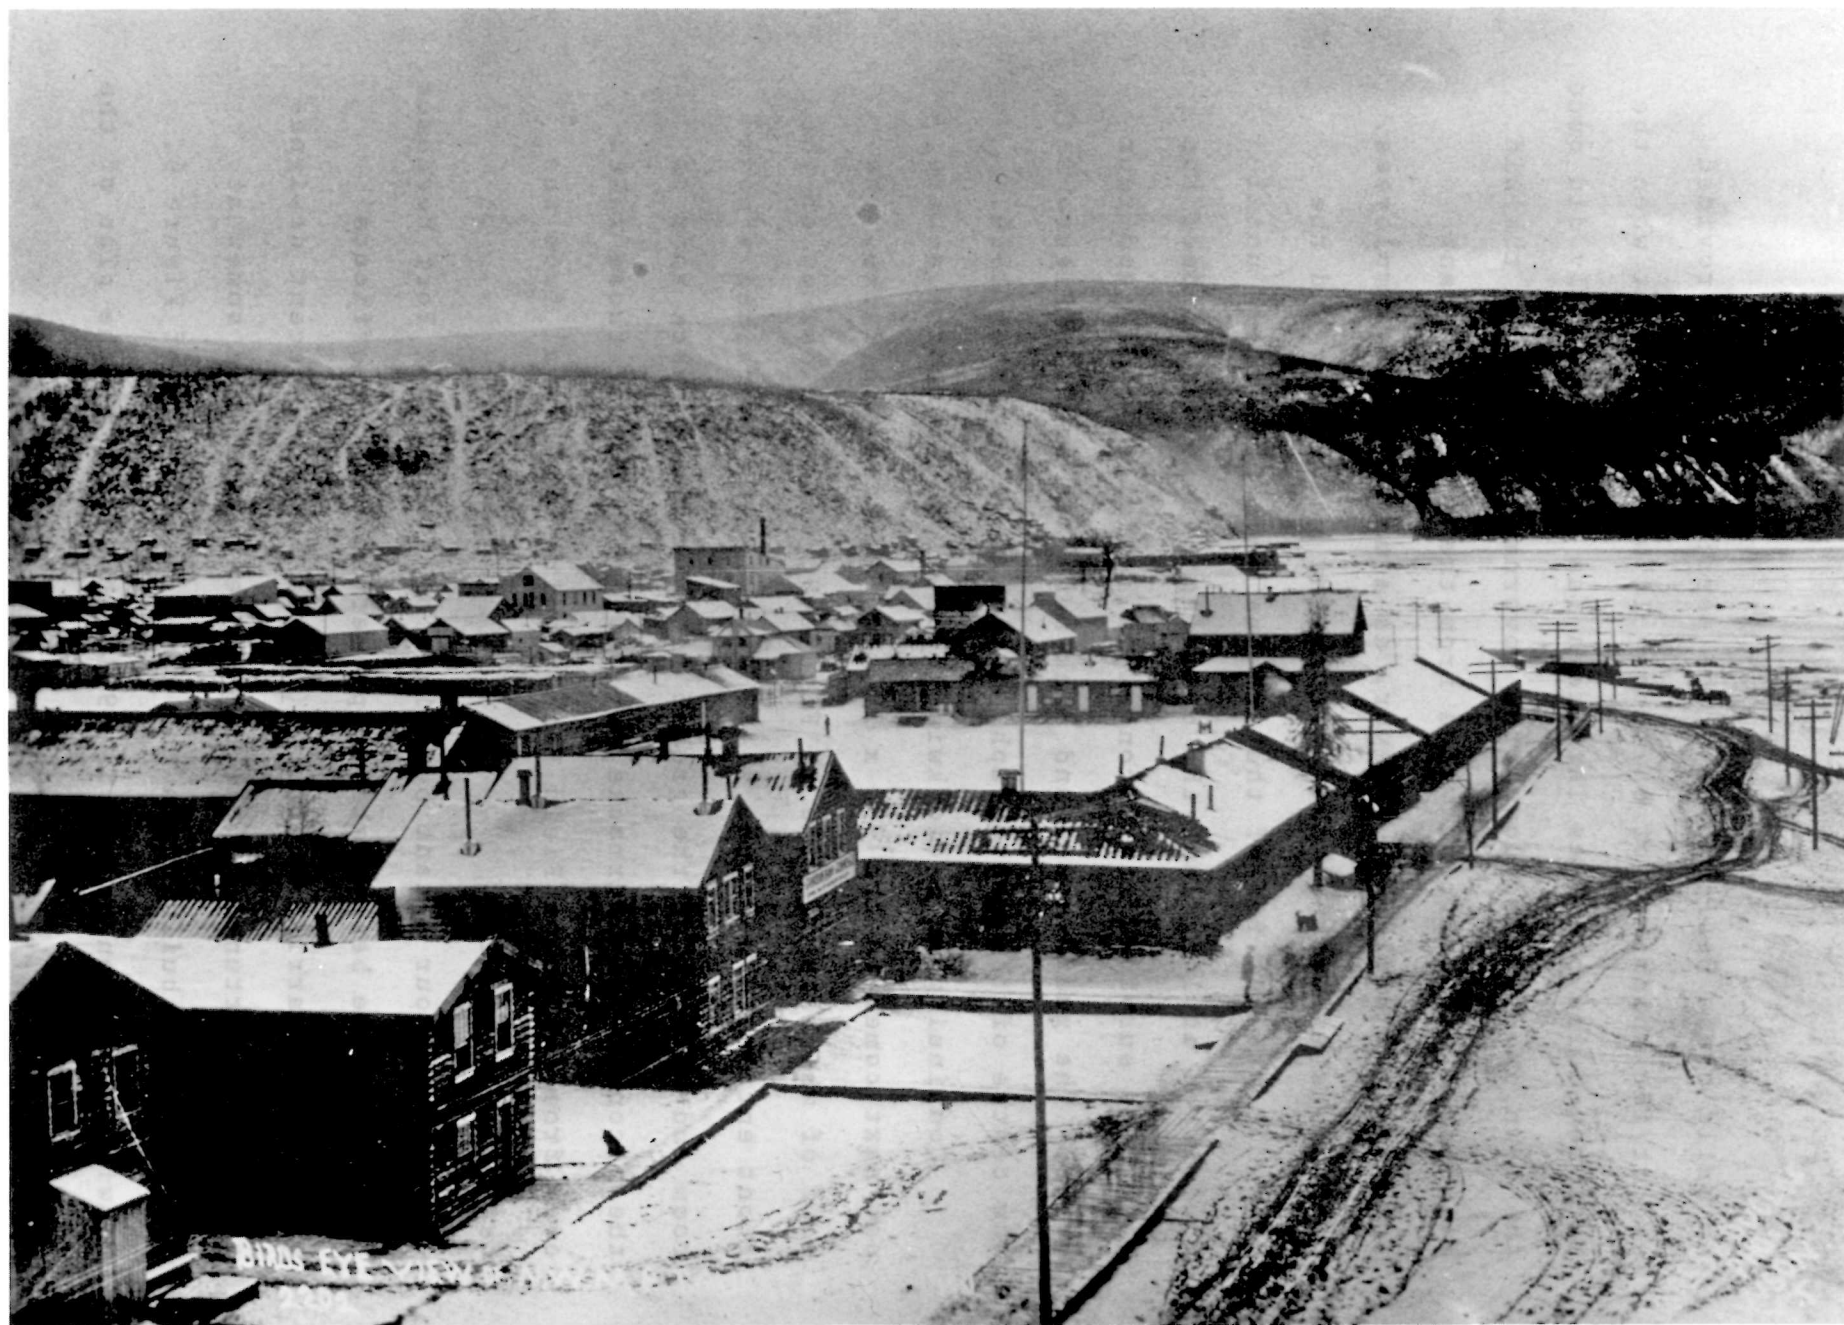
Fig. 9

View of Fort Herchmer, taken 2 Dec. 1900.

to build close beside the police post; the police provided escort for shipments of bullion. It was agreed that when the bank moved its premises into town (as it subsequently did once the town had settled down) the government would buy the old building at its current value from the bank. The bank retained the building, however, as a mess for its employees. Continuous efforts on the part of the government and the N.-W.M.P. to get rid of the incubus were frustrated until 1914, when at long last the building came down. Indeed the bank mess survived its incongruous bedfellow by a good four years. The guard-house and bank mess are seen in Figure 9 in the centre of the photograph, dating from December 1900.

Continuing in a clockwise direction around the square, one next comes to the 79' x 29' two-storeyed barracks, the roof of which is visible in Figure 9, with a close-up of the front entrance in Figure 7. This building contained a mess room and kitchen on the ground floor and a barrack room on the second. This barracks may have been one of those taken over from the Yukon Field Force on its withdrawal from the territory in 1900.

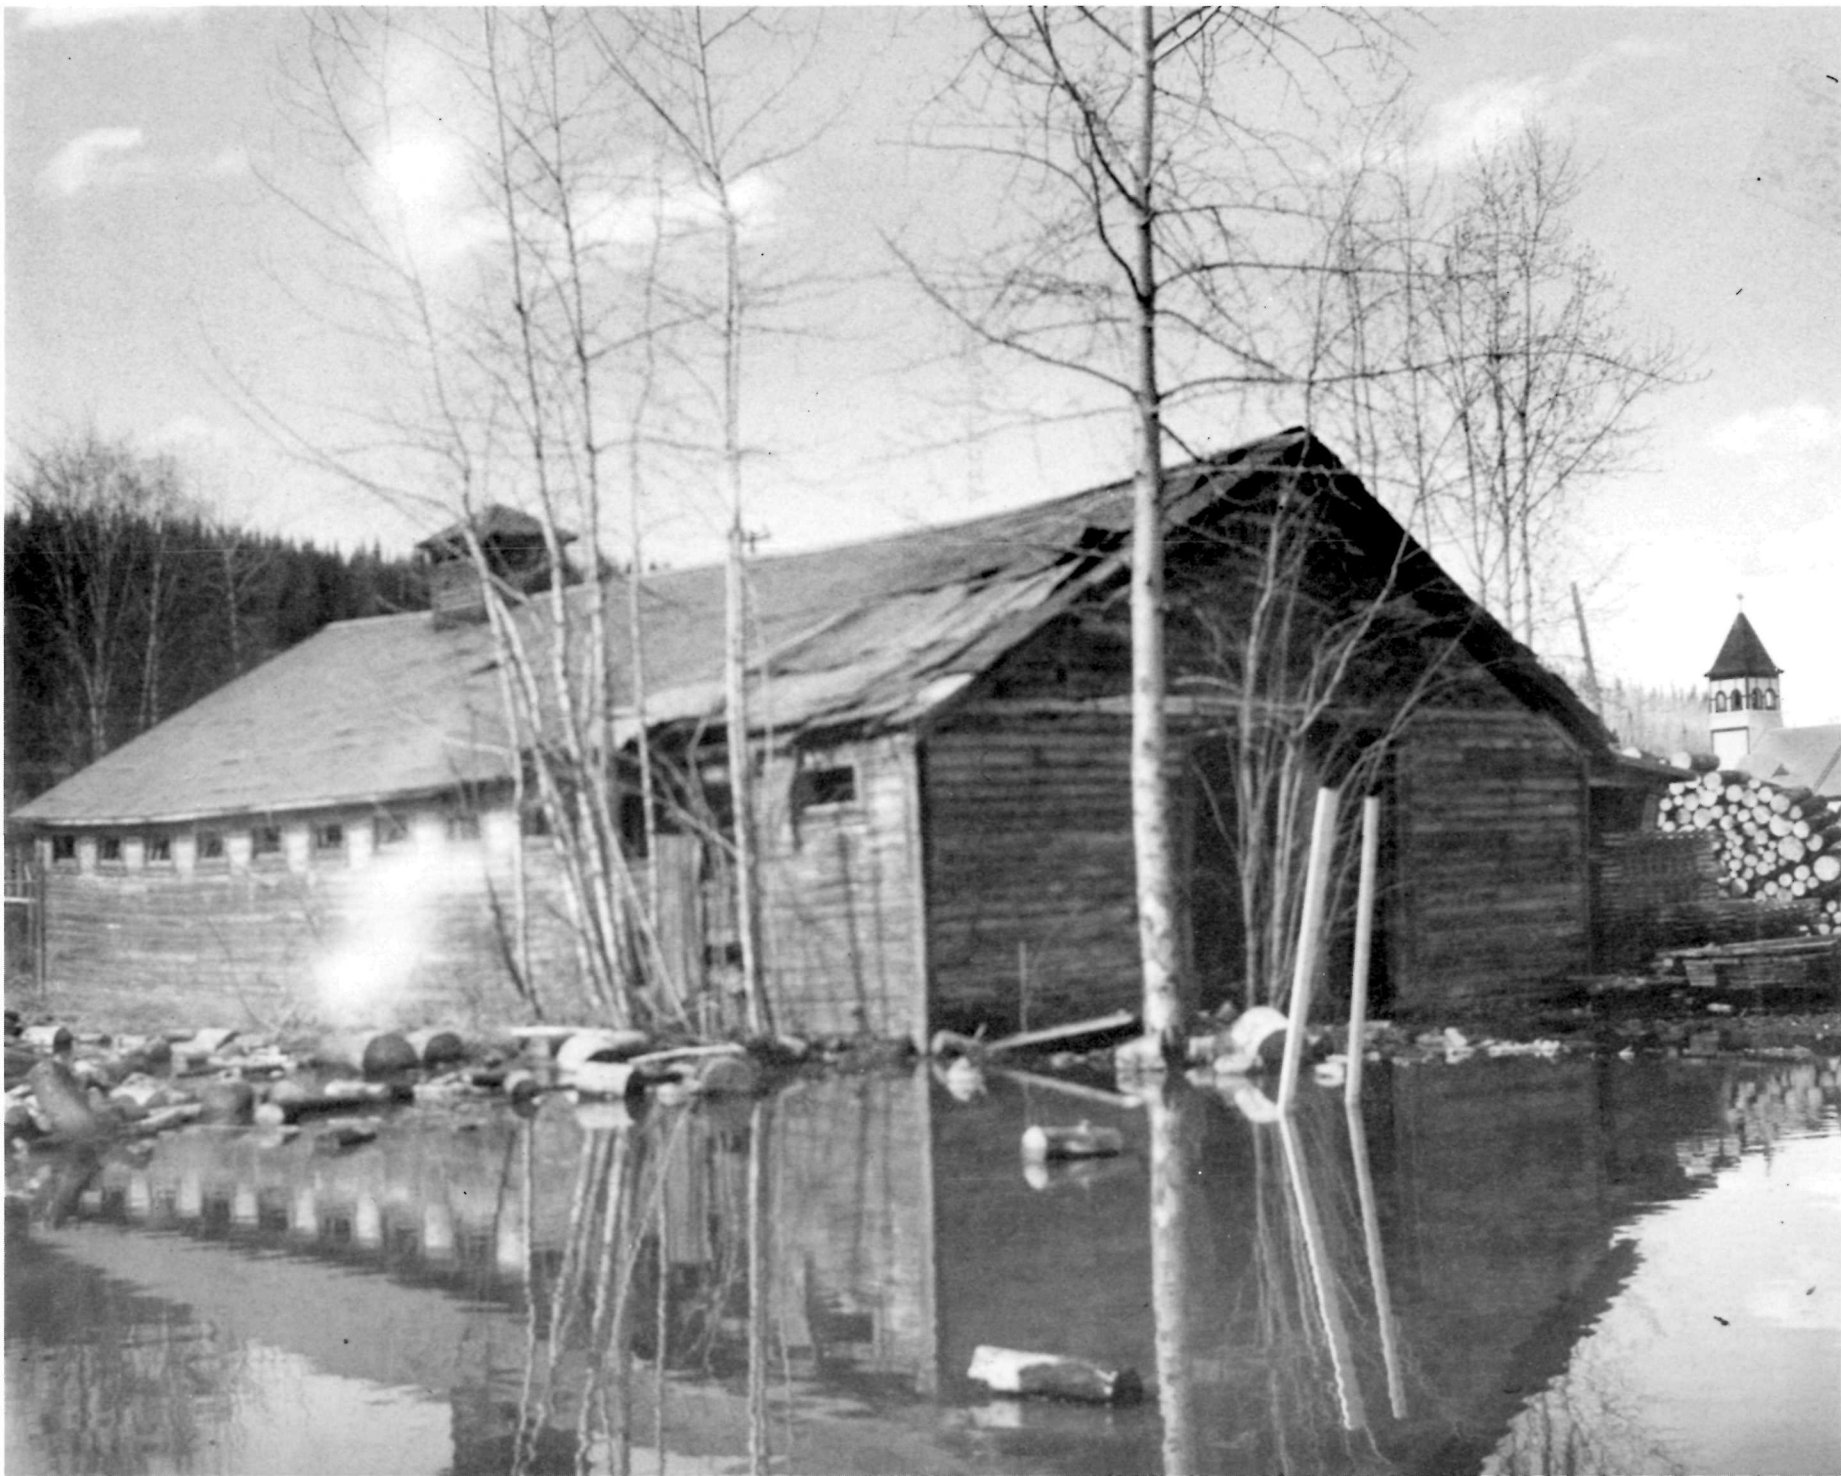
The summer of 1903 saw the erection of a new 32-stall stable with a cow stable at one end; this too is one of the four extant buildings, the attached photograph (Fig. 15) having been taken in the spring of 1972. The rectangular frame structure, with pitched roof and cupola, was built between the artisans' shops and the walk leading to the hospital. The estimate (\$3,363.75) was to include rustic outside walls, matched flooring in the harness room, dressed

Stables spring 1972, south-east.

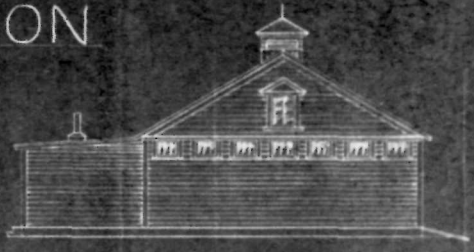
FLOOR PLAN

Blueprint of Tool House & Latrine, 1910.

2x4 Frame
Rough Boards
T. & S. Boards.

The only reason for devoting any space to this little shed is that research unearthed a bit of information concerning it. Fig. 55 is a blueprint of the plan. The tool shed was built in 1910 in an undetermined location; a frame structure of two-by-four, 17 ft. in length by 8 in width, the pitched roof was single-boarded and sheeted with

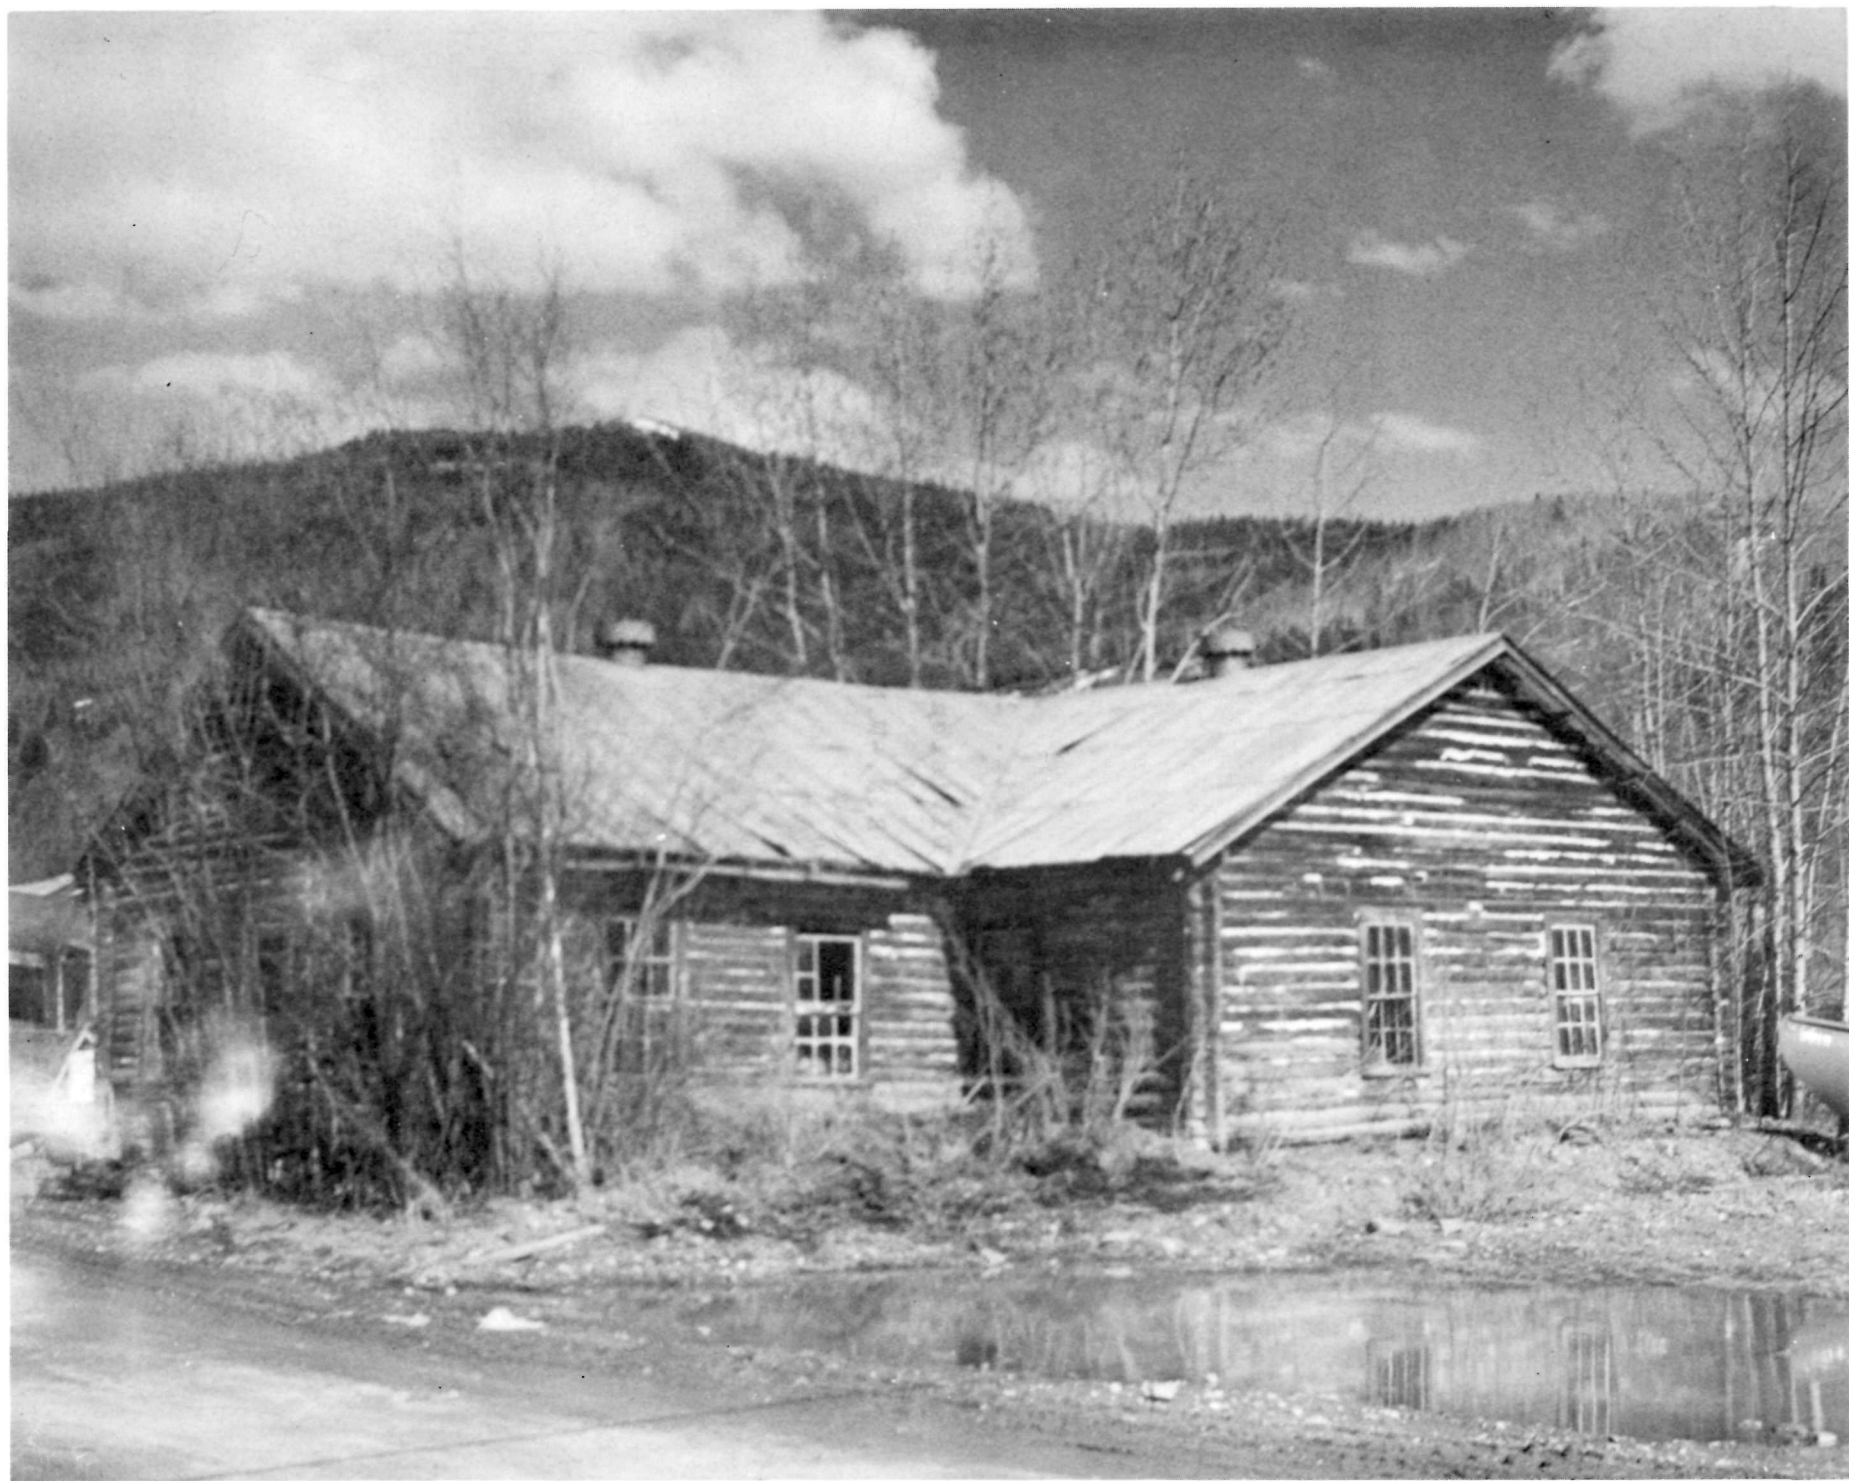
Fig. 21

The year 1910 witnessed a few changes. The hospital was gutted, but the structure survived in salvageable condition; the decision was then taken, for want of the means to replace the old building, to convert the charred hospital to serve as guard-room and gaol. Figure 21 shows the building as it

Hospital and former Gaol, spring 1972,
south-west view

stands today, a forlorn-looking structure, like so many others in Dawson. The bars are still set in one of the windows. Figure 22 is a blueprint of the interior, as re-designed for its new function. Note the cruciform shape, inherited from the structure's more respectable days as a police hospital. The central portion contained 20 cells, back to back, with central corridor, as well as passages around both cell blocks. Later a table was set up in the central corridor, so that the inmates had no longer to eat in their cells. It is not presently known how long the building was in use; its appearance today suggests that it has been abandoned for a good many years. With the conversion of the former hospital the oft-condemned old structure at the northwest corner of the compound came down. And so the long-offending bank mess outlived its contemporary by three to four years.

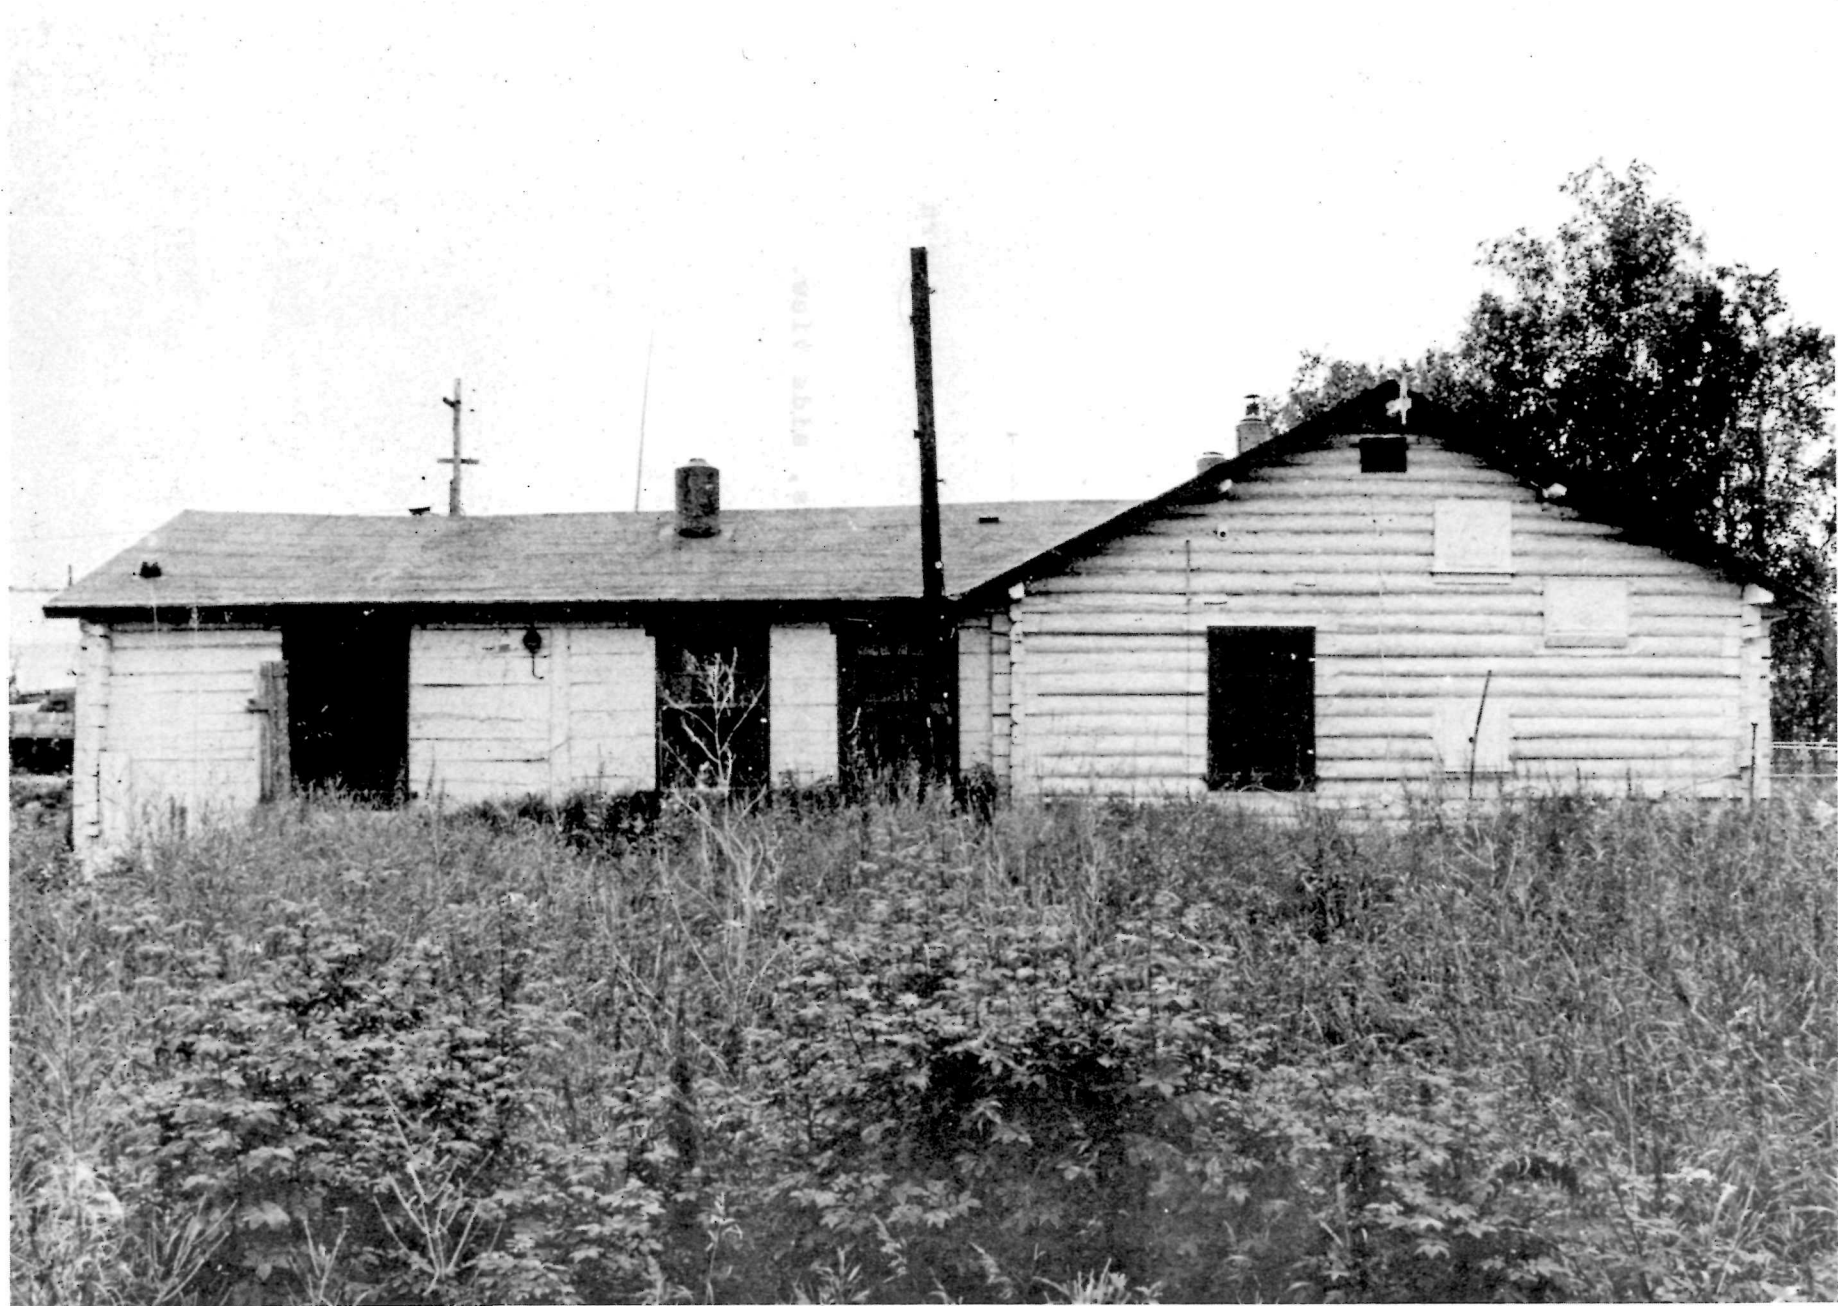
Extant officers' quarters, used until 1966
by the R.C.M.P. as married quarters.

building seems of lesser length (38 ft?), and it will be observed from Figure 10 in Part I that it has but two windows in the front, one of which is double, whereas the building identified as officers' quarters in 1901 (see Fig. 6 in Part I) has three single windows in front. These aspects of the two buildings, of similar structure and design, make it awkward to identify them as one and the same.

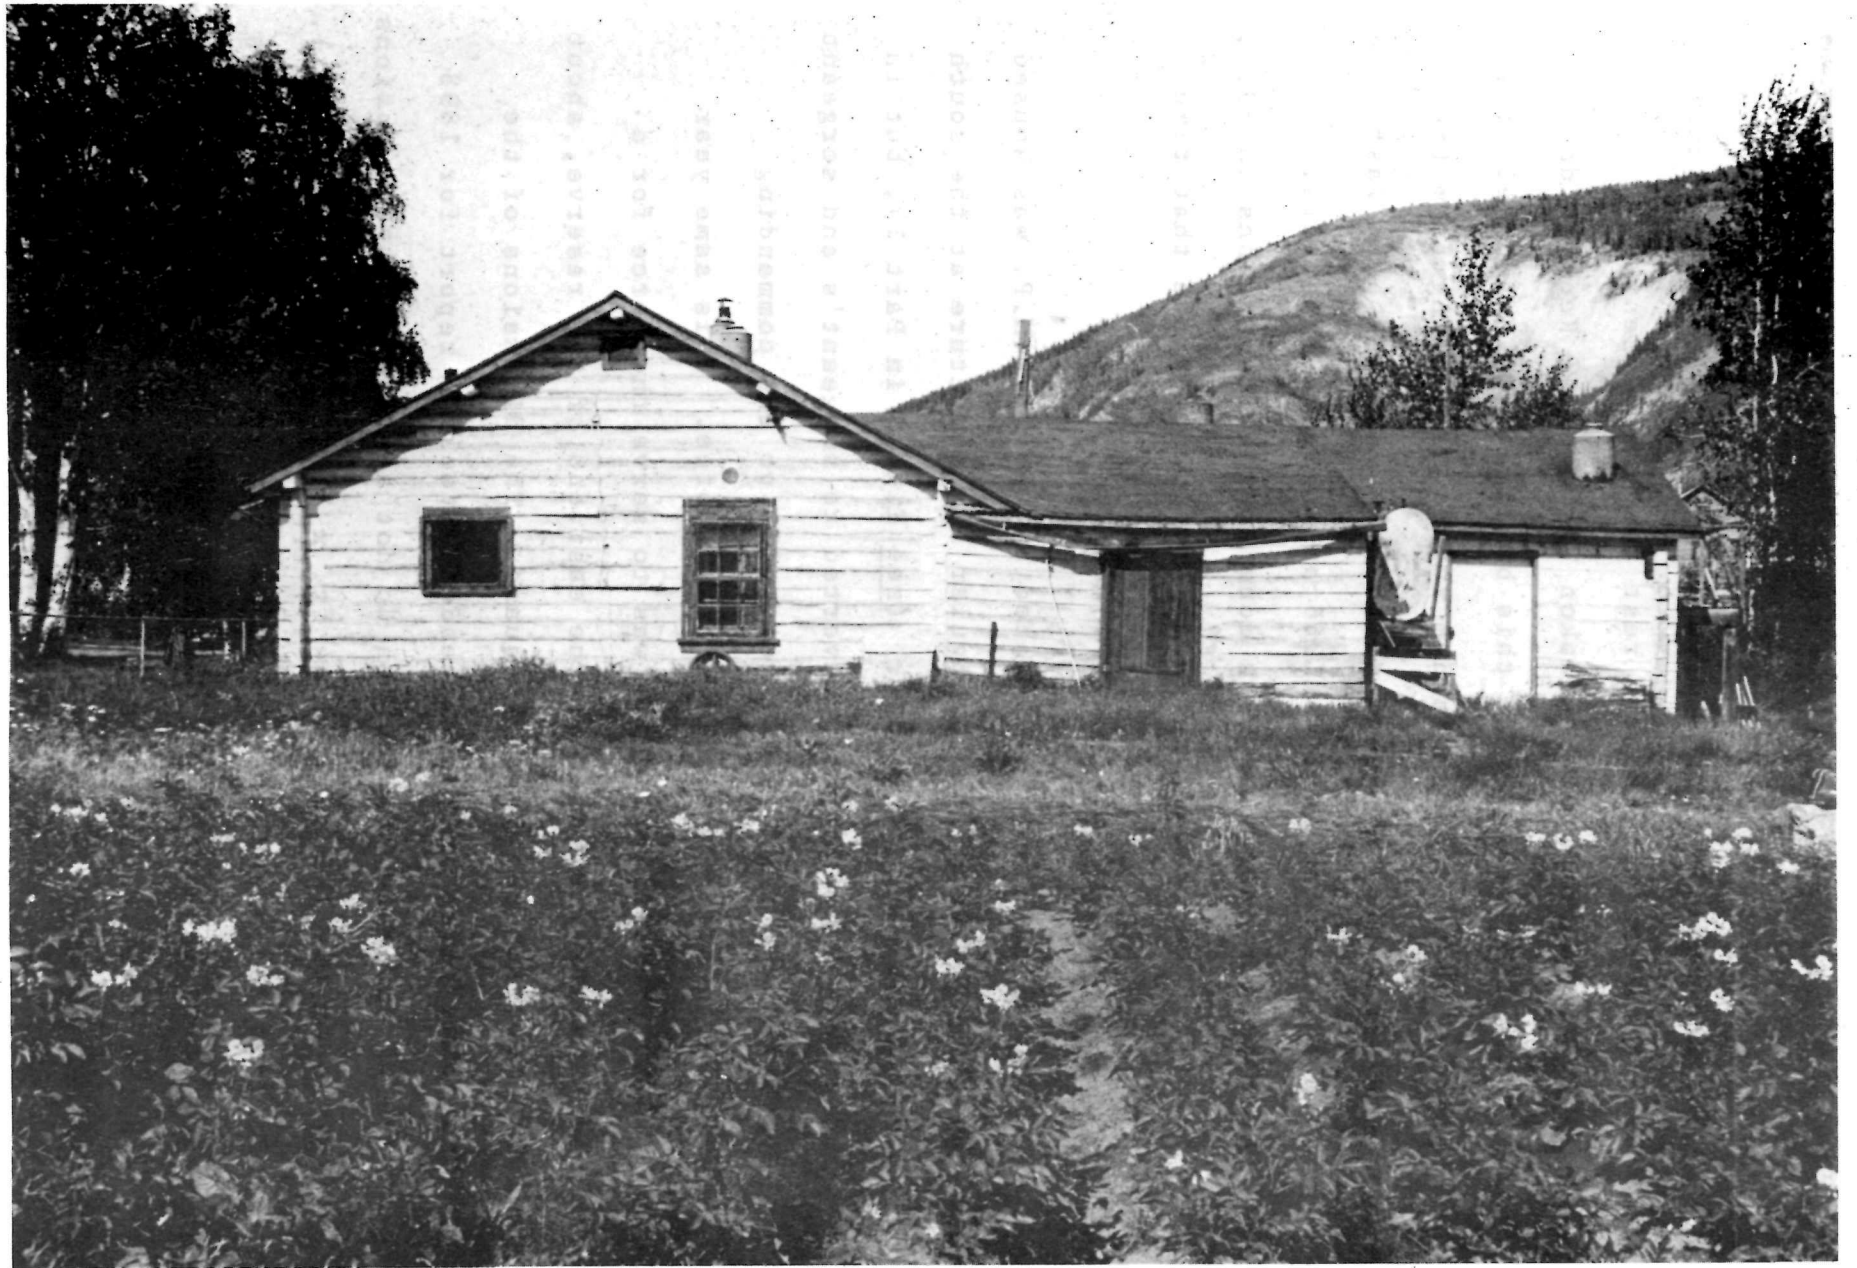
Fig. 30

(Department of Indian Affairs & Northern
Development)
Extant Officers' Quarters.

A memorandum from the Yukon Territorial Records dated October 1949 states that this building (unfortunately the plan to which the memorandum refers is missing from the file) is habitable and easy to heat, and had been last used by the police as late as 1966 as a married quarters. Extensive repairs had been done to the foundations in 1935, but there had been considerable settling since that time.⁴

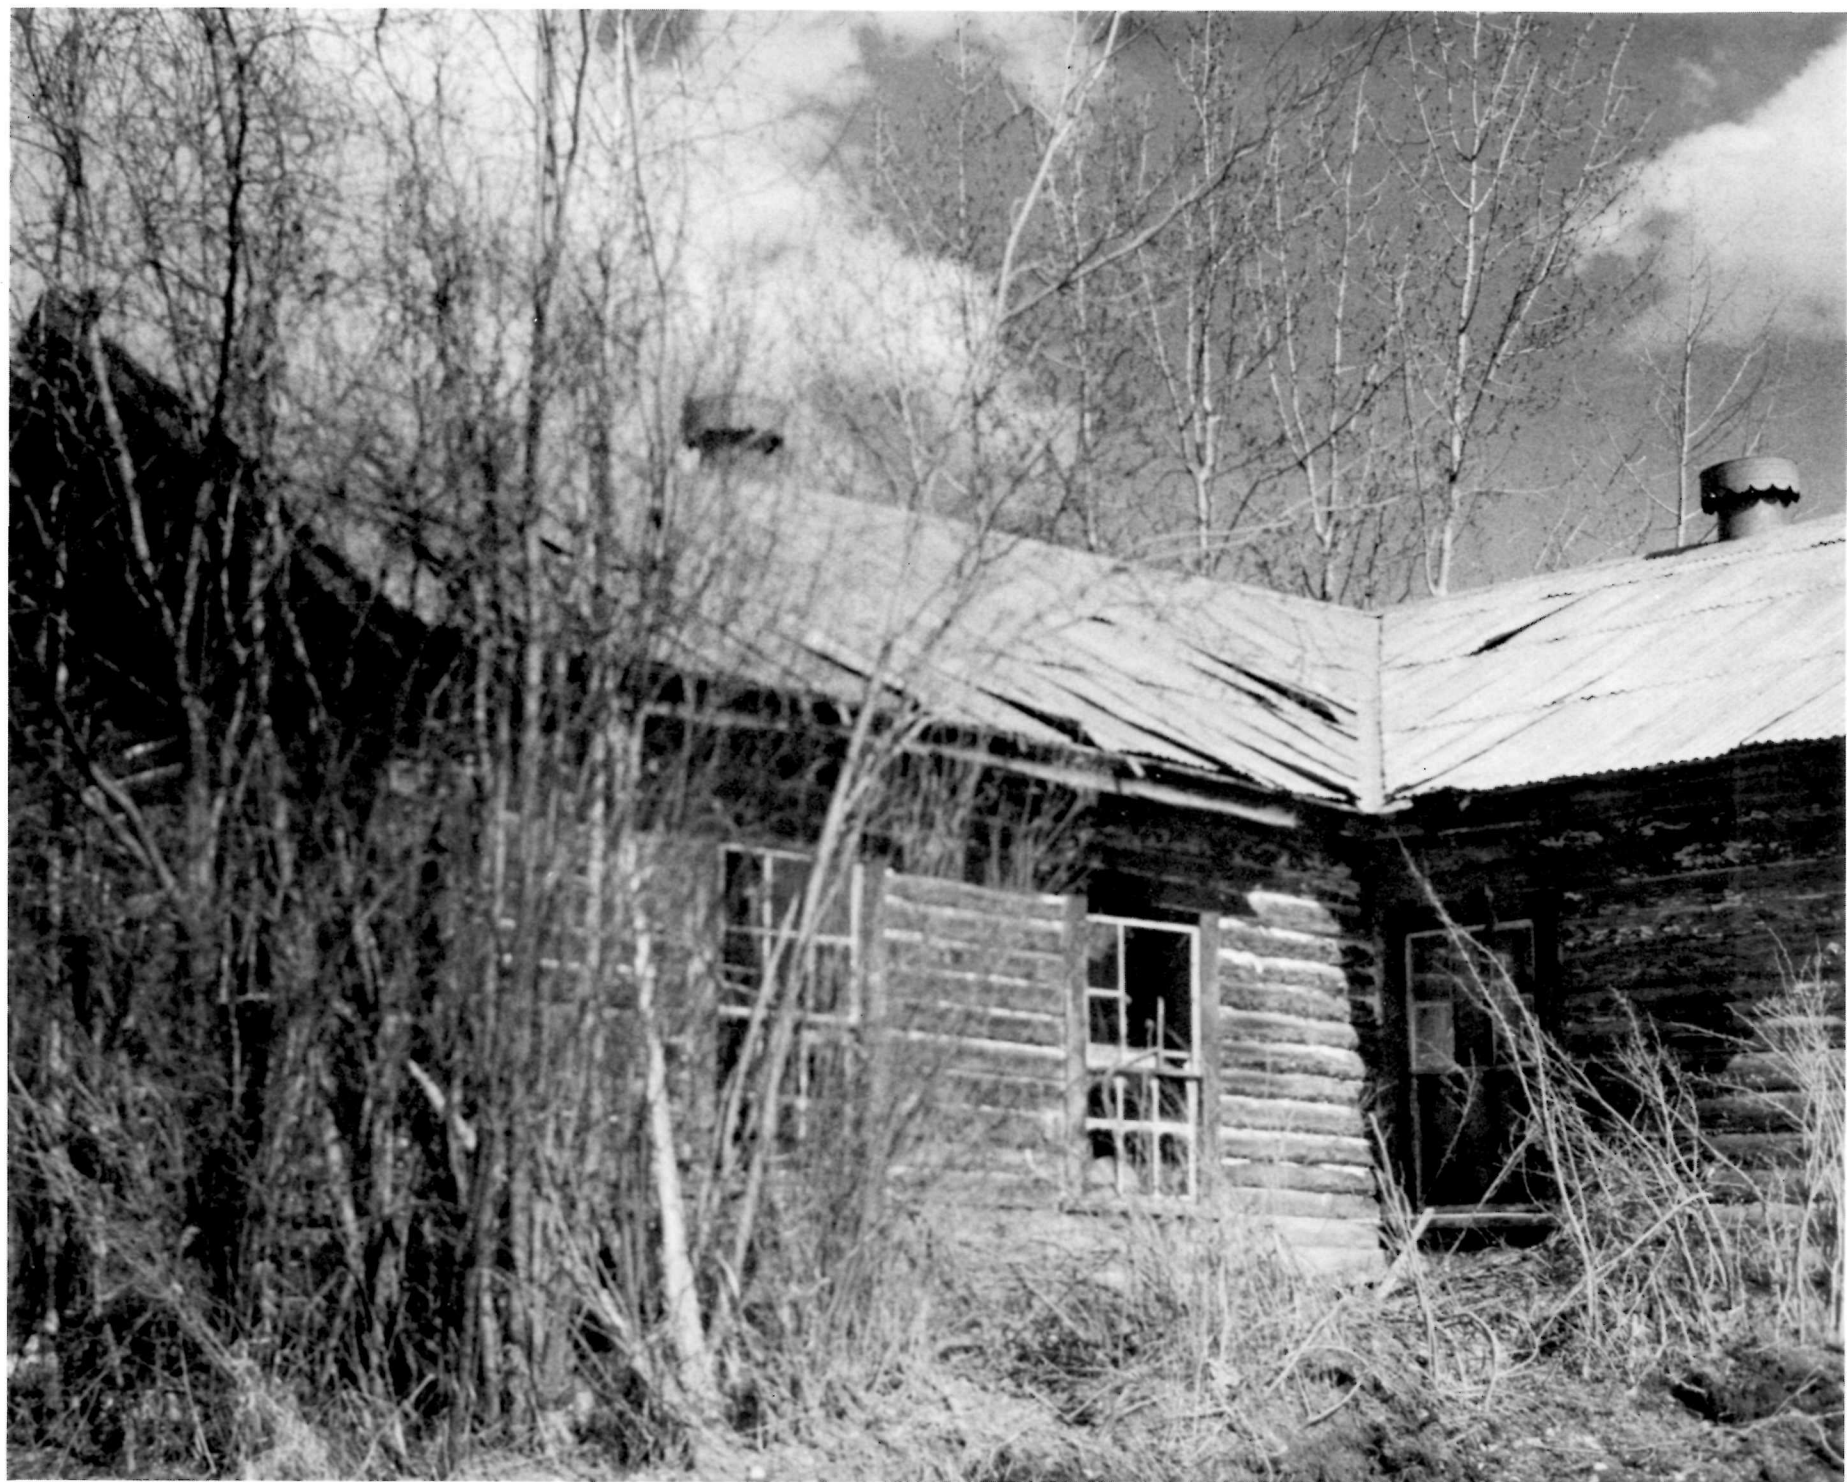
Fig. 32

Gaol, from south-west, spring 1972.

This completes the information available on this building, which is today in a rather forlorn condition, but no doubt restorable. It is not known when it was abandoned, but it appears not to have been in use, or kept up, for many years.

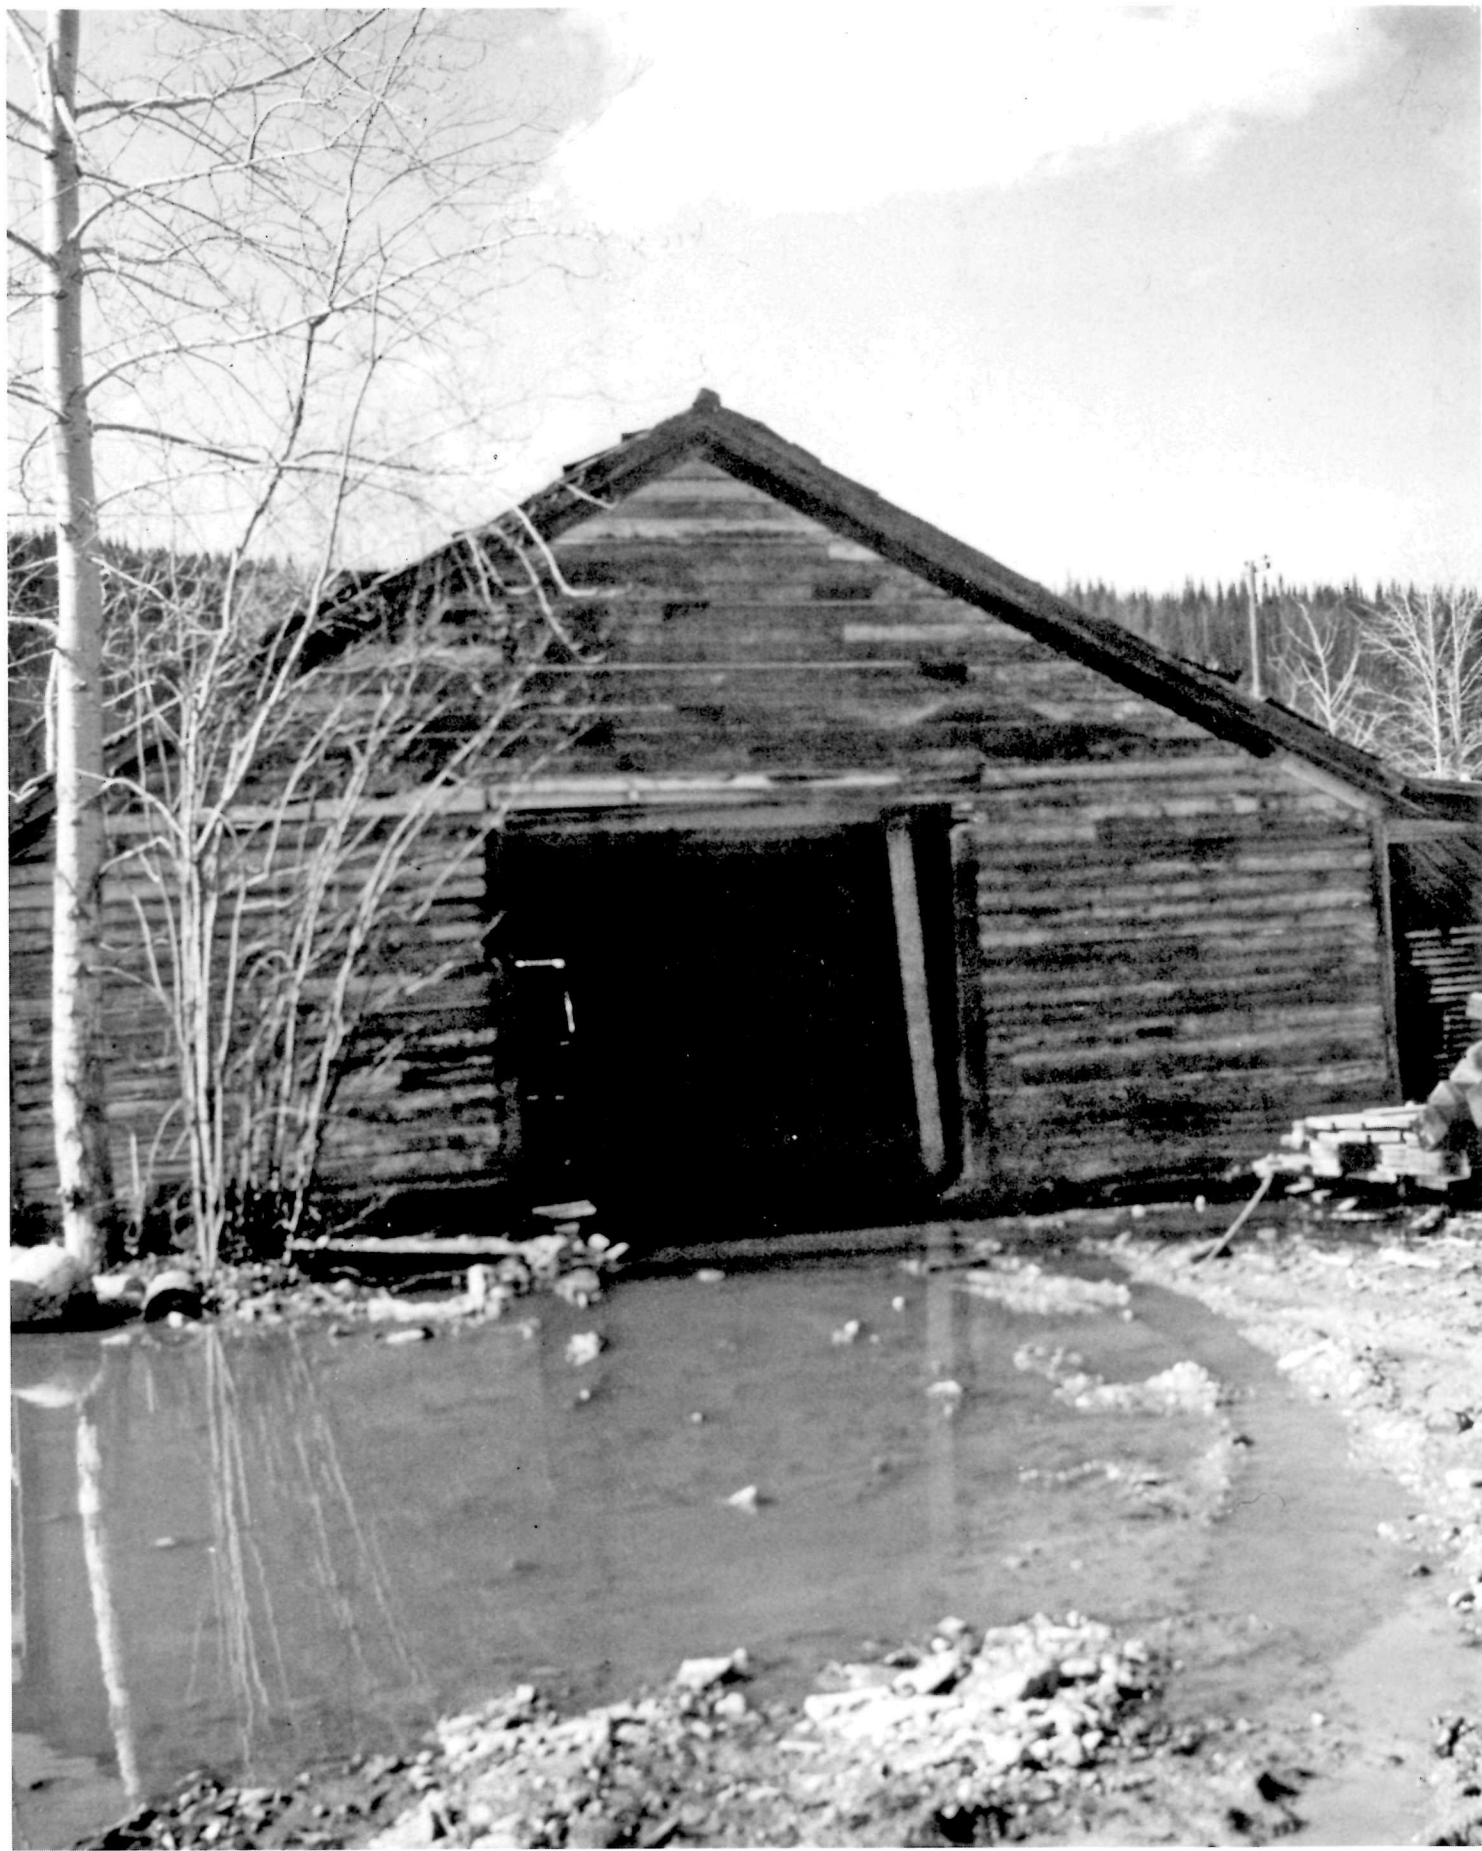
Stables east end, spring 1972. This series (Fig. 31-41 incl.), taken 9 May 1972, found this building standing in a foot of water due to permafrost.
