NATIONAL HISTORIC SITES SERVICE

MANUSCRIPT REPORT NUMBER 78

FORT HERCHMER, DAWSON:

PAST & PRESENT

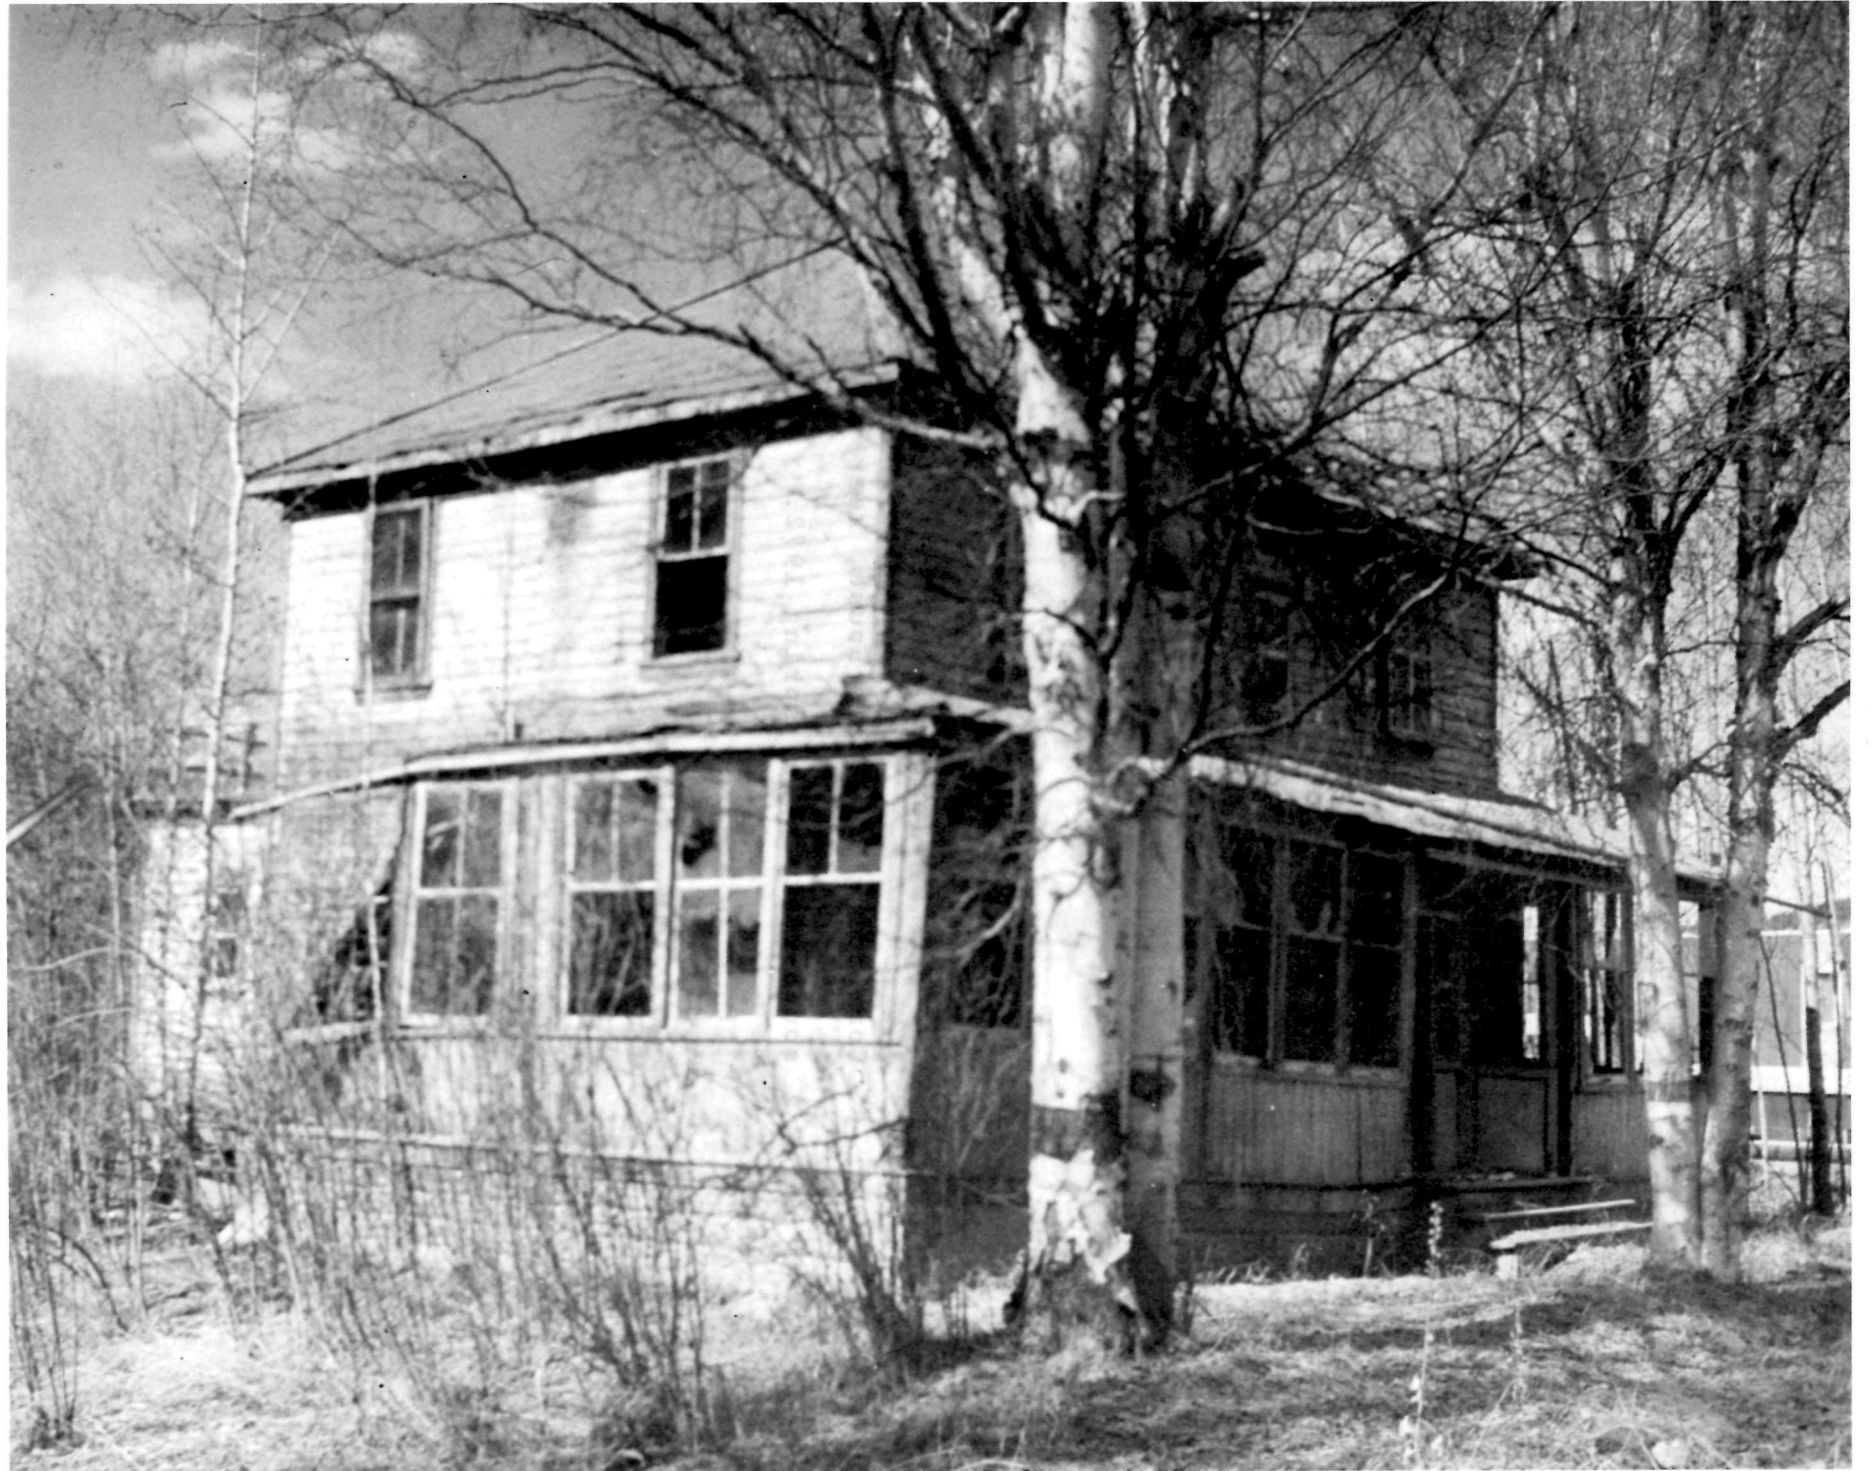
Fig. 42

Commanding Officer's House, originally
built for Major Cuthbert,
from the south-east, spring 1972.

By 1912, only ten years after its construction, the commanding officer's house was in a very poor state of repair. Despite the cellar the foundations had settled, in one place as much as ten inches, in another six. The stresses and strains had split the wallpaper in every room. Most of the water pipes leaked, probably for the same reason. The tank alongside the kitchen stove was split beyond repair, as was that on the roof. The verandah was warped out of shape. The furnace was not operating properly, and the wiring was unsafe. Prison labour was used to cope with the manifold repairs and maintenance.²⁴

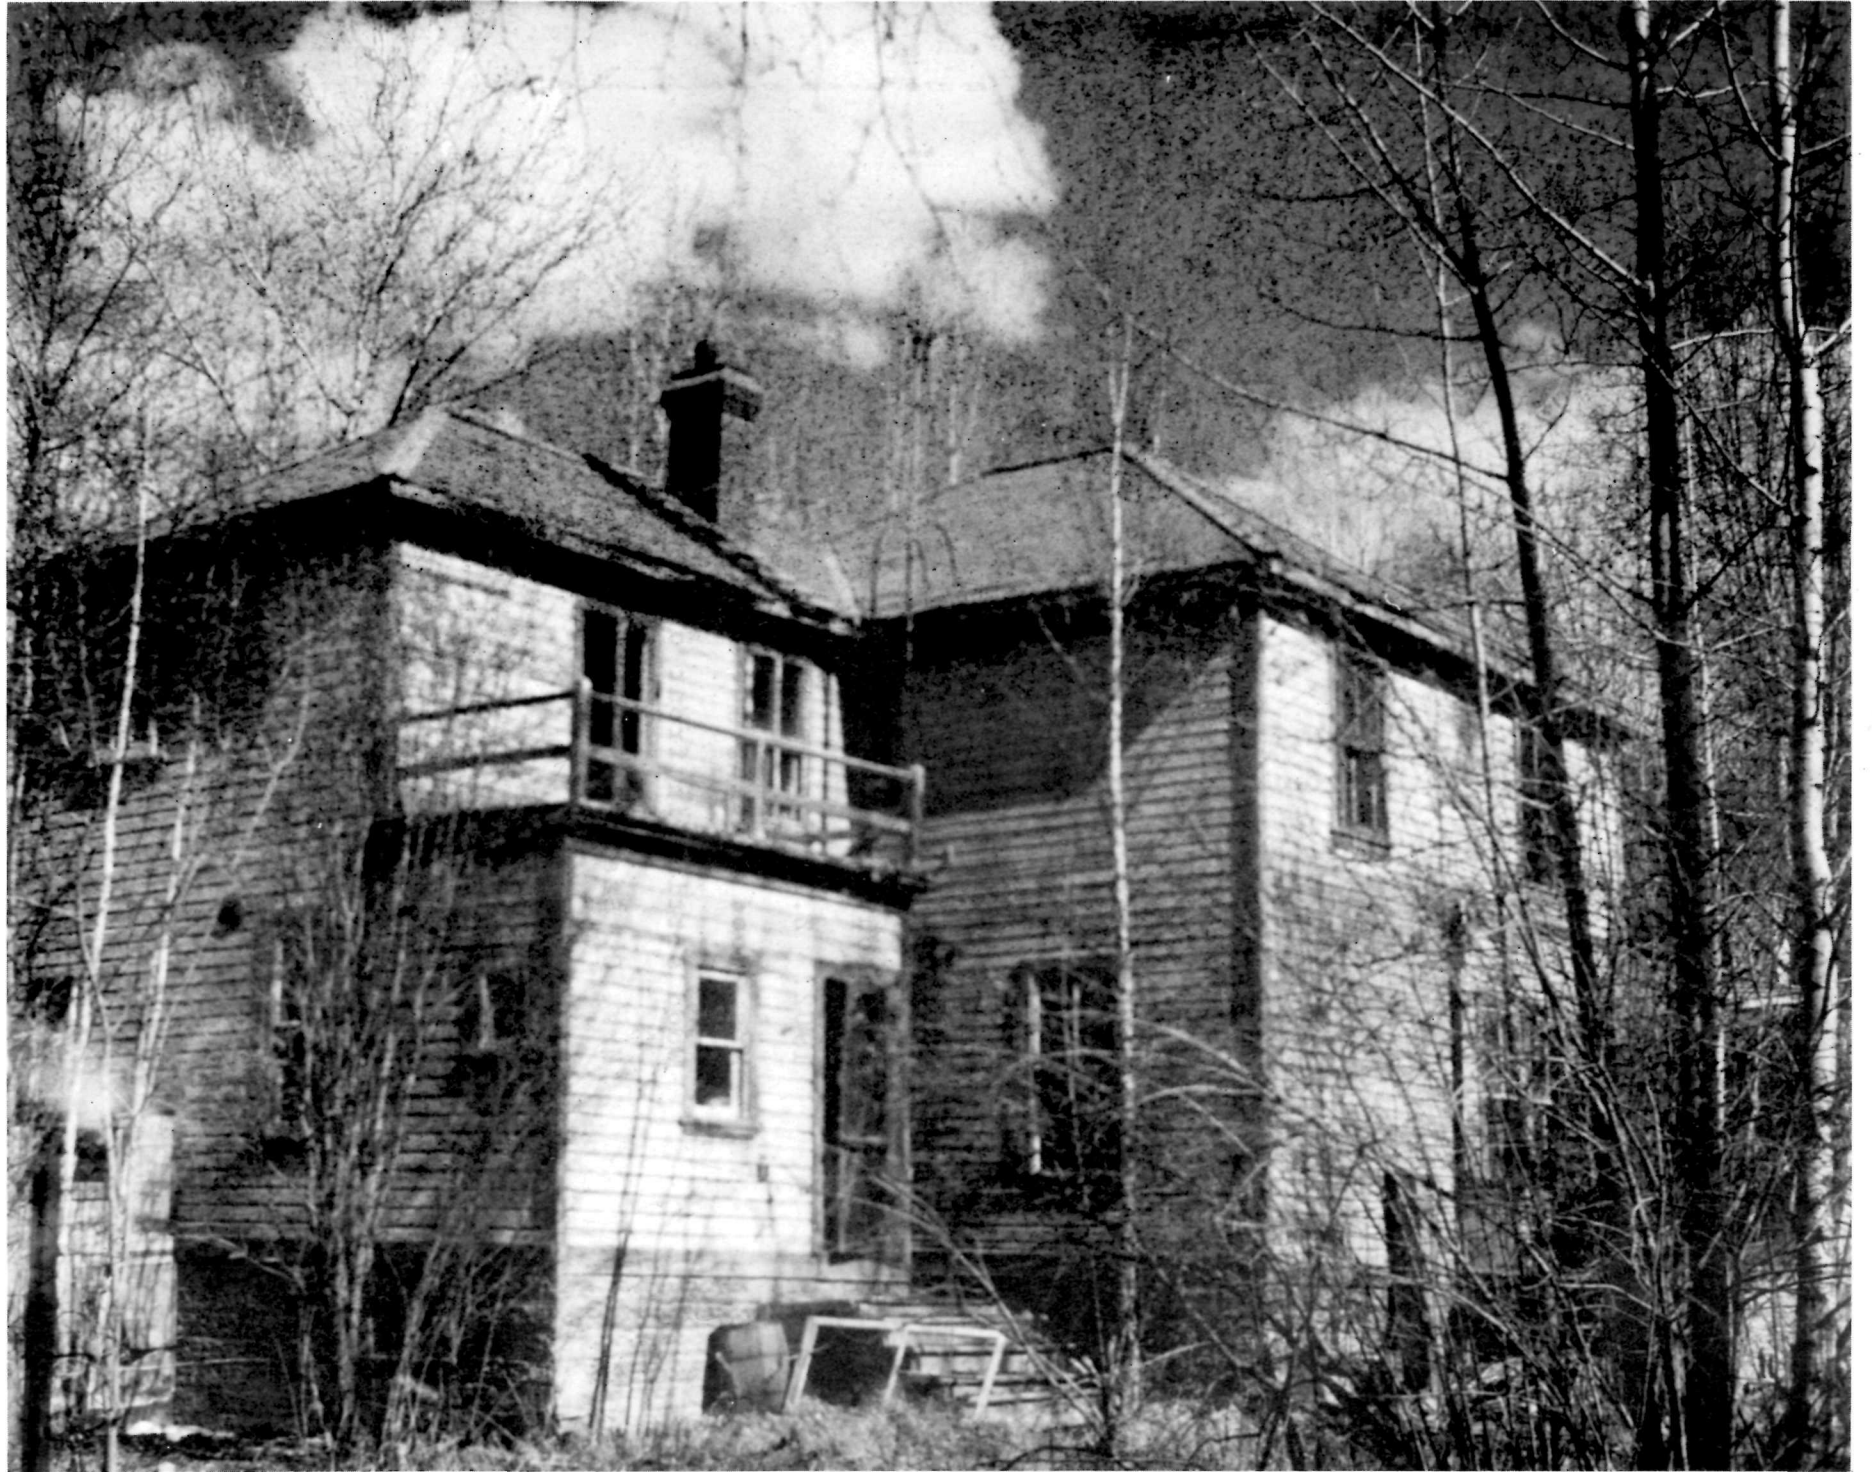
Fig. 43

Commanding Officer's House, rear view,
south-west angle, spring 1972.
