## The Blockhouses of Toronto: A Material History Study

CARL BENN

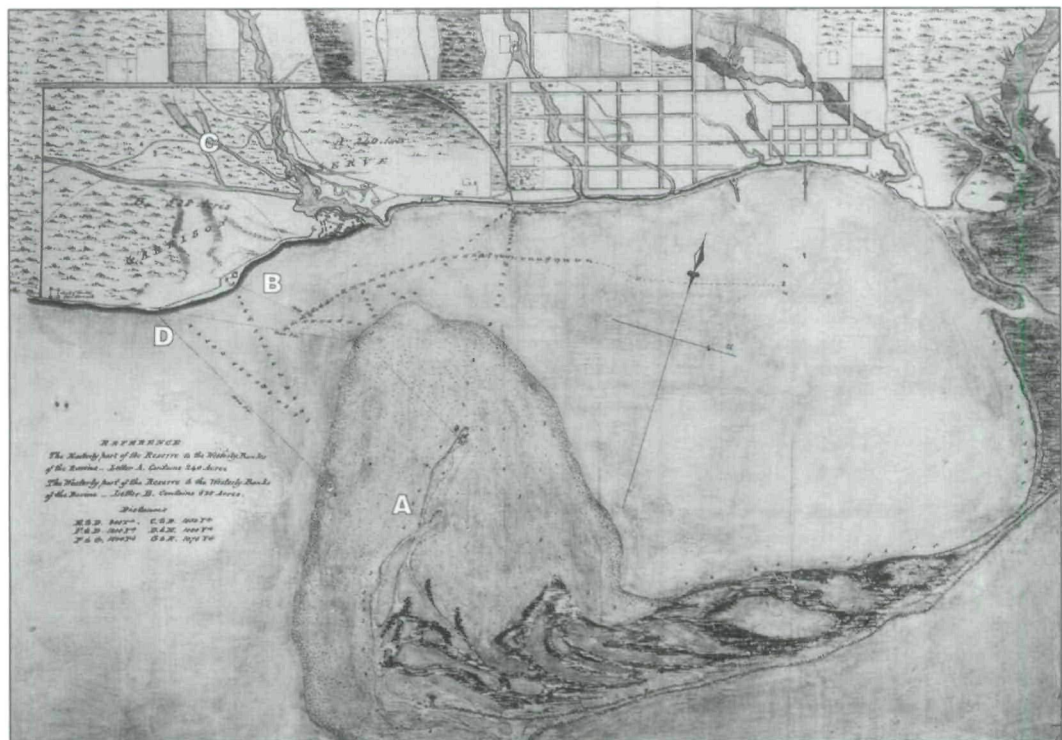
**Fig. 5**  
The locations of the Toronto blockhouses of 1813-14: 'A' Gibraltar Point Blockhouse; 'B' Fort York, site of Blockhouses Nos 1 and 2; 'C' Ravine Blockhouse; and 'D' Western Battery and Blockhouse, as superimposed on an 1833 plan but which shows Toronto much as it was late in the War of 1812. (Courtesy National Archives of Canada, NMC-21769)

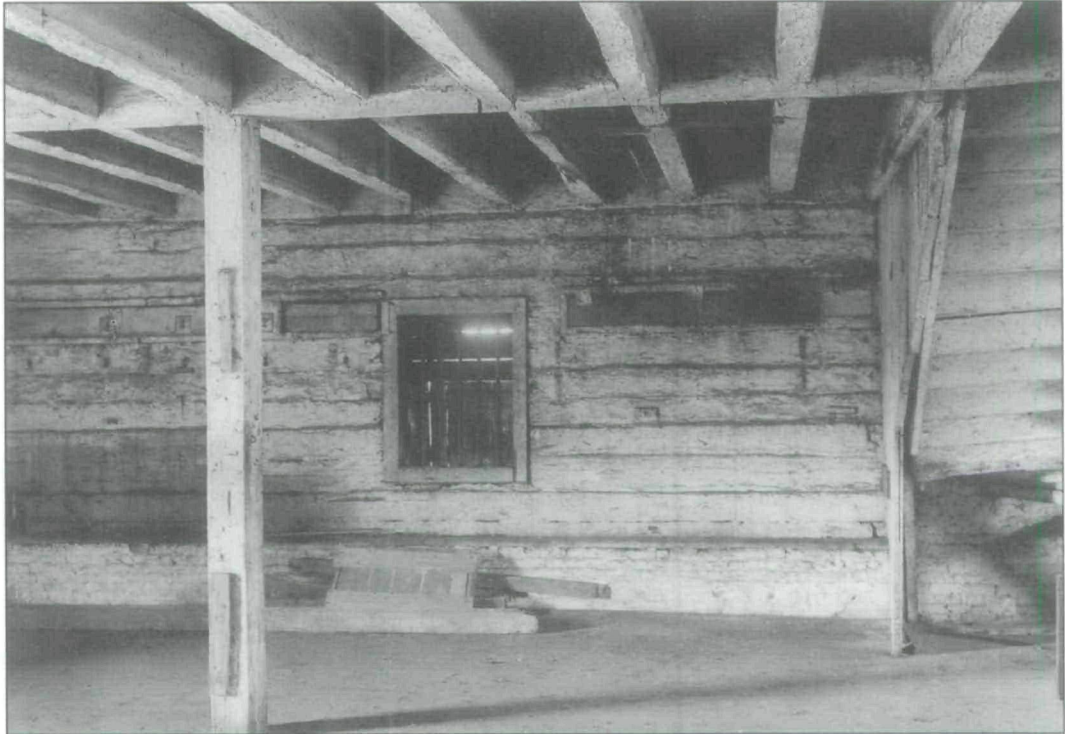
**Fig. 7**

The first-floor interior of Blockhouse No. 1 in 1933 before much restoration work had occurred. (Courtesy City of Toronto Archives, Salmon Collection 609)

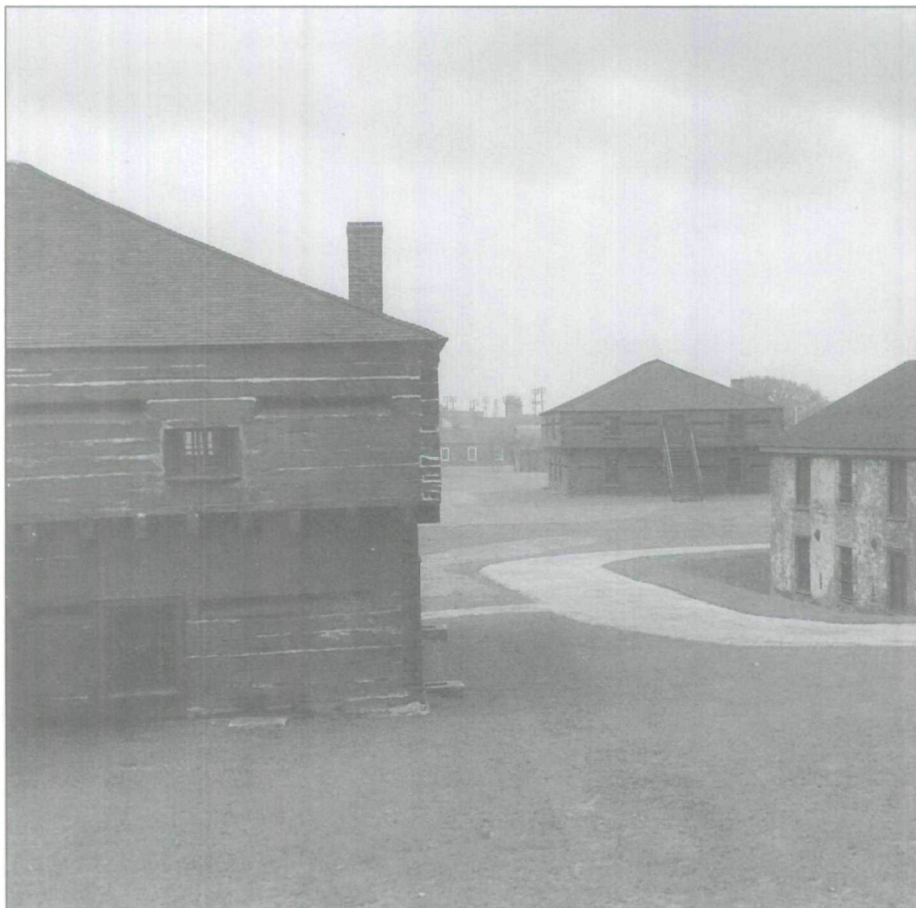
**Fig. 8**  
Blockhouse No. 1 (foreground) and No. 2 (background) as they appeared shortly after their restoration in 1934 after the weatherboarding, eavestroughs, and downspouts had been removed. (Courtesy City of Toronto Archives, Salmon Collection 810)
