MANUSCRIPT REPORT NUMBER **147**

PRELIMINARY REPORT ON A
1755 BRITISH GUARDHOUSE: 2E25
FORT BEAUSEJOUR

EXCAVATION OF DRAINAGE SYSTEM
AT FORT BEAUSEJOUR

PARKS CANADA

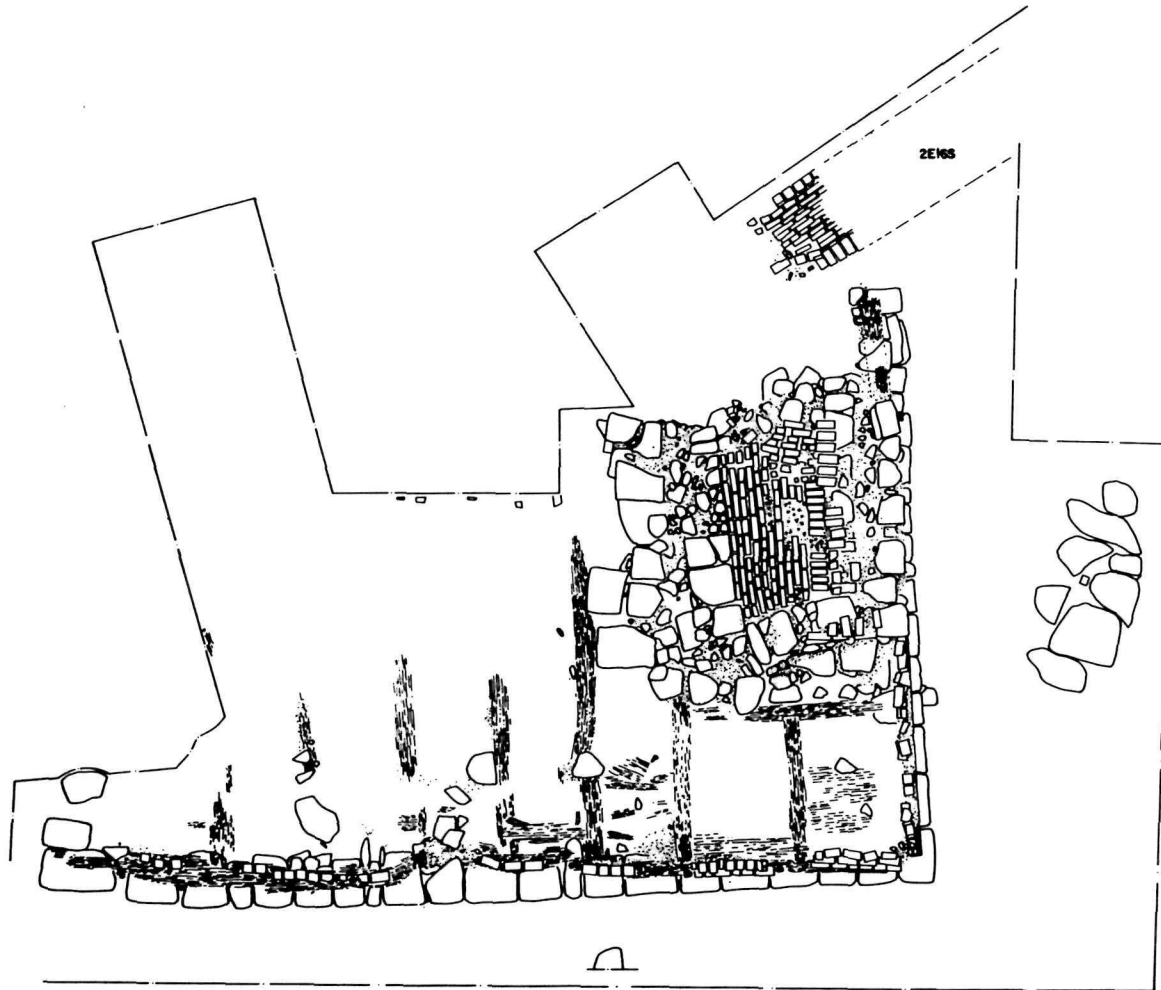
FIG.2

FORT BEAUSEJOUR N.B. SITE 2 E
GENERALIZED PLAN with MAJOR STRUCTURES CIRCA 1756-1800
no scale

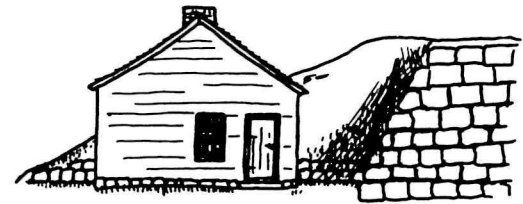
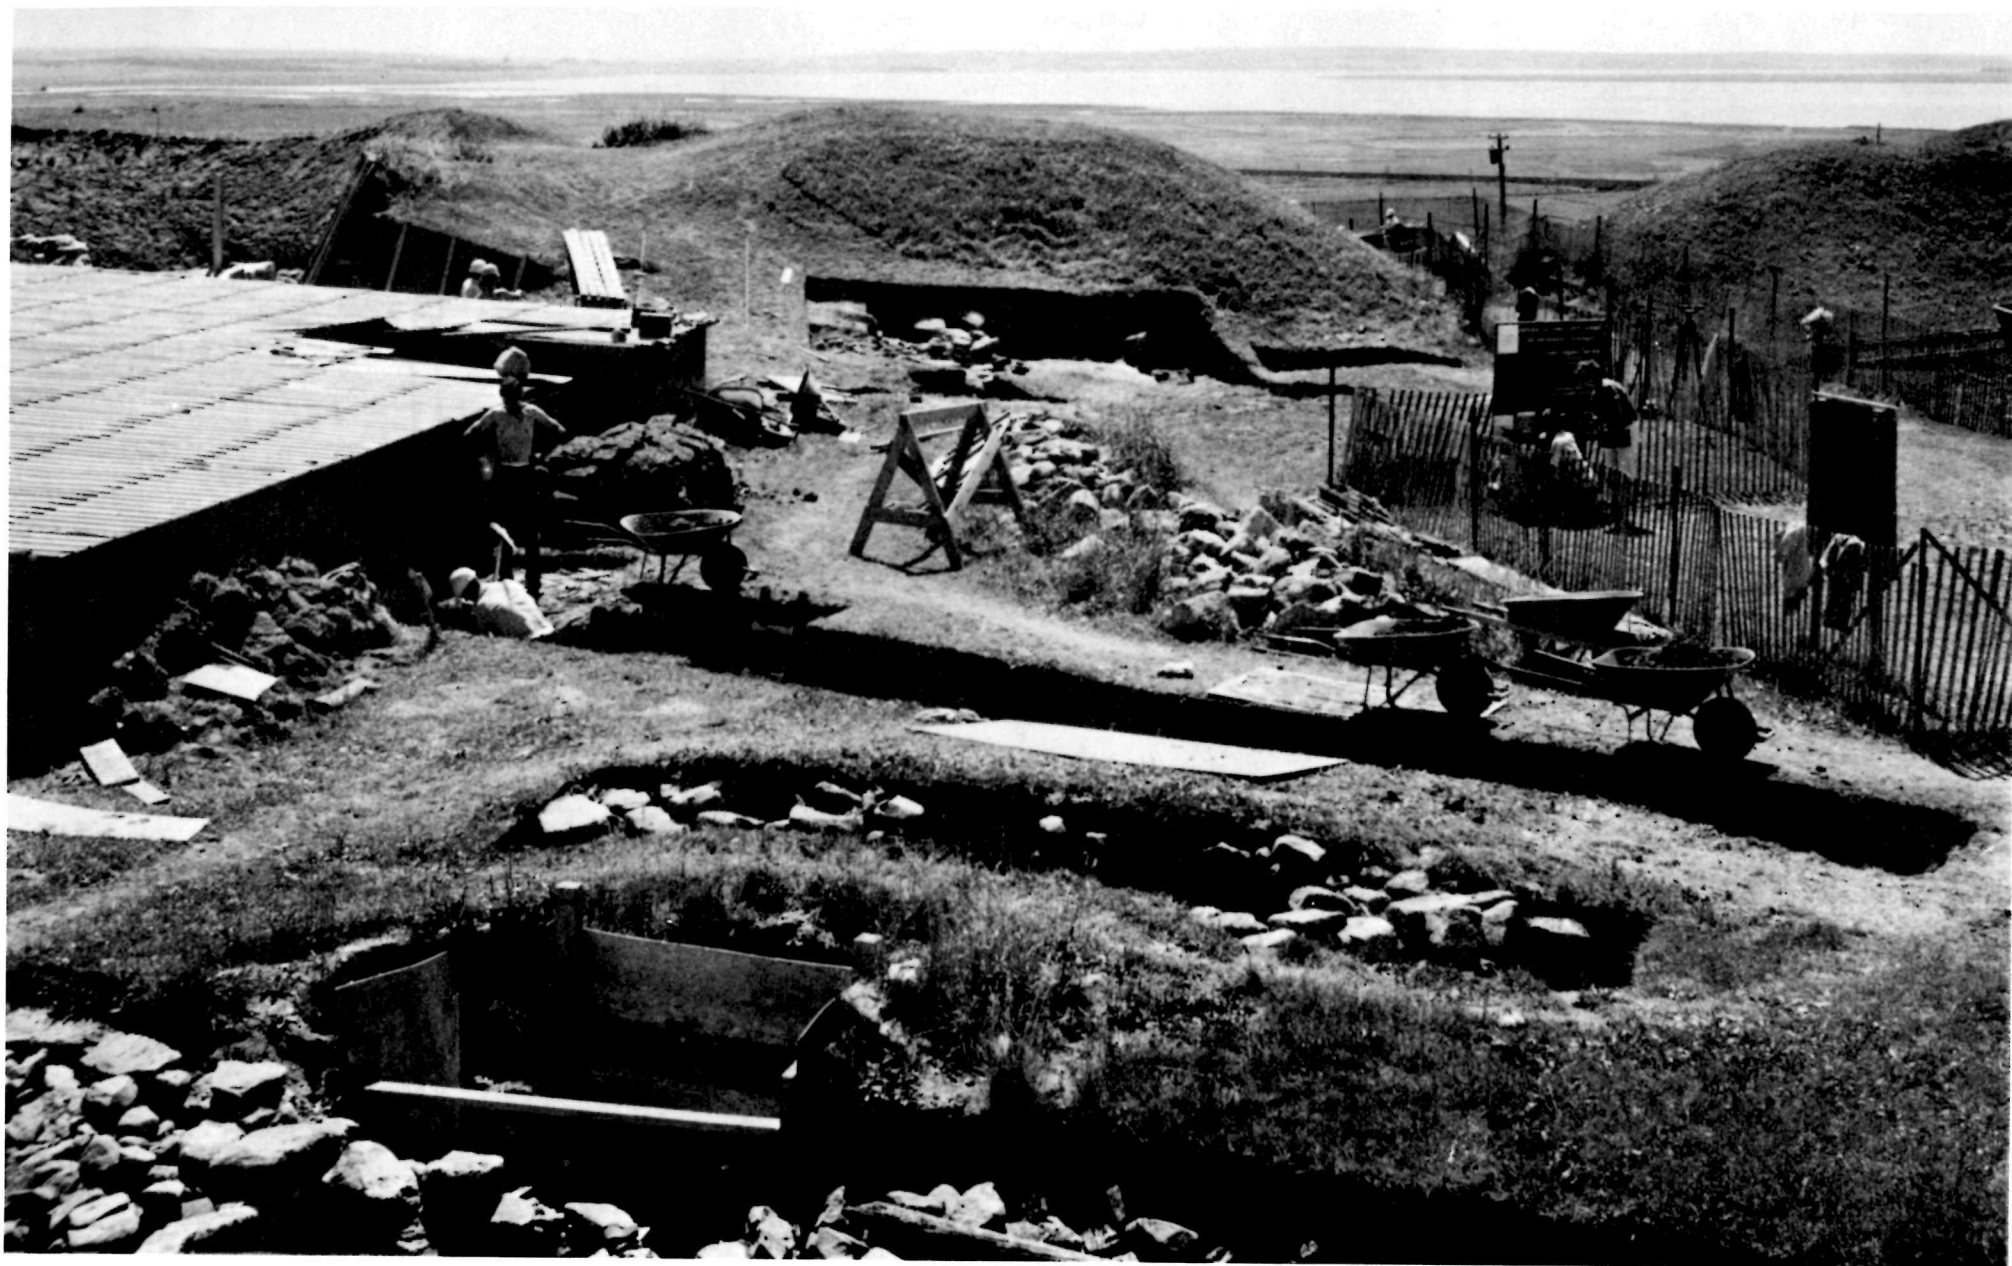
FIG.10

Figure 10 Hypothetical Reconstruction of Guardhouse
and Associated Features (2E-68-104-3)

FORT BEAUSEJOUR N.B. SITE 2E	
THE BRITISH GUARDHOUSE HYPOTHETICAL RECONSTRUCTION CIRCA 1756-1793	
approximate scale	0 10 20 30 40 ft.

side of the entrance, but we have no information on it at this time, and also with the British entrance. Figure 10 shows the relative positioning of the entrance and the guardhouse.

The reconstruction drawing shown in Figure 10 is intended to give a generalized view of the guardhouse in relation to the general configuration of the earthworks and associated features. The building shown in this drawing is generally of windows and doors is conjectural. The door may have been

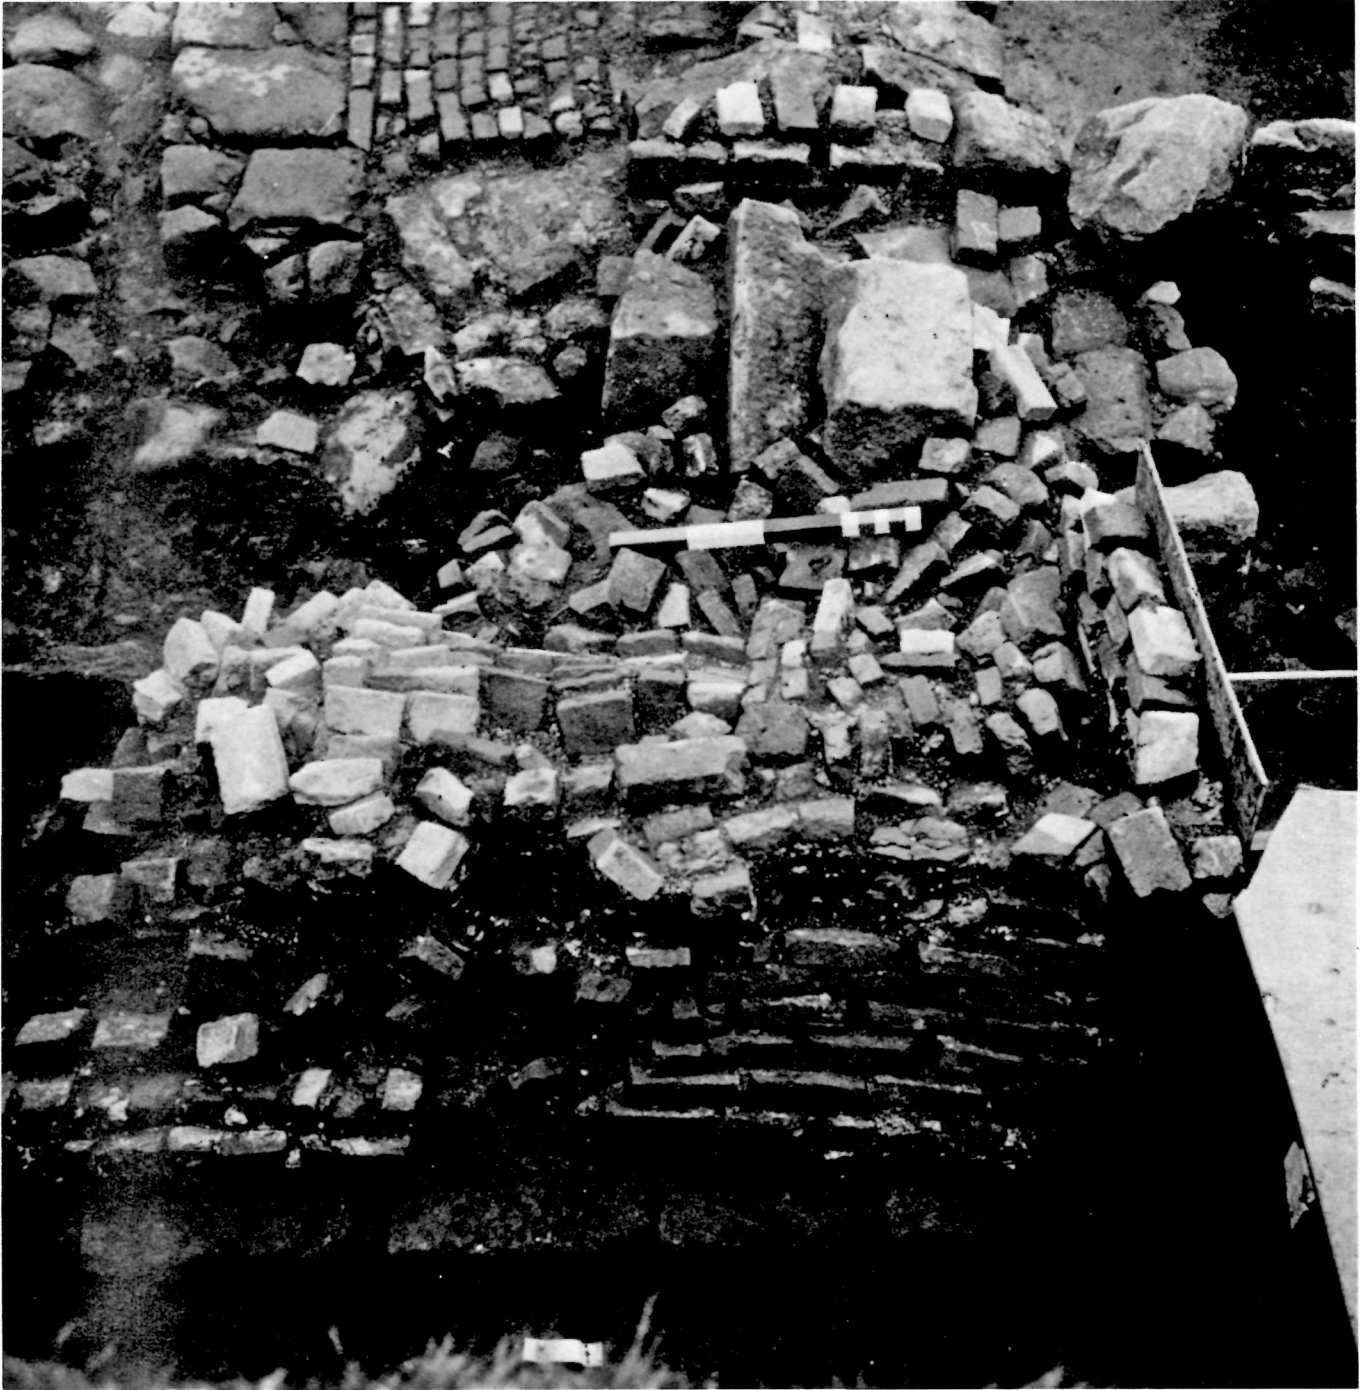
12 2E25 Post-Excavation Photo
(2E-3106-X)

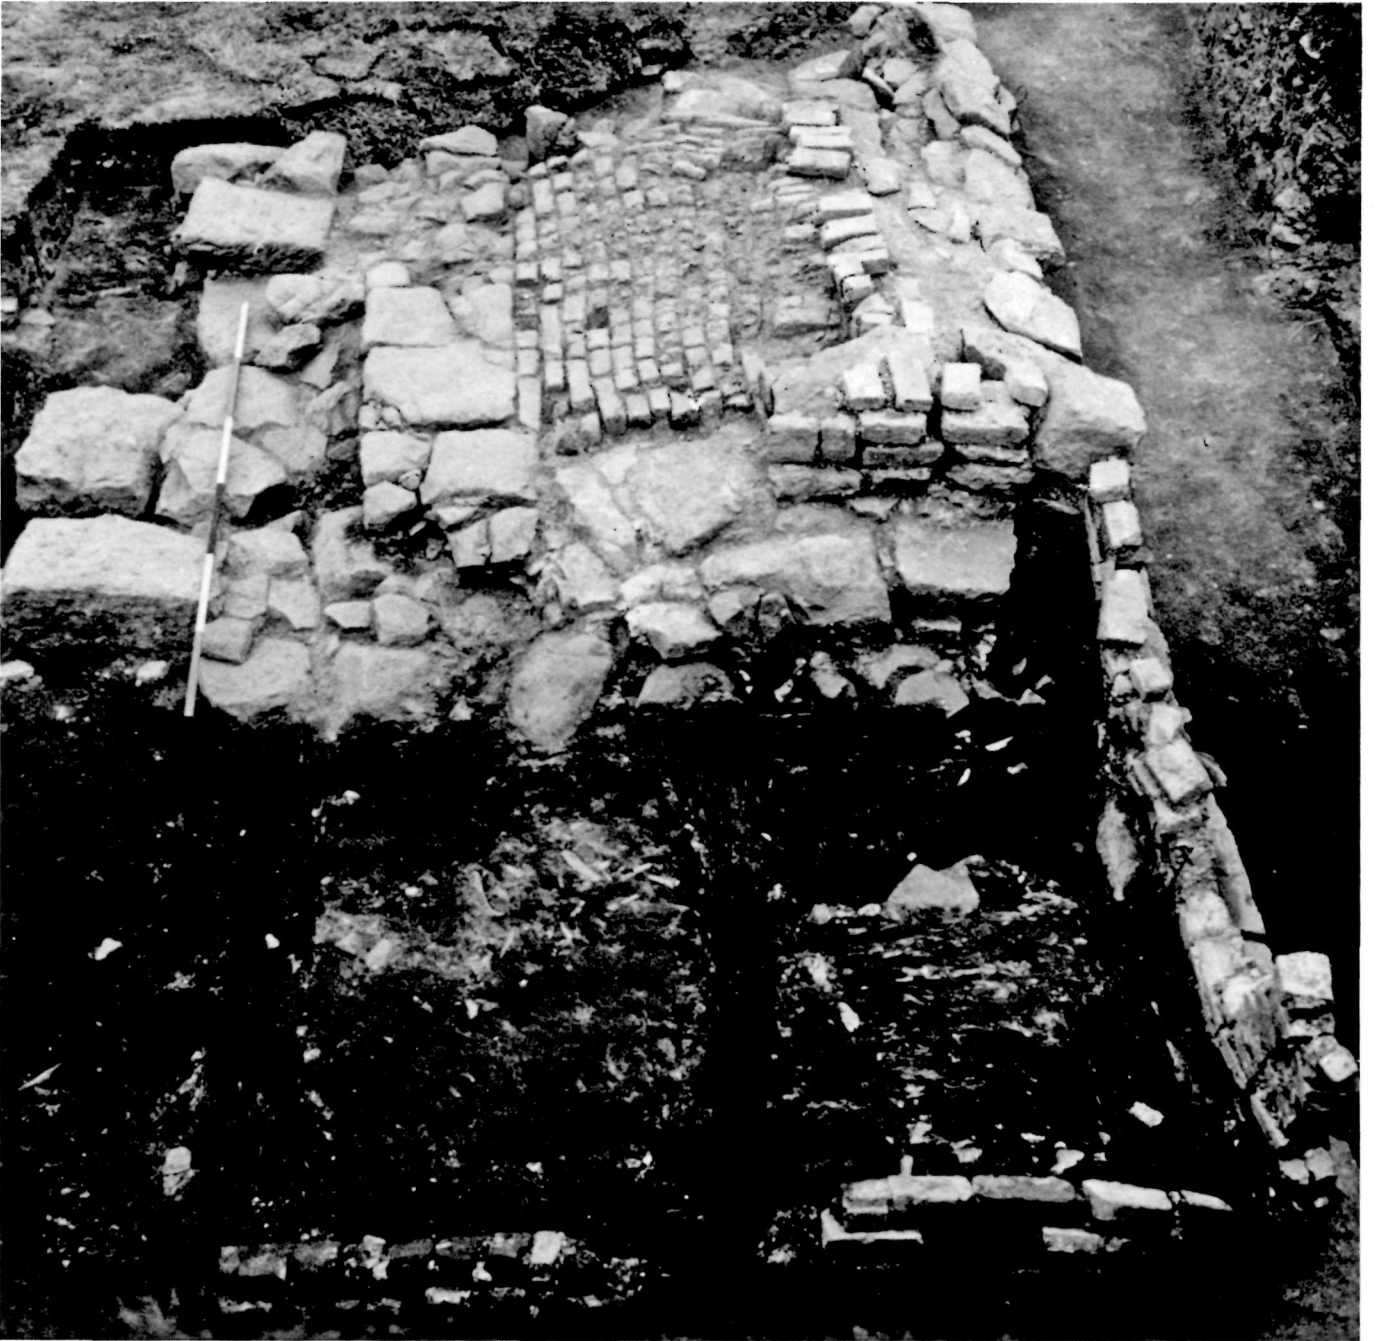
13 2E25 Brick Wall Collapse in SE Corner
Prior to Removal
(2E-3175-X)

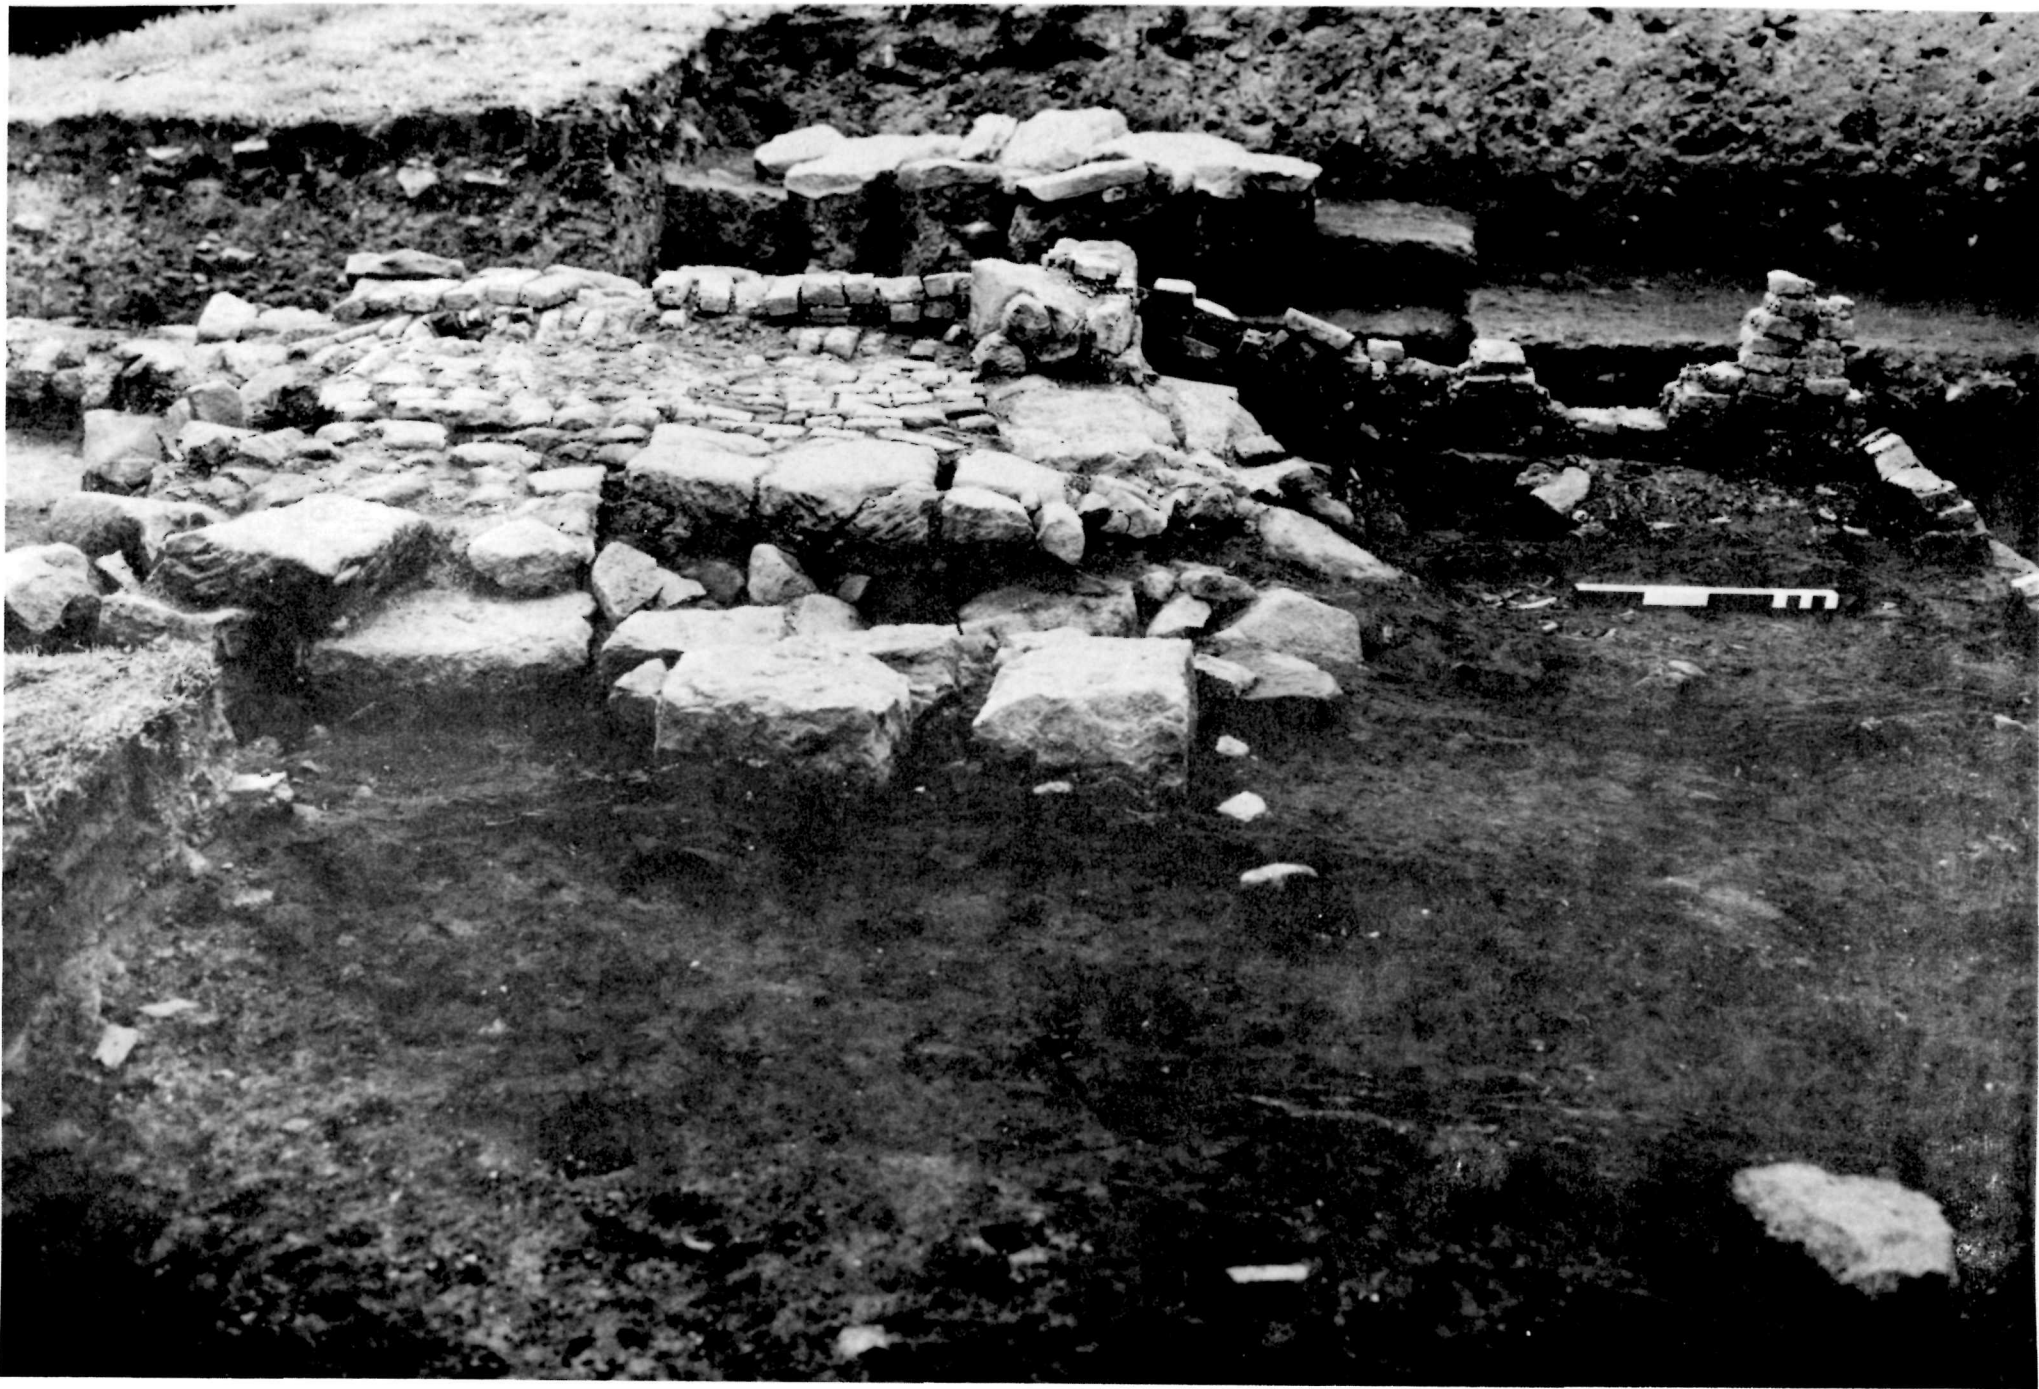
Figure 14. 2E25 SE Corner After Removal of Brick
Collapse
(2E-3104-X)

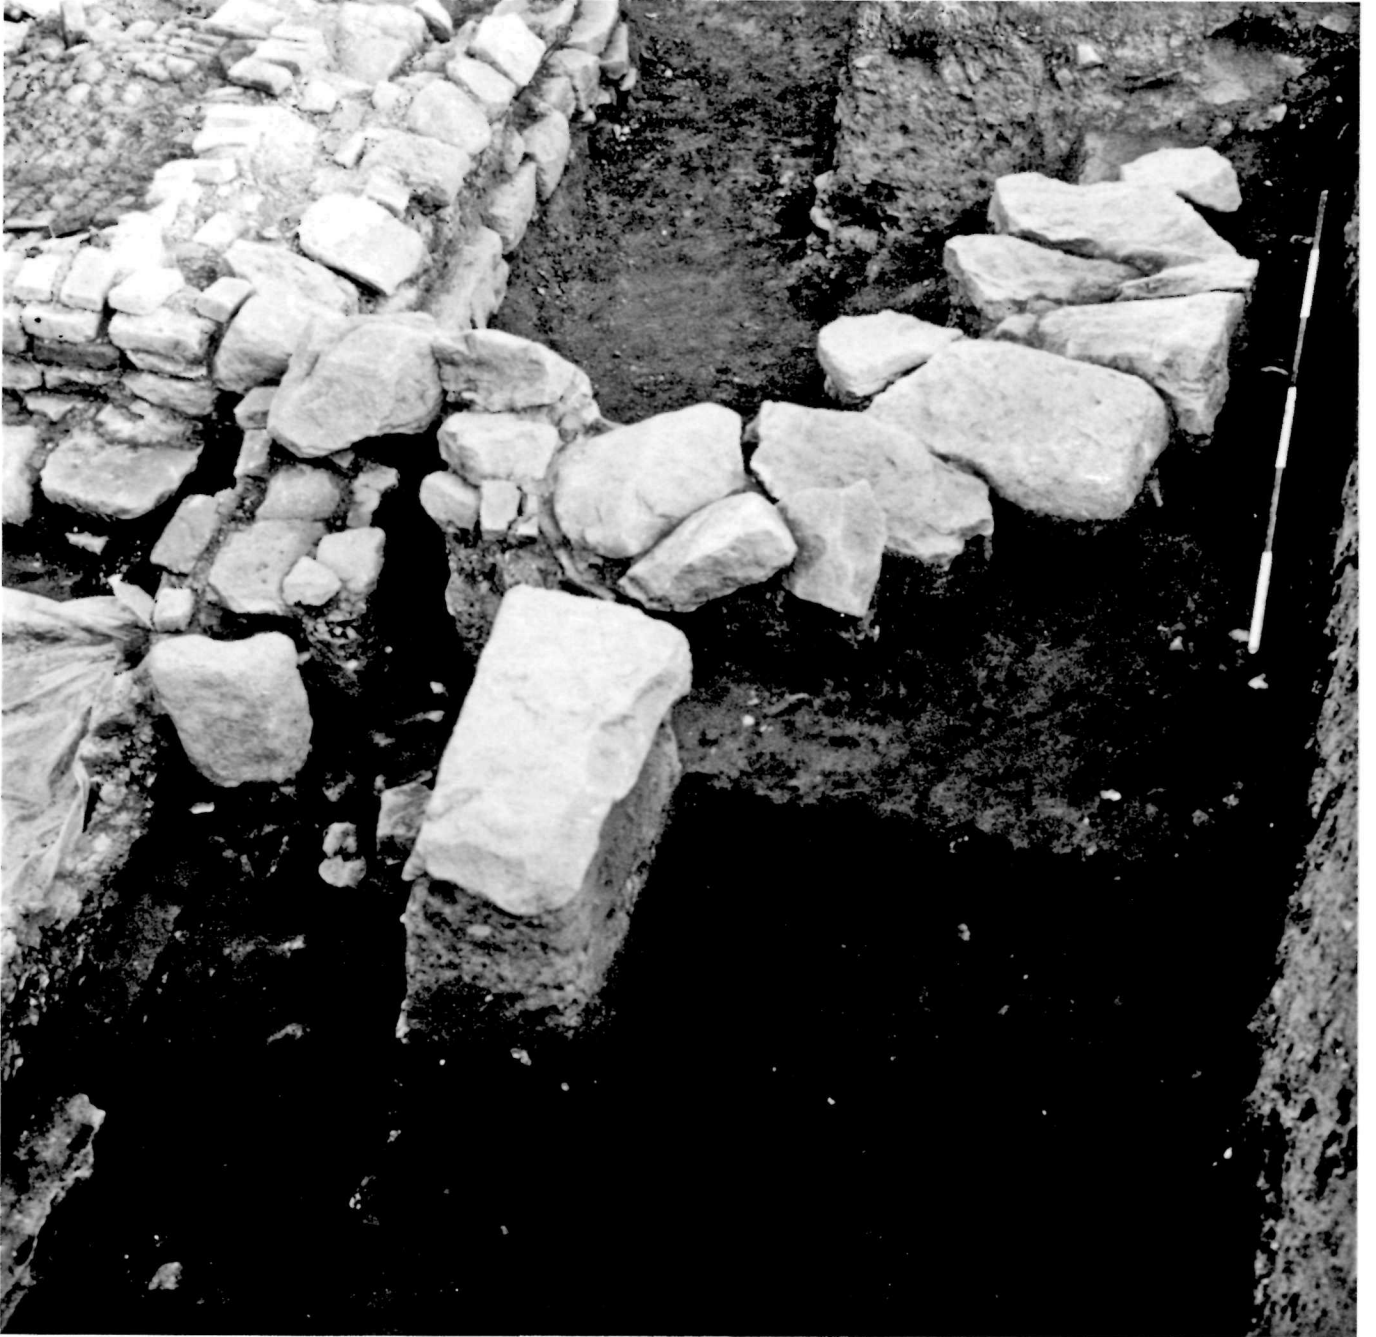
15 2E25 Post-Excavation Photo Showing
Fireplace Remains (2E-213-B)

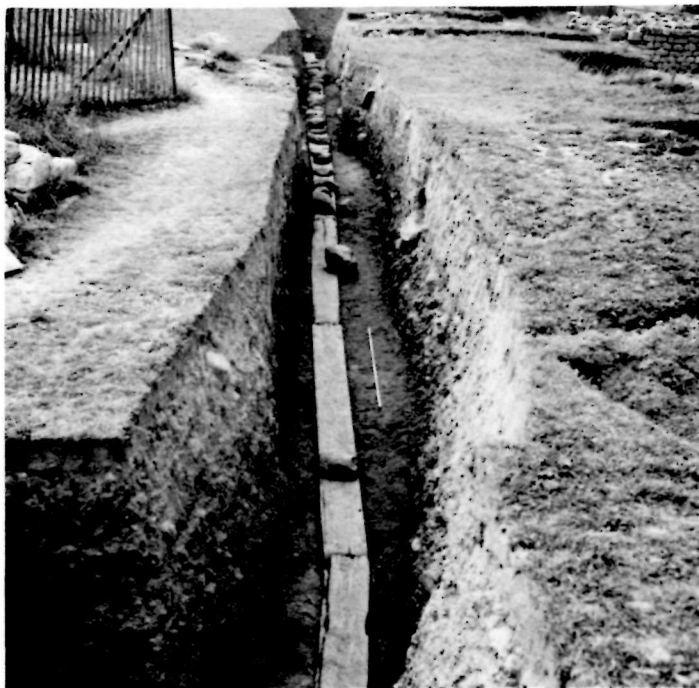
Figure 6 2E-2053 X
 2E23C. Post-excavation view of drain #3. Camera
 facing west. 6' scale aligned E-W.

On top of the cover boards of the west half of drain #3 were twenty-eight stones in a row, at intervals of from .8' to 2'. These stones ranged from about .6' to 1.2' in length, and ranged from the very west end of the drain, (where the first three were removed, before it was discovered that there were more) about halfway to the east. They stopped for no apparent reason, and only one more was present during the rest of its length (Fig. 6).

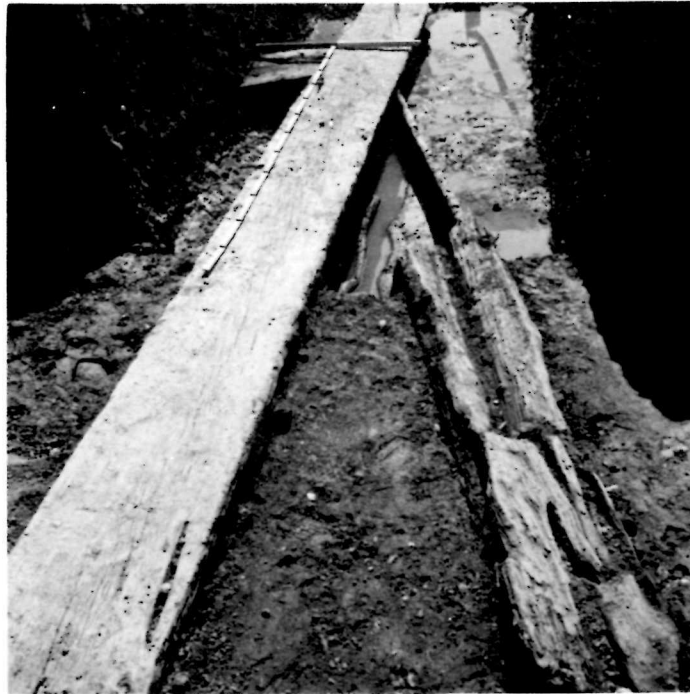
Figure 7 2E-1580 X
 2E19D14. Junction of drains. 6' scale aligned N-S.
 Camera facing south.

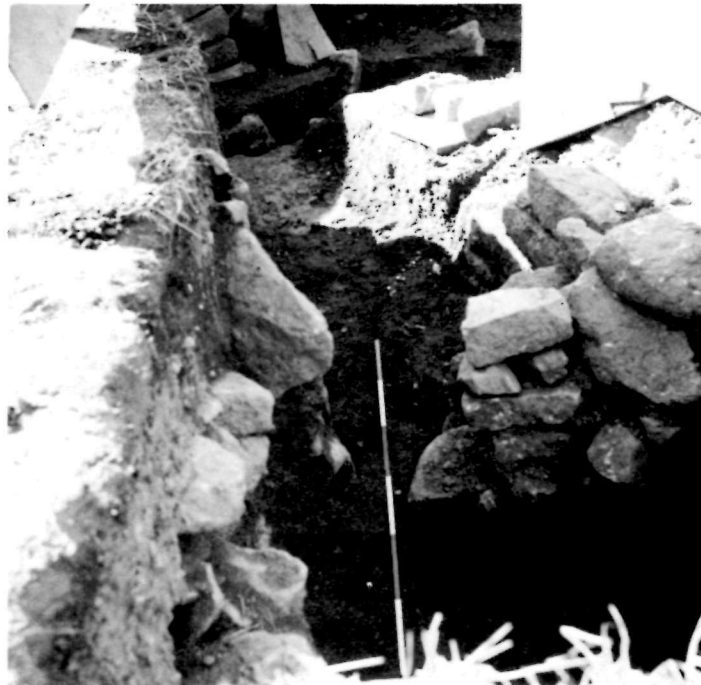
Figure 8 2E-1972 X
 2E23J2. Post-excitation shot. 6' scale aligned N-S.
 Camera facing south.

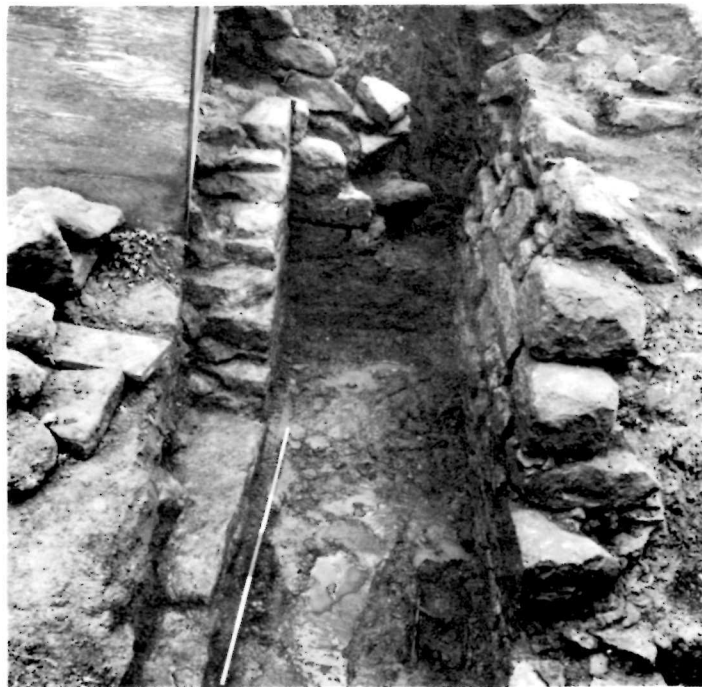
Figure 10 2E-3170 X
 2E23J3. Post-excitation shot showing E-W wall.
 Camera facing west. 6' scale aligned E-W.

The only major stone feature found during the 1968 excavation of operation 2E23 was a small stone-walled feature (Fig. 12). There was also a 4' gap in the east end of the north wall probably broken down to let drain #4 run through. This was excavated to a depth of almost 8' below surface level (Fig. 10). The lots used to dig it were 2E23J1, 2E23J2, 2E23J3, 2E23J4, and 2E23D17 extension.
