NATIONAL HISTORIC PARKS
AND SITES BRANCH

THE CHAMBLY CANAL:
A STRUCTURAL HISTORY OF THE LOCKS

by
Sandra J. Gillis

(1975)

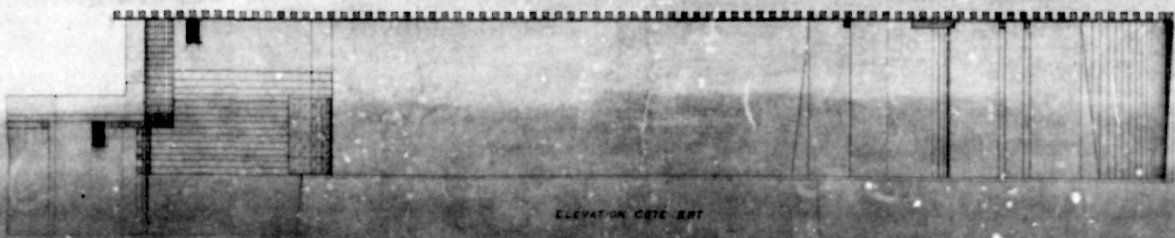
- 3 J.E. Doré's plan for the reconstruction of lock 1, ca. 1882. Note that the plan included the replacement of the inverted masonry arch floor with planking and of the masonry breast wall with timbers. Neither proposal was implemented. Note also the retaining wall extending upward from the lower east wing wall, parallel to the east chamber wall. (Quebec Canal Office, Parks Canada, Montreal.)

ELEVATION COTE OUEST

ELEVATION COTE EST

the lower entrance to the lock to protect the wings and to prevent erosion of the shore and leaking (see Figs. 3 and 5). Because the first three locks were constructed as a single masonry structure, there were, of course, no upper wing walls to lock 1. The records also mention the construction of stone steps leading up from the first to the second lock, which was not as convenient as it might seem, for it necessitated the use of wooden walkways to allow the lockmen to push the balance beams across the stairwell (see Fig. 4).

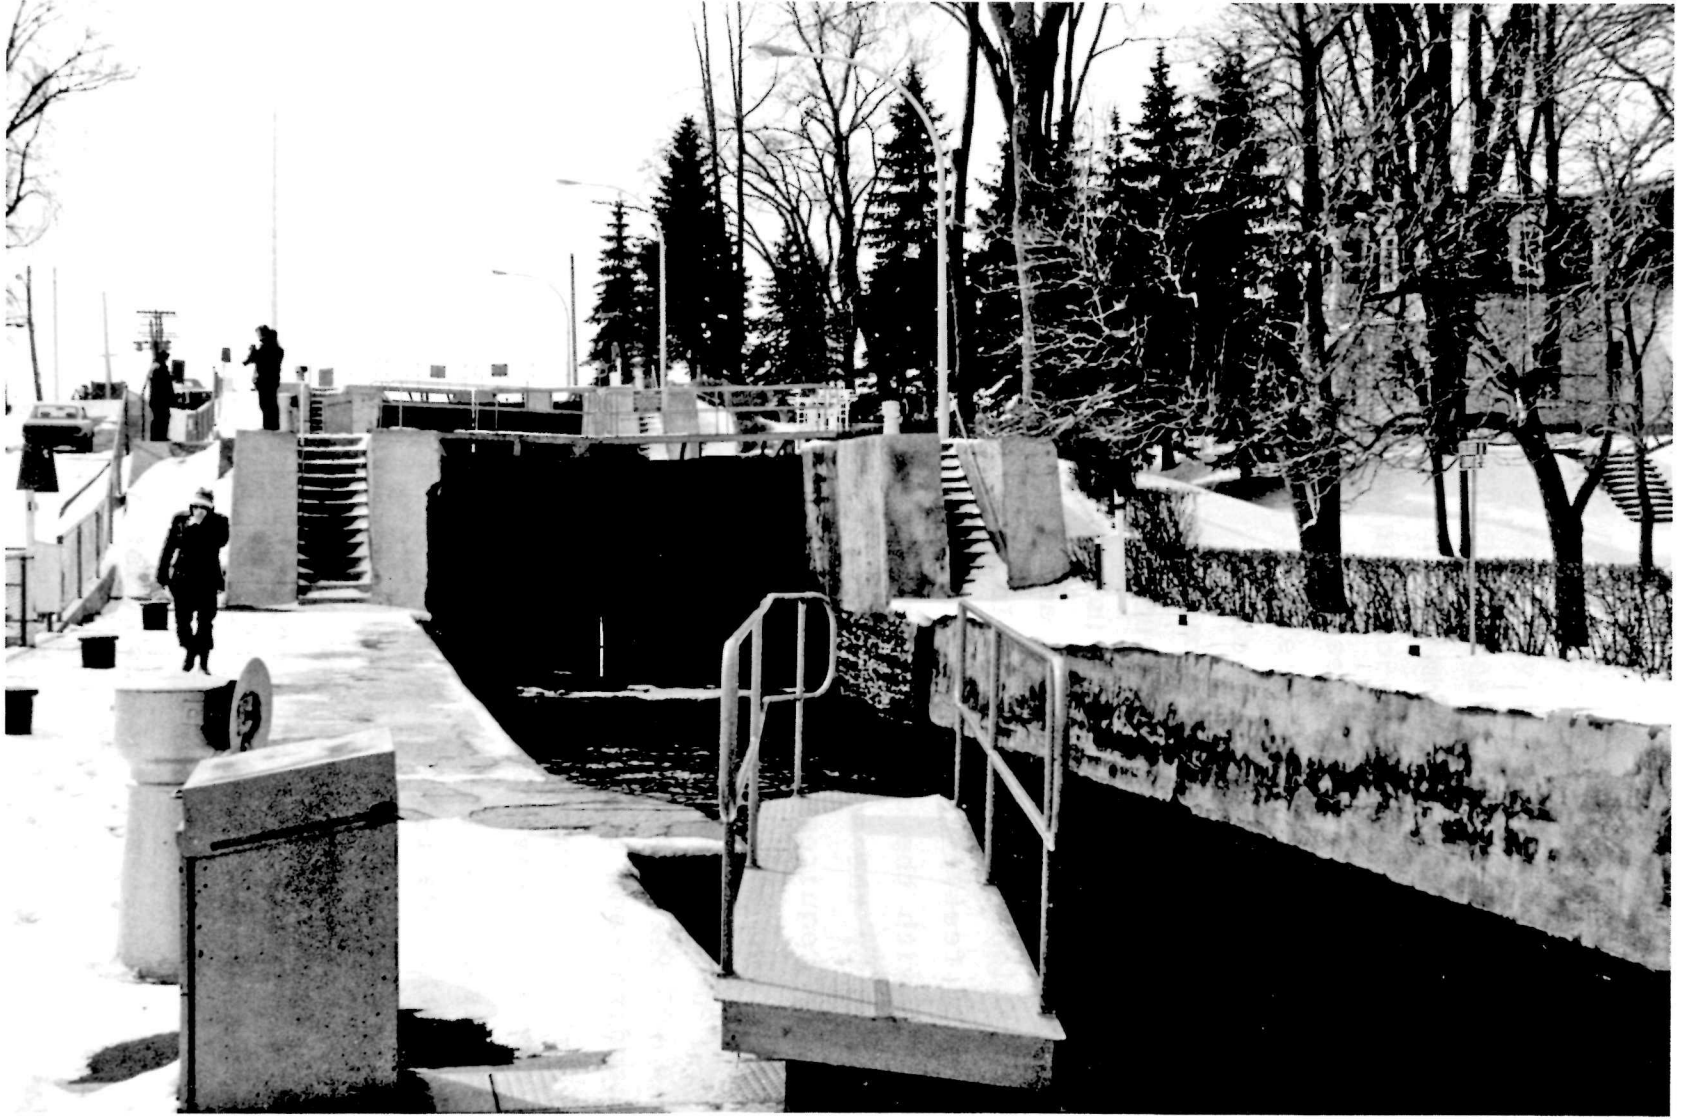
- 8 Lock 1, 1973. Note the cement facing on the chamber walls and stairwells, the steel walkways (foreground), and the new electrical system for the operation of the gates beside the earlier winches (left foreground).

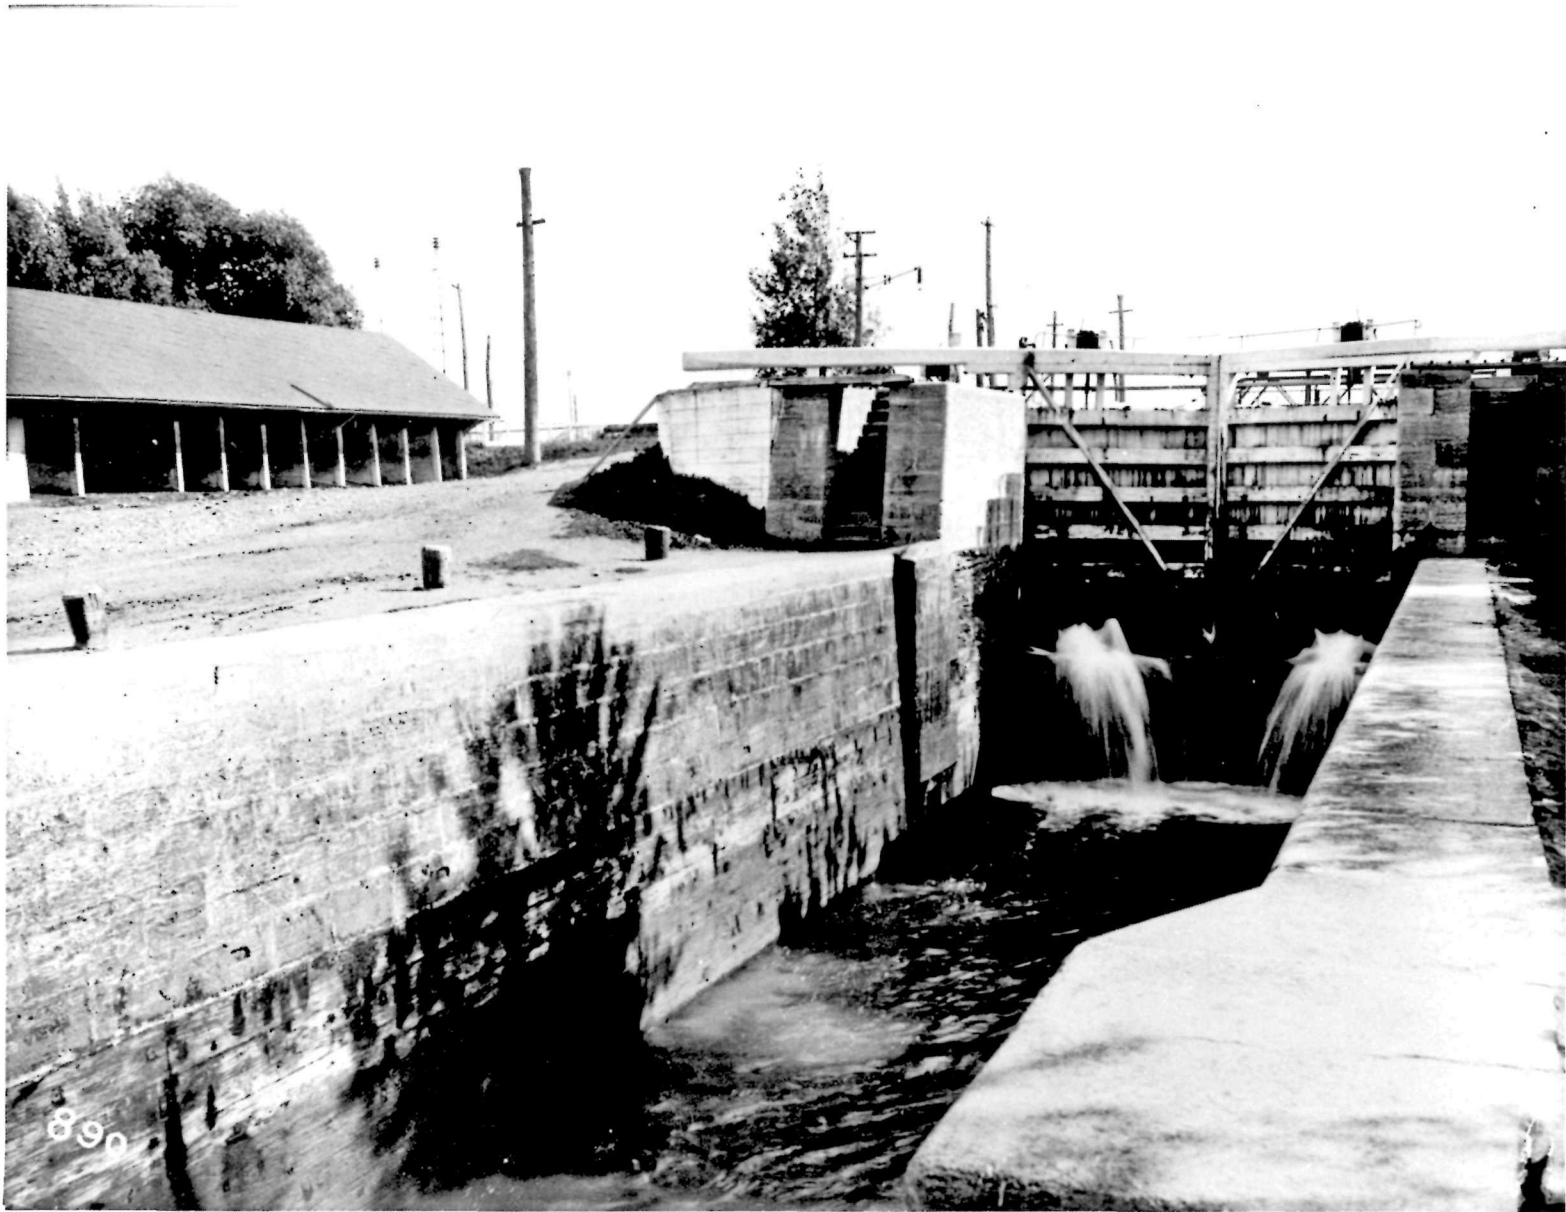
- 10 The upper east wall of lock 2 in 1911. Note the cat-walk and platform for operating the gates, the timbers on the chamber wall and at the head of the lock, sheeted at projecting corners with metal. (Public Archives of Canada.)

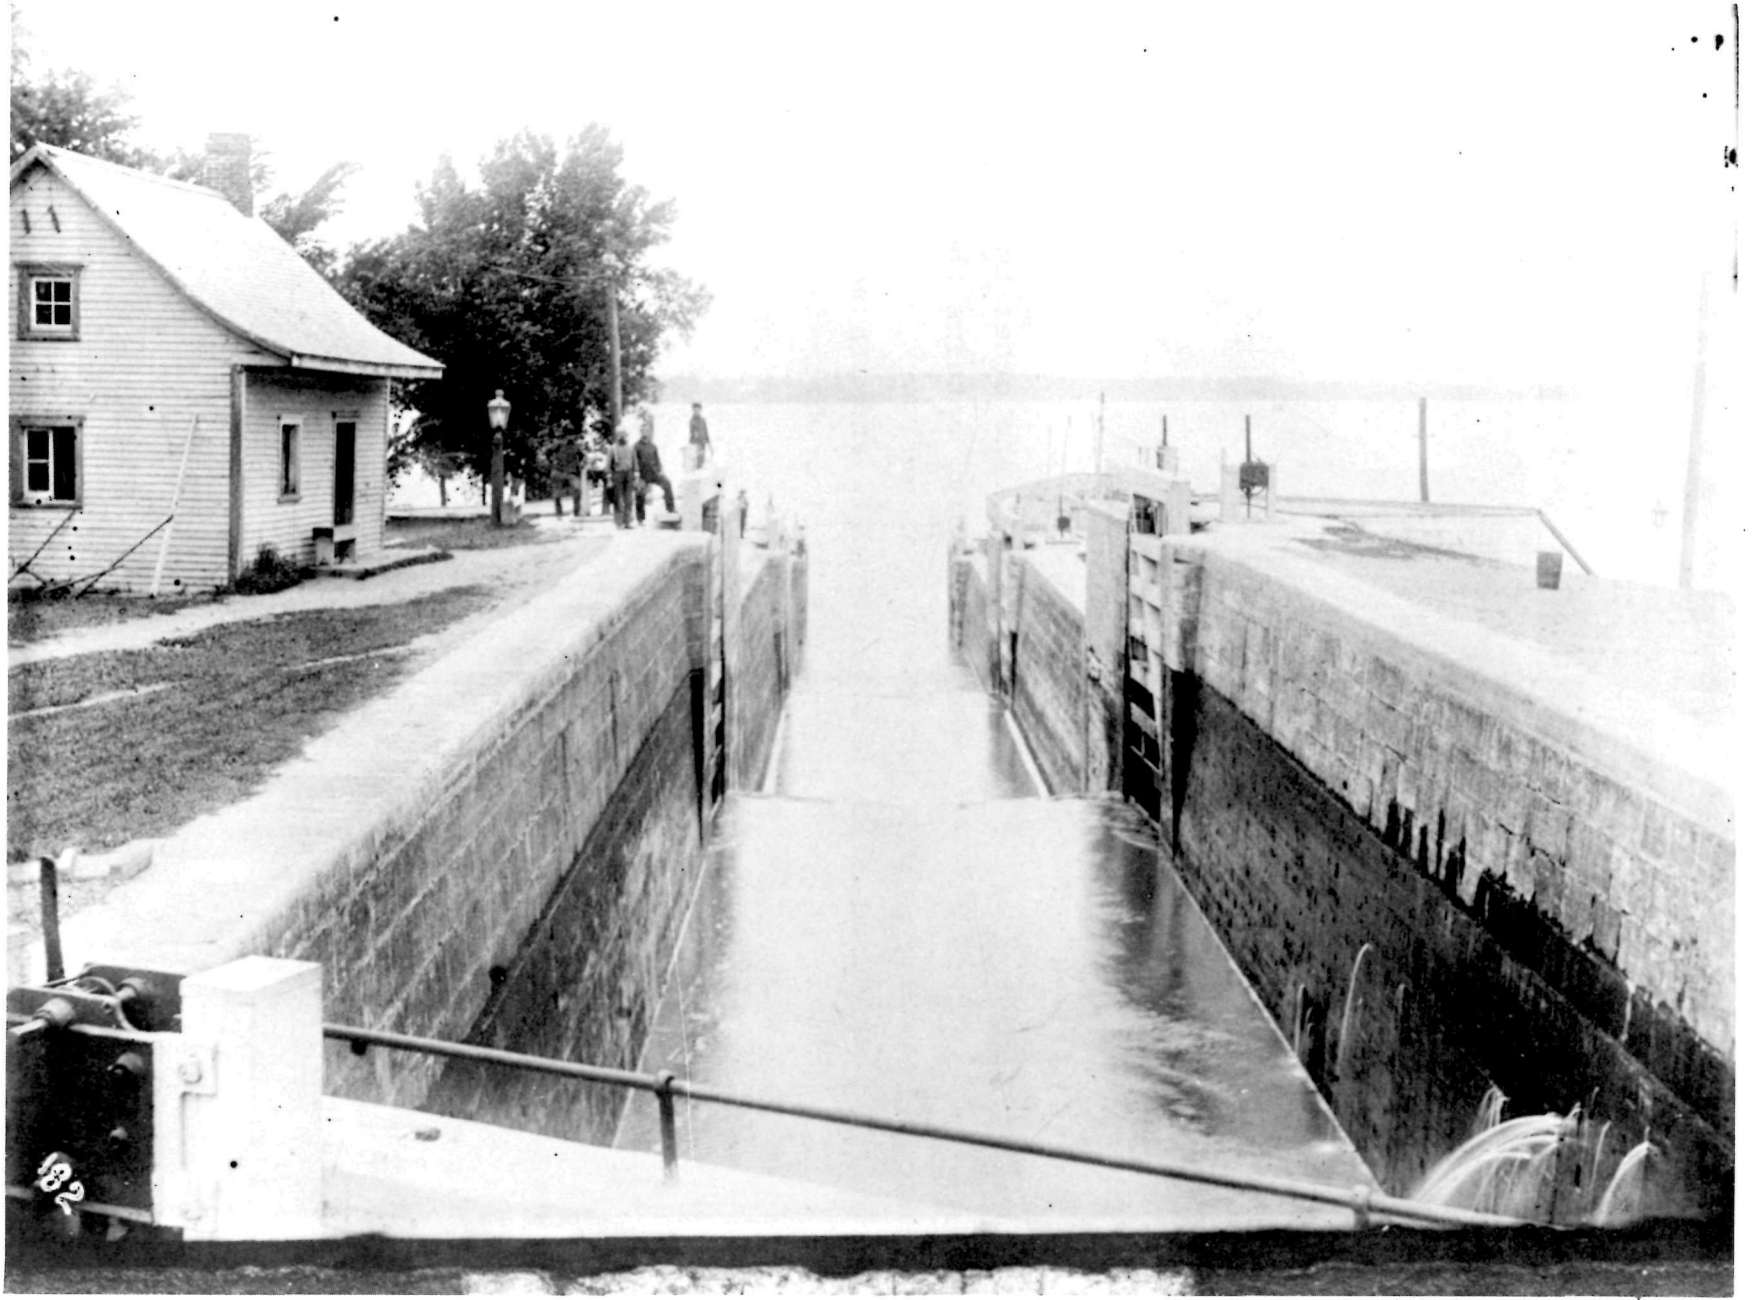
- 14 A view of the combined locks from the upper gates of lock 3, 1891. Note the half-timbered style of the 1880s rebuilding and the batter of the walls. The problem of leakage behind the walls is evident in the right foreground of the photograph. (Public Archives of Canada.)

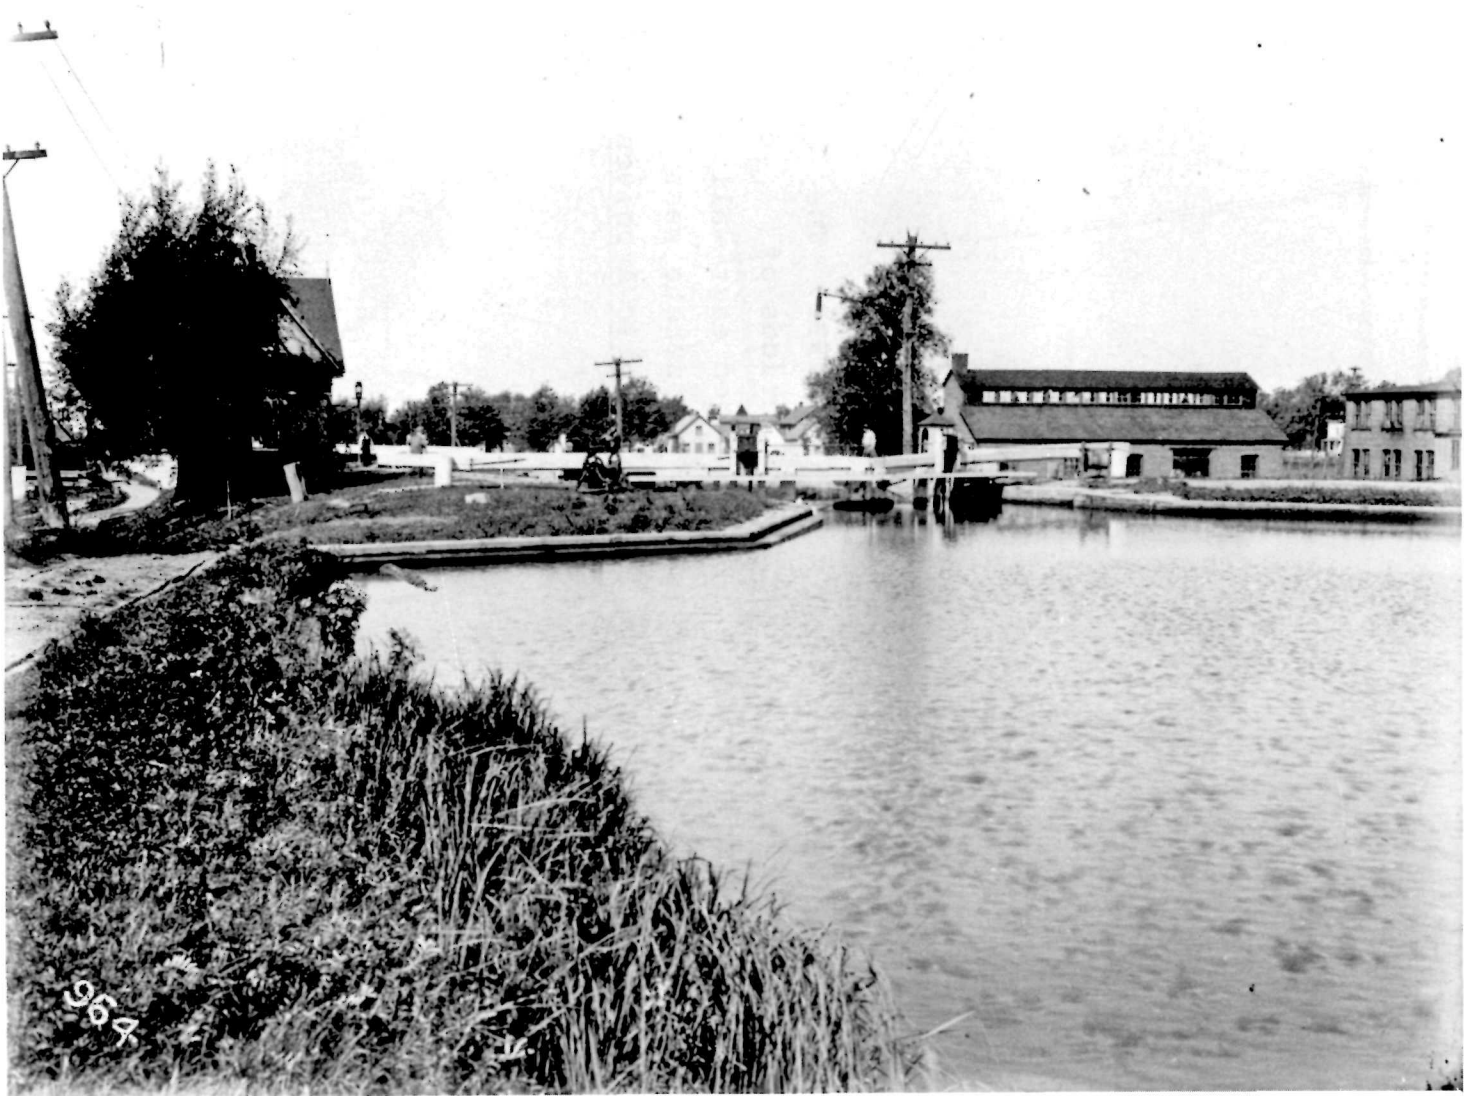
24 The upper entrance to lock 7 in 1911.
(Public Archive of Canada.)

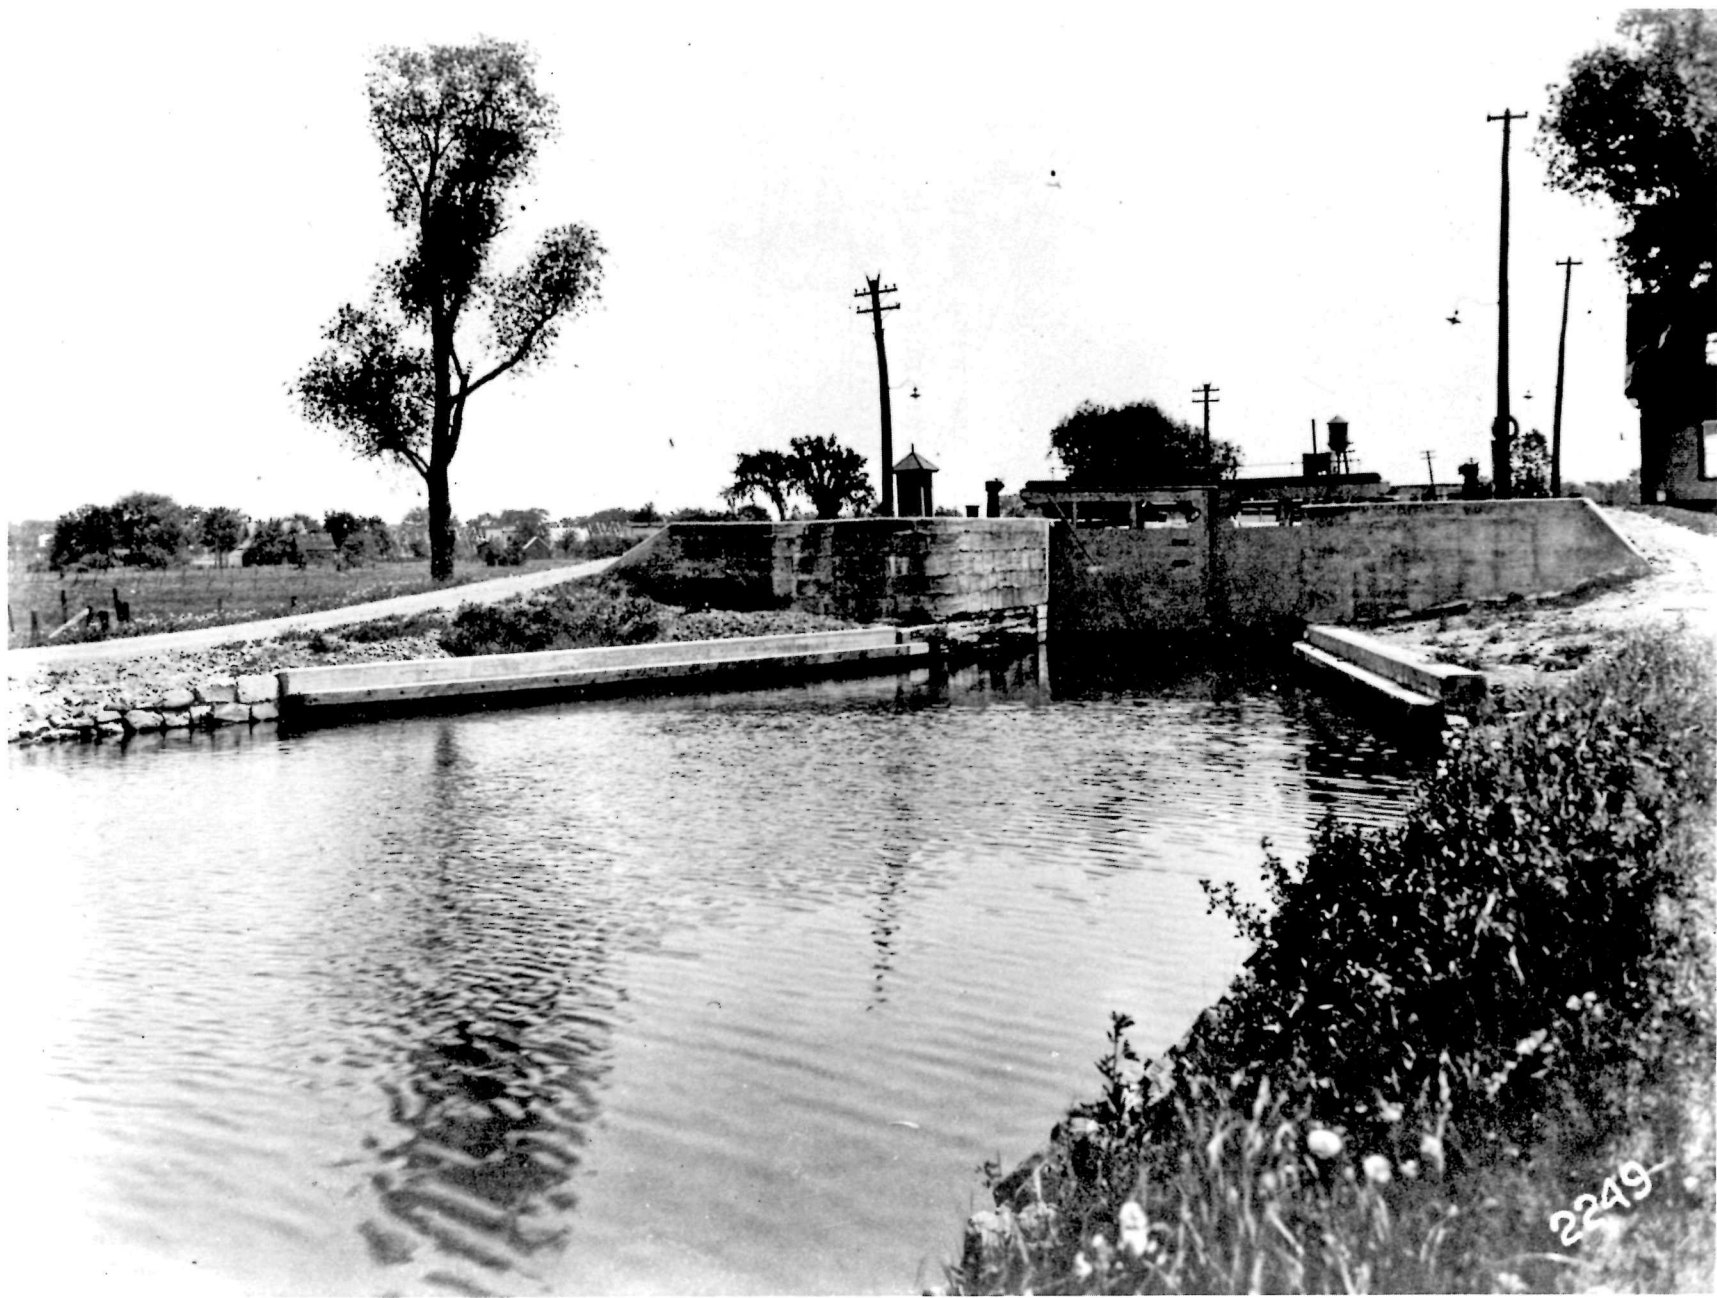
- 25 The lower entrance to lock 7 in 1933. The lower wing walls reflect two periods of reconstruction, the half-timbered east wall dating from the 1880s and the concrete west side dating from the 1930s. (Public Archives of Canada.)

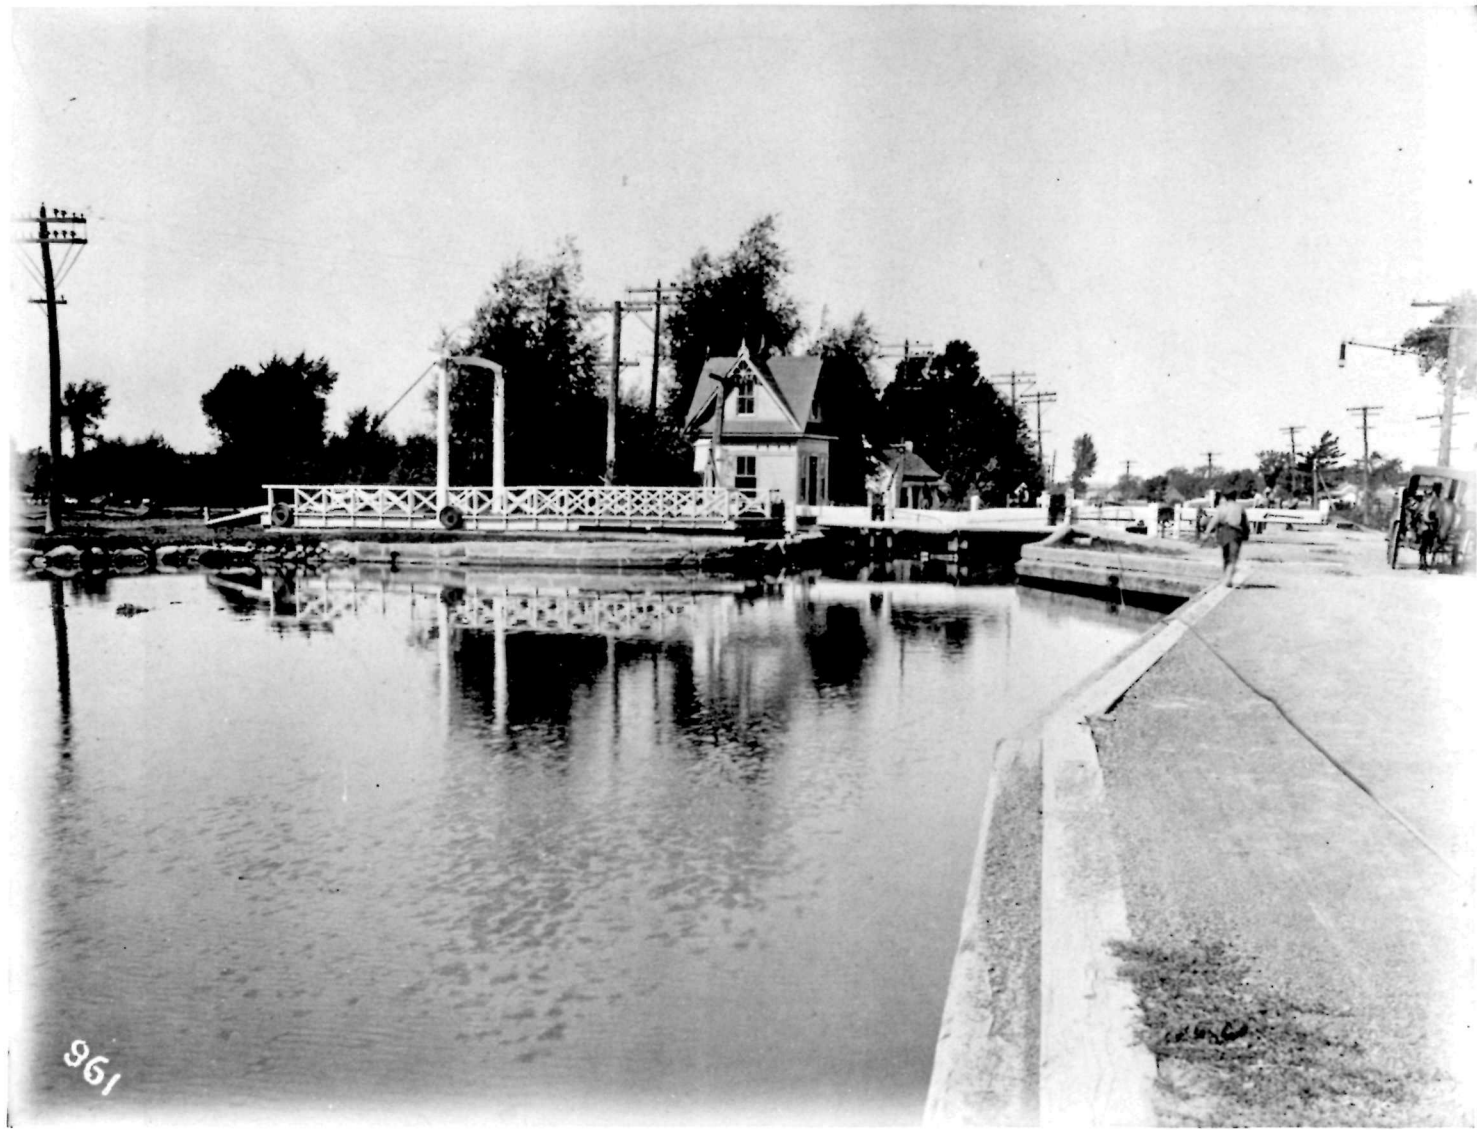
28 The upper entrance to lock 8 in 1911. The upper wing walls serve also as the abutments for the rolling bridge which allows traffic to cross the canal at this point. Note the rack and pinions just above the gates which control the flow of water through the wall sluices. (Public Archives of Canada.)

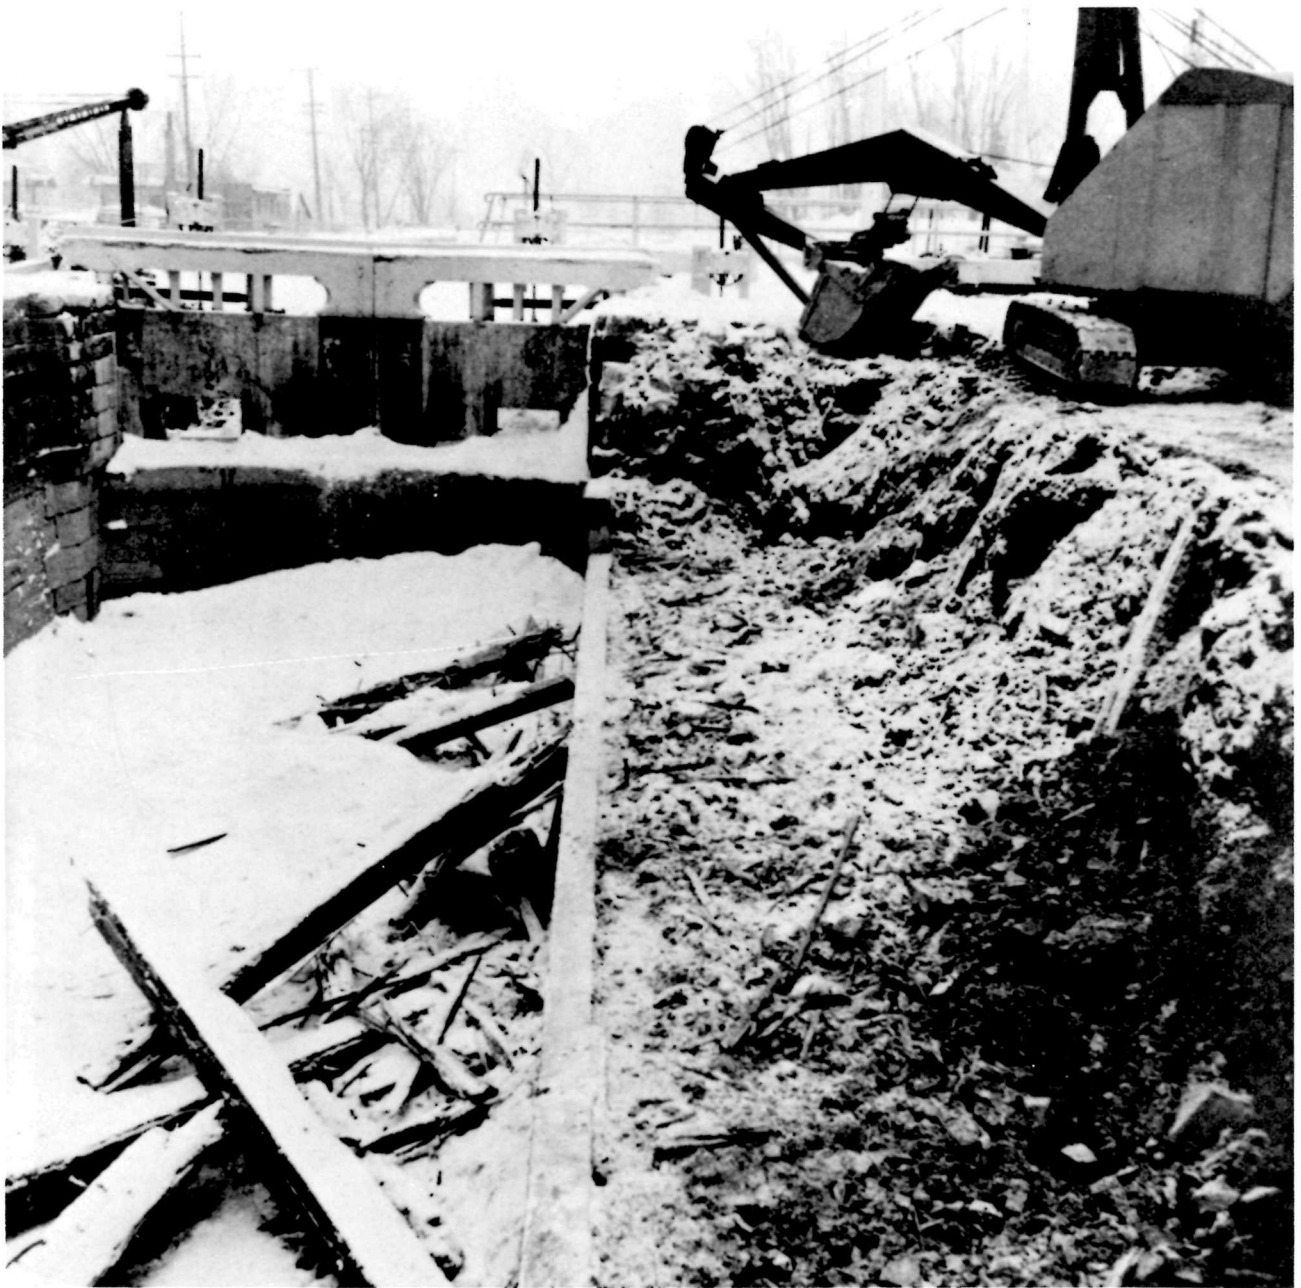
- 29 Demolition of the west chamber wall of lock 8, looking south, 1967. Clearly the timber portion of the wall consisted only of thick planking backed with earth fill. That the wall stood as long as it did is remarkable. Note that the east wall at the gates is masonry from the bottom of the lock to the coping. (Engineering and Architecture Branch, Department of Indian and Northern Affairs, Ottawa.)

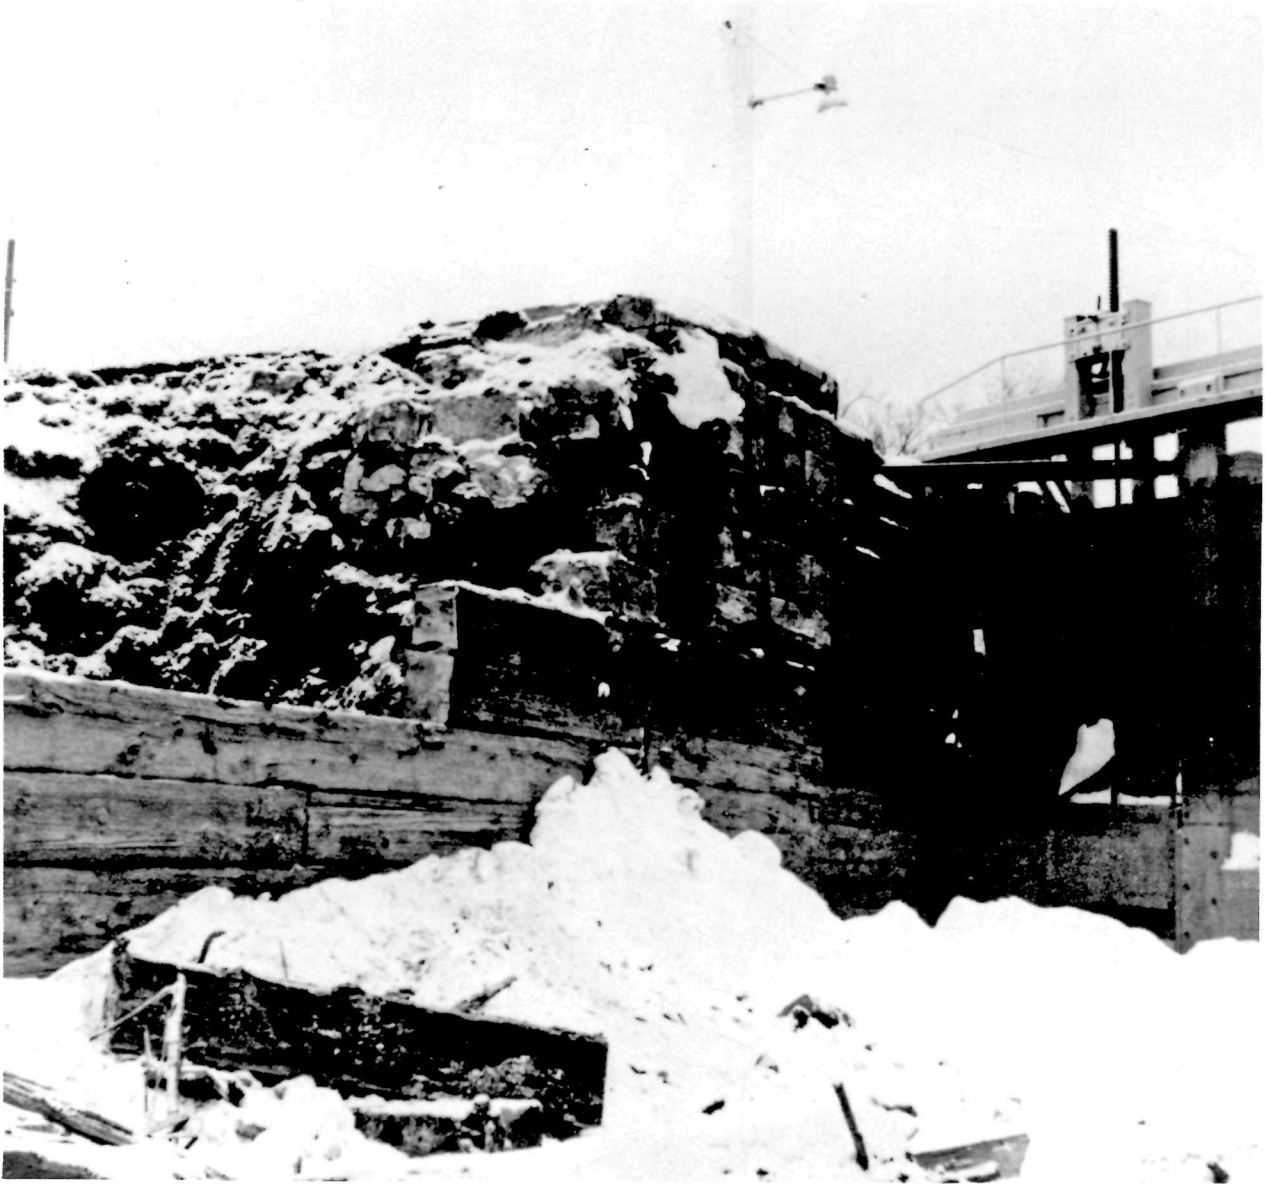
32 Lock 8, looking north from the lower gates in 1973. Here the concrete wall of the 1960s faces the timber and masonry wall as it was in 1973, little changed (or maintained) since its reconstruction in the 1880s. Recently the latter was excavated and examined. The chamber wall was stabilized with a reinforced concrete wall in the rear, re-grouted and pointed; the lower gate recess was dismantled and rebuilt in concrete with an original stone façade. (Engineering and Architectural Branch, Department of Indian and Northern Affairs, Ottawa.)

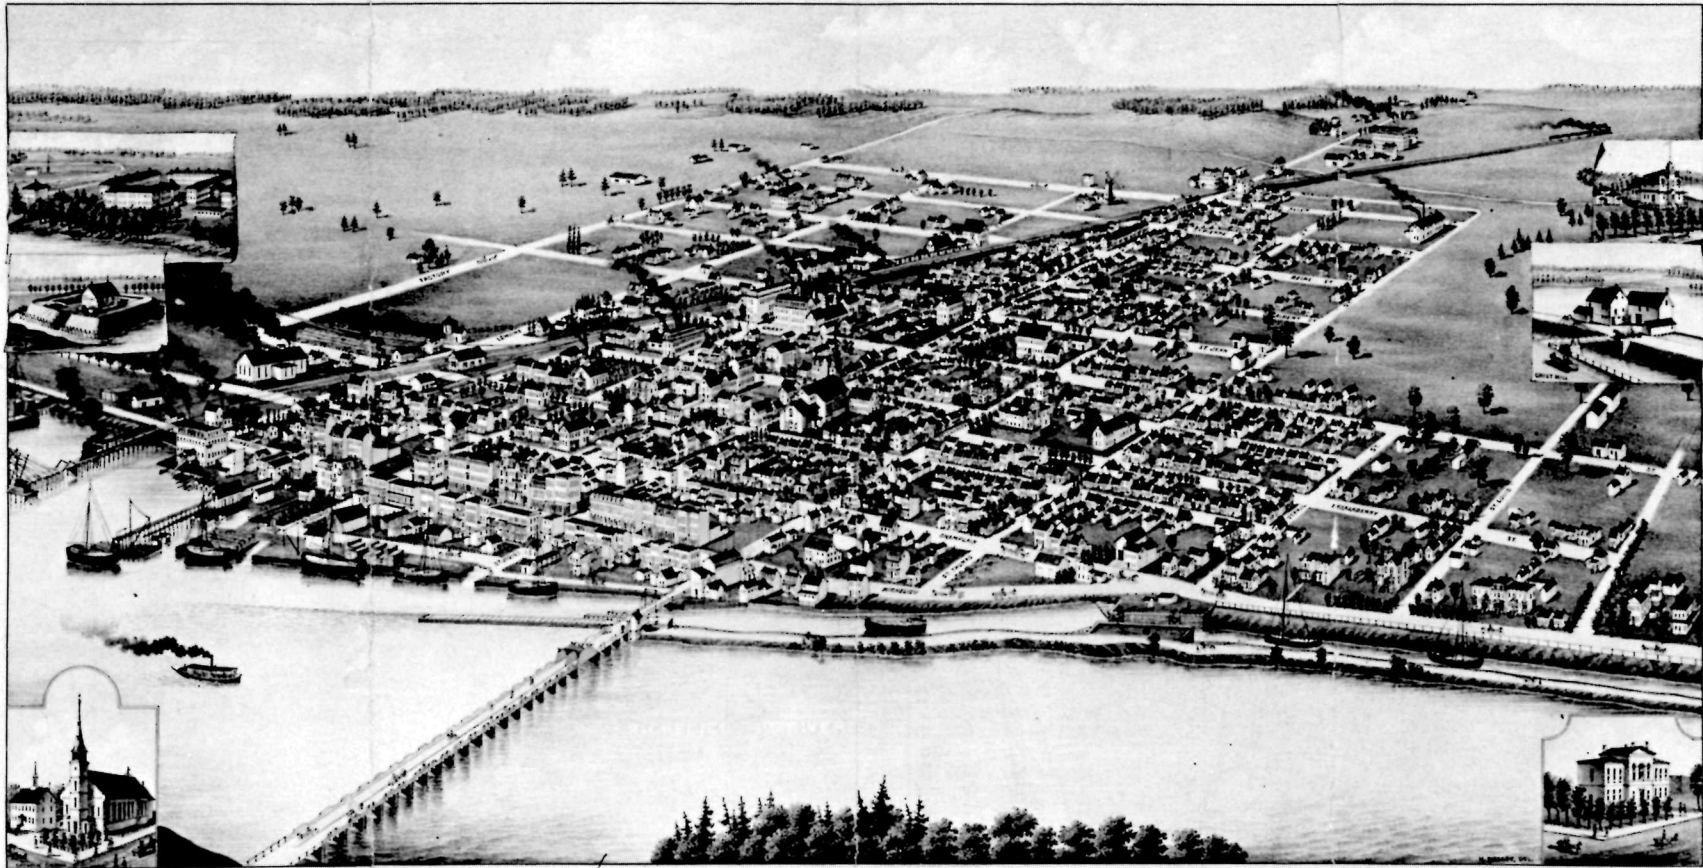
- 33 "Bird's eye view of St. John's, P.Q., Domin. of Canada," by H. Wellge. Note the guard lock and the southern entrance to the canal. (Public Archives of Canada.)

Finished in the summer of 1834, the guard lock at St. Jean was the second lock to be completed and the first on the new enlarged scale authorized by the legislature the previous year (Fig. 33). The face of the lock was constructed of cut-stone masonry from Isle La Motte with a rubble and cut-stone backing and stone counterforts at the rear. The structure probably rested on a timber foundation supported by piles like the other locks. The floor of the lock consisted of longitudinal planks. The upper wing walls were built with grooves on the face for the placement of stop logs in order to be able to drain the lock for repairs or to provide an emergency dam should the gates fail. Like the other locks built in the 1830s by the Andreses and their partners, the coping was left off the wing walls when the work stopped in 1835.

During the decade of the 1870s, parts of the lock were reconstructed in masonry, as they had been before. Between 1873 and 1875 the lower wing walls were rebuilt in this manner. At about the same time the chamber walls and the upper wing walls were repaired, although precisely what this involved is not recorded. Further repairs to the walls were made in early 1879, including relaying portions of the masonry, trimming projecting facing stones, grouting and pointing with cement. It was also reported that the lock, like many of the others, had to be braced with timber in the fall to prevent the walls from being pushed inward by the action of frost. Several years later the upper wing walls were given protection by two crib walls covered with plank, which prevented boats from crashing headlong into the masonry (see Figs. 33 and 34).⁴

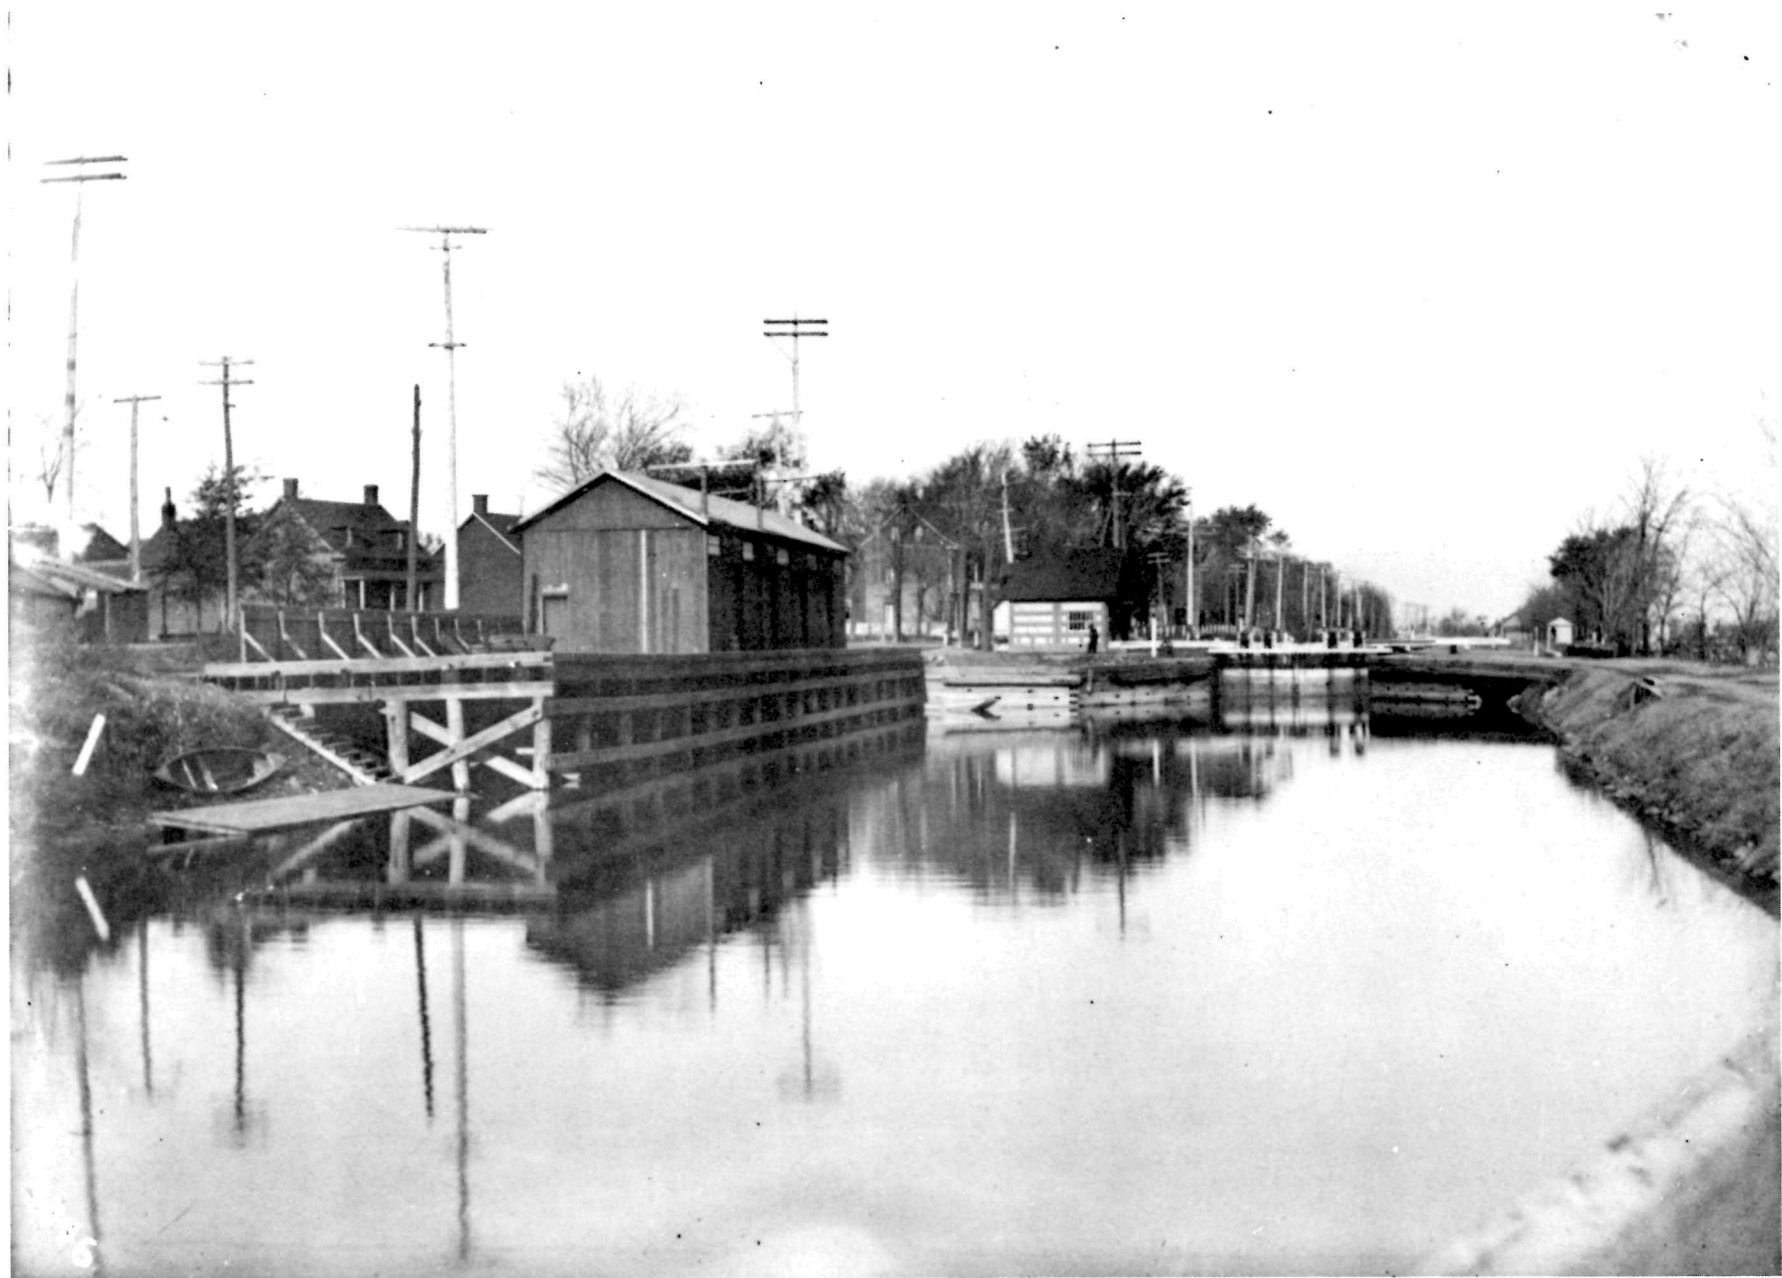
- 34 The upper entrance to lock 9, 1907. Note the timber wing and entrance walls. (Public Archives of Canada.)

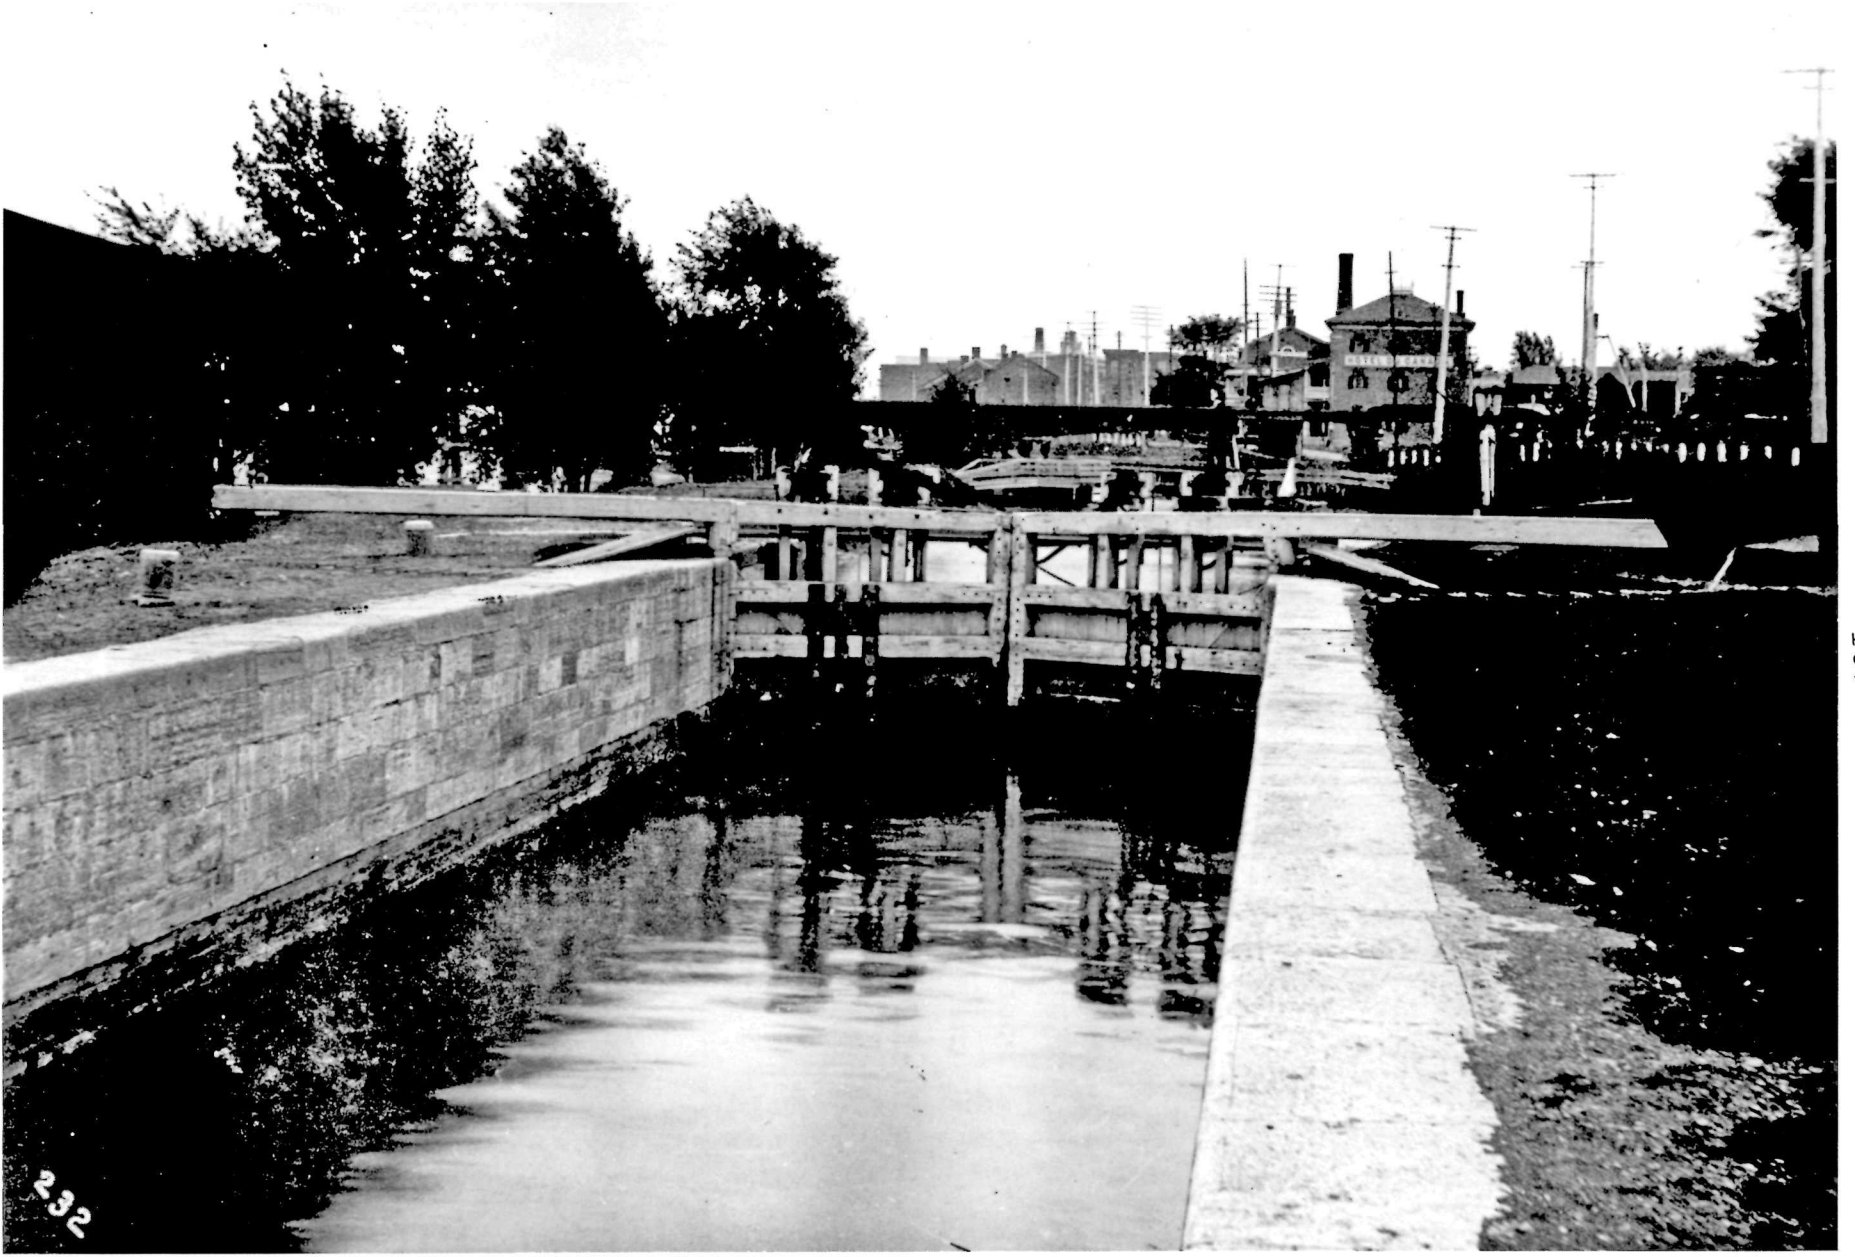
- 35 The guard lock, looking north, ca. 1904.
Note the timber and masonry chamber wall
dating from the 1880s. Note also the two
sluices on each of the upper gates. (Public
Archives of Canada.)
