NATIONAL HISTORIC PARKS
AND SITES BRANCH

THE CHAMBLY CANAL:
A STRUCTURAL HISTORY OF THE LOCKS

by
Sandra J. Gillis

(1975)

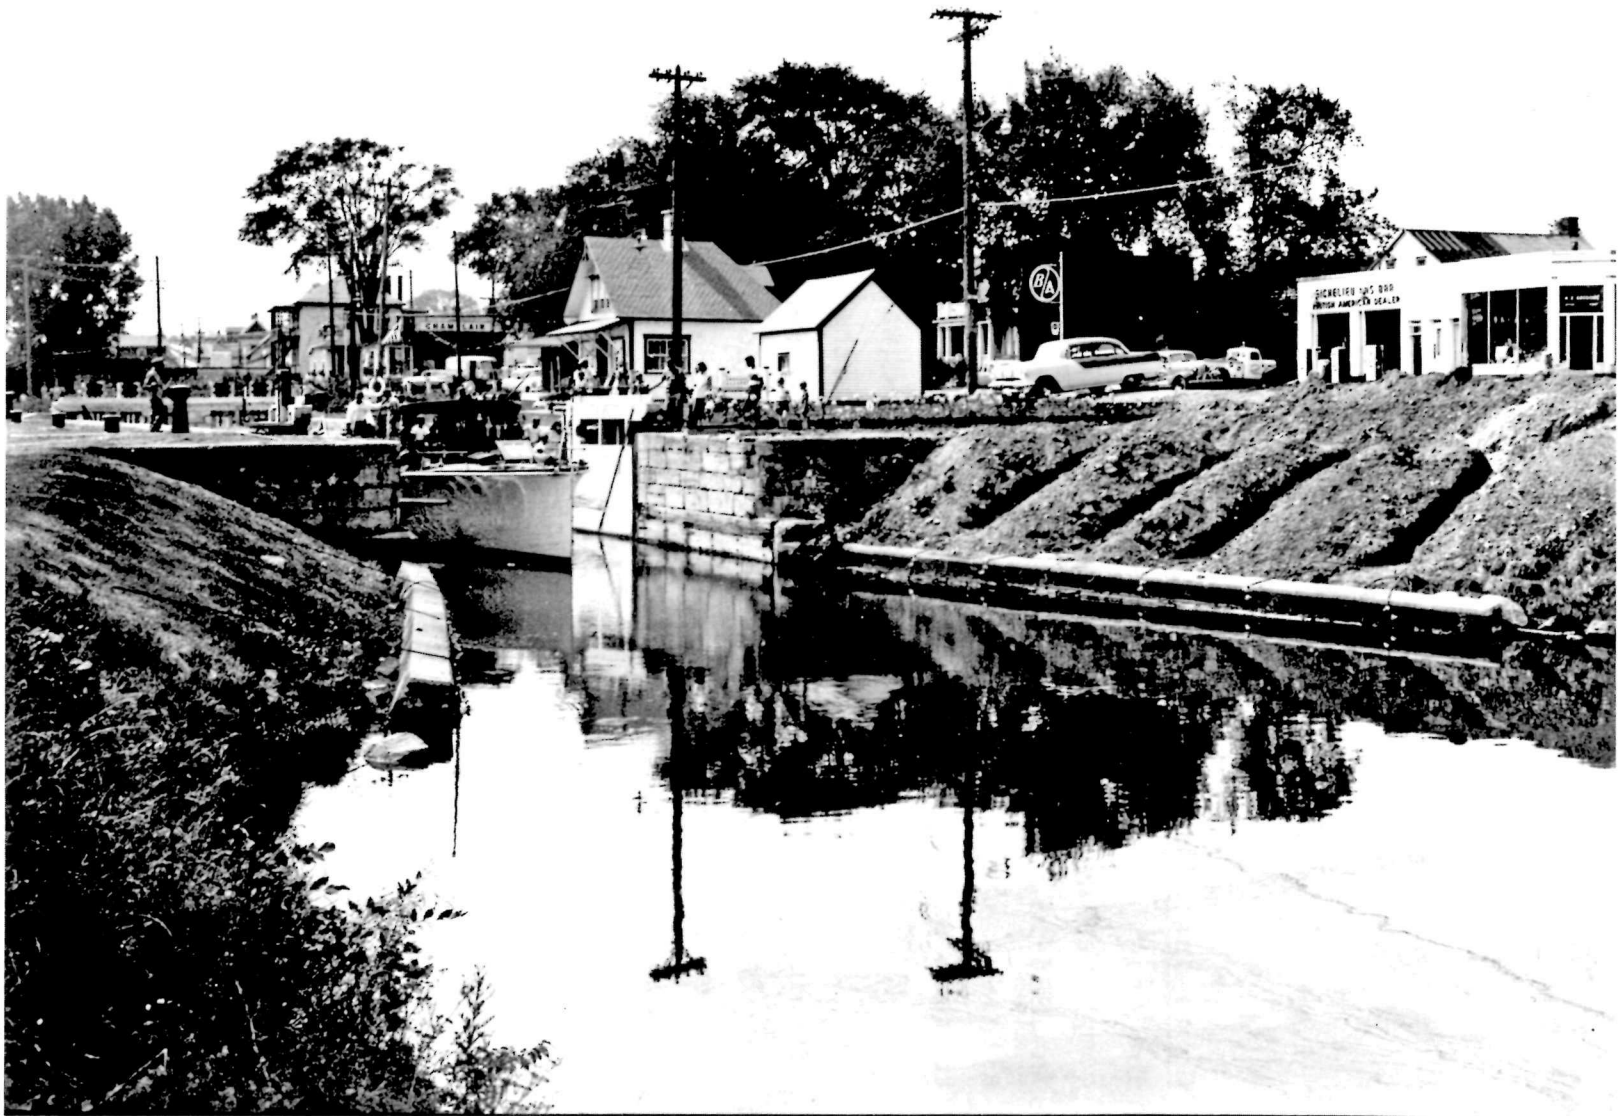
- 36 The lower entrance to lock 9 in 1954, looking southwest. Note the recent earth fill behind the concrete entrance walls. (Public Archives of Canada.)

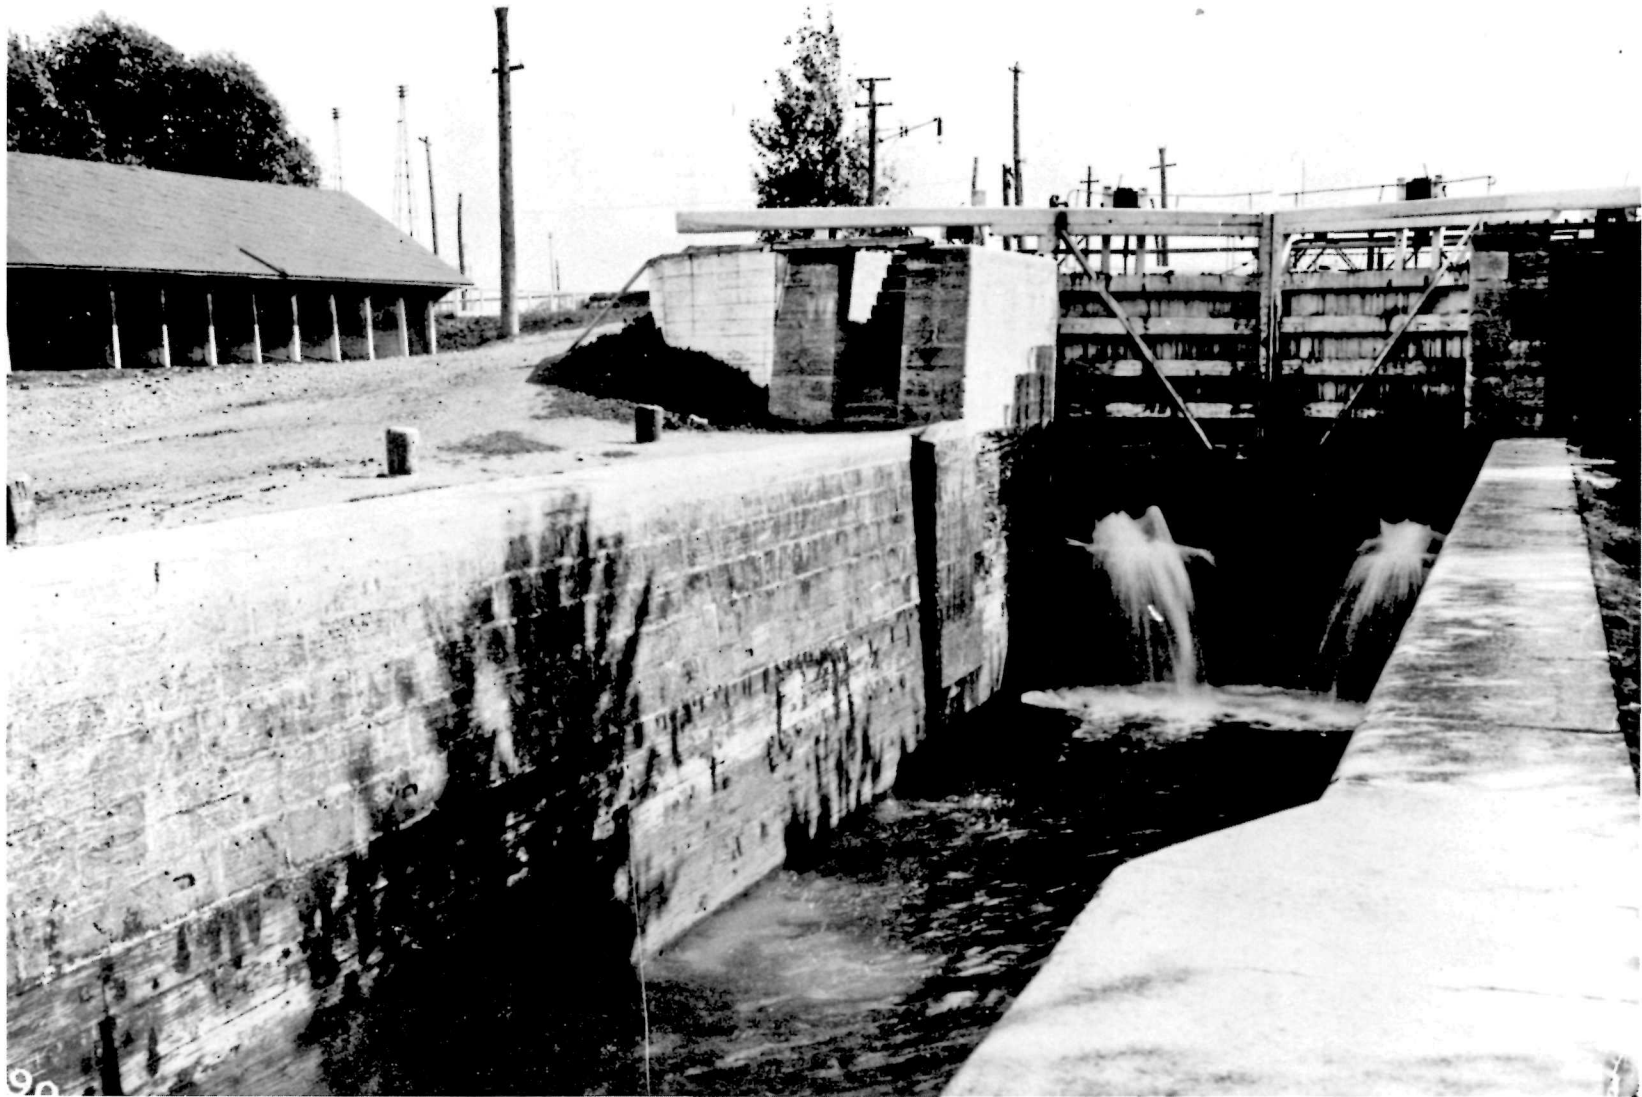
- 41 The gates at lock 2, 1911. These gates appear to be the same as the gates in the plans for the work done by Benjamin Chaffey, 1852. (Public Archives of Canada.)

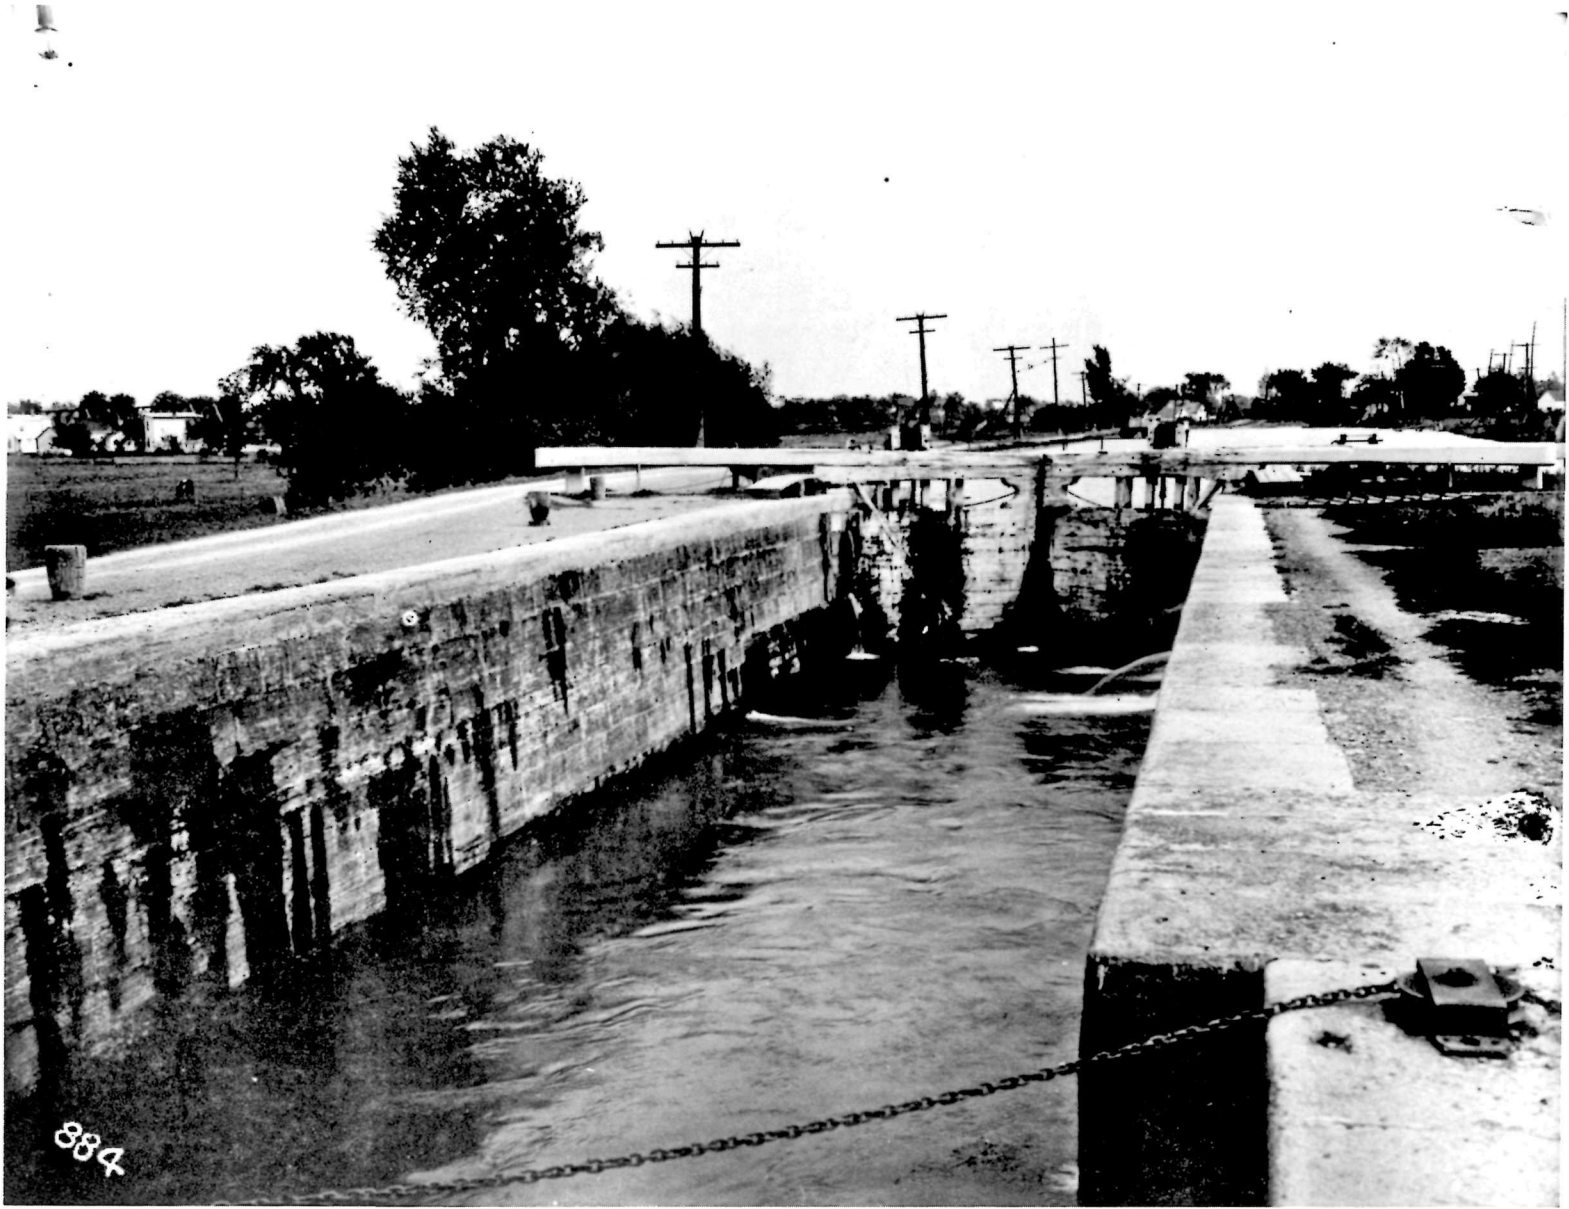
42 Gates at lock 7, 1911. Note the new style of gates at this lock, and the differences between it and the earlier style. (Public Archives of Canada.)

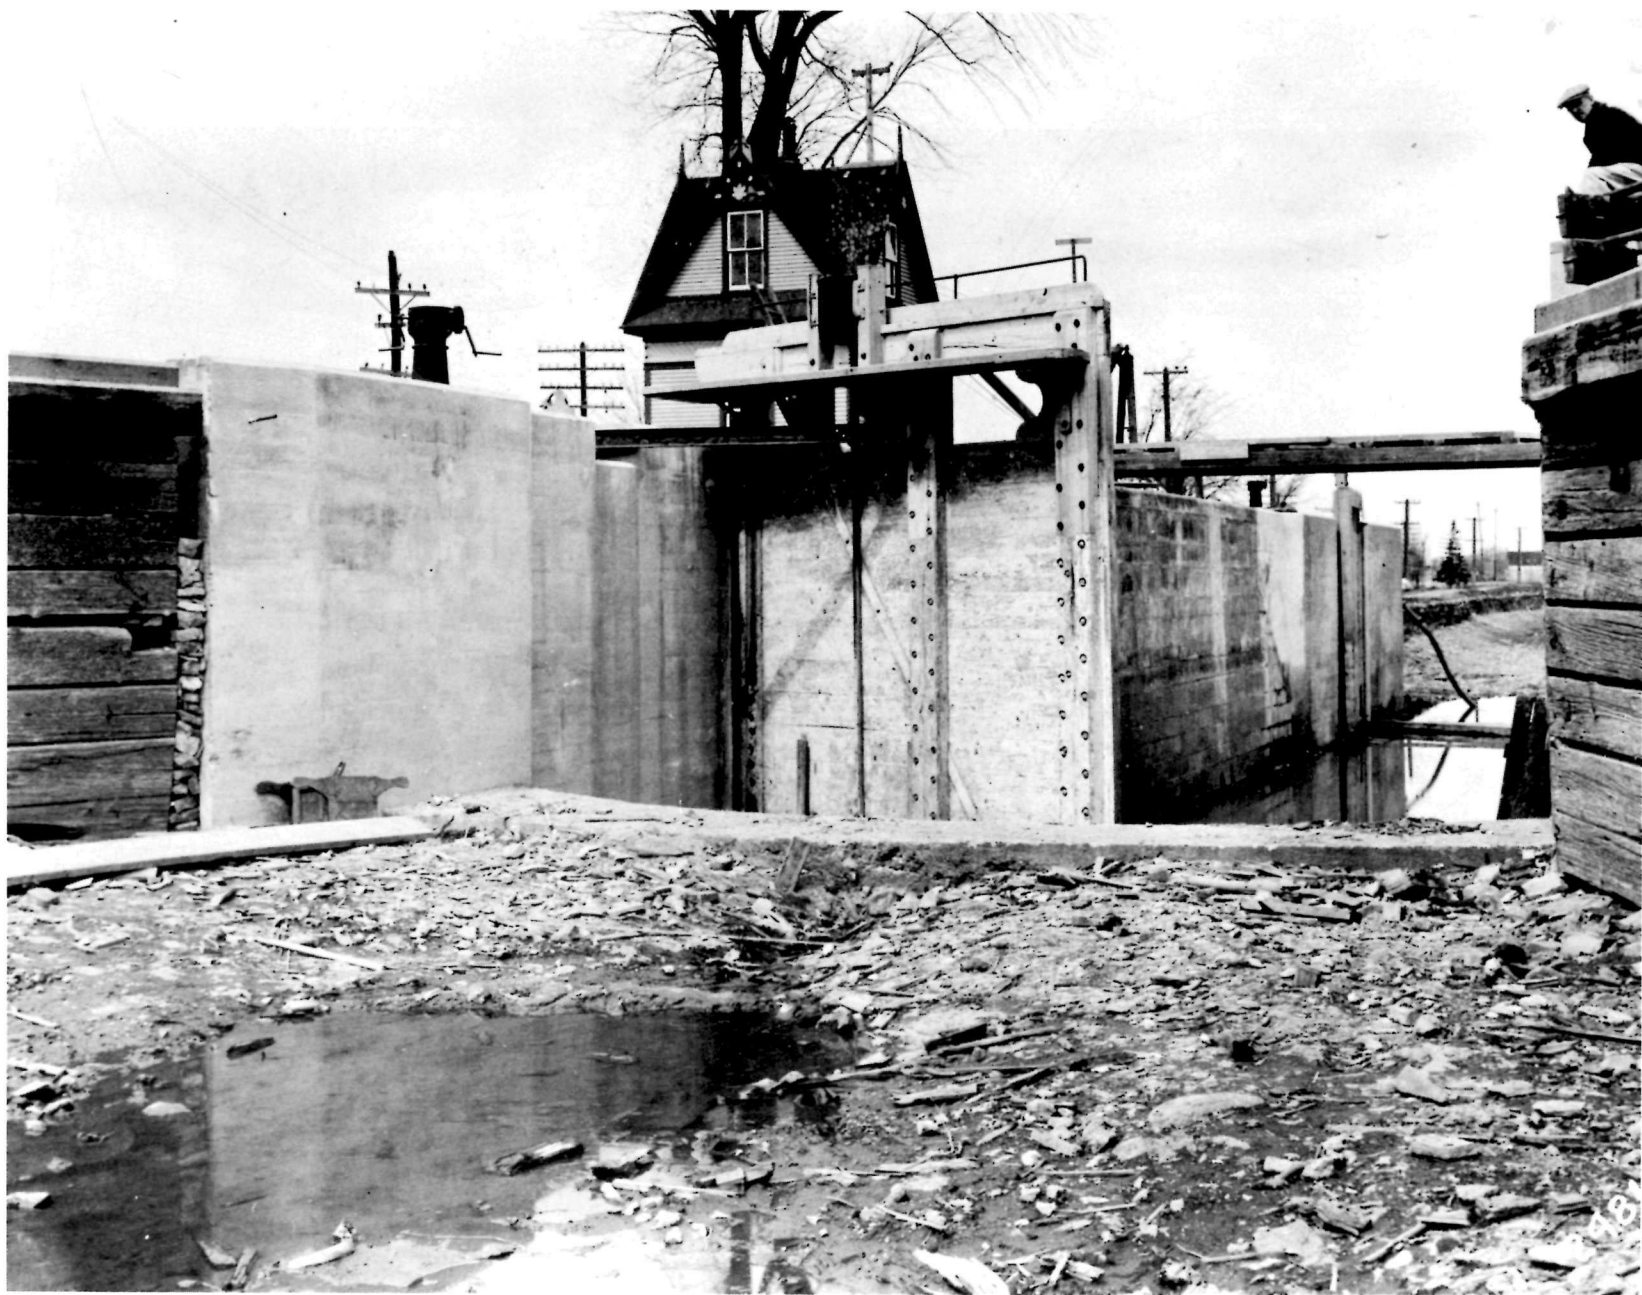
- 43 Gates and gate mechanisms at the upper west side of lock 4. Note that the gate is not planked on the upstream side. Note also the winches and bars which replaced the crabs and balance beams to operate the gates. (Public Archives of Canada.)

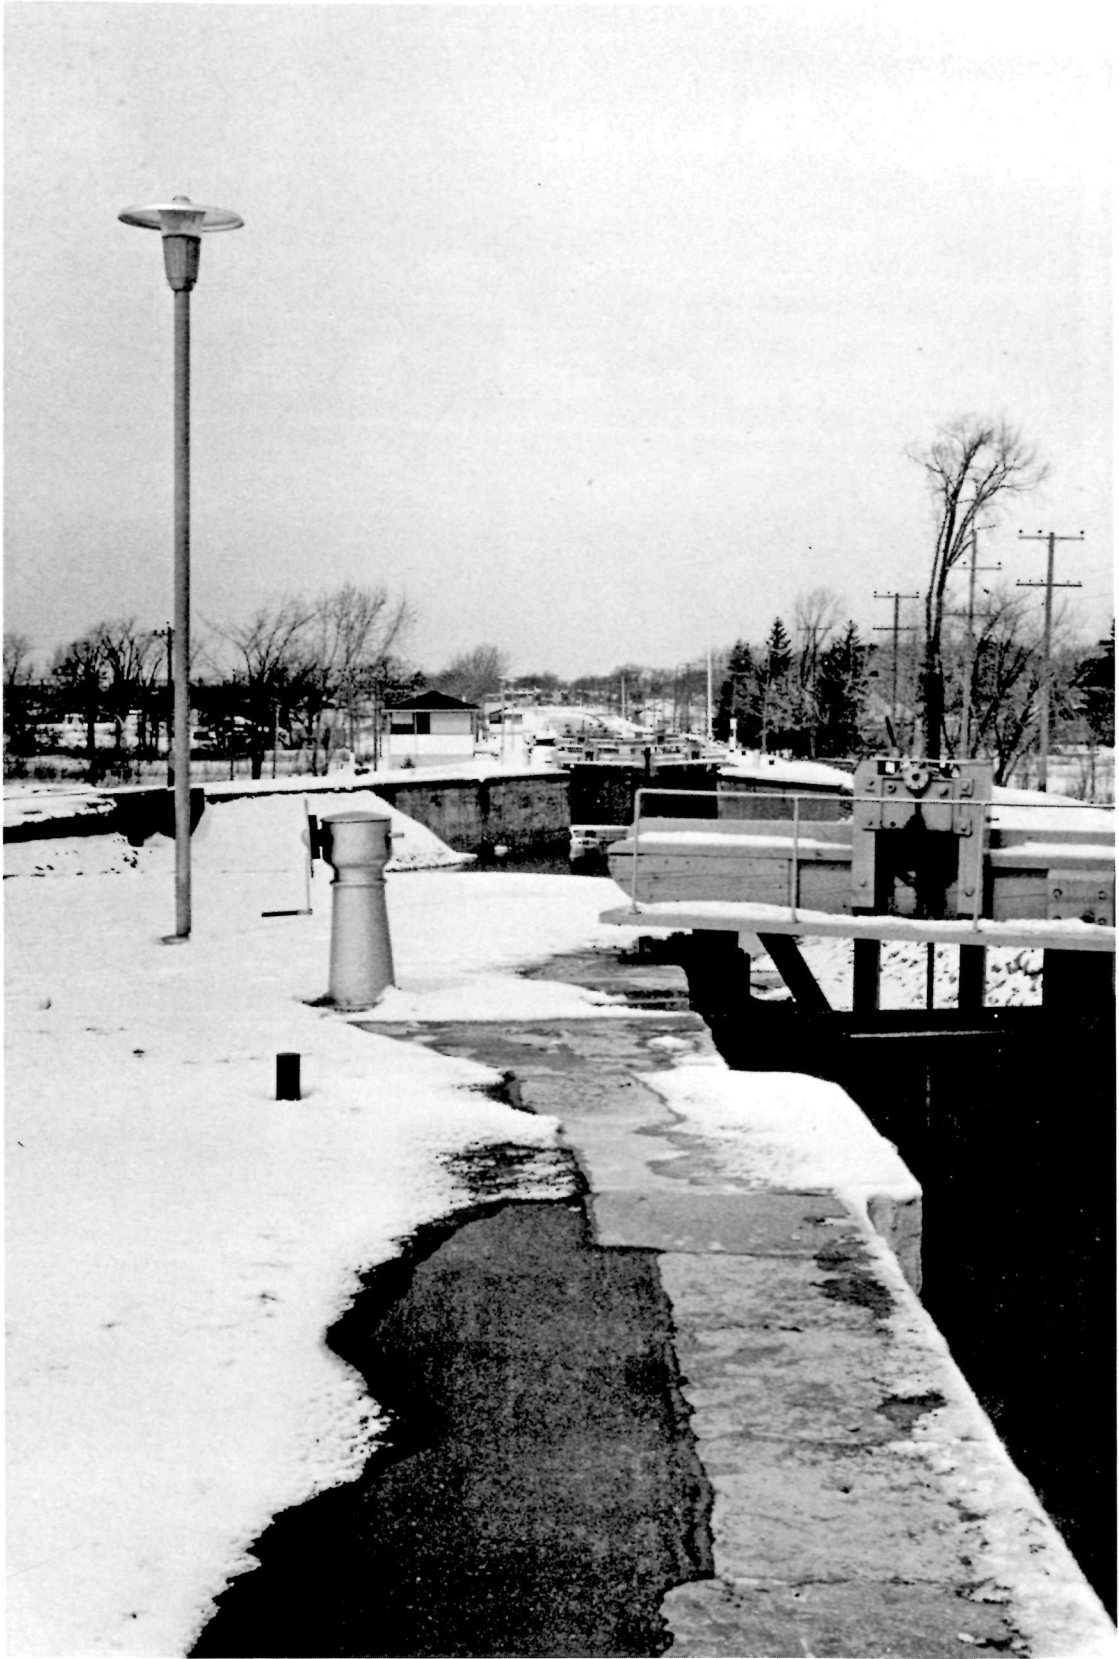
- 44 The upper west gate at lock 4 in 1973. This is the style of gate in use on the canal today. Note that this gate is still equipped with the old iron railings and the mid-19th century rack and pinions.
