THE WEST FRONT:
HALIFAX CITADEL

by
RICHARD J. YOUNG

(1977)

PARKS CANADA
DEPARTMENT OF INDIAN
AND NORTHERN AFFAIRS

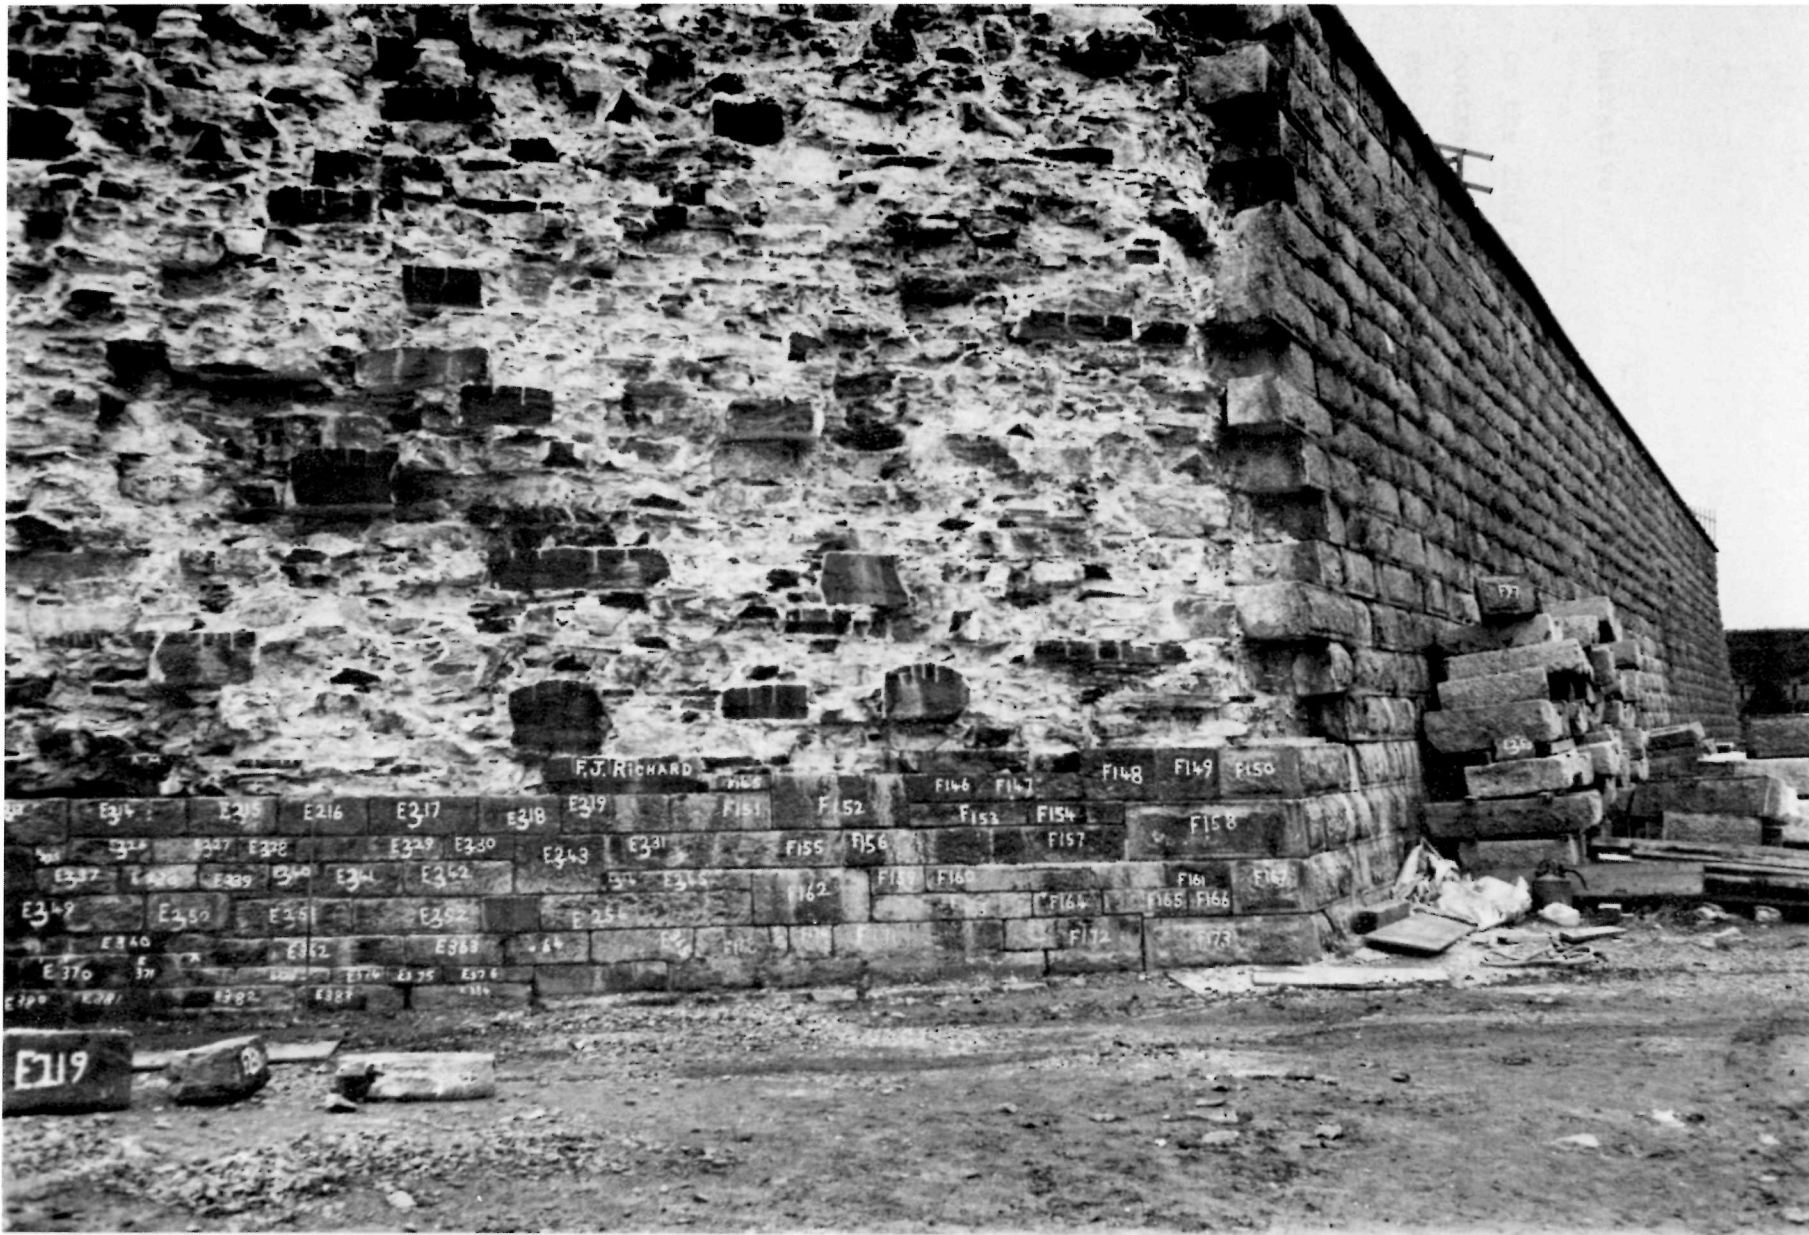
- 6 Photo of the flank and right face of the southwest demi-bastion, October 1976. The flank wall is now in the process of reconstruction. Note the large number of tie-stones which had to be cut through to remove the facing stones of the wall. This area was the portion rebuilt by Peake in 1833. The original wall to the left (not shown in photo) had no large tie-stones and the facing stones were much smaller. The right side of the photo shows the granite ashlar face wall rebuilt by Peake in 1833 -- still intact after 143 years. (Photo by author, October 1976.)

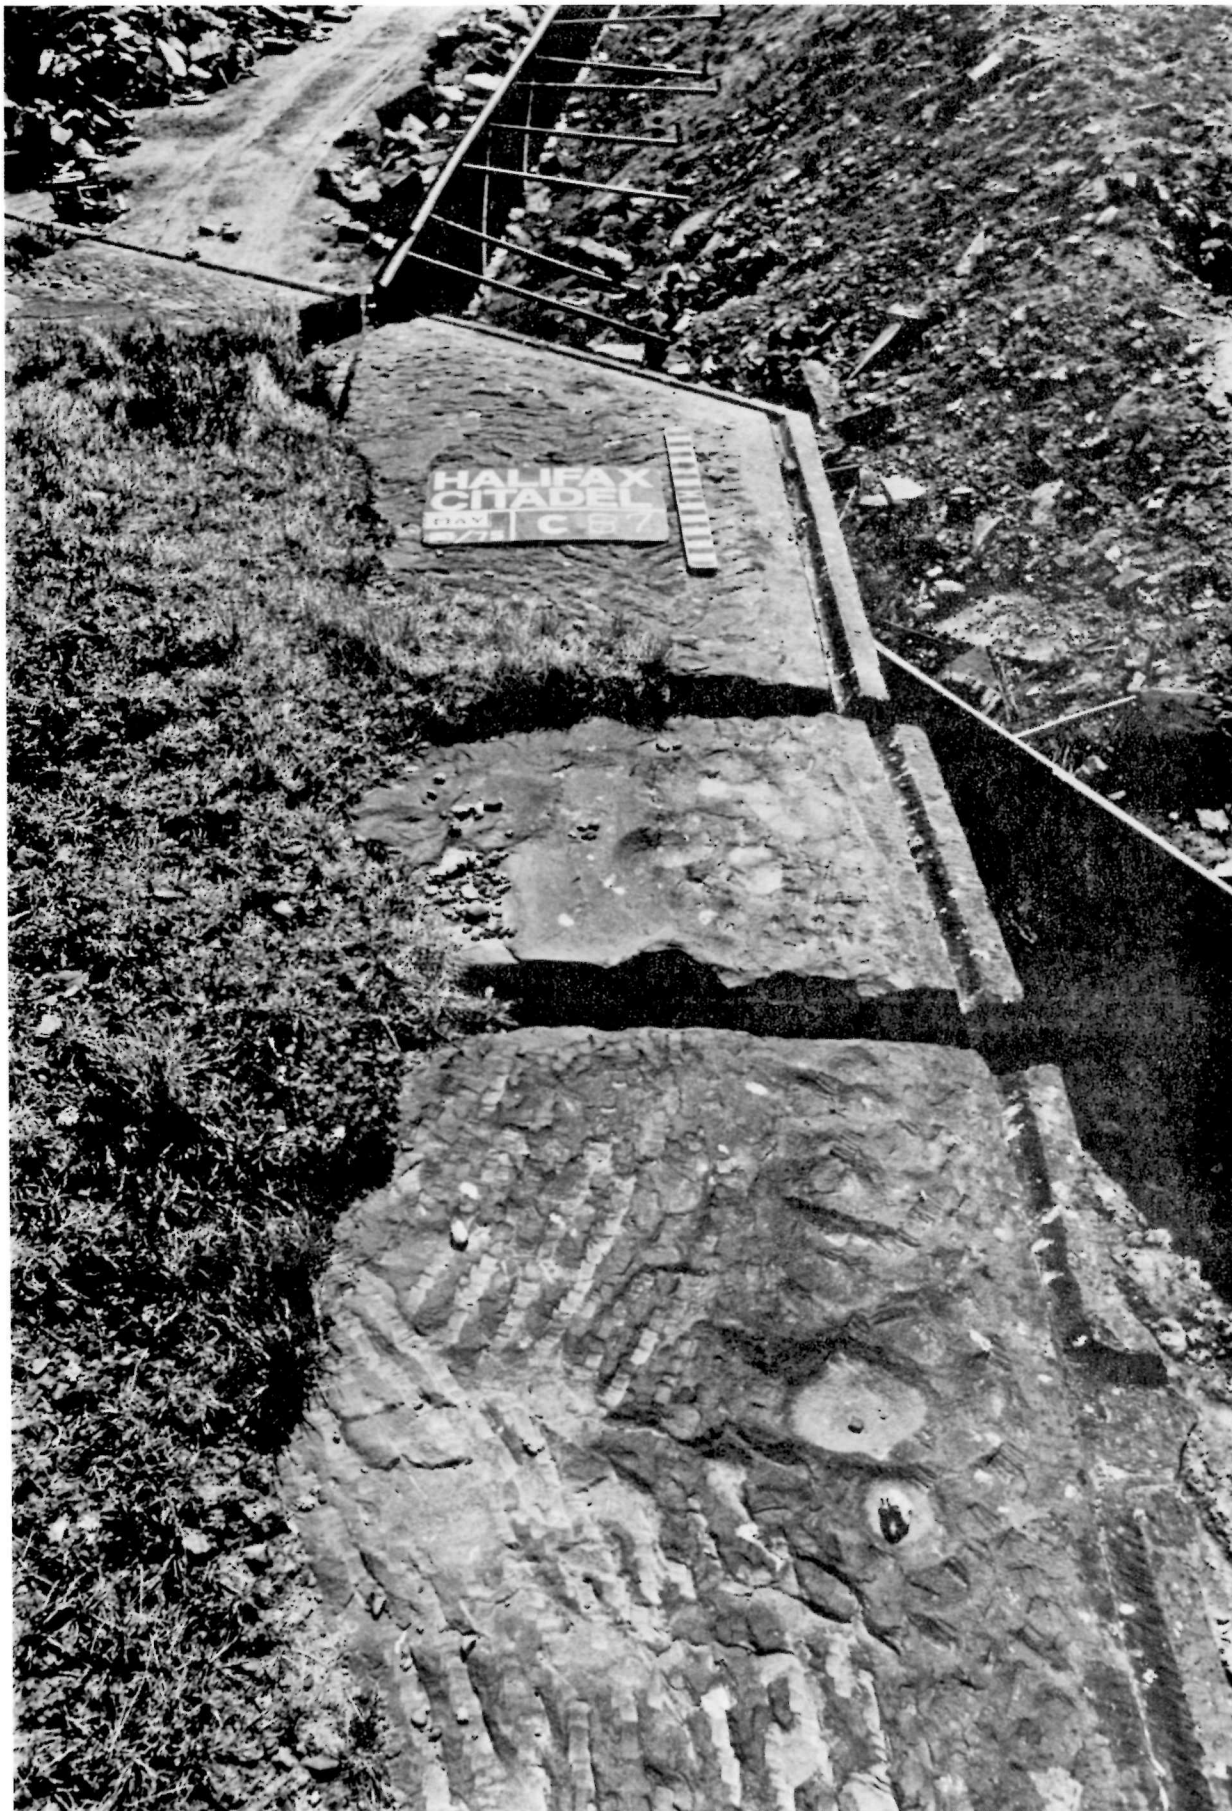
- 9 Photo of original coping (1829) above face and flank of northwest demi-bastion. Note the chiselled gutter. Also note, to the lower right, one of the spouts broken off. (Project Office, Halifax Defence Complex, as found photo file.)

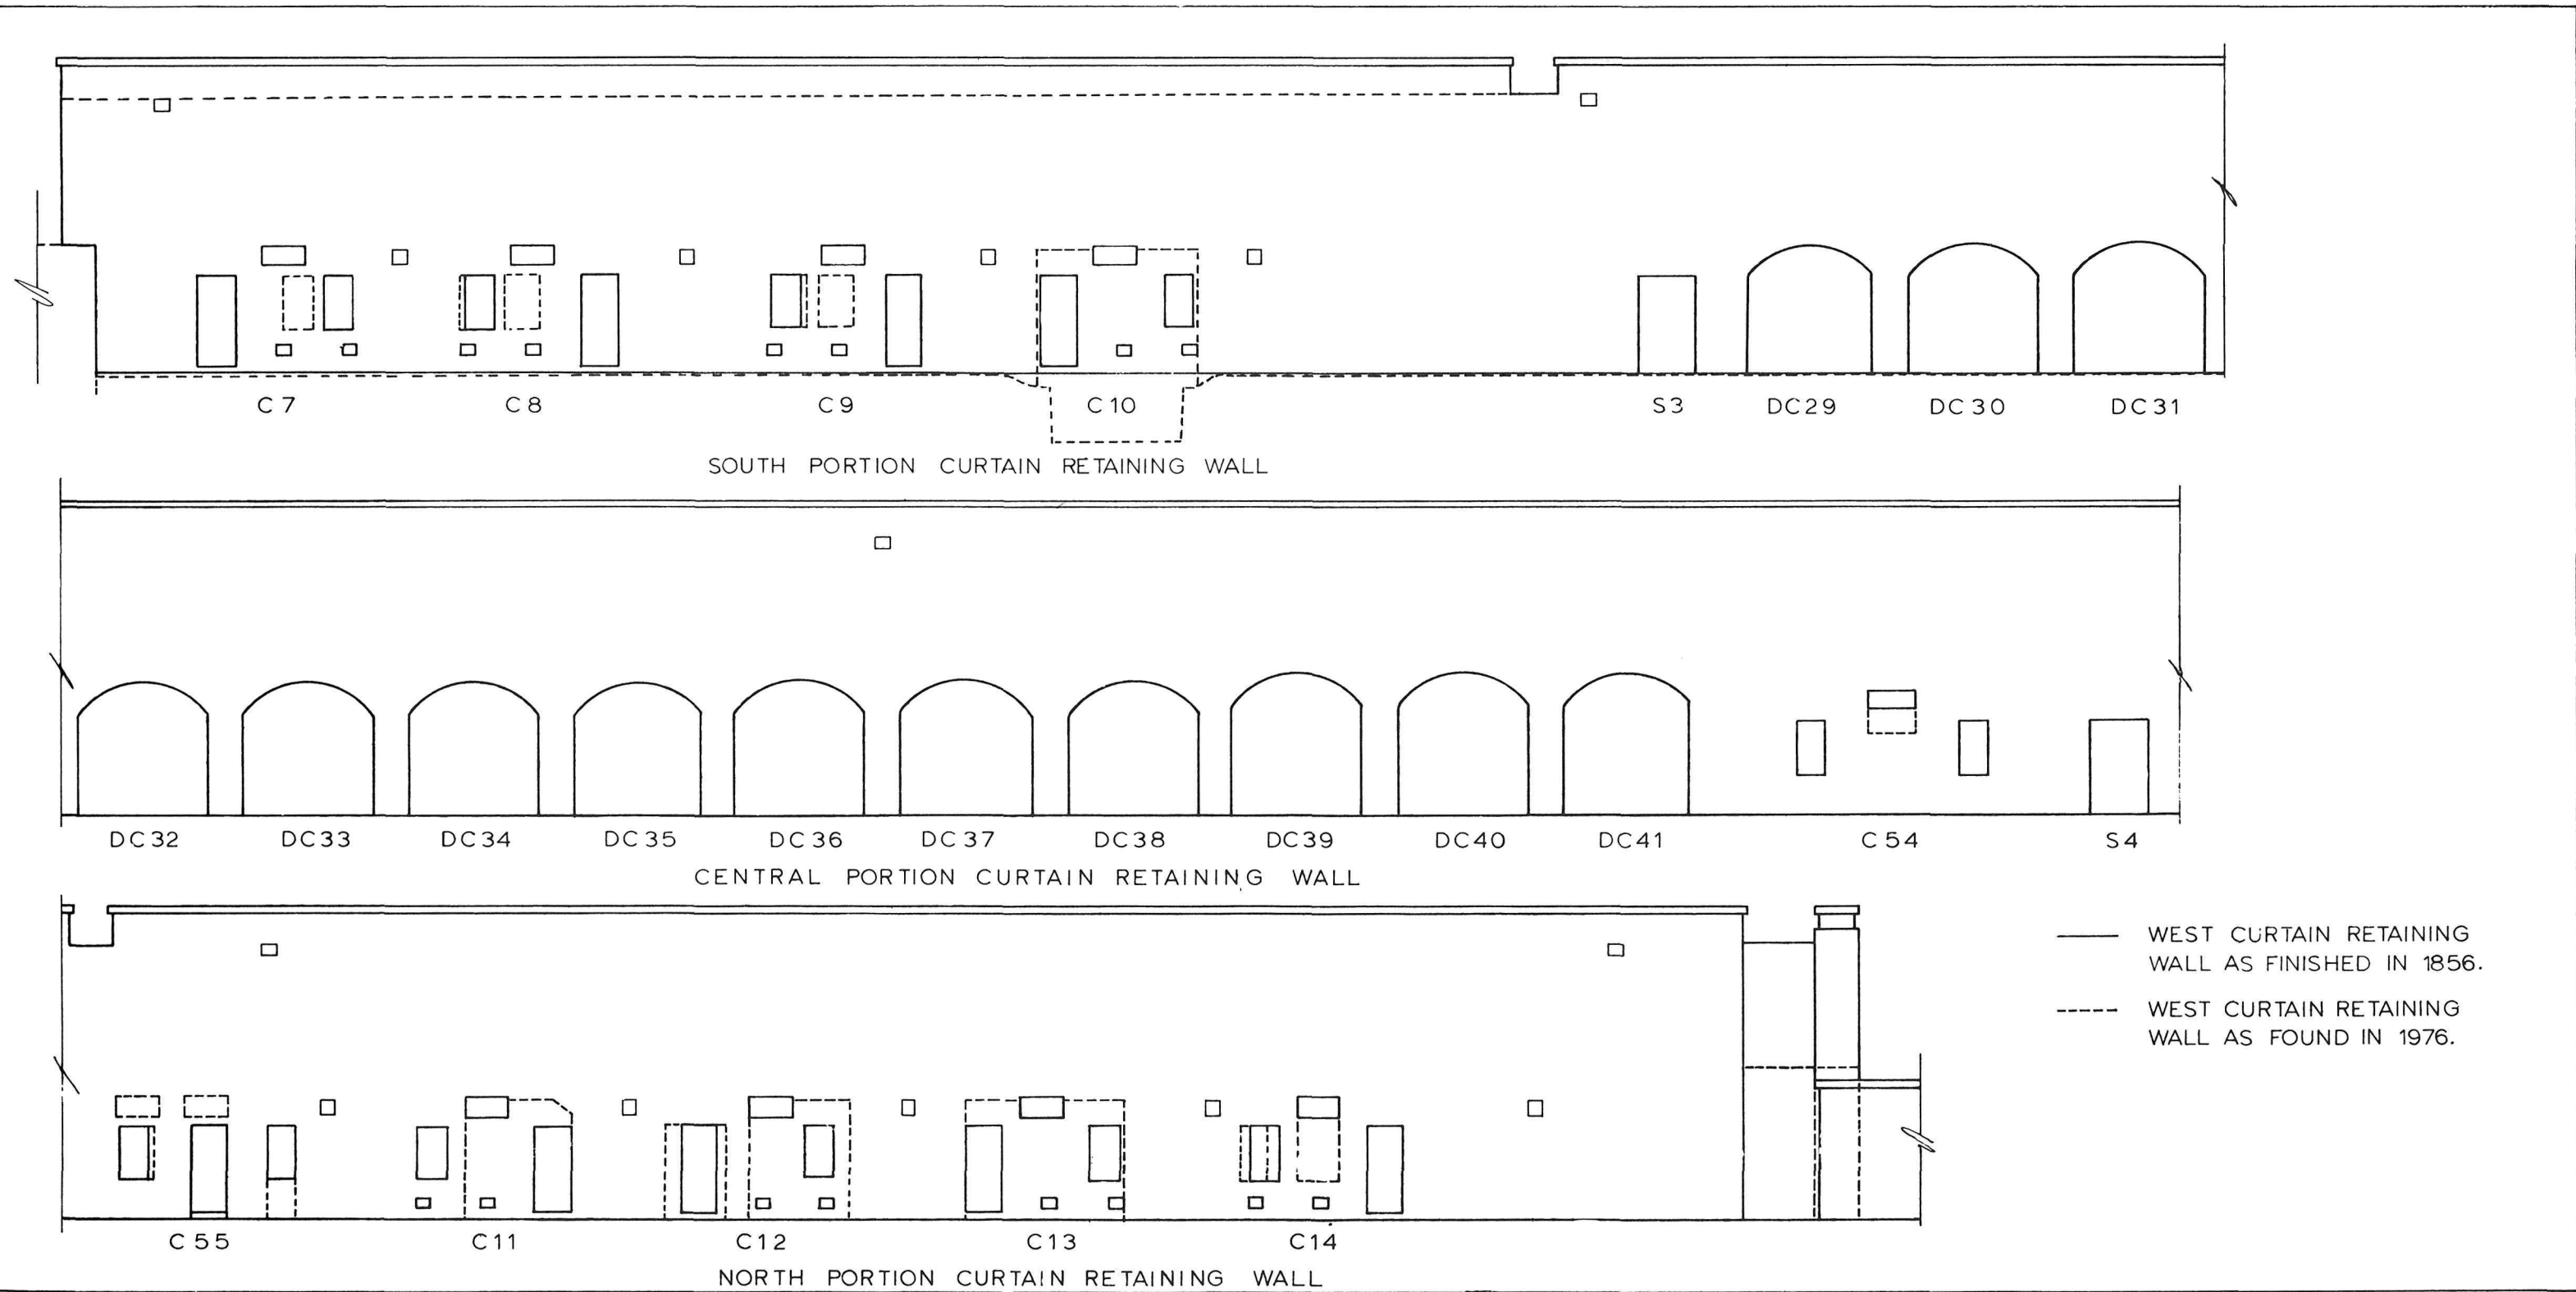
- 13 Modern composite drawing of the retaining wall to illustrate the changes that have taken place since 1856. The casemated area at the north of the wall has undergone considerable more alteration than the south portion. The extra lower windows in each of the casemates were made sometime in the 1870's. The back and front walls of casemate 10 were removed in the 1950's to provide access to the Citadel. The major door alterations to the north casemates are 20th century changes. The ammunition hoist gates, above each sallyport, were built sometime in the 1870's during the conversion of the Citadel guns from smooth bore to rifled ordnance. (As found drawings, Set C, Project Office, Halifax Defence Complex; and a number of historical plans, the most important being Calder's 1846 elevations of the casemates of defence, PAC, MG12, W055, Vol. 880, fol. 961, "Plan, Elevation, and section of the Retaining Wall to be rebuilt to 4 Casemates of Defence West Face...", Calder, 31 March 1846.)

14. See figure 13. This modern drawing is a composite of as found records, various historical plans and documents cited in the report.
15. PAC, MG12, WO55, Vol. 880, fol. 961, "Plan, Elevation and Section of Retaining Wall to be built, casemate of defence...", Calder, 31 March 1846. Also PANS, RE 56, unpaginated, "Supplementary Report and Estimate...", 31 March 1846.

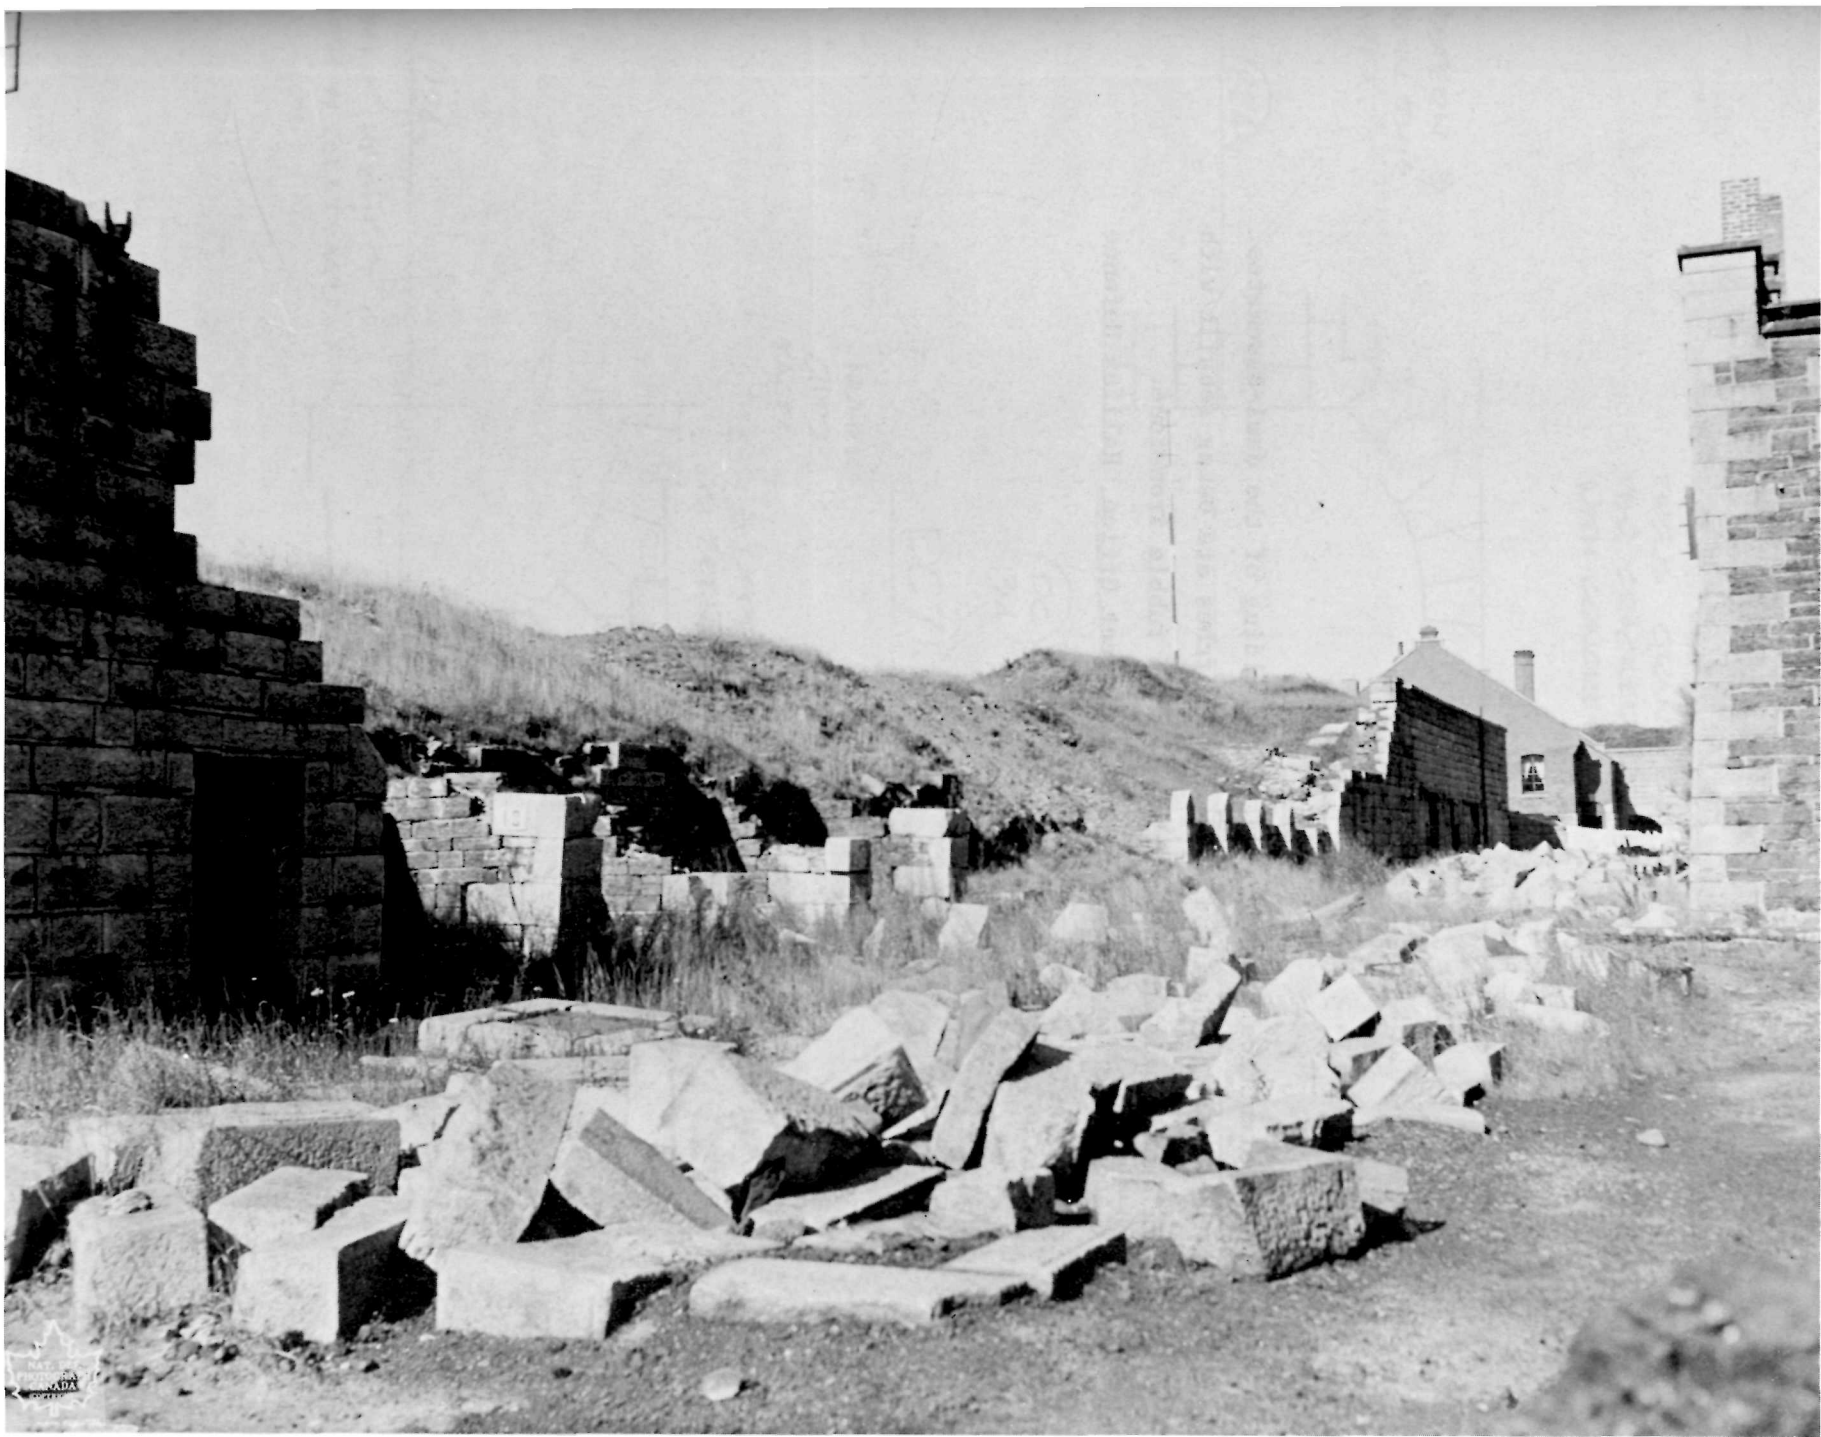
- 18 The retaining wall in 1950, at the time of the Massey Royal Commission. In the 1950's the retaining wall was rebuilt, including the demi-casemates. The demi-casemates, however, were reconstructed only to a depth of six inches. In 1975, work was begun to rebuild the demi-casemates to conform with the 19th century appearance and depth. (National Defence Photo.)

By 1950, the demi-casemated portion of the retaining wall had completely collapsed. (See figure 18) During the years of a stabilization program which followed the Massey Commission recommendation, this wall was rebuilt. During that reconstruction period, the back walls of the demi-casemates were built only to a depth of six inches from the face, with no inside arches or pier walls. In 1976, a decision was taken to rebuild the demi-casemates to their 1856 appearance. In 1976 the reconstruction work began.

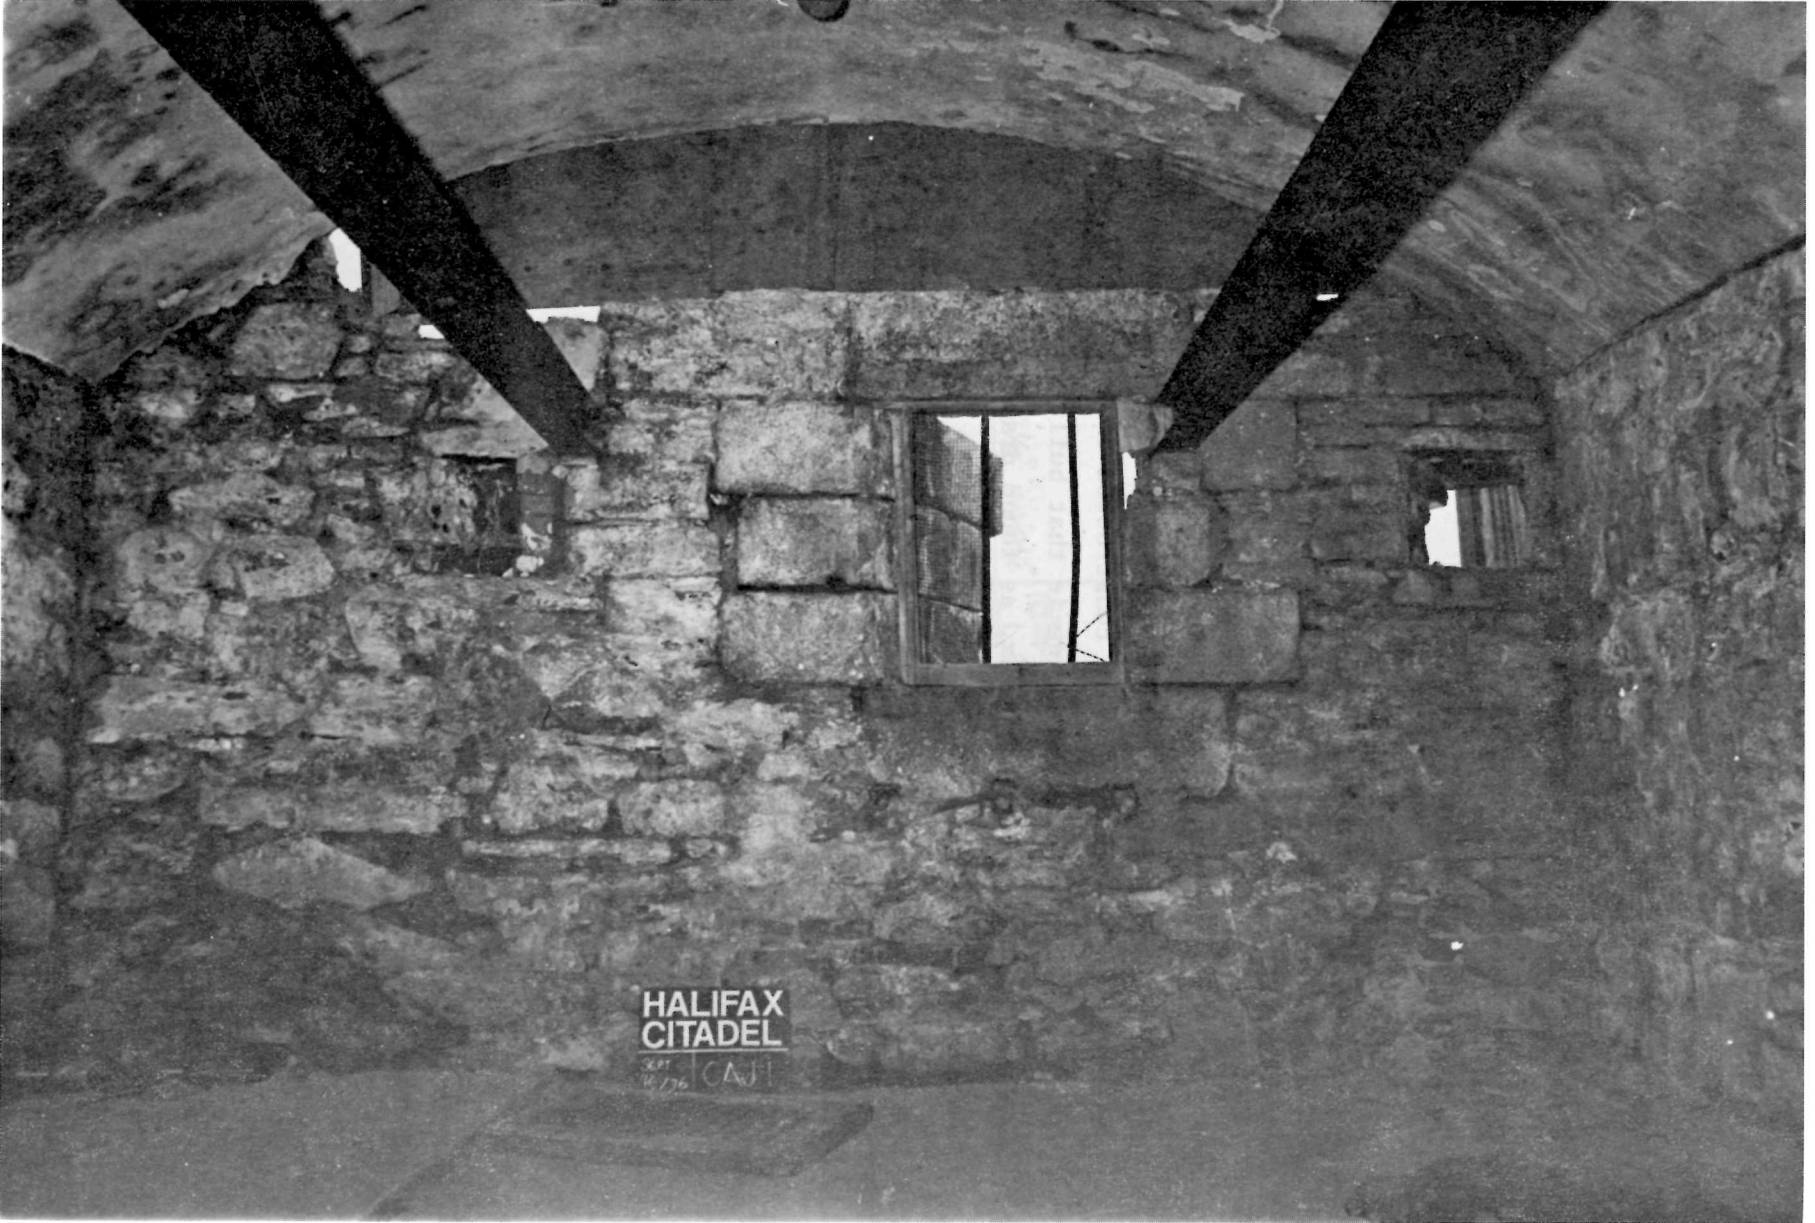
- 23 Photo of the back wall of casemate 9 in 1976. This photo was taken after a one inch cement parging was removed by workmen. Note the three rings below the gun port. These rings held the tackle for the 24 pounder guns. They are cast iron, and solidly embedded in the ironstone wall. Note also the bars in the gunport. These date from 1856 when the casemate was used as a military prison. The curtain wall, gun port, and musketry loopholes are now being reconstructed. (Project Office, Halifax Defence Complex, as found team photo, on file.)

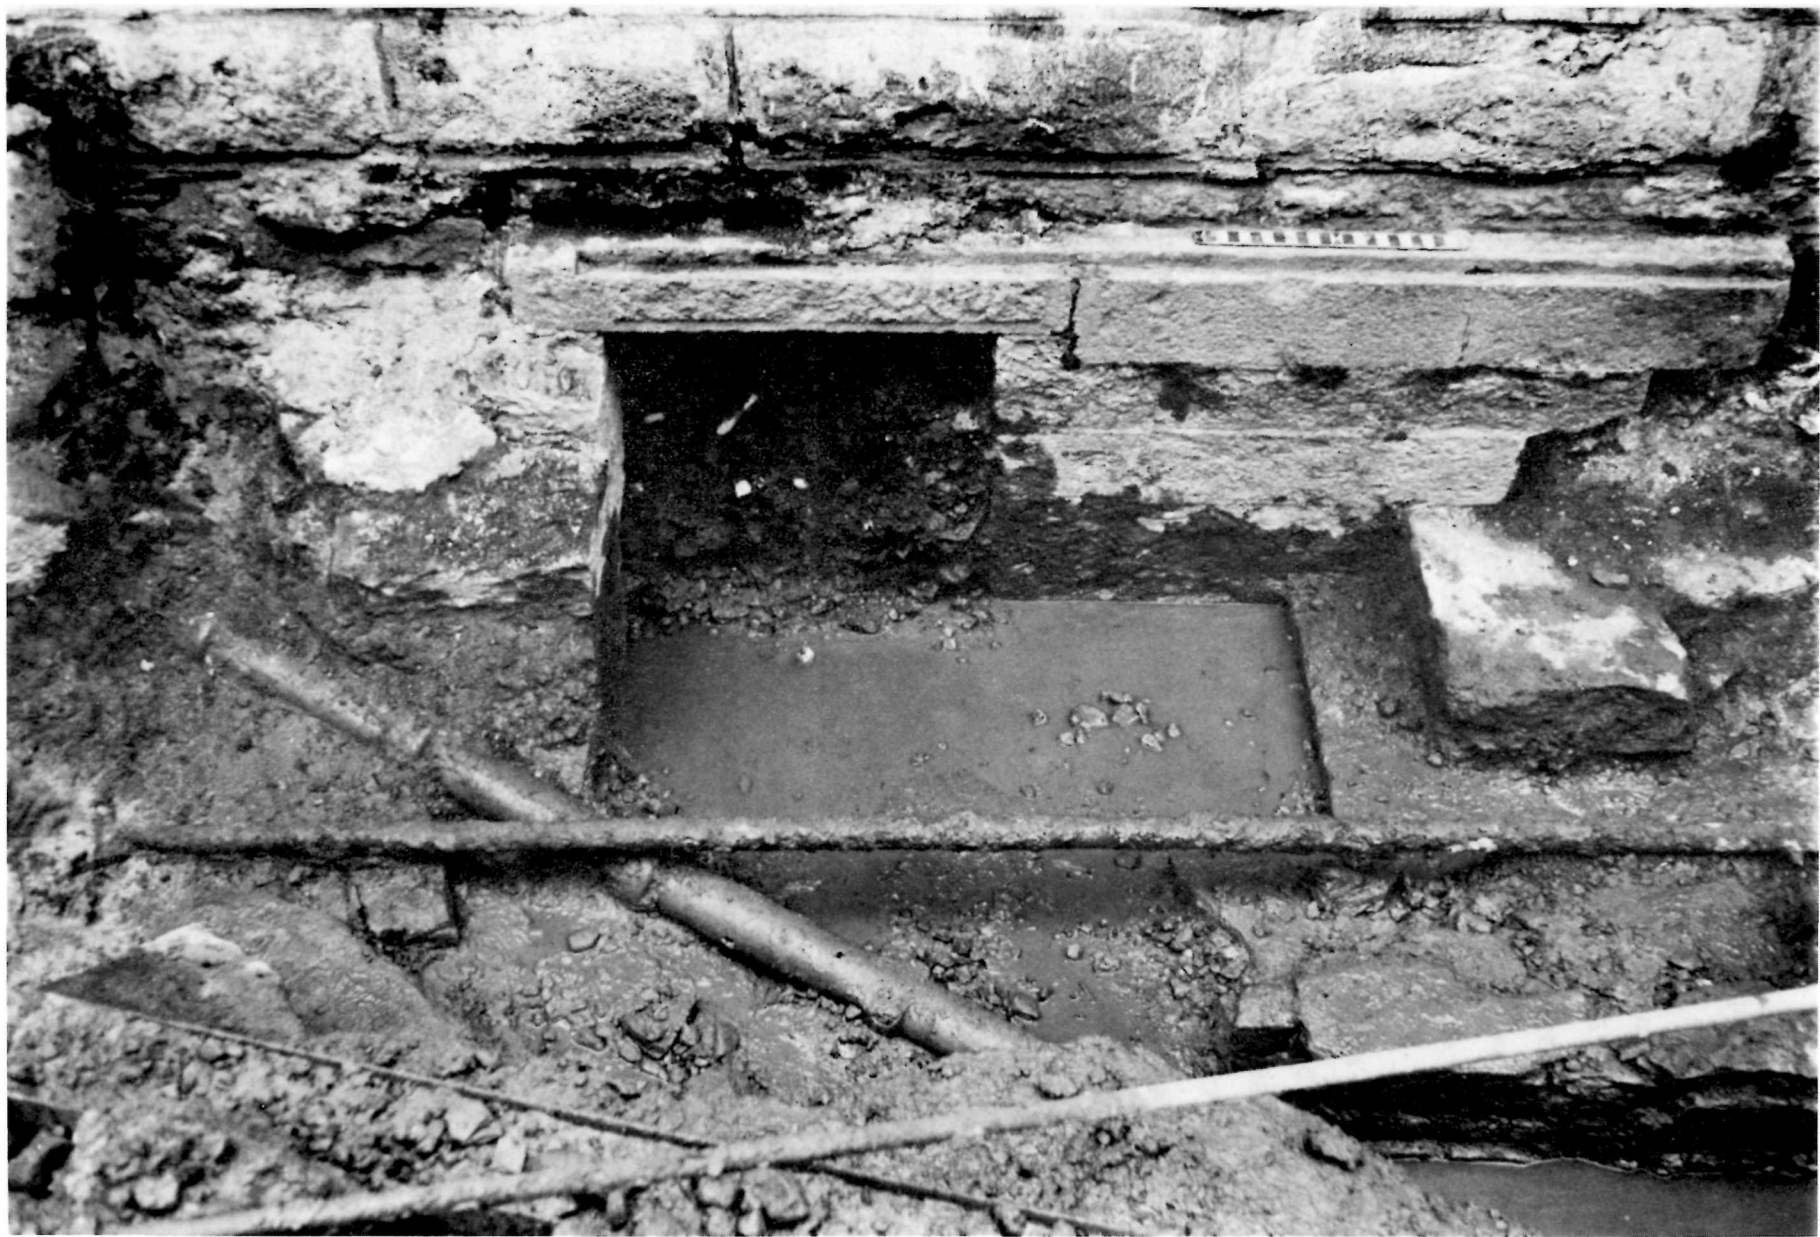
- 38 Photo of the soil pit outside C-54, after archaeology in October 1976. Note the tooled granite sill at base of retaining wall which held the wooden covers of the soil pit. Note steps at the north end, and the entrance to C-54, now blocked with ironstone rubble. (Project Office, Halifax Defence Complex, as found photo record of archaeology, 1976.)

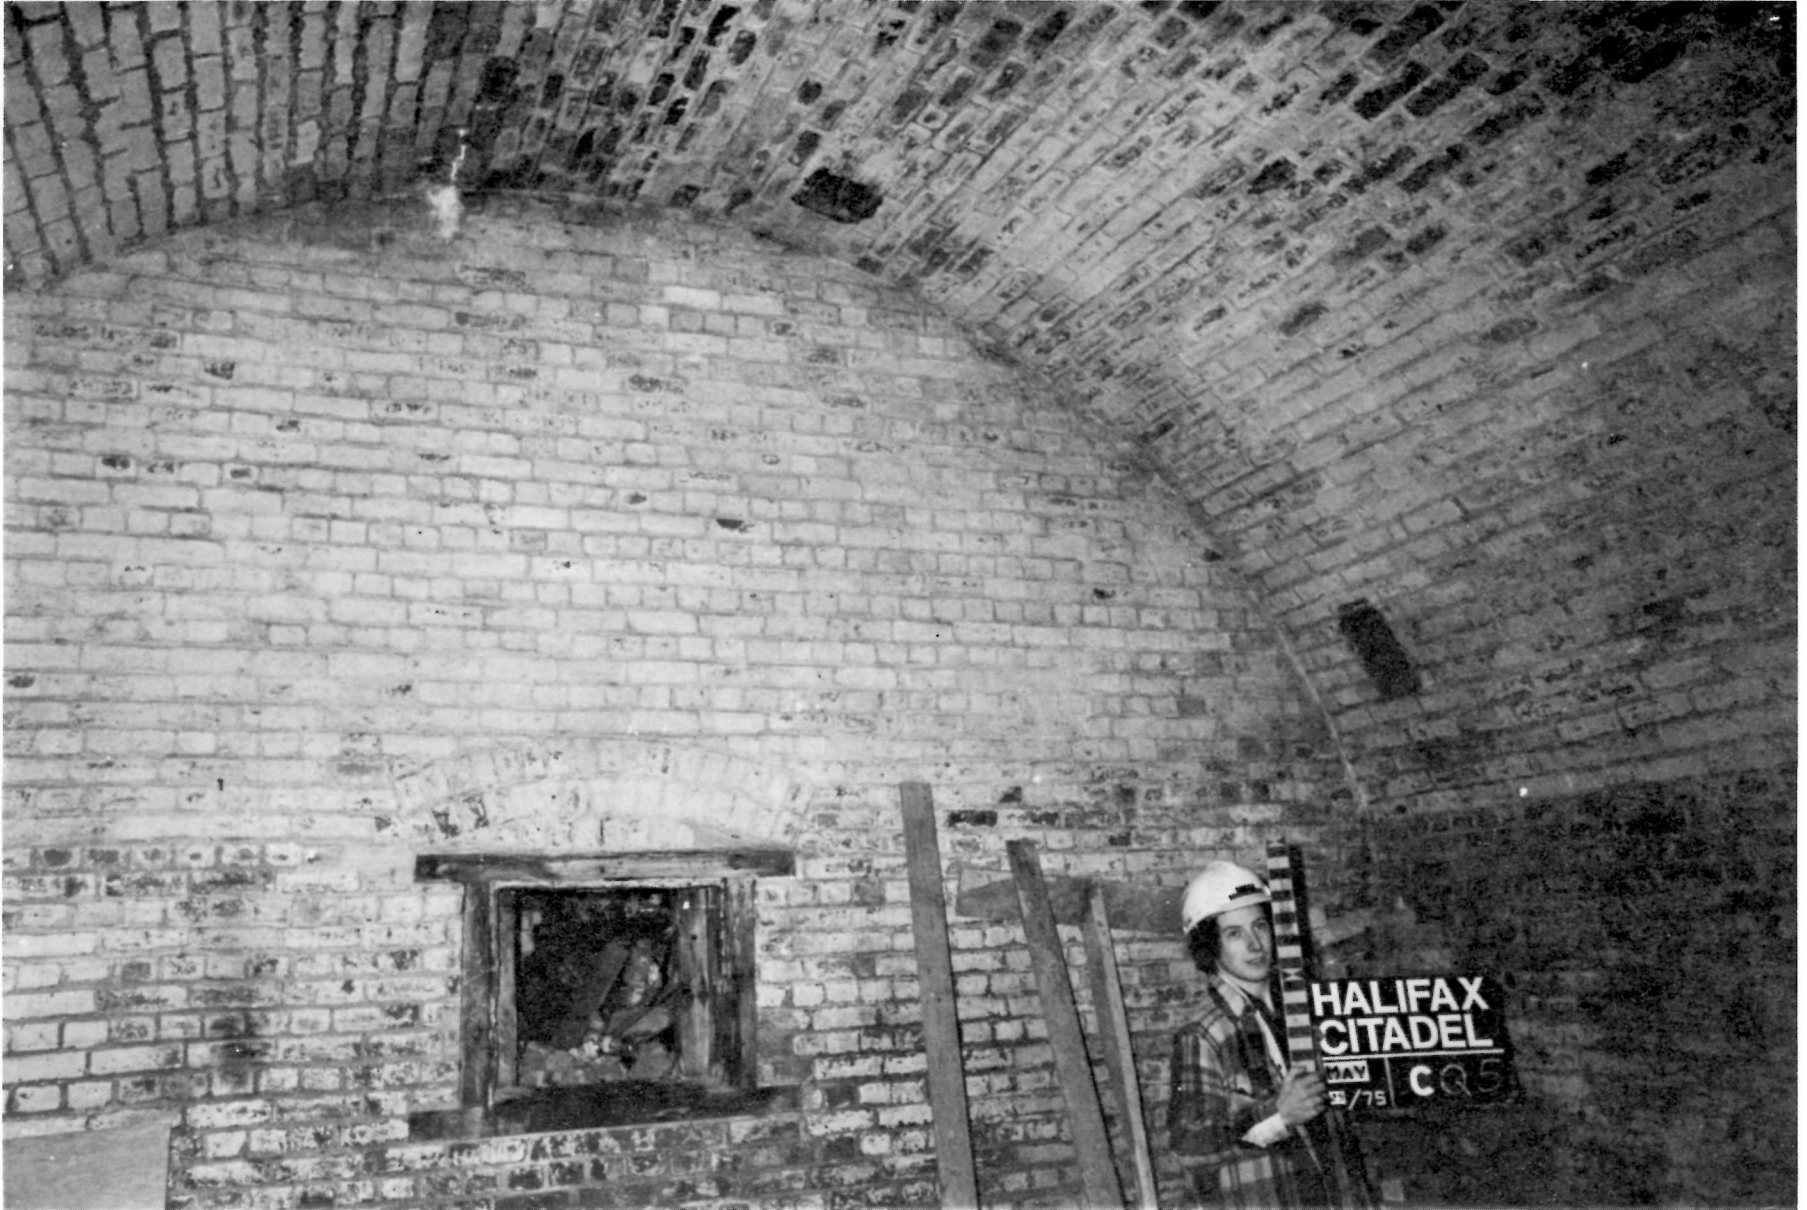
- 39 Photo of the east partition wall, cartridge store No. 1, C-53. This photo illustrates the size and location of the lamp recess in the partition wall. Note the wooden frame around the opening. When illumination was needed in the casemate, a reflector lantern was placed in this recess. The cartridge store side of the opening would have been covered with glass. Steps in the ceiling held racks for storage of the cartridges. (Project Office, Halifax Defence Complex, as found photo record, casemate 53.)

East Wall: (lamp passage partition wall) There was one opening in this wall, providing a lamp recess for the illumination of the casemate. It measured two feet six inches square on the cartridge store side, and narrowed to two feet square on the lamp passage side. Wooden frames held glass windows on each side. No details of the lamps or the glass are available. (See figure 41)
