Manuscript Report Number

349

Excavations, Halifax Citadel 1979 by John J. Connolly

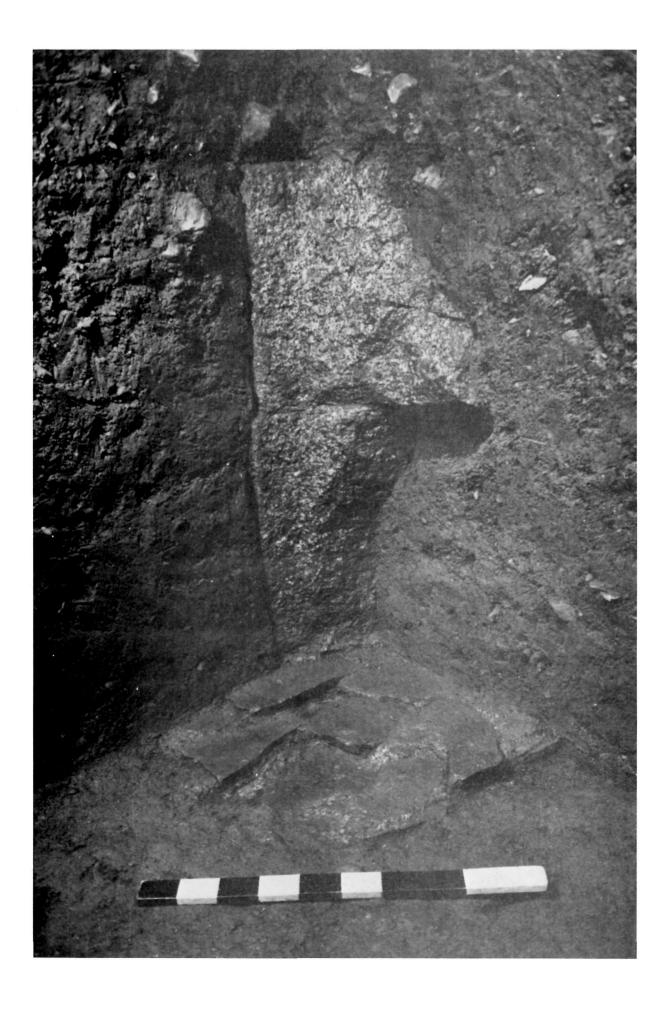
3 Corner of granite emplacement emerging from wall of pit 2B32Q. Note the extent of the foundation masonry extending past the granite segments. (Scale 0.50 m)

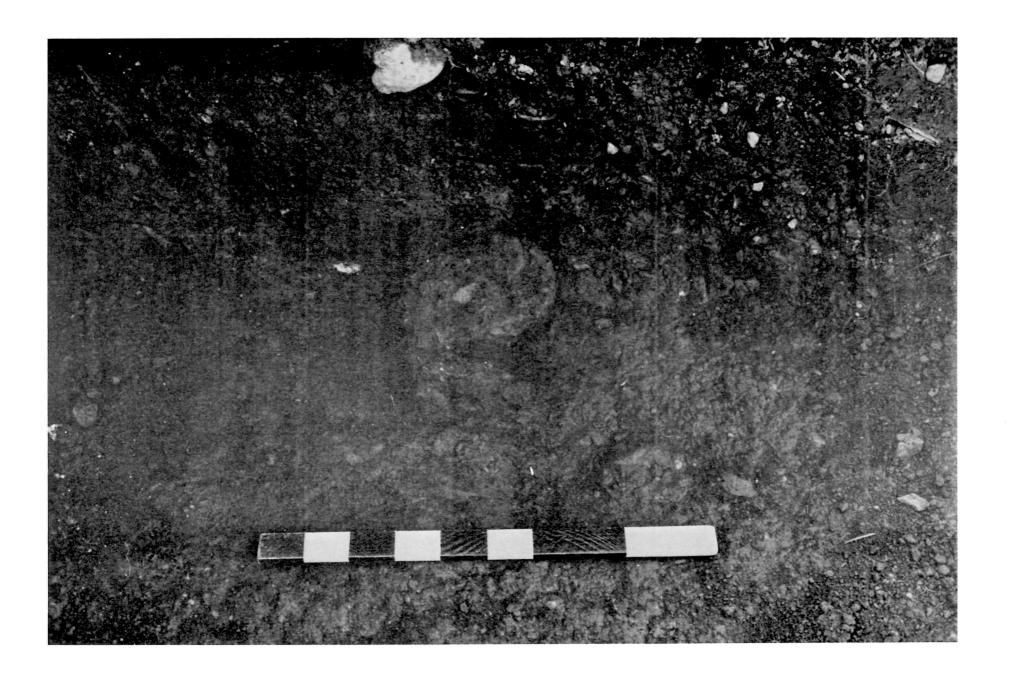
4 Emerging cast iron pivot in sub-operation 2B30F. (Scale 0.50 m)

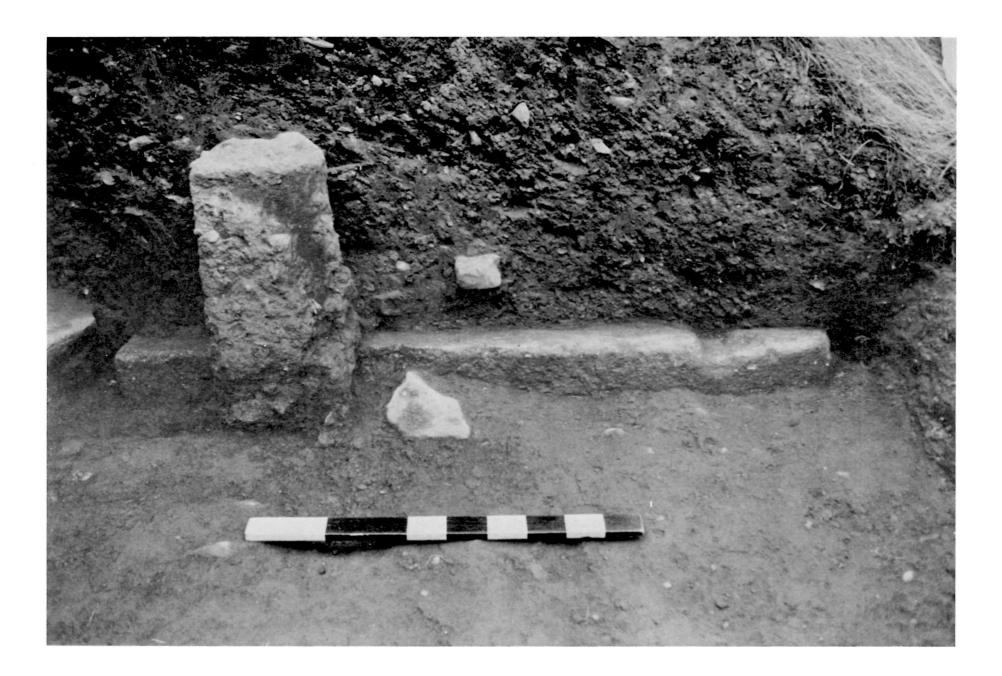
Pivot and granite in situ in sub-operation 2B30Q. One half of the granite has been removed during the dismantling of the emplacement. The groove on the right hand side of the granite is the slot for the cramp which held the two segments together. (Scale 0.50 m)

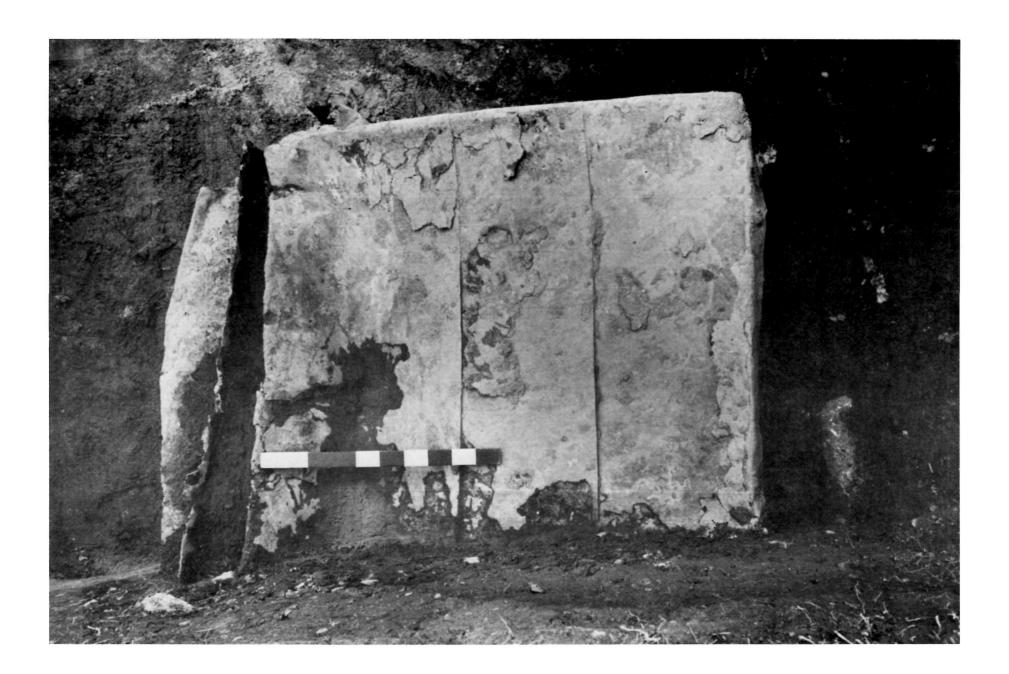
8 Partially excavated metal covered wooden box located on the right face of the northwest demi-bastion in sub-operation 2B32P. (Scale 0.50 m)

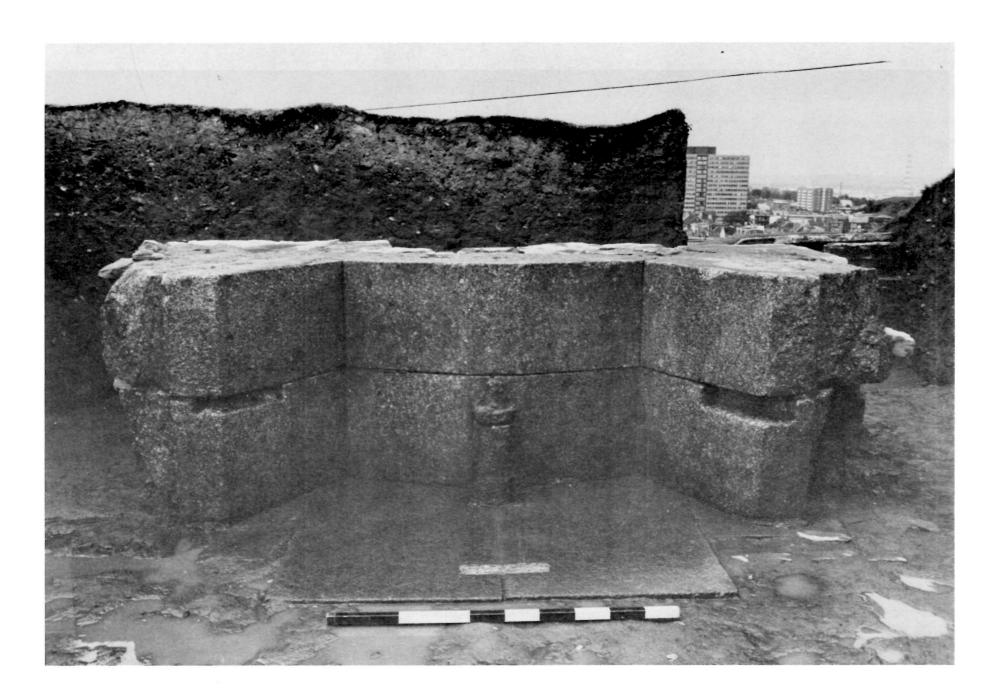
12 Front view of excavated 32-pound smoothbore emplacement on the right face of the northwest demi-bastion. Note the two slots cut into the two lower segments of granite, especially the incomplete slot on the left wing. (Scale 1.0 m)

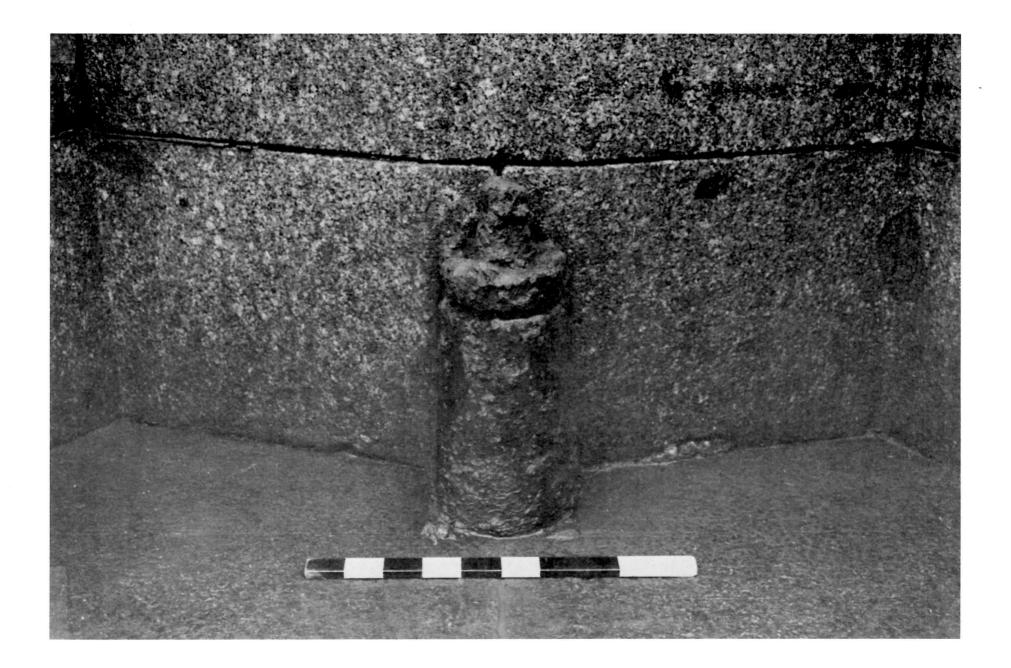
14 Cast iron pivot  $\underline{\text{in situ}}$  with forge welded wrought iron axis. Note the extremely narrow joints with mortar between the segments of the granite behind the pivot. (Scale 1.0 m)

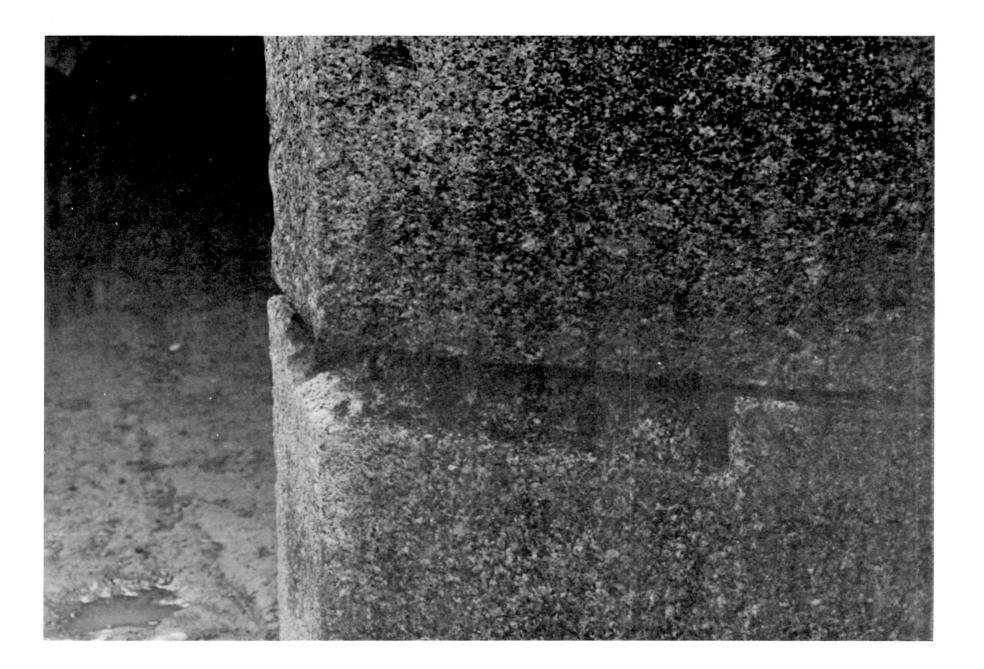
15 Close up of incomplete slot on the left wing of the genouiller of the complete emplacement. The addition of the slot after the emplacement was finished indicates that the platforms had been changed after the emplacement was built.

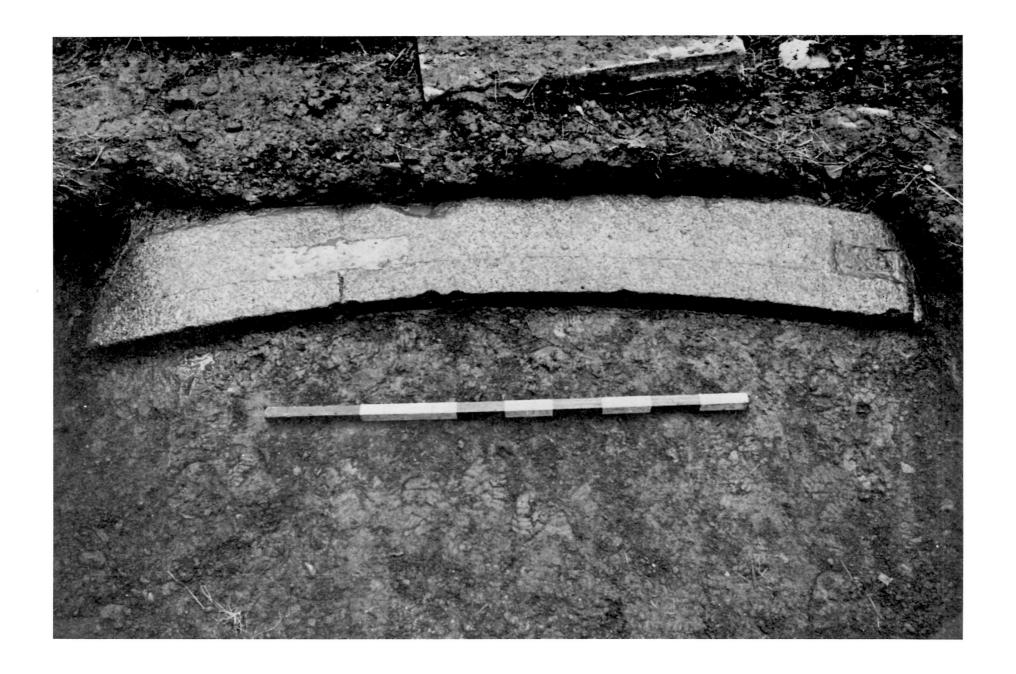
Granite racer from 32-pound emplacement on the northwest demi-bastion. Note the wear pattern on the granite indicating the gun platforms must have been moved frequently to prevent settling of the racer or rusting of the trucks. (Scale 1.0 m)

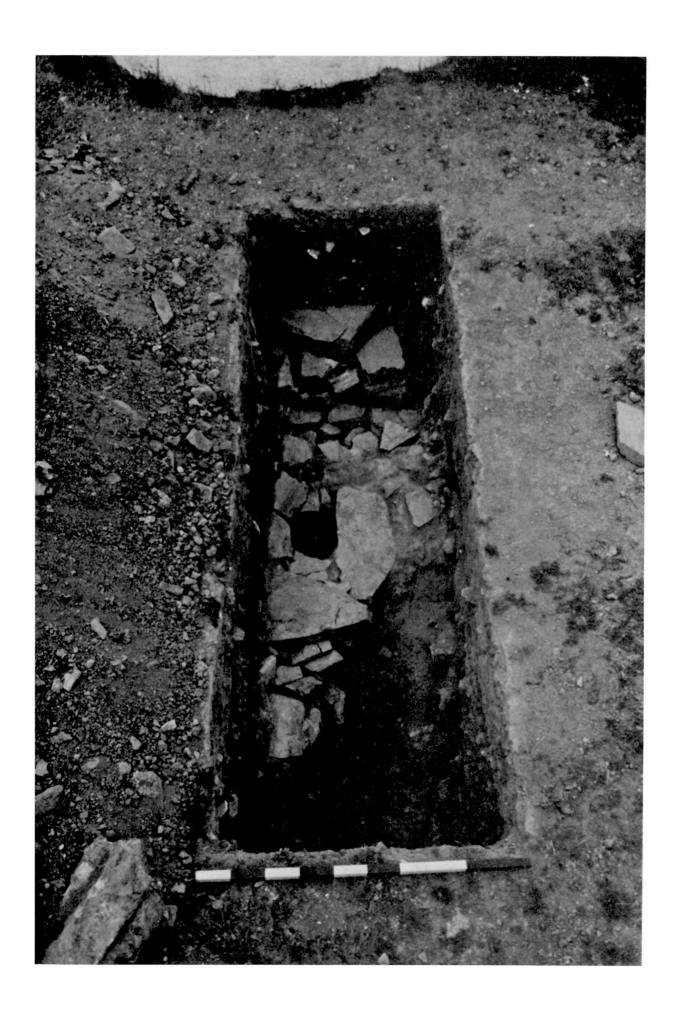
Overview of sub-operation 2B23T on right face of the southeast salient which exposed the foundation for the smoothbore emplacement and its pivot location.

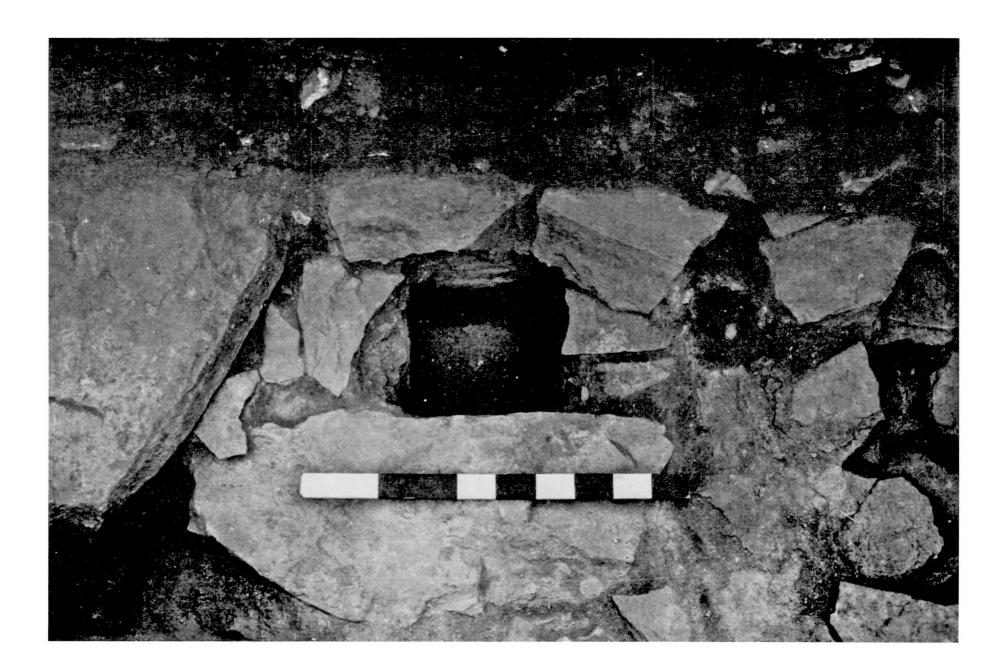
25 Pivot hole of 32-pound smoothbore emplacement on the right face of the southeast salient. This is the foundation of the emplacement with the covering granite removed. (Scale 0.50 m)

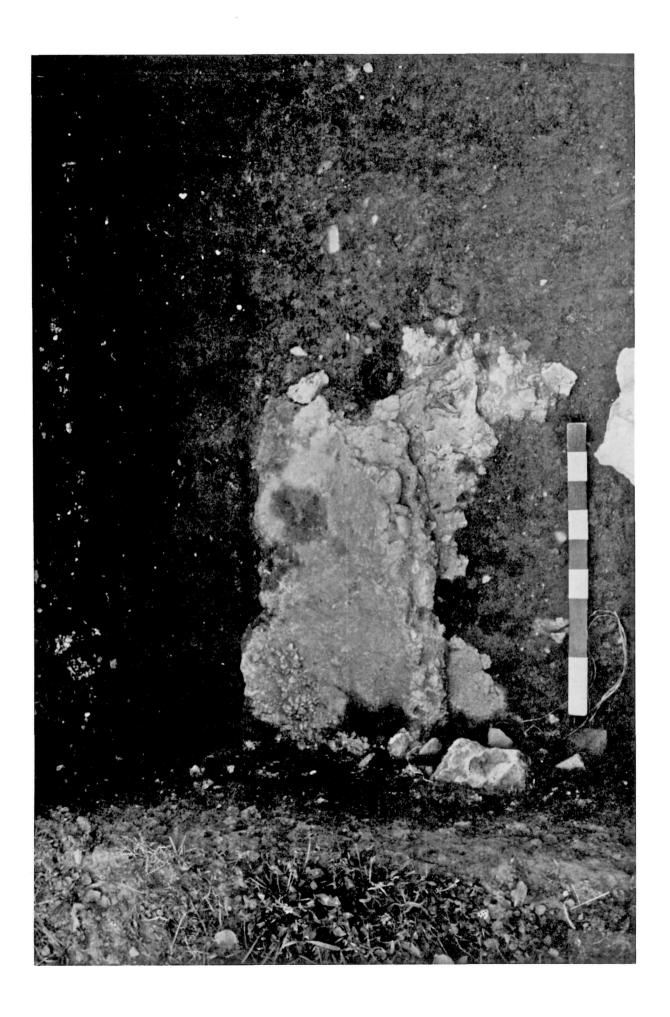
26 Fragment of cement for sleeper of signal station on the southeast salient in sub-operation 2B23S. (Scale 0.50 m)

Archaeological excavations were designed to locate traces of the earlier signal station foundation and to verify its The excavations were the continuation of a configuration. series of pits in the last field season placed to accomplish the same goals but without results. The pits were located between the present powder magazine and noonday gun shed situated on the right face of the southeast salient. The position of the pits corresponded to the south walls of the two signal stations. only evidence recovered to indicate the presence of a foundation was a section of cement parging 7.1 meters north of the escarp wall which may have been used for a base for a sleeper (Figure The cement was of an irregular shape with a maximum length of 0.82 meters and a maximum width of 0.78 meters. A raised portion of the cement suggested that the sleeper was bedded into the cement and the building constructed on this arrangement. The raised portion of the cement has a maximum width of 0.22 meters (8.7") suggesting a sleeper width of 0.203 (8"). cement was truncated and not in any definable stratum of soil. The lack of seriated evidence negates any possible way of determining the cement's period of use.

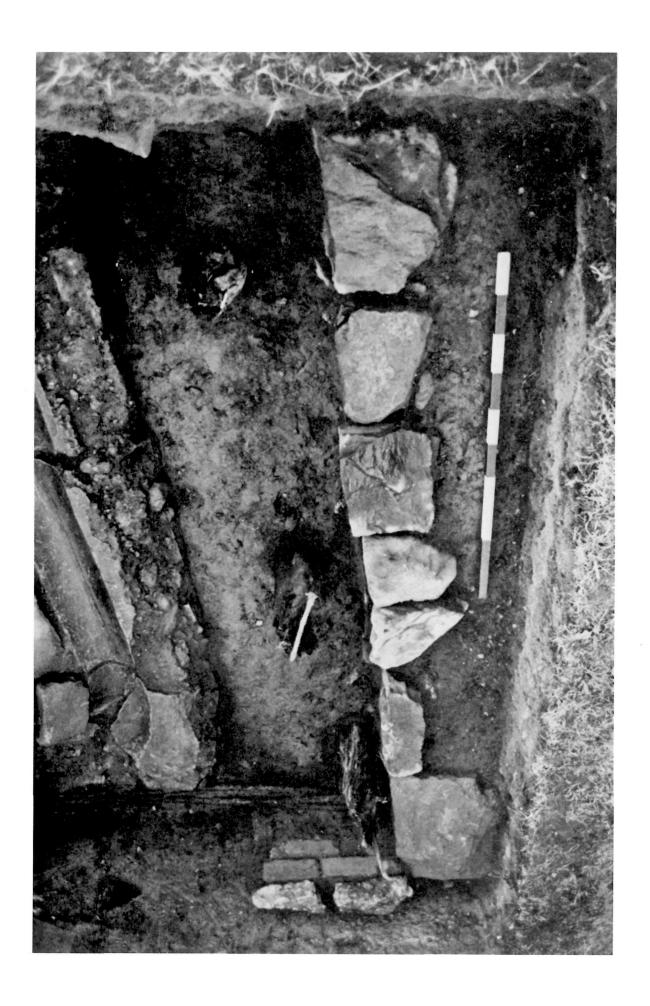
27 Foundation of the building associated with the storm signal mast. This excavation (2B23N) completed in the last field season did not fully provide the dimensions of the structure. (Scale 1.0 m)

- 5. The final objective of the excavations was to complete the work around the southeast salient to determine the configuration of the buildings surrounding the storm signal mast and the location of the foundation of the British signal station. Excavations accomplished in this location in the previous field season did not fully determine the relationship of the features and the signal mast.

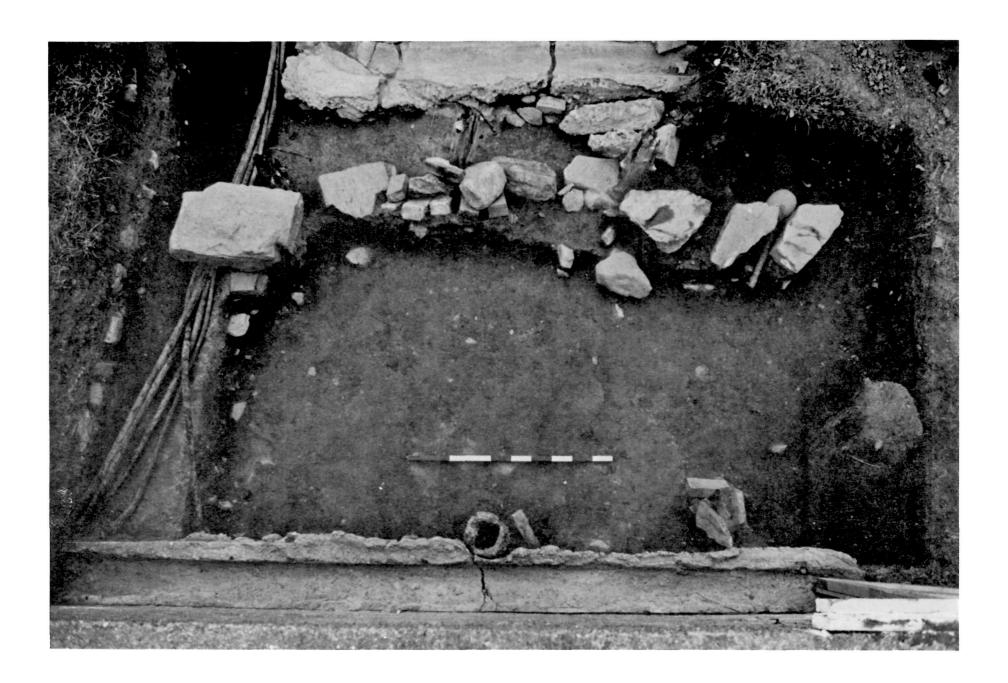
Overview of sub-operation (2B23P) excavated this field season to determine the entire limits of the building associated with the storm signal mast. The stump of the mast was uncovered but its relationship to the building was not fully documented.

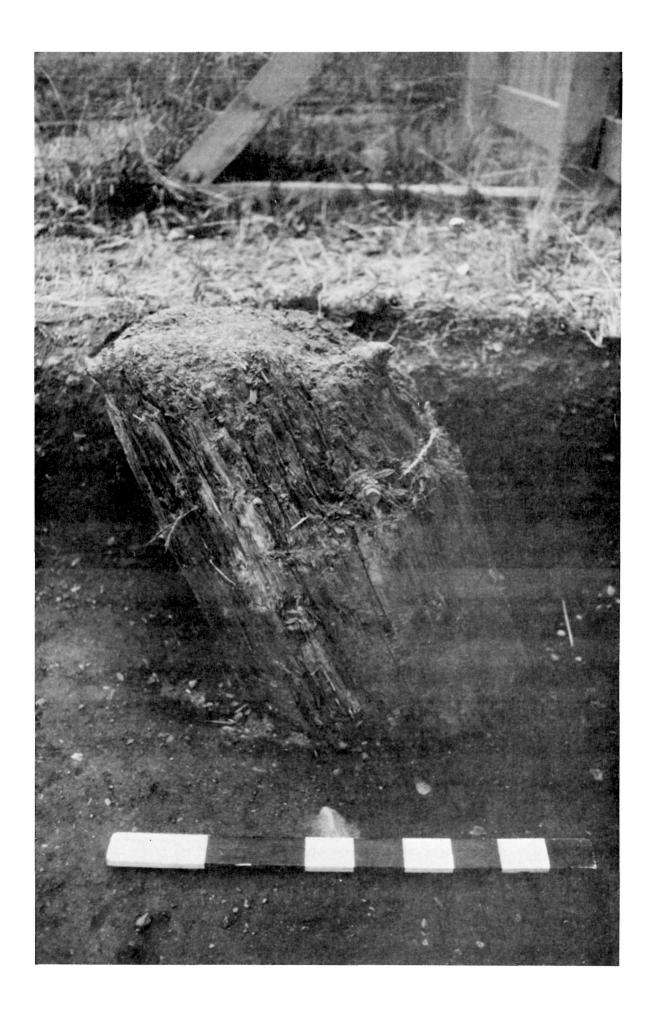
29 Close up of the stump of the storm signal mast in suboperation 2B23P. (Scale 0.50 m)
